# ***Tommie Lim Appraisal***

## **VEHICLE INSPECTION REPORT**

Ref. no.	: TLA/2024/04/049	3rd party Veh.	: QX2509J
Accident on	: 12 Mar 2024	Claim tyre	: Third Party
Assign on	: 24 Apr 2024	Claim number	: To be advice
Inspection on	: 24 Apr 2024	Policy number	: To be advice
Workshop name	: SERVE YOU MOTOR PTE LTD	Finalize on	: 24 Jun 2024
Inspection at	: Block 5033 Ang Mo Kio Industrial P	Final report on	: 24 Jun 2024
	#01-265 Ang Mo Kio Industrial Park 2		
	Singapore 569536

Vehicle number	: PC7454Y	Registration date	: 20 Jul 2004
Make	: MITSUBISHI	Chassis number	: RM117NB20278
Model	: RM117NSRDEB	Engine number	: 6D16962006
Body colour	: WHITE	Engine capacity	: 7545 CC
Odometer	: 36293 KM	Transmission	: MANUAL

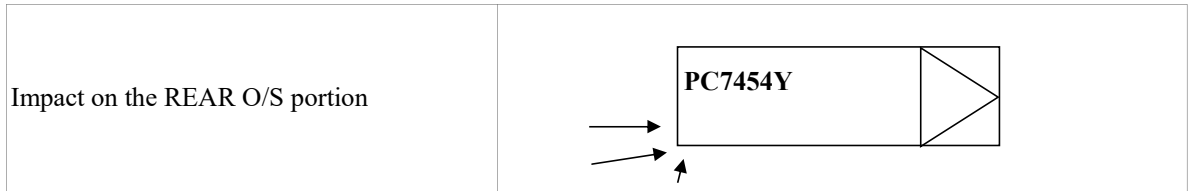
## POINT OF IMPACT

The impact of the collision has damaged/affected the rear bumper centre, rear bumper side, rear o/s taillamp, rear compartment door and etc...
