Vehicle No. SMB 5890A
Insured Veh. SKZ 2740S
Claim No. SNM24D203618
Policy No. DMPCSNW00002992407
Accident Date 21/06/2024
Inspection Date 16/08/2024

LKK Auto Consultants Pte Ltd

ADJUSTMENT ON REPAIR COST FOR VEHICLE NO SMB 5890A

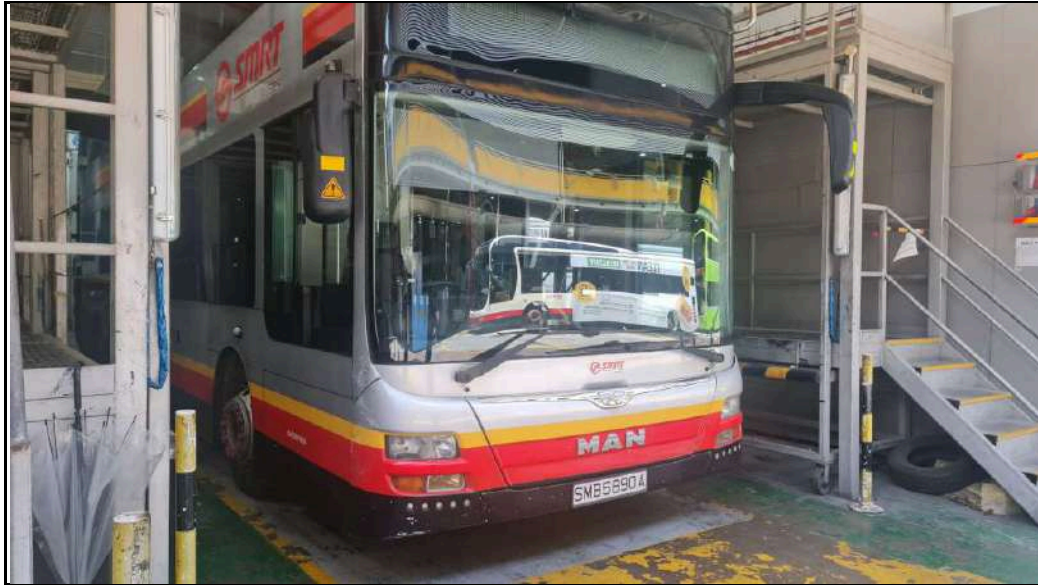
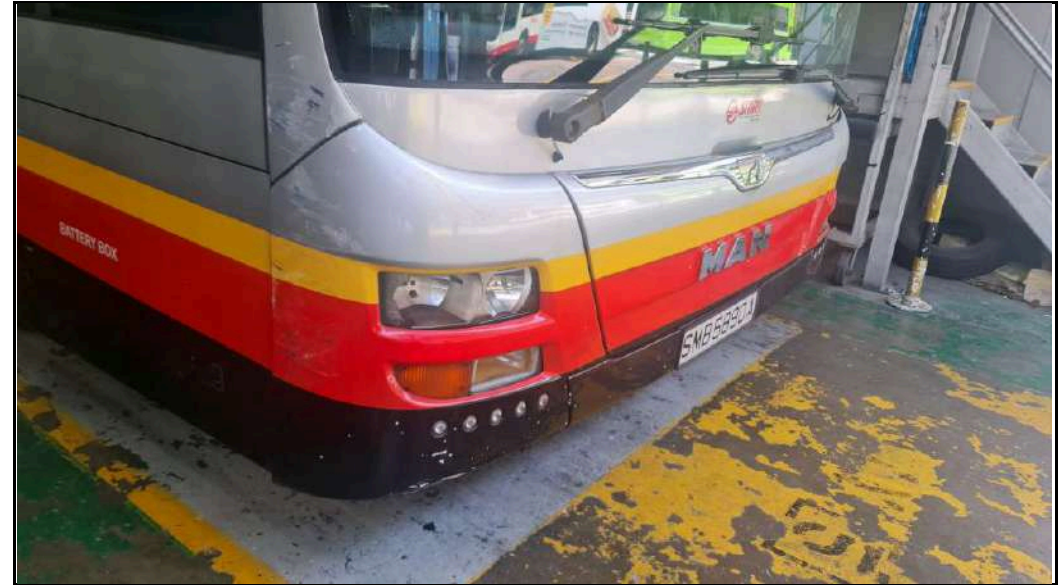
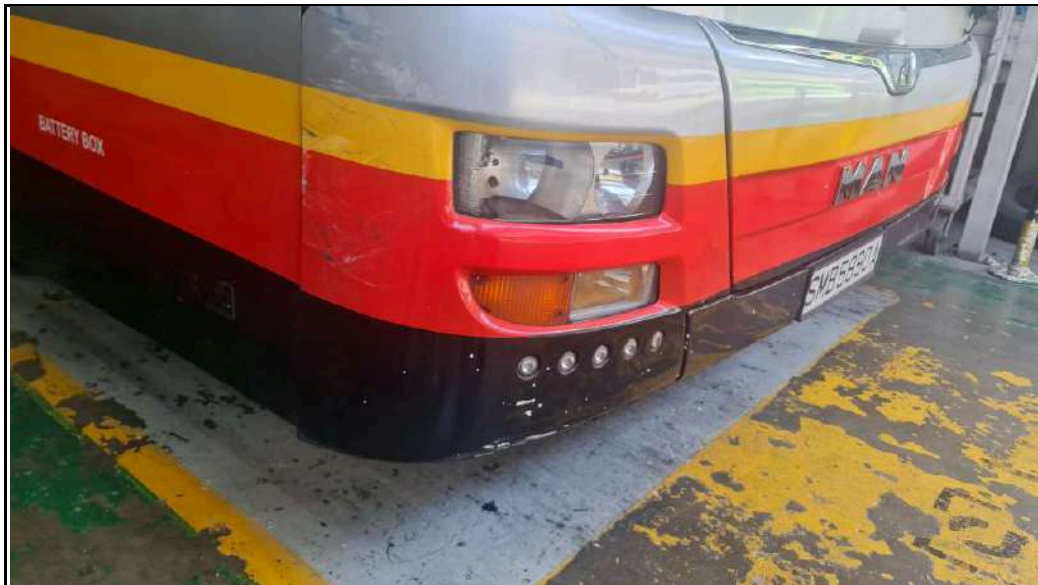
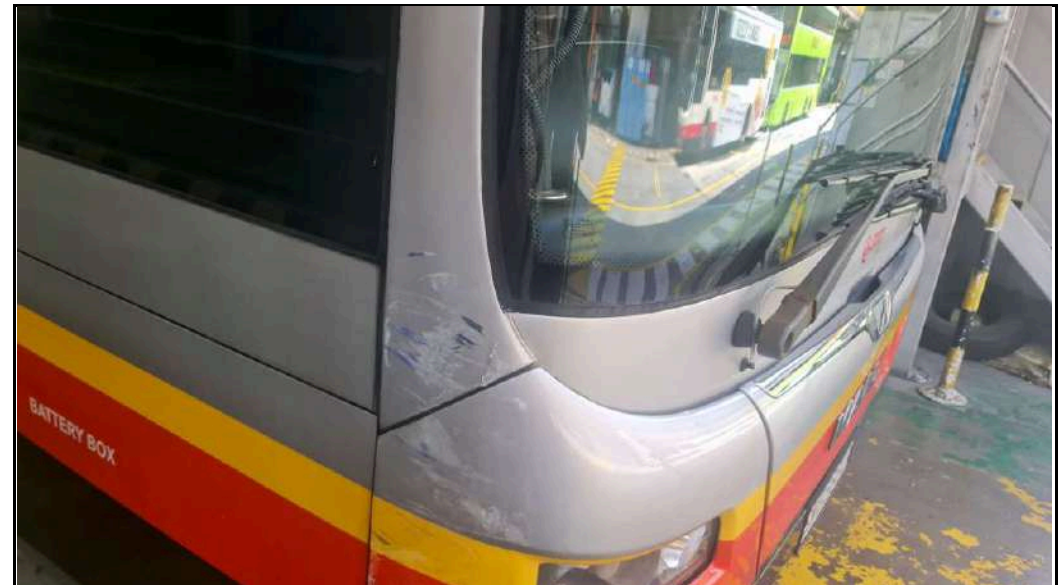
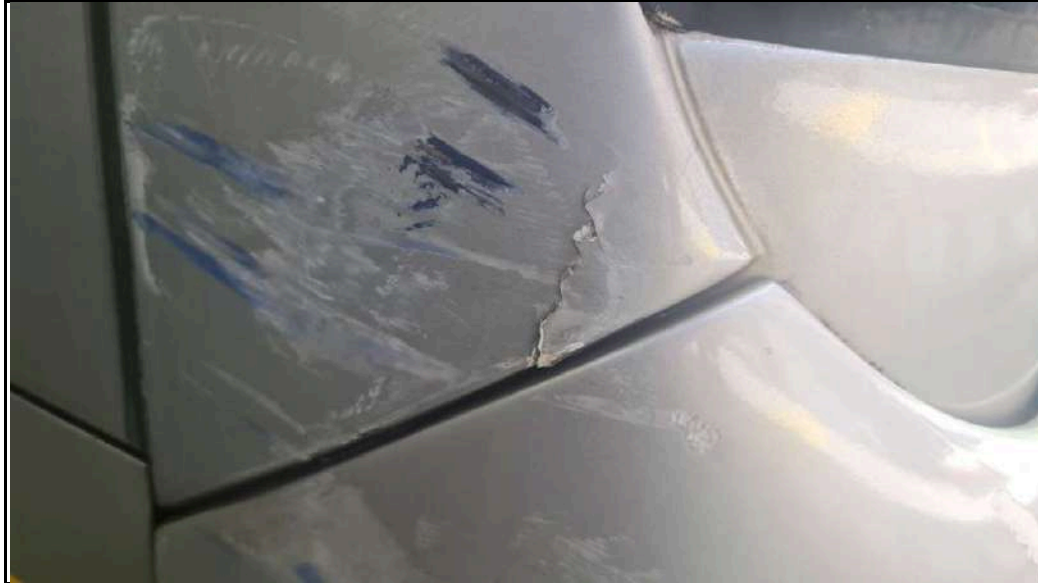
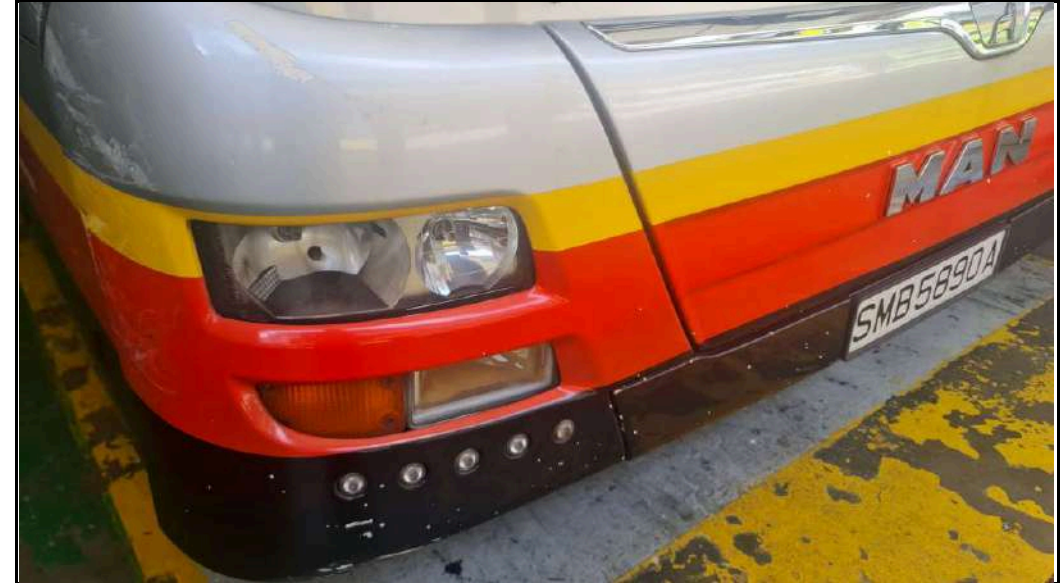
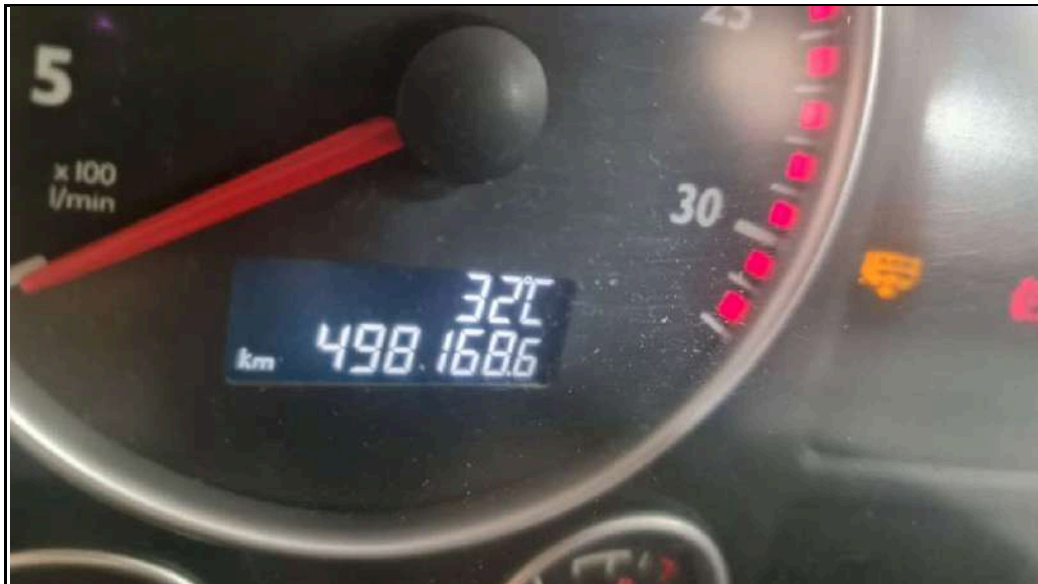
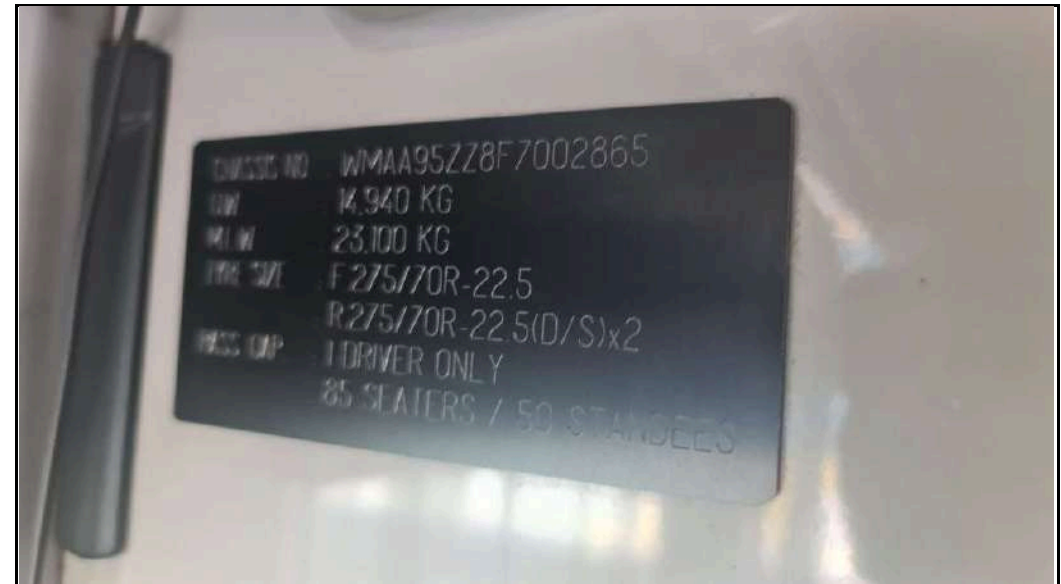
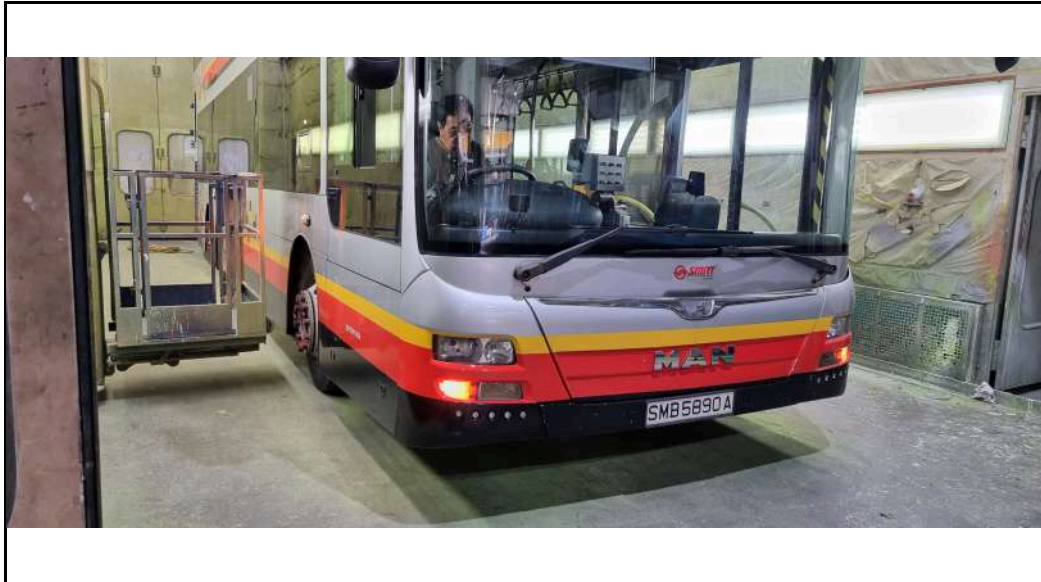
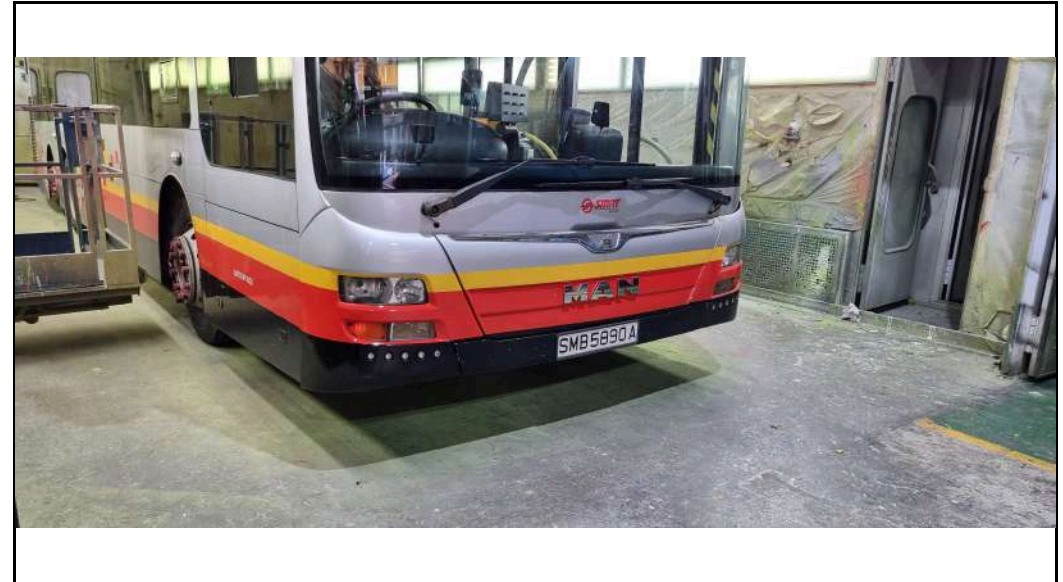
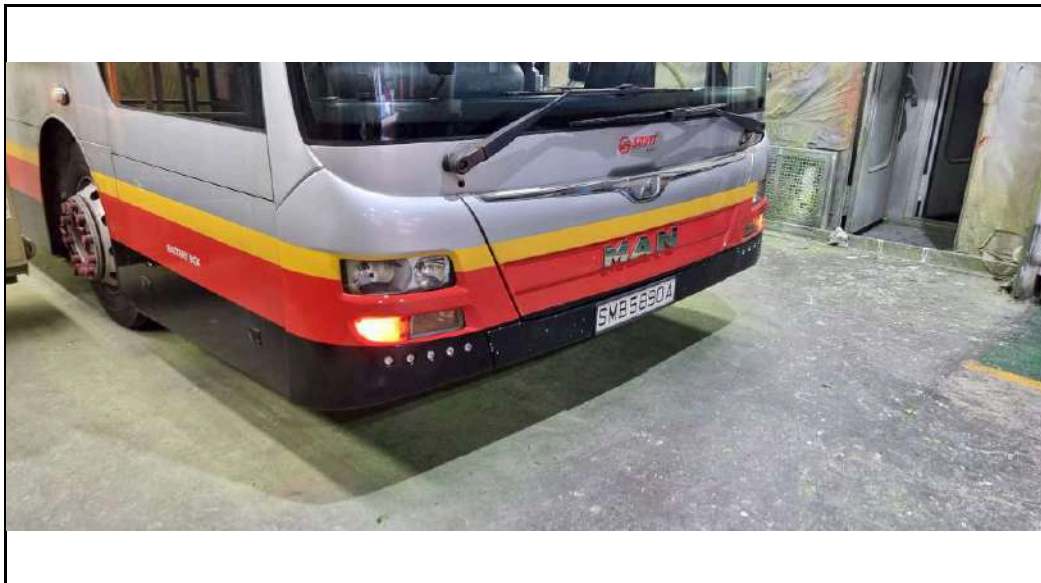
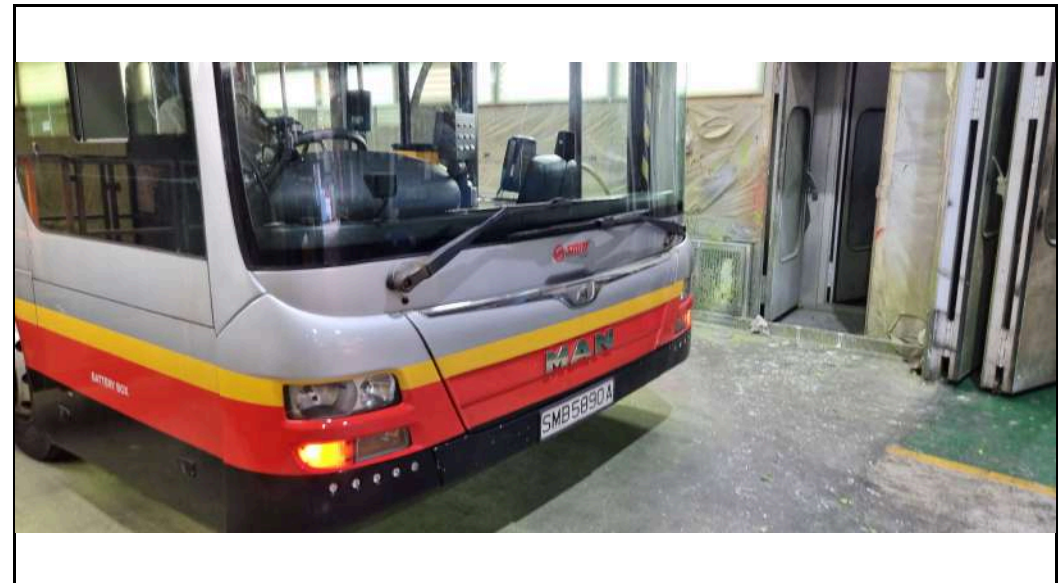
PHOTOGRAPHS FOR VEHICLE NO. : SMB 5890A

THE VEHICLE SUSTAINED DAMAGES AT THE O/S FRONT PORTION.

Labour				
	Description of Parts	Condition	Workshop Estimate (\$)	Our Adjusted (\$)
	TO REPAIR RH PORTION. INCLUSIVE OF THE REPAIR OF BUMPER CORNER R/H FOR ADL E500 DD BUS AND DOEM FRONT PANEL FOR ADL E500 DD BUS.		\$1,060.00	\$530.00
	PROVIDE LABOUR AND MATERIAL TO PUTTY AND RESPRAY ABOVE REPAIR ITEMS		\$878.00	\$708.00
			\$1,938.00	\$1,238.00
