Your Ref: SNM24D204642  
Our Ref: CS/CTI24080282/J

**M/s China Taiping Insurance (Singapore) Pte. Ltd.**

**TECHNICAL INVESTIGATION REPORT OF FIRE INCIDENT INVOLVING THE  
INSURED VEHICLE SLA 3862L ON 16 AUGUST 2024**

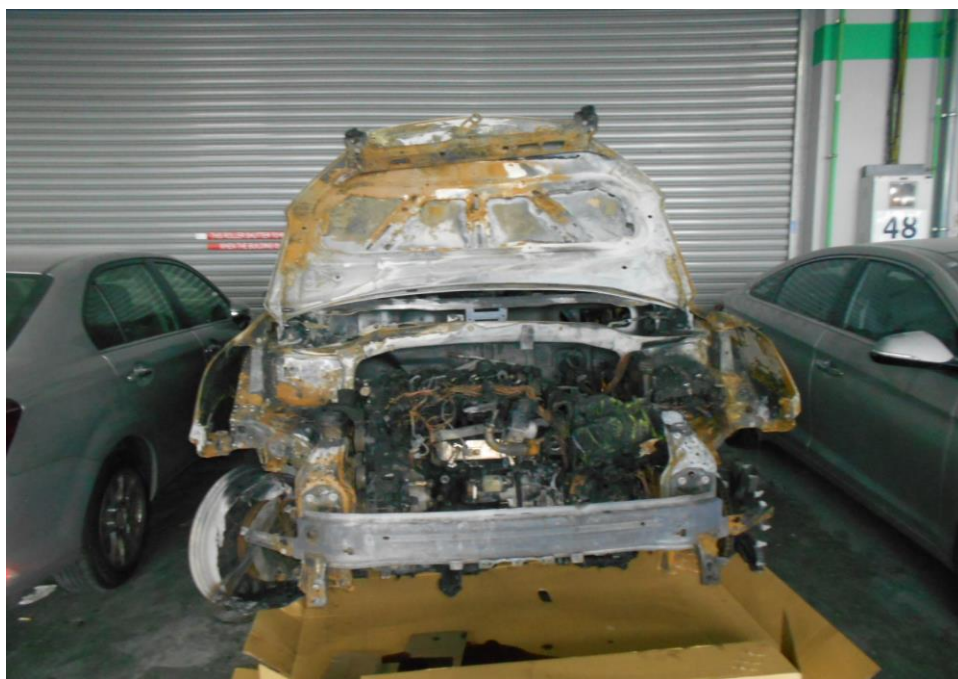
**Photo 1** shows the general view of the frontal portion of the Insured Vehicle at the time of our inspection. The Insured Vehicle was observed to have sustained extensive fire damage all around. Its engine compartment and interior compartment were completely burnt. Rust had accumulated all over the Insured Vehicle as a result of exposure to environmental condition for a period of time.

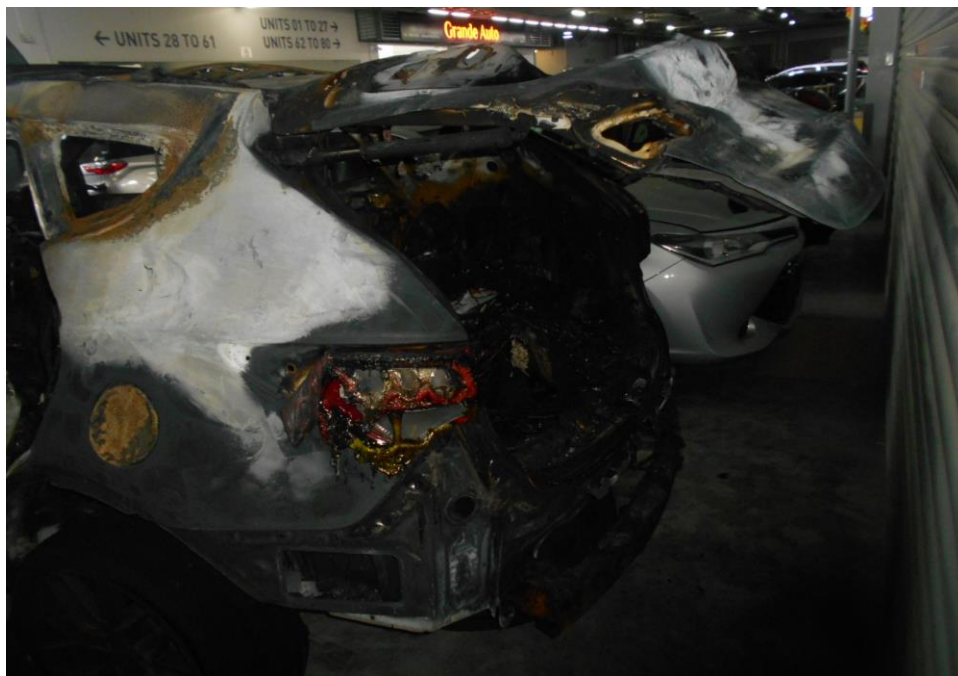
**Photo 2** shows the general view of the rear portion of the Insured Vehicle at the time of our inspection. The Insured Vehicle was observed to have sustained extensive fire damage all around. Its engine compartment and interior compartment were completely burnt. Rust had accumulated all over the Insured Vehicle as a result of exposure to environmental condition for a period of time.

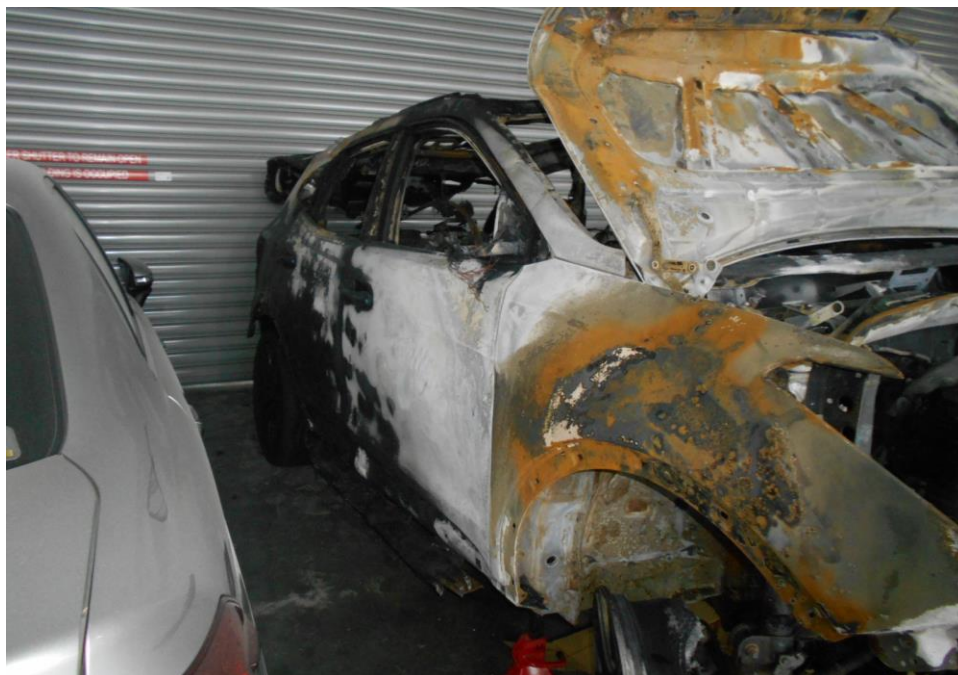
**Photo 3** shows the general view of the right body of the Insured Vehicle at the time of our inspection. The Insured Vehicle was observed to have sustained extensive fire damage all around. Its engine compartment and interior compartment were completely burnt. Rust had accumulated all over the Insured Vehicle as a result of exposure to environmental condition for a period of time.

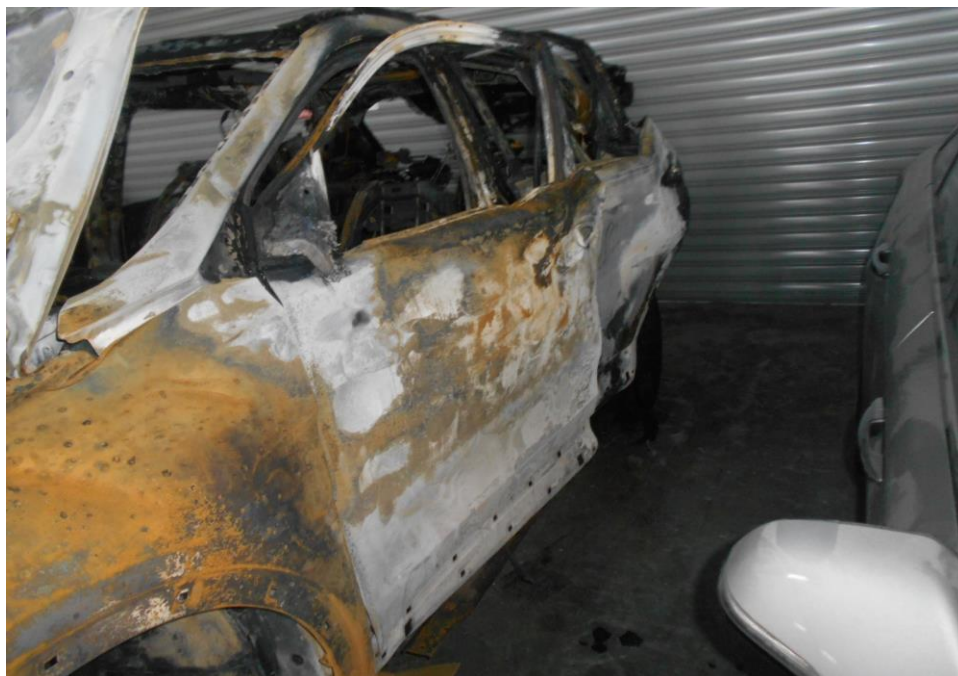
**Photo 4** shows the general view of the left body of the Insured Vehicle at the time of our inspection. The Insured Vehicle was observed to have sustained extensive fire damage all around. Rust had accumulated all over the Insured Vehicle as a result of exposure to environmental condition for a period of time.

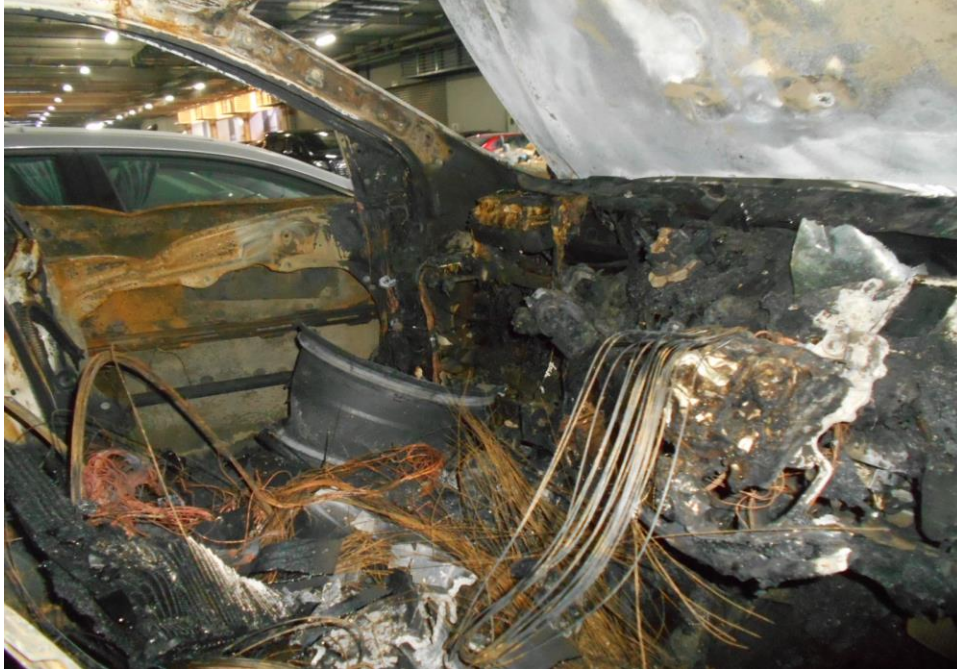
**Photo 5** shows the interior compartment of the Insured Vehicle, which was significantly affected by the fire.

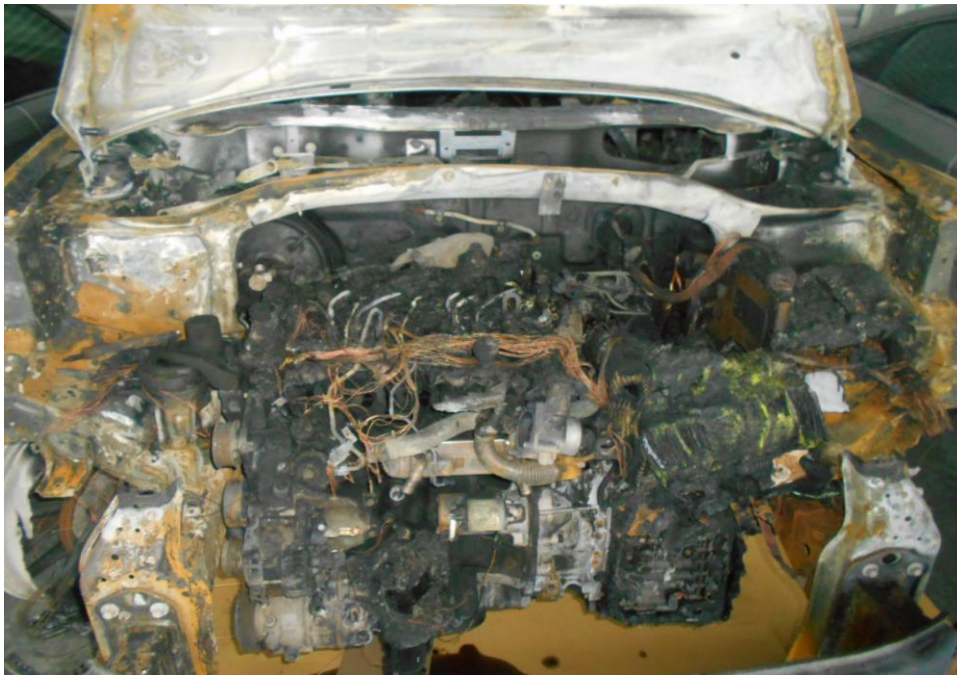
**Photo 6** shows a general view of the engine compartment of the Insured Vehicle at the time of our inspection. Most of the components inside the engine compartment were found to be severely burnt and/or melted as a result of the fire.

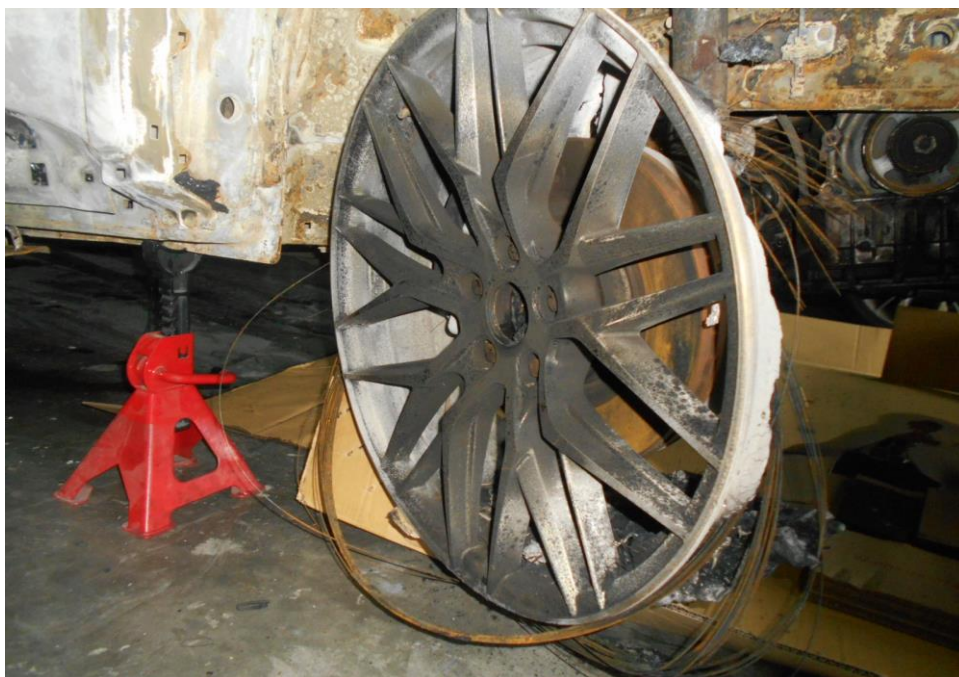
7. At the time of physical inspection of the Insured Vehicle, we had found aftermarket 20- inch alloy rims. All these fitted components were not the standard type for the Insured Vehicle. See photo 7 below.

**Photo 7** shows the non-standard rim found to be fitted on the Insured Vehicle at the time of our inspection. The 20- inch alloy rims fitted on the Insured Vehicle were not the standard type for the Insured Vehicle.

20. We found the Insured Vehicle to be fitted with 20- inch alloy rims. The tyre rims fitted do not require prior approval from LTA.
21. Although the aftermarket alloy rims fitted on the Insured Vehicle were not the standard type for the Insured Vehicle, we are of the view that these parts did not cause and/or contribute to the fire incident.

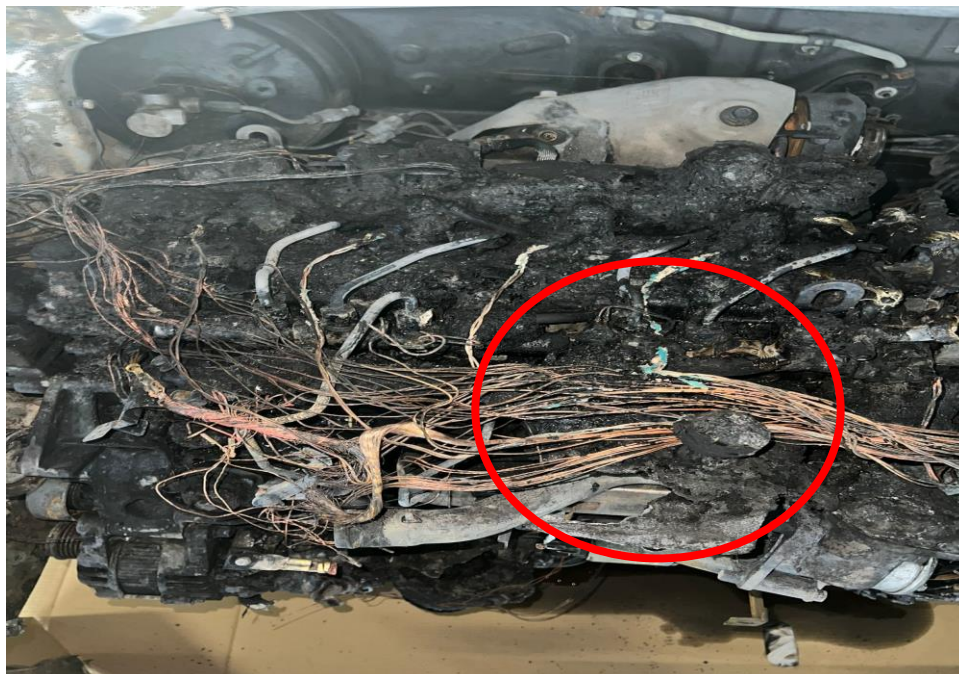
8. For this particular case, the fire appears to have originated within the engine compartment of the Insured Vehicle, somewhere around the front centre portion of the engine compartment. This can be determined from the greenish residue that was found on several stretches of burnt original factory fitted wirings mainly around the right rear portion of the engine compartment. The presence of greenish residue indicates internal heating of copper wires, a sign of an electrical short circuit occurring. The greenish residue is normally left behind from oxidation as a result of chemical reaction involving the copper wires. This physical evidence would appear to suggest that the cause of fire to the Insured Vehicle could have possibly been due to electrical in nature. See photos 8 - 10 below.

**Photo 8** shows the burnt wirings around the front centre portion of the engine compartment which is near to the vicinity where the fire to the Insured Vehicle had likely started (circled).

18. Having investigated and technically analysed the damages of burnt nature to the Insured Vehicle, we are of the view that the cause of fire to the Insured Vehicle was of electrical in nature. For this particular case, the fire had originated along the wirings inside the engine compartment, somewhere around the front centre portion of the engine compartment. The wirings were original factory fitted wirings of the Insured Vehicle.

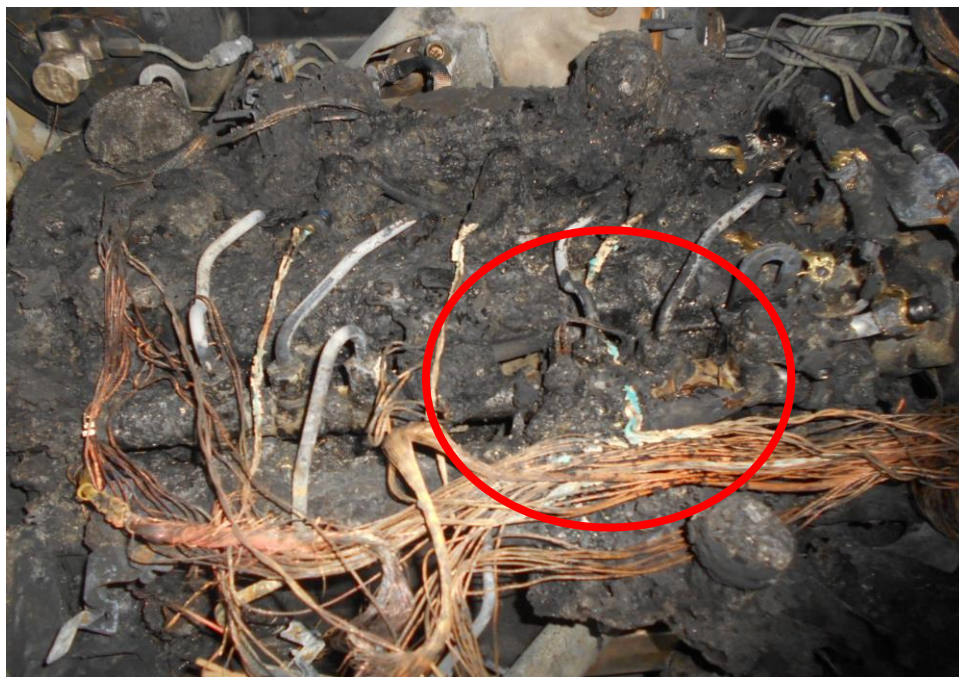
**Photo 9** shows a closer view of the wirings with greenish residue found around the front centre portion of the engine compartment of the Insured Vehicle (red arrows). The presence of such greenish residue suggests occurrence of an electrical short circuit.

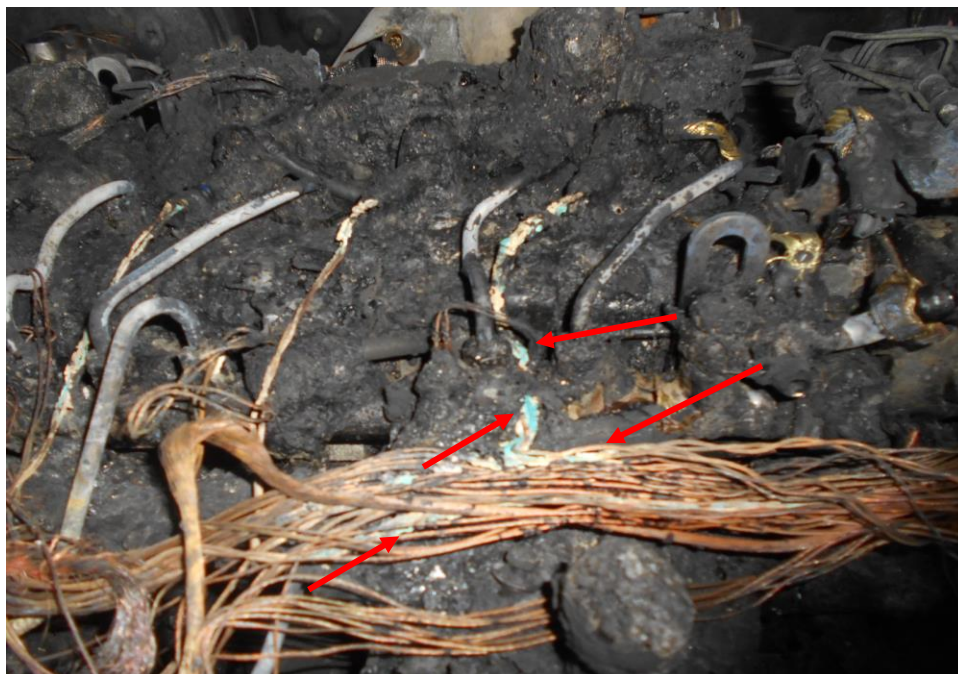
**Photo 10** shows a close up view of the wirings with greenish residue found around the front centre portion of the engine compartment of the Insured Vehicle (red arrow). The presence of such greenish residue suggests occurrence of an electrical short circuit.

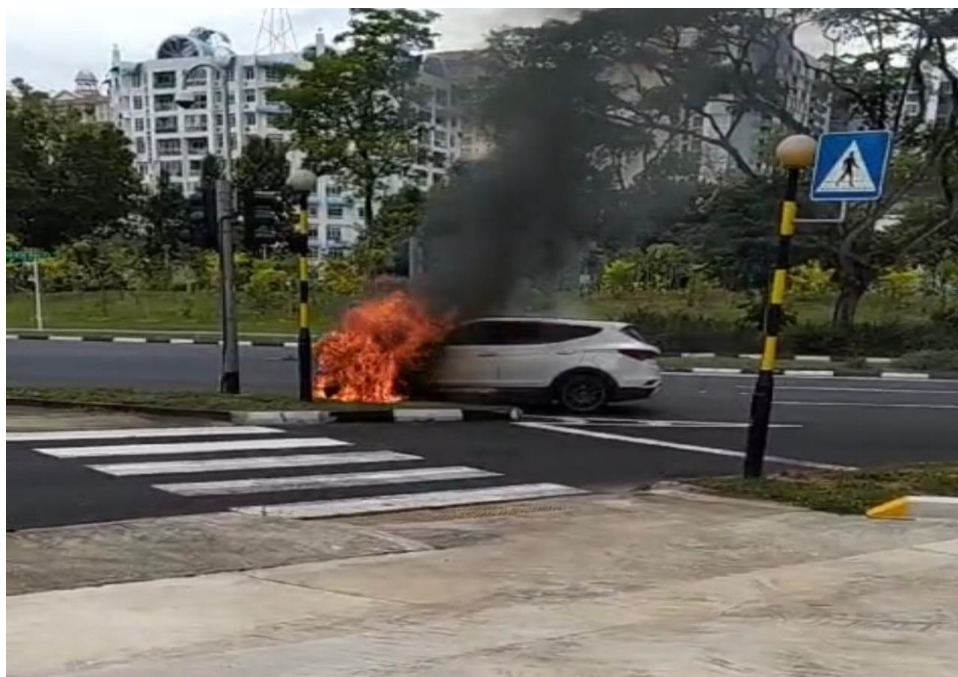
**Photo 11** shows the Insured Vehicle bursting into flames shortly before the arrival of the SCDF.

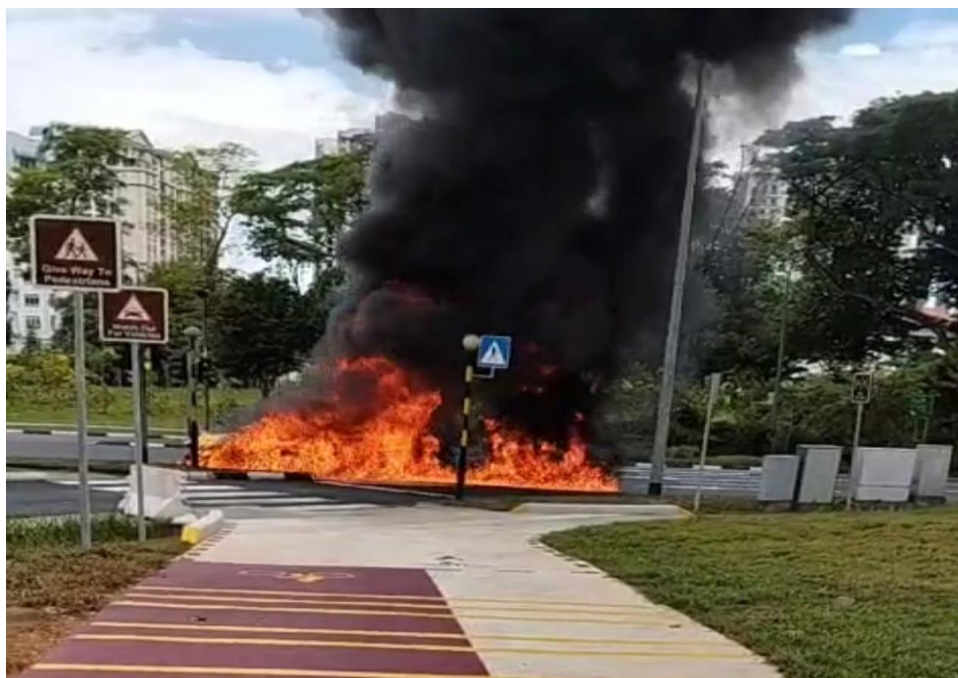
**Photo 12** shows the Insured Vehicle engulfed in flames shortly before the arrival of the SCDF.

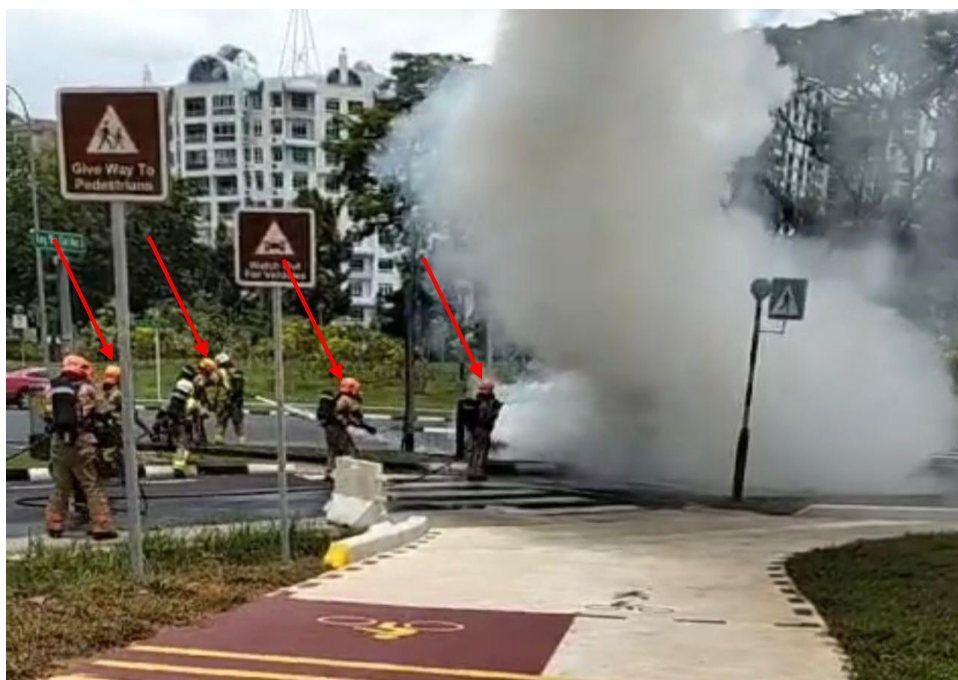
**Photo 13** shows the SCDF fire fighters (red arrows) extinguishing the fire to the Insured Vehicle.
