Your Ref: NM23D204743C01  
Our Ref : CS/CTI24080412/N

**TECHNICAL INVESTIGATION REPORT OF FIRE INCIDENT INVOLVING THE  
INSURED VEHICLE SLN 5752P ON 22 AUGUST 2024**

Vehicle Registration No.	: SLN 5752P
Make / Model	: MERCEDES BENZ E220D SE AUTO
Chassis No	: WDD2130042A185927
Year of Registration	: May 2017
Mileage	: N.A (battery melted)

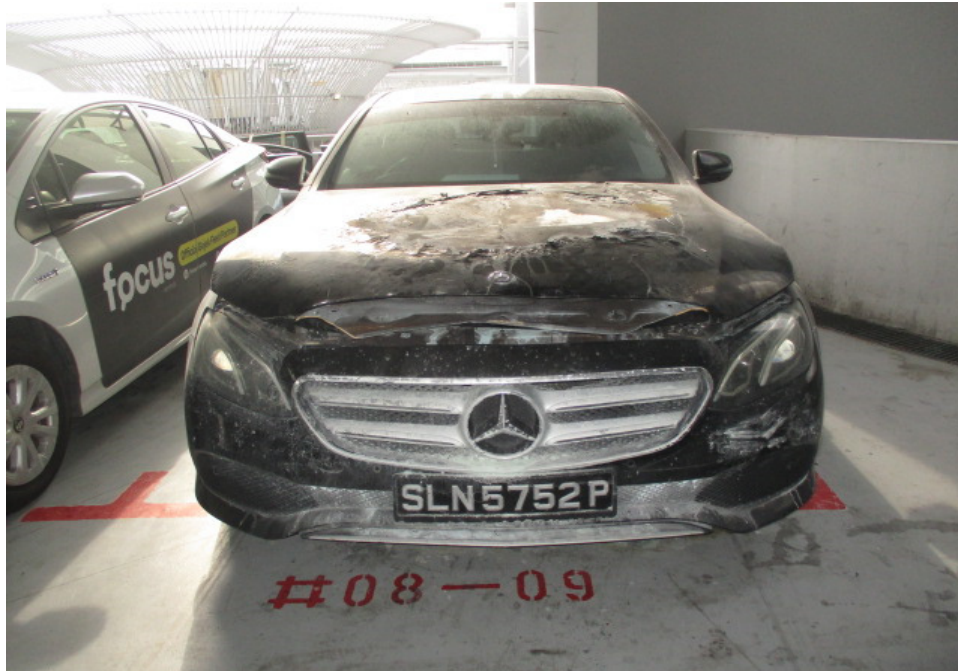
**Photo 1** shows the general view of the frontal portion of the Insured Vehicle at the time of our inspection. The exterior body of the Insured Vehicle had sustained visible fire damage. This included its front windscreen, front bonnet, front windscreen wiper garnish, front windscreen wipers and front fenders.

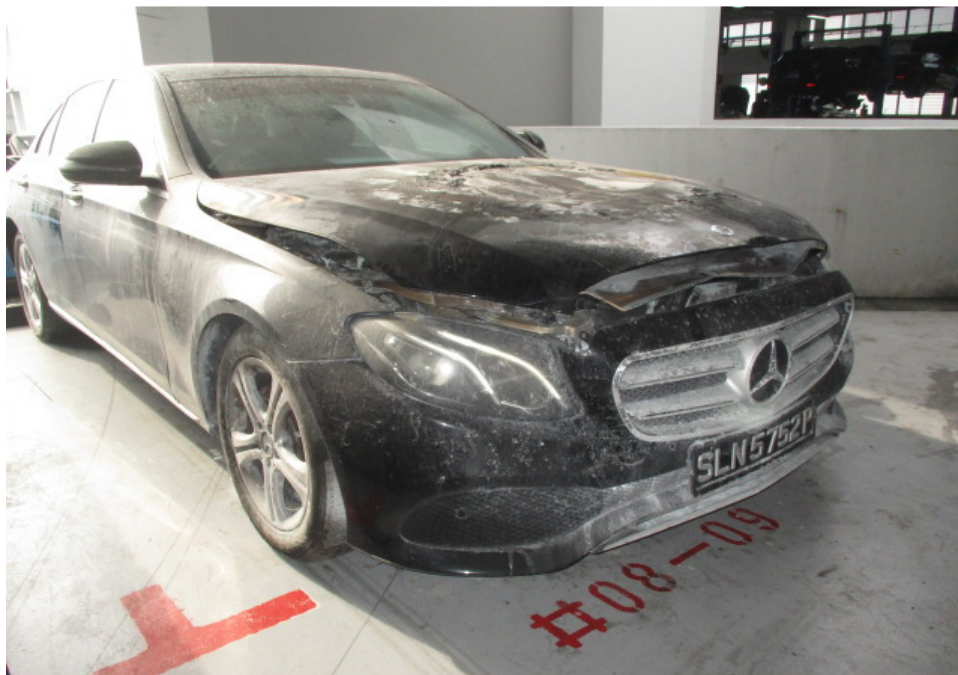
**Photo 2** shows the general view of the right frontal portion of the Insured Vehicle at the time of our inspection. The exterior body of the Insured Vehicle had sustained visible fire damage. This included its front windscreen, front bonnet, front windscreen wiper garnish, front windscreen wipers and right front fender.

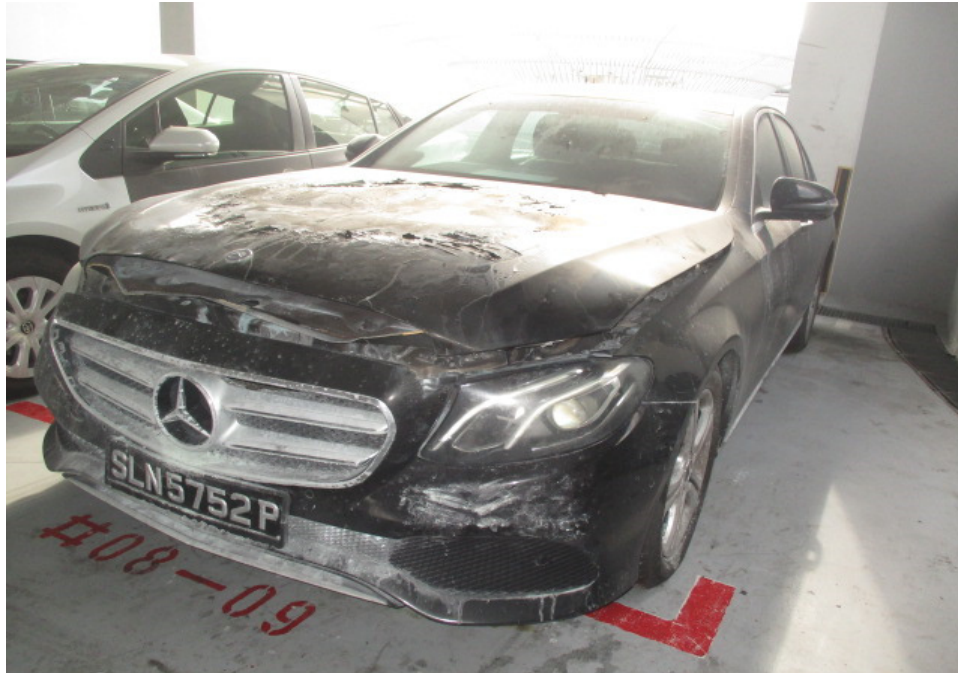
**Photo 3** shows the general view of the left portion of the Insured Vehicle at the time of our inspection. The exterior body of the Insured Vehicle had sustained visible fire damage. This included its front windscreen, front bonnet, front windscreen wiper garnish, front windscreen wipers and left front fender.

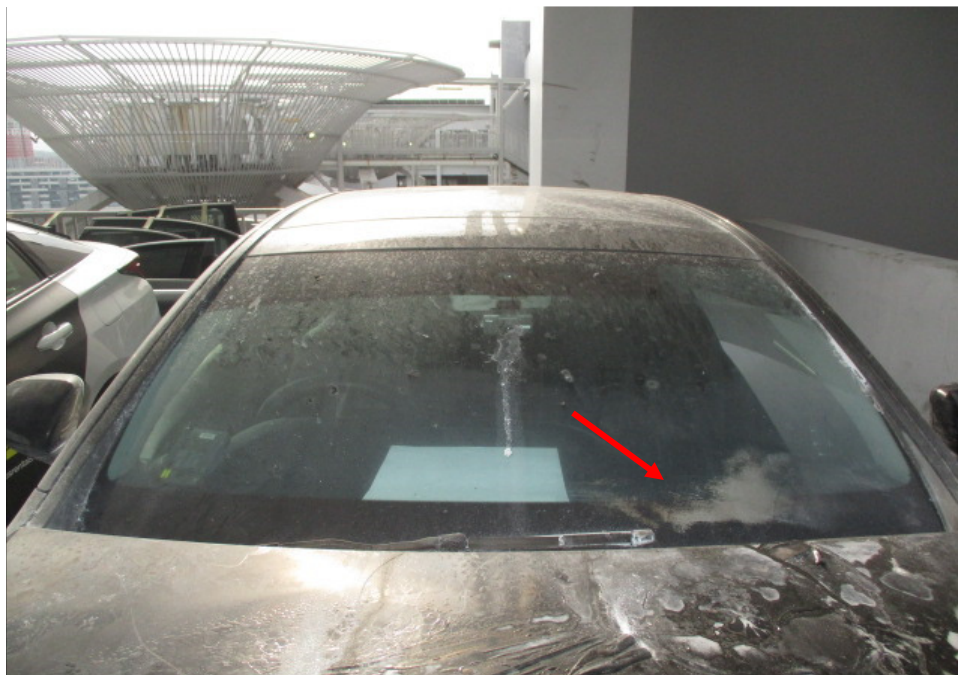
**Photo 4** shows a closer view of the front windscreen of the Insured Vehicle at the time of our inspection. The front windscreen had sustained slight fire damage (arrowed).

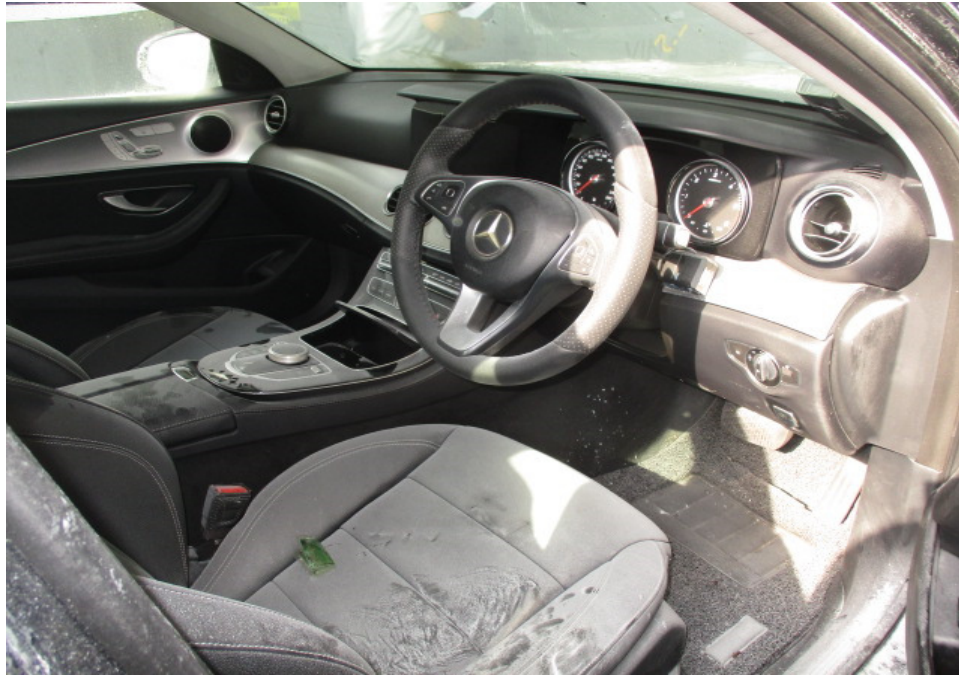
**Photo 5** shows the interior compartment of the Insured Vehicle at the time of our inspection. The interior compartment of the Insured Vehicle was observed to be relatively unaffected by the fire.

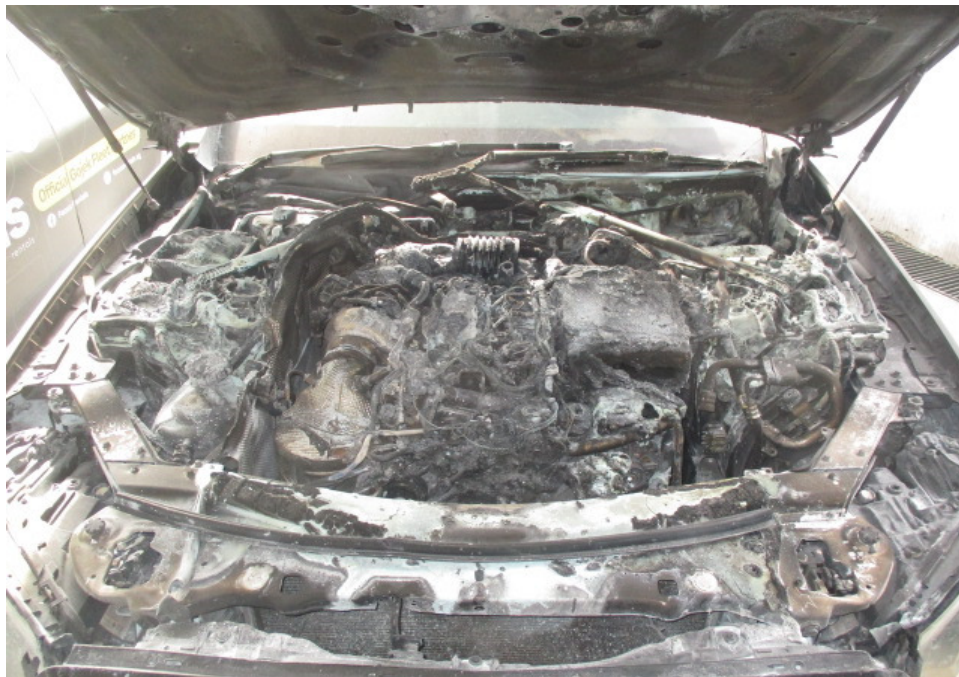
**Photo 6** shows a general view of the engine compartment of the Insured Vehicle at the time of our inspection. Most of the components inside the engine compartment were found to be severely burnt and/or melted as a result of the fire.

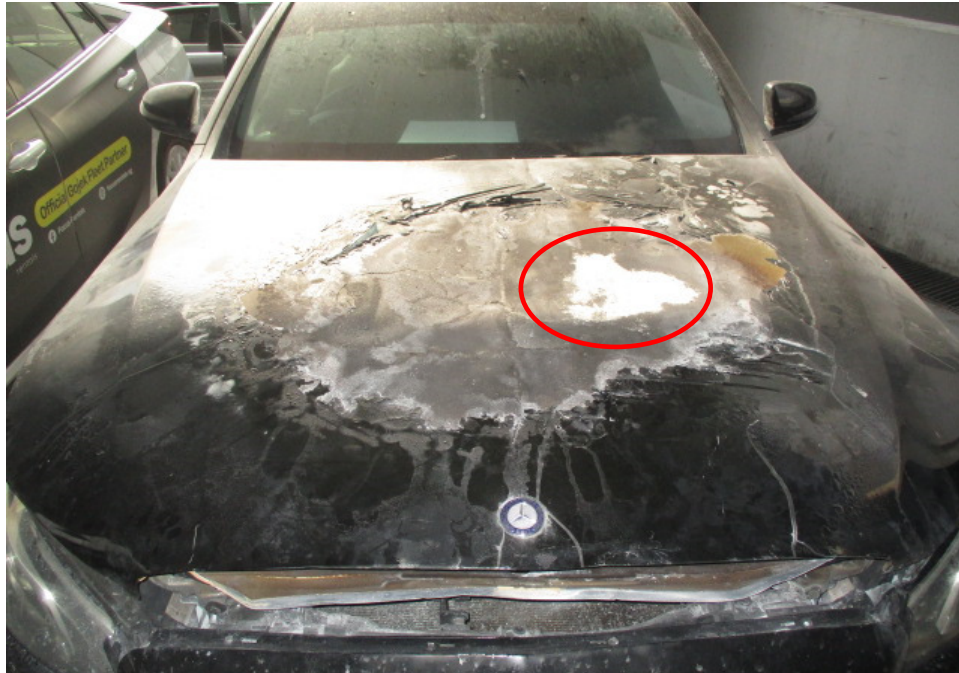
8. For this particular case, the fire appears to have originated within the engine compartment of the Insured Vehicle, somewhere around the centre portion of the engine compartment. This can be determined from the whitish burn marks on the centre portion of the front bonnet of the Insured Vehicle and also the rust that had developed on the underside of the front bonnet, at the centre portion.

9. The whitish burn marks are a result of exposure to prolonged heat intensity. Rust would normally start to develop around these areas soon after a fire as prolonged exposure to high heat intensity usually causes steel/metal material body parts to be exposed to natural environmental condition. The rust that had developed on the underside of the front bonnet, around the centre portion, is an indication that the centre portion of the engine compartment had sustained exposure to prolonged high heat intensity. See photos 7 - 10 below.

**Photo 7** shows the burn pattern and whitish burn marks that were found on the centre portion of the front bonnet of the Insured Vehicle (circled). Such whitish burn marks are a result of exposure to prolonged heat intensity, which may indicate where the fire had started. Rust would also begin to develop on these areas soon after the fire.

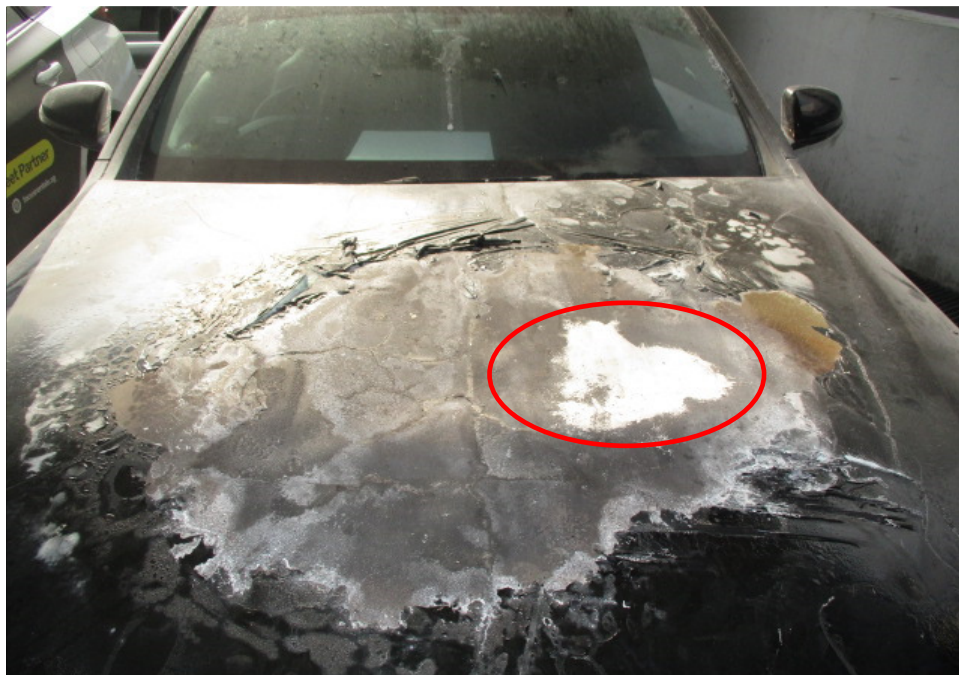
**Photo 8** shows a closer view of the burn pattern and whitish burn marks that were found on the centre portion of the front bonnet of the Insured Vehicle (circled).

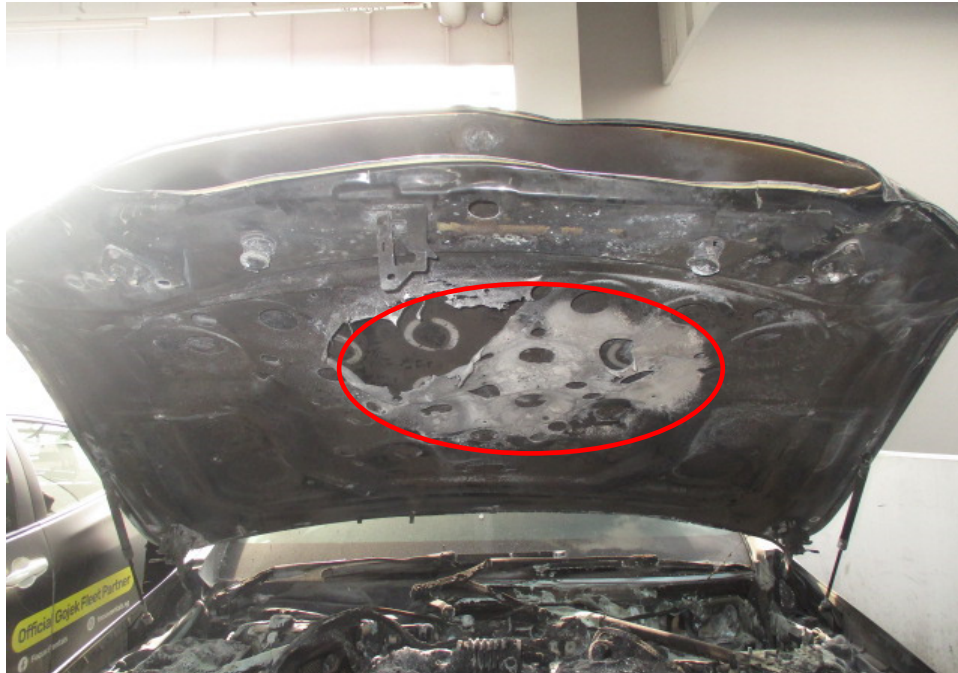
**Photo 9** shows the rust that had developed on the underside of the front bonnet, around the centre portion (circled). The development of rust is an indication that this area was subjected to prolonged exposure to high heat intensity, which had caused the steel/metal material of the front bonnet to be exposed to natural environmental condition. Hence the fire to the Insured Vehicle can be determined to have originated towards the centre portion of the engine compartment.

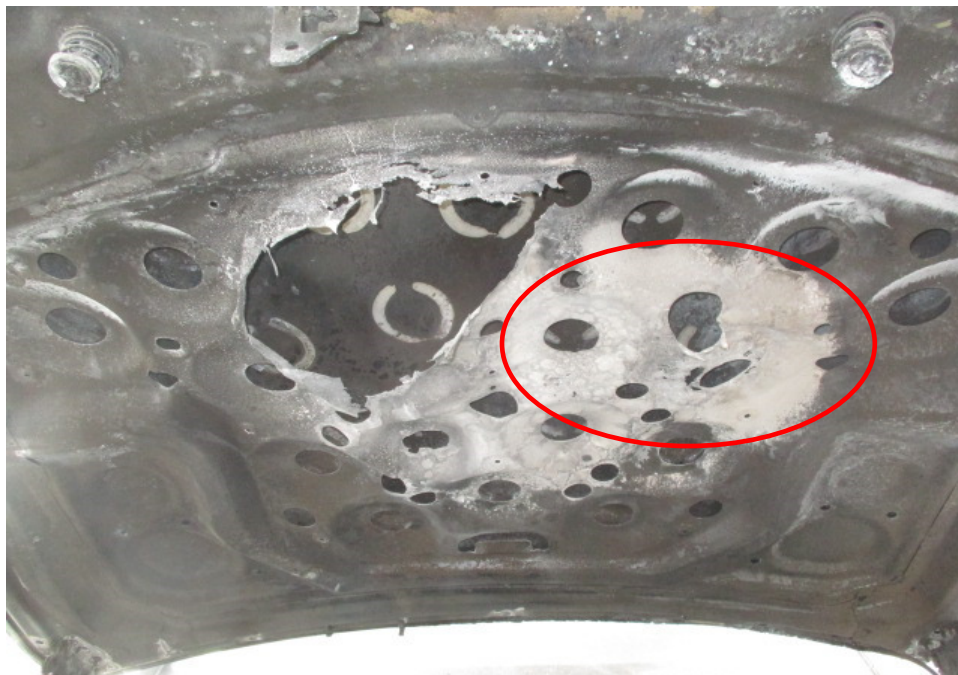
**Photo 10** shows a closer view of the rust that had developed on the underside of the front bonnet, around the centre portion (circled).

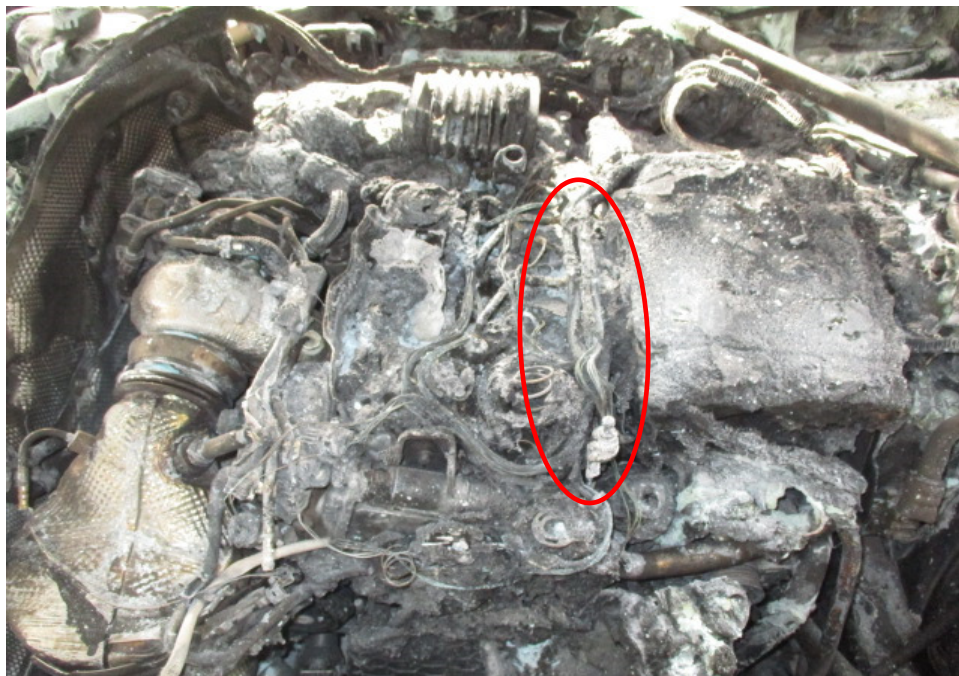
10. Upon closer examination of the centre portion of the engine compartment which was where the fire to the Insured Vehicle had likely started, we had found several stretches of wirings with greenish residue. These wirings were original factory fitted wirings of the Insured Vehicle. The presence of greenish residue indicates internal heating of copper wires, a sign of an electrical short circuit occurring. The greenish residue is normally left behind from oxidation as a result of chemical reaction involving the copper wires. This physical evidence would appear to suggest that the cause of fire to the Insured Vehicle could have possibly been due to electrical in nature. See photos 11 – 15 below.

**Photo 11** shows the wirings around the centre portion of the engine compartment which is near to the vicinity where the fire to the Insured Vehicle had likely started. We observed greenish residue on some of the burnt wirings of the Insured Vehicle (circled). The presence of greenish residue indicates internal heating of copper wires, a sign of an electrical short circuit occurring.

23. The possibility of the fire being due to electrical in nature would then seem more likely given that engine overheating and external factors would both seem unlikely. The fire being due to electrical nature is also supported by the greenish residue that was found on the wirings of the Insured Vehicle, which was earlier discussed in paragraph 10 above.

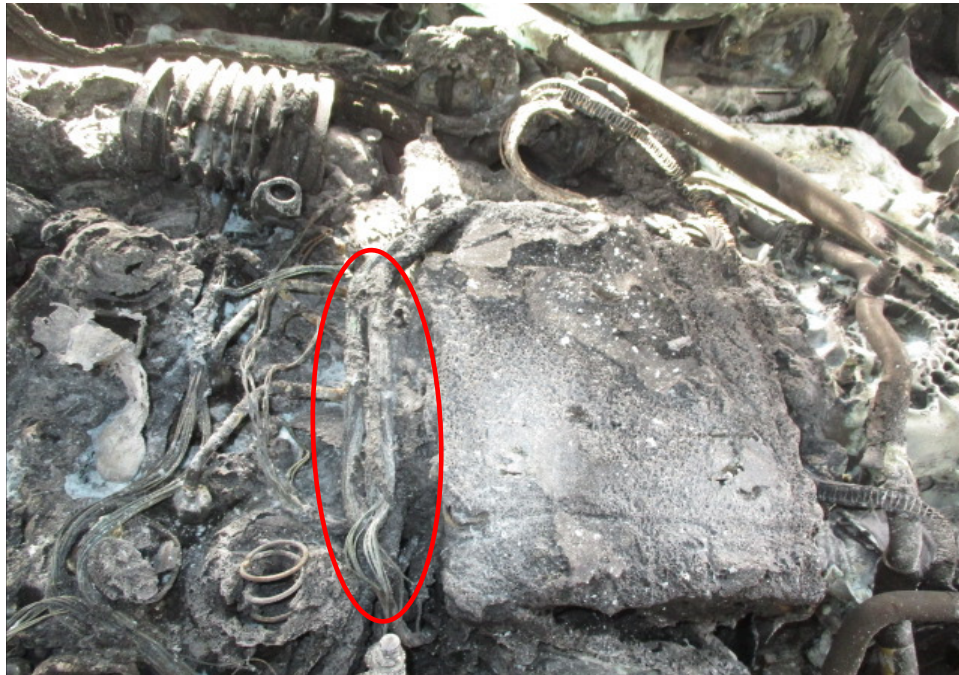
**Photo 12** shows a closer view of the greenish residue on some of the burnt wirings of the Insured Vehicle (circled). The presence of greenish residue indicates internal heating of copper wires, a sign of an electrical short circuit occurring. The greenish residue is normally left behind from oxidation as a result of chemical reaction involving the copper wires.

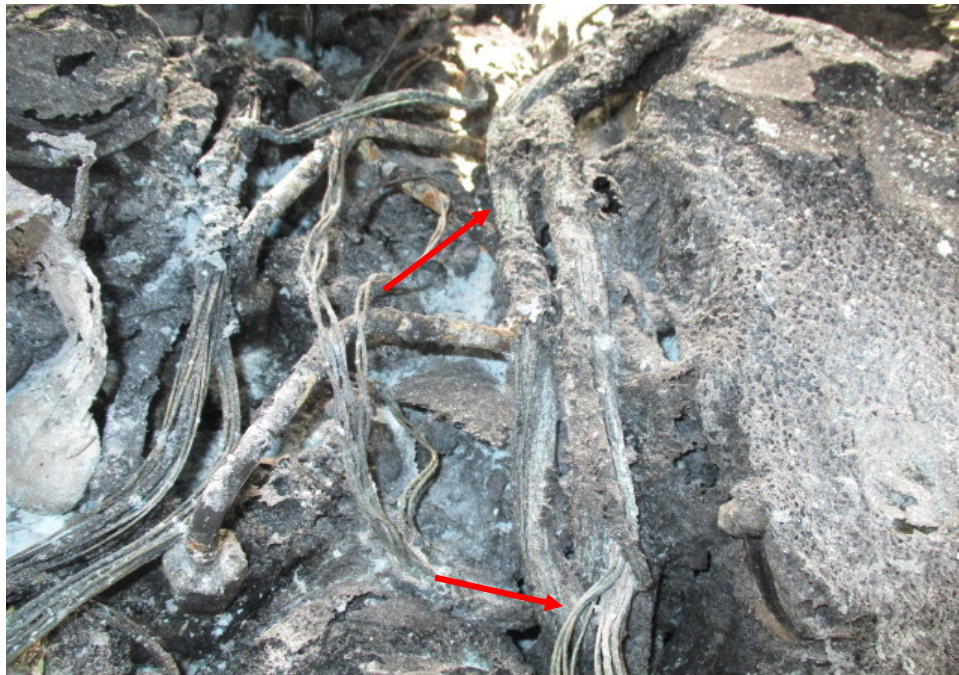
**Photo 13** shows a closer view of the greenish residue on the wirings of the Insured Vehicle (red arrows). The presence of such greenish residue suggests occurrence of an electrical short circuit.

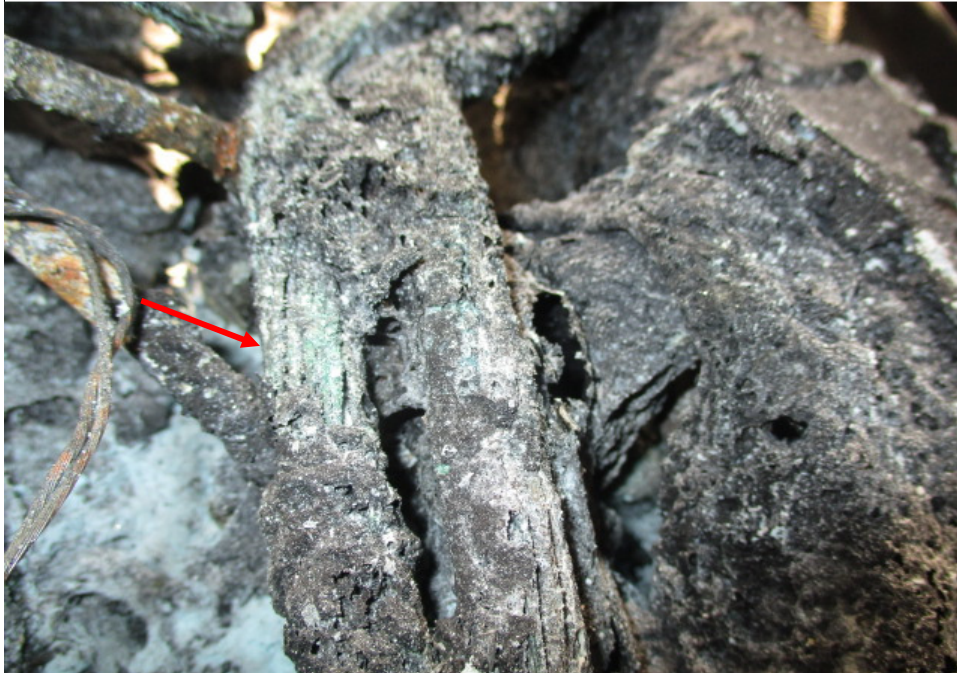
**Photo 14** shows a close up view of the greenish residue on the wirings of the Insured Vehicle (arrowed). The presence of such greenish residue suggests occurrence of an electrical short circuit.

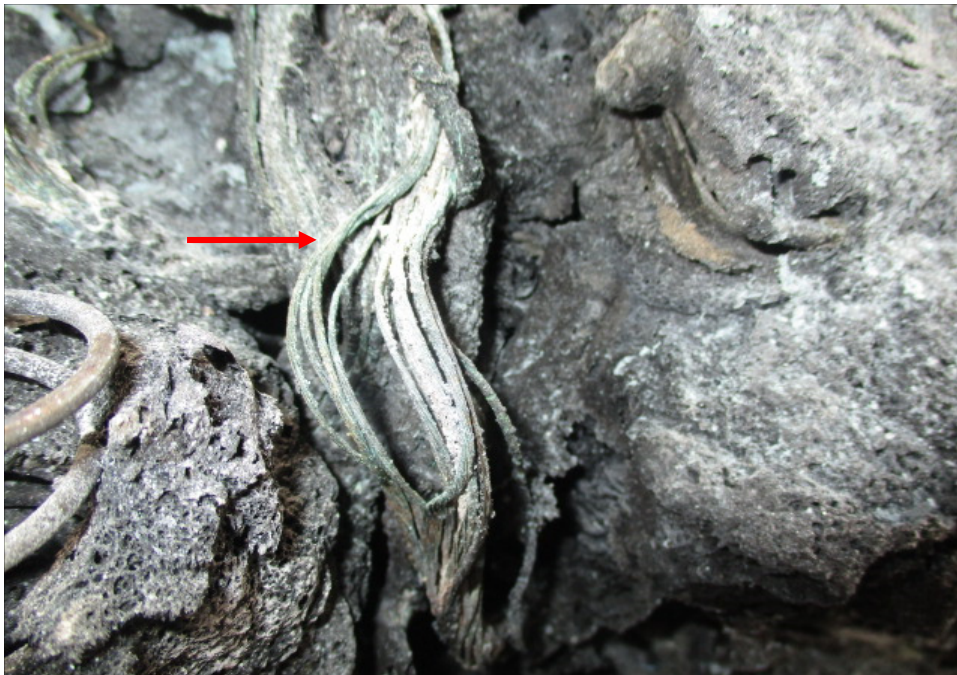
**Photo 15** shows a close up view of the greenish residue on the wirings of the Insured Vehicle (arrowed). The presence of such greenish residue suggests occurrence of an electrical short circuit.

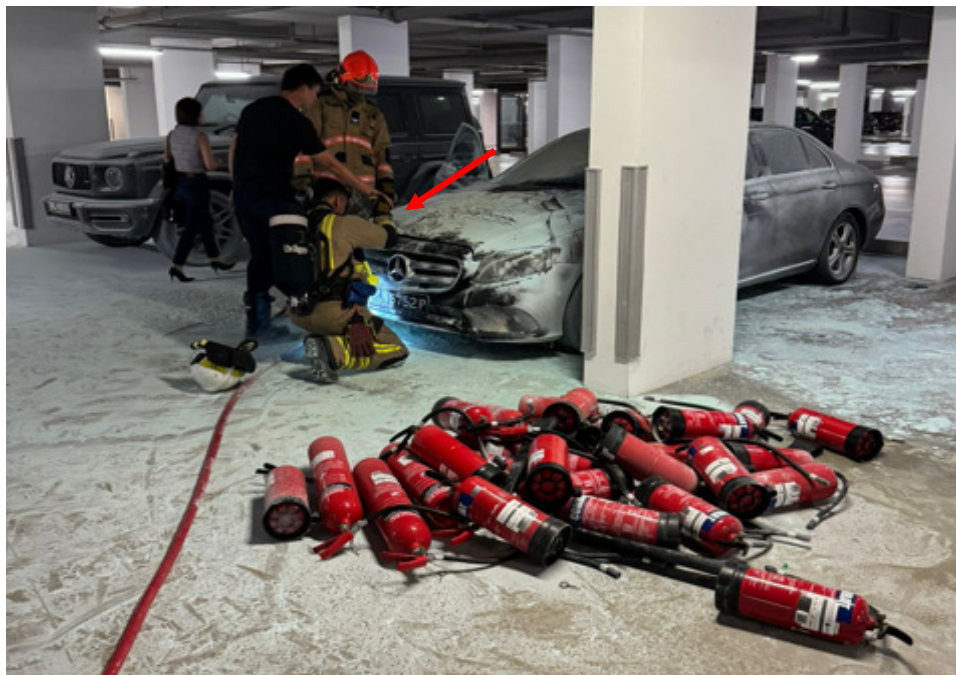
**Photo 16** shows firefighters making sure the fire to the Insured Vehicle was put out (arrowed). In general, the information that could be gathered from this photograph had corresponded to the events that were related to us by Mr Ouyang which is the fire was put out by the time he arrived at the incident scene.

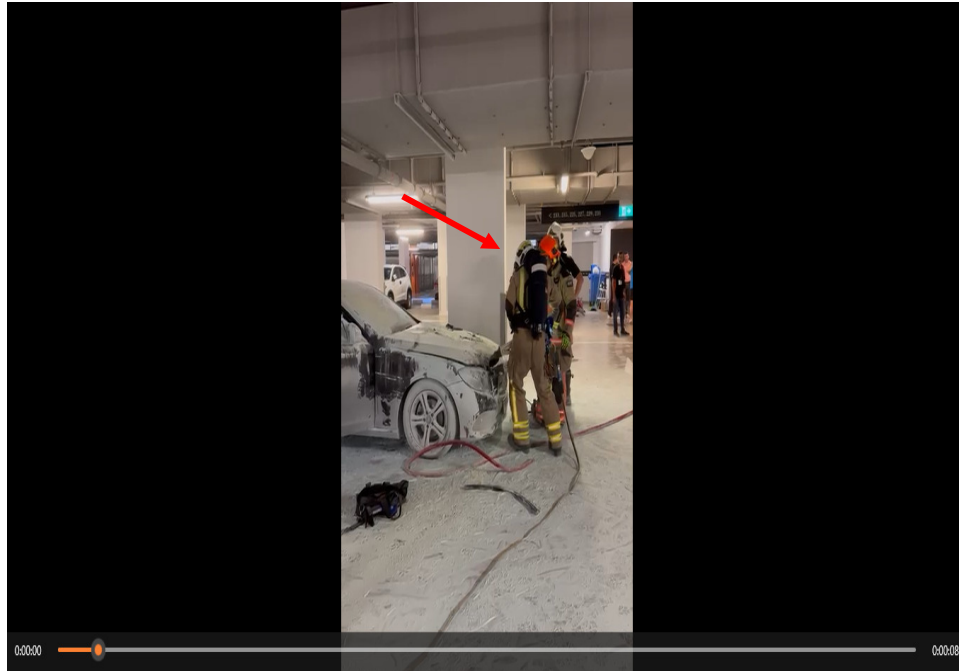
**Photo 17** shows a screenshot taken from the video recording that was provided by Mr Ouyang. In general, the information that could be gathered from this screenshot had corresponded to the events that were related to us by Mr Ouyang which is firefighters prised open the front bonnet of the Insured Vehicle using hydraulic rescue equipment post- incident (arrowed).

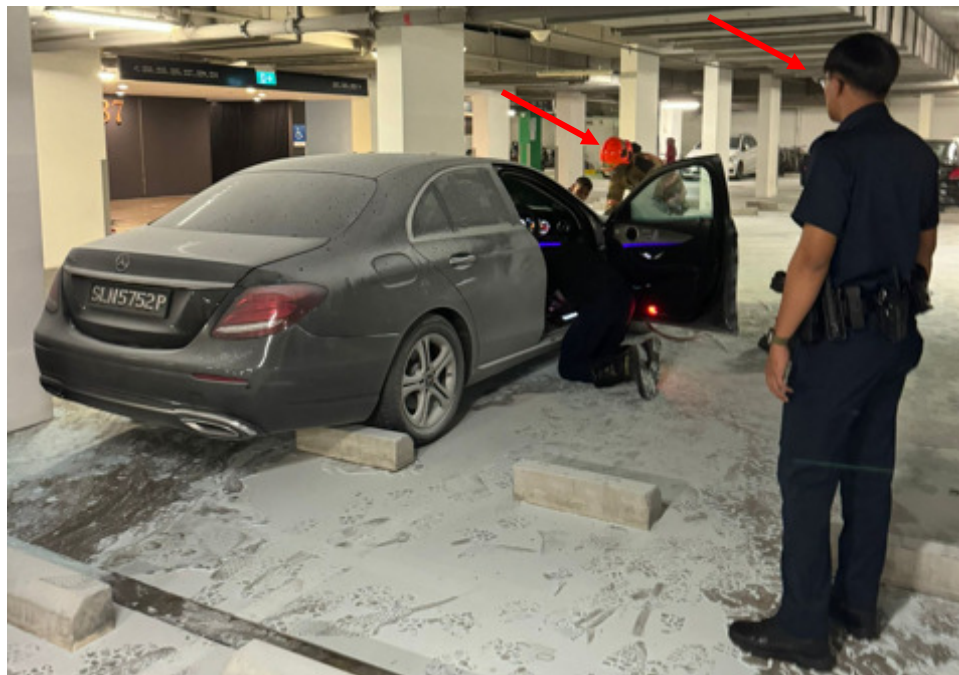
**Photo 18** shows the Insured Vehicle after the fire was extinguished. In general, the information that could be gathered from this photograph had corresponded to the events that were related to us by Mr Ouyang which is the police and SCDF had responded to the incident (arrowed).

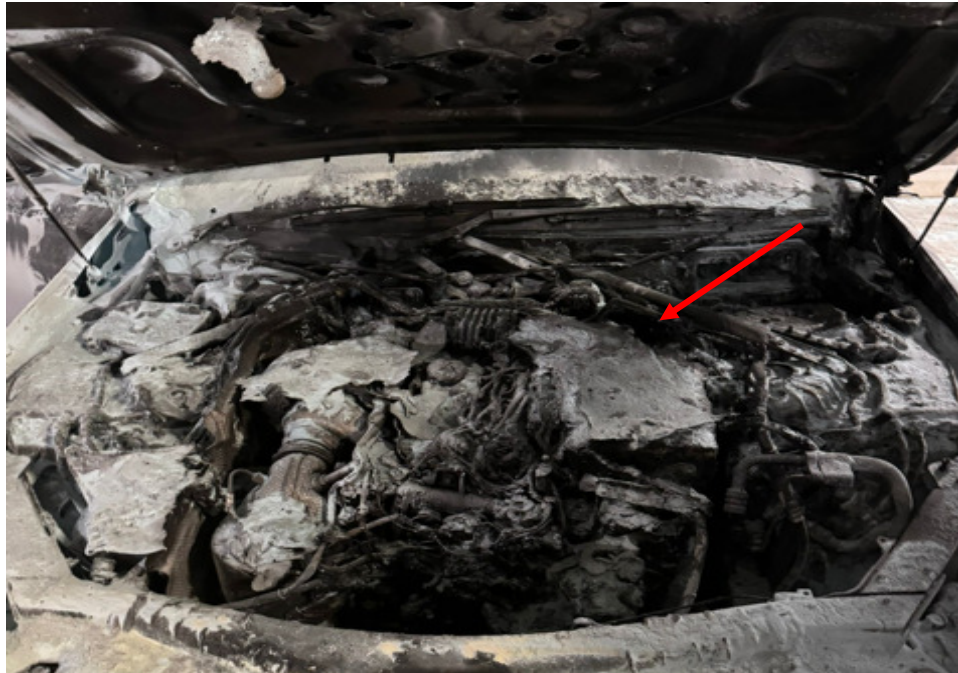
**Photo 19** shows the engine compartment of the Insured Vehicle at the post-incident after the front bonnet was prised open by the SCDF. The severity of damage of the frontal portion had corresponded to the events that were related to us by Mr Ouyang, which is the fire had started from the engine compartment of the Insured Vehicle (arrowed).
