# *Tommie Lim Appraisal*

## VEHICLE INSPECTION REPORT

Ref. no.	: TLA/2024/08/018	3rd party Veh.	: TP357A
Accident on	: 22 Aug 2024	Claim tyre	: Third Party
Assign on	: 27 Aug 2024	Claim number	: To be advice
Inspection on	: 27 Aug 2024	Policy number	: To be advice
Workshop name	: INFINITY AUTO 57 PTE LTD	Finalize on	: 09 Sep 2024
Inspection at	: Blk 3020A, #01-33, Ubi Road 1 Singapore 408714	Final report on	: 10 Sep 2024

Vehicle number	: SMM348A	Registration date	: 14 Jun 2019
Make	: HONDA	Body colour	: BLUE
Model	: FREED HYBRID	Engine number	: LEB5611069
Chassis number	: GB71075803	Engine capacity	: 1496 CC
Odometer	: 185515 KM	Transmission	: AUTOMATIC

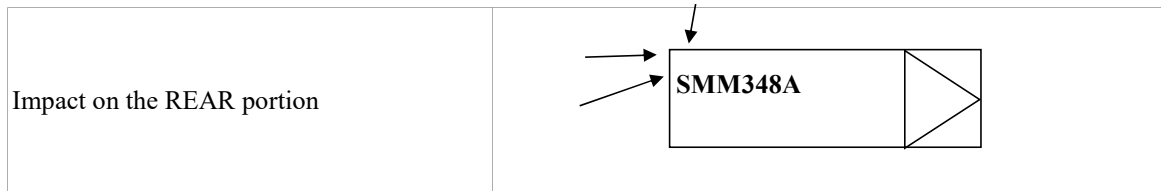
## POINT OF IMPACT

The impact of the collision has damaged/affected the tailgate assy, rear bumper assy, rear n/s taillamp, rear n/s fender, rear end panel and etc...
