Our Ref : CS/LPC24080524/J

3 September 2024

**TECHNICAL INVESTIGATION REPORT OF FIRE INCIDENT INVOLVING THE
INSURED VEHICLE YP 1982D ON 29 August 2024**

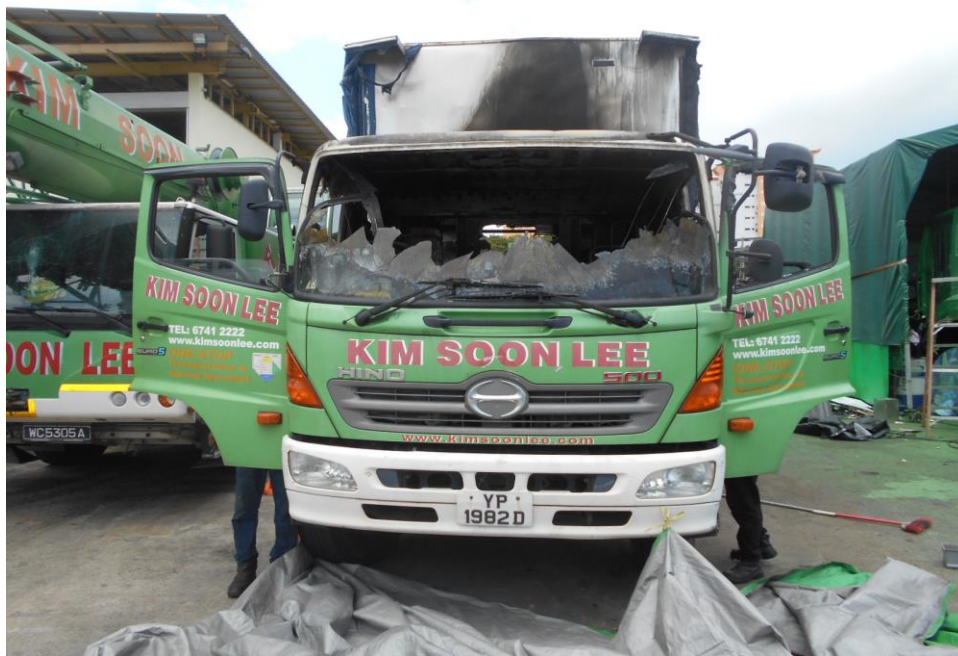
5. The exterior front body of the Insured Vehicle sustained visible fire damage. This included its front windscreen, front right body panel and front left body panel.
6. The fire had resulted in extensive damage to the interior compartment of the Insured Vehicle. Most of the components inside the interior compartments were found to be severely burnt and/or melted as a result of the fire. See photos 1 – 6 below.

Photo 1 shows the general view of the frontal portion of the Insured Vehicle at the time of our inspection. The exterior of the Insured Vehicle had sustained visible fire damages. This included its front windscreen.

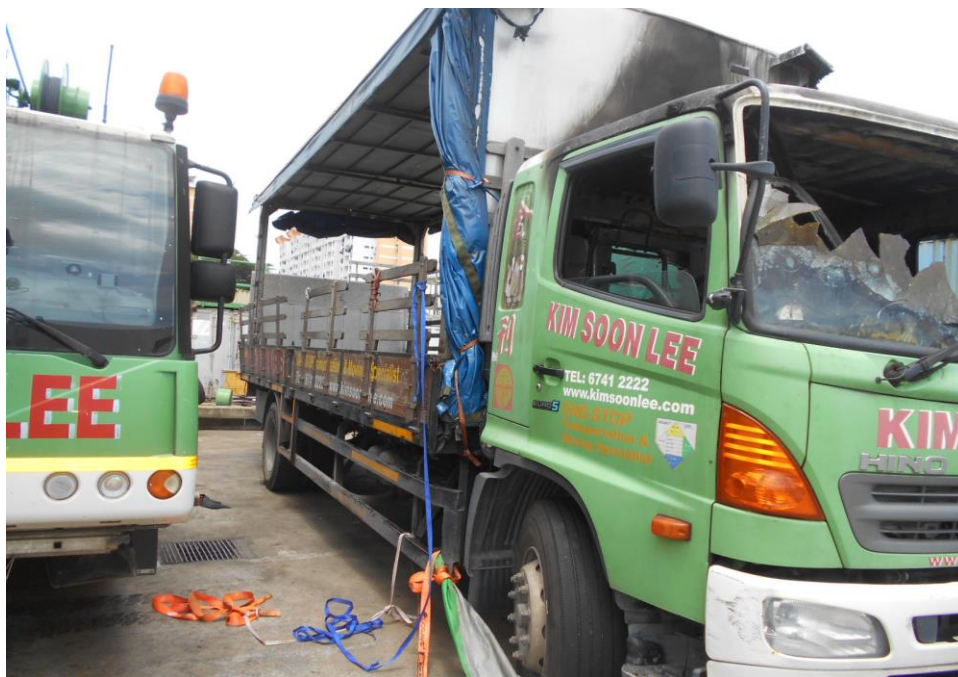
Photo 2 shows the general view of the right body of the Insured Vehicle at the time of our inspection. The exterior of the Insured Vehicle had sustained visible fire damages. This included its front right body panel.

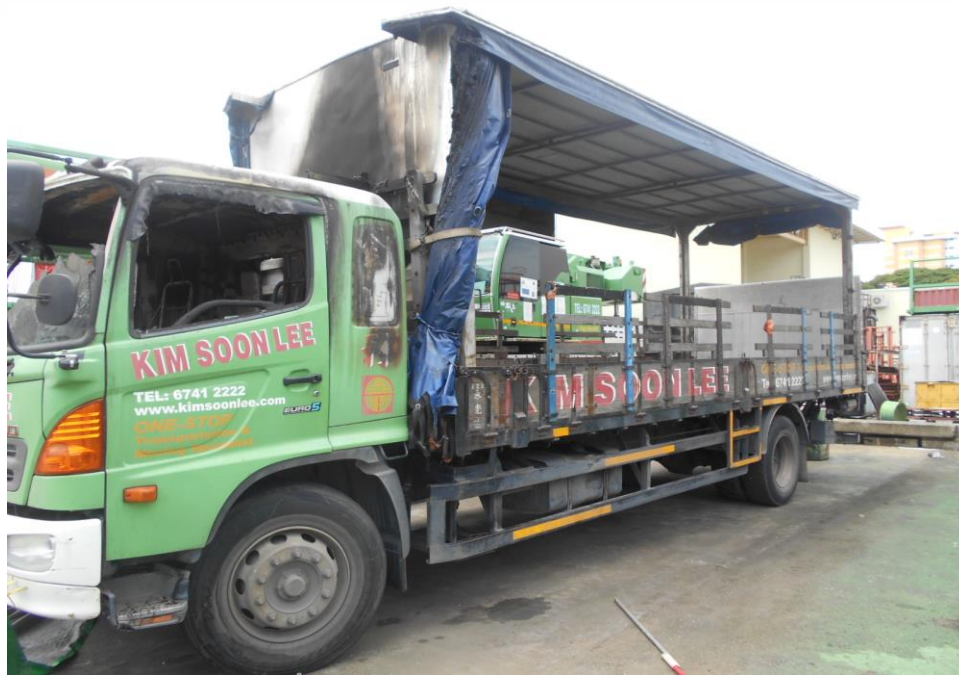
Photo 3 shows the general view of the left body of the Insured Vehicle at the time of our inspection. The exterior of the Insured Vehicle had sustained visible fire damages. This included its front left body panel.

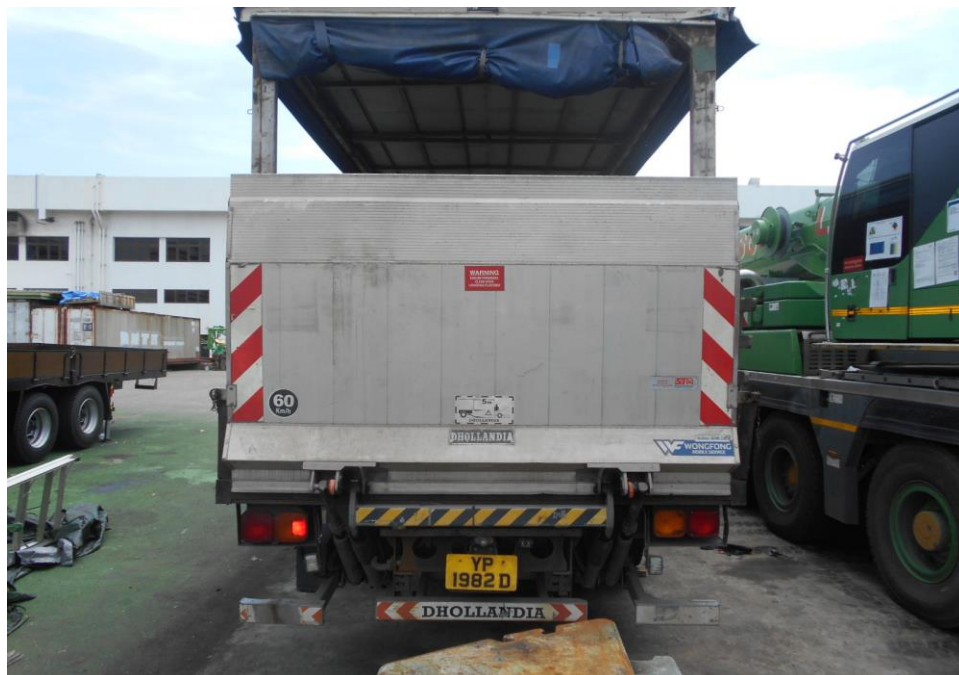
Photo 4 shows the general view of the rear portion of the Insured Vehicle at the time of our inspection. The rear portion appears to be intact and unaffected by the fire.

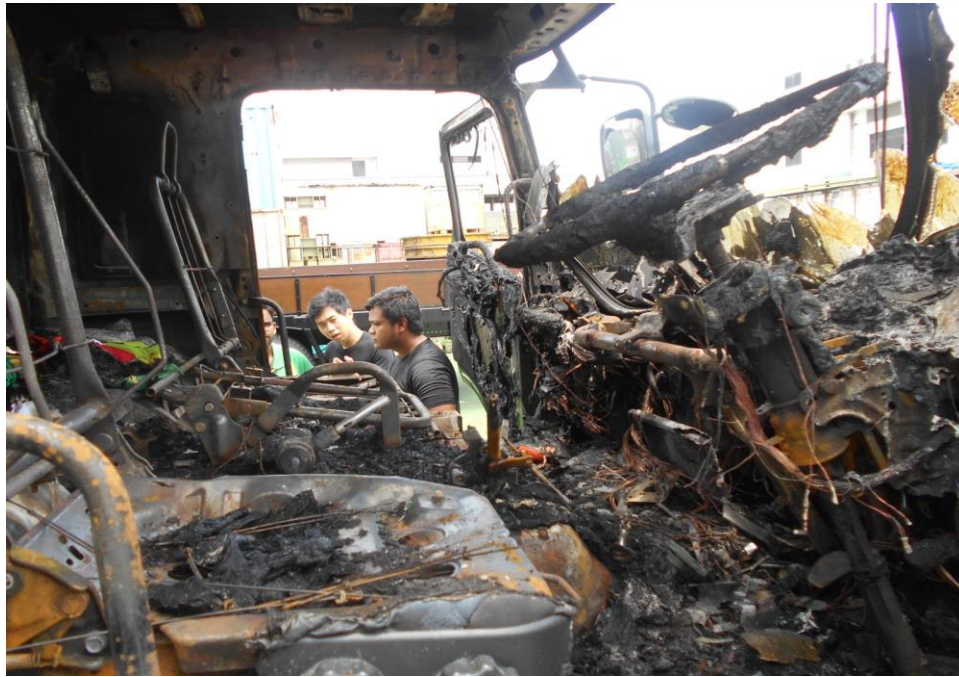
Photo 5 shows the interior compartment of the Insured Vehicle, which was significantly affected by the fire.

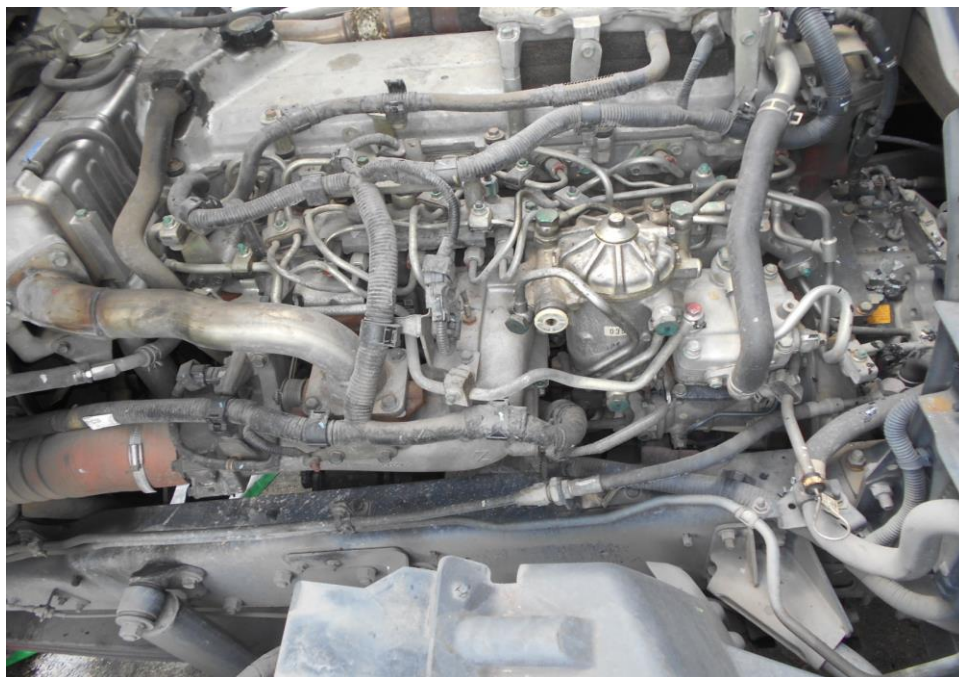
Photo 6 shows the general view of the engine portion of the Insured Vehicle at the time of our inspection. The fire damage to the Insured Vehicle was confined to its interior portion. Its engine compartment is observed to be unaffected by the fire.

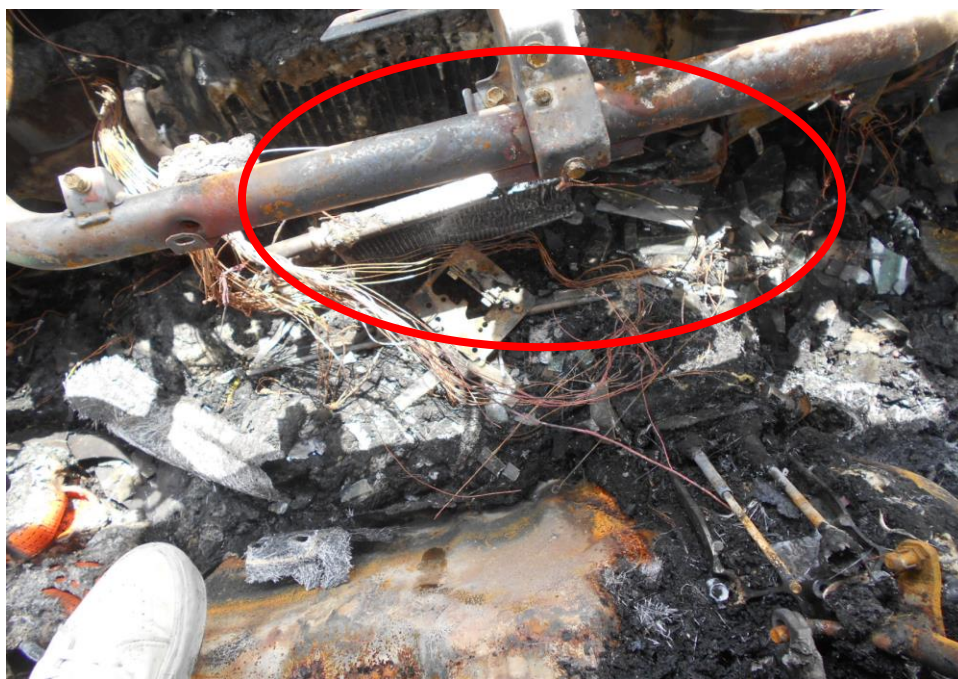
7. For this particular case, the fire appears to have originated within the interior compartment of the Insured Vehicle, somewhere around the front centre portion of the dashboard. This can be determined from the greenish residue that was found on several stretches of burnt original factory fitted wirings mainly around the centre portion of the interior compartment. The presence of greenish residue indicates internal heating of copper wires, a sign of an electrical short circuit occurring. The greenish residue is normally left behind from oxidation as a result of chemical reaction involving the copper wires. This physical evidence would appear to suggest that the cause of fire to the Insured Vehicle could have possibly been due to electrical in nature. See photos 7 - 9 below.

Photo 7 shows the burnt wirings around the front centre portion of the interior dashboard which is near to the vicinity where the fire to the Insured Vehicle had likely started (circled).

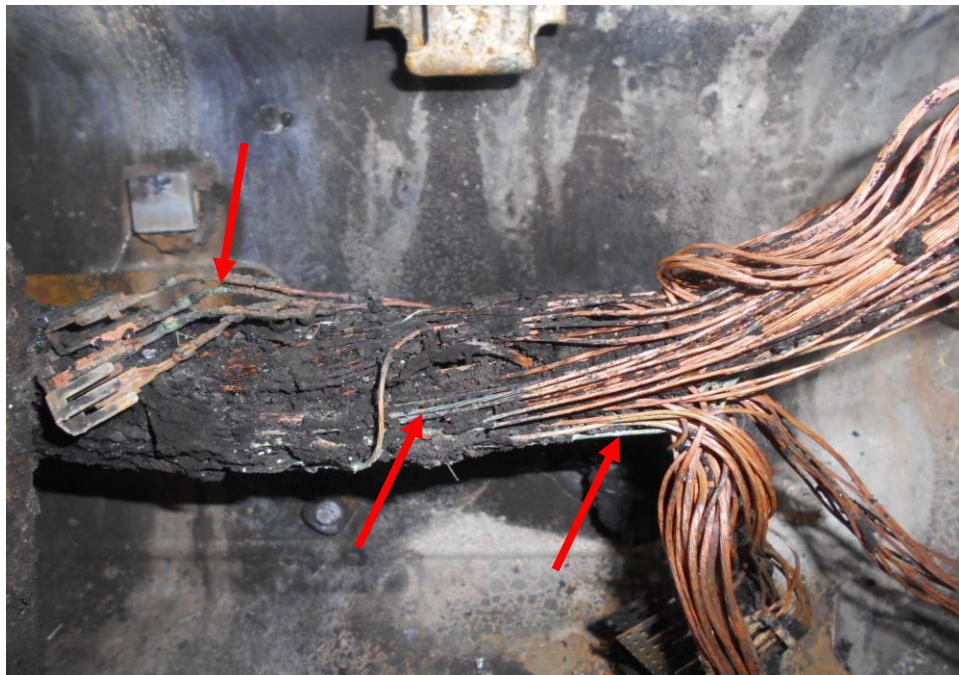
Photo 8 shows a closer view of the wirings with greenish residue found around the centre portion of the interior dashboard of the Insured Vehicle (red arrows). The presence of such greenish residue suggests occurrence of an electrical short circuit.

18. The possibility of the fire being due to electrical in nature would then seem more likely given that engine overheating and external factors would both seem unlikely. The fire being due to electrical nature is also supported by the condition of the wirings around the centre portion of the interior dashboard of the Insured Vehicle, which was earlier discussed in paragraph 7 above.

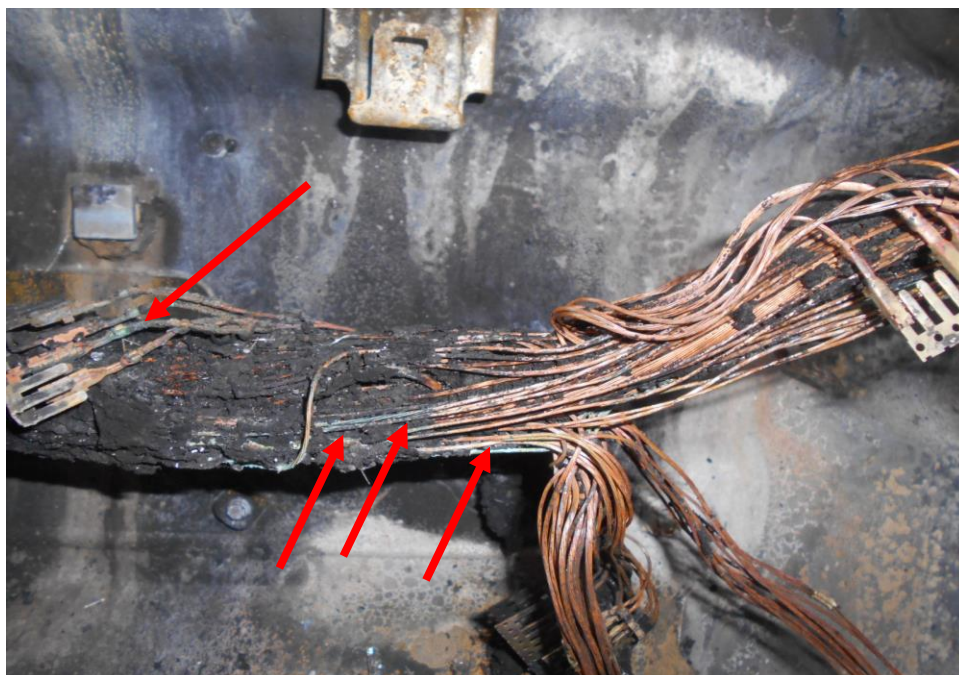
Photo 9 shows a close up view of the wirings with greenish residue found around the centre portion of the interior dashboard of the Insured Vehicle (red arrows). The presence of such greenish residue suggests occurrence of an electrical short circuit.

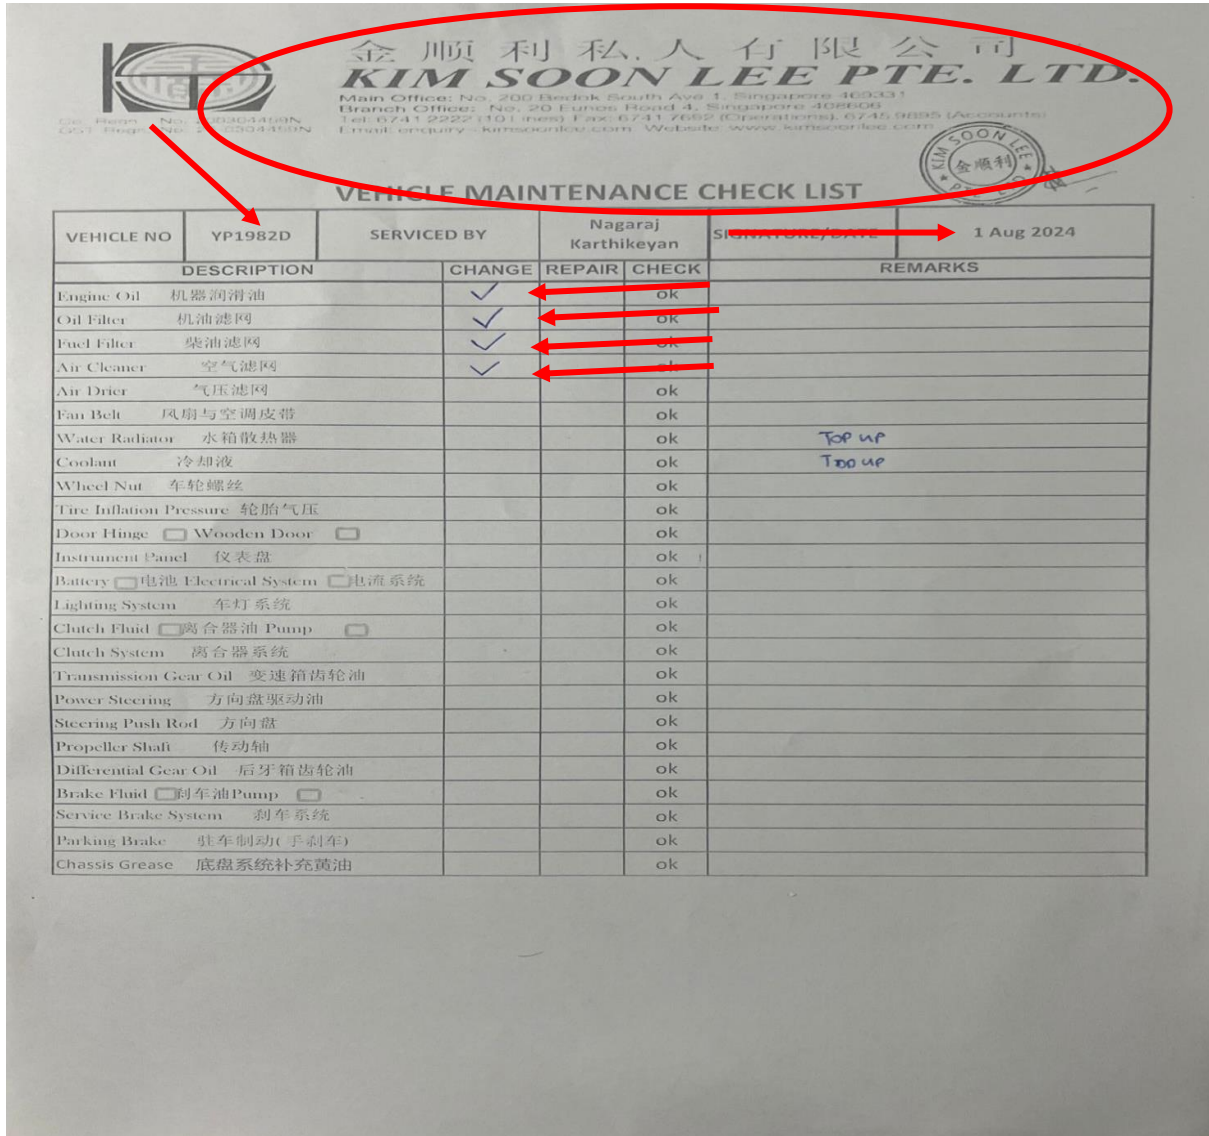
Invoice 1 shows the latest recorded service history conducted on the 1 August 2024 by Kim Soon Lee Pte Ltd (red circle) which includes replacing of engine oil, engine oil filter, fuel filter and air cleaner/air filter (red arrows).

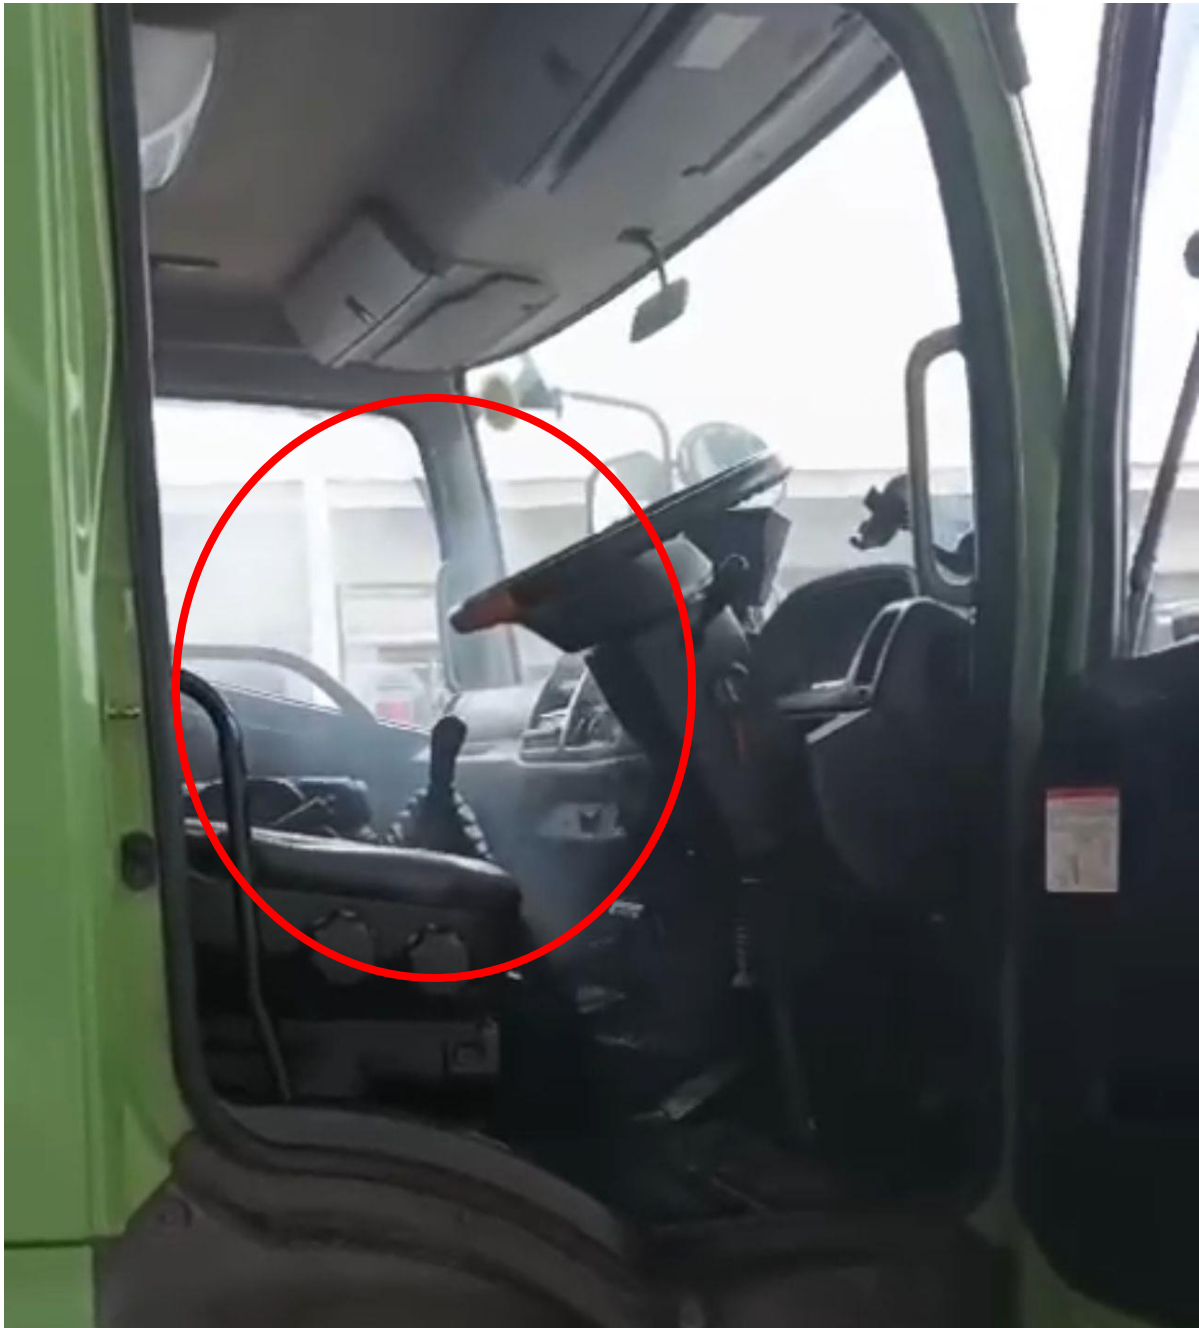
Photo 10 shows white smoke emitting from the centre dashboard of the Insured Vehicle interior compartment. (red circle).

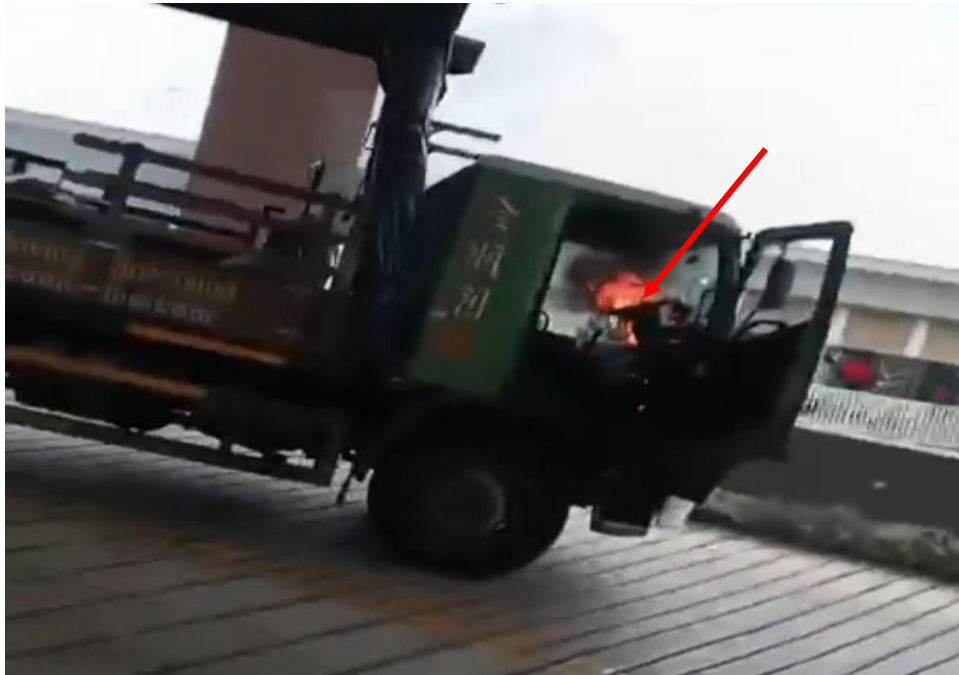
Photo 11 shows flames emitting from the centre dashboard of the Insured Vehicle interior compartment. (red arrow).

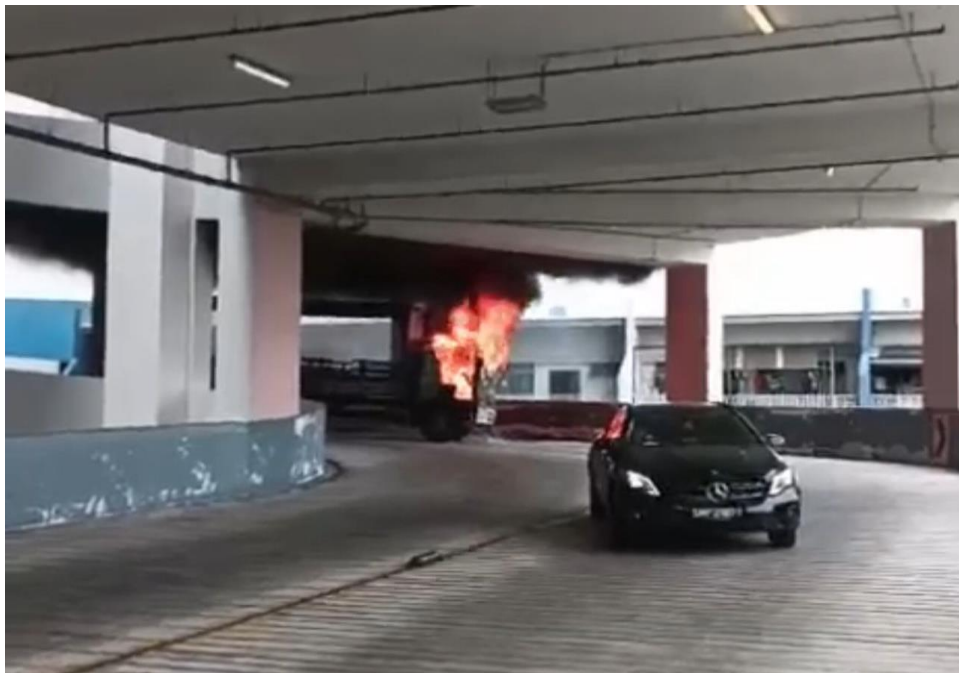
Photo 12 shows the Insured Vehicle bursting into flames shortly before the arrival of the SCDF.

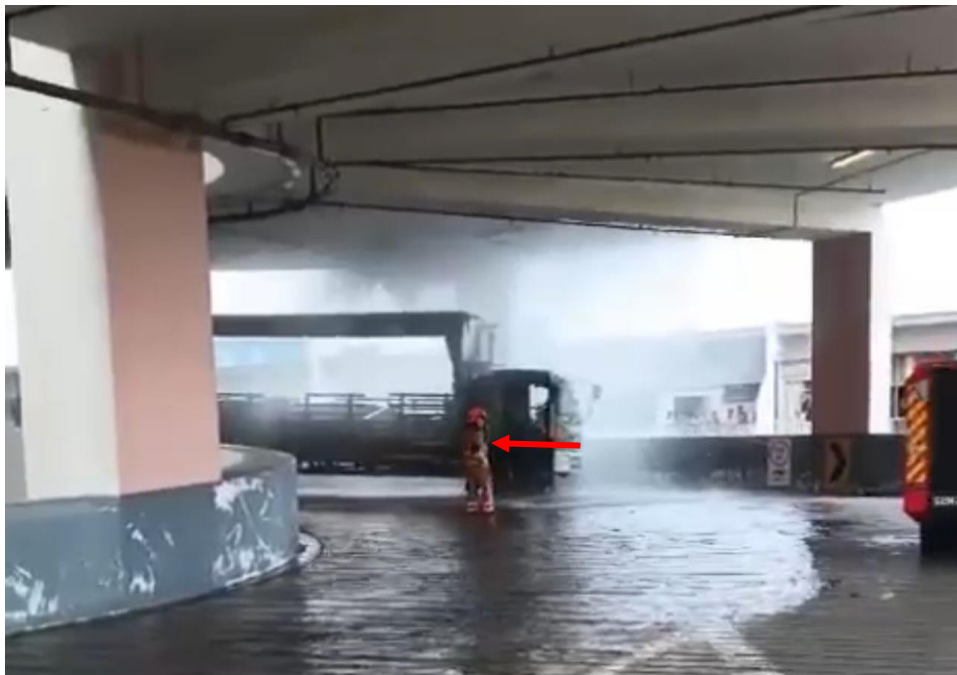
Photo 13 shows the SCDF fire fighter (red arrow) extinguishing the fire to the Insured Vehicle.
