Your Ref: 23/24/24/VC06/029746  
Our Ref : CS/LPC24090028/J

**TECHNICAL INVESTIGATION REPORT OF FIRE INCIDENT INVOLVING THE  
INSURED VEHICLE XD 2119Z ON 21 August 2024**

Vehicle Registration No.	: XD 2119Z
Make / Model	: ISUZU CYZ52L
Chassis No	: JALCYZ52L87000005
Year of Registration	: JANURARY 2008
Mileage	: N/A

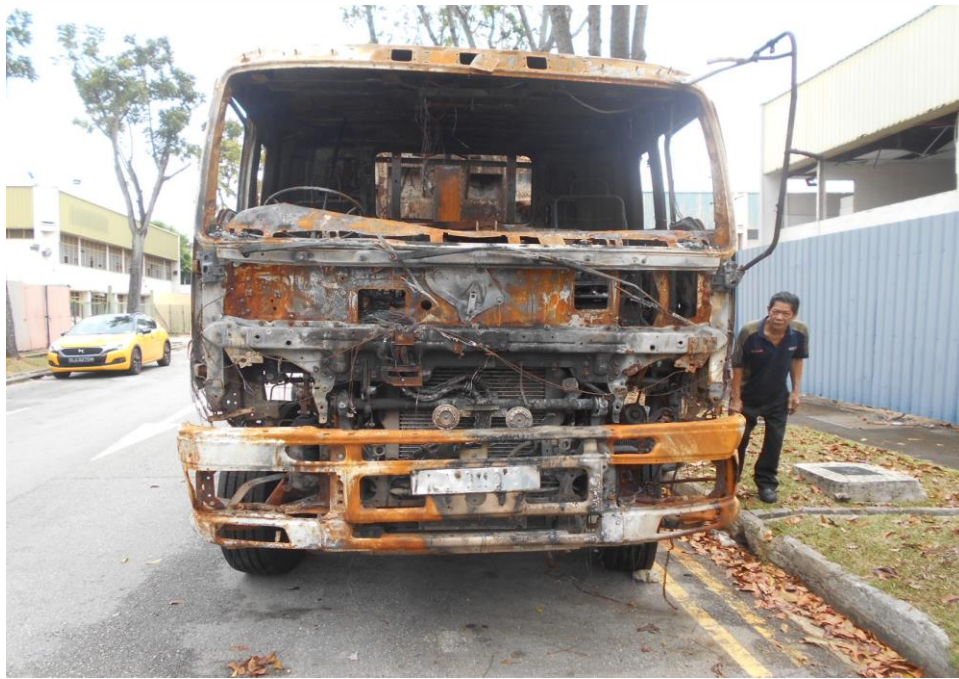
**Photo 1** shows the general view of the frontal portion of the Insured Vehicle at the time of our inspection. The exterior of the Insured Vehicle had sustained visible fire damage. This included its front windscreen, front body panels and headlights.

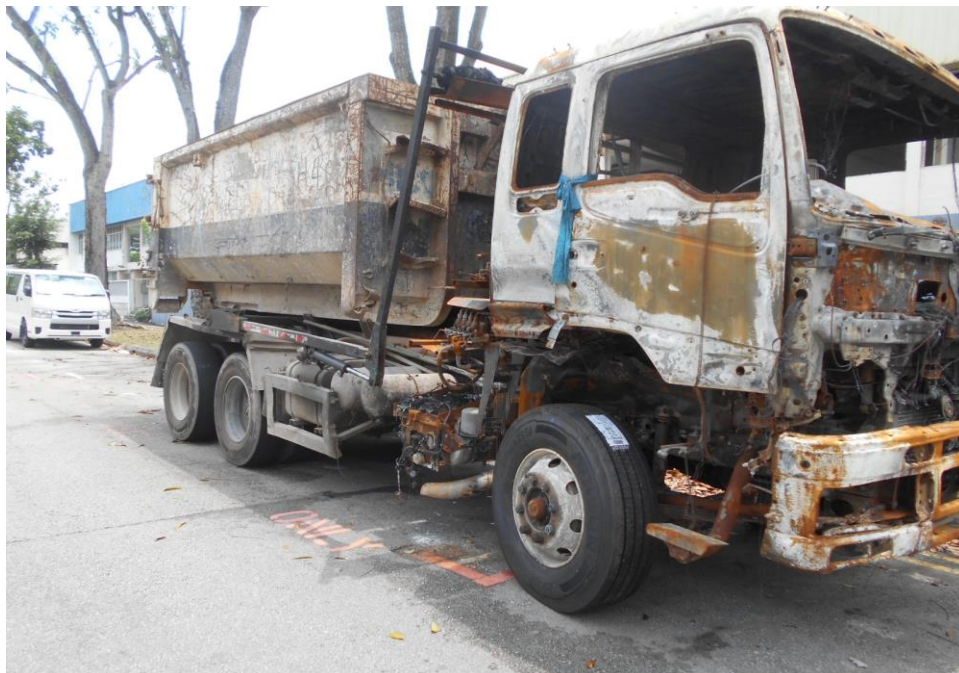
**Photo 2** shows the general view of the right body of the Insured Vehicle at the time of our inspection. The exterior of the Insured Vehicle had sustained visible fire damages. This included its side panels and front right door.

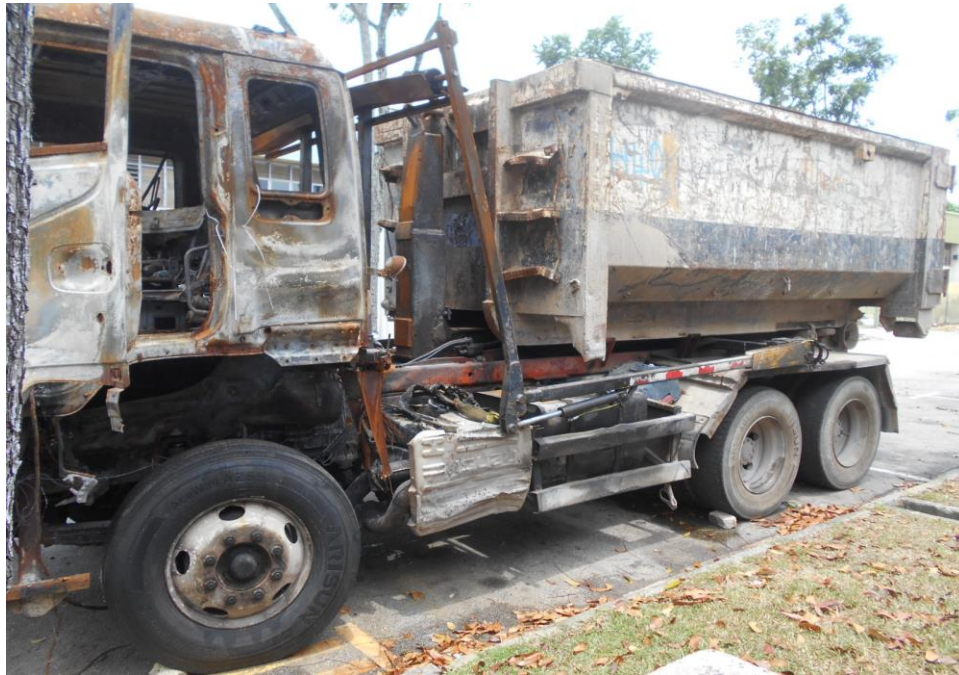
**Photo 3** shows the general view of the left body of the Insured Vehicle at the time of our inspection. The exterior of the Insured Vehicle had sustained visible fire damages. This included its side panels and front left door.

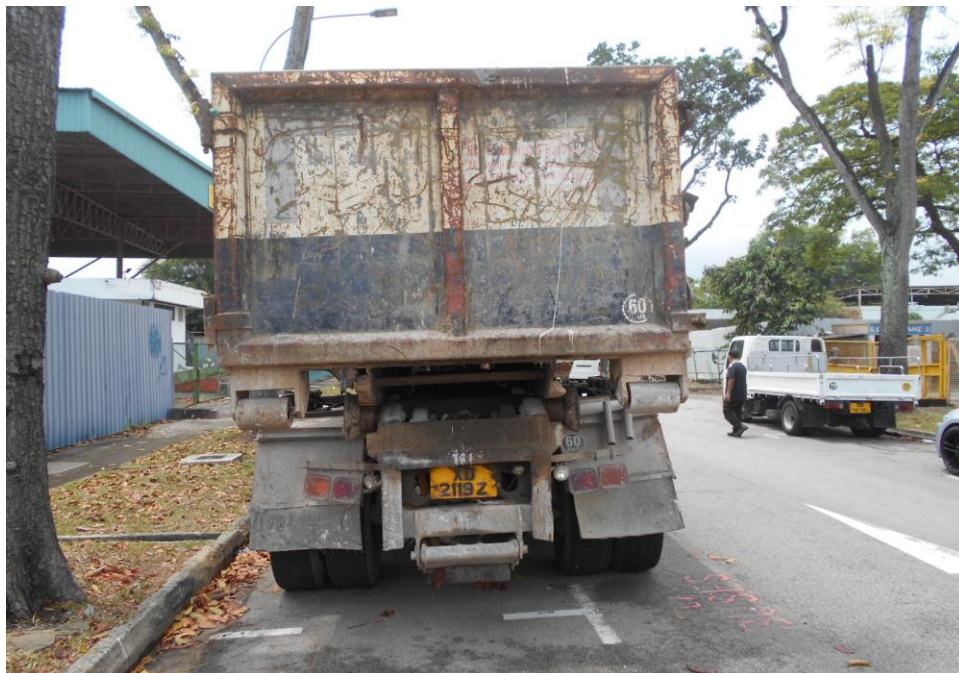
**Photo 4** shows the general view of the rear portion of the Insured Vehicle at the time of our inspection. The rear portion appears to be intact and unaffected by the fire.

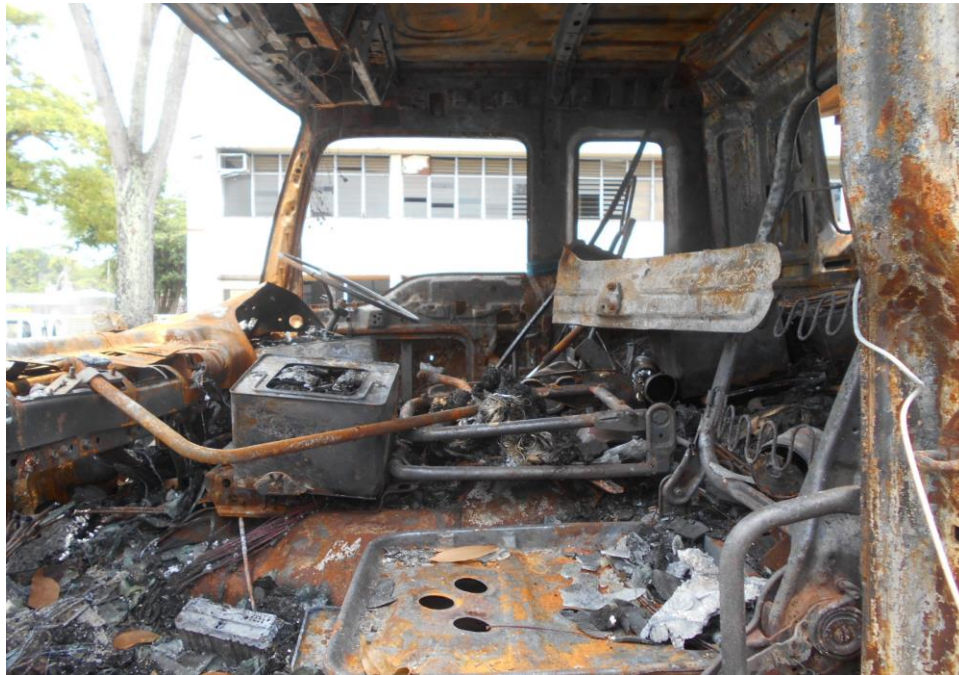
**Photo 5** shows the interior compartment of the Insured Vehicle, which was significantly affected by the fire.

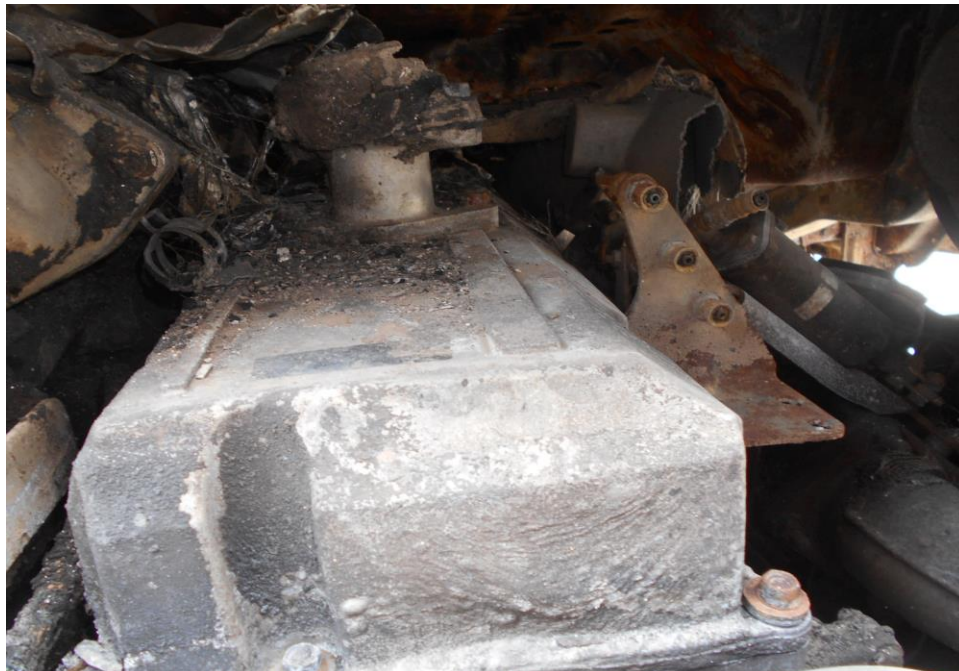
**Photo 6** shows the general view of the engine portion of the Insured Vehicle at the time of our inspection. The fire damage to the Insured Vehicle was confined to its interior and exterior portion. Its engine compartment is observed to be unaffected by the fire.

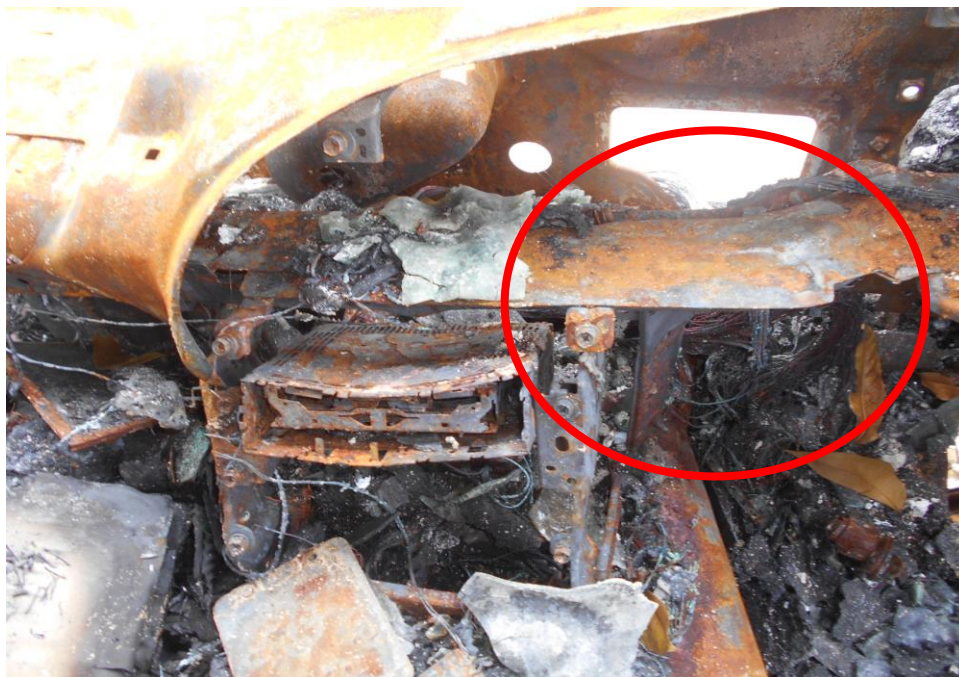
7. For this particular case, the fire appears to have originated within the interior compartment of the Insured Vehicle, somewhere around the front right driver portion of the dashboard. This can be determined from the greenish residue that was found on several stretches of burnt original factory fitted wirings mainly around the centre portion of the interior compartment. The presence of greenish residue indicates internal heating of copper wires, a sign of an electrical short circuit occurring. The greenish residue is normally left behind from oxidation as a result of chemical reaction involving the copper wires. This physical evidence would appear to suggest that the cause of fire to the Insured Vehicle could have possibly been due to electrical in nature. See photos 7 - 10 below.

**Photo 7** shows the burnt wirings around the front right driver portion of the interior dashboard which is near to the vicinity where the fire to the Insured Vehicle had likely started (circled).

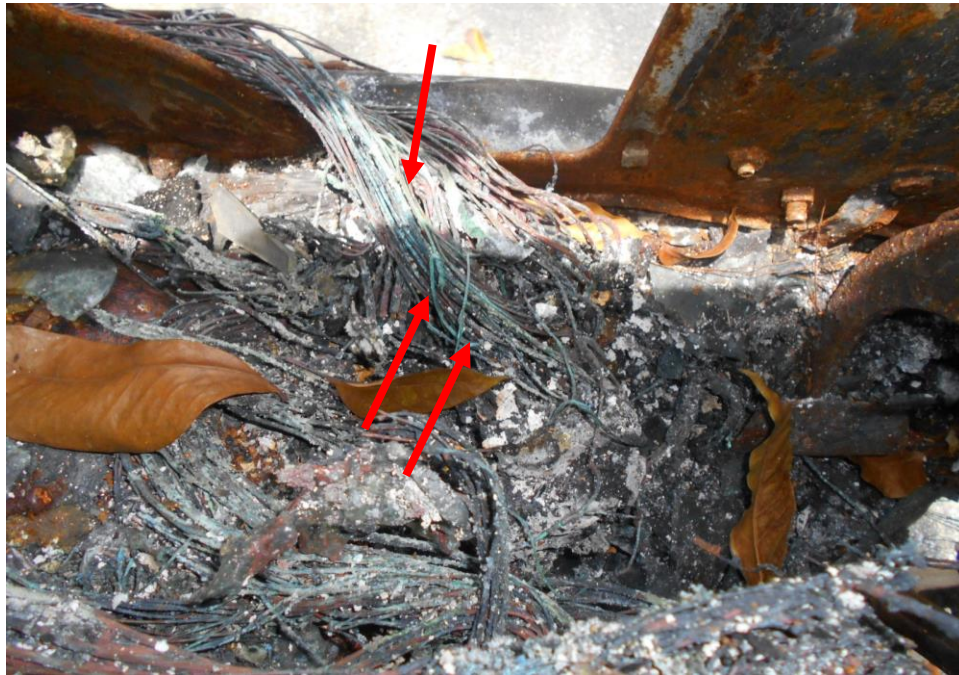
**Photo 8** shows a closer view of the wirings with greenish residue found around the front right driver portion of the interior dashboard of the Insured Vehicle (red arrows). The presence of such greenish residue suggests occurrence of an electrical short circuit.

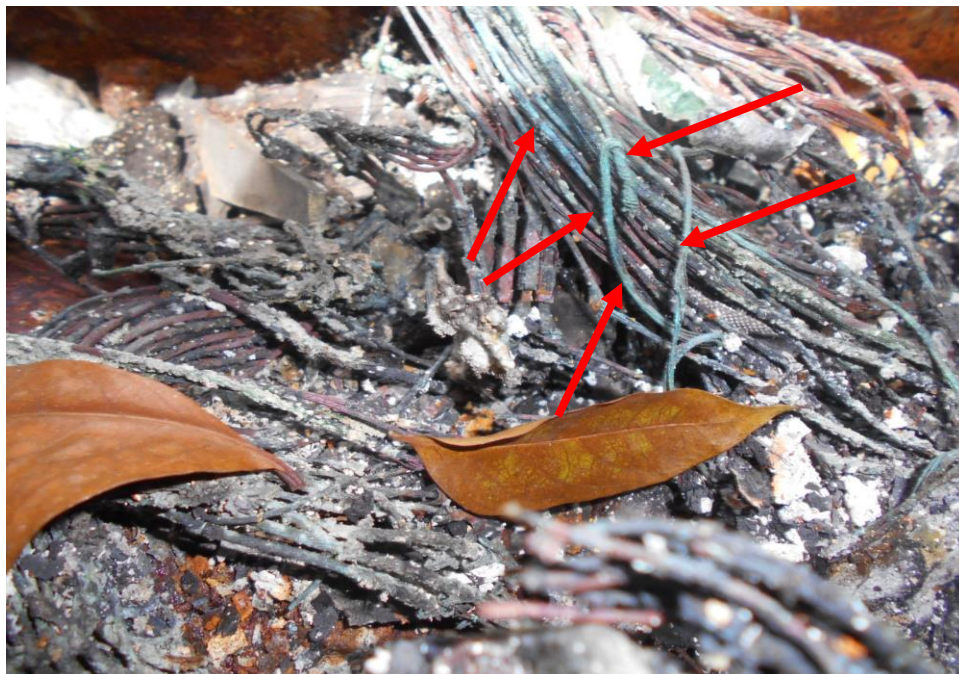
**Photo 9** shows a close up view of the wirings with greenish residue found around the front right driver portion of the interior dashboard of the Insured Vehicle (red arrows). The presence of such greenish residue suggests occurrence of an electrical short circuit.

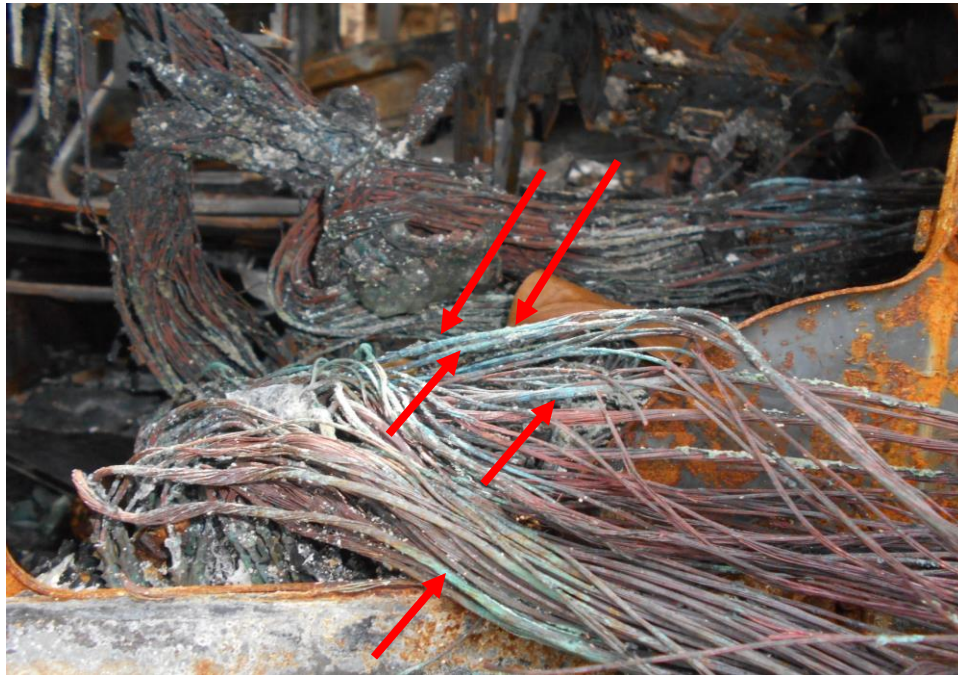
**Photo 10** shows a close up view of the wirings with greenish residue found around the front right driver portion of the interior dashboard of the Insured Vehicle (red arrows). The presence of such greenish residue suggests occurrence of an electrical short circuit.

18. The possibility of the fire being due to electrical in nature would then seem more likely given that engine overheating and external factors would both seem unlikely. The fire being due to electrical nature is also supported by the condition of the wirings around the front right driver portion of the interior dashboard of the Insured Vehicle, which was earlier discussed in paragraph 7 above.

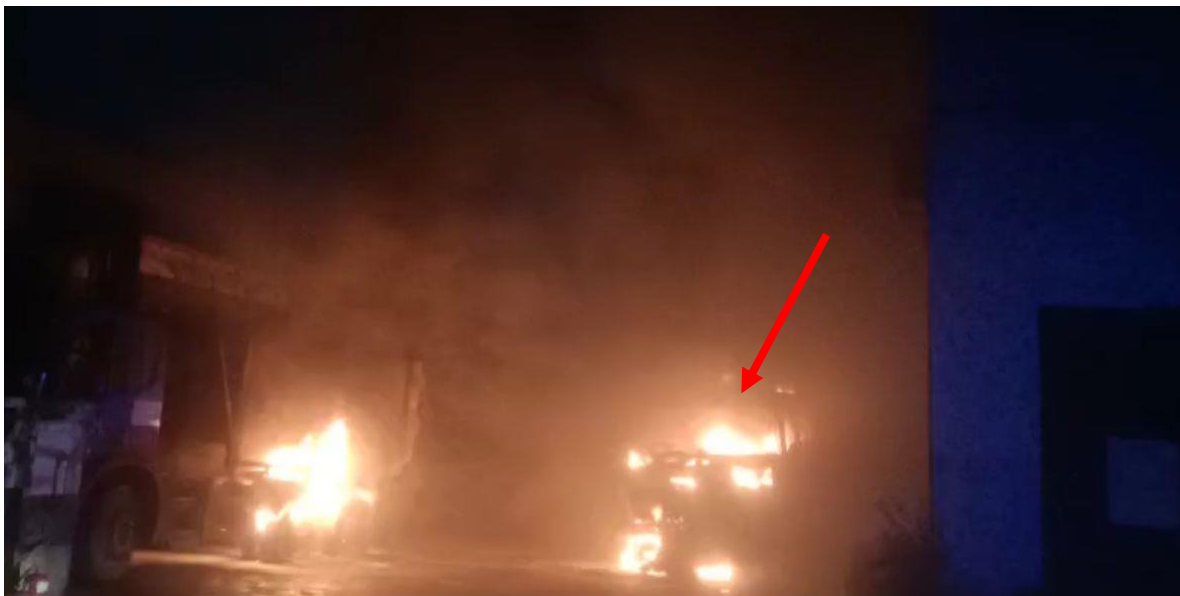
**Photo 11** shows the Insured Vehicle (red arrow) bursting into flames before the arrival of SCDF.

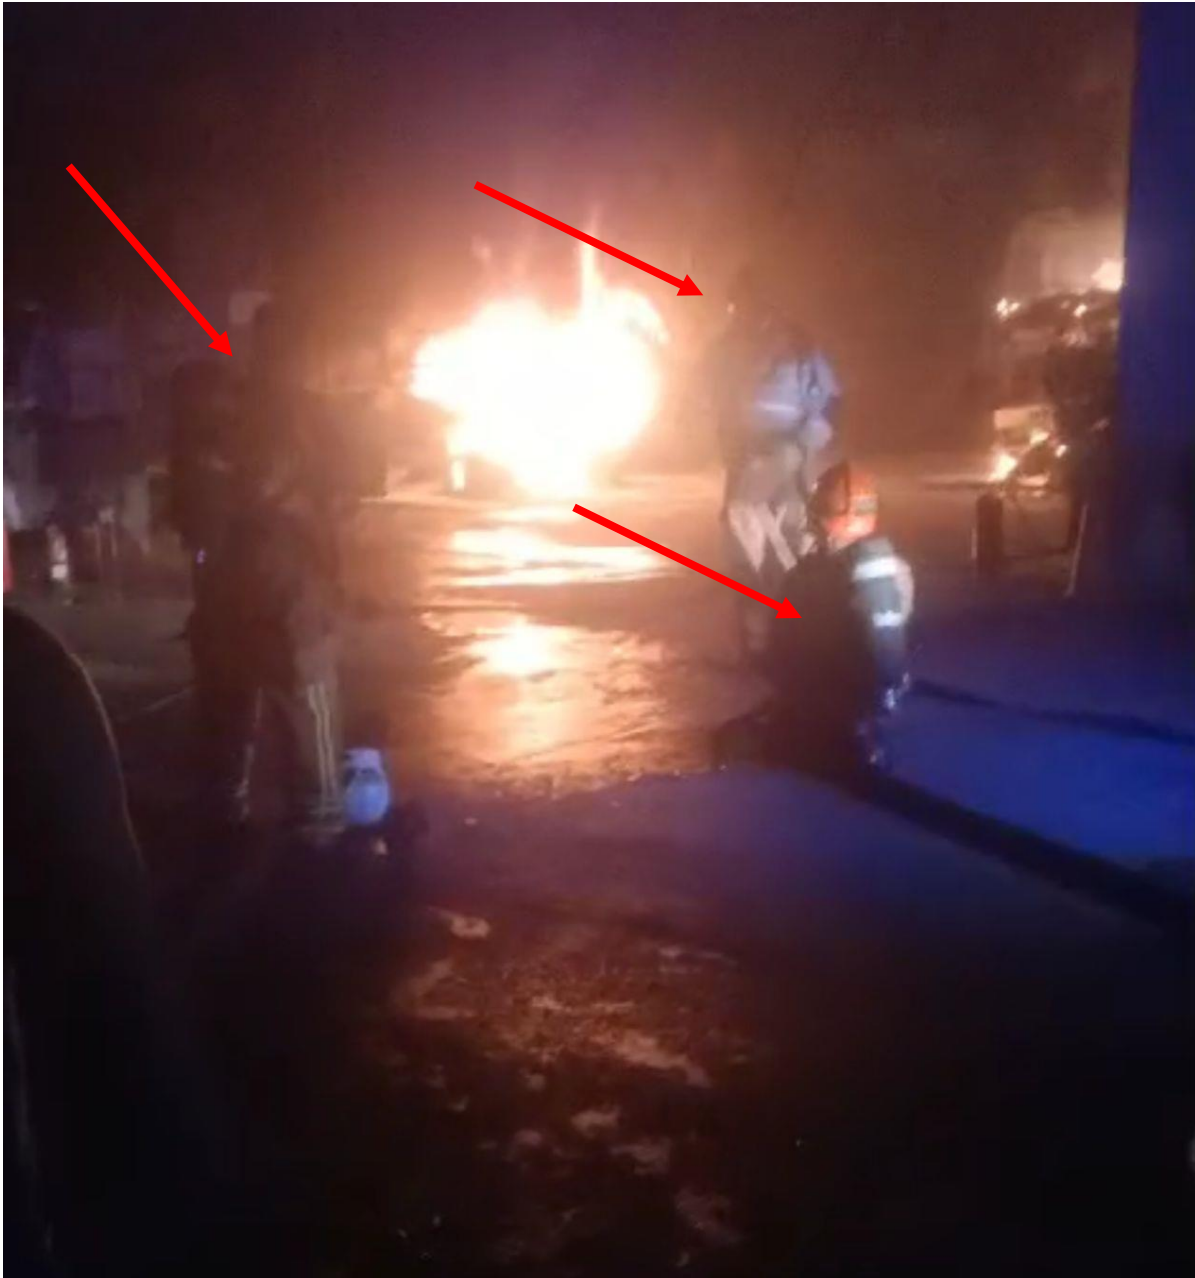
**Photo 12** shows firefighters (red arrows) arriving to the scene and extinguishing the fire to the Insured Vehicle.

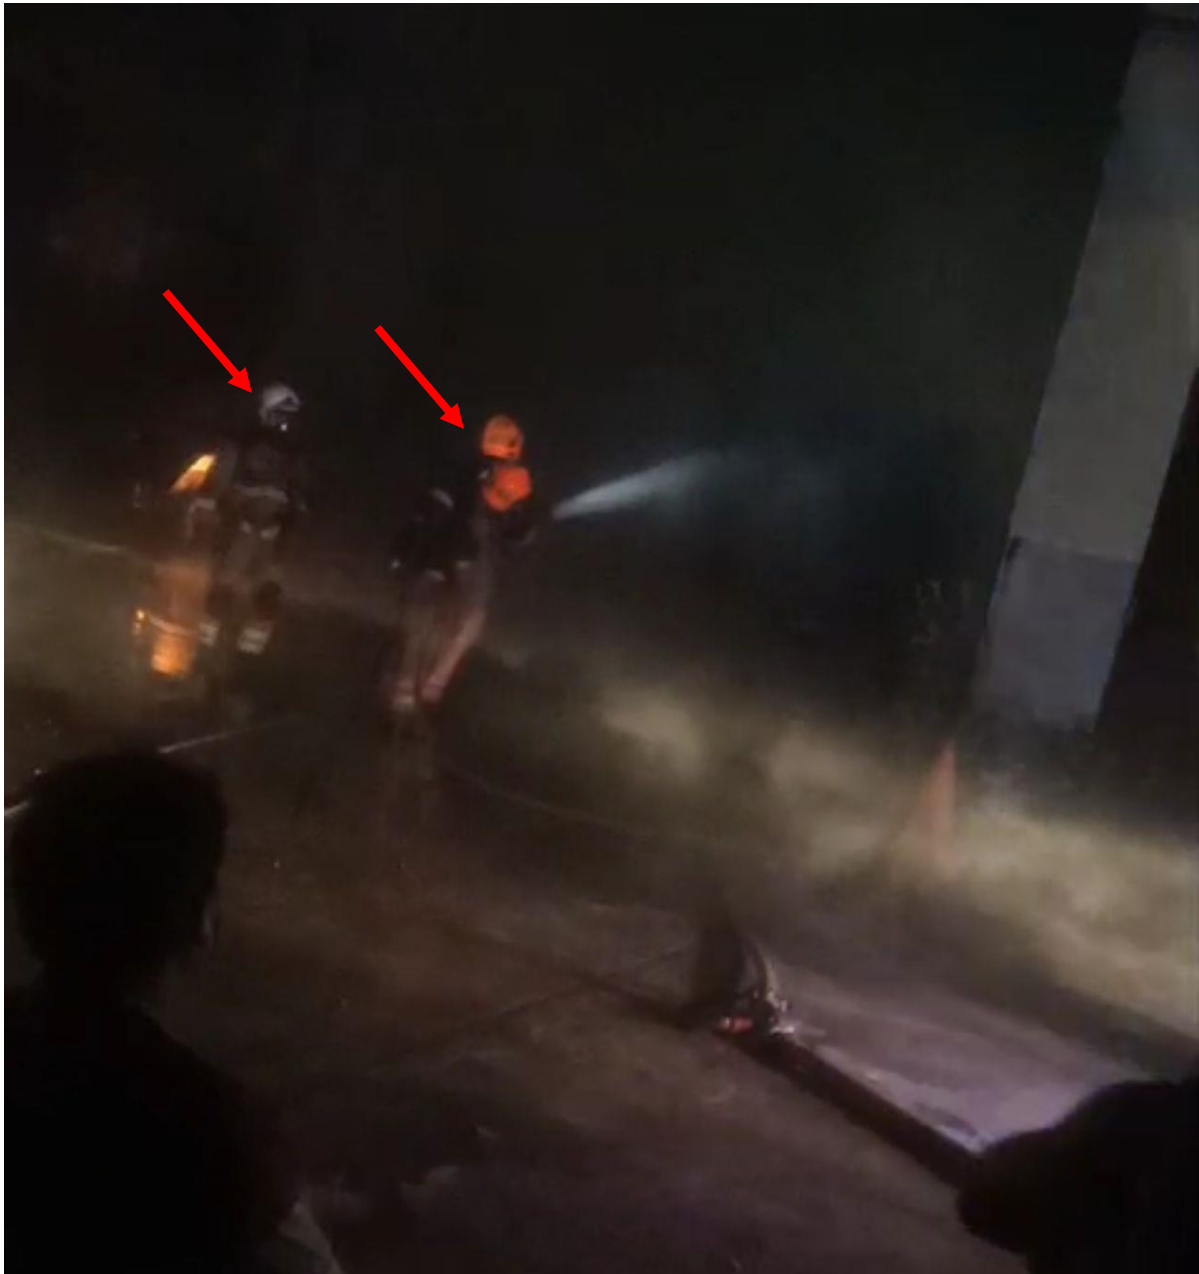
**Photo 13** shows firefighters (red arrows) extinguishing the last remnants of the fire to the Insured Vehicle.
