Your Ref: 23/24/24/VC06/029746  
Our Ref : CS/LPC24090028/J

5 September 2024

**TECHNICAL INVESTIGATION REPORT OF FIRE INCIDENT INVOLVING THE  
INSURED VEHICLE XD 2119Z ON 21 August 2024**

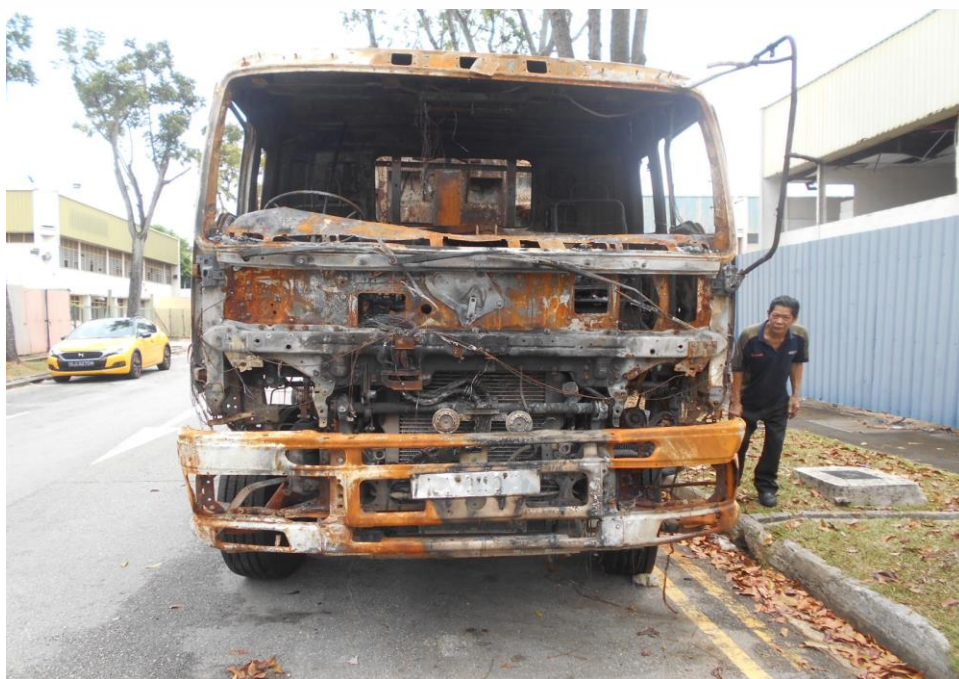
5. The exterior front portion, right body, left body and interior compartment of the Insured Vehicle sustained visible fire damage. This included its front windscreen, front body panels, front bumper, headlights, front bumper, side panels, front right door, front left door and dashboard.
6. The fire had resulted in extensive damage to the interior compartment of the Insured Vehicle. Most of the components inside the interior compartments were found to be severely burnt and/or melted as a result of the fire. However the engine compartment of the Insured Vehicle was appeared to be intact and unaffected by the fire. See photos 1 – 6 below.

**Photo 1** shows the general view of the frontal portion of the Insured Vehicle at the time of our inspection. The exterior of the Insured Vehicle had sustained visible fire damage. This included its front windscreen, front body panels and headlights.

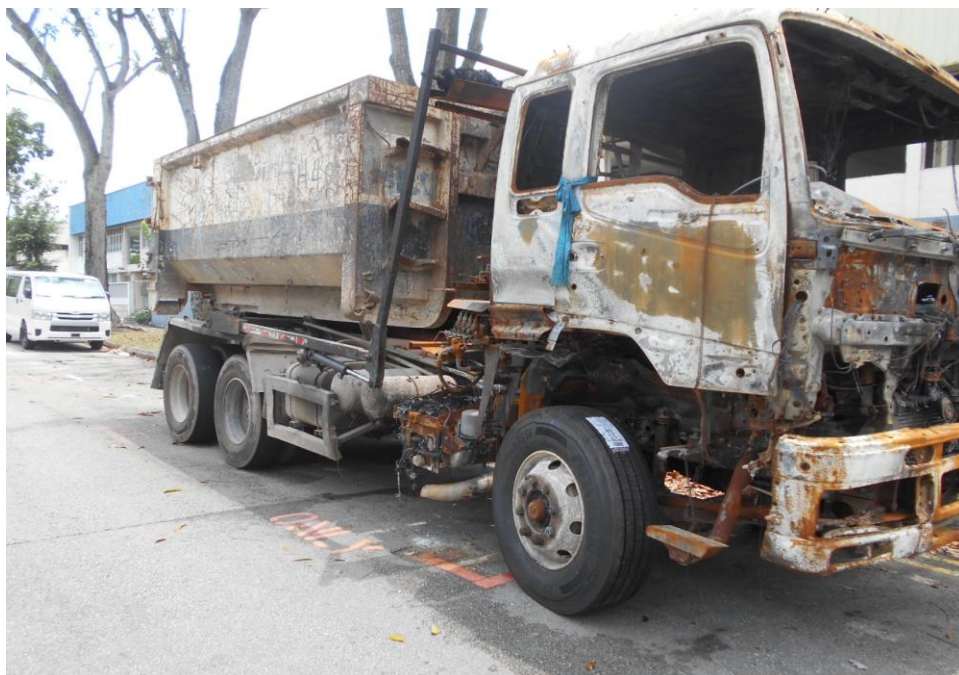
**Photo 2** shows the general view of the right body of the Insured Vehicle at the time of our inspection. The exterior of the Insured Vehicle had sustained visible fire damages. This included its side panels and front right door.

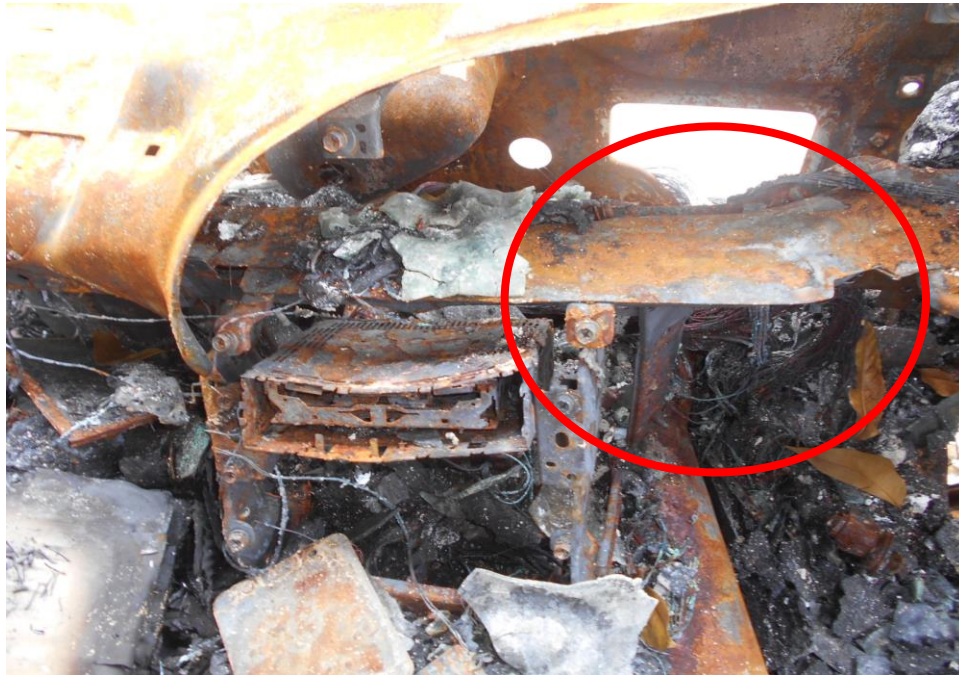
7. For this particular case, the fire appears to have originated within the interior compartment of the Insured Vehicle, somewhere around the front right driver portion of the dashboard. This can be determined from the greenish residue that was found on several stretches of burnt original factory fitted wirings mainly around the centre portion of the interior compartment. The presence of greenish residue indicates internal heating of copper wires, a sign of an electrical short circuit occurring. The greenish residue is normally left behind from oxidation as a result of chemical reaction involving the copper wires. This physical evidence would appear to suggest that the cause of fire to the Insured Vehicle could have possibly been due to electrical in nature. See photos 7 - 10 below.

**Photo 7** shows the burnt wirings around the front right driver portion of the interior dashboard which is near to the vicinity where the fire to the Insured Vehicle had likely started (circled).

20. Having investigated and technically analysed the damages of burnt nature to the Insured Vehicle, we are of the view that the cause of fire to the Insured Vehicle was of electrical in nature. For this particular case, the fire had originated along the wirings inside the interior compartment, somewhere around the front right centre driver portion of the dashboard. The wirings were original factory fitted wirings of the Insured Vehicle.

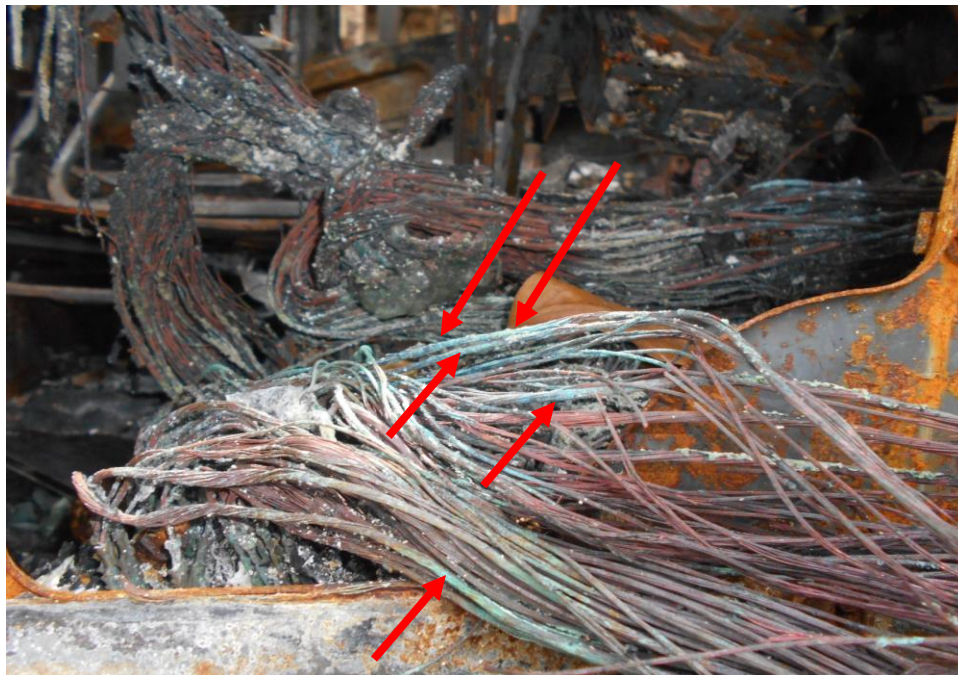
**Photo 10** shows a close up view of the wirings with greenish residue found around the front right driver portion of the interior dashboard of the Insured Vehicle (red arrows). The presence of such greenish residue suggests occurrence of an electrical short circuit.

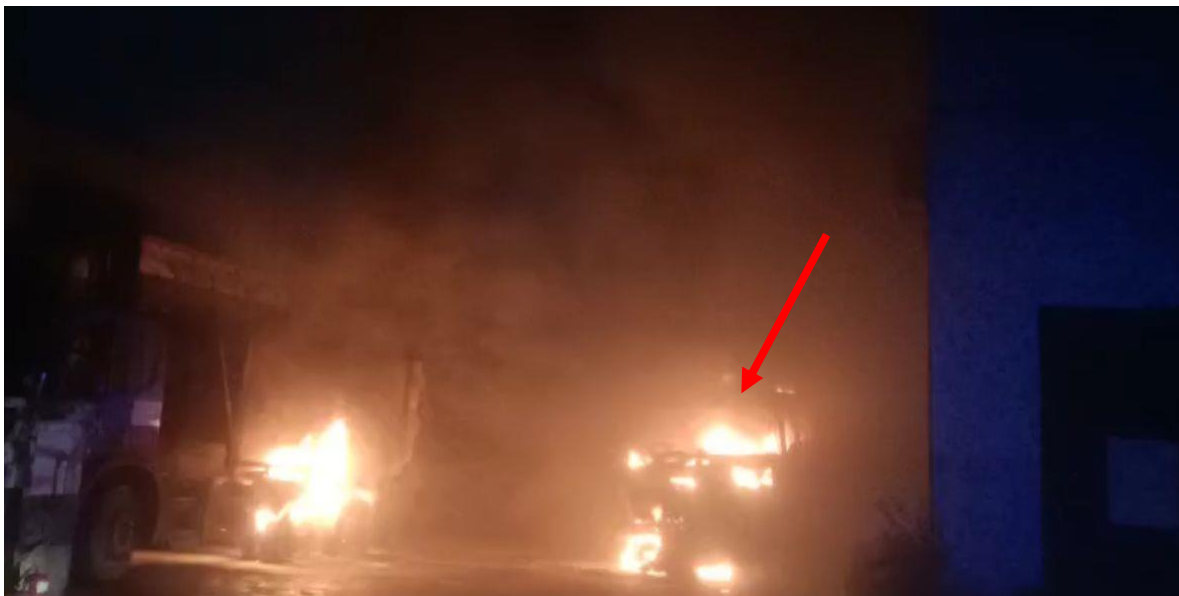
**Photo 11** shows the Insured Vehicle (red arrow) bursting into flames before the arrival of SCDF.
