Your Ref: SNM24D204964
Our Ref: CS/CTI24090067/N

10 September 2024

**TECHNICAL INVESTIGATION REPORT OF FIRE INCIDENT INVOLVING THE
INSURED VEHICLE SLH 144J ON 3 SEPTEMBER 2024**

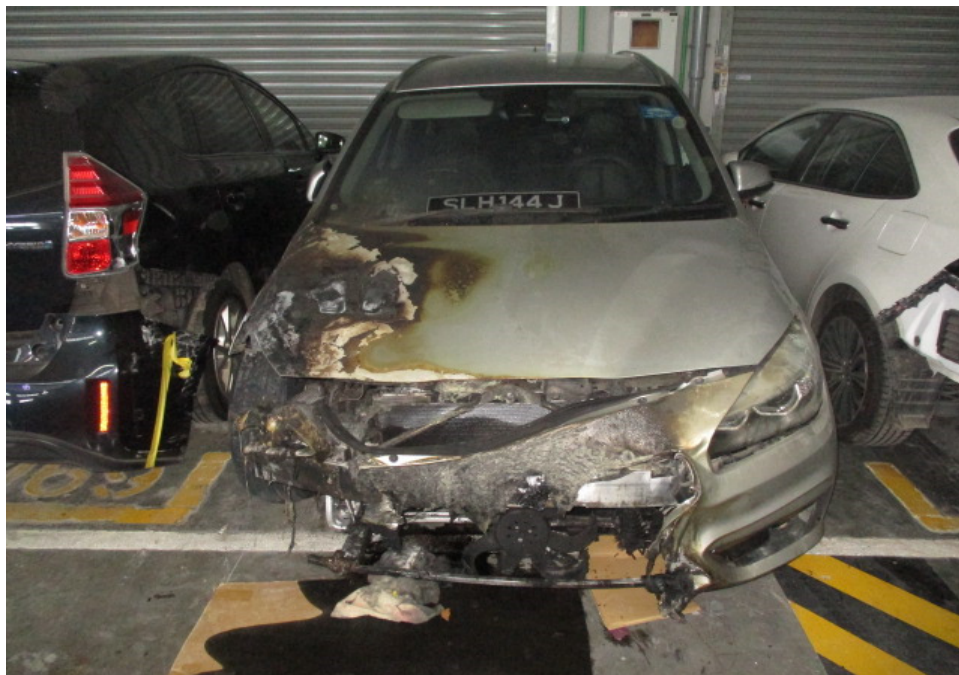
Photo 1 shows the general view of the frontal portion of the Insured Vehicle at the time of our inspection. The fire damage to the Insured Vehicle was confined to its frontal portion.

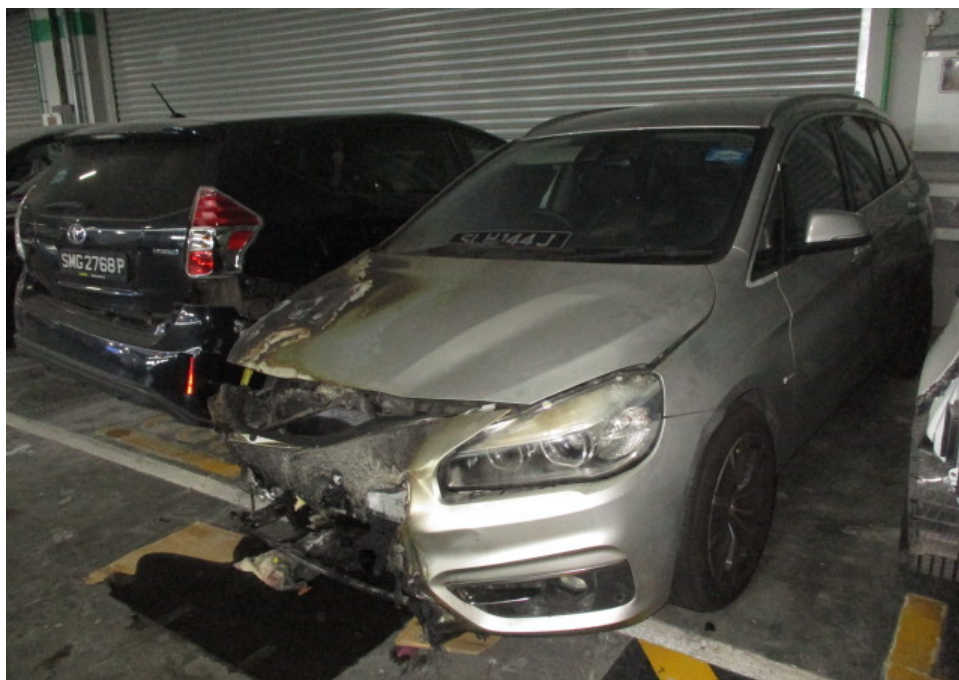
Photo 2 shows the general view of the left front body of the Insured Vehicle at the time of our inspection. The fire damage to the Insured Vehicle was confined to its frontal portion. The entire engine compartment of the Insured Vehicle was observed to be severely burnt while the interior compartment was observed to be relatively unaffected by the fire.

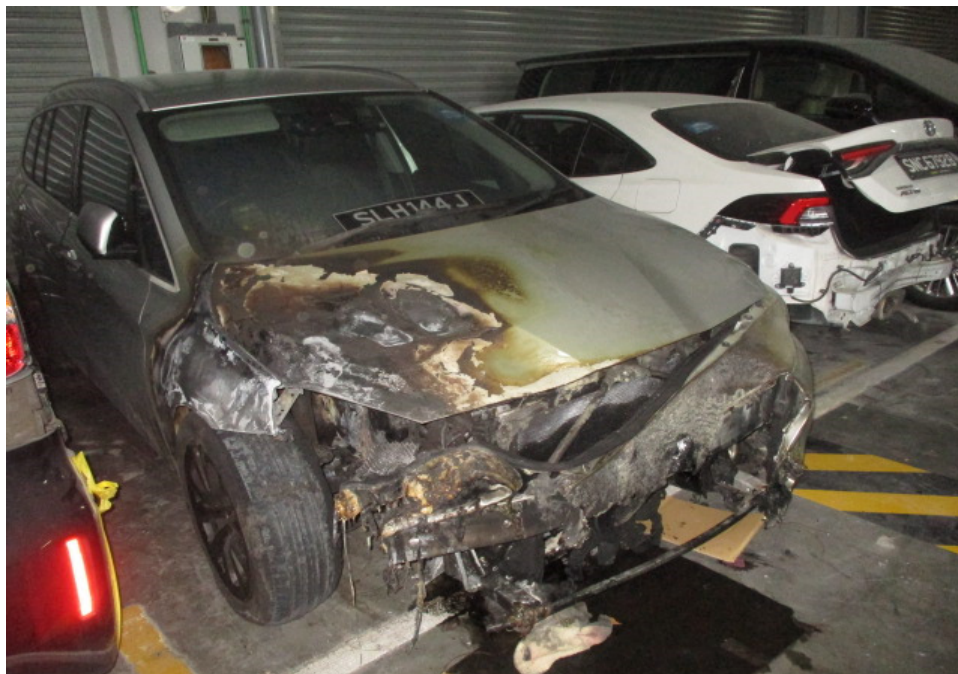
Photo 3 shows the closer view of the right front body of the Insured Vehicle at the time of our inspection. The fire damage to the Insured Vehicle was confined to its frontal portion. Its front bumper, front bonnet, front support panel, front grille, headlamps, front windscreen, front wheel rims, front fenders and front tyres, amongst others were amongst the body parts that were found to have been affected by the fire.

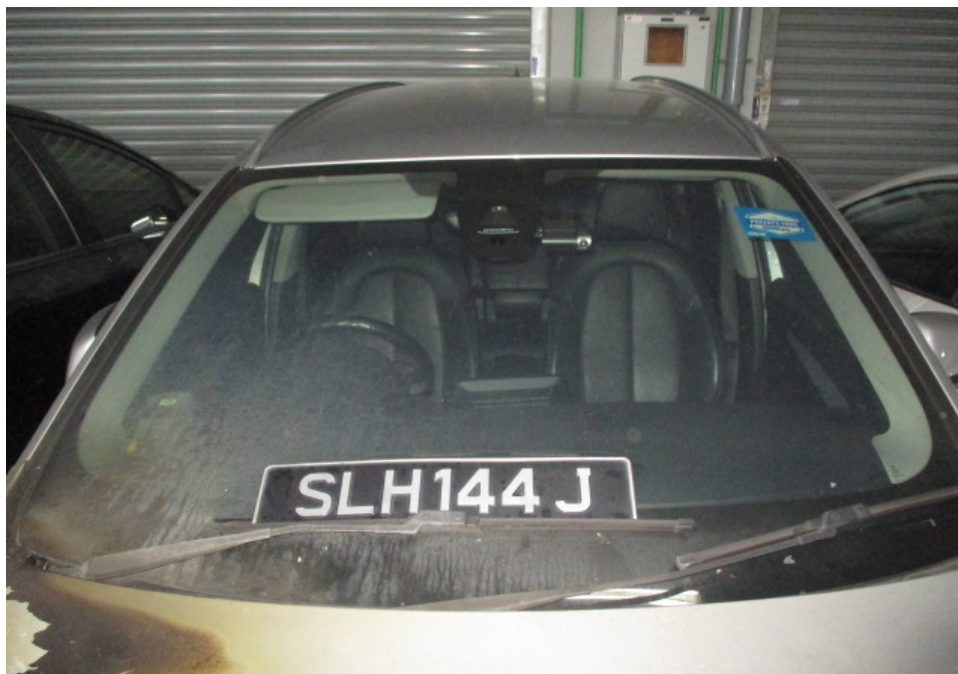
Photo 4 shows the general view of the front windscreen of the Insured Vehicle at the time of our inspection. The front windscreen had sustained serious fire damage.

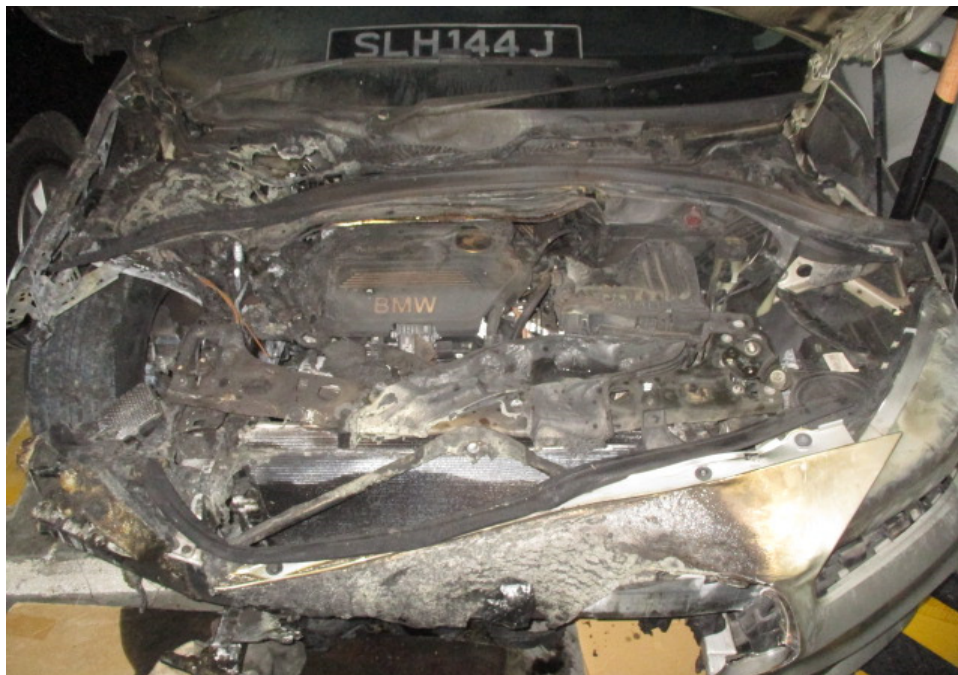
Photo 5 shows the engine compartment of the Insured Vehicle at the time of our inspection. The entire engine compartment of the Insured Vehicle was observed to be severely burnt. Most of the parts inside the engine compartment were found to be burnt and/or melted as a result of the fire.

8. For this particular case, the fire appears to have originated within the engine compartment of the Insured Vehicle as this was the area where the damage of fire nature was most severe.
9. Upon closer examination of the right frontal portion of the engine compartment, which was where the fire to the Insured Vehicle had likely started, we had found traces of greenish residue on several stretches of burnt wirings. The presence of greenish residue indicates internal heating of copper wires, a sign of an electrical short circuit occurring. The greenish residue is normally left behind from oxidation as a result of chemical reaction involving the copper wires. This would then appear to suggest that the cause of fire to the Insured Vehicle could have possibly been due to electrical in nature. See photos 7 - 9 below.

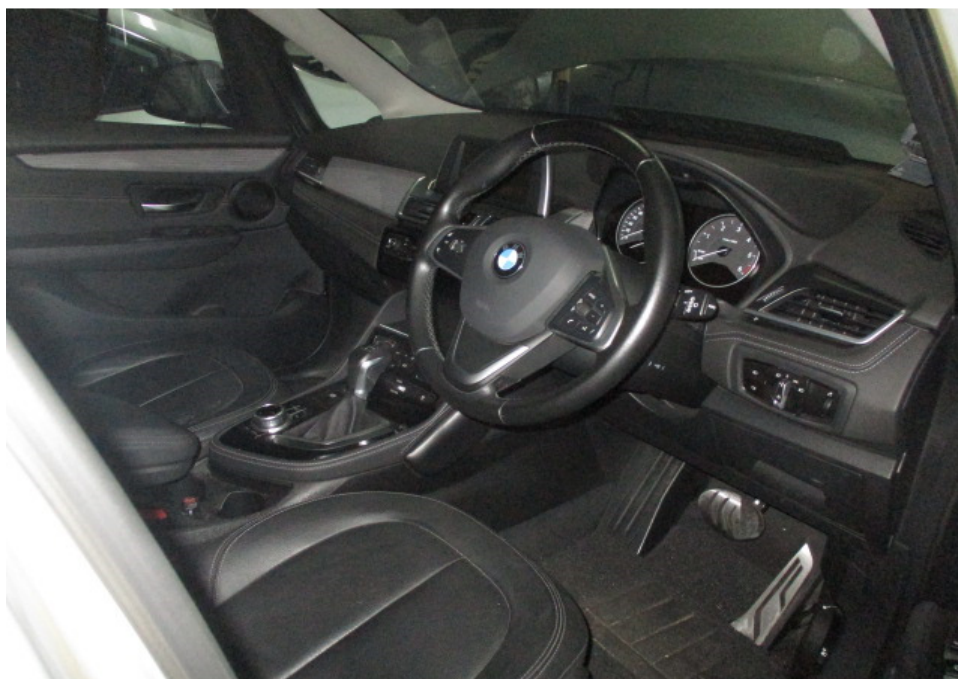
Photo 6 shows the interior compartment of the Insured Vehicle, which was relatively unaffected by the fire.

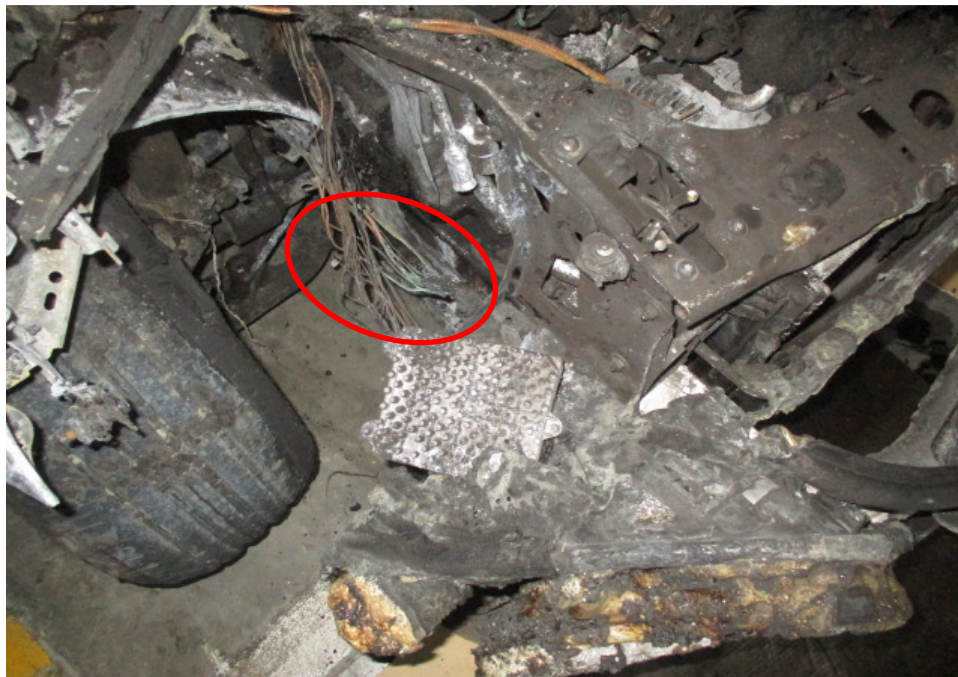
Photo 7 shows the wirings around the right frontal portion of the engine compartment, which is in the immediate vicinity where the fire to the Insured Vehicle had likely started. We noticed greenish residue on several stretches of burnt wirings (circled). The presence of greenish residue indicates internal heating of copper wires, a sign of an electrical short circuit occurring.

23. The possibility of the fire being due to electrical in nature would then seem more likely given that engine overheating and external factors would both seem unlikely. The fire being due to electrical nature is also supported by the condition of the wirings that were found in the engine compartment of the Insured Vehicle, which was earlier discussed in paragraph 9 above.

26. Having investigated and technically analysed the damages to the Insured Vehicle, we are of the view that the cause of fire to the Insured Vehicle was of electrical in nature. For this particular case, the fire had originated along the wirings inside the engine compartment, somewhere at the right frontal portion. The wirings were original factory wirings of the Insured Vehicle.

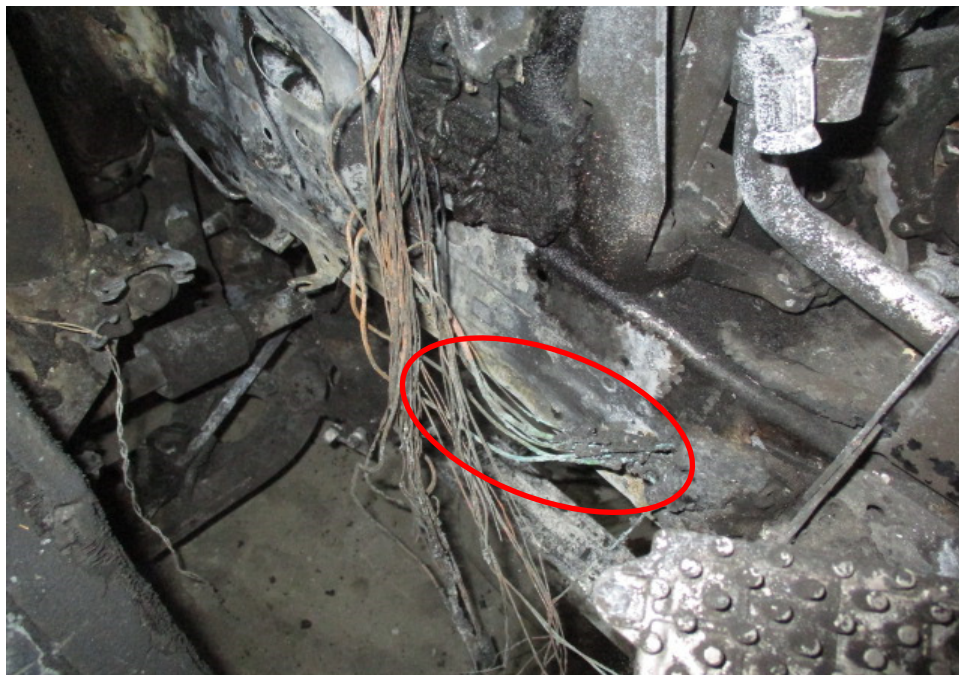
Photo 8 shows a closer view of the burnt wirings around the right frontal portion of the engine compartment. We noticed greenish residue on several stretches of the burnt wirings (circled). The greenish residue is normally left behind from oxidation as a result of chemical reaction involving the copper wires.

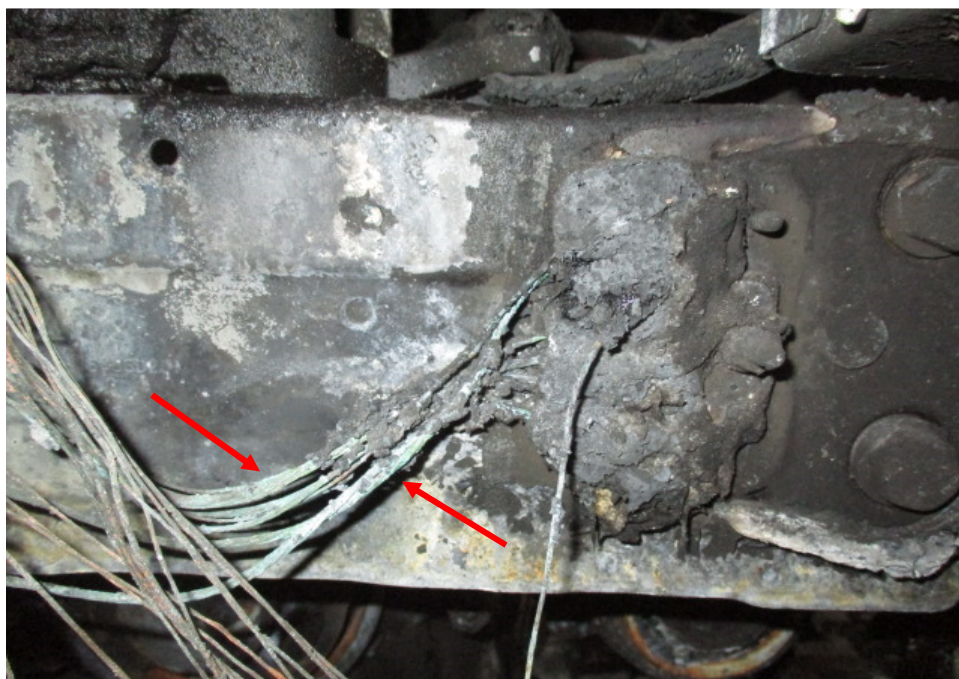
Photo 9 shows a close up view of the greenish residue found on several stretches of burnt wirings (red arrows). The presence of such greenish residue suggests occurrence of an electrical short circuit.

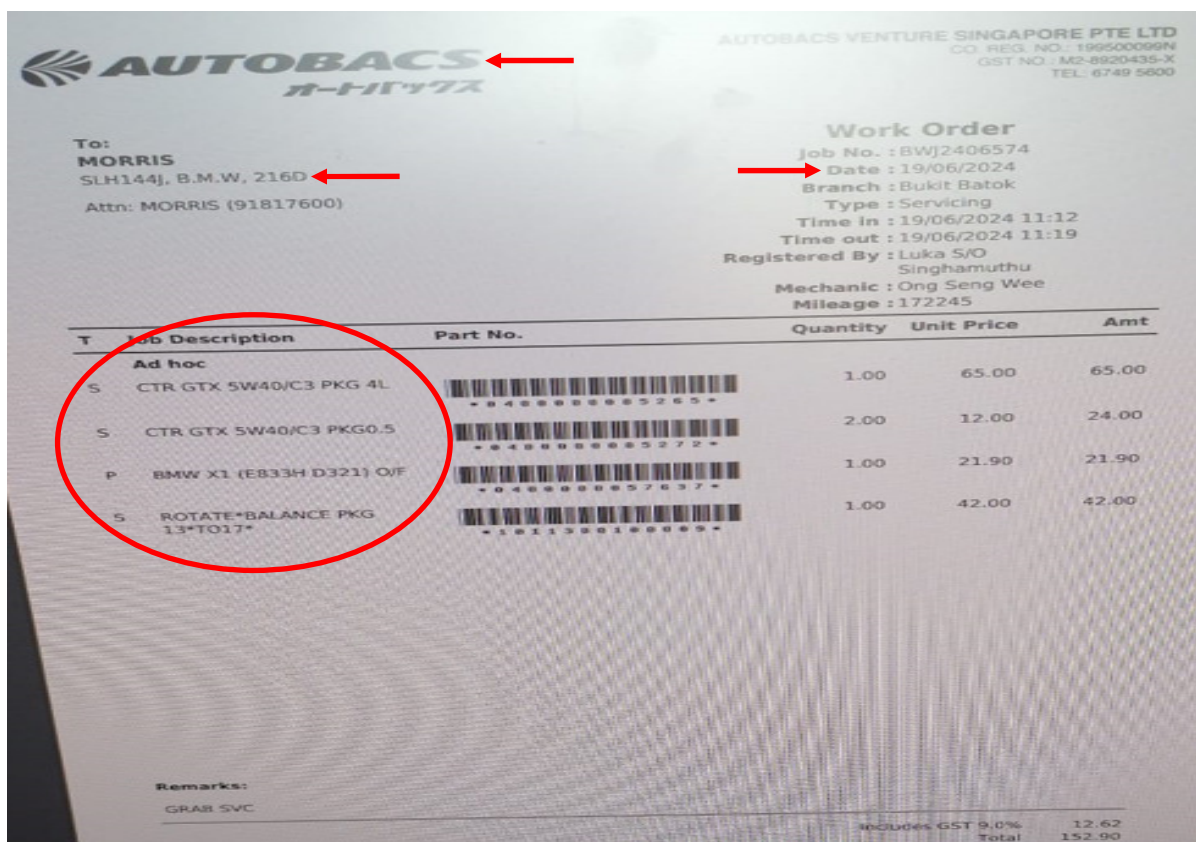
Invoice 1 shows the last servicing package done on the Insured Vehicle on 19 June 2024 at Autobacs (red arrows) which included changing of engine oil and oil filter. The tyres were also rotated and balanced (circled).

20. Based on the vehicle service record invoice provided, we are of the opinion that it is unlikely that the fire could have been caused by poor maintenance of the Insured Vehicle.

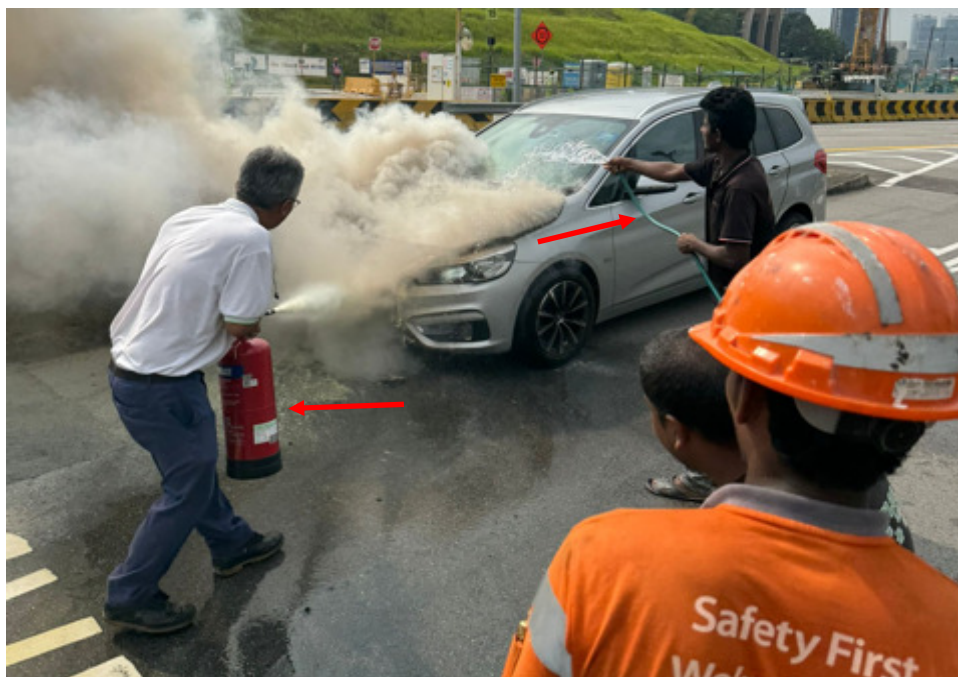
Photo 10 shows the Insured Vehicle on fire before the arrival of the SCDF. In general, the information that could be gathered from this photograph had corresponded to the events that were related to us by Mr Kong which is the staff from Fun's Florist & Nursery were assisting him to put out the fire to the Insured Vehicle with fire extinguishers and a hose reel (red arrows).

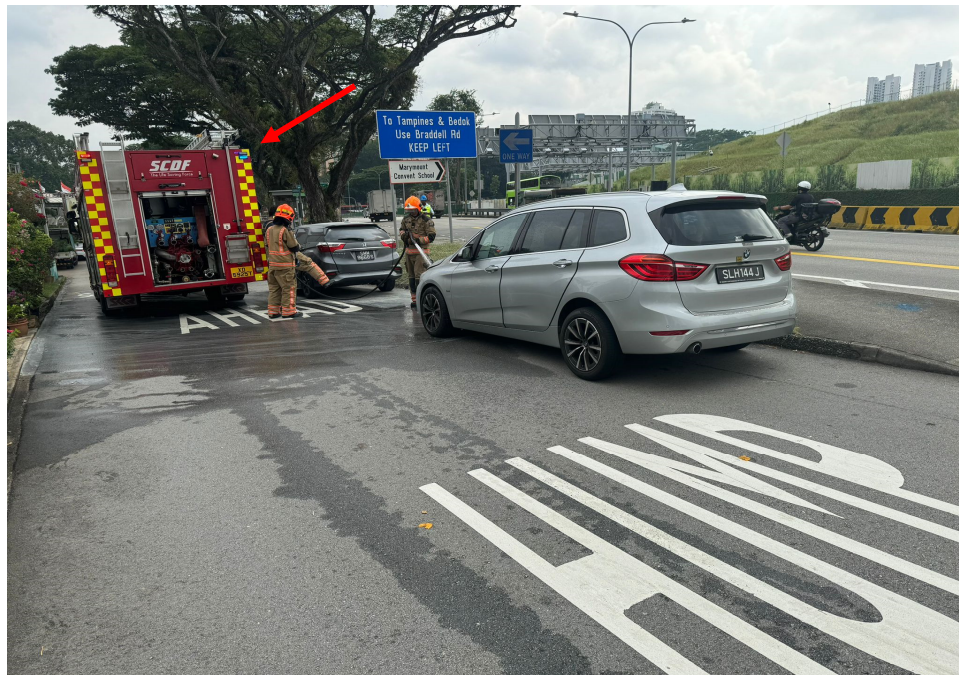
Photo 11 shows the SCDF spraying water on the engine compartment of the Insured Vehicle to make sure the fire is completely put out after prising open the front bonnet. In general, the information that could be gathered from this photograph had corresponded to the events that were related to us by Mr Kong which is the SCDF was present at the incident location (arrowed).

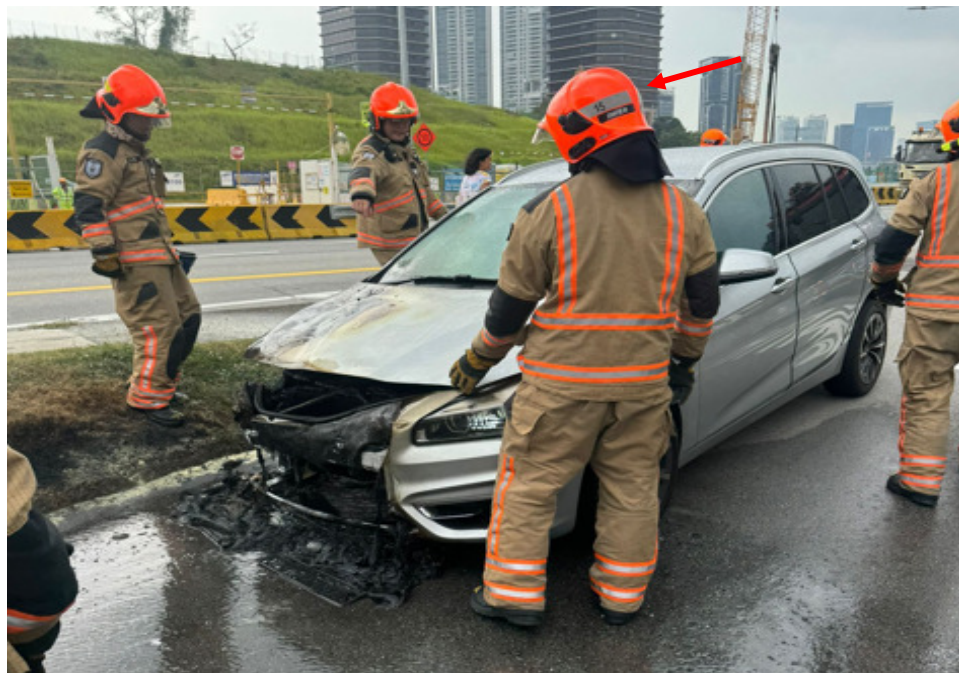
Photo 12 shows the SCDF conducting preliminary investigations after putting out the fire to the Insured Vehicle (arrowed).

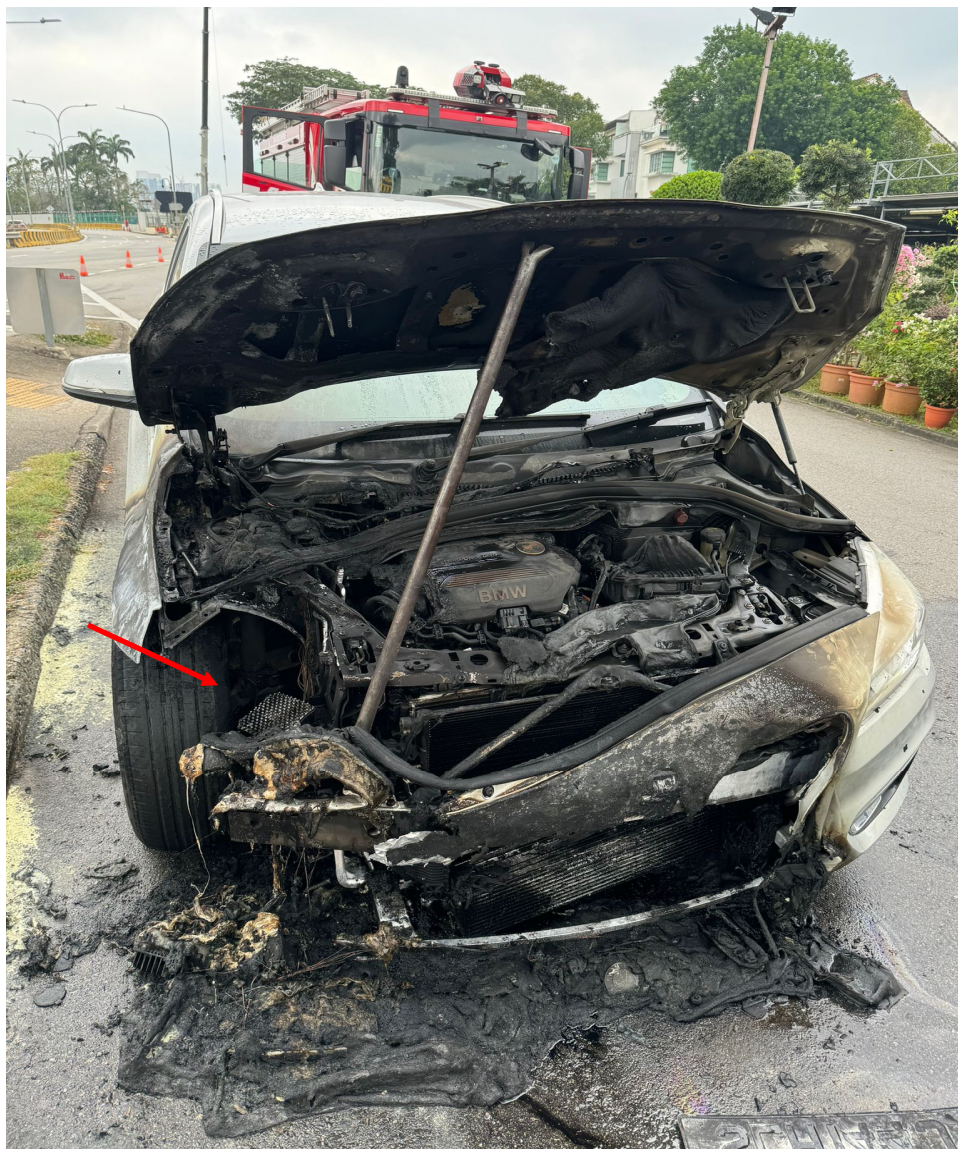
Photo 13 shows the Insured Vehicle post- incident. In general, the information that could be gathered from this photograph had corresponded to the events that were related to us by Mr Kong which is the fire had started from the engine compartment of the Insured Vehicle (arrowed).

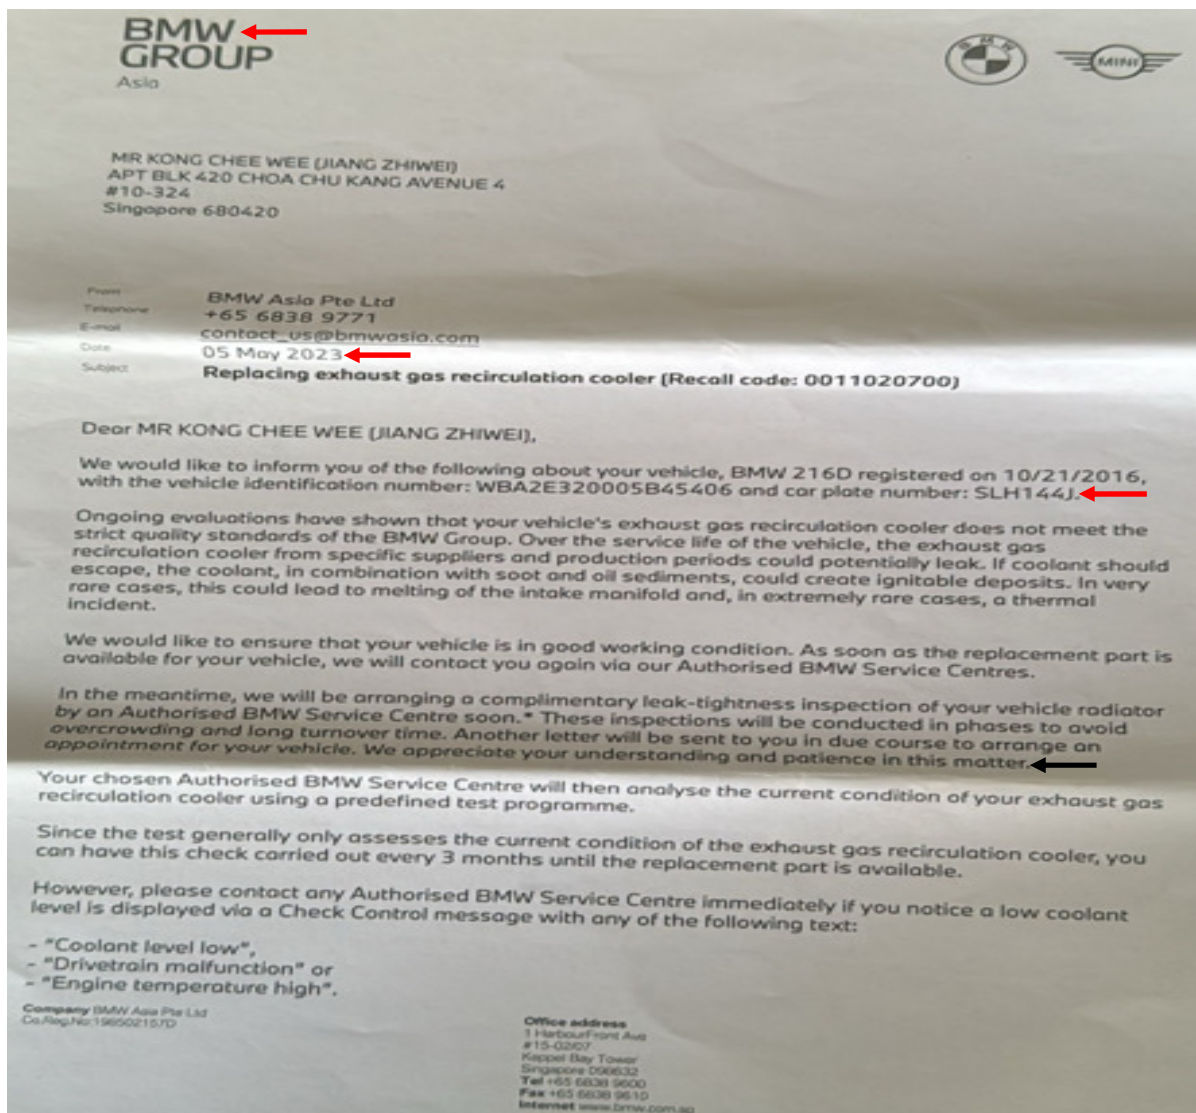
25. We asked Mr Kong regarding the manufacturer recall on 21 April 2023 which was not rectified. Mr Kong mentioned that he received a letter from PML dated 5 May 2023 that he would be contacted again once the replacement part had arrived. He was also informed that a complimentary leak tightness inspection would be performed on the Insured Vehicle in due course. On 22 August 2023 he brought the Insured Vehicle to Performance Motors Limited located at 303A Alexandra Road, Singapore 159941. Checks were performed on the Insured Vehicle and it was found that the EGR was in good condition. Refer to photo 14 and the Repair Order below.

Photo 14 shows the letter dated 5 May 2023 which Mr Kong had received from Performance Motors Limited notifying him of the manufacturer recall and that he would be contacted again once the replacement part had arrived (red arrows). He was also informed that a complimentary leak tightness inspection would be performed on the Insured Vehicle in due course (black arrow).
