Your Ref: M2404769
Our Ref: CS/TMI24090111/Pqp3e2

M/s TOKIO MARINE INSURANCE SINGAPORE LTD

**TECHNICAL INVESTIGATION REPORT OF FIRE INCIDENT INVOLVING THE
INSURED VEHICLE GBK 6307U ON 2nd August 2024**

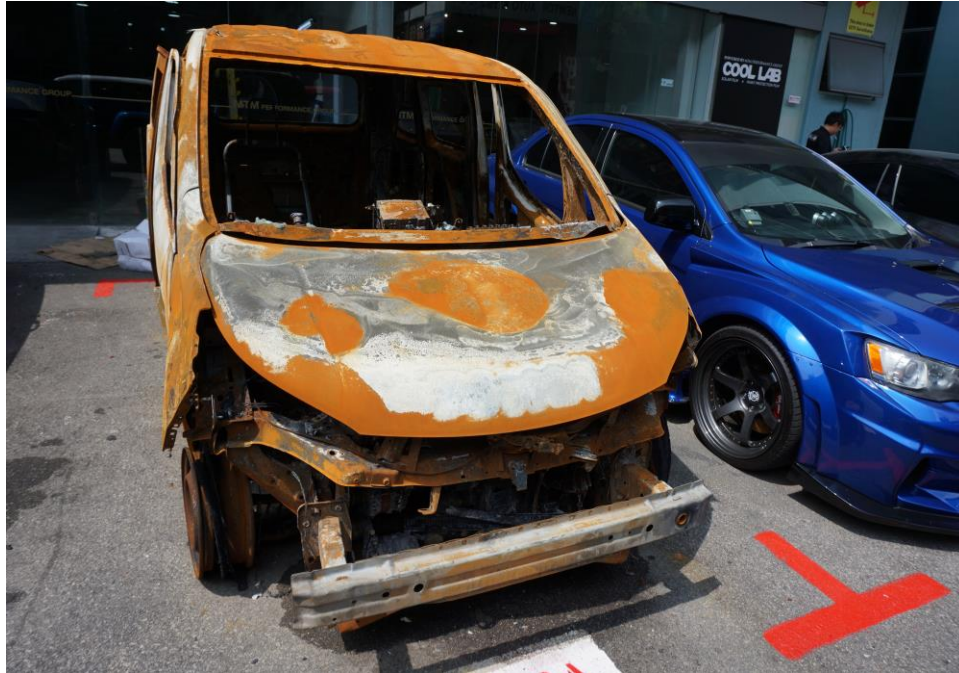
Photo 1 shows the general view of the front portion of the Insured Vehicle at the time of our inspection. The Insured Vehicle was observed to have sustained extensive fire damage all around. Its engine compartment and interior compartment were completely burnt. Rust had accumulated all around the Insured Vehicle as a result of exposure to environmental condition for a period of time.

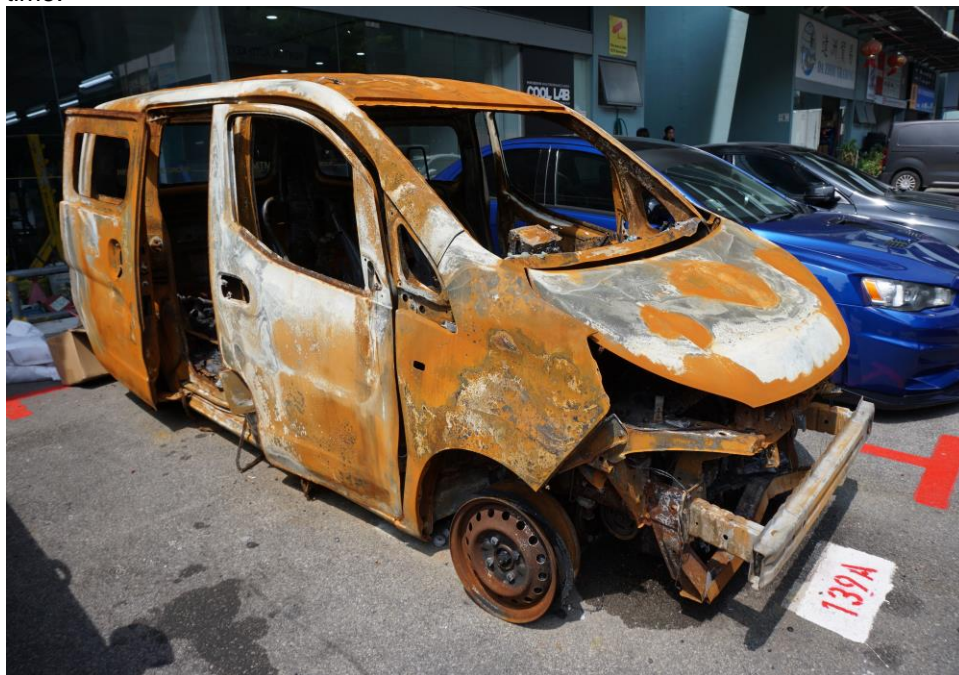
Photo 2 shows the general view of the right body of the Insured Vehicle at the time of our inspection. The Insured Vehicle was observed to have sustained extensive fire damage all around. Rust had accumulated all around the Insured Vehicle as a result of exposure to environmental condition for a period of time.

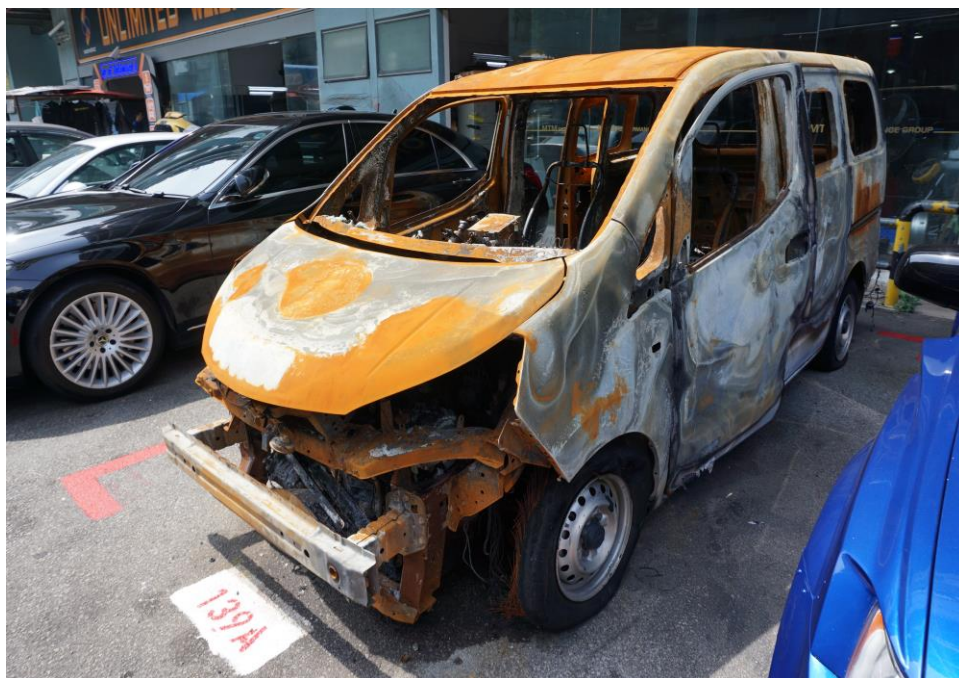
Photo 3 shows the general view of the left body of the Insured Vehicle at the time of our inspection. The Insured Vehicle was observed to have sustained extensive fire damage all around. Rust had accumulated all around the Insured Vehicle as a result of exposure to environmental condition for a period of time.

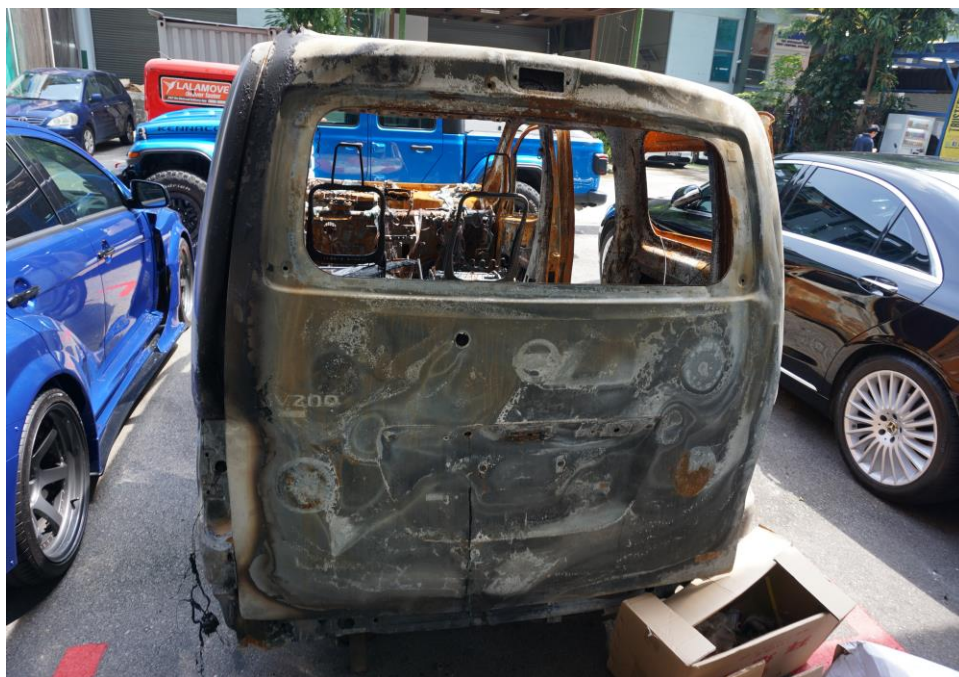
Photo 4 shows the general view of the rear portion of the Insured Vehicle. The Insured Vehicle was observed to have sustained extensive fire damage all around. Rust had accumulated all around the Insured Vehicle as a result of exposure to environmental condition for a period of time.

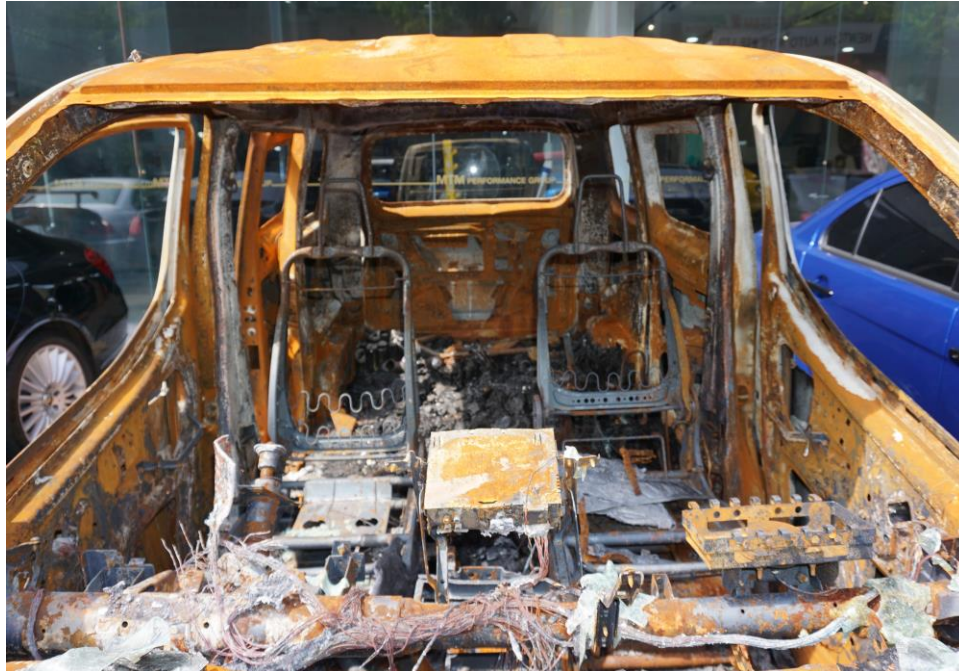
Photo 5 shows the general view of the interior compartment of the Insured Vehicle at the time of our inspection. Its interior compartment was completely burnt as a result of the fire.

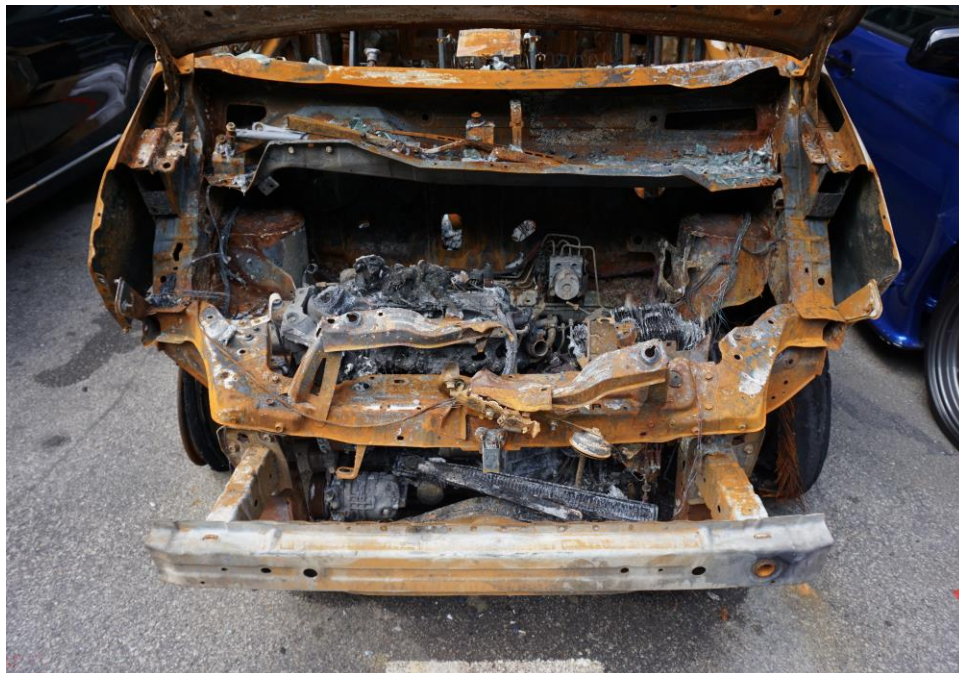
Photo 6 shows the engine compartment of the Insured Vehicle at the time of our inspection. The entire engine compartment of the Insured Vehicle was observed to be severely burnt. Most of the parts inside the engine compartment were found to be burnt and/or melted as a result of the fire.

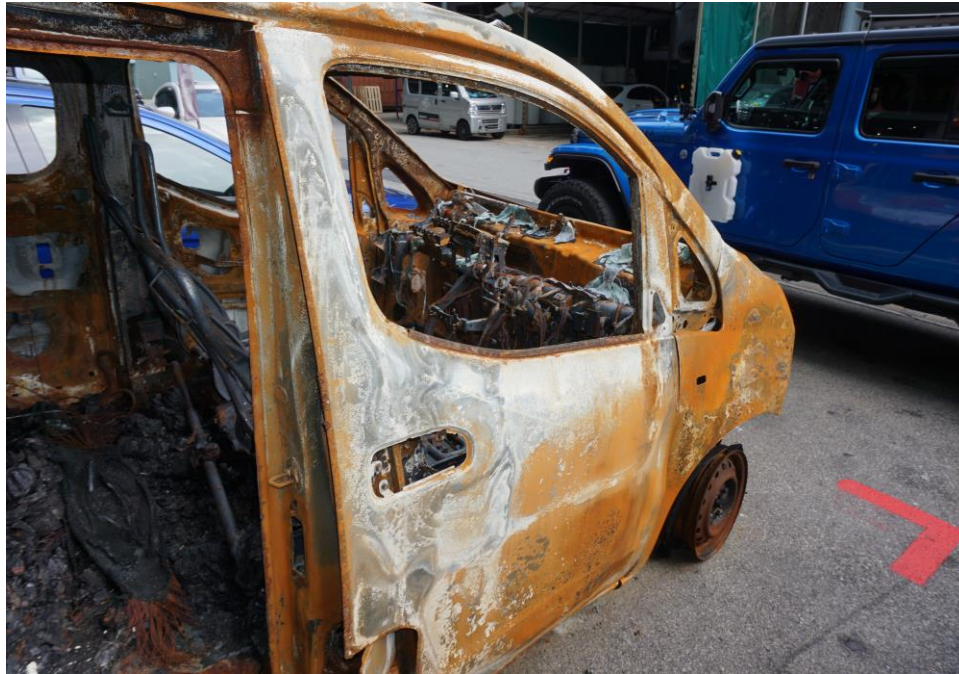
15. Based on the circumstances for this particular case, the fire appears to have originated from the interior cabin of the Insured Vehicle, somewhere around the driver's portion and had spread to the whole vehicle. This can be determined basing on the area where the extent of fire damage was most severe, the circumstances of the fires' origin at the material time of incident and also the high heat intensity burn marks (whitish burn marks) that were found on the exterior surface of its front right portion.

16. These whitish burn marks are a result of exposure to prolong heat intensity. Rust would normally start to develop around these areas soon after a fire as the prolonged exposure to high heat intensity usually causes the bare steel/metal material of the body parts to be exposed to natural environmental condition. The rust that had developed on the whole vehicle, in the immediate vicinity of where these whitish burn marks were found, would also support our findings of where the fire had affected the Insured Vehicle. See photo 7 and 8 below.

Photo 7 shows the exterior of the front right portion of the Insured Vehicle at the time of our inspection. The high heat intensity burn marks (whitish burn marks) and rust that had development found on the exterior surface of the bonnet indicates that the fire had originated from the front right portion of the Insured Vehicle.

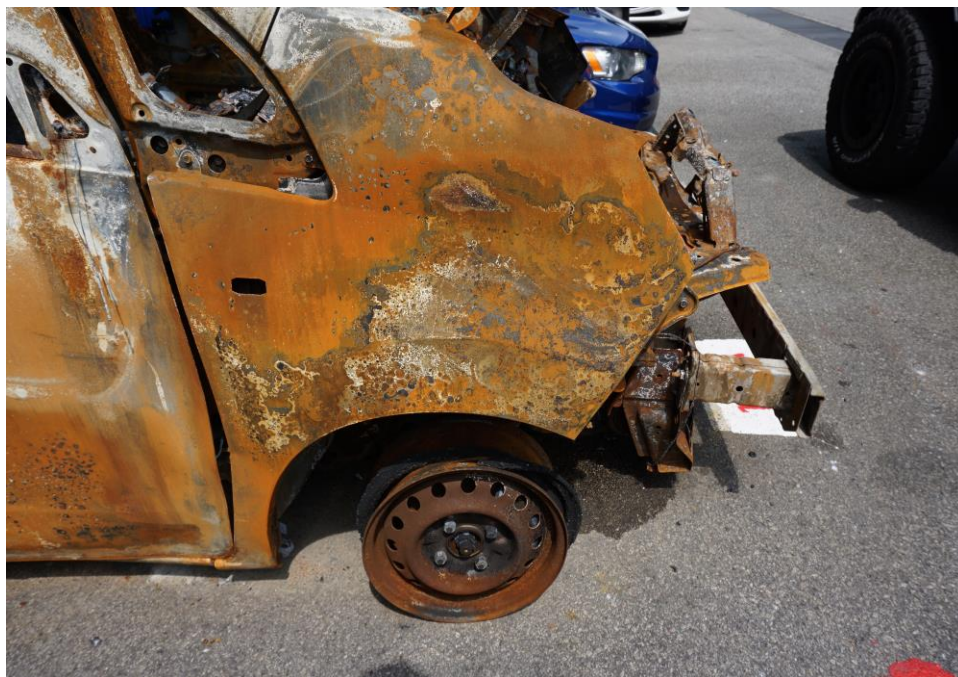
Photo 8 shows the front right fender of the Insured Vehicle at the time of our inspection. The High heat intensity burn marks (whitish burn marks) and rust that had development found on the exterior surface of the front right fender indicates that the fire had originated from the front right portion of the Insured Vehicle.

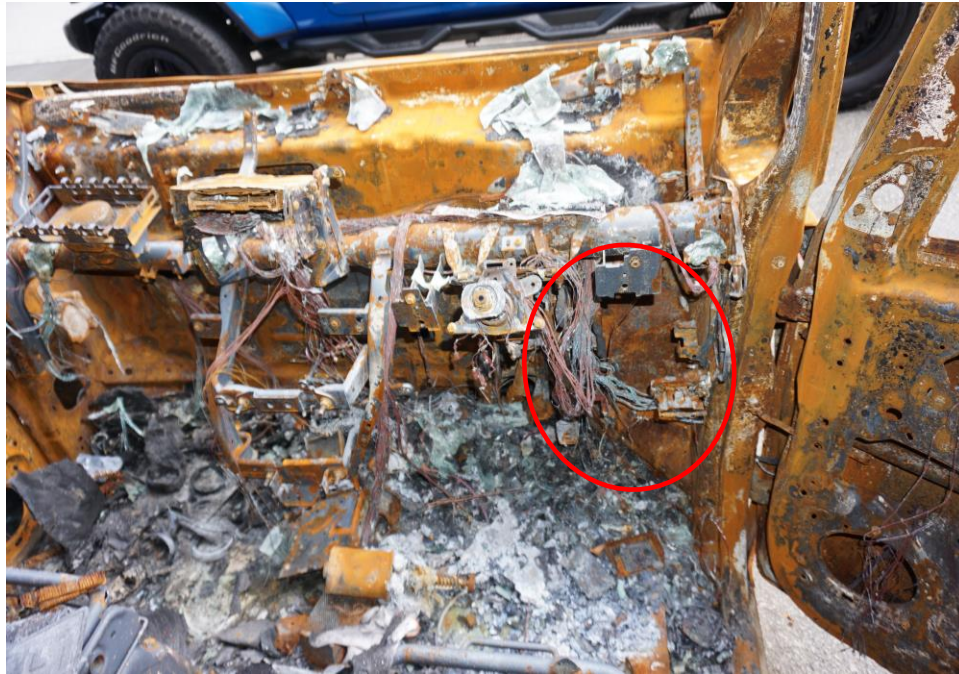
17. Upon closer examination of the cabin interior right portion of the Insured Vehicle which was where the fire had started, we had observed that the front driver's portion of the engine compartment had sustained a stronger high heat intensity burn mark as compared to the surrounding areas of the engine compartment.

Photo 9 shows the general view of the driver interior compartment of the Insured Vehicle at the time of our inspection. We had observed that the driver's right portion (circled) had sustained a stronger high heat intensity burn marks.

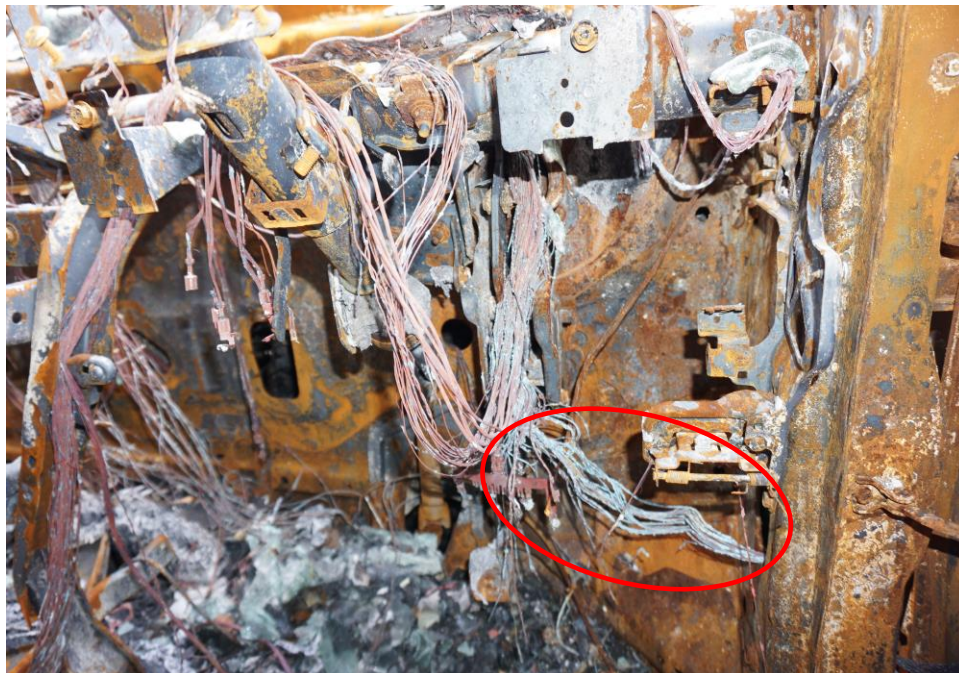
18. We had also found broken copper wirings and traces of greenish residue on these wirings harnesses that were leading from the battery to the electrical components in the cabin of the Insured Vehicle. This due likely been where the fire had started from.

19. The wirings were original wirings fitted from the manufacturer. The presence of greenish residue indicates internal heating of copper wires, a sign of an electrical short circuit occurring. The greenish residue is normally left behind from the oxidation as a result of chemical reaction involving the copper wires and the broken copper wiring was due to the intense heat generate from the short circuit that had caused it to break off. This physical evidence would then appear to suggest that the cause of fire to the Insured Vehicle could have possibly been due to electrical in nature. See photos 9 - 11 below.

Photo 10 shows the close up view of the driver interior compartment of the Insured Vehicle at the time of our inspection. We had observed that the driver's right portion we had also found traces of greenish residue on the wirings harnesses (circled) leading from the battery to the electrical components in the cabin of the Insured Vehicle.

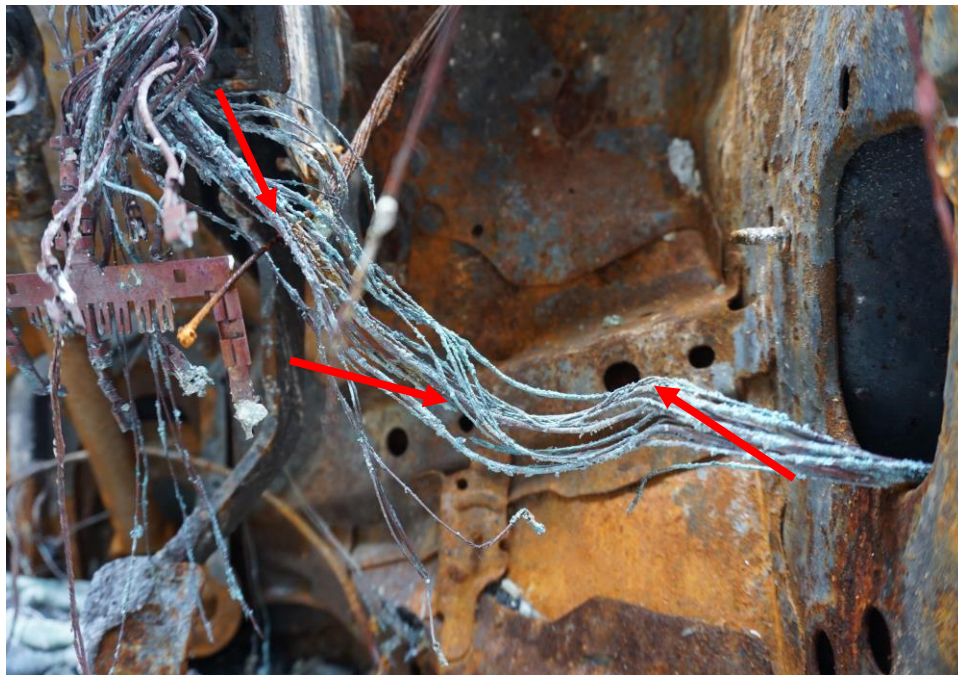
Photo 11 shows the close up view of the driver interior compartment of the Insured Vehicle at the time of our inspection. We had also found traces of greenish residue on the wirings harnesses and the broken copper wirings this is due to the intense heat generate from the short circuit that had likely been where the fire had started from (arrowed) leading from the battery to the electrical components in the cabin of the Insured Vehicle.

26. Having investigated and technically analysed the damages of burnt nature to the Insured Vehicle, we are of the view that the cause of fire to the Insured Vehicle was of electrical nature. For this particular case, the fire had originated along the original wiring harnesses leading from the battery to the electrical components of the Insured Vehicle.
27. We did not find any evidence which had suggested that the cause of fire to the Insured Vehicle was due to poor maintenance and/or recurring electrical problem.

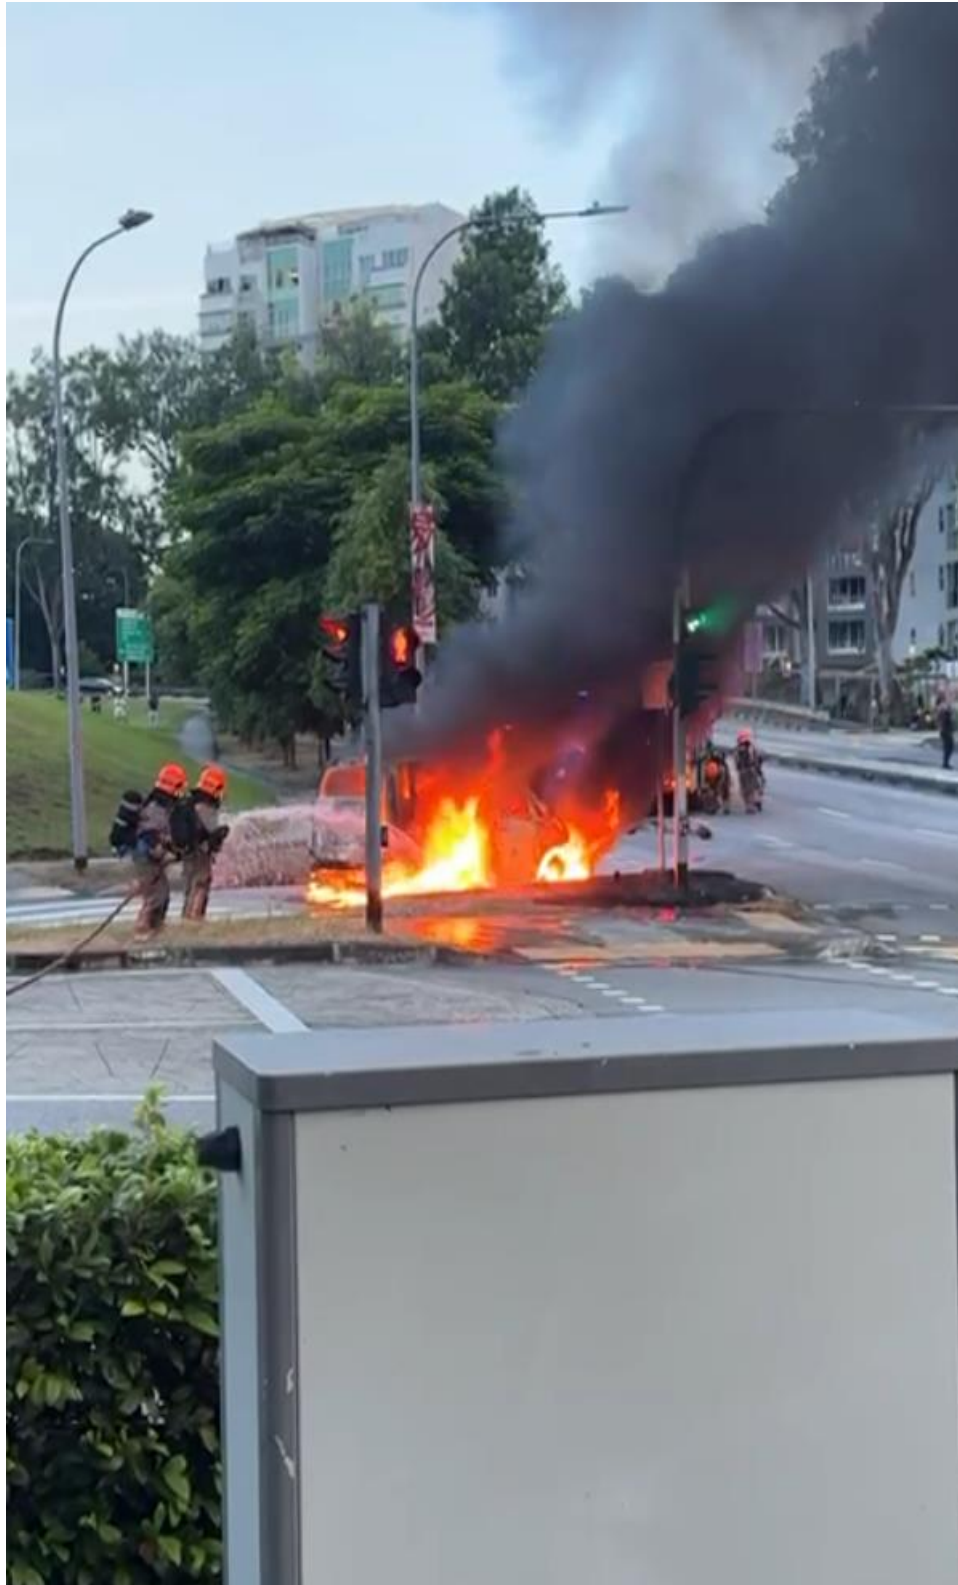
Photo 12 shows the Insured Vehicle on fire and the fire observed to be emitting from the interior of the Insured Vehicle. In general, the information that could be gathered from this photograph had corresponded to the events that were related to us by Mr Chan, location when the fire broke out.

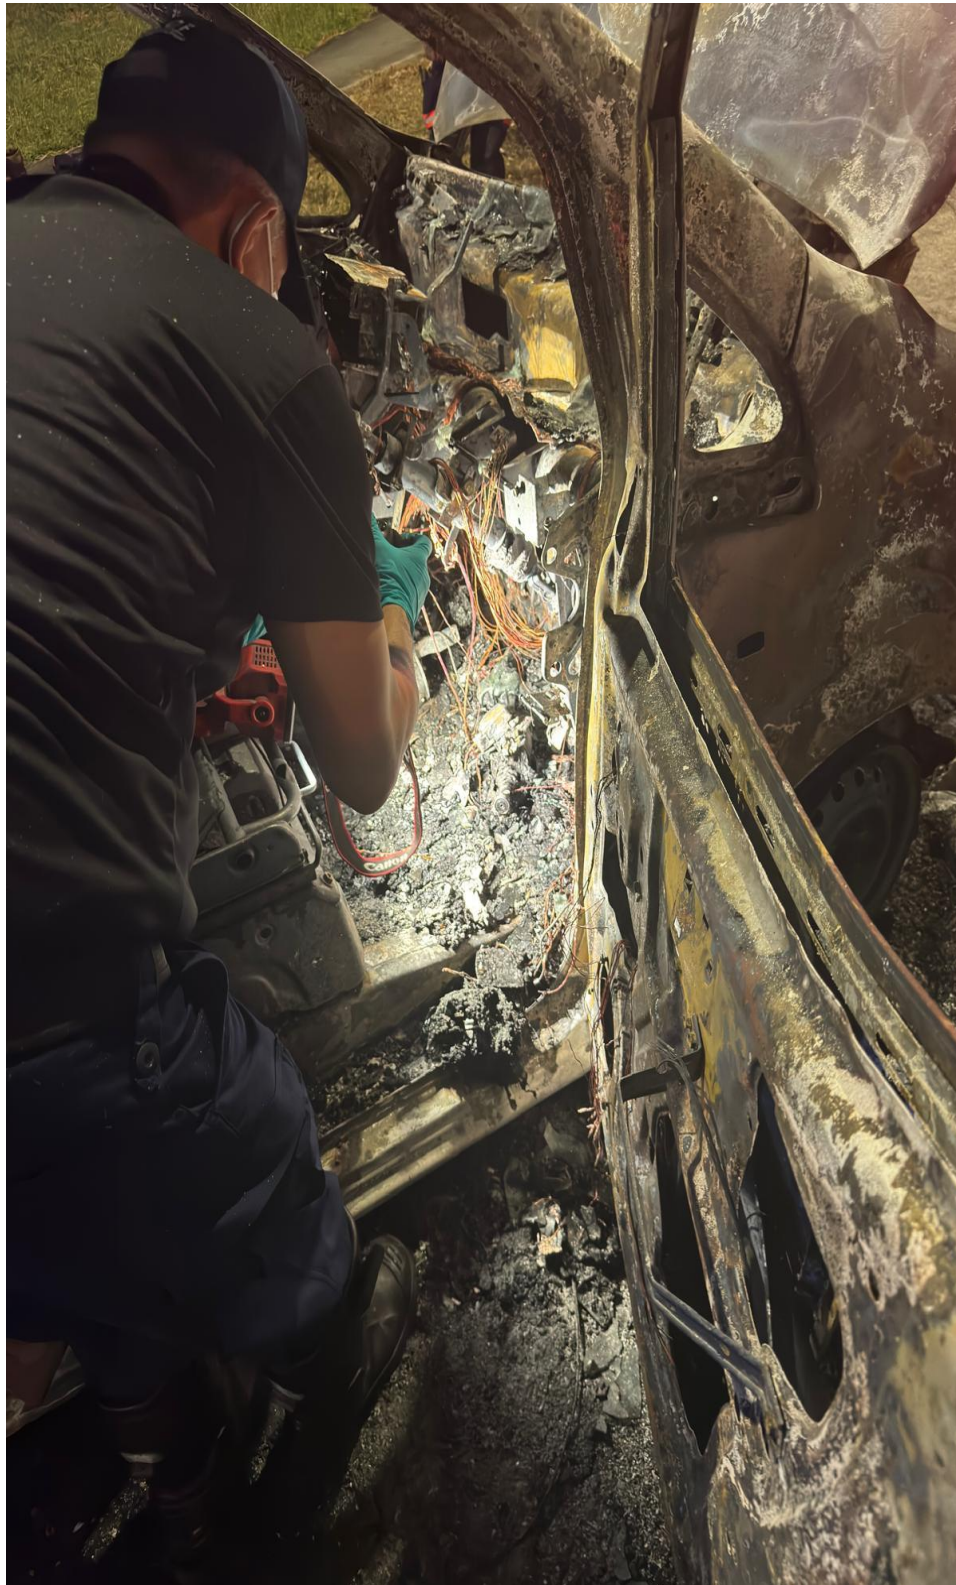
Photo 13 shows the SCDF officers on scene investigating the Insured Vehicle after the fire was put out. In general, the information that could be gathered from this photograph had corresponded to the events that were related to us by Mr Chan, location when the fire broke out.
