Your Ref: SNM24D204995
Our Ref : CS/CTI24090156/N

16 September 2024

**TECHNICAL INVESTIGATION REPORT OF FIRE INCIDENT INVOLVING THE
INSURED VEHICLE SKD 6339H ON 4 SEPTEMBER 2024**

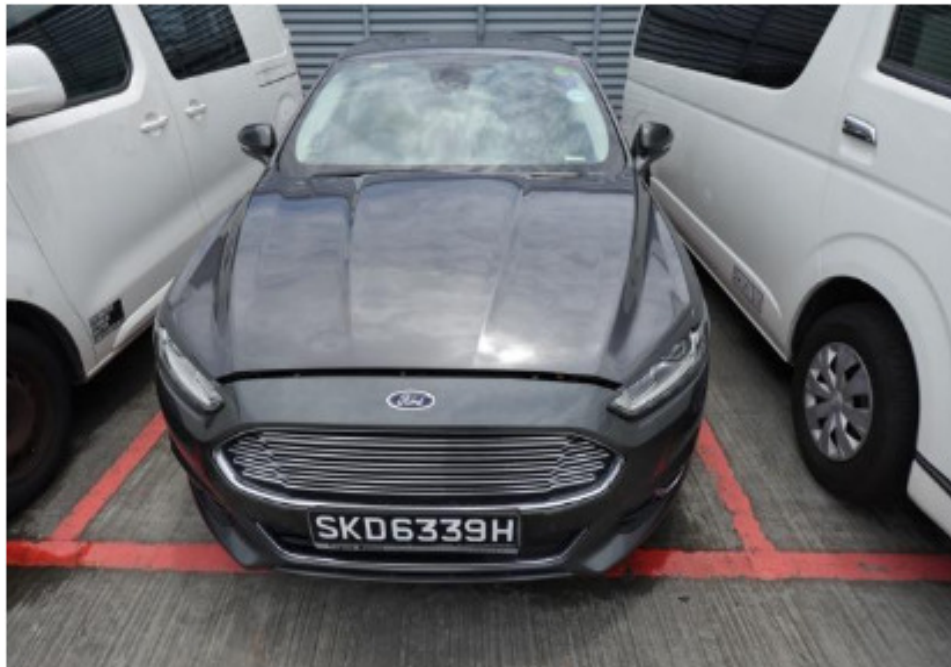
Photo 1 shows the general view of the frontal portion of the Insured Vehicle at the time of our inspection. The front portion of the Insured Vehicle was relatively unaffected by the fire.

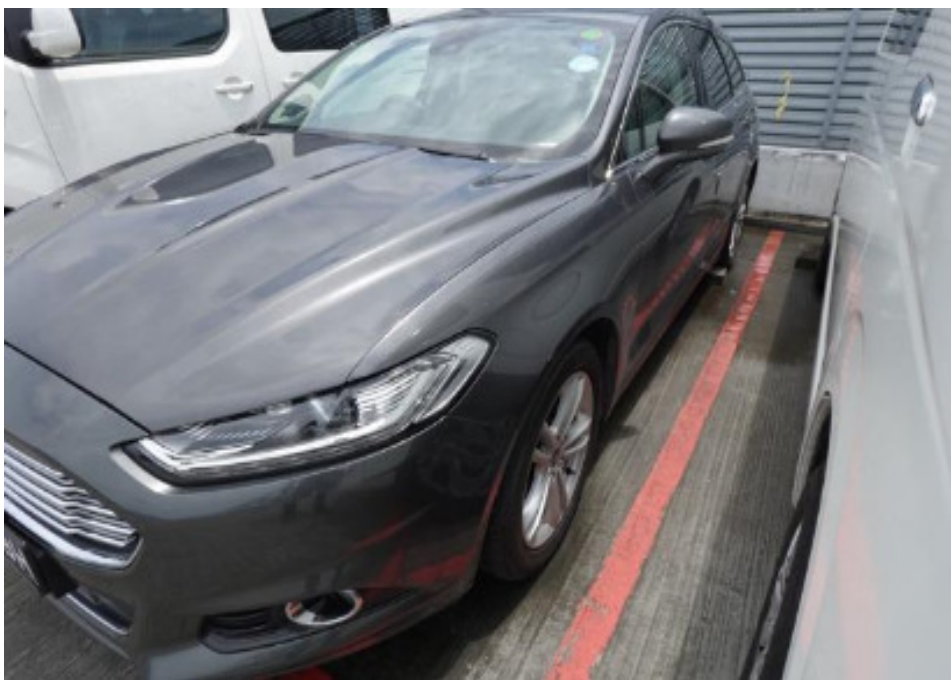
Photo 2 shows the general view of the left frontal portion of the Insured Vehicle at the time of our inspection. The left frontal portion of the Insured Vehicle was relatively unaffected by the fire.

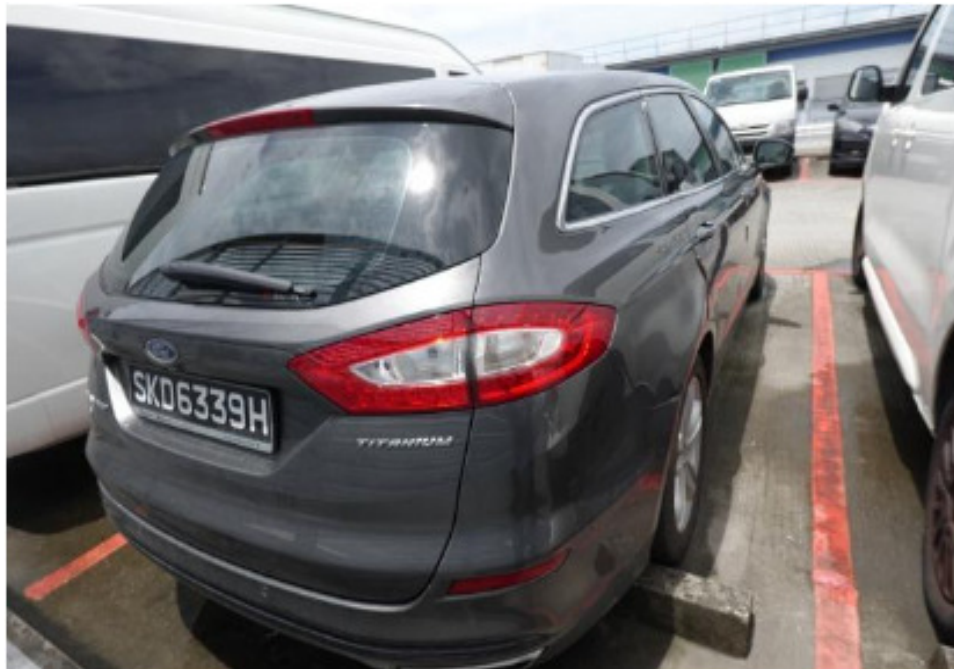
Photo 3 shows the general view of the rear right portion of the Insured Vehicle at the time of our inspection. The rear portion of the Insured Vehicle was relatively unaffected by the fire.

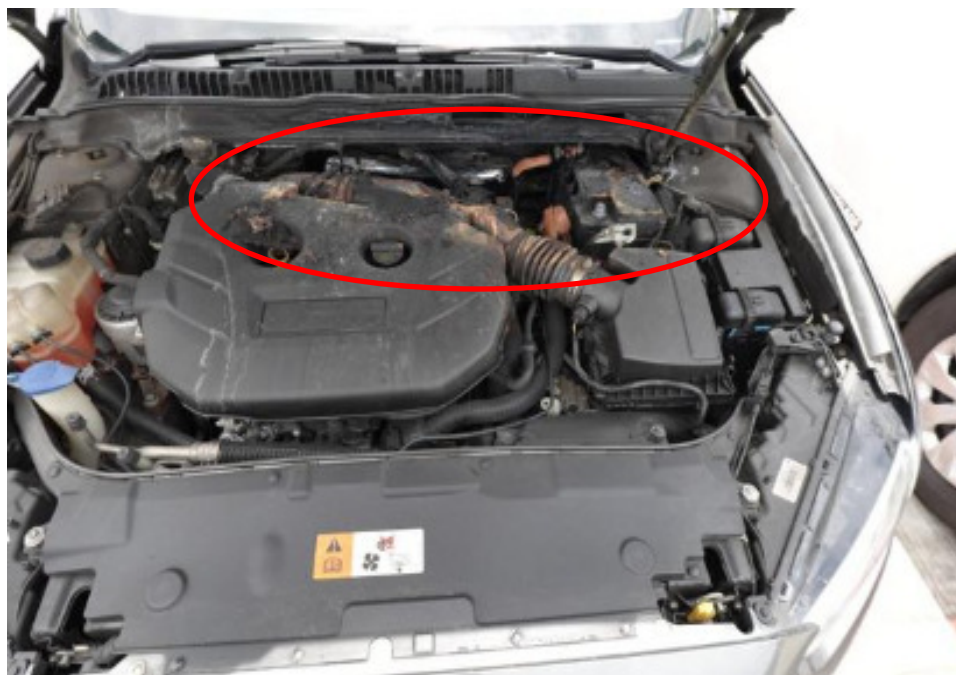
5. The Insured Vehicle was noted to have sustained fire damage that was confined to within the engine compartment. The rear portion of the engine compartment of the Insured Vehicle was observed to be partially burnt and/or melted while the exterior portion and the interior compartment was observed to have been relatively unaffected by the fire. See photos 1 – 5 below.

Photo 4 shows the general view of the engine compartment of the Insured Vehicle at the time of our inspection. The fire damage was confined to rear portion as observed by the burnt nature of the engine components towards the rear portion of the engine (circled).

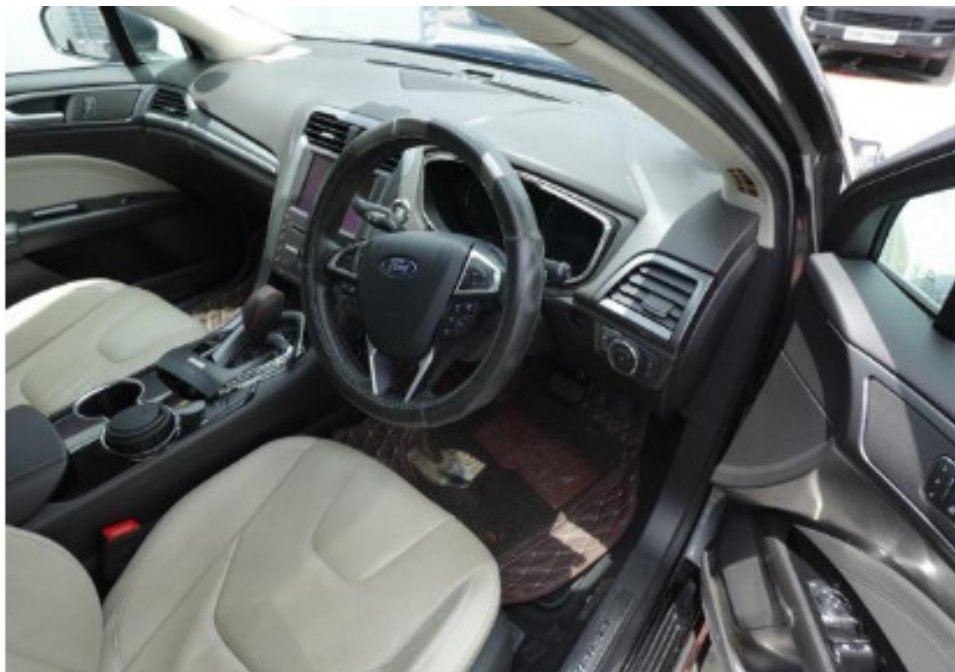
Photo 5 shows the interior compartment of the Insured Vehicle, which was observed to be relatively unaffected by the fire.

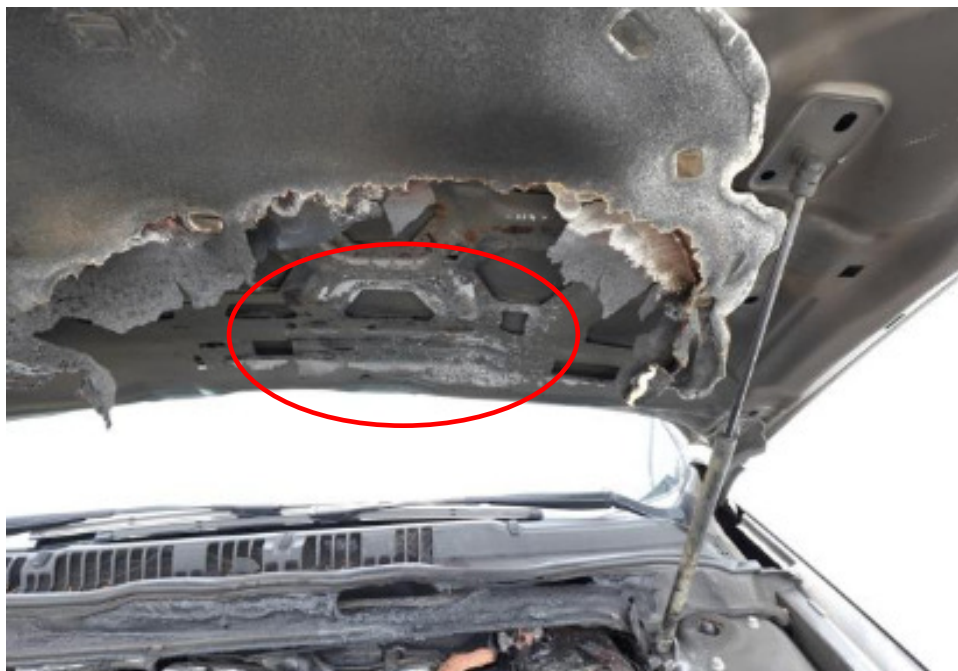
7. For this particular case, the fire appears to have originated within the engine compartment of the Insured Vehicle, somewhere around the rear portion of the engine compartment. This can be determined from the whitish burn marks and also the rust that had developed on the underside of the front bonnet of the Insured Vehicle, at the bottom portion.
8. The whitish burn marks are a result of exposure to prolonged heat intensity. Rust would normally start to develop around these areas soon after a fire as prolonged exposure to high heat intensity usually causes steel/metal material body parts to be exposed to natural environmental condition. The rust that had developed on the underside of the front bonnet, around the bottom portion, is an indication that the rear portion of the engine compartment had sustained exposure to prolonged high heat intensity.

Photo 6 shows the burn pattern and whitish burn marks that were found on the underside of the front bonnet of the Insured Vehicle, at the bottom portion (circled). Such whitish burn marks are a result of exposure to prolonged heat intensity, which may indicate where the fire had started. Rust would also begin to develop on these areas soon after the fire.

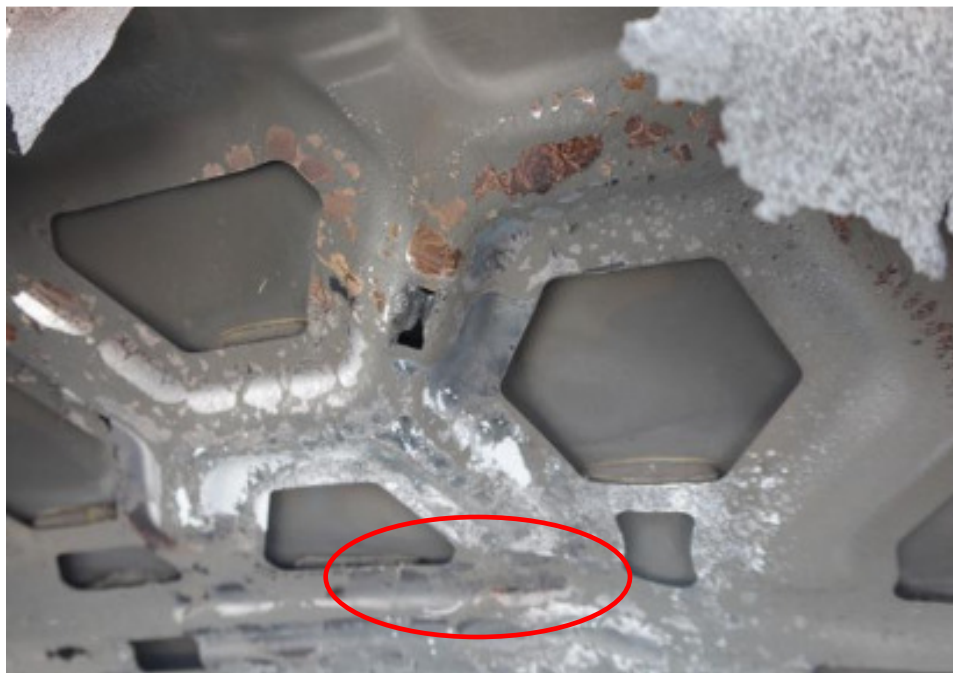
Photo 7 shows the rust that had developed on the underside of the front bonnet, around the bottom portion (circled). The development of rust is an indication that this area was subjected to prolonged exposure to high heat intensity, which had caused the steel/metal material of the front bonnet to be exposed to natural environmental condition. Hence the fire to the Insured Vehicle can be determined to have originated towards the rear portion of the engine compartment.

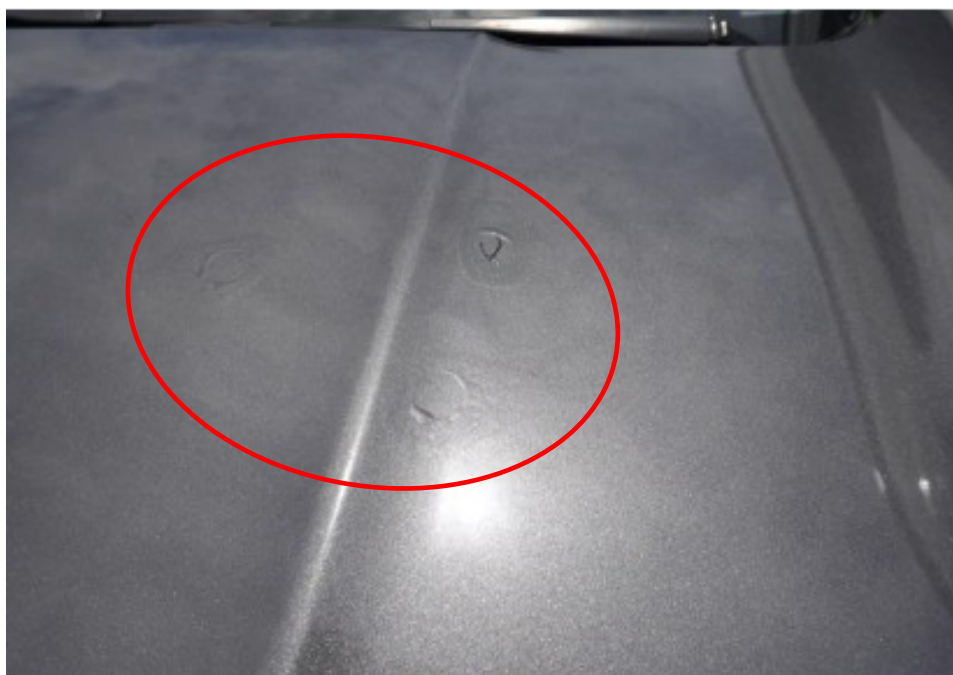
9. We also observed paint bubbles on the rear portion of the front bonnet. In general the location of the fires' origin was determined given that the damage of fire nature was confined to these particular areas on the Insured Vehicle. See photos 6 - 8 below.

Photo 8 shows paint bubbles on the rear portion of the front bonnet (circled).

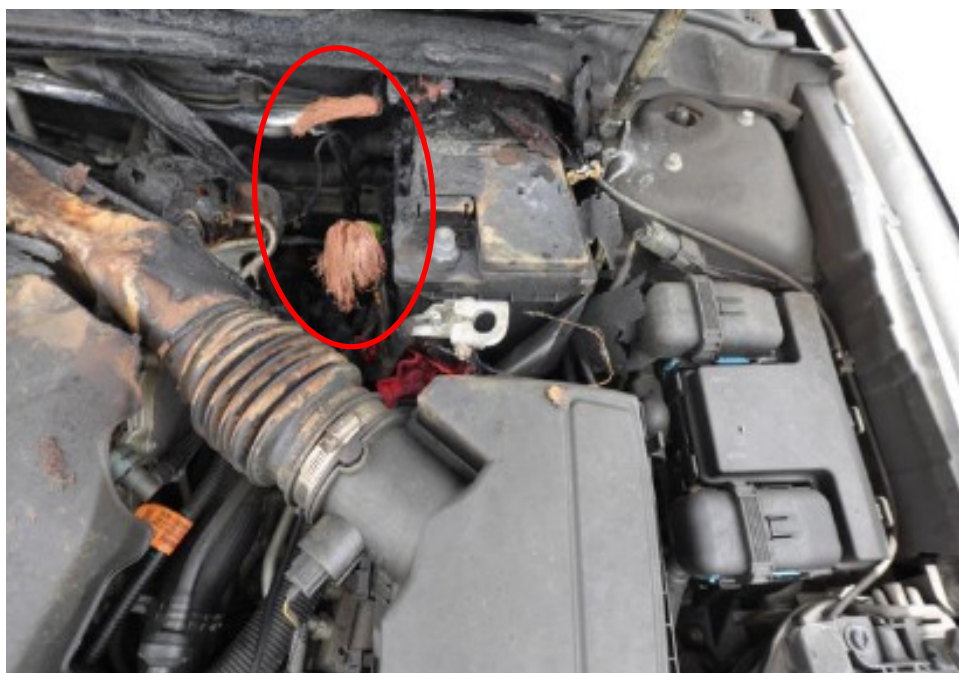
10. Upon closer examination of the rear portion of the engine compartment, which was where the fire to the Insured Vehicle had likely started, we had found several stretches of wirings leading from the battery burnt internally to its bare copper state. Such condition normally indicates internal heating of copper wires which is a sign of an electrical short circuit occurring. This physical evidence would then appear to suggest that the cause of fire to the Insured Vehicle could have possibly been due to electrical in nature. See photos 9 - 11 below.

Photo 9 shows the wirings around the rear portion of the engine compartment, which is in the immediate vicinity where the fire to the Insured Vehicle had likely started. The wirings leading from the battery (circled) were found to have been burnt internally to its bare copper state, suggesting occurrence of an electrical short circuit.

26. The possibility of the fire being due to electrical in nature would then seem more likely given that engine overheating and external factors would both seem unlikely. The fire being due to electrical nature is also supported by the condition of the wirings that were found in the engine compartment of the Insured Vehicle, which was earlier discussed in paragraph 10 above.

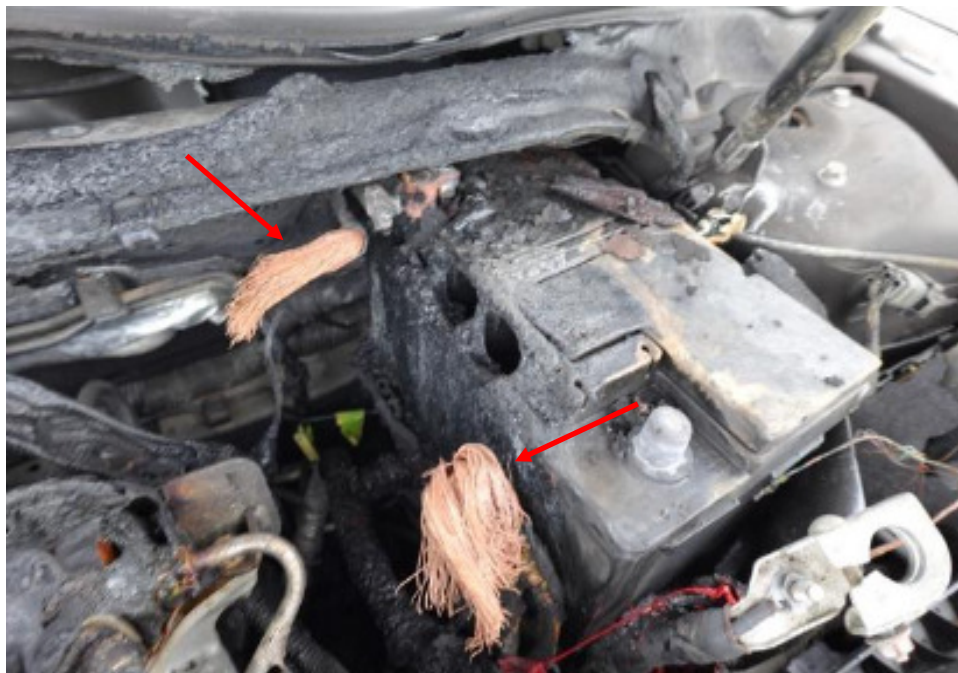
Photo 10 shows a closer view of the wirings around the rear portion of the engine compartment, which is in the immediate vicinity where the fire to the Insured Vehicle had likely started. The wirings leading from the battery (red arrows) were found to have been burnt internally to its bare copper state, suggesting occurrence of an electrical short circuit.

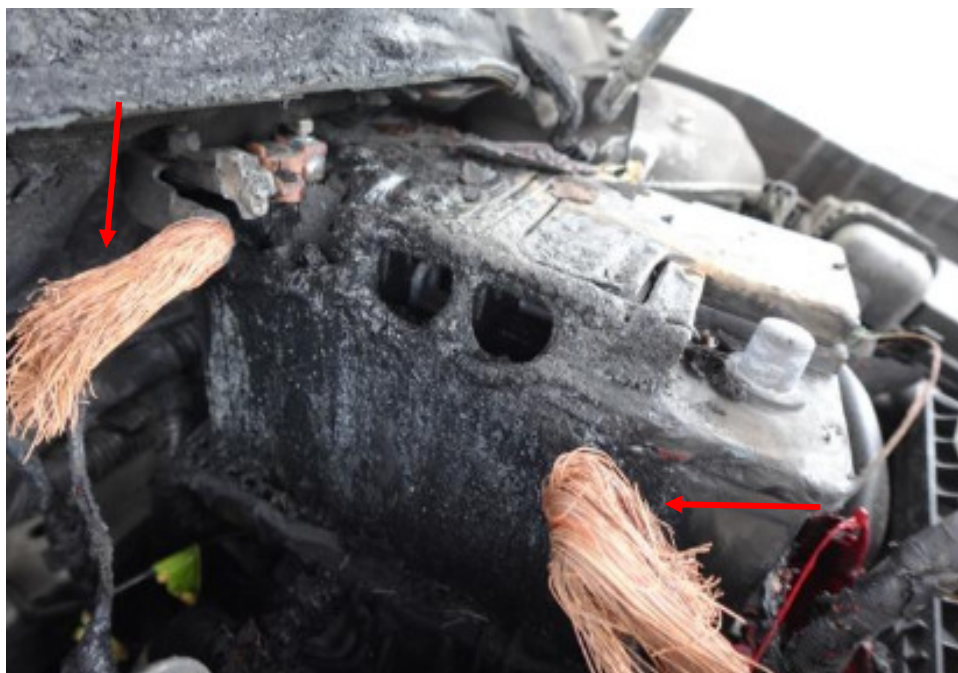
Photo 11 shows a close up view of the wirings leading from the battery (red arrows) which were found to have been burnt internally to its bare copper state, suggesting occurrence of an electrical short circuit.

28. Having investigated and technically analysed the damages to the Insured Vehicle, we are of the view that the cause of fire to the Insured Vehicle was of electrical in nature. For this particular case, the fire had originated along the wirings inside the engine compartment, somewhere around the rear portion. The wirings were original factory wirings of the Insured Vehicle.
29. We did not find any evidence which had suggested that the cause of fire to the Insured Vehicle was due to poor maintenance and/or recurring electrical problem.
30. There were no modification(s) or additional electronic and/or electrical component(s) fitted on the Insured Vehicle at the time of our inspection of the Insured Vehicle.

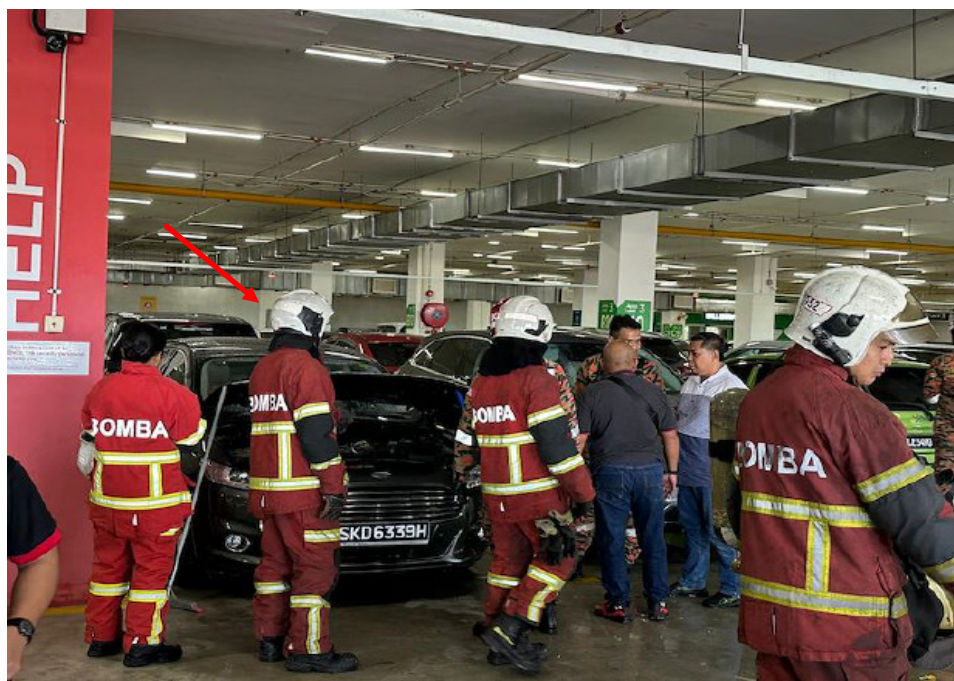
Photo 12 shows the Insured Vehicle after the fire was extinguished. In general, the information that could be gathered from this photograph had corresponded to the events that were related to us by Mr Yin, which is firefighters had responded to the incident (arrowed).

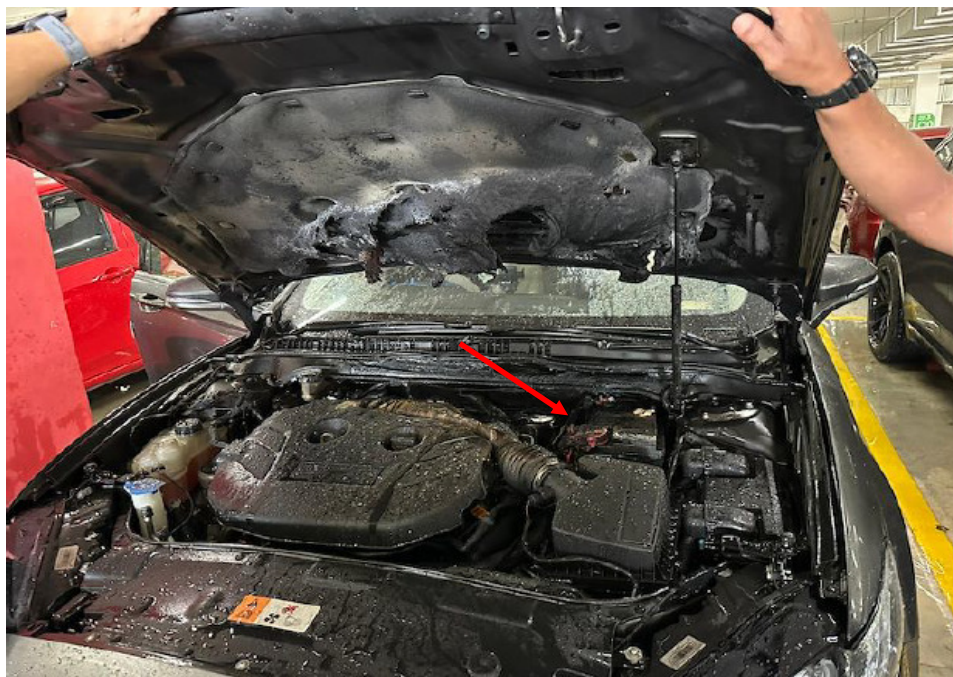
Photo 13 shows the engine compartment of the Insured Vehicle at the incident location post- incident. In general, the information that could be gathered from this photograph had corresponded to the events that were related to us by Mr Yin, which is the fire to the Insured Vehicle had started from the rear portion of the engine compartment (arrowed).
