LKK Auto Consultants Pte Ltd

1. Policy Particulars :- PRE-REPAIR SURVEY			
Insured Veh.	SHB 983H	Veh. Inspected	FBQ 5424P
Policy No.	-	Coverage	0
Claim No.	TAX/09/24/2004	Excess	\$0.00
Assign From	ANA	Assign Date	10/09/2024

2. Vehicle Details			
Make & Model	YAMAHA AEROX	C.C	155
Engine No.	G3J1E0434450	Year of Reg.	29/10/2019
Chassis No.	MH3SG4620KJ069295	Colour	BLACK
Odometer	- KM	Steering	IN ORDER
Brakes	IN ORDER	General	GOOD
Modification(s)	RIMS: STANDARD ALLOY RIM

PHOTOGRAPHS FOR VEHICLE NO. : FBQ 5424P

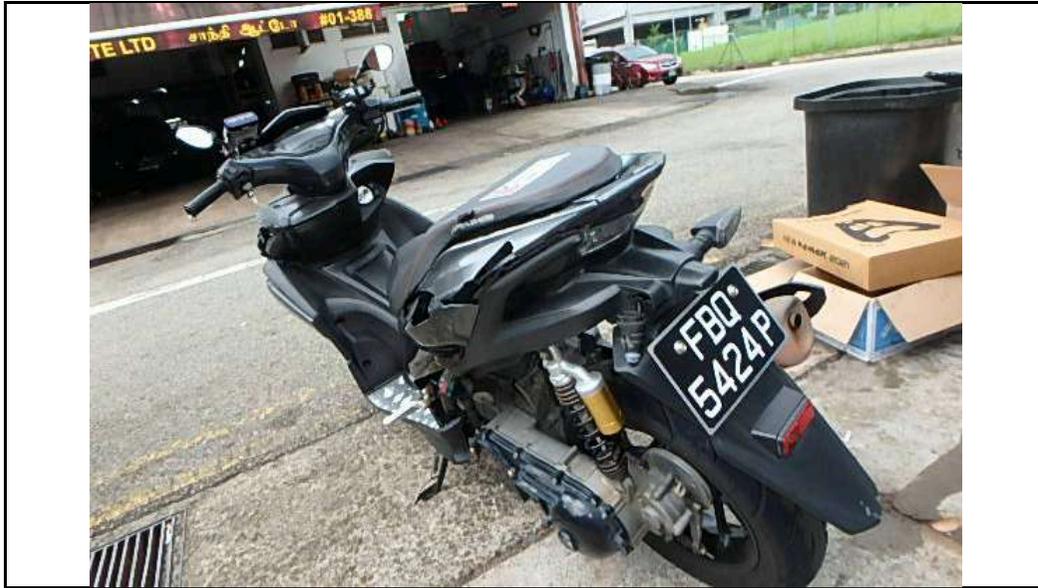
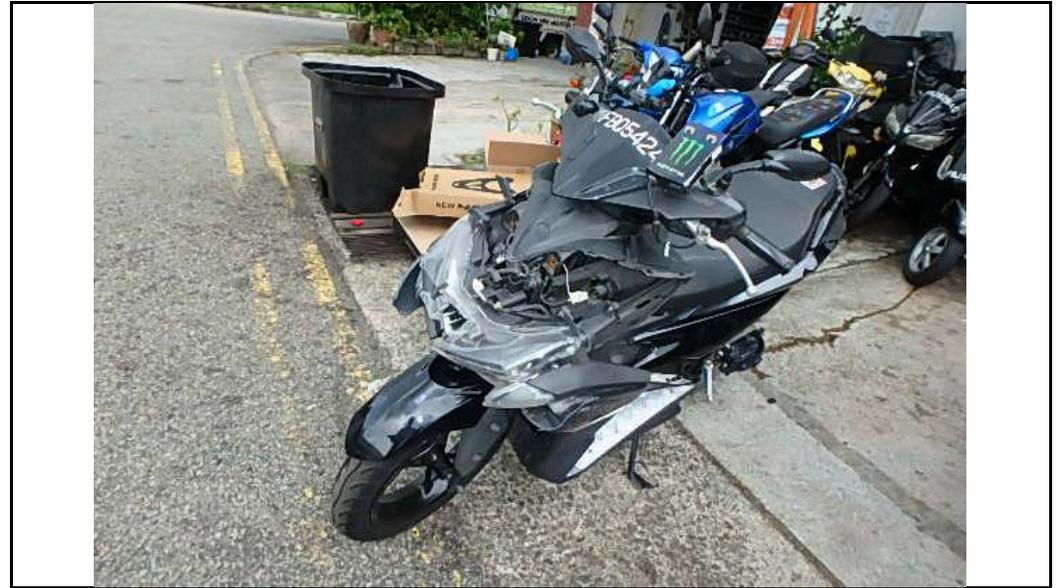
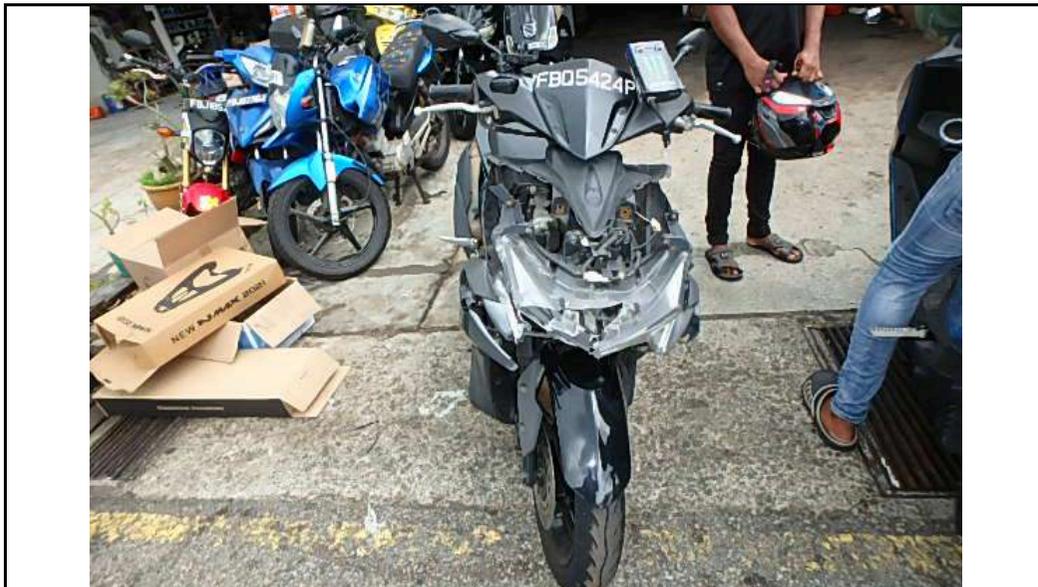
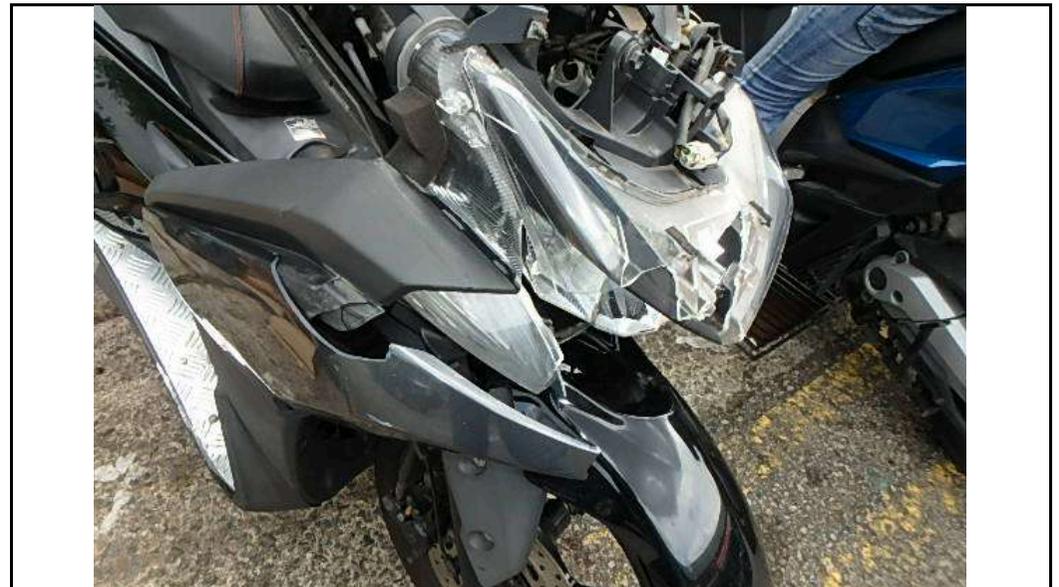
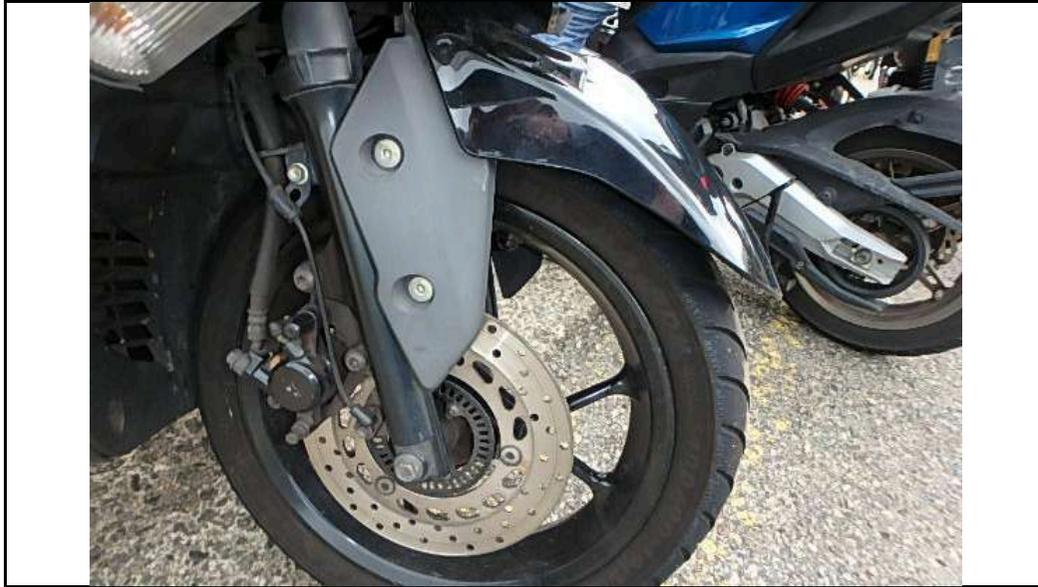
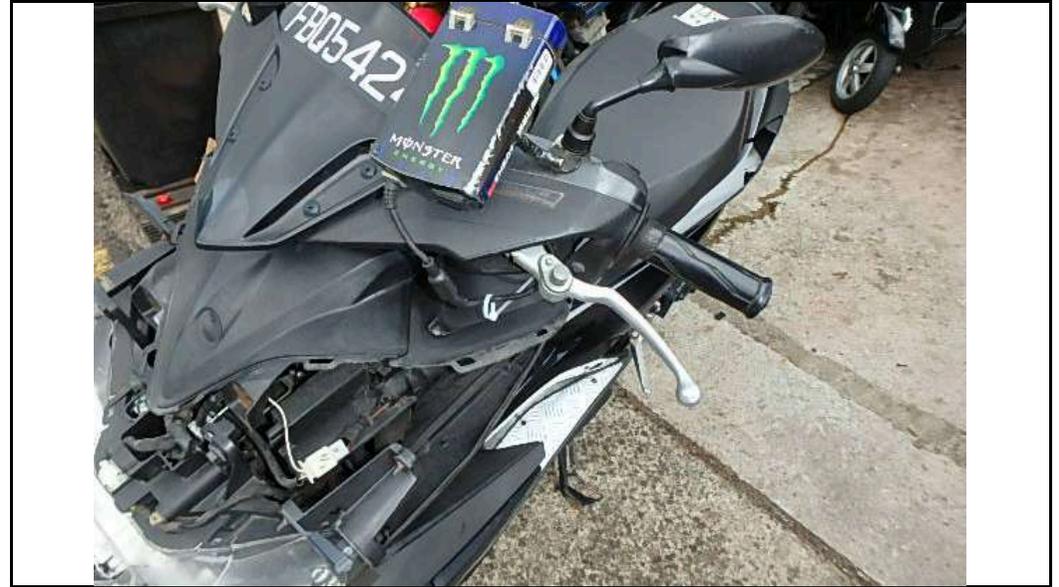
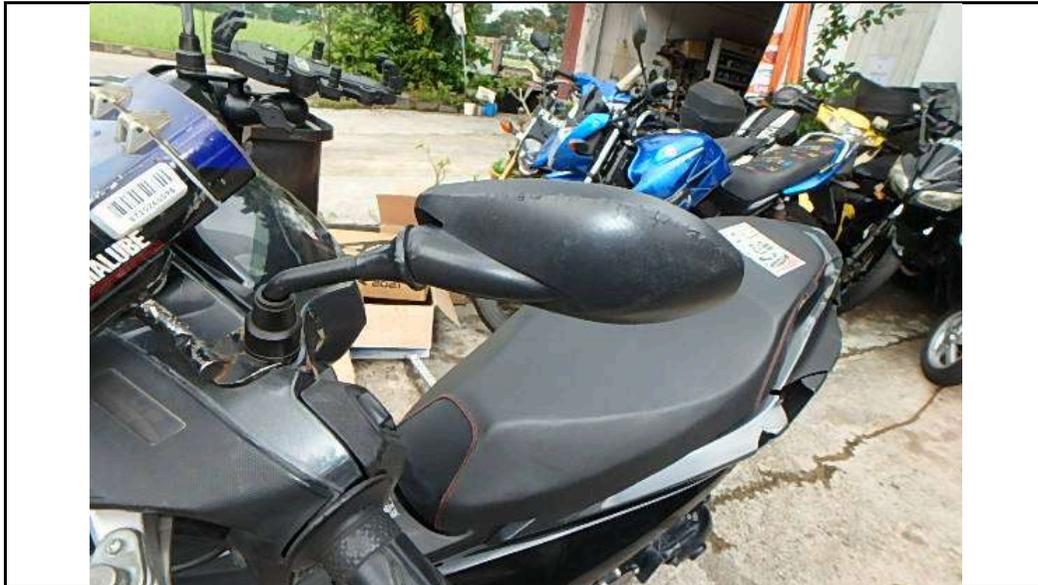
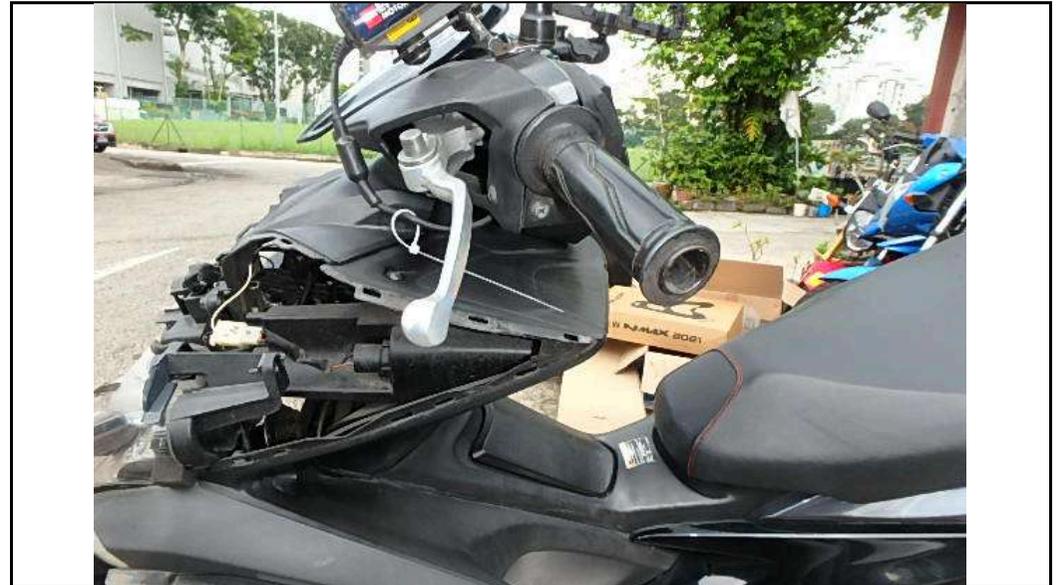
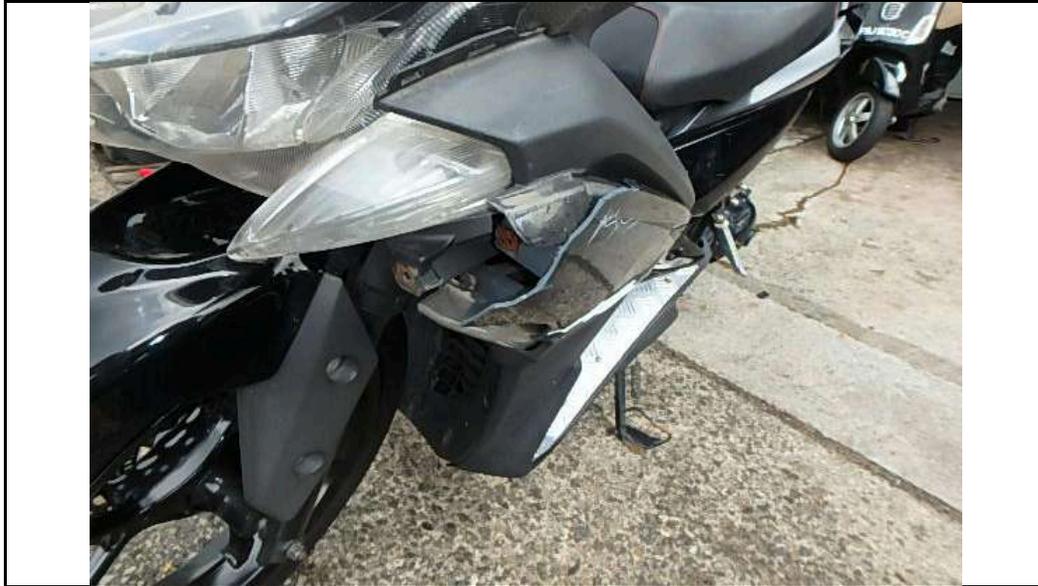
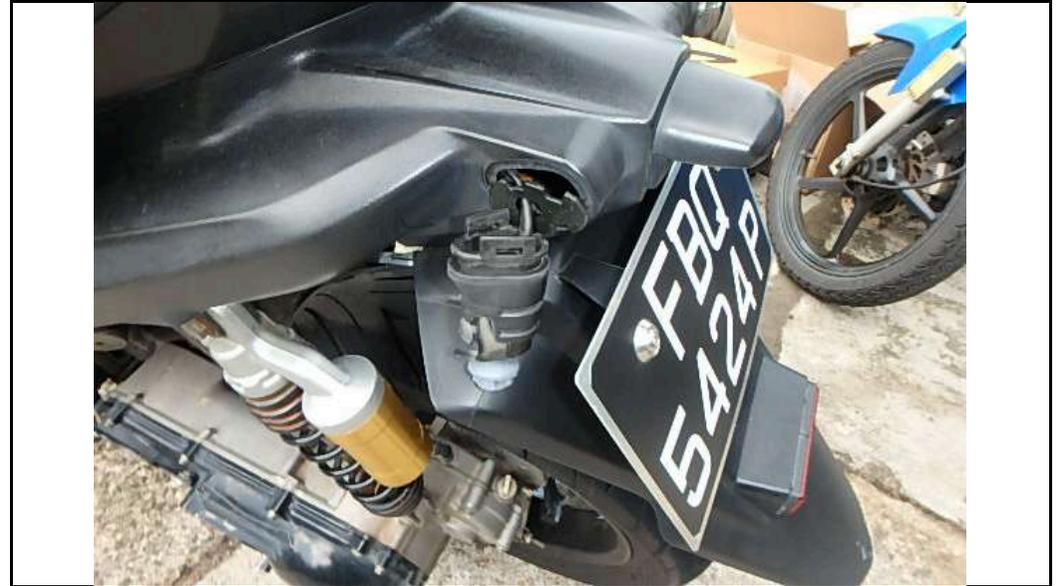
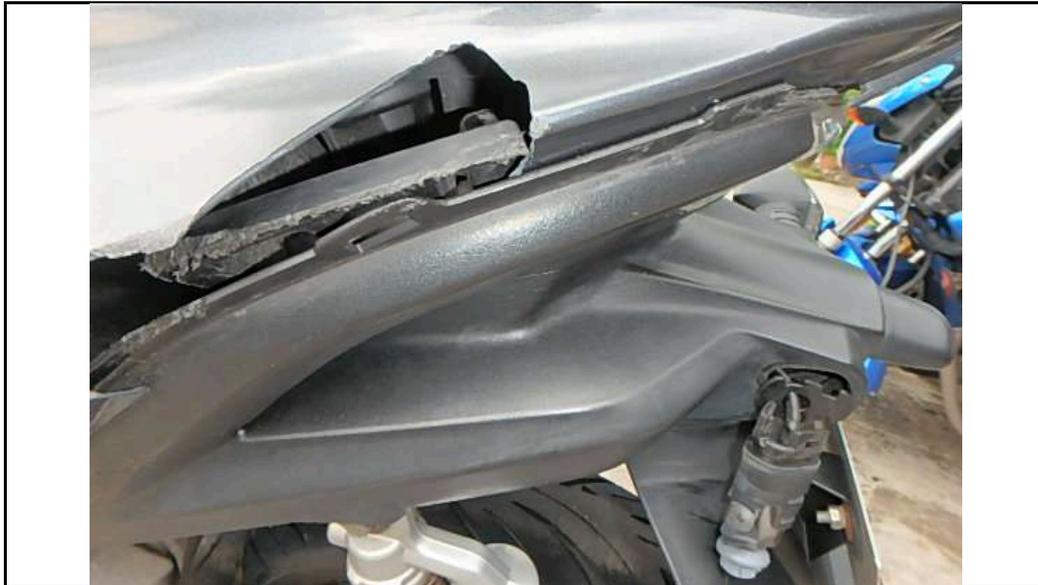
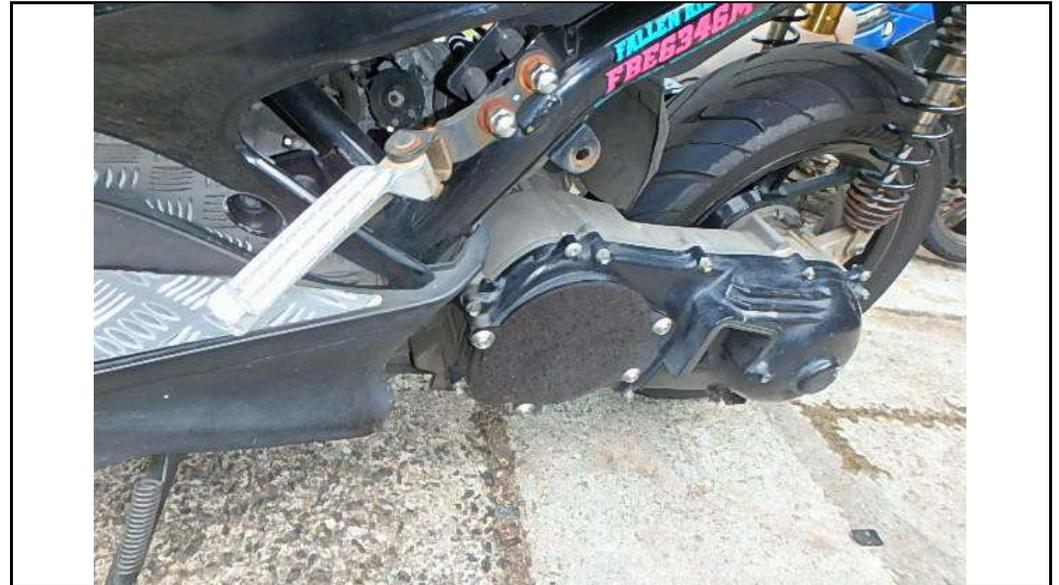
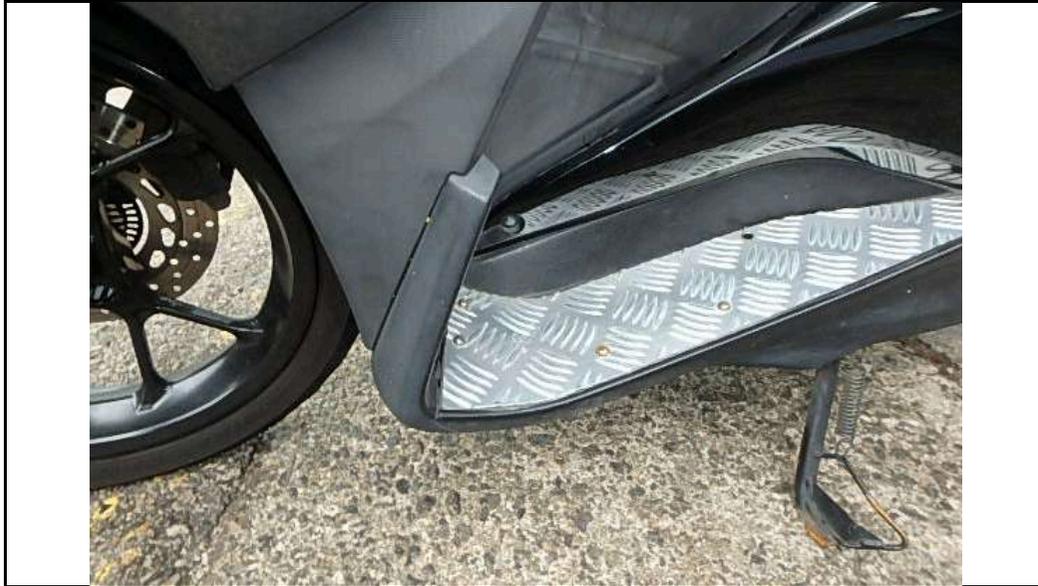
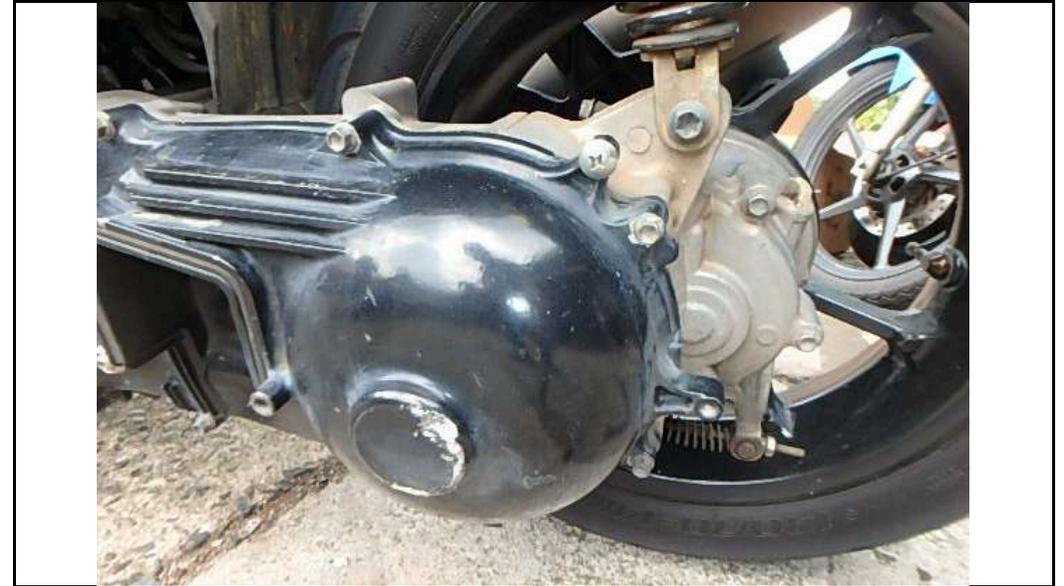
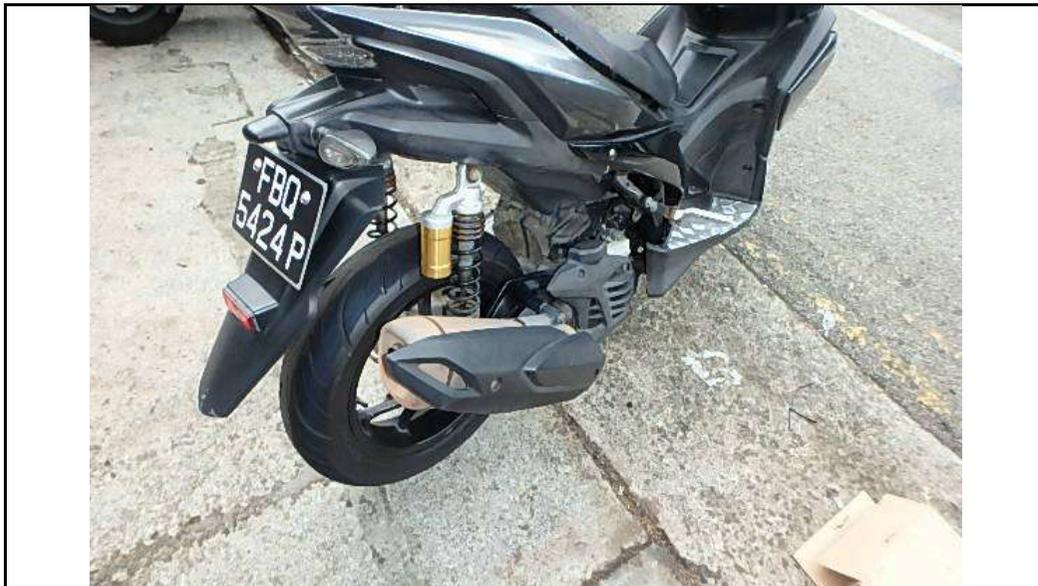
3. Conditions of Tyres			
	Size	Make	Balance (mm)
R/H Front Tyre	100/80R14	MAXXIS	4
L/H Front Tyre			
R/H Rear Tyre	140/70R14	SHINKO	3
L/H Rear Tyre			
4. Description of Damages			
THE VEHICLE SUSTAINED DAMAGES AT THE FRONT PORTION AND N/S BODY.

A) THE INSPECTION WAS CONDUCTED ON A "WITHOUT PREJUDICE" BASIS. B) THE REPAIR ESTIMATE WAS NOT PRESENTED AT THE TIME OF INSPECTION. THE REPAIRER WAS TOLD TO PREPARE THE ESTIMATE. C) ENCLOSED PLEASE FIND DAMAGED VEHICLE PHOTOGRAPHS. D) THE ESTIMATED REPAIR COST OF THE DAMAGED VEHICLE IS IN THE REGION OF \$3,000-\$4,000			
5b. Estimate Days of Repair			
ESTIMATED NORMAL PERIOD FOR REPAIR: 4 Working Days
