Your Ref: 373082
Our Ref: CS/MSG24090233/R

17 September 2024

**TECHNICAL INVESTIGATION REPORT OF FIRE INCIDENT INVOLVING THE
INSURED VEHICLE SKZ 1550E ON 11 SEPTEMBER 2024**

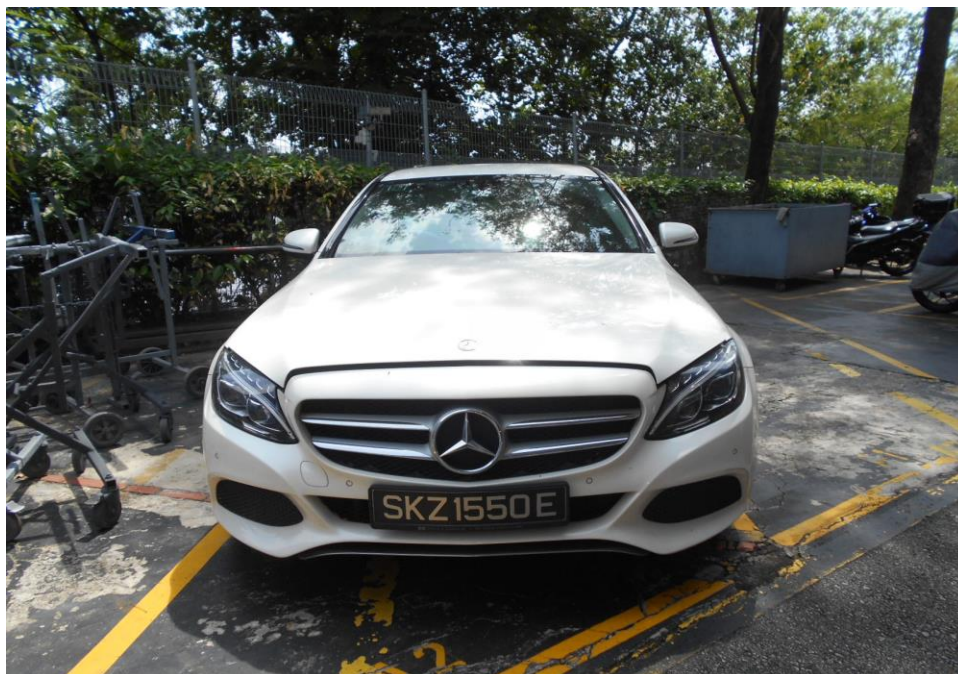
Photo 1 shows the general view of the frontal portion of the Insured Vehicle at the time of our inspection. The frontal portion appears to be intact and unaffected by the fire.

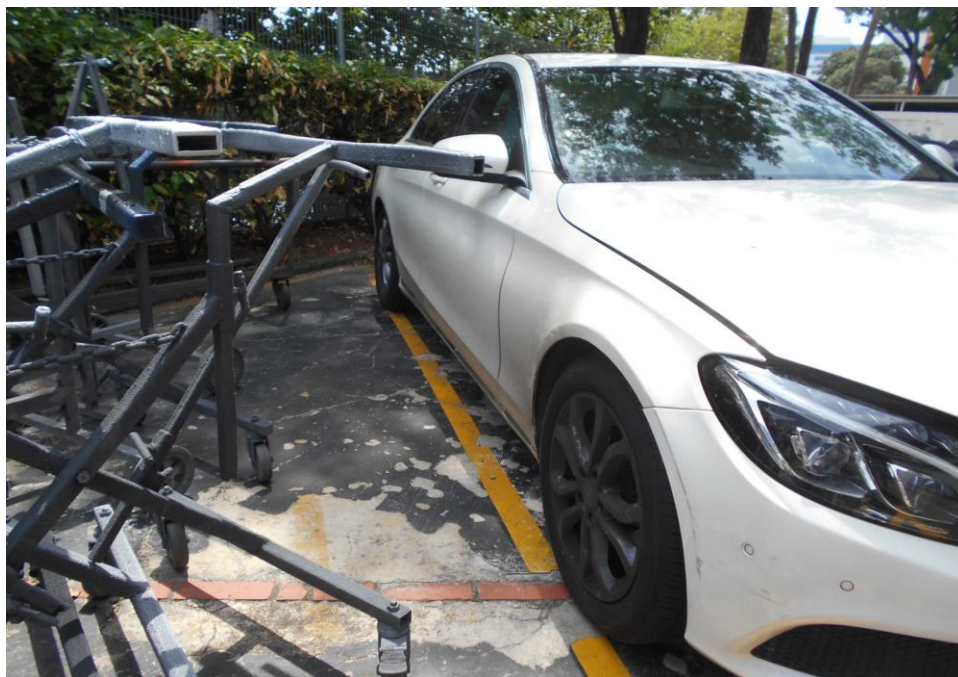
Photo 2 shows the general view of the right body of the Insured Vehicle at the time of our inspection. The right body appears to be intact and unaffected by the fire.

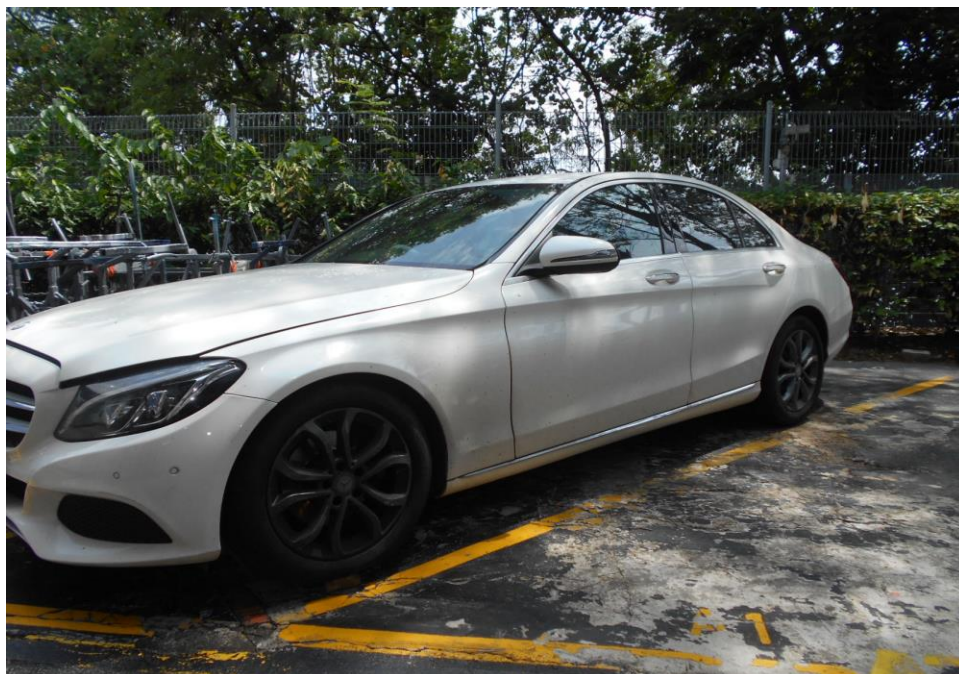
Photo 3 shows the general view of the left body of the Insured Vehicle at the time of our inspection. The left body appears to be intact and unaffected by the fire.

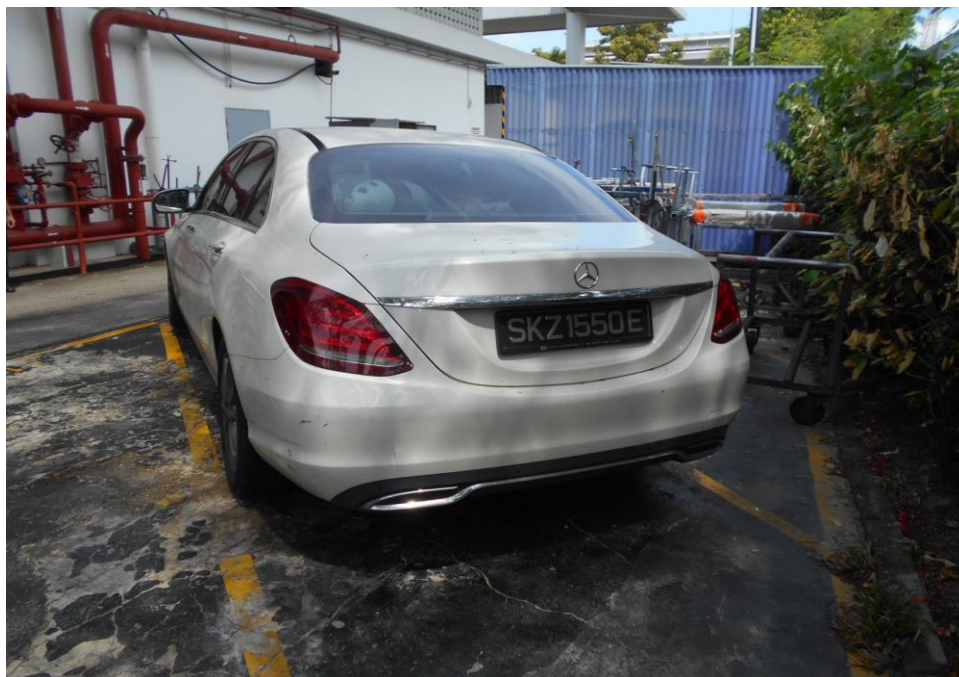
Photo 4 shows the general view of the rear portion of the Insured Vehicle at the time of our inspection. The rear portion appears to be intact and unaffected by the fire.

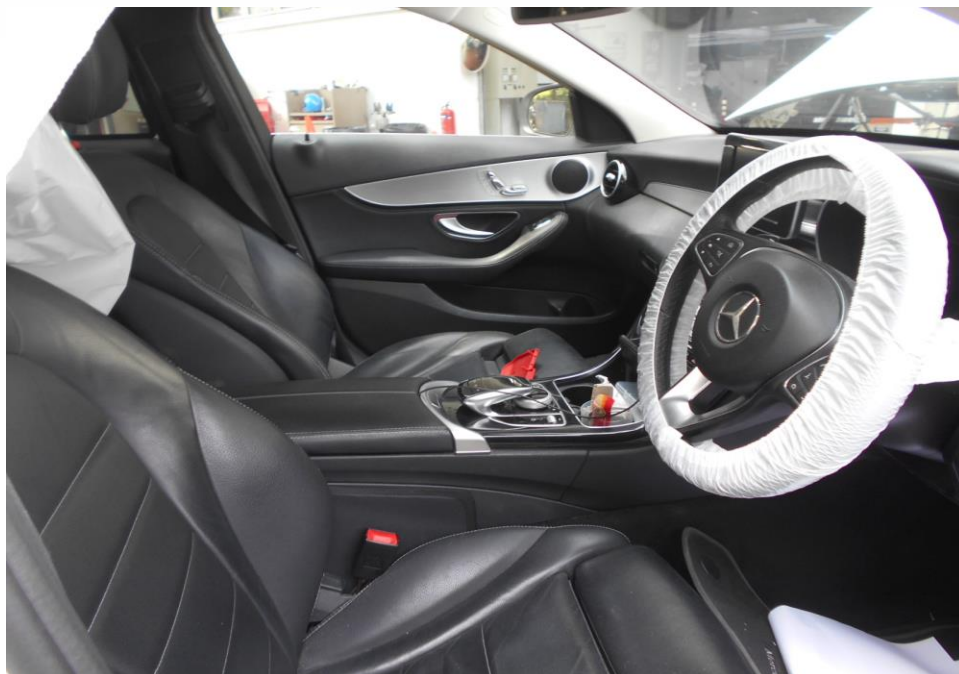
Photo 5 shows the interior view from the right side of the Insured Vehicle at the time of our inspection. The right side of the Insured Vehicle was observed to be unaffected by the fire.

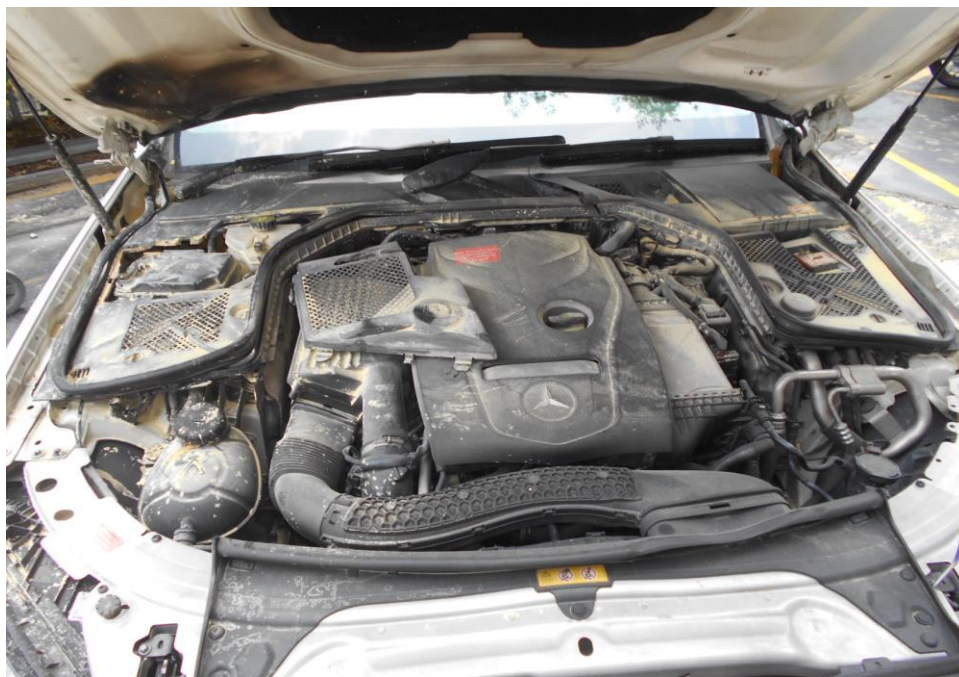
5. The exterior body of the Insured Vehicle was found to be intact and unaffected by the fire.
6. The fire had resulted in minor fire damages to the engine compartment of the Insured Vehicle. Most of the components inside the engine compartments were found to be intact and unaffected by the fire. See photos 1 – 6 below.

Photo 6 shows a general view of the engine compartment of the Insured Vehicle at the time of our inspection. Most of the components inside the engine compartment were found to be intact and unaffected by the fire.

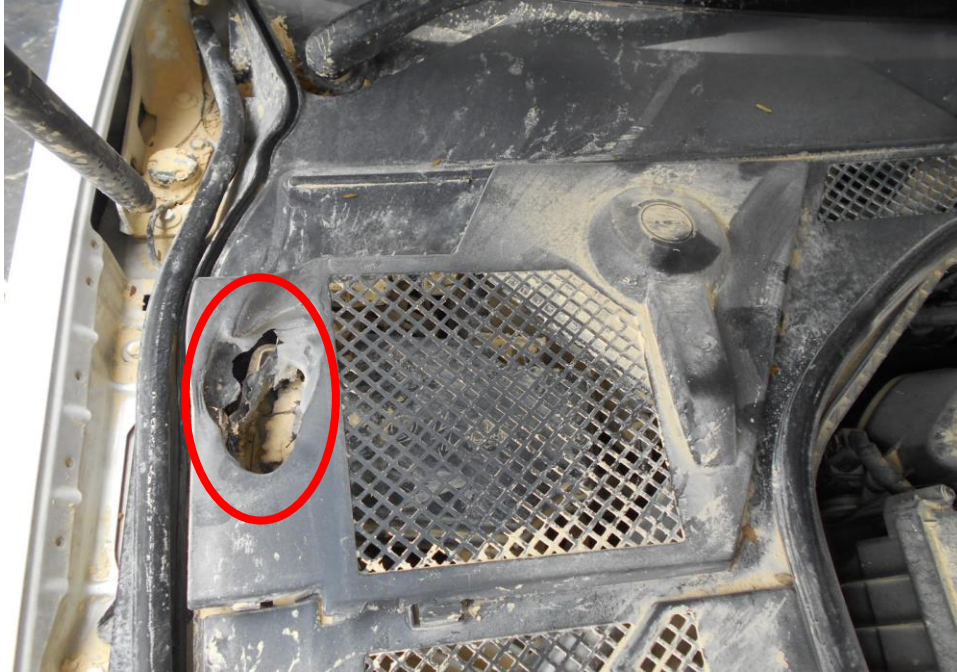
7. For this particular case, the fire appears to have been of electrical nature originated from the rear right portion of the Insured Vehicle, where the Engine Fuse and Relay Box is located. This can be determined from the burn pattern of the Engine Fuse and Relay Box and assembly components which were observed to have sustained visible fire damage on the rear right engine compartment.

Photo 7 shows the general view of the Engine Fuse and Relay box top plastic cover located at the rear right of the engine bay which had sustained visible fire damages resulting in a hole found on the Engine Fuse and Relay Box top plastic cover (red circle).

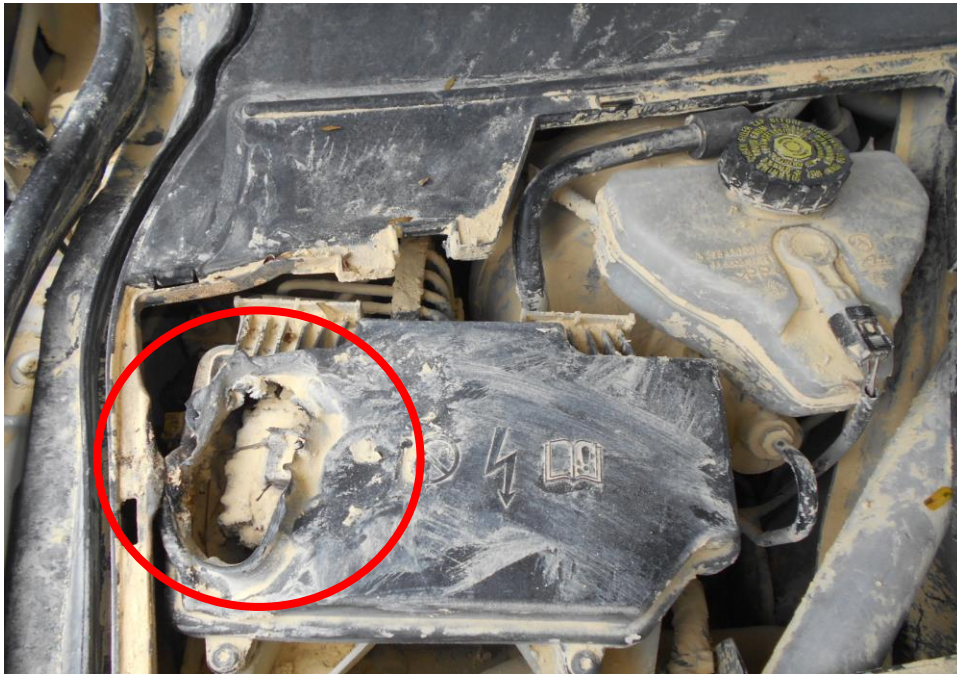
Photo 8 shows the general view of the Engine Fuse and Relay box upon removing the top plastic cover located at the rear right of the engine bay. The Engine Fuse and Relay Box had sustained visible fire damages resulting in a hole found on the Engine Fuse and Relay Box (red circle).

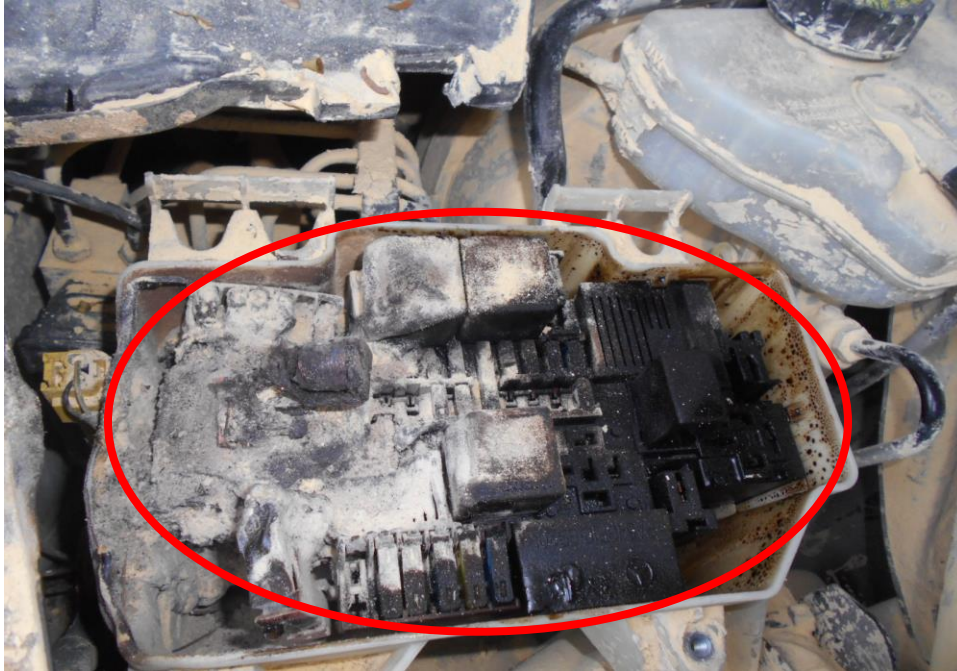
Photo 9 shows the general view of the Engine Fuse and Relay box upon removing the top plastic cover and exposing the Engine Fuse and Relays located at the rear right of the engine bay. The Engine Fuse and Relays had sustained visible fire damages at the time of my inspection (red circle).

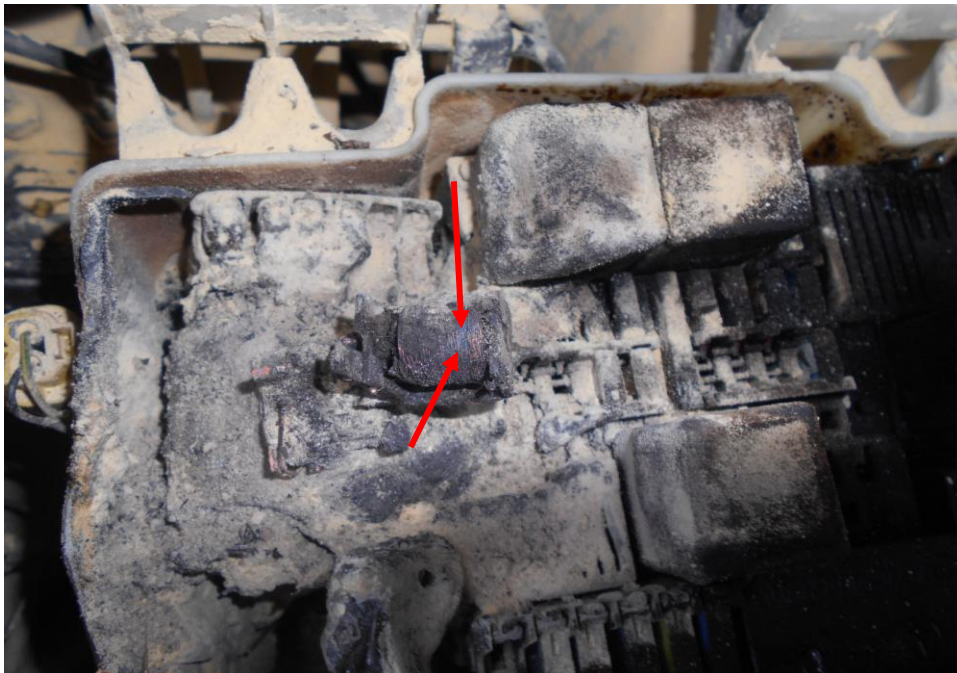
8. Upon closer examination of the rear right portion of the Insured Vehicle which was where the fire had likely started, we had found traces of greenish residue along the original fitted fuse located in side of the Engine Fuse and Relay Box. The presence of greenish residue found along the wirings of the fuses indicates internal heating of copper wires, a sign of an electrical short circuit occurring. The greenish residue is normally left behind from oxidation as a result of chemical reaction involving the copper wires. This physical evidence would then appear to suggest that the cause of fire to the Insured Vehicle could have possibly been due to electrical in nature. See photos 7 - 11 below.

Photo 10 shows the general view of the Engine Fuse and Relay along with the original fitted wirings found in the relay. The presence of greenish residue (red arrows) indicates internal heating of copper wires, a sign of an electrical short circuit occurring. The greenish residue is normally left behind from oxidation as a result of chemical reaction involving the copper wires.

21. The possibility of the fire being due to electrical in nature would then seem more likely given that engine overheating and external factors would both seem unlikely. The fire being due to electrical nature is also supported by the condition of the original fitted wirings found in the Engine Fuse and Relays, which was earlier discussed in paragraph 7 above.

23. Having investigated and technically analysed the damages of burnt nature to the Insured Vehicle, we are of the view that the cause of fire to the Insured Vehicle as of electrical nature and the fire had originated from a short circuit along the factory original wirings of the Engine Fuse and Relays located at the rear right of the engine compartment.
24. At the time of inspection, we did not find any unusual skeletal remains which could have suggested that there was possible modification(s) and/or additionally fitted electronic and/or electrical component(s) on the Insured Vehicle.
25. We did not find any evidence which had suggested that the cause of fire to the Insured Vehicle was due to poor maintenance and/or recurring electrical problem.

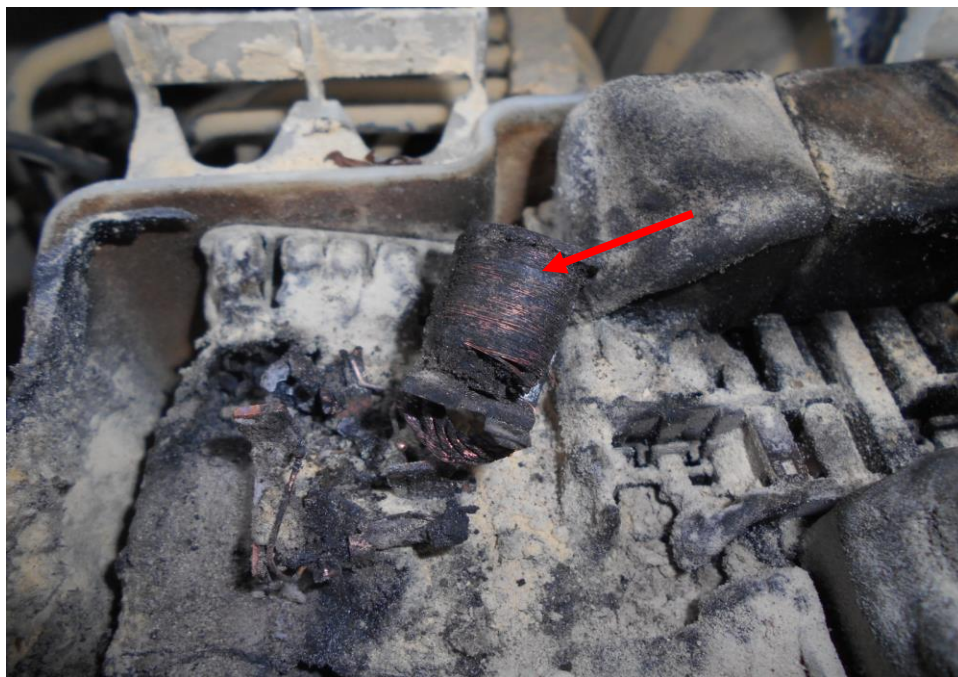
Photo 11 shows the close up view of the Engine Fuse and Relay along with the original fitted wirings found in the relay. The presence of greenish residue (red arrow) indicates internal heating of copper wires, a sign of an electrical short circuit occurring. The greenish residue is normally left behind from oxidation as a result of chemical reaction involving the copper wires.

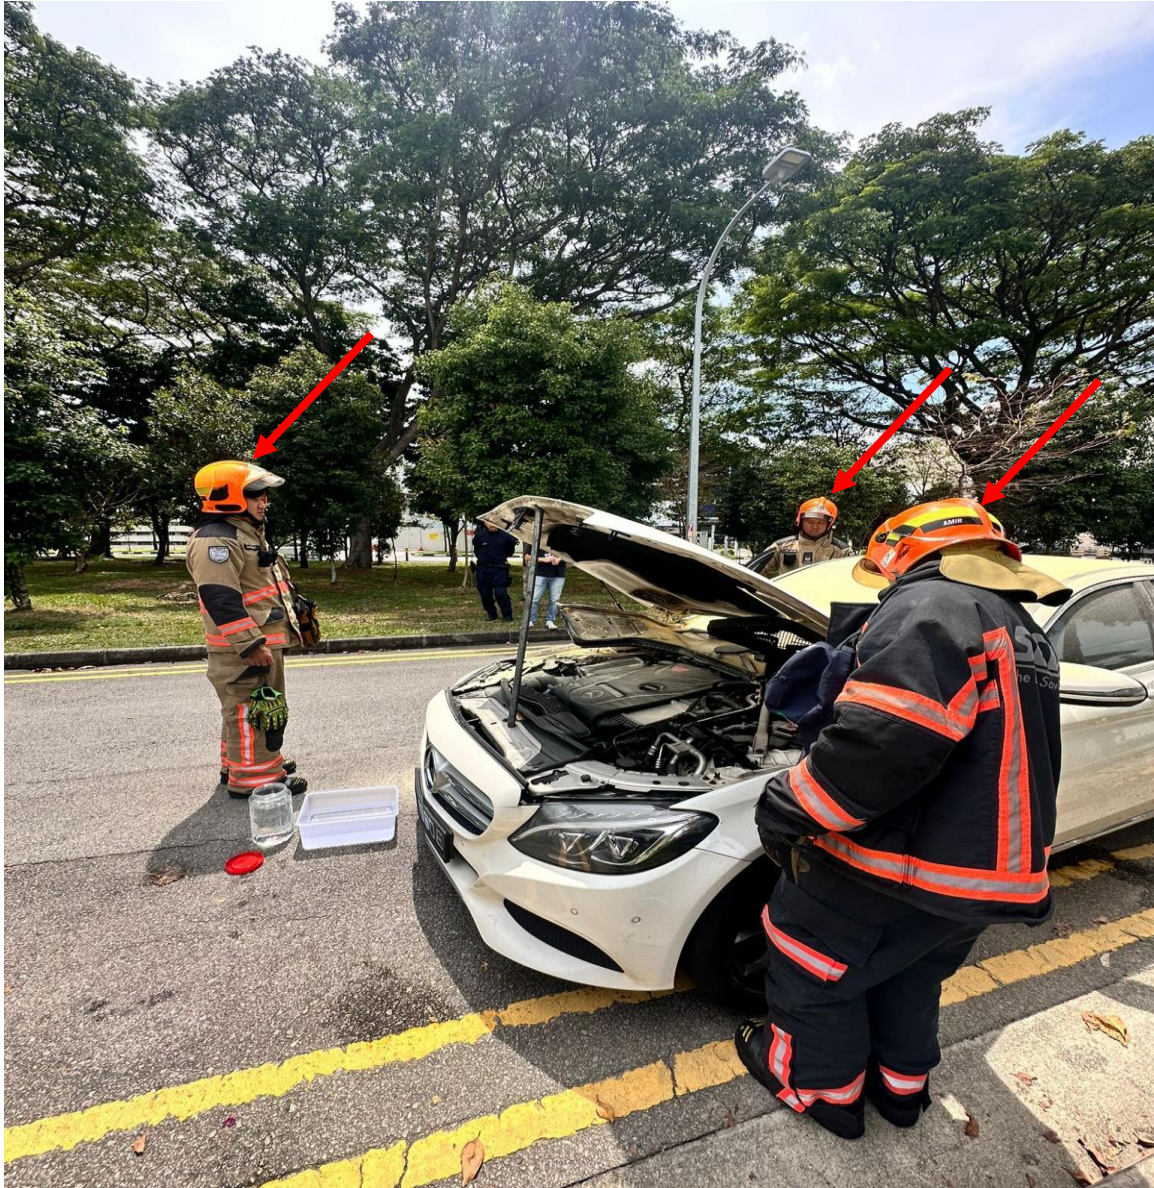
Photo 12 shows firefighters (red arrows) ensuring the last remnants of the fire has been taken out on the Insured Vehicle.

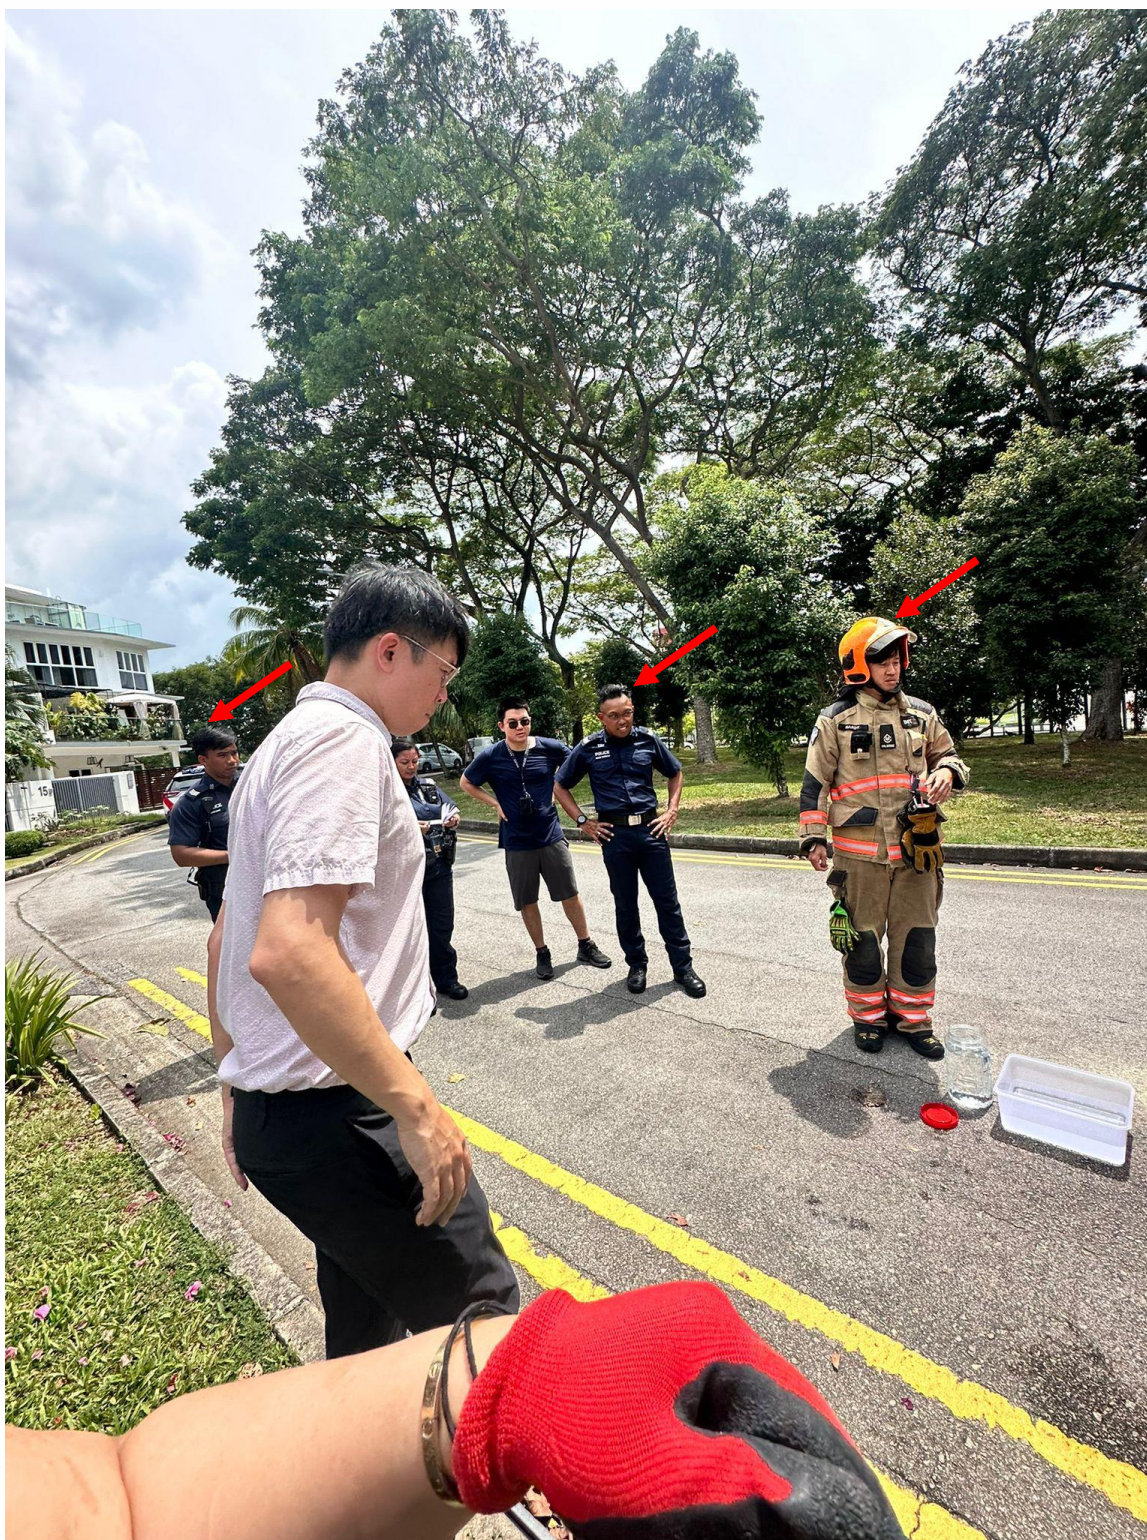
Photo 13 shows firefighters and the police (red arrows) ensuring the last remnants of the fire has been taken out on the Insured Vehicle.
