Your Ref: 4622234556SG
Our Ref : CS4/AIG24004989/J

4 July 2024

**TECHNICAL INVESTIGATION REPORT OF FIRE INCIDENT INVOLVING THE
INSURED VEHICLE SDA 7818J ON 19 JUNE 2024**

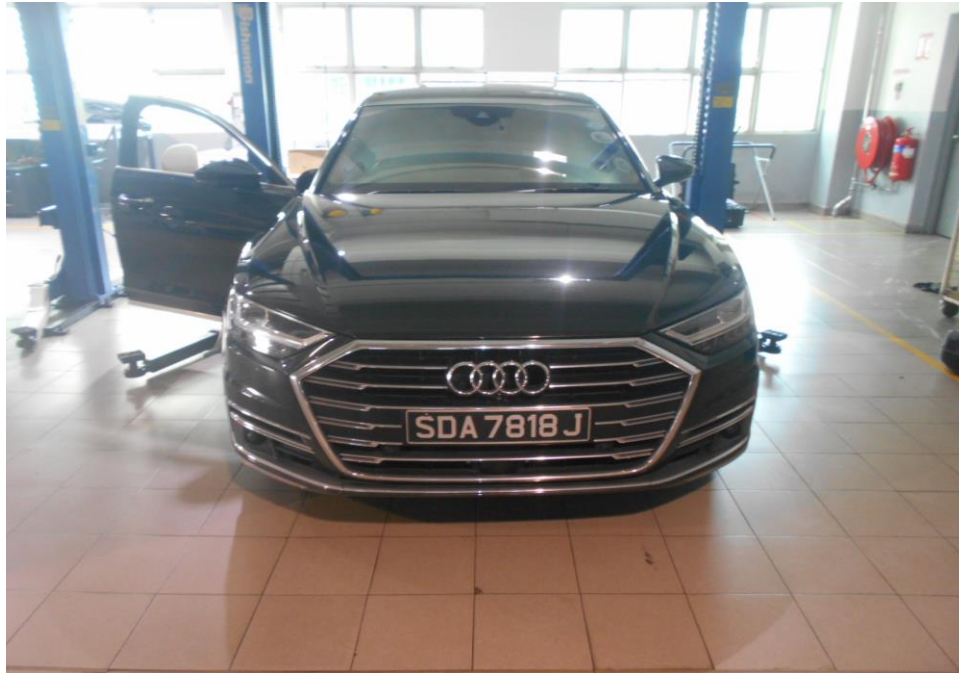
Photo 1 shows the general view of the front portion of the Insured Vehicle at the time of our inspection. The fire damage to the Insured Vehicle was confined to its interior portion. Its exterior is observed to be unaffected by the fire.

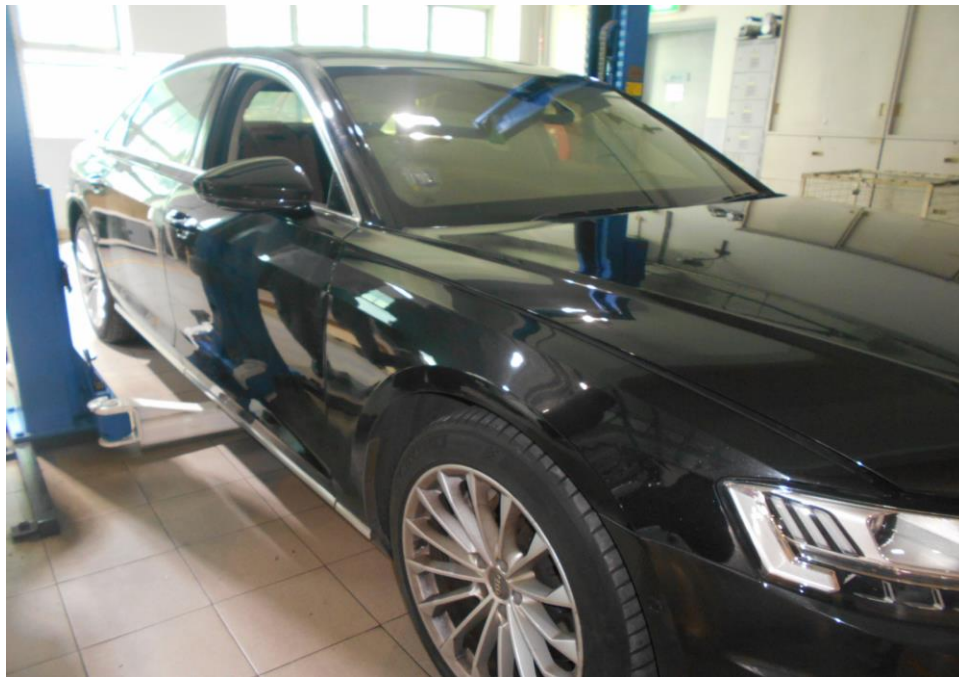
Photo 2 shows the general view of the right body of the Insured Vehicle at the time of our inspection. The fire damage to the Insured Vehicle was confined to its interior portion. Its exterior is observed to be unaffected by the fire.

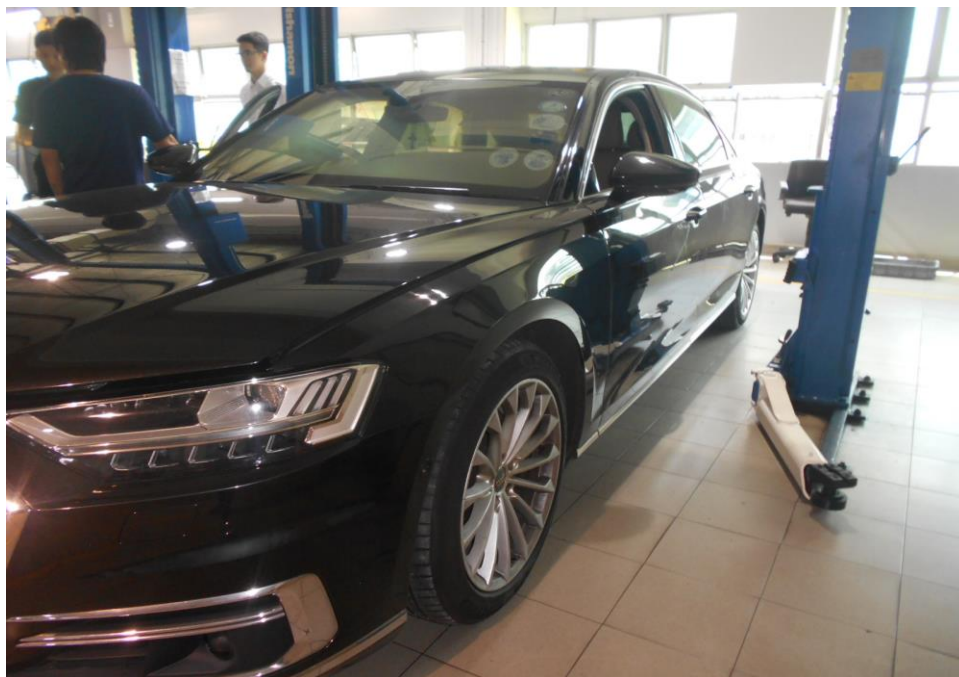
Photo 3 shows the general view of the left body of the Insured Vehicle at the time of our inspection. The fire damage to the Insured Vehicle was confined to its interior portion. Its exterior is observed to be unaffected by the fire.

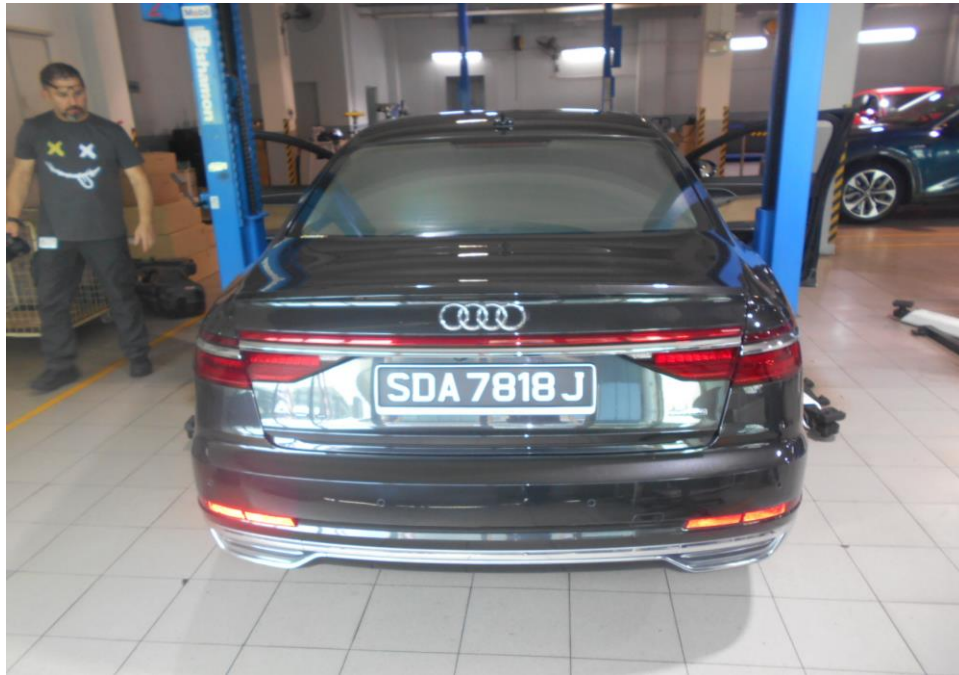
Photo 4 shows the general view of the rear portion of the Insured Vehicle at the time of our inspection. The fire damage to the Insured Vehicle was confined to its interior portion. Its exterior is observed to be unaffected by the fire.

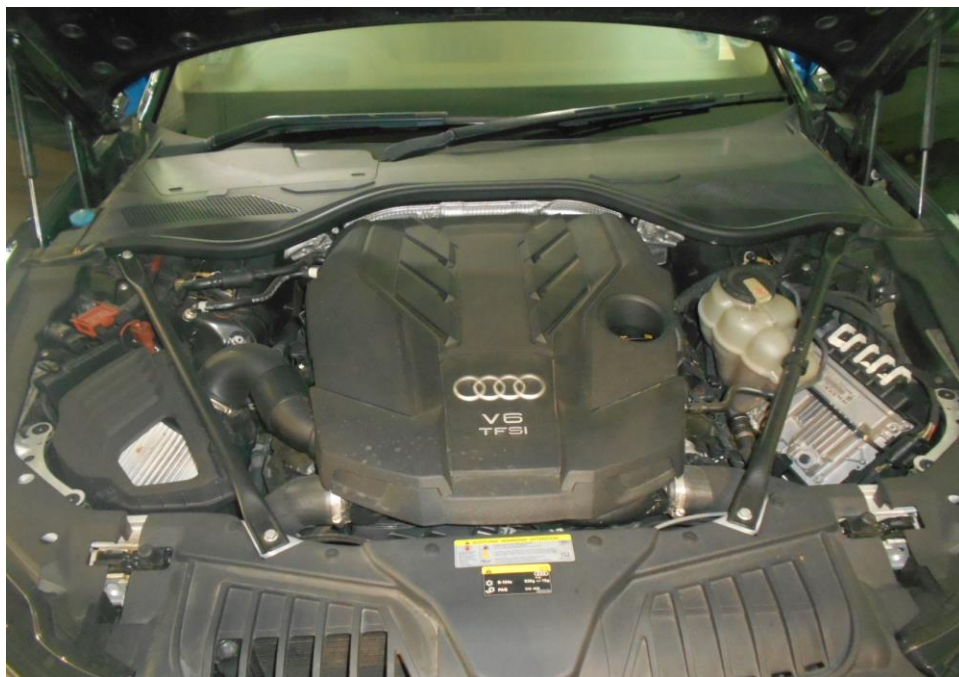
Photo 5 shows the general view of the engine portion of the Insured Vehicle at the time of our inspection. The fire damage to the Insured Vehicle was confined to its interior portion. Its engine compartment is observed to be unaffected by the fire.

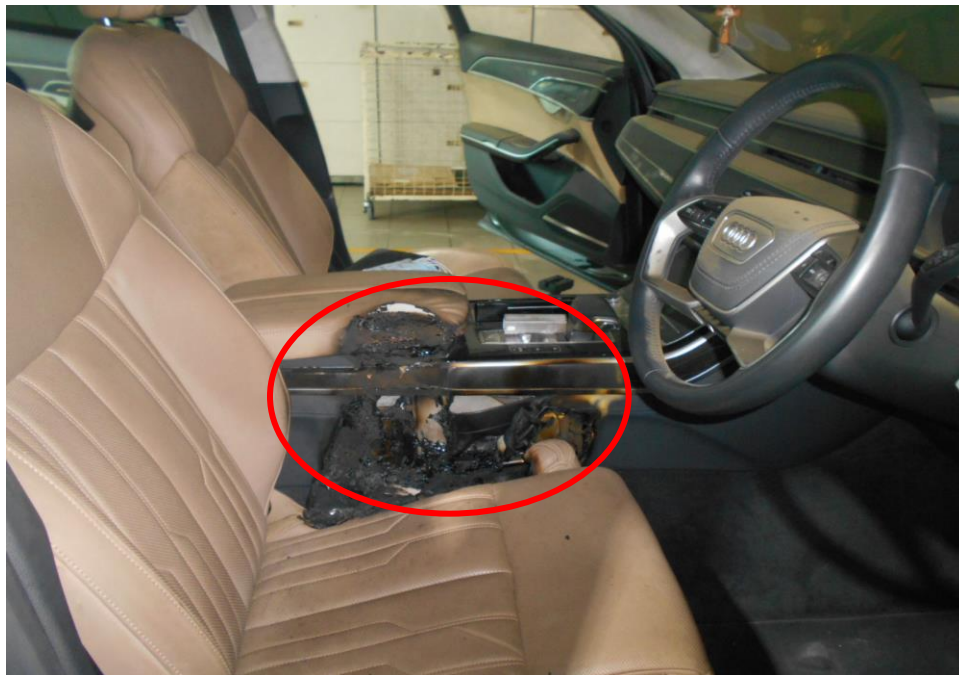
6. Upon checking the interior compartment, it was observed that the front right driver seat left portion, multimedia infotainment head-unit, digital climate control panel, dashboard trims, centre console armrest and roof headliner had sustained fire/smoke damage. See photos 1 – 10 below.

Photo 6 shows the general view of the interior compartment of the Insured Vehicle at the time of our inspection. Parts and components (circled) that had sustained fire/smoke damage

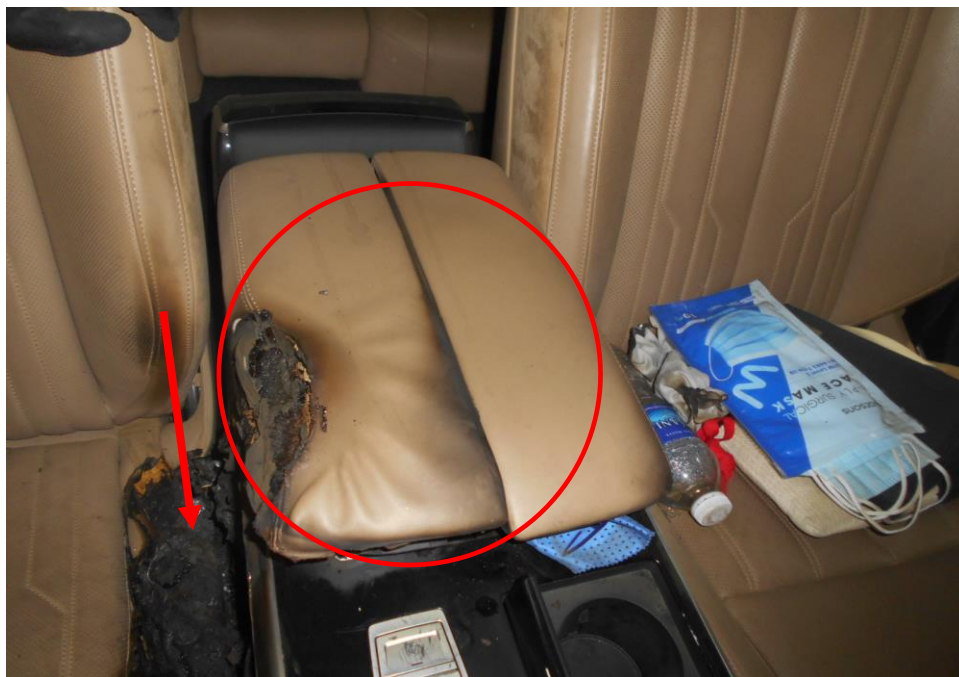
Photo 7 shows the close up view of the from the driver seating compartment of the Insured Vehicle at the time of our inspection. Its centre console armrest (red circle) and front right driver seat (red arrow) was found to have been burnt and melt as a result of the fire.

7. During examination of the Insured Vehicle's interior compartment, it was noted that the area around the left side of the driver's seat had sustained the most severe fire/smoke damage as compared to other areas inside the interior compartment of the Insured Vehicle. This suggests that the fire originated at the left side of the driver's seat

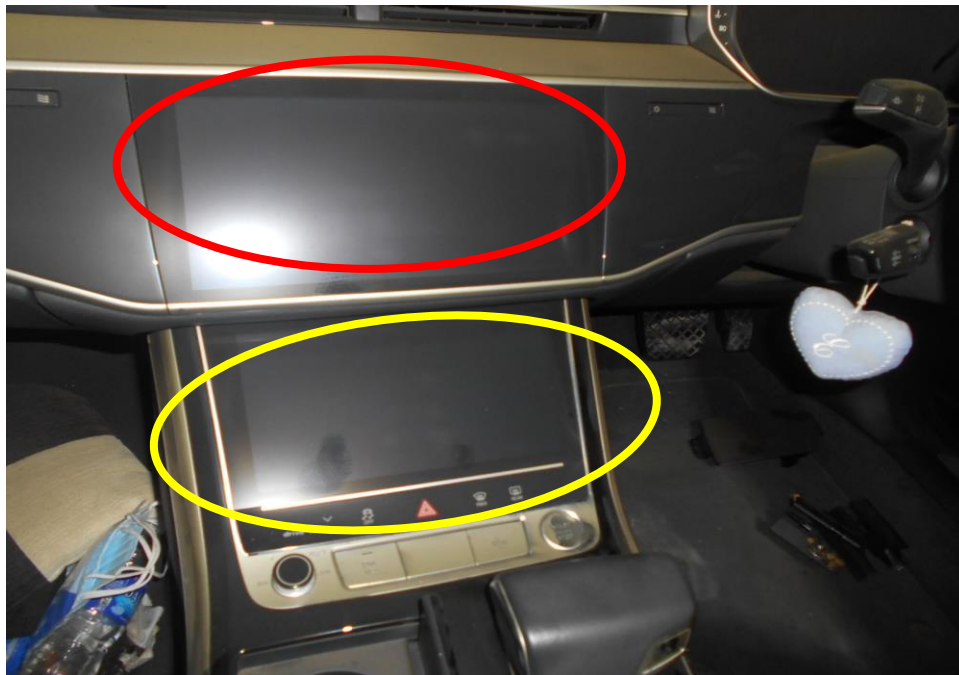
Photo 8 shows the general view of the multimedia infotainment head-unit (red circle) and digital climate control panel (yellow circle) of the Insured Vehicle at the time of our inspection. The unit was not illuminated when turned on and the surface on it had suffered heat and minor smoke damages as a result of the fire.

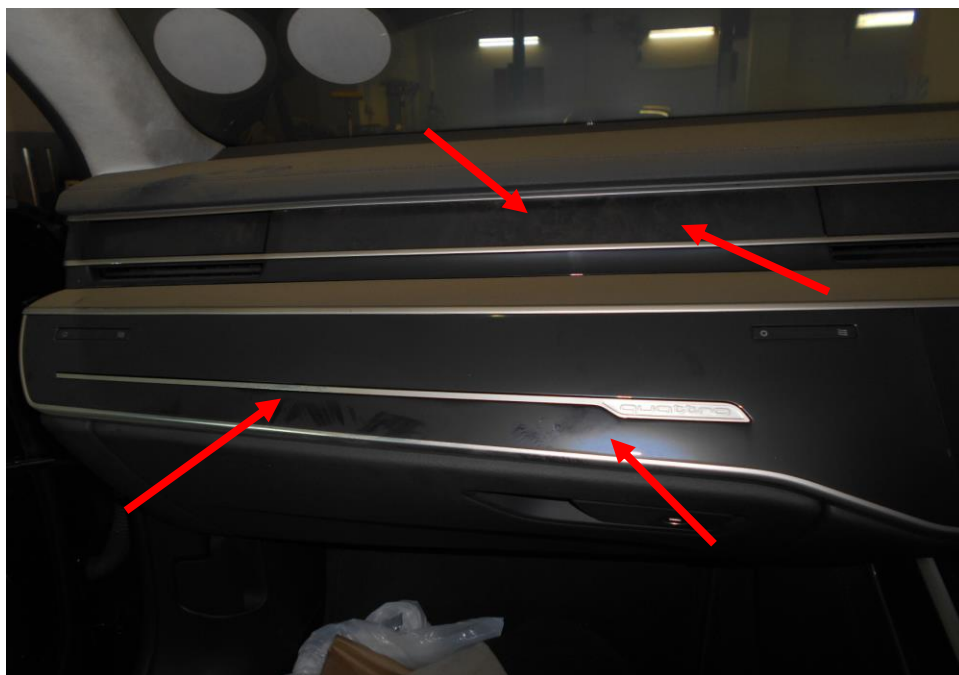
Photo 9 shows the general view of the dashboard trims of the Insured Vehicle at the time of our inspection. The surface had suffered heat and smoke damages (red arrows) as a result of the fire.

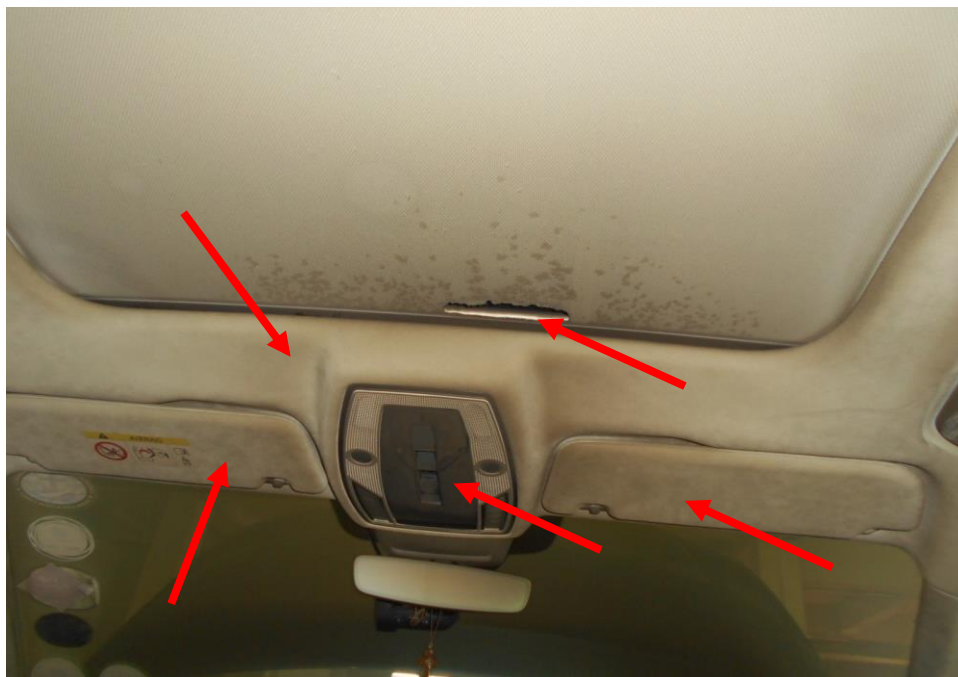
Photo 10 shows the general view of the interior roof headliner trim of the Insured Vehicle at the time of our inspection. The surfaces had suffered heat and smoke damages (red arrows) as a result of the fire.

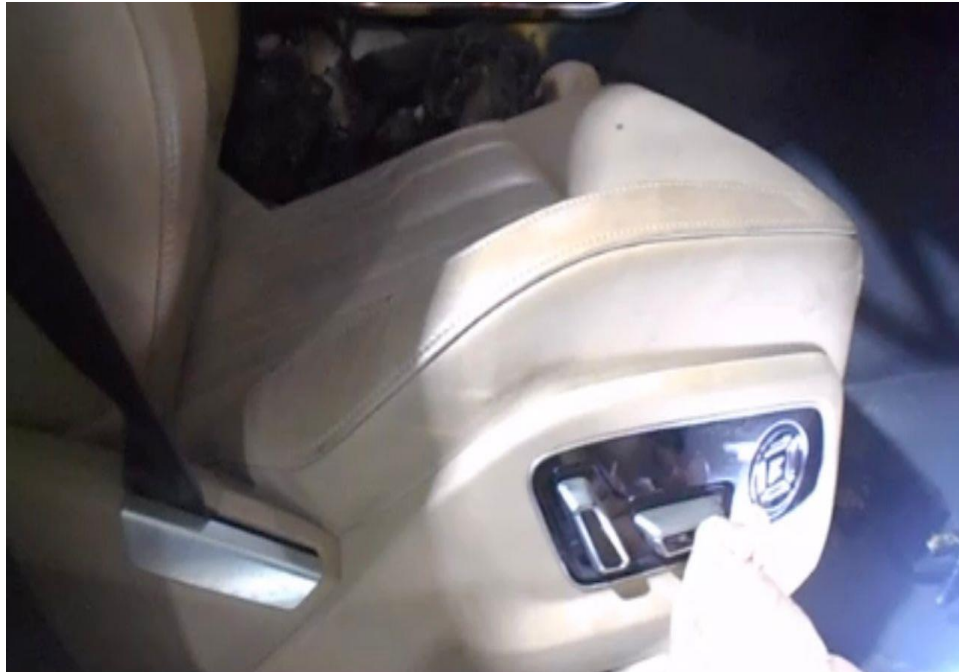
Photo 11 shows the driver electric power seat controls being pushed towards the seat decline position (red arrow) during the operational/functionality test.

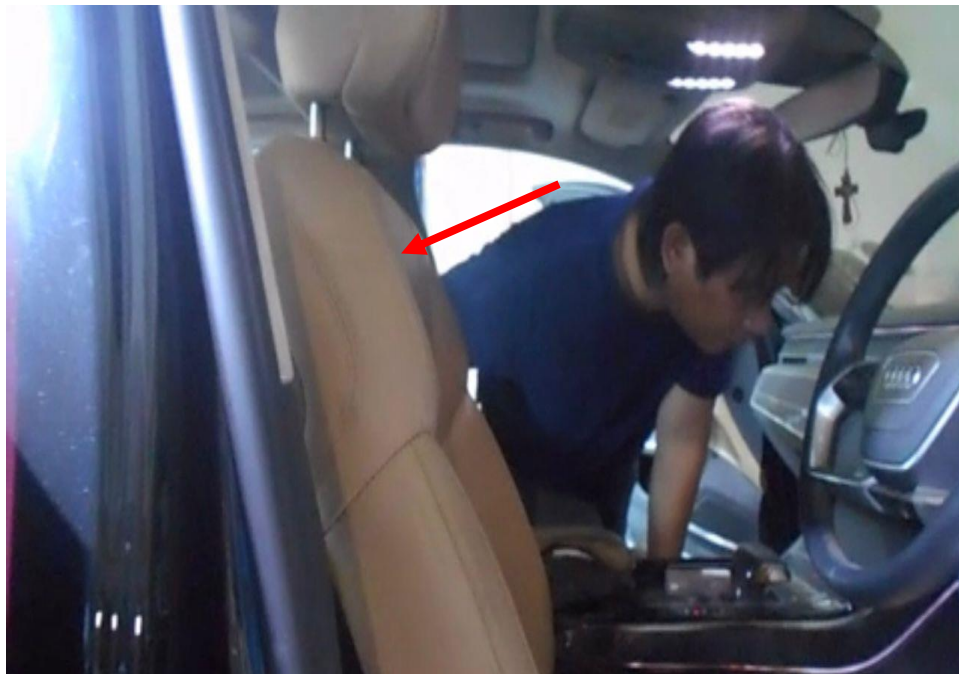
Photo 12 shows the driver seat at its decline position (red arrow) during the operational/functionality test.

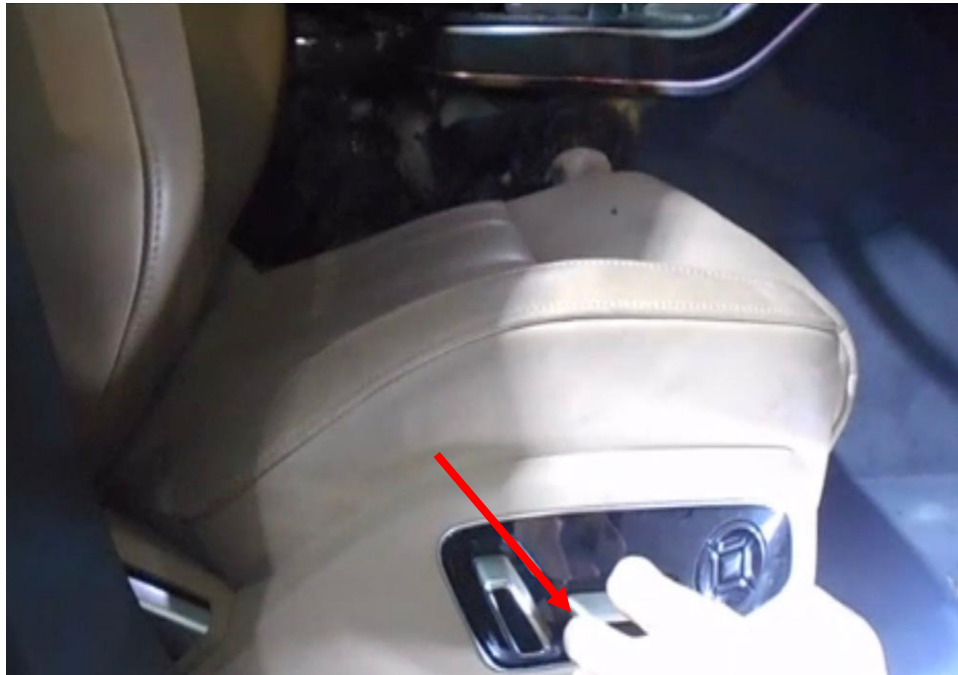
Photo 13 shows the drive electric power seat controls being pushed towards the seat incline position (red arrow) during the operational/functionality test.

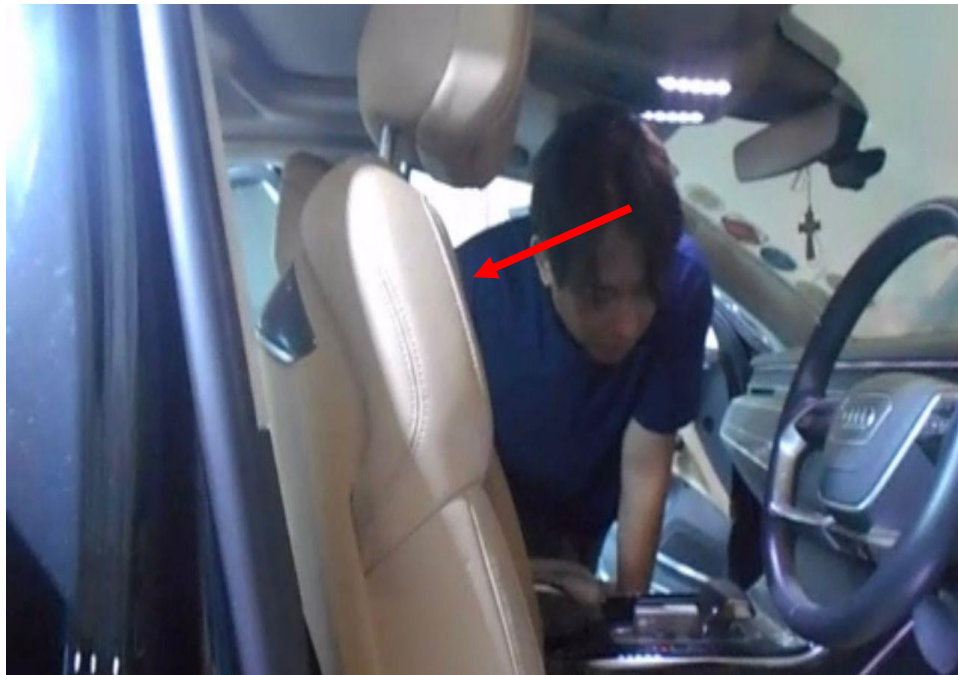
Photo 14 shows the driver seat at its incline position during the operational/functionality test.

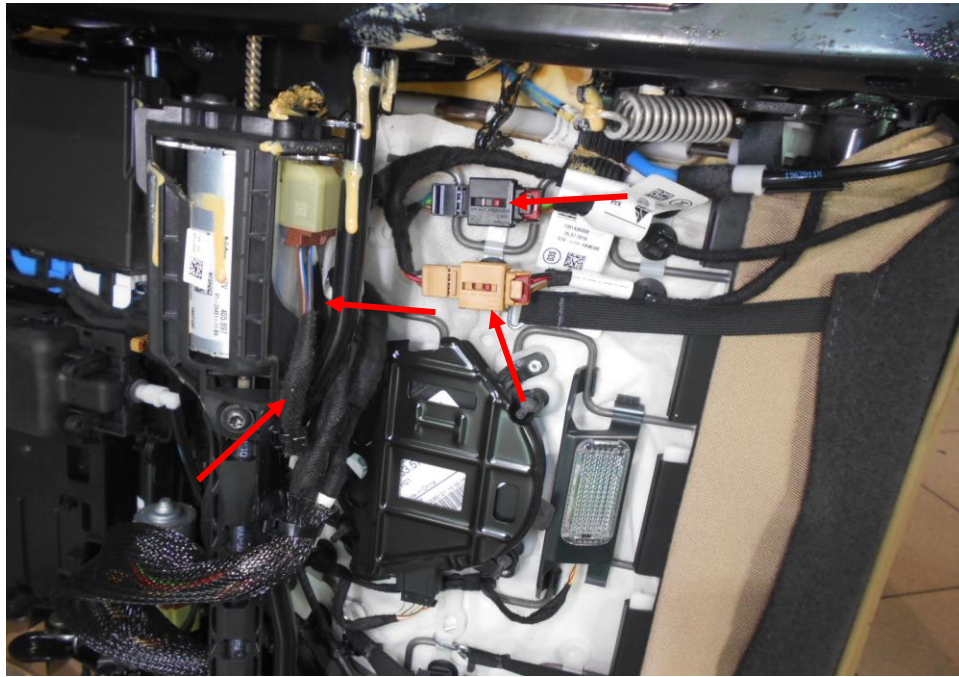
Photo 17 shows the general view of the driver seating compartment of the Insured Vehicle at the time of our inspection. The electronic power seat motor along with the factory fitted wirings (red arrows) was observed to be intact and unaffected by the fire.

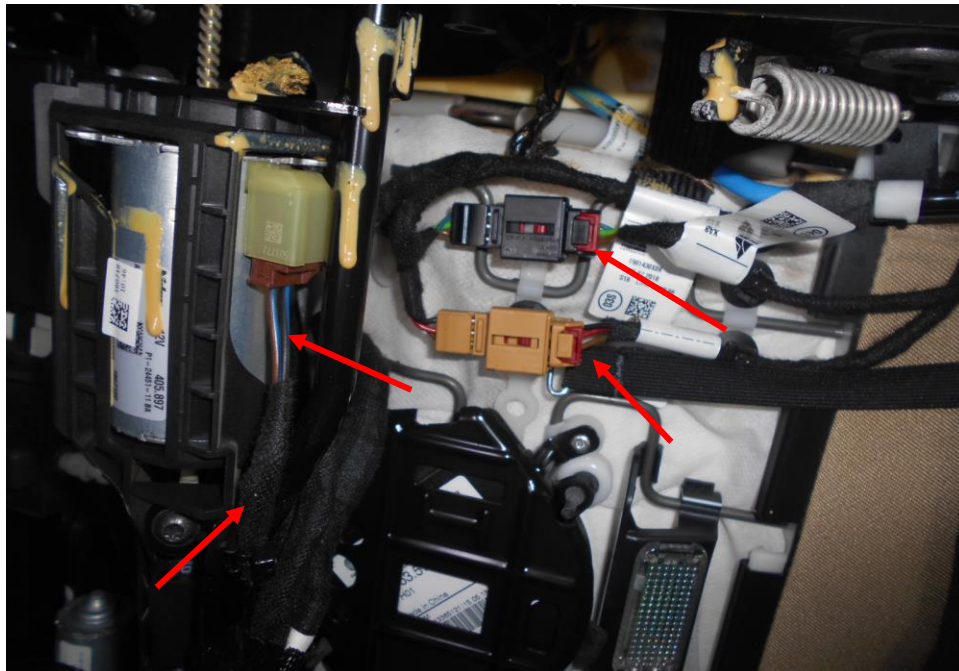
Photo 18 shows a close up view of the driver seating compartment of the Insured Vehicle at the time of our inspection. The electronic power seat motor along with the factory fitted wirings (red arrows) was observed to be intact and unaffected by the fire.

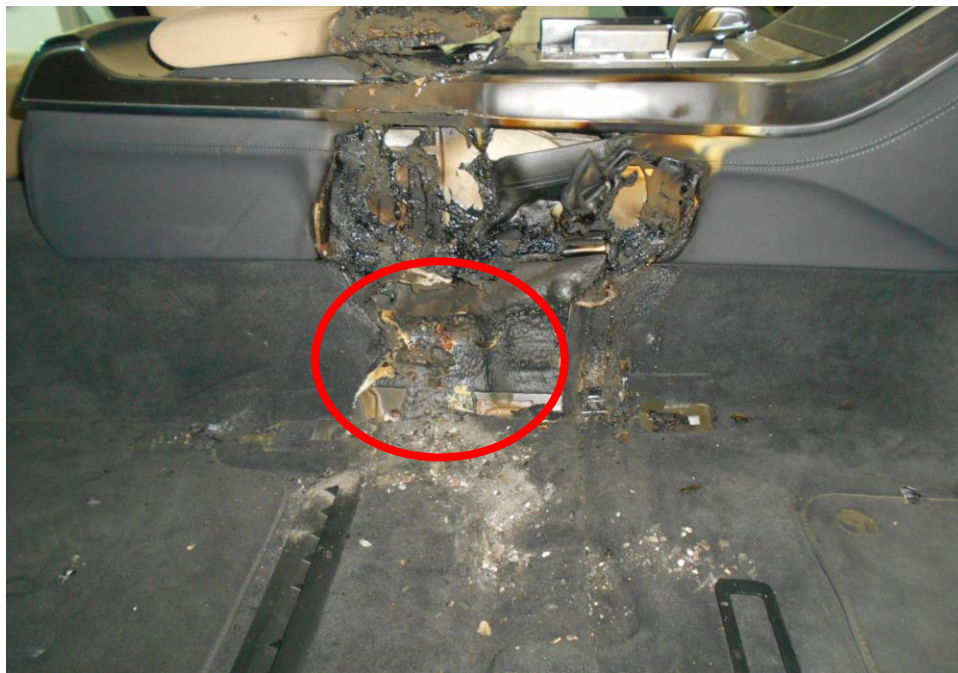
9. Upon checking the upholstery area of the Insured Vehicle, at the left side of the driver's seat, after it (driver seat) was removed, we had found remains of a burnt cigarette lighter as well as components of the cigarette lighter such as fork spring, flint spring and flint ignitor. See photo 19- 21 below.

Photo 19 shows a general view of the driver seating compartment of the Insured Vehicle upon dismantling the driver seat. Its front right foot well (circled) where remains of a burnt cigarette lighter along with components of the cigarette lighter such as the fork spring, flint spring and flint ignitor was found within the vicinity of the driver footwell/seat railing area.

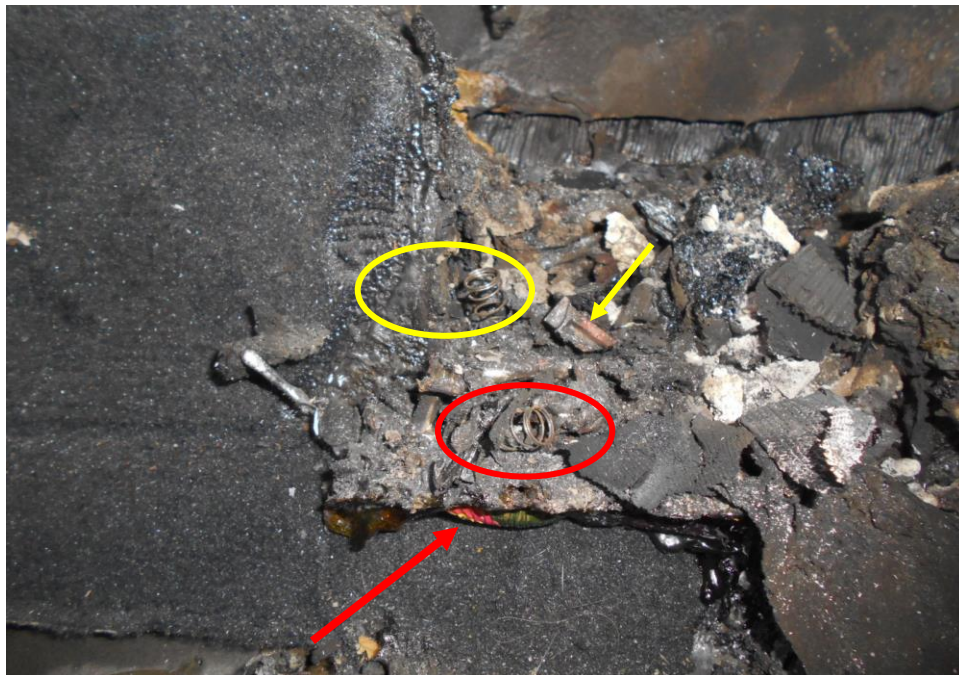
Photo 20 shows a close up view of the driver seating compartment of the Insured Vehicle upon dismantling the driver seat. Its front right foot well where reminiscent of a burnt cigarette lighter (red arrow) along with components of the cigarette lighter such as the fork spring (red circle), flint spring (yellow circle) and flint ignitor (yellow arrow) was found within the vicinity of the driver footwell/seat railing area.

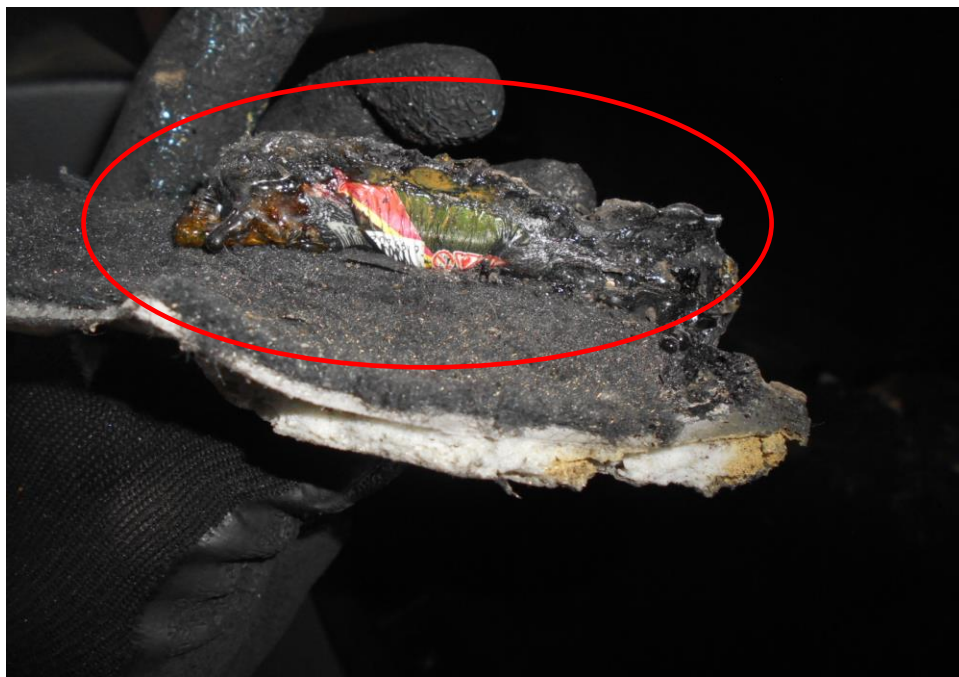
Photo 21 shows the close up view of the burnt cigarette lighter (circled) that was found in the immediate vicinity of the fire.

21. Having investigated and technically analysed the damages of burnt nature to the Insured Vehicle. We are of view that, the fire had likely originated from the cigarette lighter that was found stuck at left side of the driver's seat. Fire to the Insured Vehicle was hence due to external factor.
22. From our understanding the Insured Vehicle is equipped with Audi's Easy Entry access system whereby the driver's seat will electronically move backward automatically to a position that makes exit to the interior compartment of the Insured Vehicle easier after turning off the engine and opening of driver's door. When entering the interior compartment, the driver's seat will then electronically move automatically to its pre-set memory seat position.

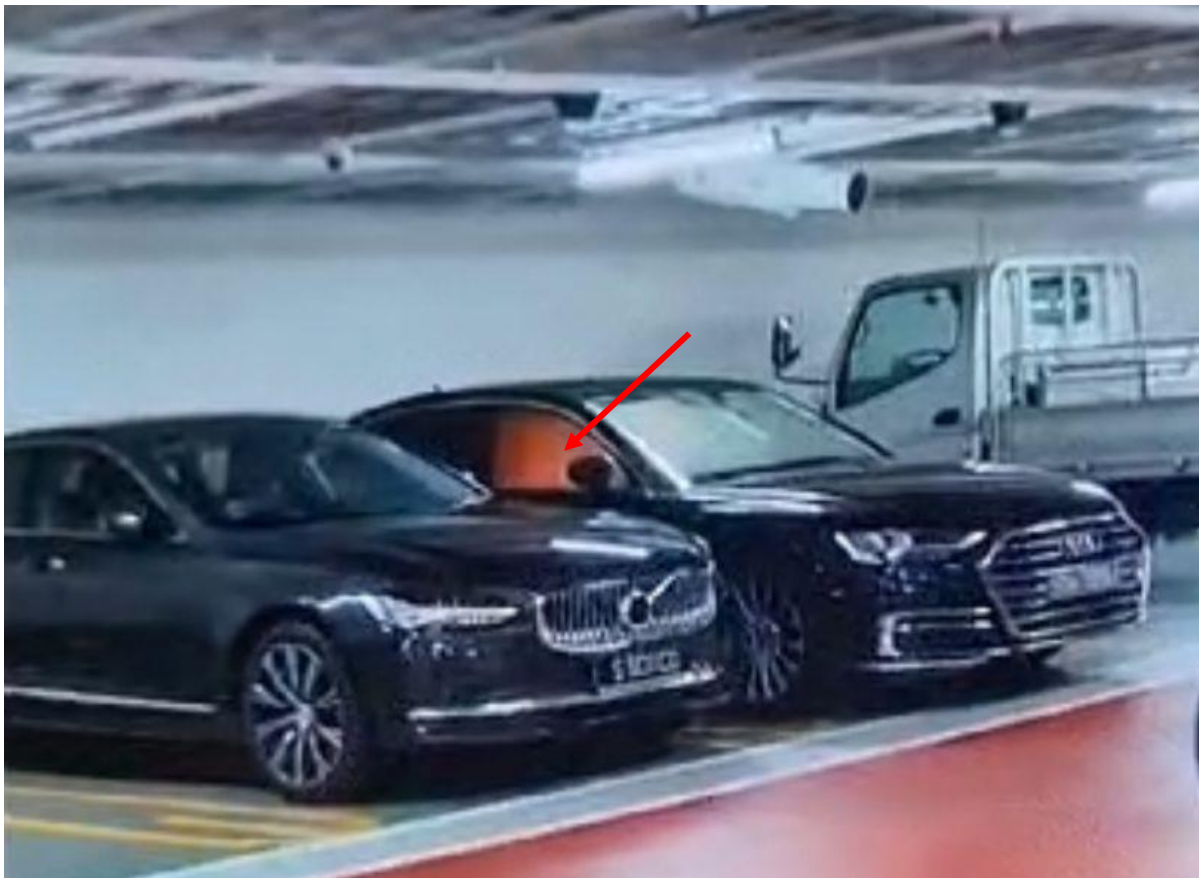
Photo 22 shows the Insured Vehicle with flames confined to its interior compartment portion (red arrow).

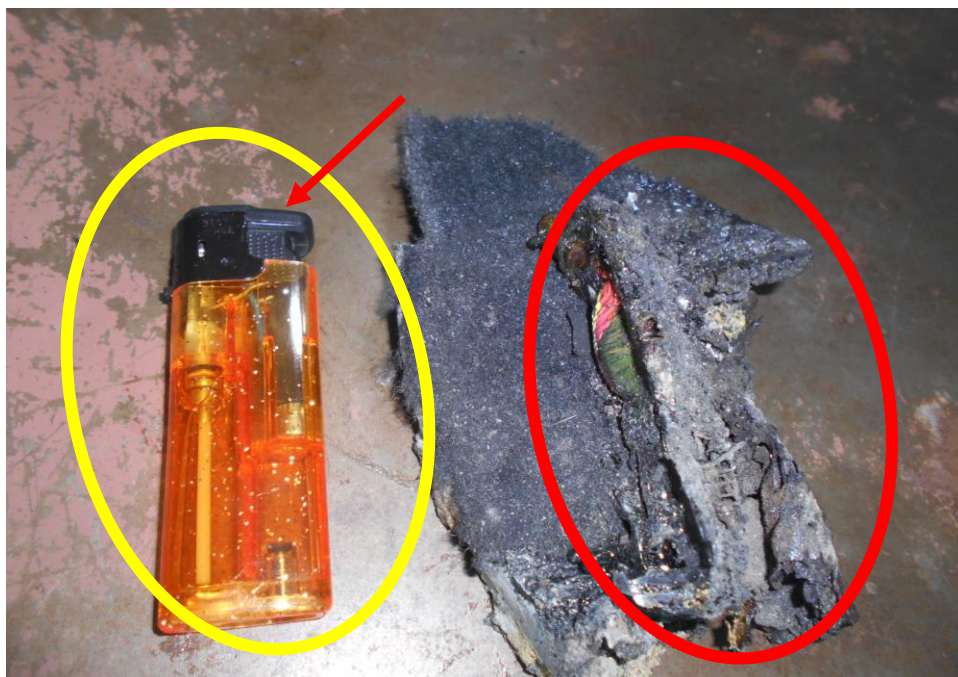
23. We are further of opinion that a cigarette lighter had fallen into the gap between the centre console arm rest and the left side of the Insured Vehicle's driver's seat. The occurrence of when this had happened could not be established. At the material time, When Mr Tan opened the driver's door to alight after parking the Insured Vehicle, the driver's seat had electronically moved backwards automatically (due to easy access feature). The backward movement of the driver's seat had flicked the head of the cigarette lighter into an "open" position, causing the lighter to ignite flames, ultimately leading to the fire to the interior compartment of the Insured Vehicle. See photo 25 below.

Photo 25 shows the close up view of the burnt cigarette lighter (red circle) that was removed from the Insured Vehicle's placed alongside a cigarette lighter that we believe to be similar type. (yellow circle). The head of the cigarette lighter (red arrow) had flicked into an "open" position when the driver's seat had electronically moved backwards automatically (due to easy access feature). This had caused the lighter to ignite flames, ultimately leading to the fire to the interior compartment of the Insured Vehicle.
