CS/LAW24090482/Knp3

## ASSIGNMENT

SMU1093K

## Repair Estimates

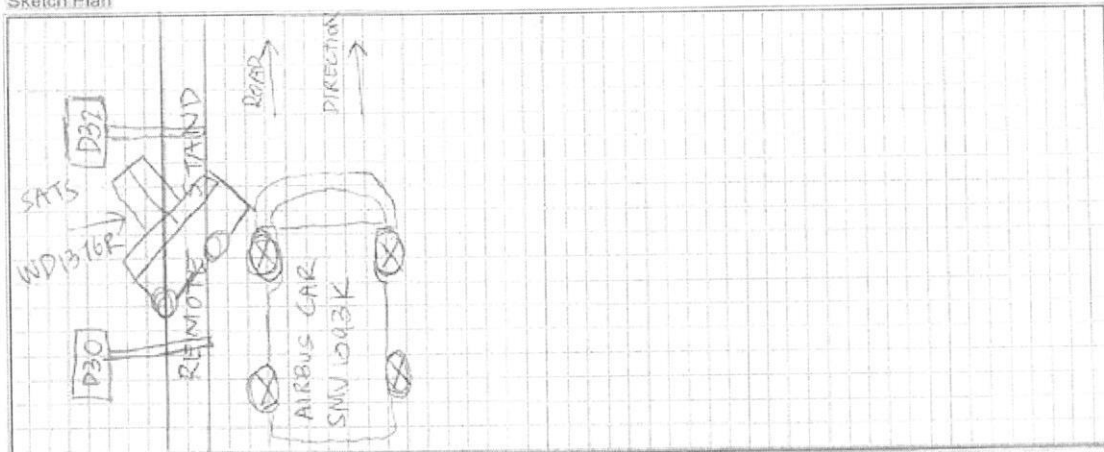
SKETCH PLAN #2

At approximately 1400 HRS, I (Imran Bin Ali DRIVER) along with 2 other passengers (George Lim (beside driver) and See Yap Yong (back seat) were heading towards Bay D36 SIAEC Airbus team office. We had just come from declaring the serviceability of 9V-SKM (SIA A380) which was parked at B2. (Departure SQ406)

Upon exiting the Terminal 1 Baggage handling area (speed limit of 15 KM/H), we made a left turn into Bay D30. For info, this area speed limit is 30 KM/H and car picked up speed.

After passing D30 bay at approximately 1410 HRS, a SATS tractor vehicle number WD1376R inched out of the remote stand and hit our car.
