NCVI INVOLVING 6TON (21812MID) AND SBS BUS (SMB3161J) ALONG SEMBAWANG ROAD ON 27 SEP 2024 AT AROUND 1140H

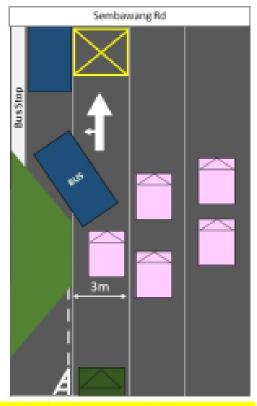
Figure A-3

BUS (SMB3161J) Turned on hazard light, Signalling to Stop. Car behind slowing down to a halt.

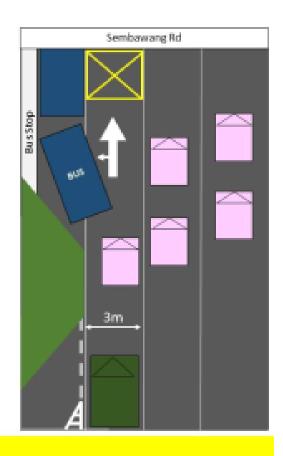
Figure A-4

BUS (SMB3161J) Starts moving into bus stop lane.

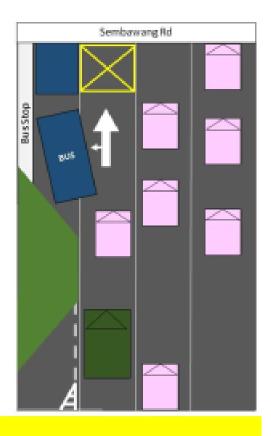
Figure A-5

BUS (SMB3161J) Starts moving into bus stop lane.

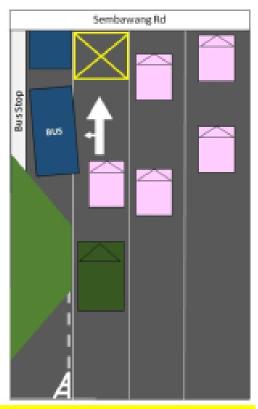
Figure A-8

White Car Infront is clear and proceeds past the BUS (SMB3161J).

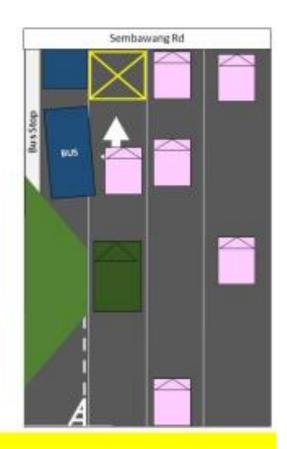
Figure A-9

White Car Infront drives past the BUS (SMB3161J) .

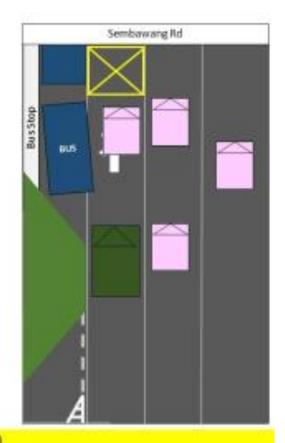
Figure A-10

6TON (MID21812) Drives forward towards BUS (SMB3161J)

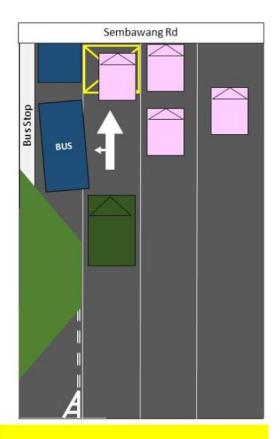
Figure A-12

6TON (MID21812) Drives forward towards BUS (SMB3161J)

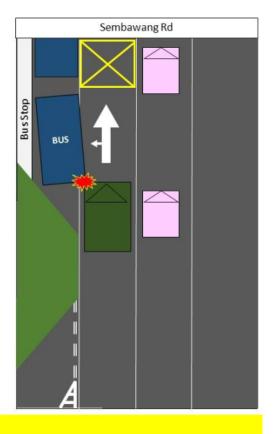
Figure A-13

6TON (MID21812) Hits and grazes BUS (SMB3161J)

The 6-Ton left side mirror collided against the right rear side of the bus, this happened at bus-stop 57029, along Sembawang Road.

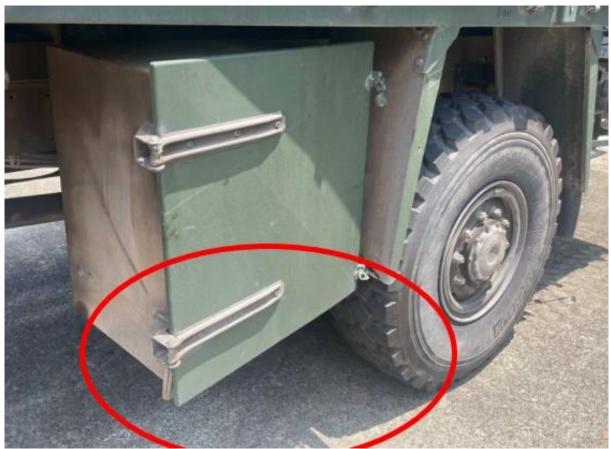
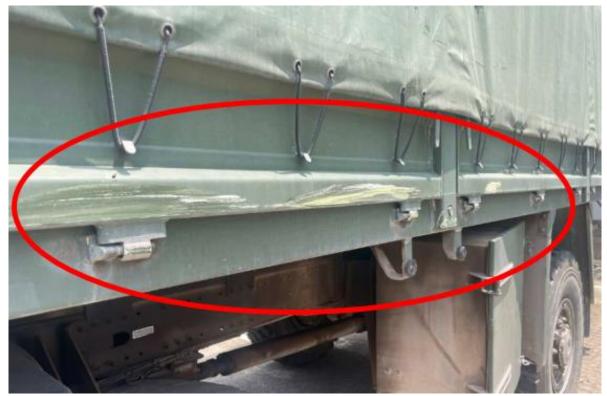
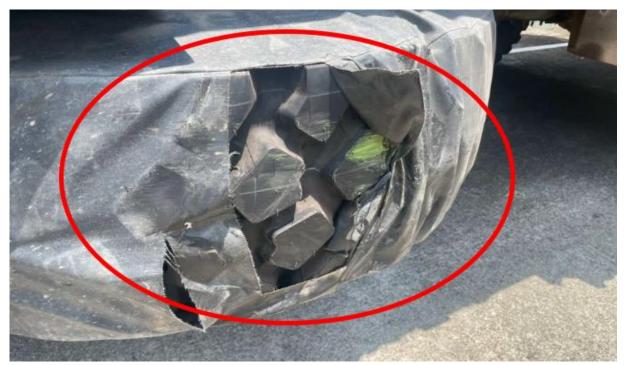
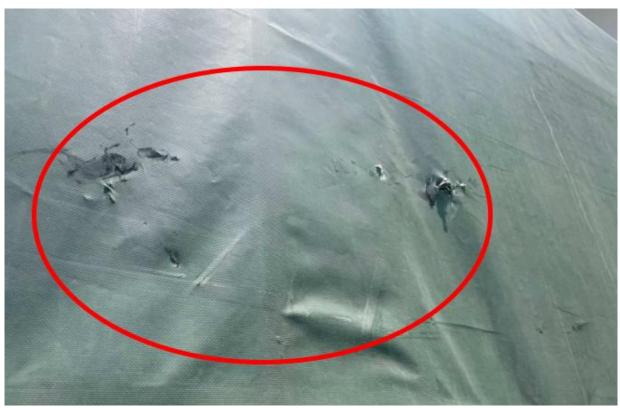
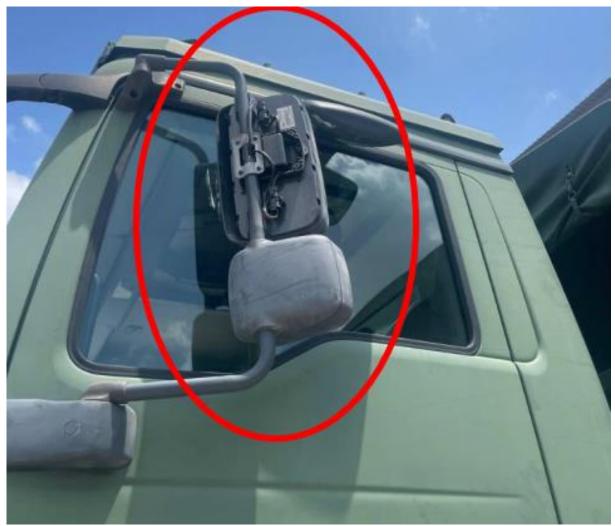
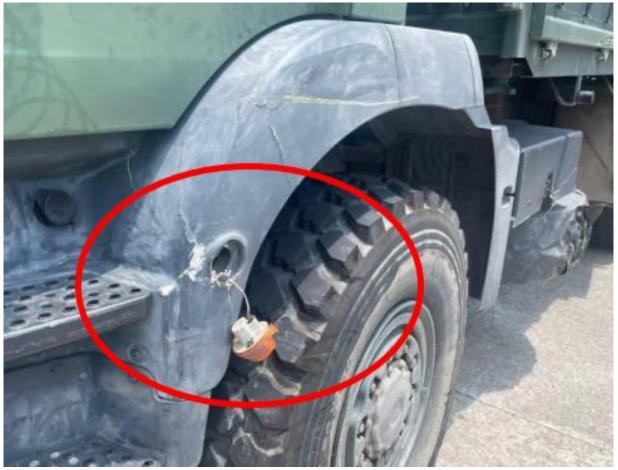
Figure B-5: Close-up View of Damages to MID21812

Figure B-6: Close-up View of Damages to MID21812

Figure B-7: Close-up View of Damages to MID21812

Figure B-8: Close-up View of Damages to MID21812

Figure B-9: Close-up View of Damages to MID21812

Figure B-10: Close-up View of Damages to MID21812

Damage Assessment: MID 21812 sustained the following damages:

- 1. Torn Canopy
- 2. Scratches along left hand side
- 3. Torn spare wheel cover
- 4. Dented toolbox
- 5. Broken side light
- 6. Broken left side-view mirror
- 7. Cracked front-left mudguard

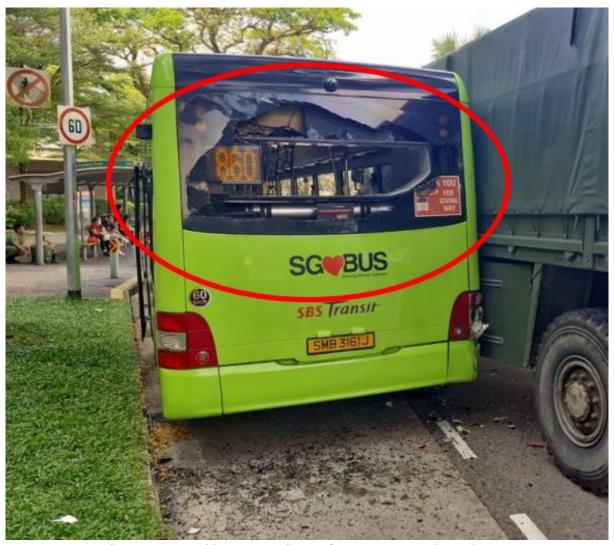
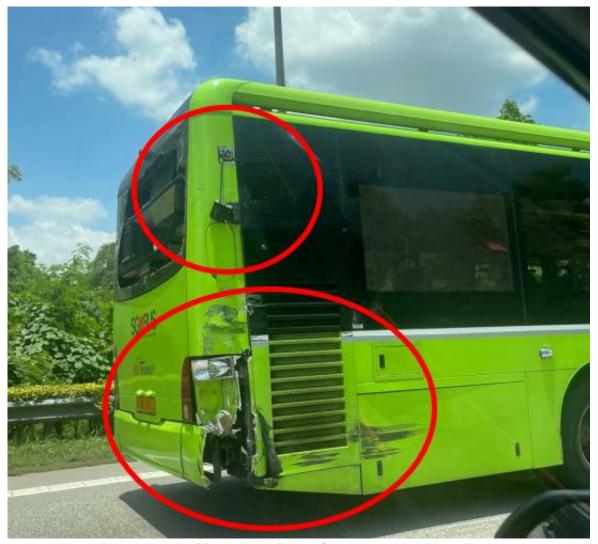
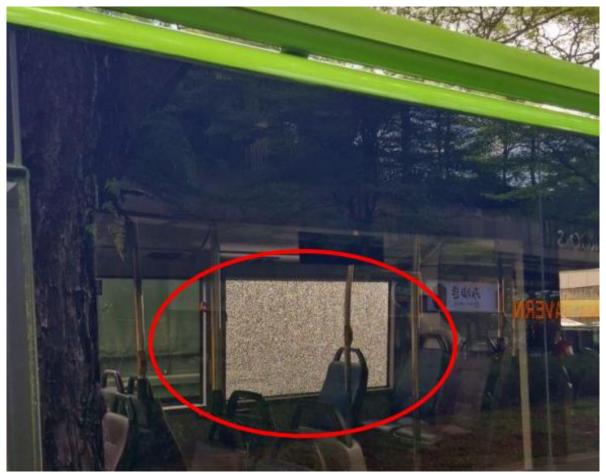
Figure B-11: Close-up View of Damages to SMB2161J

Figure B-12: Close-up View of Damages to SMB2161J

Figure B-13: Close-up View of Damages to SMB2161J

Damage Assessment: SMB2161J sustained the following damages:

- 1. Broken right tail light
- 2. Shattered rear window pane
- 3. Broken Rear Camera
- 4. Shattered rear right window pane shattered
