Your Ref: 23/24/24/VC05/029893
Our Ref : CS/LPC24100120/K

14 October 2024

**TECHNICAL INVESTIGATION REPORT OF INSURED VEHICLE YQ 1422Z
INVOLVED IN AN ACCIDENT ON 10 SEPTEMBER 2024**

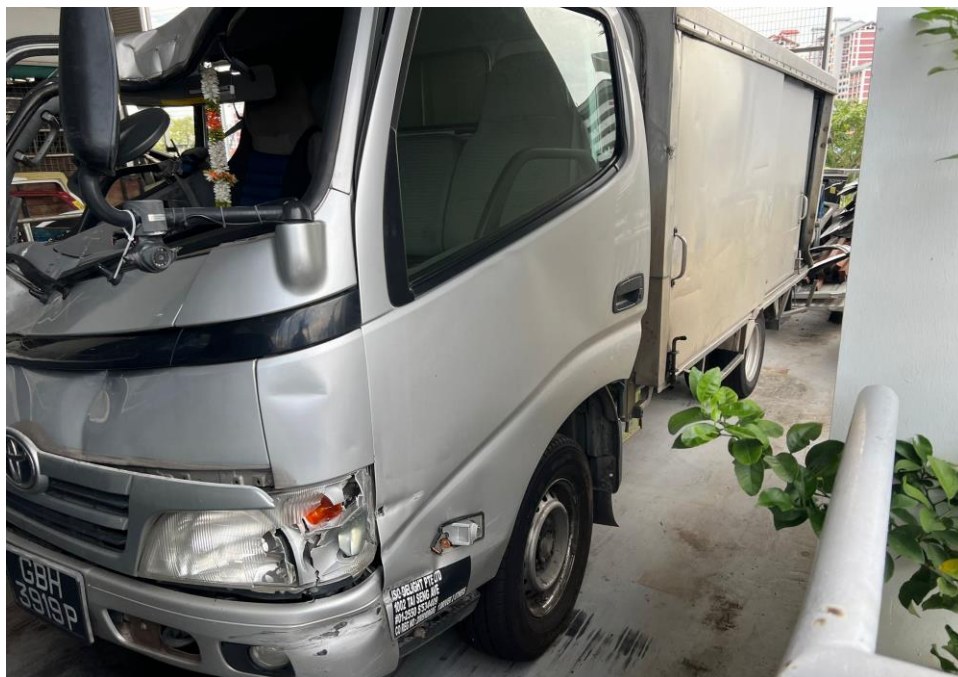
Photo 3 shows the general view of the left body of the insured vehicle at the time of my inspection its unaffected by the accident.

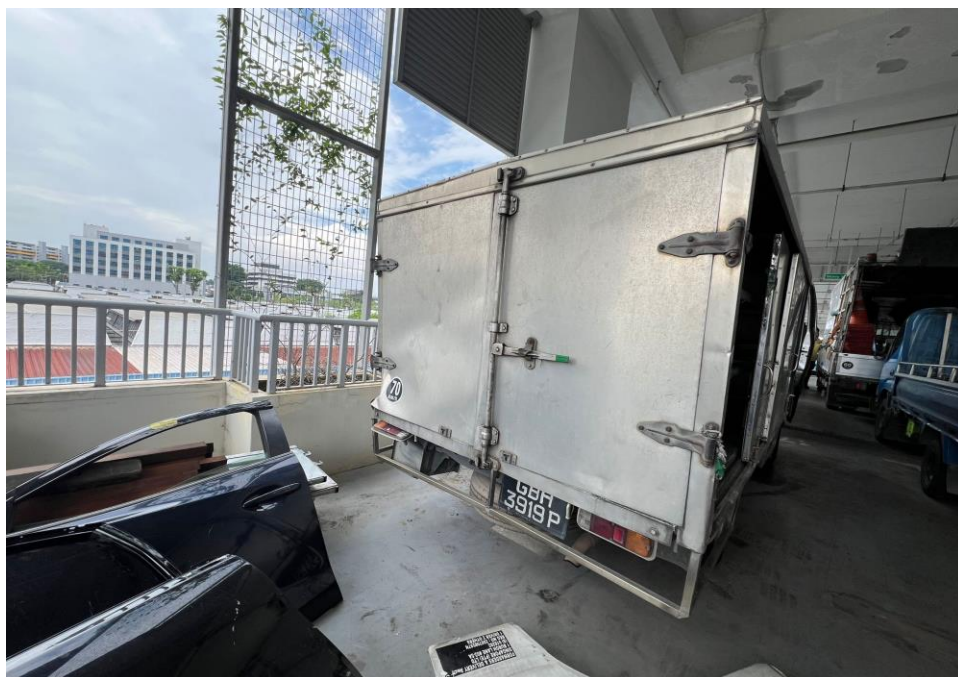
Photo 4 shows the general view of the rear portion of the insured vehicle at the time of my inspection its unaffected by the accident.

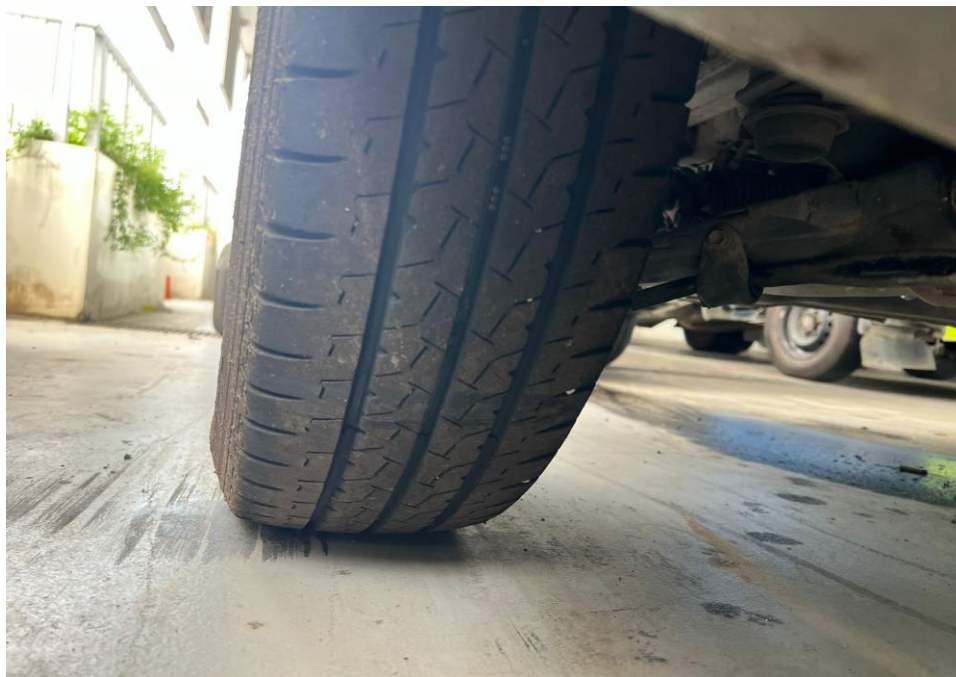
Photo 8 shows the front left tyre of the insured vehicle at the time of my inspection. The front left tyre of the insured vehicle was observed to be in serviceable condition with the remaining tread depth of 4.8mm which is within LTA requirements.

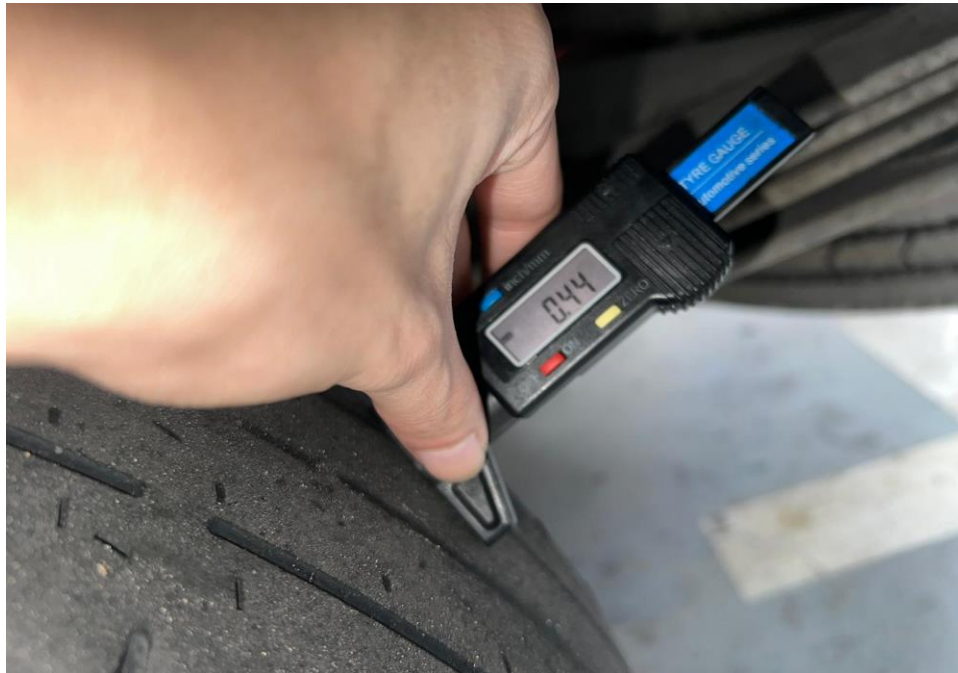
Photo 17 shows the tread depth of the rear left inner tyre (inner tread) on the insured vehicle at the time of my inspection. The remaining tread depth is 0.4mm which is not within the LTA requirements.

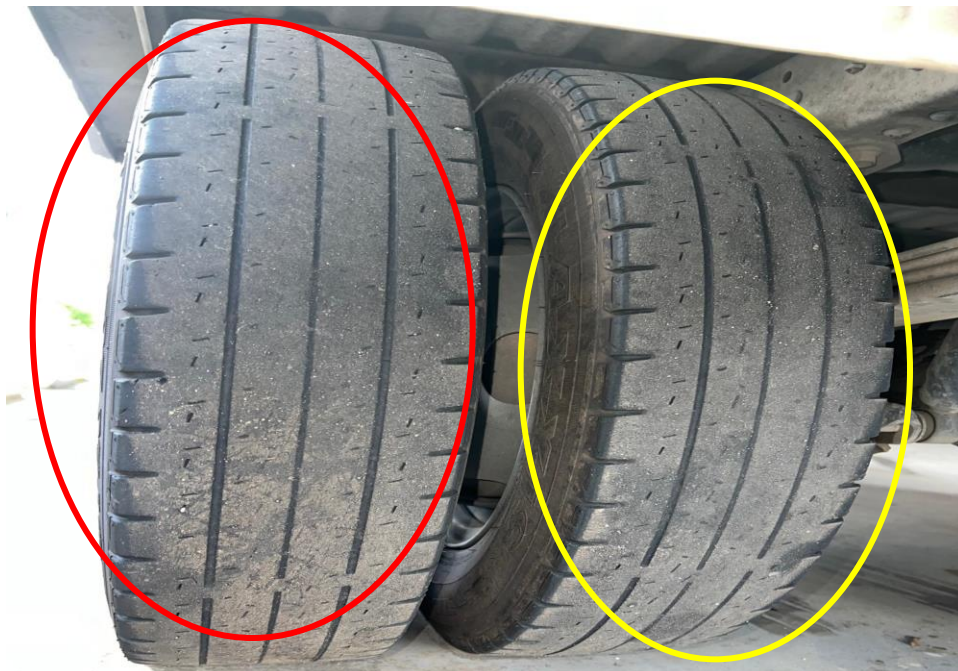
Photo 18 shows the general view of the rear left tyre tyres of the insured vehicle at the time of my inspection. The rear left tyres of the insured vehicle with remaining tread depth of 0.3mm- 0.9mm on the rear left outer tyre (red circle) and 0.4mm- 0.9mm on the rear left inner tyre (yellow circle).

13. In general, having physically inspected the Insured Vehicle, we are in view that the condition of the rear left outer and inner of the Insured Vehicle was not within the requirements of SECTION 109(f) CAP 276 of THE MOTOR VEHICLES (CONSTRUCTION AND USE) RULES, 1974, 1978 OF THE ROAD TRAFFIC ACT. SECTION 109(e) of THE ROAD TRAFFIC ACT, ROAD TRAFFIC (MOTOR VEHICLES, CONSTRUCTION AND USE) RULES. The condition of the rear left inner and outer tyre tread depth of 0.3mm- 0.9mm would have likely contributed the accident on 10 September 2024.
