14 October 2024

**TECHNICAL INVESTIGATION REPORT OF INSURED VEHICLE GBH 3919P  
INVOLVED IN AN ACCIDENT ON 10 SEPTEMBER 2024**

Registration Number : GBH 3919P  
Make & Model : TOYOTA DYNA 3.0 DIESEL TURBO M/T 2WD LORRY  
Year of Registration : MAY 2018  
Chassis Number : KDY2318025287  
Speedo Reading : N/A

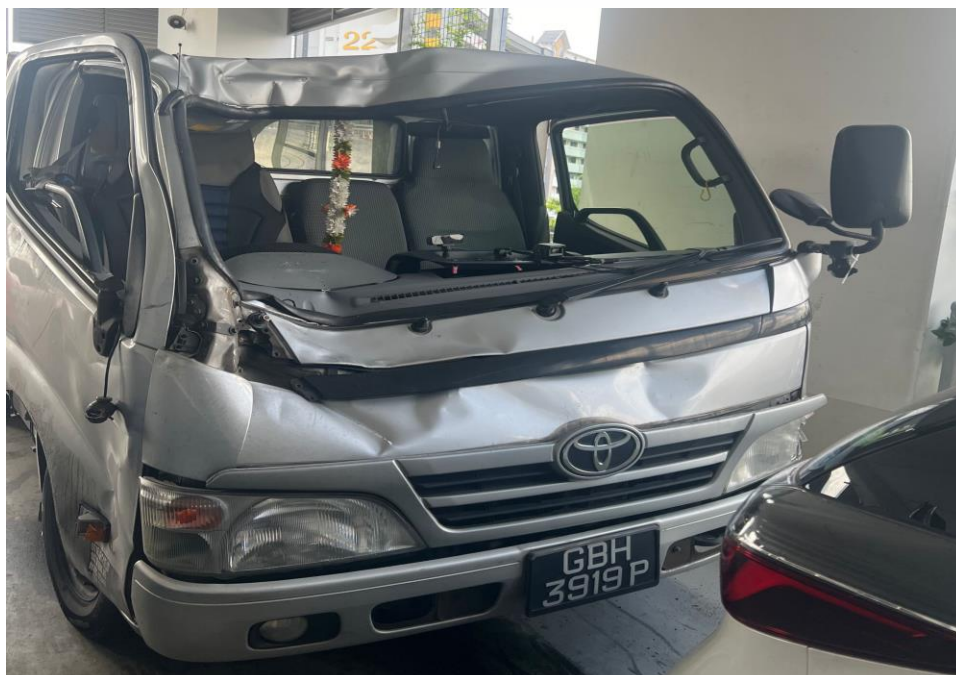
**Photo 1** shows a general view of the Insured Vehicle front portion at the time of my inspection. The Insured Vehicle was observed to have sustained damage at its front portion. Its front windscreen, front body panel, front left headlamp and front bumper was amongst the body parts damaged as a result of the accident.

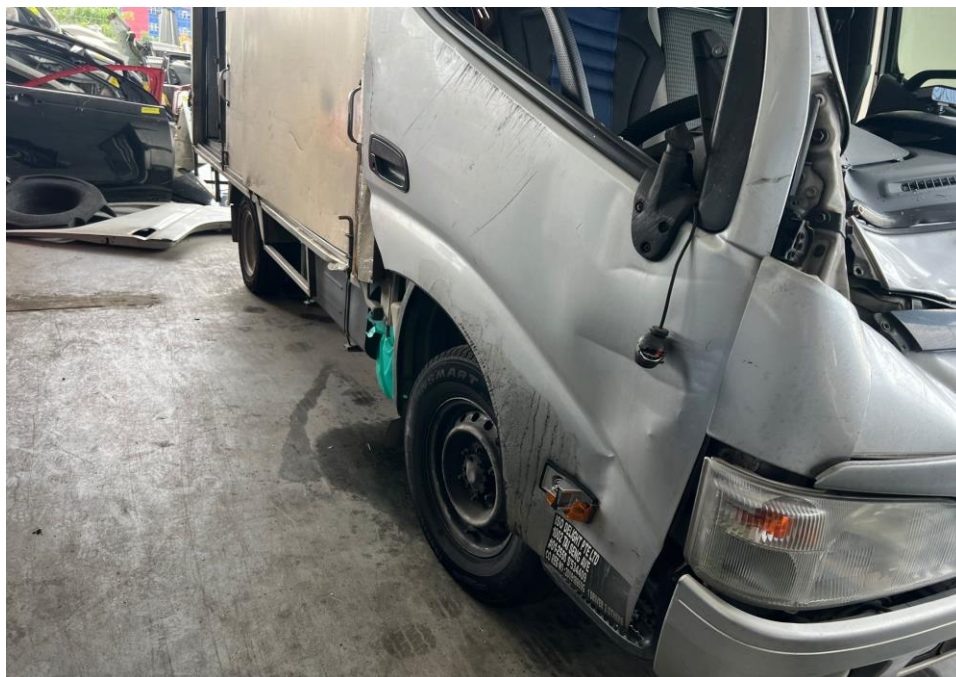
**Photo 2** shows the close up view of the right body of the insured vehicle at the time of my inspection. Its front right door was observed to be damaged as a result of the accident.

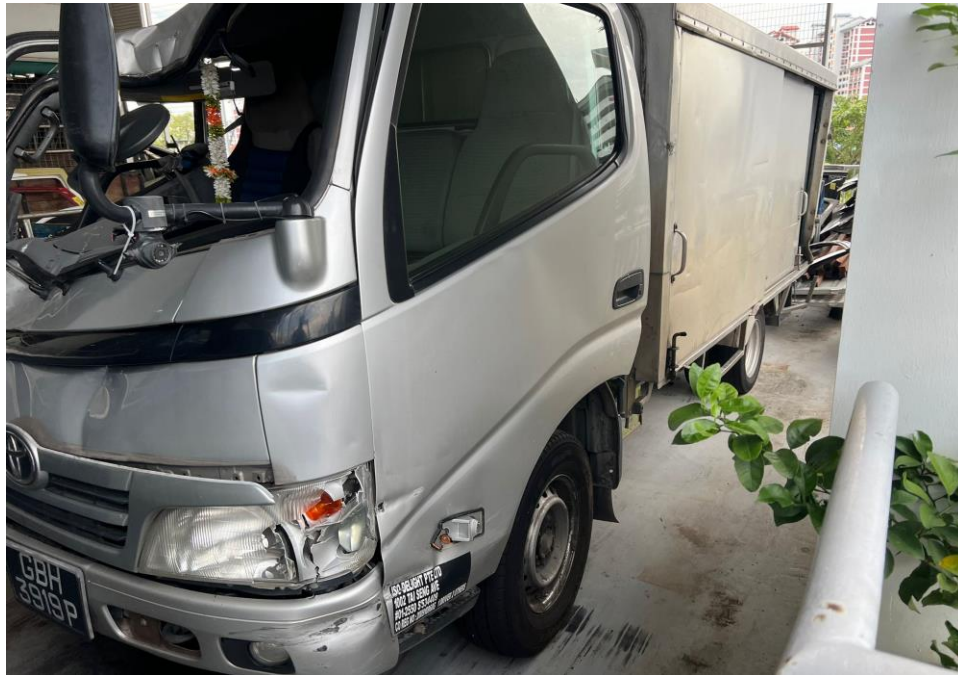
**Photo 3** shows the close up view of the left body of the insured vehicle at the time of my inspection. Its front left door was observed to be damaged as a result of the accident.

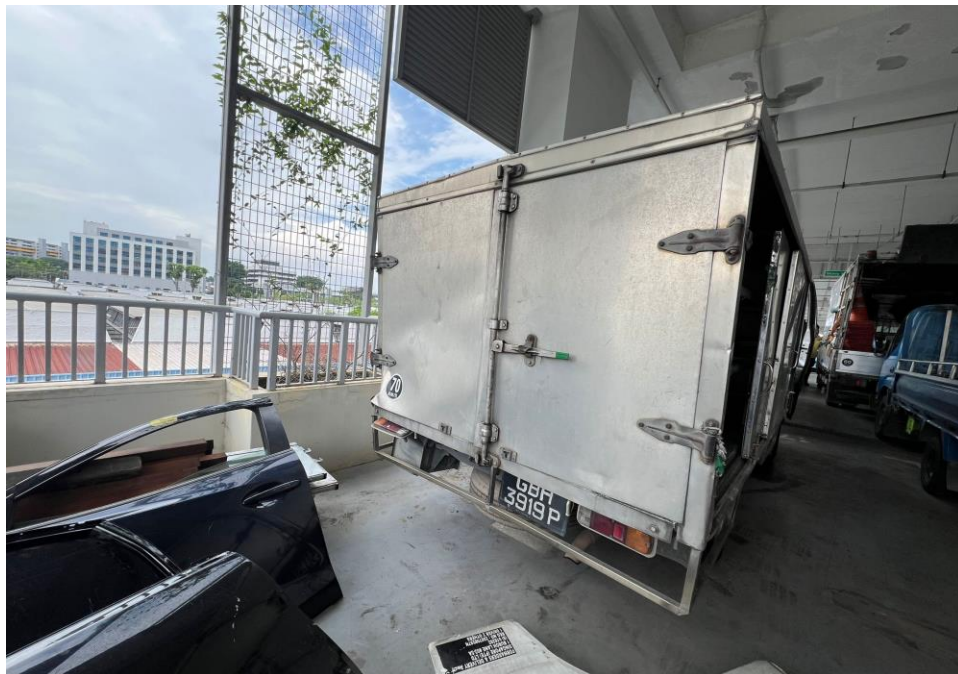
**Photo 4** shows the general view of the rear portion of the insured vehicle at the time of my inspection its unaffected by the accident.

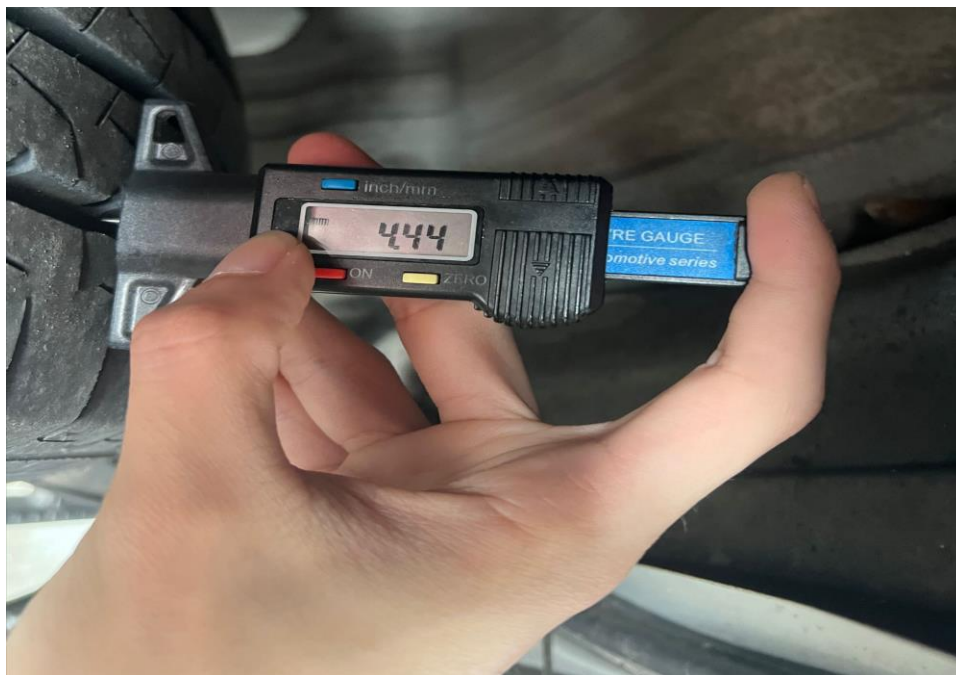
**Photo 5** shows the tread depth of the front right tyre on the insured vehicle at the time of my inspection. The remaining tread depth is 4.4mm which is within the LTA requirements.

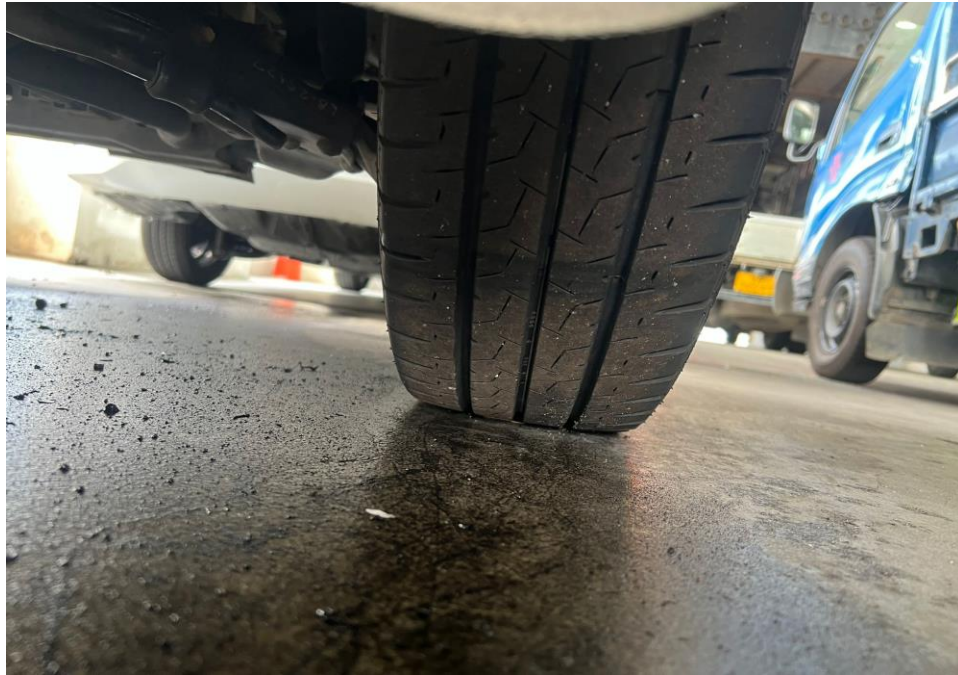
**Photo 6** shows front right tyre of the insured vehicle at the time of my inspection. The front right tyre of the insured vehicle was observed to be in serviceable condition with remaining tread depth of 4.4mm which is within LTA requirements.

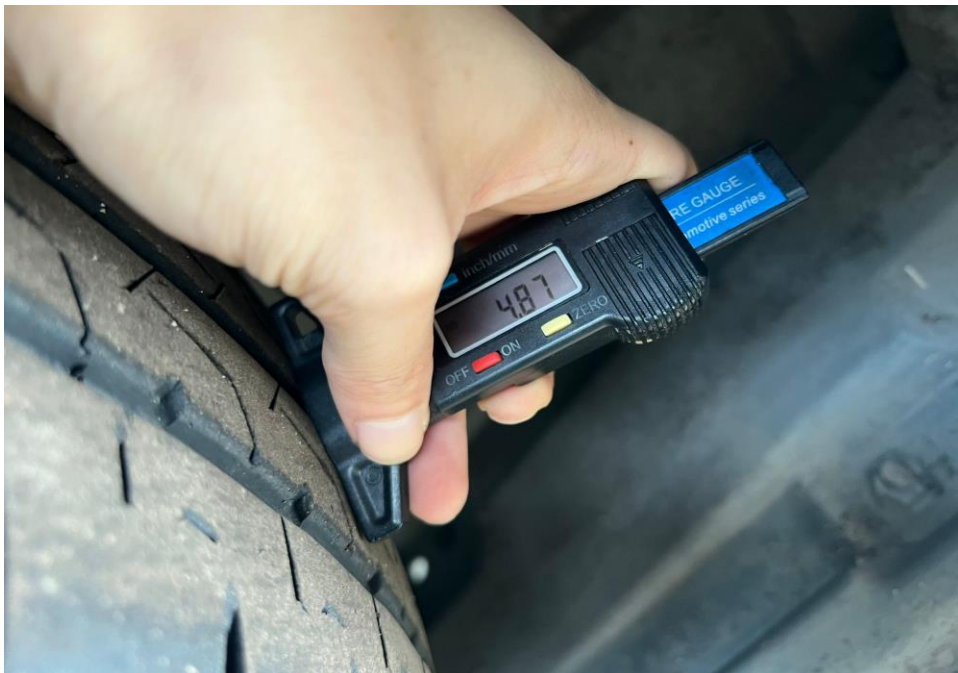
**Photo 7** shows the tread depth of the front left tyre on the insured vehicle at the time of my inspection. The remaining tread depth is 4.8mm which is within the LTA requirements.

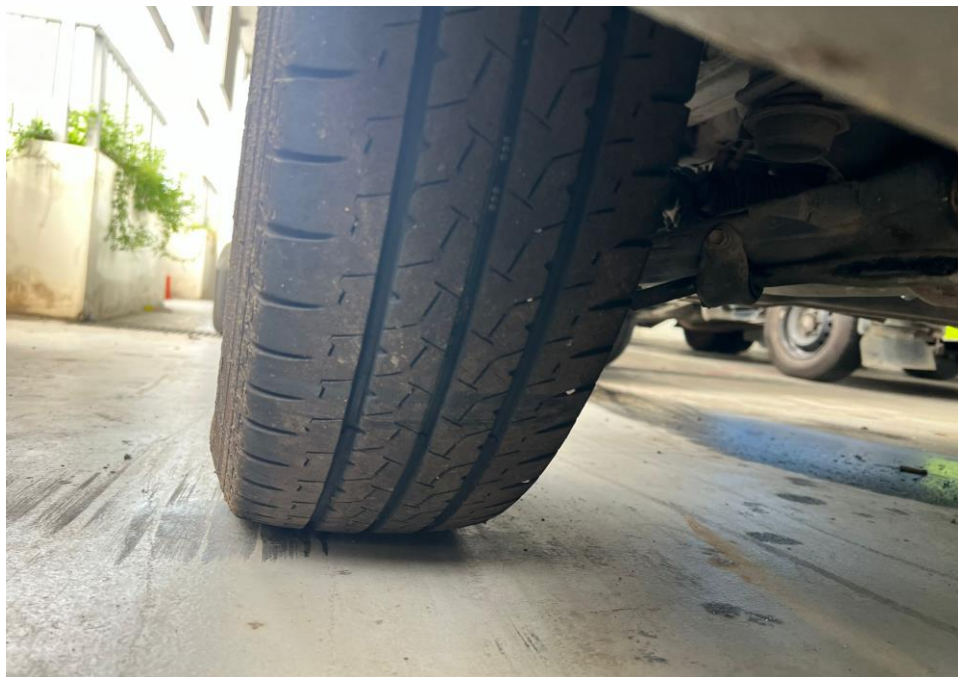
**Photo 8** shows the front left tyre of the insured vehicle at the time of my inspection. The front left tyre of the insured vehicle was observed to be in serviceable condition with the remaining tread depth of 4.8mm which is within LTA requirements.

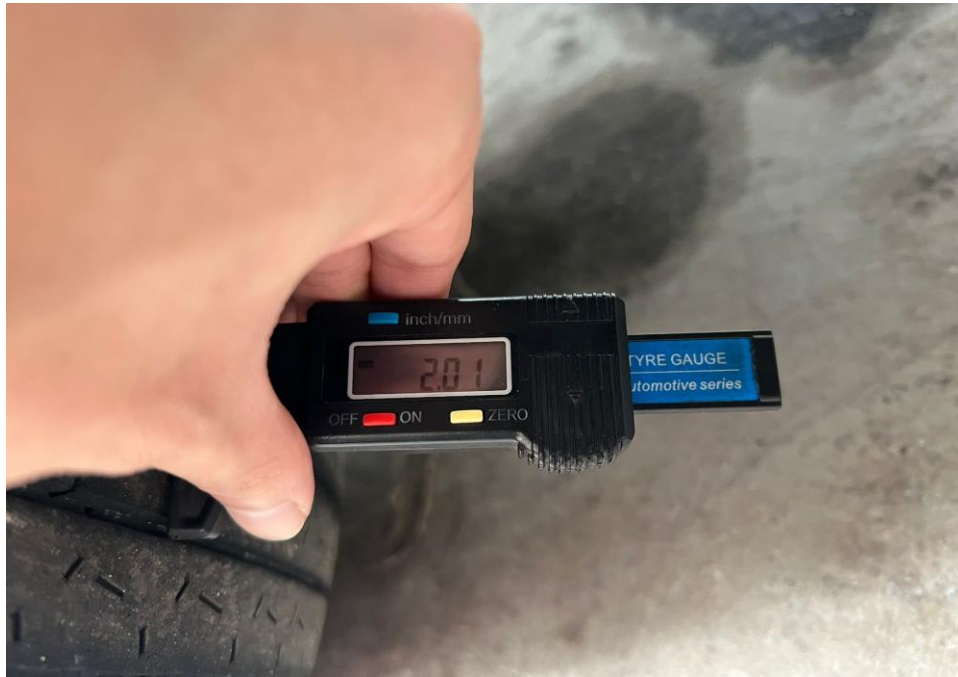
**Photo 9** shows the tread depth of the rear right outer tyre on the insured vehicle at the time of my inspection. The remaining tread depth is 2.0mm which is within the LTA requirements.

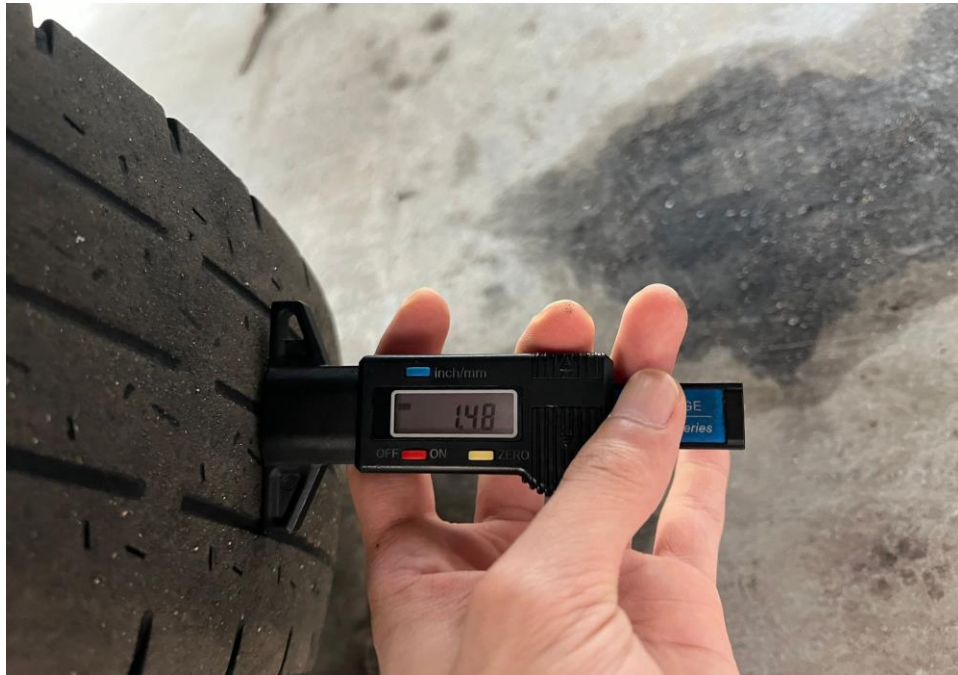
**Photo 10** shows the tread depth of the rear right inner tyre on the insured vehicle at the time of my inspection. The remaining tread depth is 1.4mm which is within the LTA requirements.

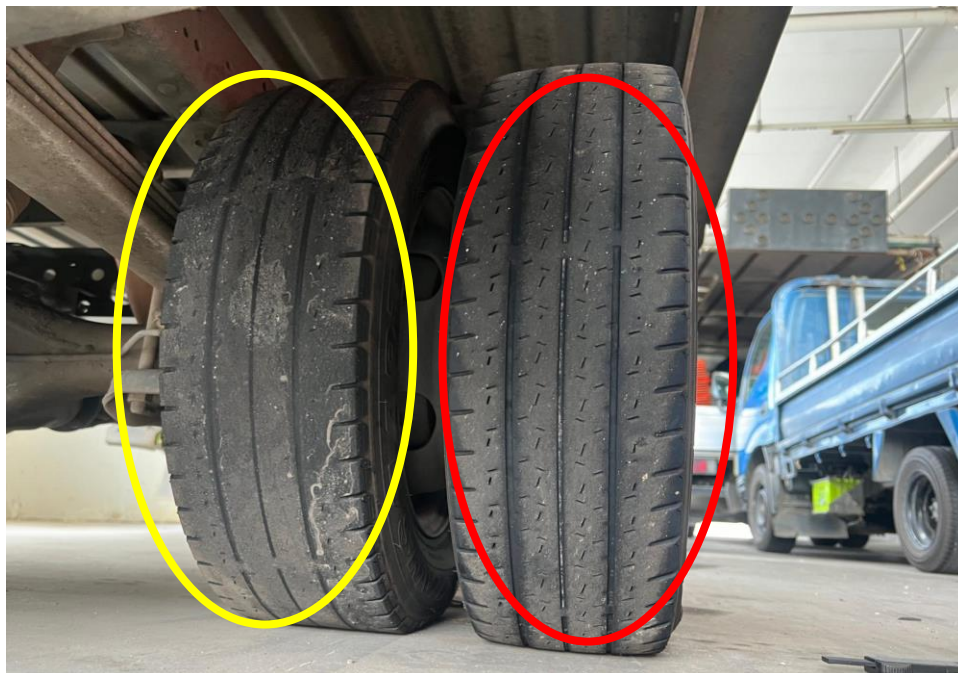
**Photo 11** shows rear right tyre tyres of the insured vehicle at the time of my inspection. The rear right tyres of the insured vehicle was observed to be in serviceable condition with remaining tread depth of 2.0mm on the rear right outer tyre (red circle) and 1.4mm on the rear right inner tyre (yellow circle) which is within LTA requirements.

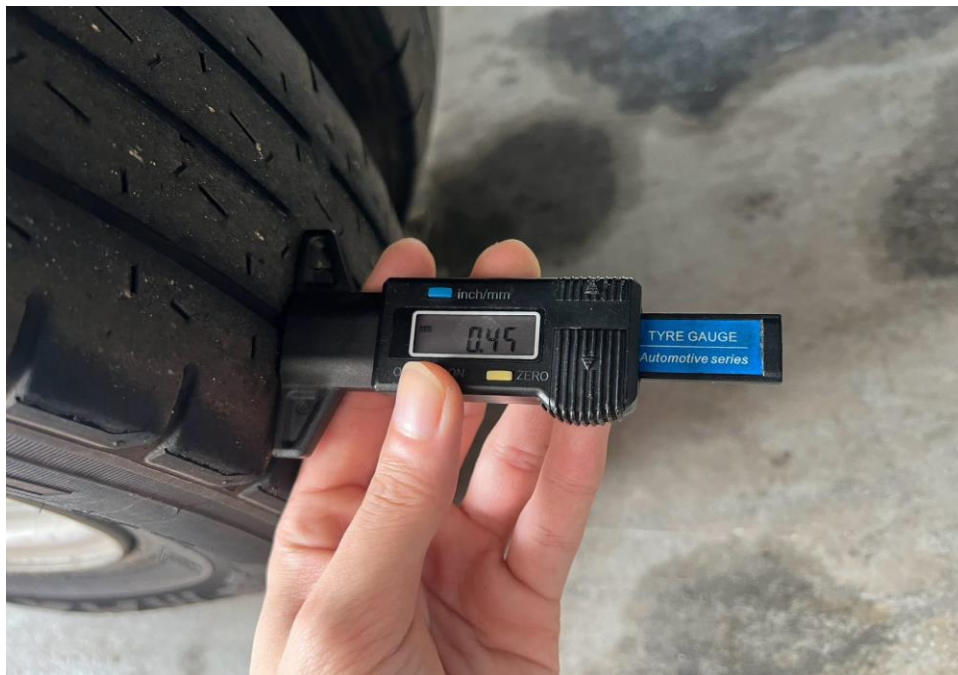
**Photo 12** shows the tread depth of the rear left outer tyre (outer tread) on the insured vehicle at the time of my inspection. The remaining tread depth is 0.4mm which is not within the LTA requirements.

10. However, we are in view that the condition of the rear left outer and inner tyre of the Insured Vehicle was not within the requirements of SECTION 109(f) CAP 276 of THE MOTOR VEHICLES (CONSTRUCTION AND USE) RULES, 1974, 1978 OF THE ROAD TRAFFIC ACT. Under this section it states that “no person shall use, or cause or permit to be used on a road any motor vehicle or trailer, a wheel of which is fitted with a pneumatic tyre, where the tyre is fitted to the wheel of any other motor vehicle or any trailer, the tread pattern (excluding any tie-bar) of the tyre does not have a depth of at least one millimetre throughout at least 75% of the breadth of the tread and round the entire outer circumference of the tyre and the rear left outer and inner tyre tread depth was observed to be at 0.3mm-0.9mm.

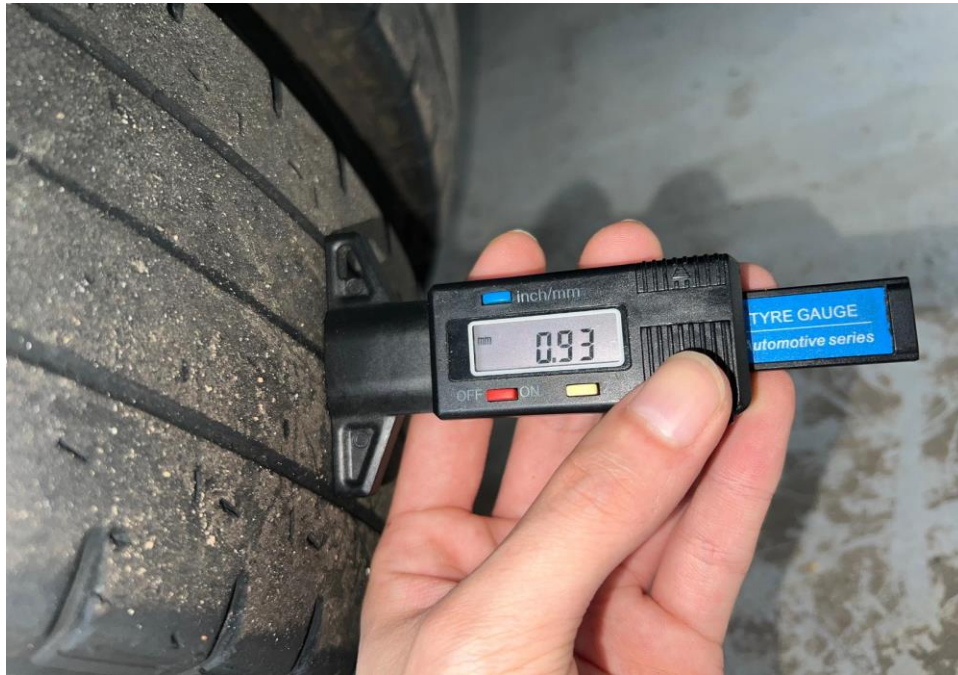
**Photo 13** shows the tread depth of the rear left outer tyre (centre tread) on the insured vehicle at the time of my inspection. The remaining tread depth is 0.9mm which is not within the LTA requirements.

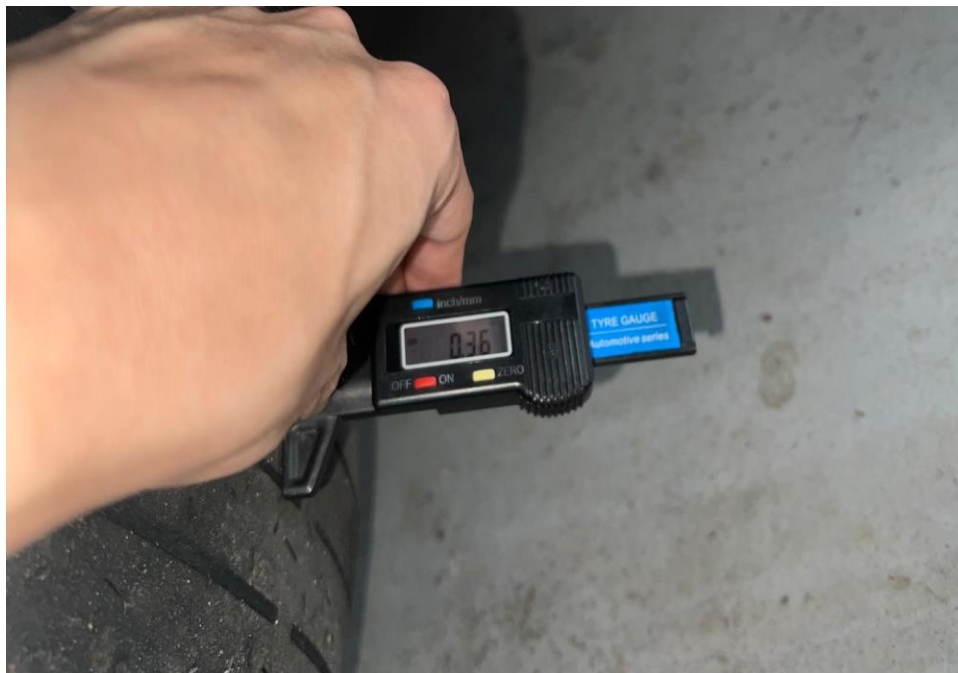
**Photo 14** shows the tread depth of the rear left outer tyre (inner tread) on the insured vehicle at the time of my inspection. The remaining tread depth is 0.3mm which is not within the LTA requirements.

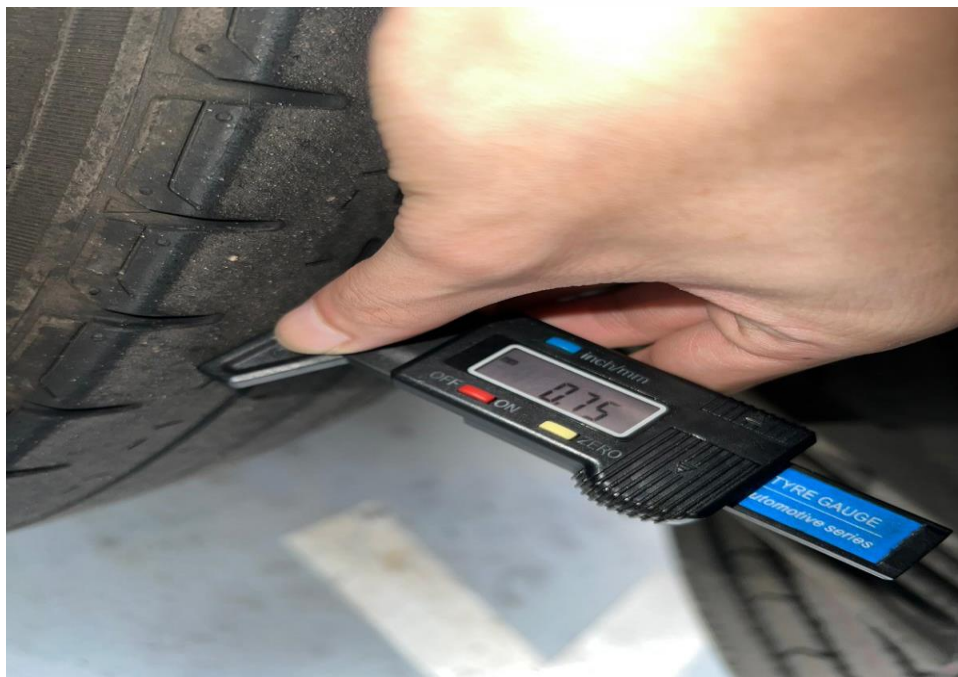
**Photo 15** shows the tread depth of the rear left inner tyre (outer tread) on the insured vehicle at the time of my inspection. The remaining tread depth is 0.7mm which is not within the LTA requirements.

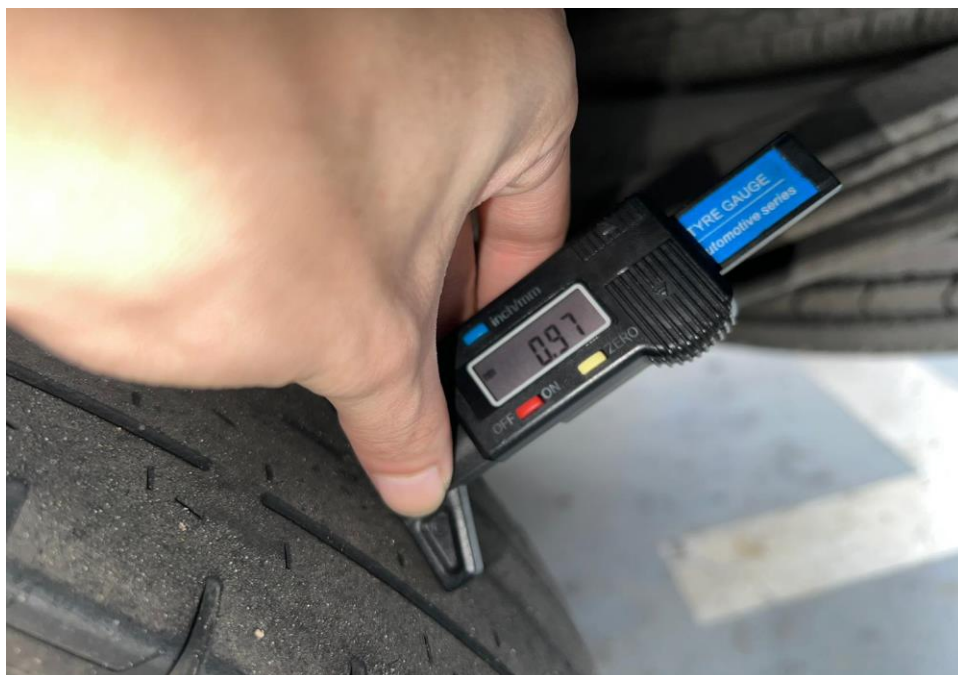
**Photo 16** shows the tread depth of the rear left inner tyre (centre tread) on the insured vehicle at the time of my inspection. The remaining tread depth is 0.4mm which is not within the LTA requirements.

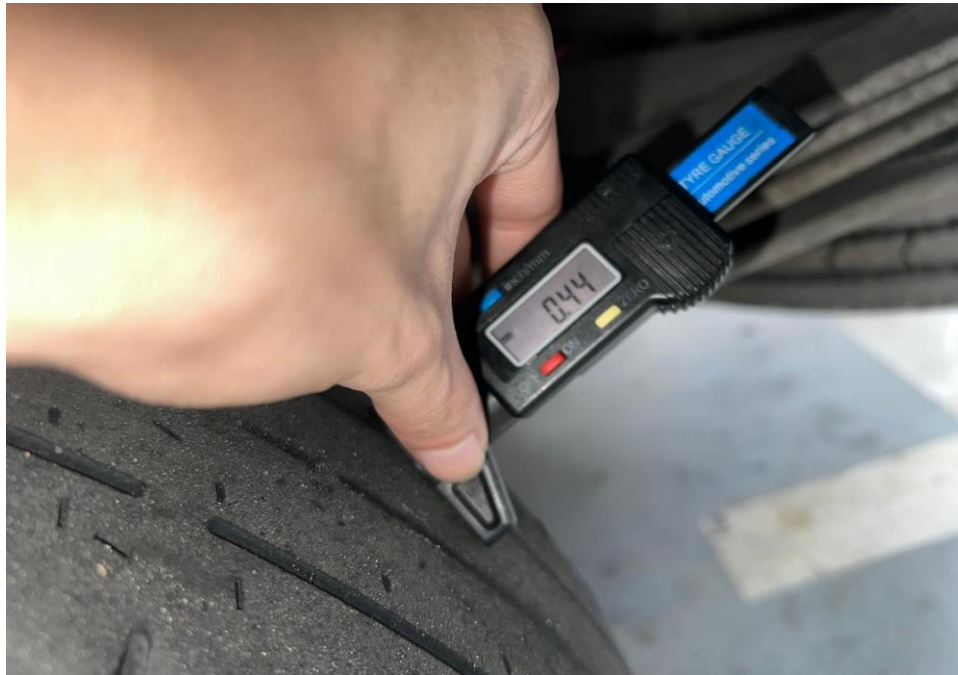
**Photo 17** shows the tread depth of the rear left inner tyre (inner tread) on the insured vehicle at the time of my inspection. The remaining tread depth is 0.4mm which is not within the LTA requirements.

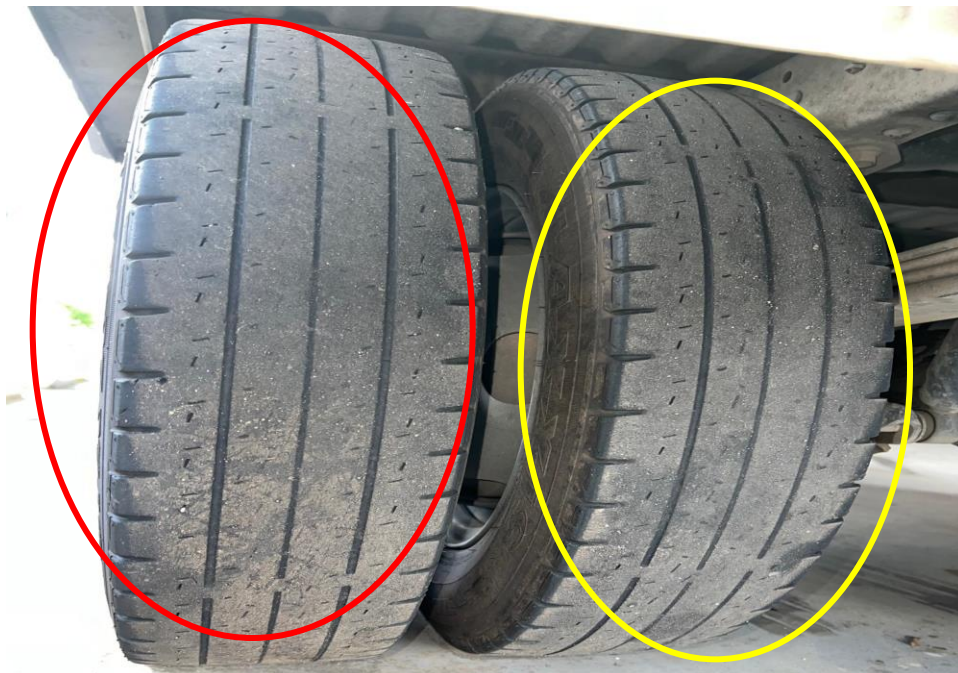
**Photo 18** shows the general view of the rear left tyre tyres of the insured vehicle at the time of my inspection. The rear left tyres of the insured vehicle with remaining tread depth of 0.3mm- 0.9mm on the rear left outer tyre (red circle) and 0.4mm- 0.9mm on the rear left inner tyre (yellow circle).

13. In general, having physically inspected the Insured Vehicle, we are in view that the condition of the rear left outer and inner of the Insured Vehicle was not within the requirements of SECTION 109(f) CAP 276 of THE MOTOR VEHICLES (CONSTRUCTION AND USE) RULES, 1974, 1978 OF THE ROAD TRAFFIC ACT. SECTION 109(e) of THE ROAD TRAFFIC ACT, ROAD TRAFFIC (MOTOR VEHICLES, CONSTRUCTION AND USE) RULES. The condition of the rear left inner and outer tyre tread depth of 0.3mm- 0.9mm would have likely contributed the accident on 10 September 2024.
