Your Ref: CMTD2403237/GPL (THE)
Our Ref: CS/SMO24100146/N

10 October 2024

**TECHNICAL INVESTIGATION REPORT OF FIRE INCIDENT INVOLVING THE
INSURED VEHICLE SKX 1759G ON 6 OCTOBER 2024**

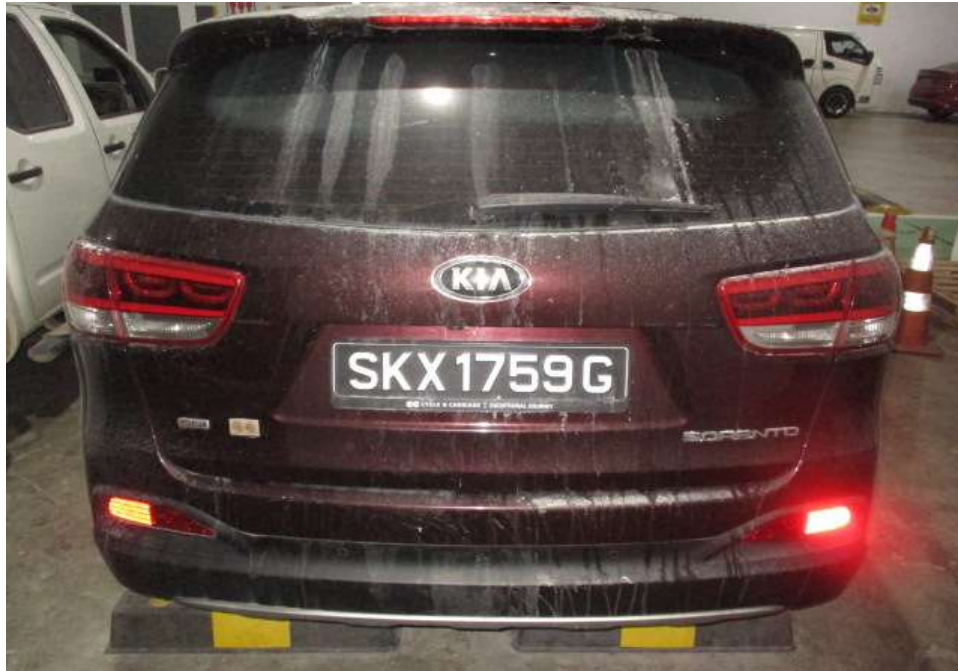
Photo 1 shows the general view of the rear portion of the Insured Vehicle at the time of our inspection. The rear portion of the Insured Vehicle was relatively unaffected by the fire.

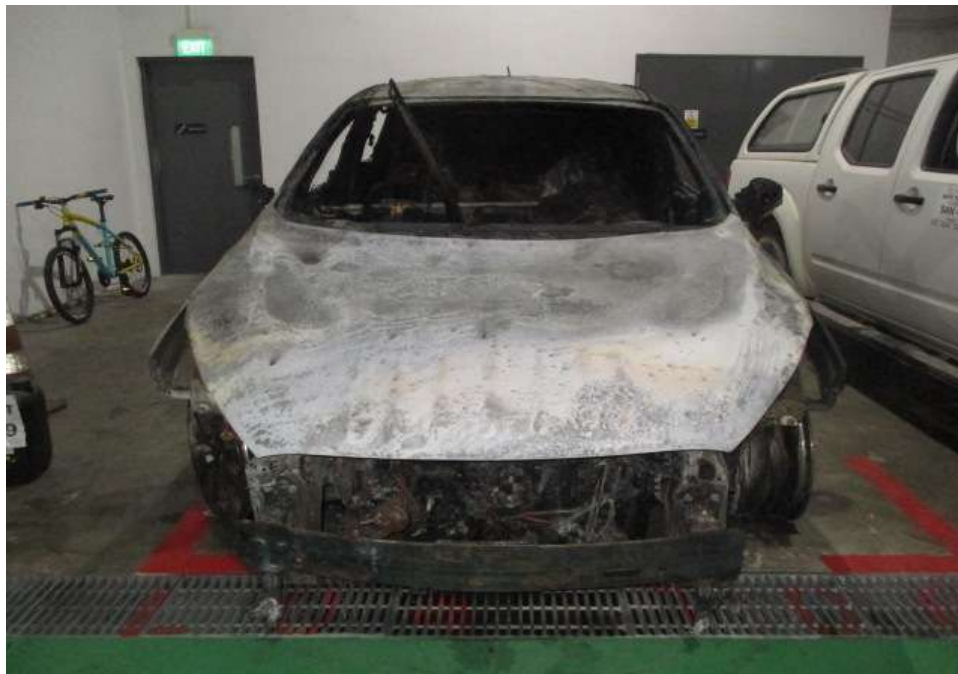
5. The Insured Vehicle was noted to have sustained fire damage that was confined to its frontal portion. The entire engine compartment of the Insured Vehicle was observed to be severely burnt while the interior compartment was observed to be severely affected by the fire.
6. The fire had resulted in the body parts at the frontal portion of the Insured Vehicle to be burnt. This had included its front bumper, front bonnet, front support panel, front grille, headlamps, front windscreen, front wheel rims, front fenders and front tyres, amongst others. See photos 1 – 6 below.

Photo 2 shows the general view of the frontal portion of the Insured Vehicle at the time of our inspection. The fire damage to the Insured Vehicle was confined to its frontal portion. The entire engine compartment of the Insured Vehicle was observed to be severely burnt while the interior compartment was observed to be severely affected by the fire.

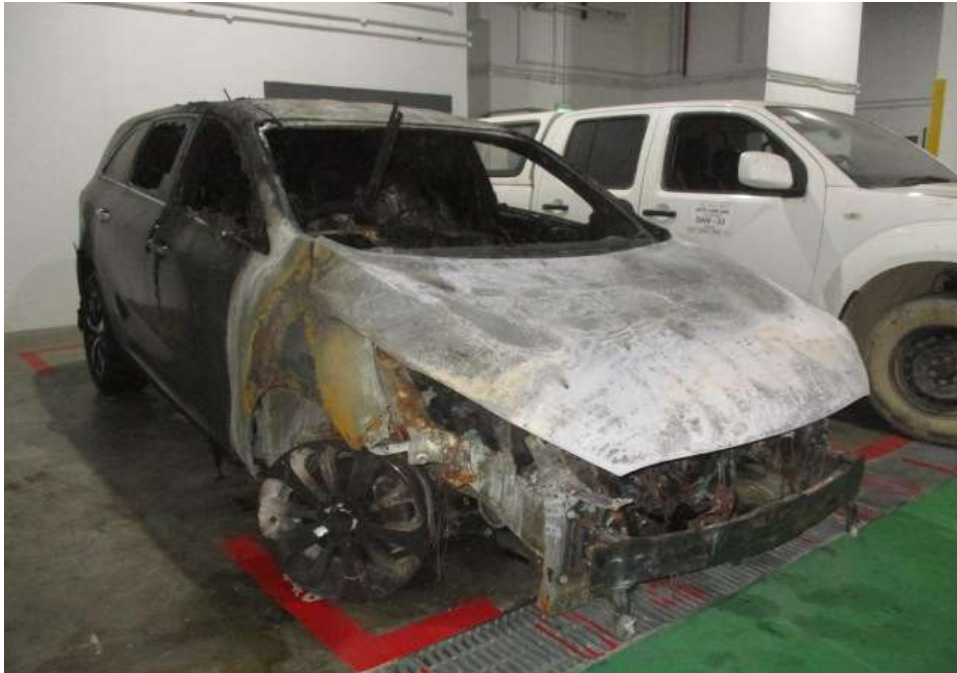
Photo 3 shows the closer view of the right front body of the Insured Vehicle at the time of our inspection. The fire damage to the Insured Vehicle was confined to its frontal portion. Its front bumper, front bonnet, headlamps, front windscreen, front wheel rims, front fenders and front tyres were amongst the body parts that were found to have been affected by the fire.

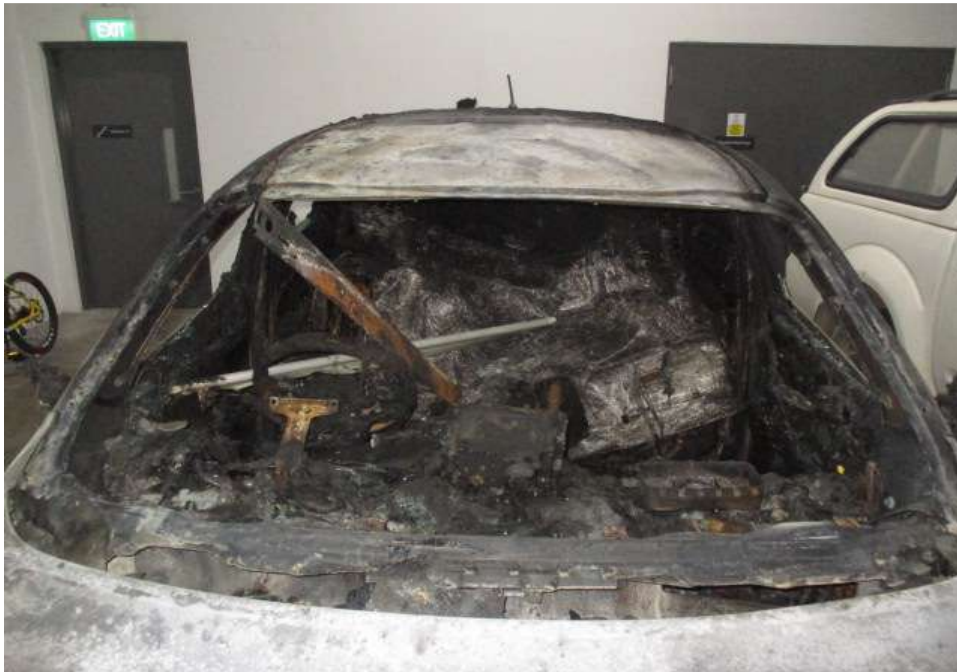
Photo 4 shows the general view of the front windscreen of the Insured Vehicle at the time of our inspection. The fire damage to the front windscreen was extensive.

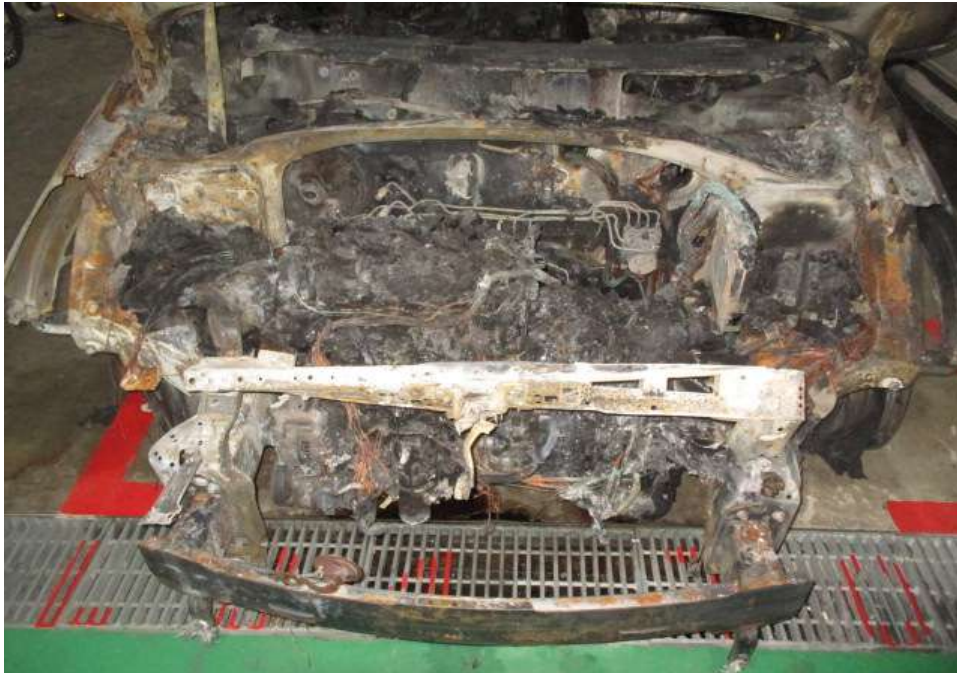
Photo 5 shows the engine compartment of the Insured Vehicle at the time of our inspection. The entire engine compartment of the Insured Vehicle was observed to be severely burnt. Most of the parts inside the engine compartment were found to be burnt and/or melted as a result of the fire.

8. For this particular case, the fire appears to have originated within the engine compartment of the Insured Vehicle as this was the area where the damage of fire nature was most severe.
9. Upon closer examination of the left rear portion of the engine compartment, which was where the fire to the Insured Vehicle had likely started, we had found traces of greenish residue on several stretches of burnt wirings leading from the Engine Control Module (ECM). The presence of greenish residue indicates internal heating of copper wires, a sign of an electrical short circuit occurring. The greenish residue is normally left behind from oxidation as a result of chemical reaction involving the copper wires. This physical evidence would then appear to suggest that the cause of fire to the Insured Vehicle could have possibly been due to electrical in nature. See photos 7 - 9 below.

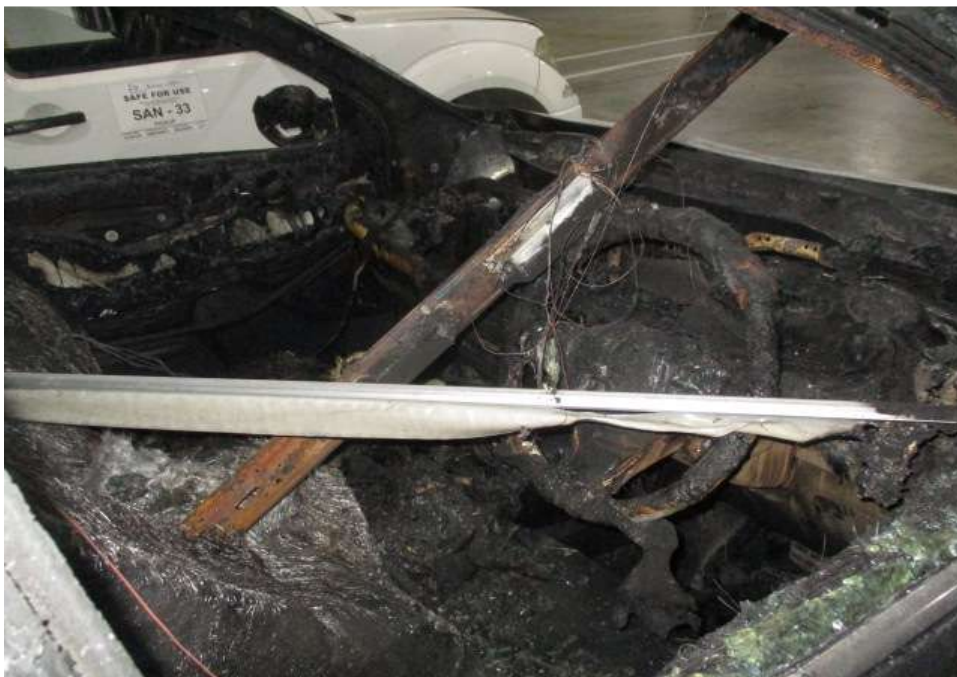
Photo 6 shows the interior compartment of the Insured Vehicle, which was severely affected by the fire.

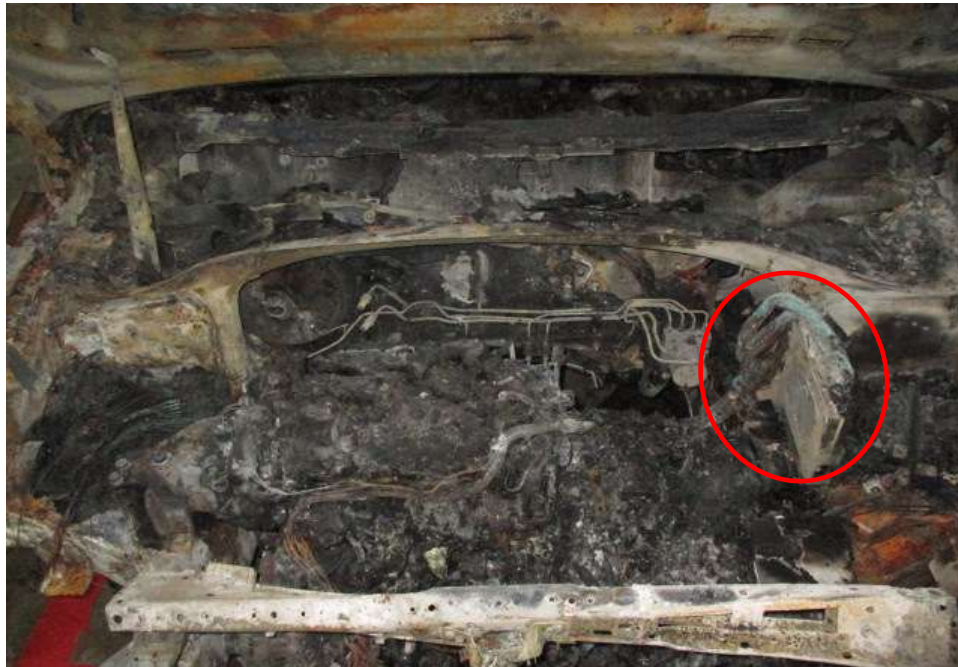
Photo 7 shows the wirings around the left rear portion of the engine compartment, which is in the immediate vicinity where the fire to the Insured Vehicle had likely started. We noticed greenish residue on several stretches of burnt wirings (circled). The presence of greenish residue indicates internal heating of copper wires, a sign of an electrical short circuit occurring.

23. The possibility of the fire being due to electrical in nature would then seem more likely given that engine overheating and external factors would both seem unlikely. The fire being due to electrical nature is also supported by the condition of the wirings that were found in the engine compartment of the Insured Vehicle, which was earlier discussed in paragraph 9 above.

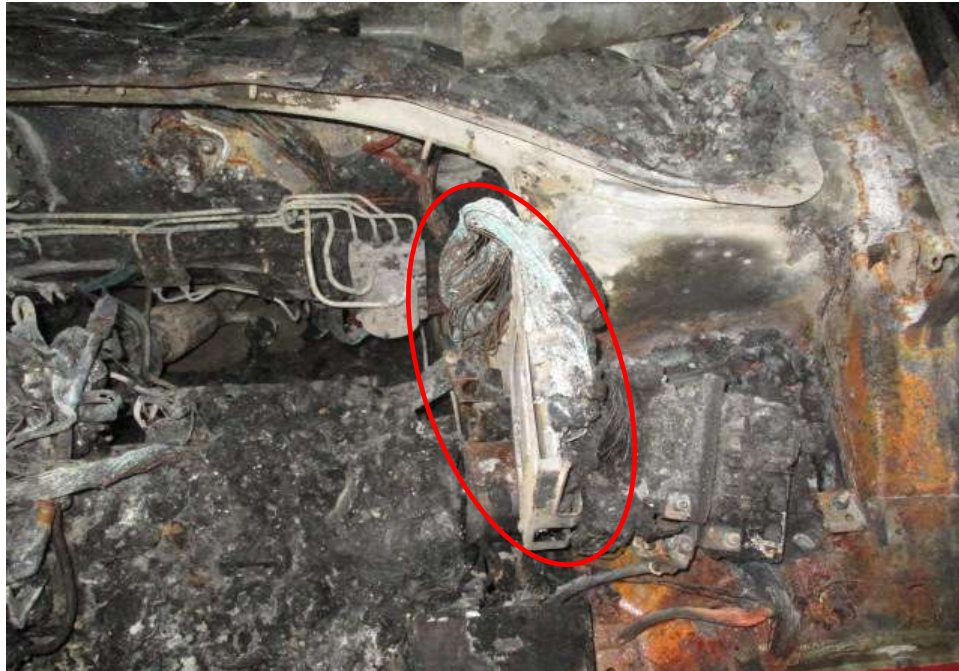
Photo 8 shows a closer view of the burnt wirings around the left rear portion of the engine compartment. We noticed greenish residue on several stretches of the burnt wirings leading from the Engine Control Module (ECM) (circled). The greenish residue is normally left behind from oxidation as a result of chemical reaction involving the copper wires.

25. Having investigated and technically analysed the damages to the Insured Vehicle, we are of the view that the cause of fire to the Insured Vehicle was of electrical in nature. For this particular case, the fire had originated along the wirings inside the engine compartment, somewhere at the left rear portion. The wirings were original factory wirings leading from the Engine Control Module (ECM) of the Insured Vehicle.

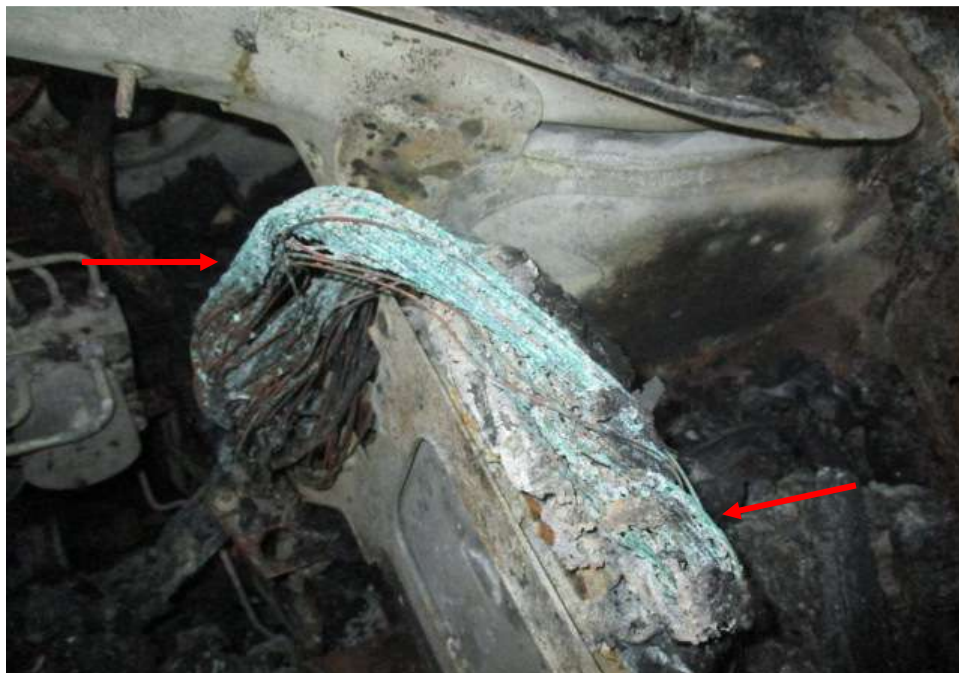
Photo 9 shows a close up view of the greenish residue found on several stretches of burnt wirings leading from the ECM of the Insured Vehicle (red arrows). The presence of such greenish residue suggests occurrence of an electrical short circuit.

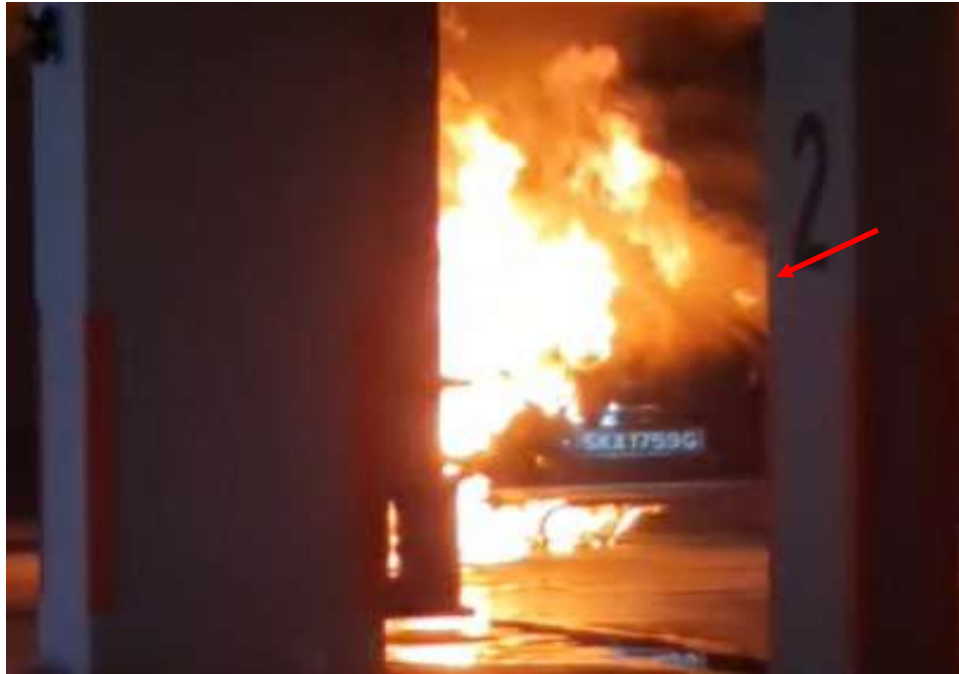
Photo 10 shows a screenshot of the video recording taken by Ms Kim of the Insured Vehicle on fire before the arrival of the SCDF. In general, the information that could be gathered from this photograph had corresponded to the events that were related to us by Ms Kim which is the fire had started from the engine compartment of the Insured Vehicle (arrowed).

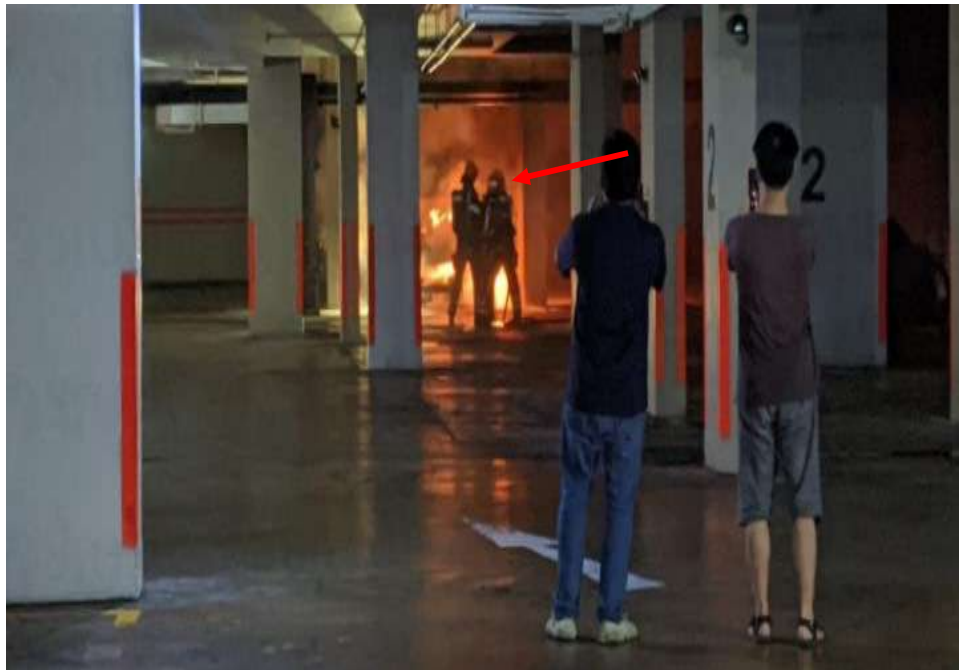
Photo 11 shows firefighters attempting to put out the fire to the Insured Vehicle. In general, the information that could be gathered from this photograph had corresponded to the events that were related to us by Ms Kim which is SCDF had responded to the incident (arrowed).
