Your Ref: CMTD2403237/GPL (THE)  
Our Ref: CS/SMO24100146/N

10 October 2024

**TECHNICAL INVESTIGATION REPORT OF FIRE INCIDENT INVOLVING THE  
INSURED VEHICLE SKX 1759G ON 6 OCTOBER 2024**

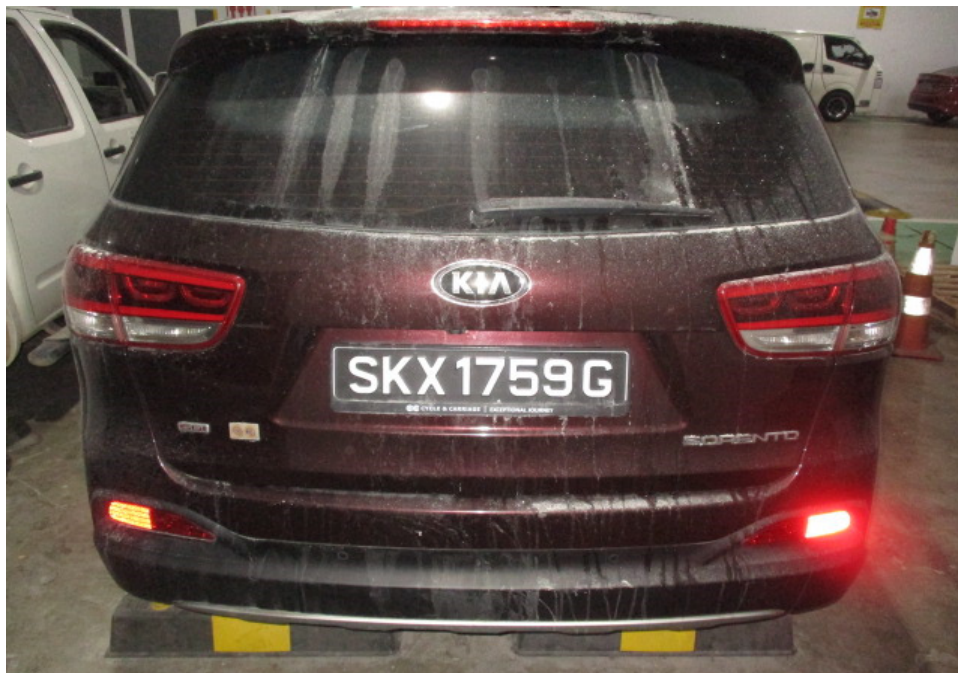
**Photo 1** shows the general view of the rear portion of the Insured Vehicle at the time of our inspection. The rear portion of the Insured Vehicle was relatively unaffected by the fire.

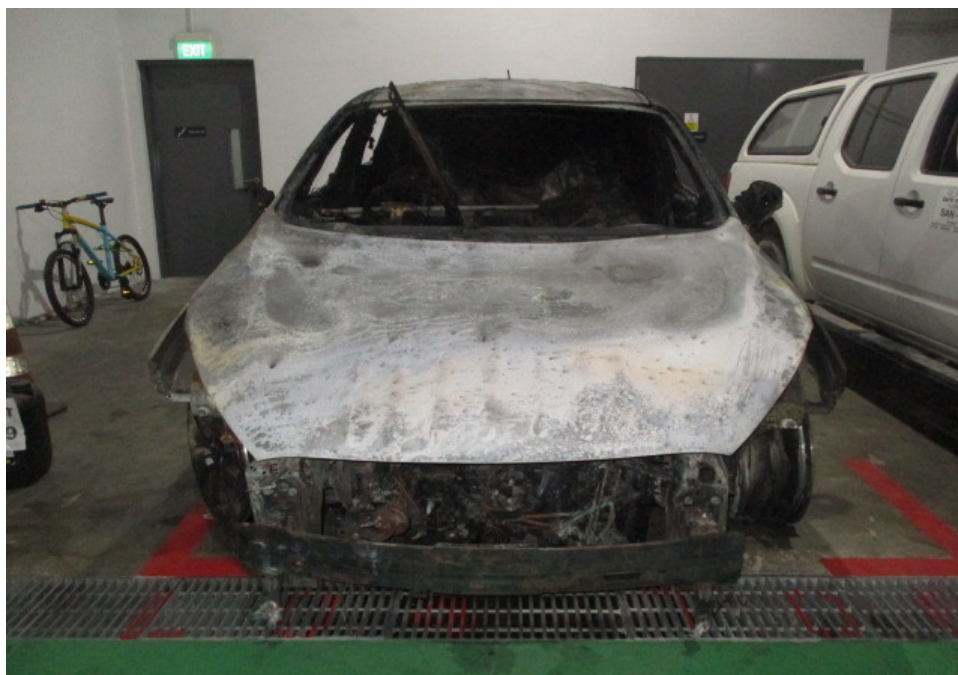
5. The Insured Vehicle was noted to have sustained fire damage that was confined to its frontal portion. The entire engine compartment of the Insured Vehicle was observed to be severely burnt while the interior compartment was observed to be severely affected by the fire.
6. The fire had resulted in the body parts at the frontal portion of the Insured Vehicle to be burnt. This had included its front bumper, front bonnet, front support panel, front grille, headlamps, front windscreen, front wheel rims, front fenders and front tyres, amongst others. See photos 1 – 6 below.

**Photo 2** shows the general view of the frontal portion of the Insured Vehicle at the time of our inspection. The fire damage to the Insured Vehicle was confined to its frontal portion. The entire engine compartment of the Insured Vehicle was observed to be severely burnt while the interior compartment was observed to be severely affected by the fire.

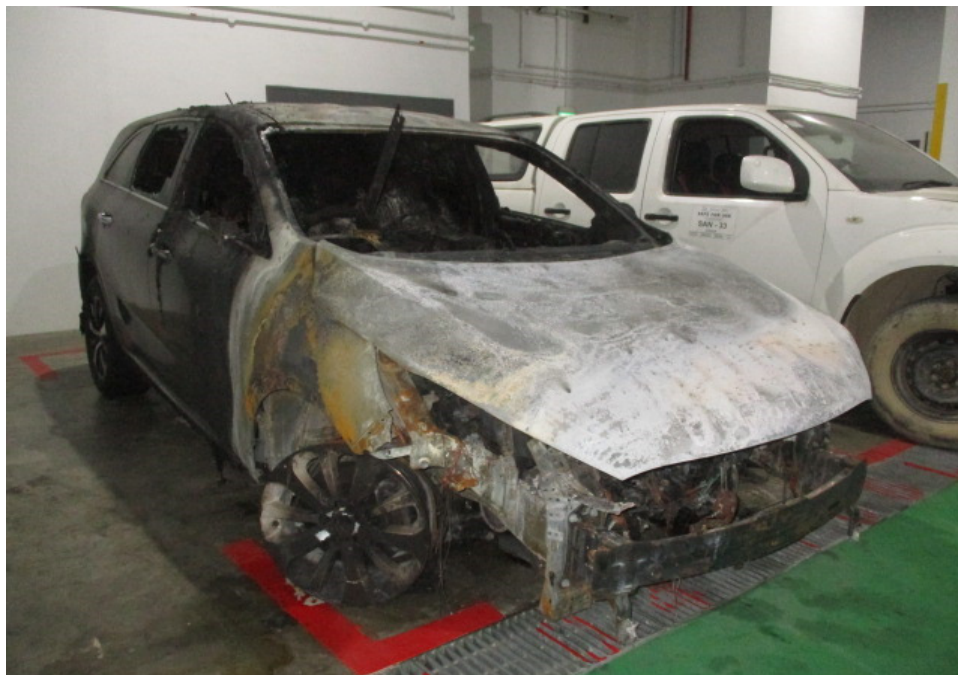
**Photo 3** shows the closer view of the right front body of the Insured Vehicle at the time of our inspection. The fire damage to the Insured Vehicle was confined to its frontal portion. Its front bumper, front bonnet, headlamps, front windscreen, front wheel rims, front fenders and front tyres were amongst the body parts that were found to have been affected by the fire.

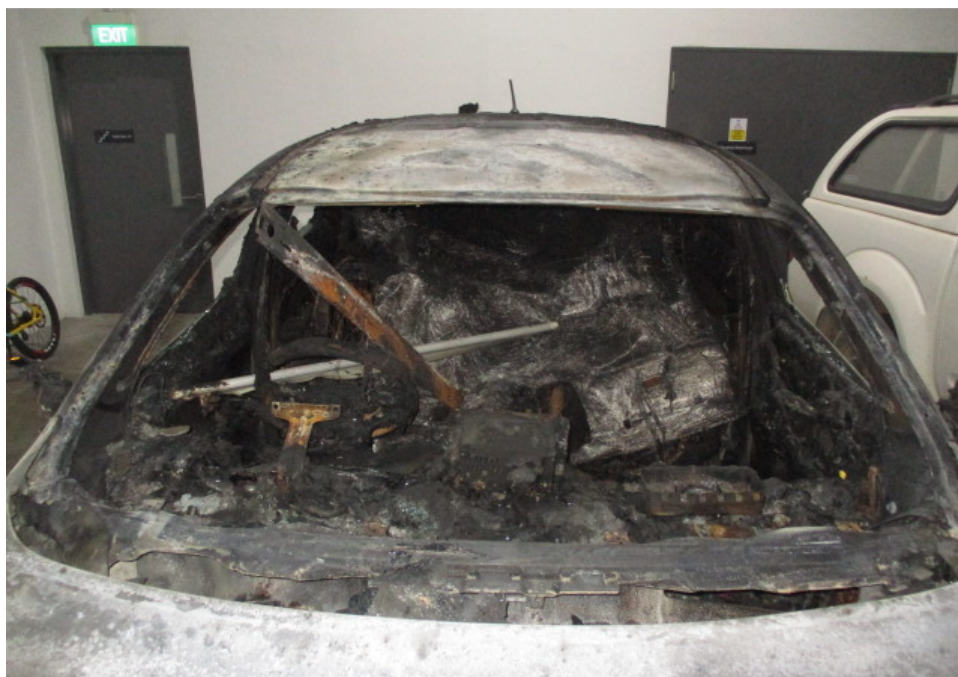
**Photo 4** shows the general view of the front windscreen of the Insured Vehicle at the time of our inspection. The fire damage to the front windscreen was extensive.

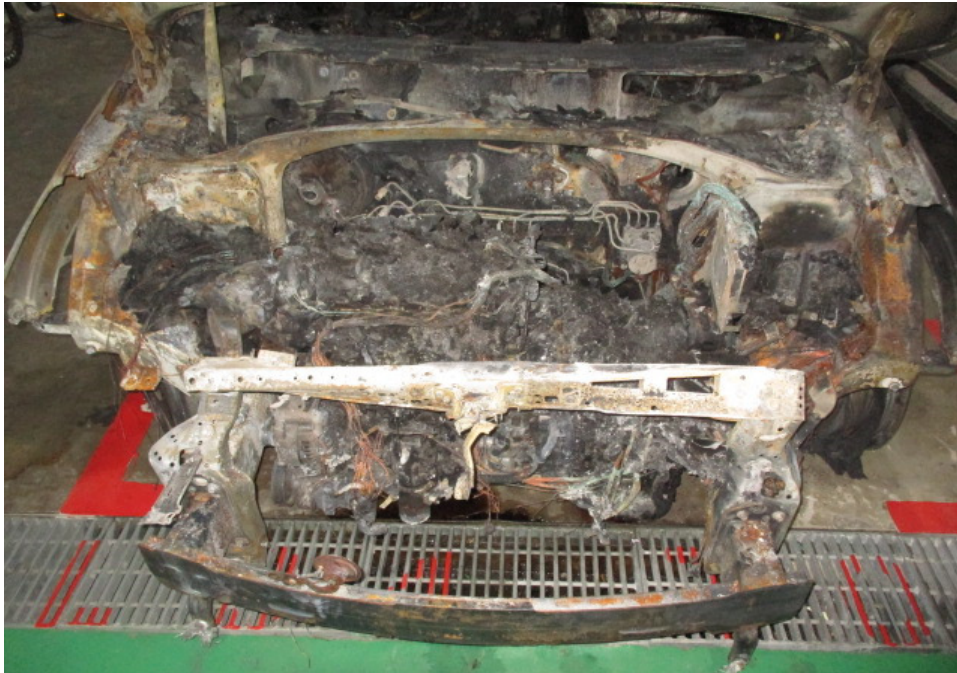
**Photo 5** shows the engine compartment of the Insured Vehicle at the time of our inspection. The entire engine compartment of the Insured Vehicle was observed to be severely burnt. Most of the parts inside the engine compartment were found to be burnt and/or melted as a result of the fire.

8. For this particular case, the fire appears to have originated within the engine compartment of the Insured Vehicle as this was the area where the damage of fire nature was most severe.
9. Upon closer examination of the left rear portion of the engine compartment, which was where the fire to the Insured Vehicle had likely started, we had found traces of greenish residue on several stretches of burnt wirings leading from the Engine Control Module (ECM). The presence of greenish residue indicates internal heating of copper wires, a sign of an electrical short circuit occurring. The greenish residue is normally left behind from oxidation as a result of chemical reaction involving the copper wires. This physical evidence would then appear to suggest that the cause of fire to the Insured Vehicle could have possibly been due to electrical in nature. See photos 7 - 9 below.

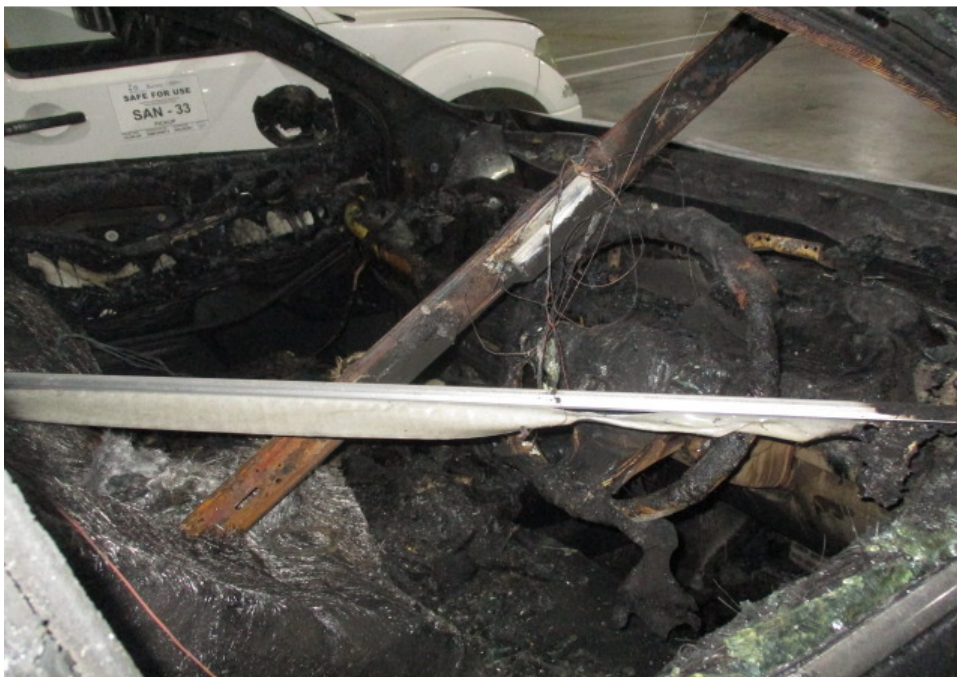
**Photo 6** shows the interior compartment of the Insured Vehicle, which was severely affected by the fire.

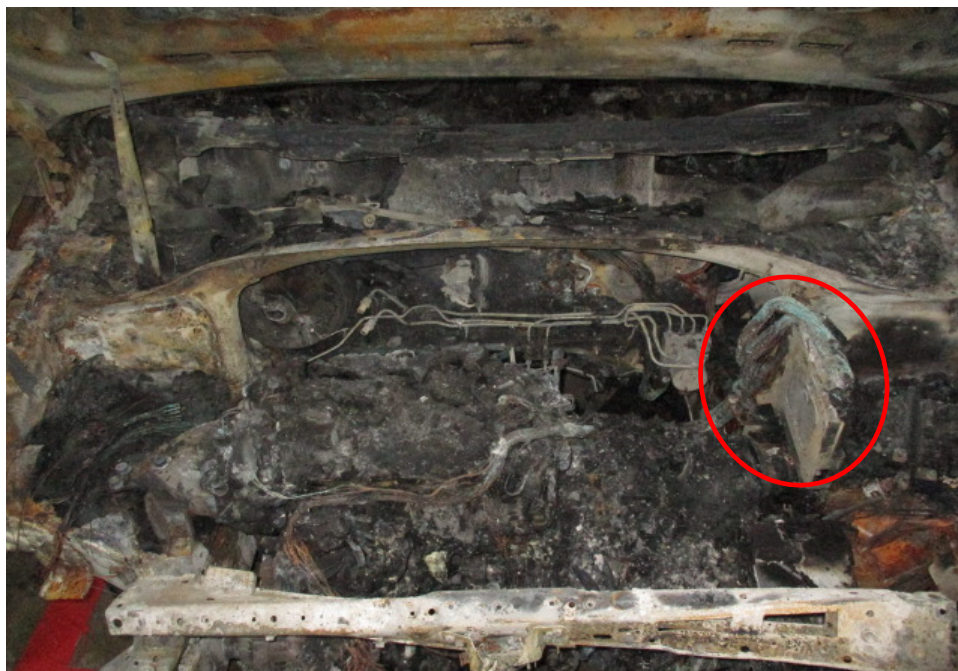
**Photo 7** shows the wirings around the left rear portion of the engine compartment, which is in the immediate vicinity where the fire to the Insured Vehicle had likely started. We noticed greenish residue on several stretches of burnt wirings (circled). The presence of greenish residue indicates internal heating of copper wires, a sign of an electrical short circuit occurring.

23. The possibility of the fire being due to electrical in nature would then seem more likely given that engine overheating and external factors would both seem unlikely. The fire being due to electrical nature is also supported by the condition of the wirings that were found in the engine compartment of the Insured Vehicle, which was earlier discussed in paragraph 9 above.

25. Having investigated and technically analysed the damages to the Insured Vehicle, we are of the view that the cause of fire to the Insured Vehicle was of electrical in nature. For this particular case, the fire had originated along the wirings inside the engine compartment, somewhere at the left rear portion. The wirings were original factory wirings leading from the Engine Control Module (ECM) of the Insured Vehicle.

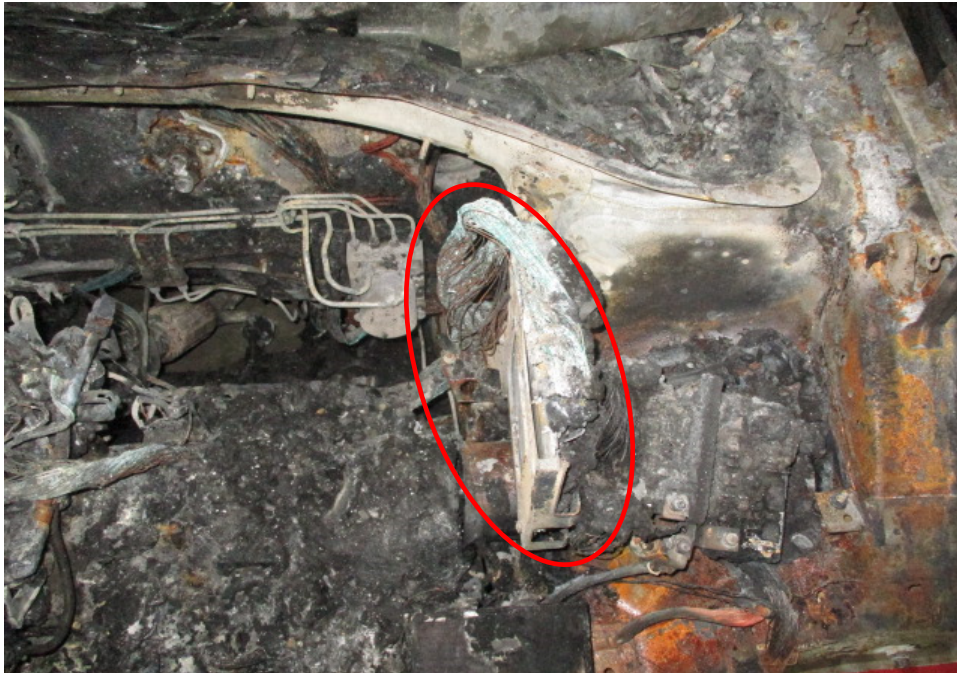
**Photo 8** shows a closer view of the burnt wirings around the left rear portion of the engine compartment. We noticed greenish residue on several stretches of the burnt wirings leading from the Engine Control Module (ECM) (circled). The greenish residue is normally left behind from oxidation as a result of chemical reaction involving the copper wires.

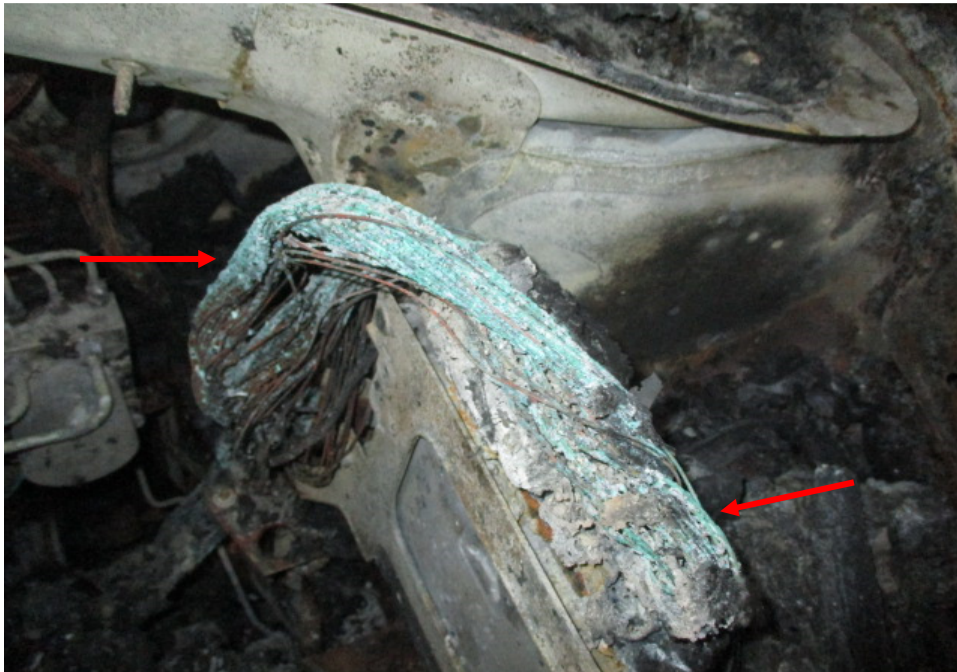
**Photo 9** shows a close up view of the greenish residue found on several stretches of burnt wirings leading from the ECM of the Insured Vehicle (red arrows). The presence of such greenish residue suggests occurrence of an electrical short circuit.

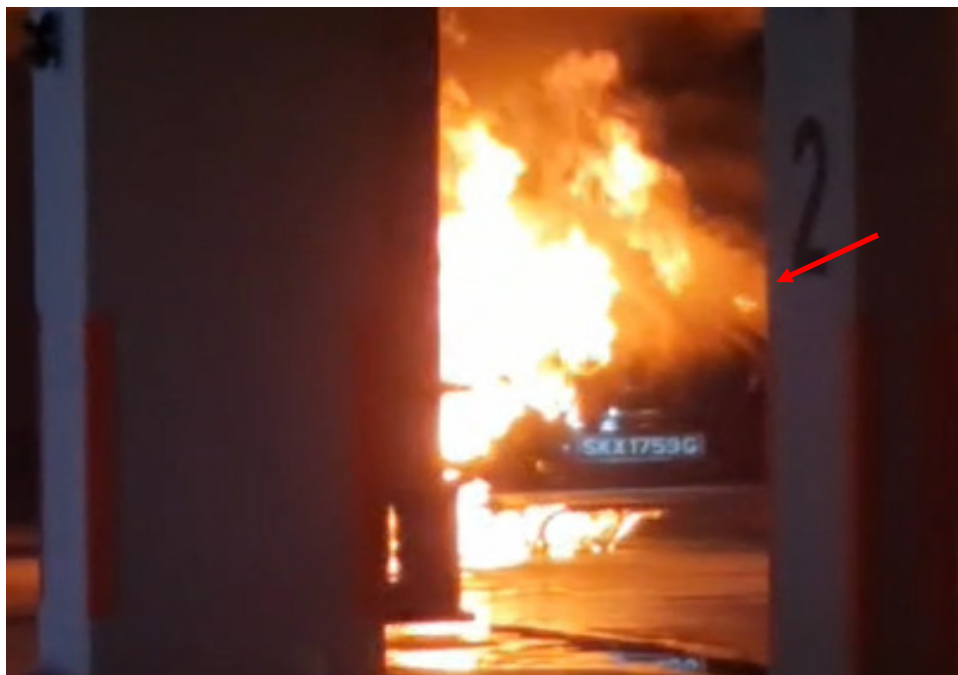
**Photo 10** shows a screenshot of the video recording taken by Ms Kim of the Insured Vehicle on fire before the arrival of the SCDF. In general, the information that could be gathered from this photograph had corresponded to the events that were related to us by Ms Kim which is the fire had started from the engine compartment of the Insured Vehicle (arrowed).

22. The possibility of the fire being due to external factors (foreign material(s) stuck on hot surfaces, arson and sabotage amongst others) would also seem unlikely given that our examination of the available incident scene photographs did not reveal any unusual material(s)/object(s) found on the ground where the Insured Vehicle was parked. The location of where the Insured Vehicle was parked was also observed to be not at a secluded location.

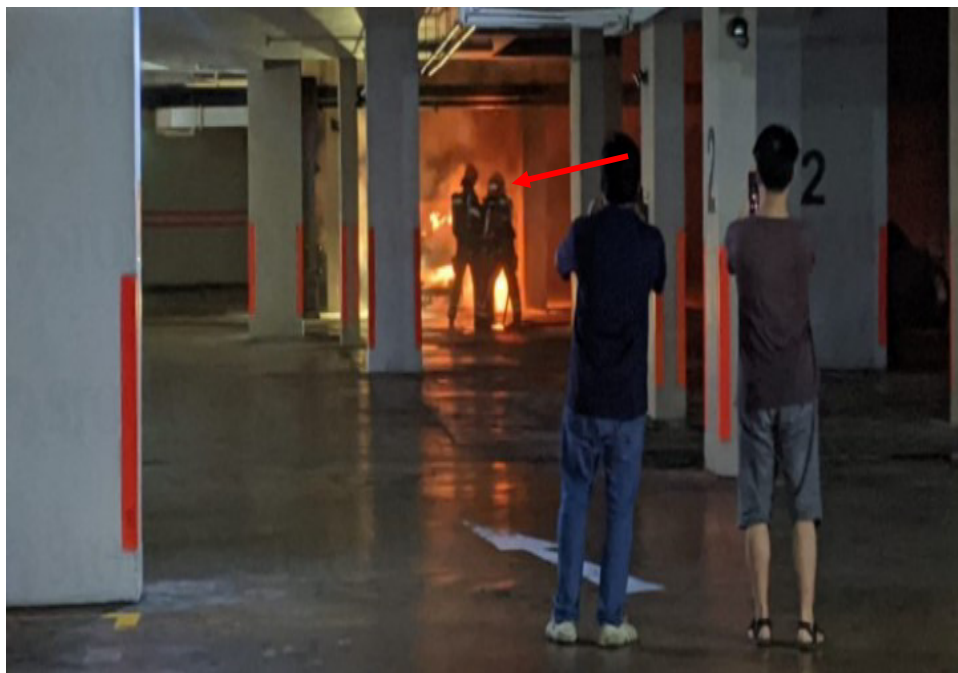
**Photo 11** shows firefighters attempting to put out the fire to the Insured Vehicle. In general, the information that could be gathered from this photograph had corresponded to the events that were related to us by Ms Kim which is SCDF had responded to the incident (arrowed).
