Your Ref: 9285154575SG
Our Ref : CS/AIG24100194/P

8th November 2024

**MECHANICAL TECHNICAL INSPECTION REPORT OF INSURED VEHICLE
ES 707K**

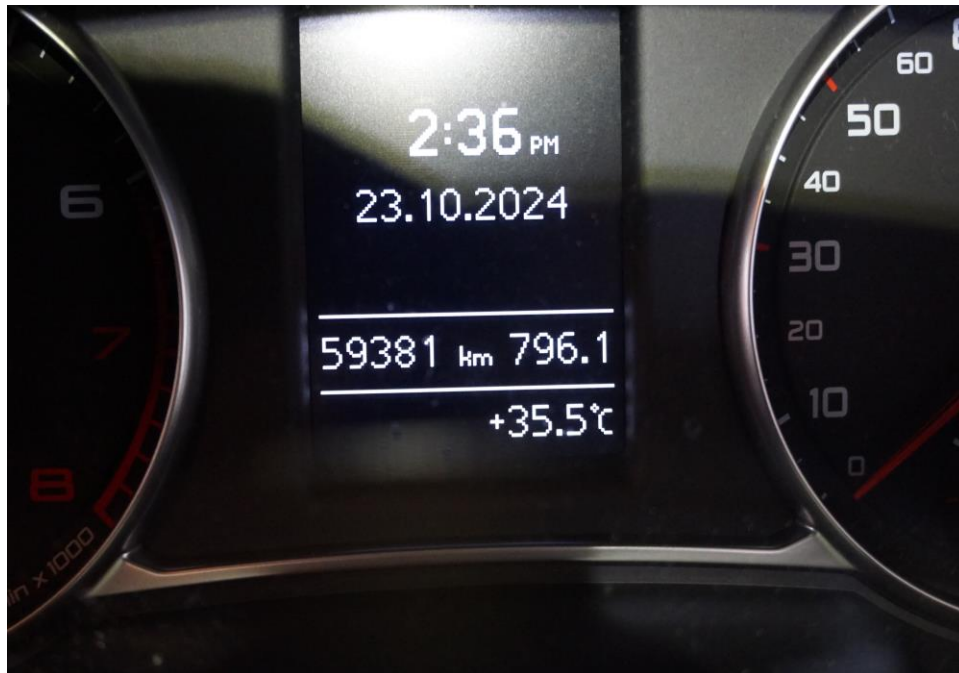
Photo 1 shows the mileage of the Insured Vehicle recorded at the time of my inspection was 59,381km.

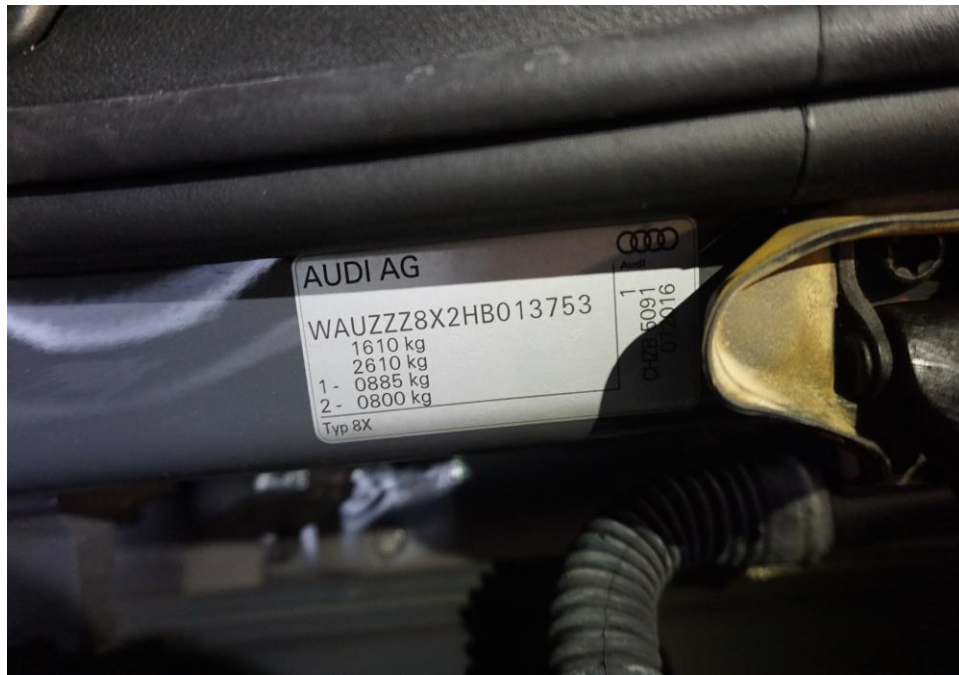
Photo 2 shows the chassis number of the Insured Vehicle recorded at the time of my inspection.

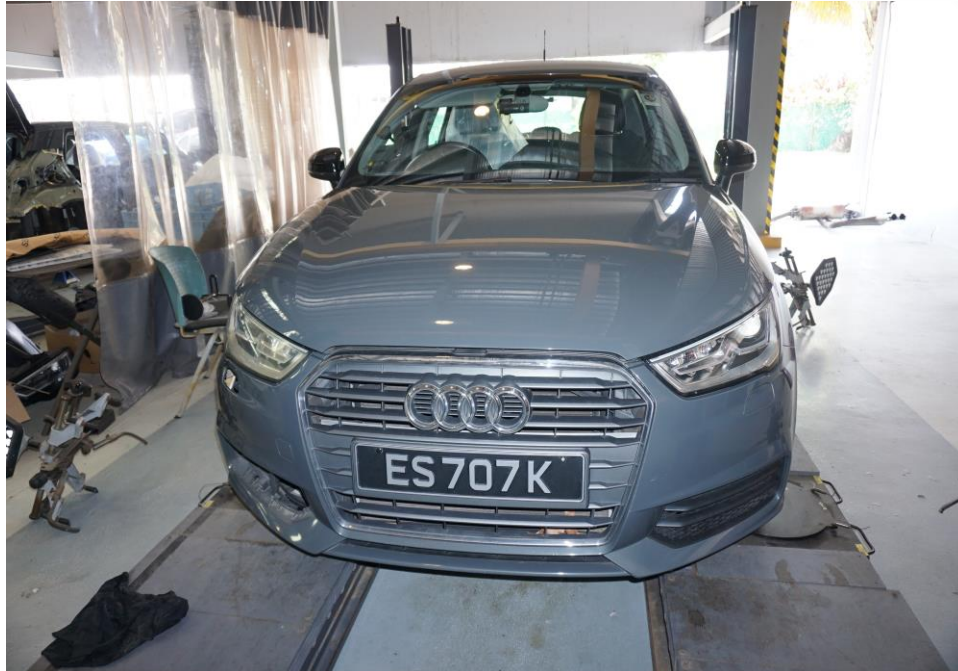
Photo 3 shows the front body of the Insured Vehicle. The Insured Vehicle was observed to be in a satisfactory condition with no loose exterior fittings observed.

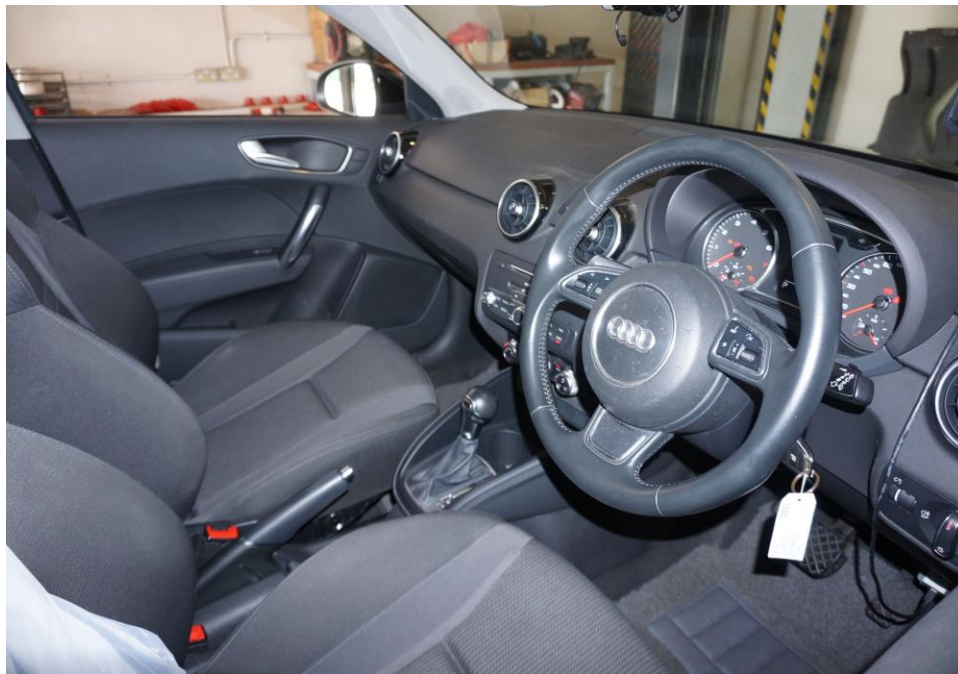
Photo 4 shows the interior of the Insured Vehicle. The interior of the Insured Vehicle was observed to be in a satisfactory condition with no loose exterior fittings observed.

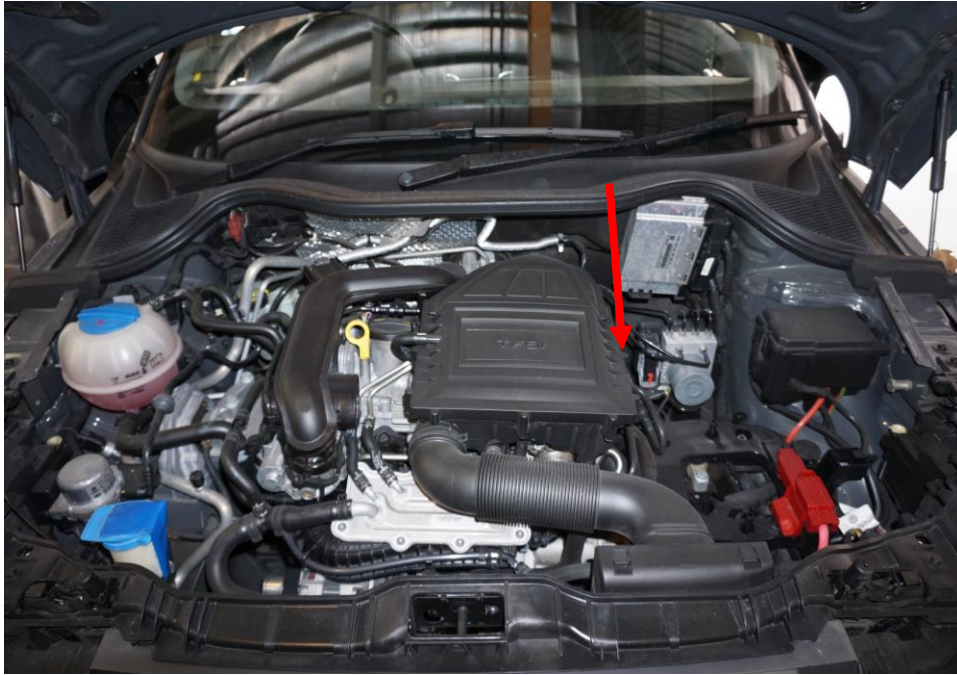
Photo 5 shows a general view of the engine compartment of the Insured Vehicle at the time of my inspection. The engine compartment was observed to be unaffected by any damages. The gear shifting cable connector that was dislodged from the gearbox of the Insured Vehicle, was fitted at the bottom right side in the engine compartment of the Insured Vehicle. The location of the dislodged gear shifting cable connector is indicated by the red arrow.

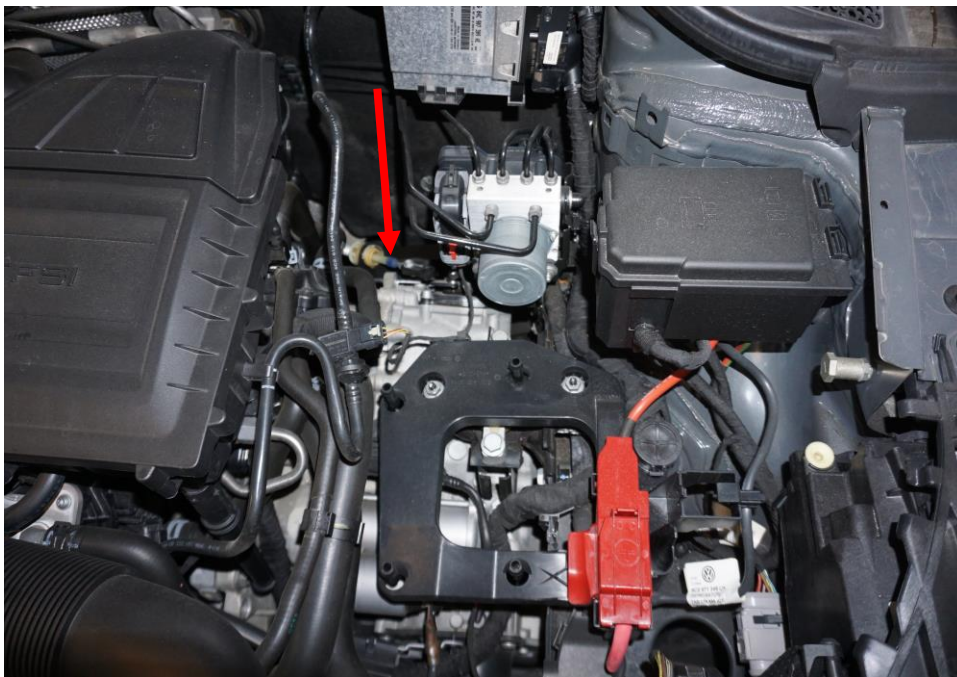
Photo 6 shows a close up view of the engine compartment of the Insured Vehicle at the time of my inspection. The engine compartment was observed to be unaffected by any damages. The gear shifting cable connector that was dislodged from the gearbox of the Insured Vehicle, was fitted at the bottom right side in the engine compartment of the Insured Vehicle. The location of the dislodged gear shifting cable connector is indicated by the red arrow.

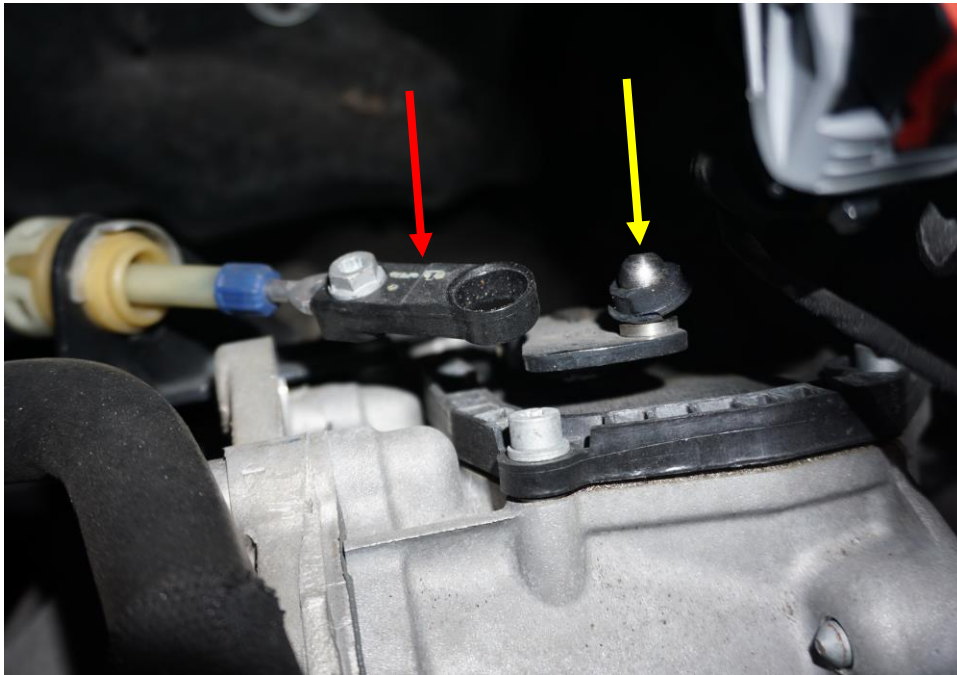
Photo 7 shows a close up view of the engine compartment of the Insured Vehicle at the time of my inspection. The gear shifting cable connector that was dislodged from the gearbox of the Insured Vehicle, was fitted at the bottom right side in the engine compartment of the Insured Vehicle. The location of the dislodged gear shifting cable connector is indicated by the red arrow and the gearbox connecting ball is indicated by the yellow arrow.

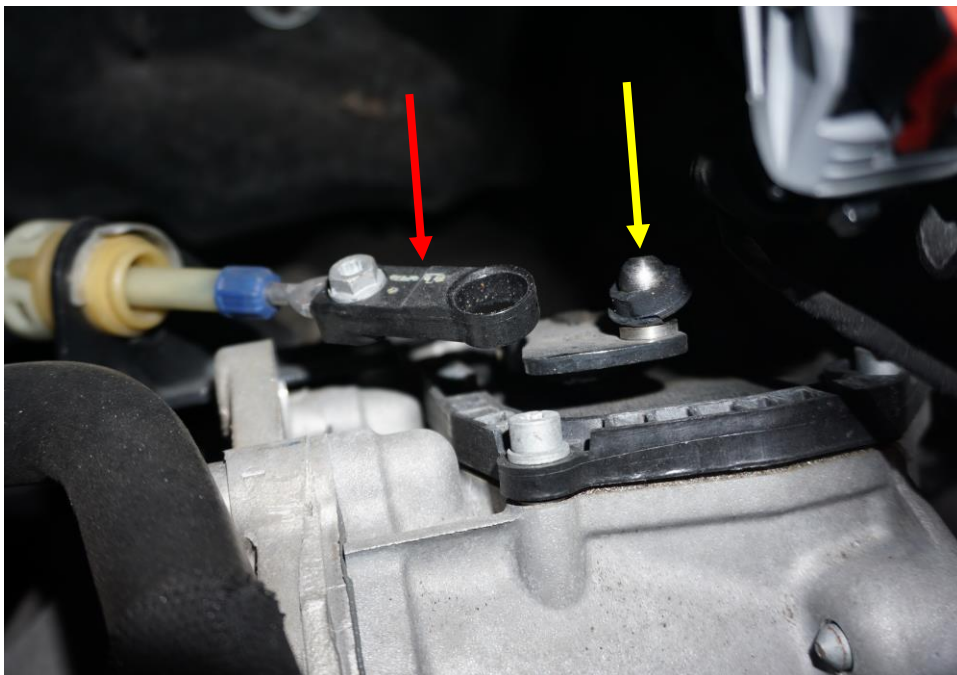
Photo 8 shows a close up view of the engine compartment of the Insured Vehicle at the time of my inspection. The gear shifting cable connector that was dislodged from the gearbox of the Insured Vehicle, was fitted at the bottom right side in the engine compartment of the Insured Vehicle. The location of the dislodged gear shifting cable connector is indicated by the red arrow and the gearbox connecting ball is indicated by the yellow arrow.

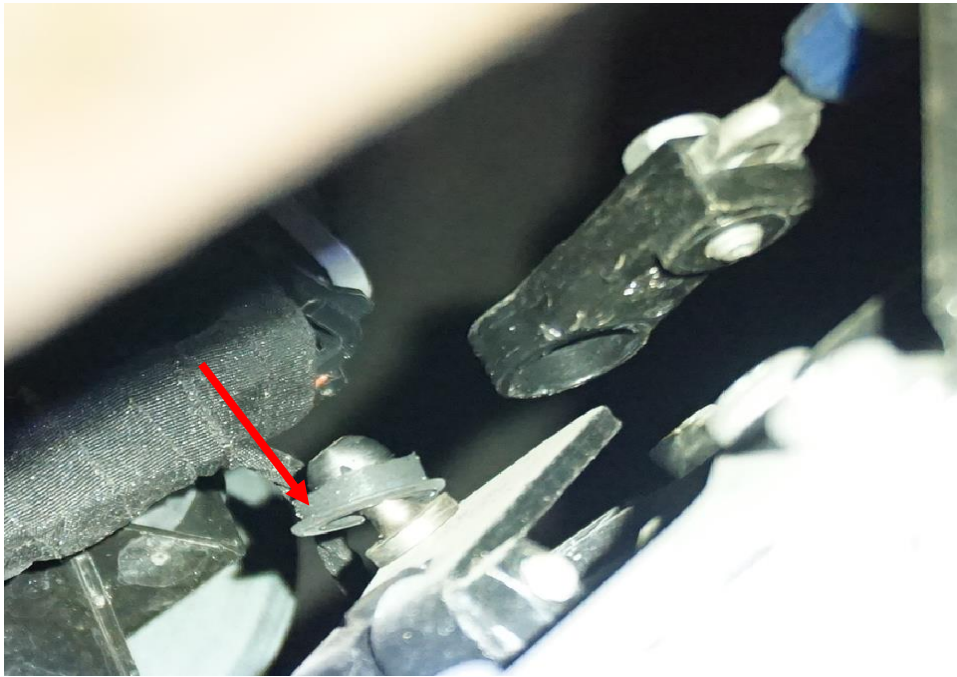
Photo 9 shows a close up view from the underside of the engine compartment of the Insured Vehicle at the time of my inspection. We noticed that there was a broken piece of rubber material on the connecting ball of the gearbox (arrowed). The gear shifting cable connector that was dislodged from the gearbox of the Insured Vehicle, was fitted at the bottom right side in the engine compartment of the Insured Vehicle.

8. Based on the observations gathered during my inspection of the Insured Vehicle, which also included the dislodged gear shifting cable connector away from the gearbox's connection ball, it would appear to me that the dislodging of the Insured Vehicle's gear shifting cable connector was due to a material failure of the rubber grommet as a result of natural wear to the material and at the time of inspection.

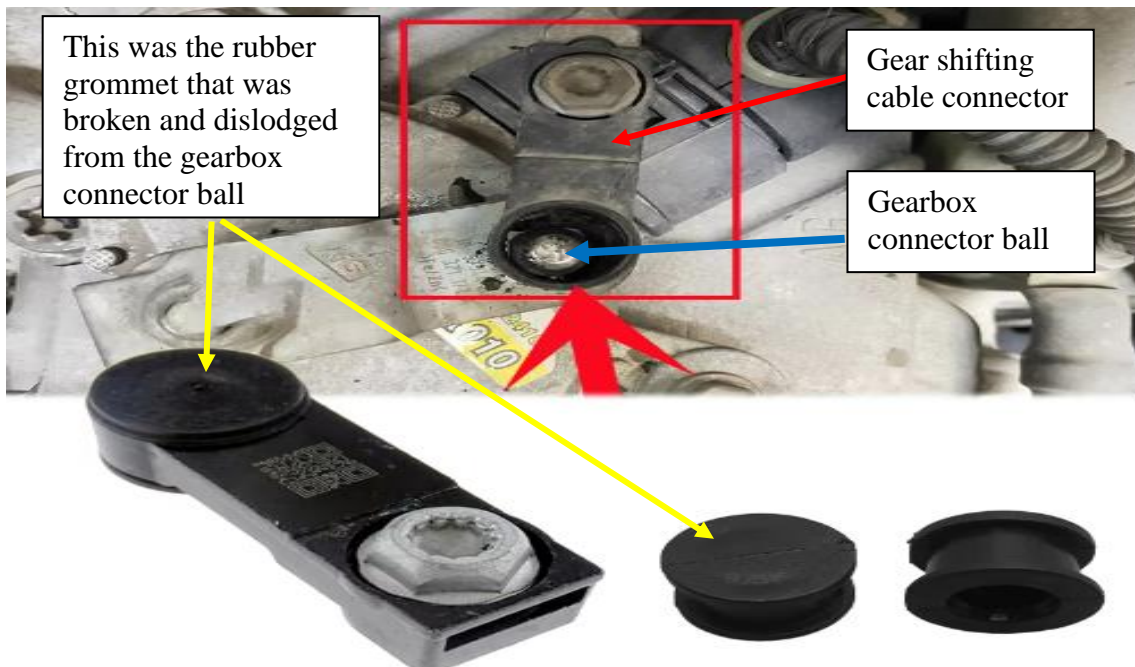
Photo 10 shows an illustration of a gear shifting cable connector (red arrow), the rubber grommet (yellow arrow) and the gearbox connector ball (blue arrow). The rubber grommet connects and secures the gear shifting cable connector to the gearbox connector ball of the gearbox.

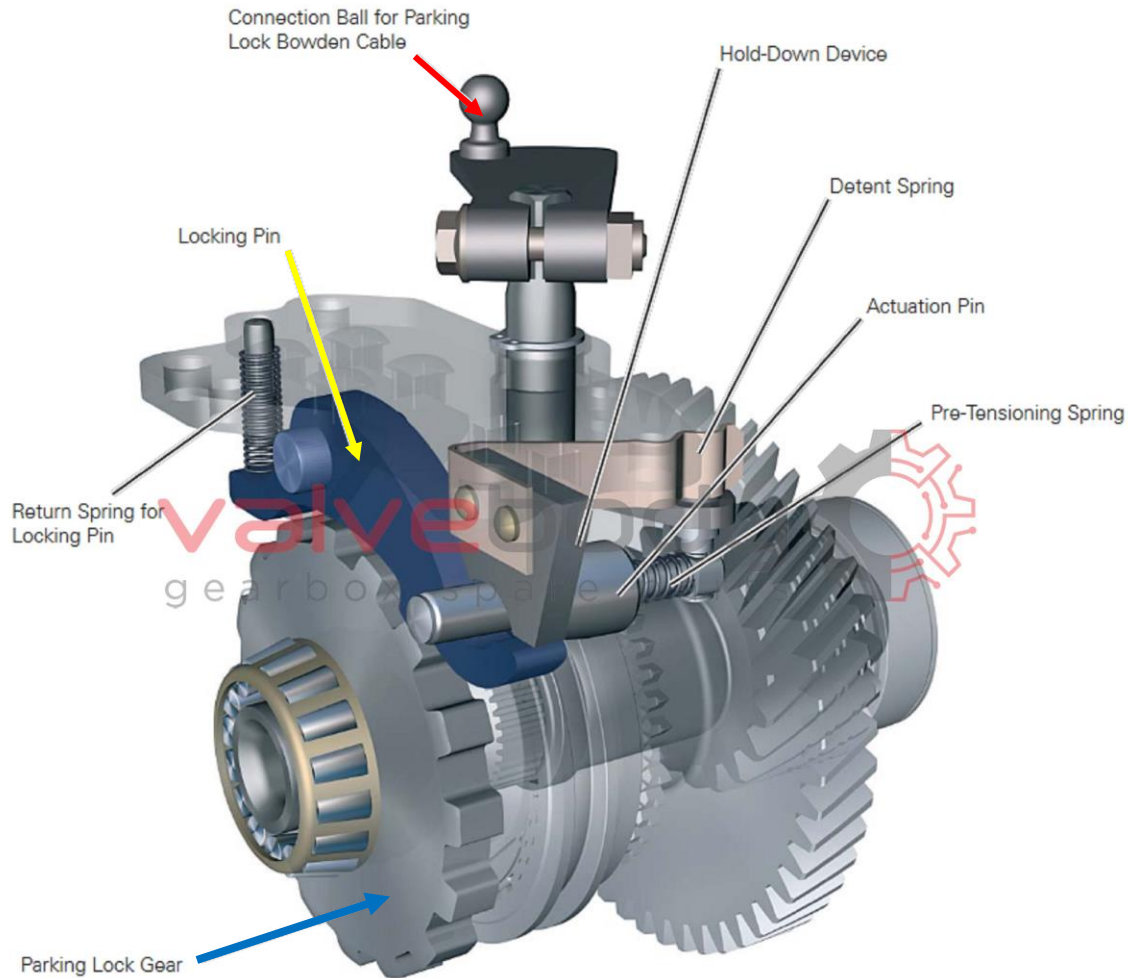
Photo 11 shows an illustration of the gearbox internals of the Insured Vehicle and the connection ball (red arrow) is where the gear shifting cable connector and its rubber grommet is attached onto (red arrow), when the P gear (Parking gear) is engaged, it controls the shifting cable and move the locking pin/parking pawl (yellow arrow) into the grooves of the parking lock gear (blue arrow) to stop the Insured Vehicle from rolling forward or backwards.

- Under normal circumstance when P gear (Parking gear) is shifted into P gear position by the driver's input, the gear shifting cable connector will move the connection ball of the gearbox and it will then engage the locking pin/parking pawl and locking the parking lock gear in the gearbox, locking it in place preventing the Insured Vehicle from rolling forward or backwards. However, for this particular case, the broken rubber grommet has cause the gear shifting cable connector to dislodged out from the connection ball resulting to the parking lock/parking pawl to not engaged and lock into the parking lock gear of the gearbox of the Insured Vehicle.
