Your Ref: SNM24D205689
Our Ref : CS/CTI24100218/J

17 October 2024

TECHNICAL INVESTIGATION REPORT OF FIRE INCIDENT INVOLVING THE INSURED VEHICLE SNH 6969H ON 7 OCTOBER 2024

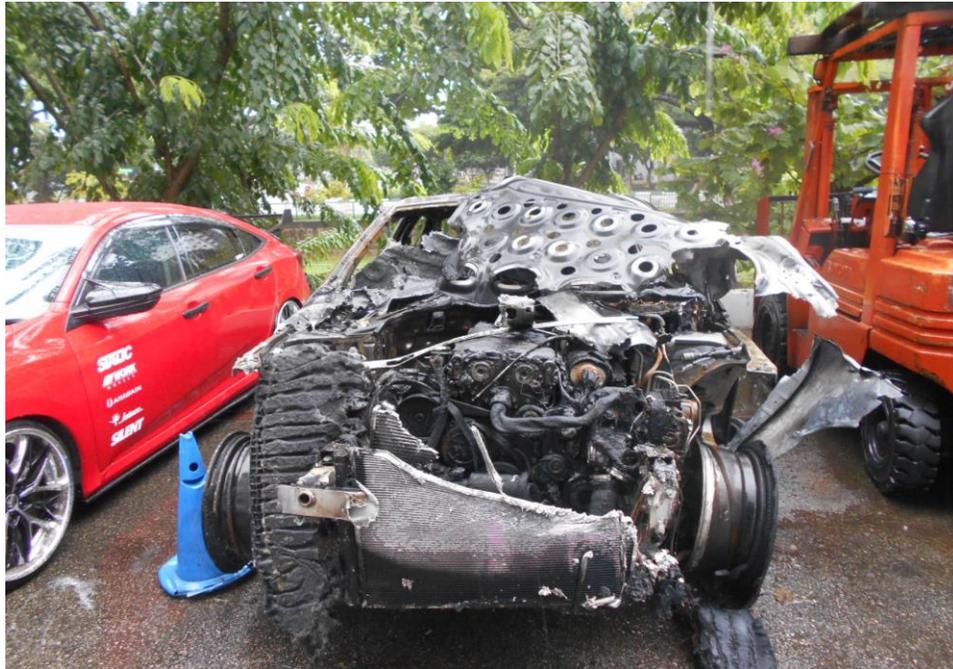
Photo 1 shows the general view of the frontal portion of the Insured Vehicle at the time of our inspection. The Insured Vehicle was observed to have sustained extensive fire damage all around. Its engine compartment and interior compartment were completely burnt. Rust had accumulated all over the Insured Vehicle as a result of exposure to environmental condition for a period of time.

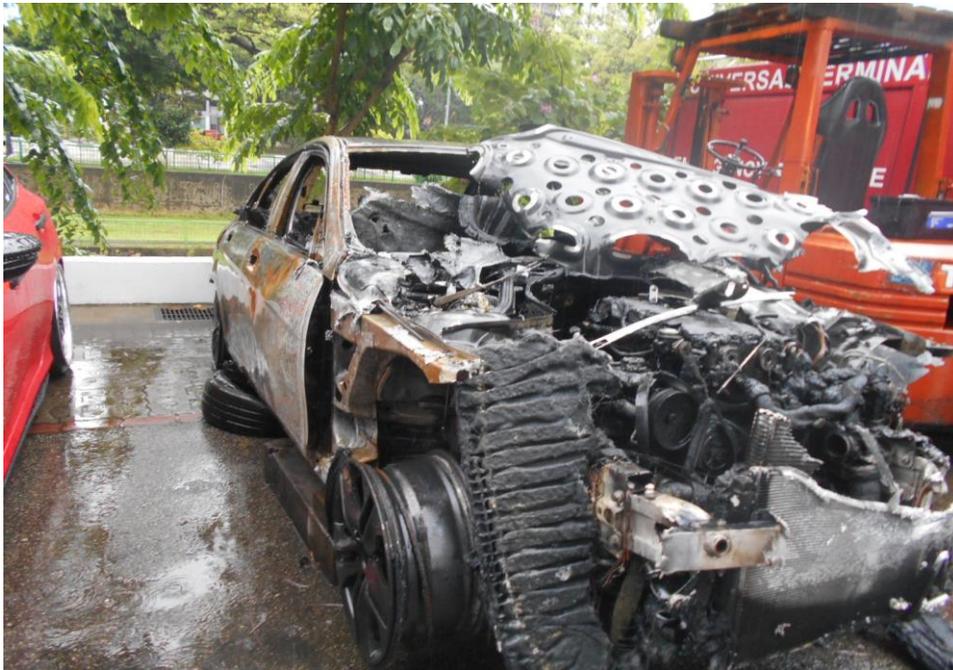
Photo 2 shows the general view of the right body of the Insured Vehicle at the time of our inspection. The Insured Vehicle was observed to have sustained extensive fire damage all around. Its engine compartment and interior compartment were completely burnt. Rust had accumulated all over the Insured Vehicle as a result of exposure to environmental condition for a period of time.

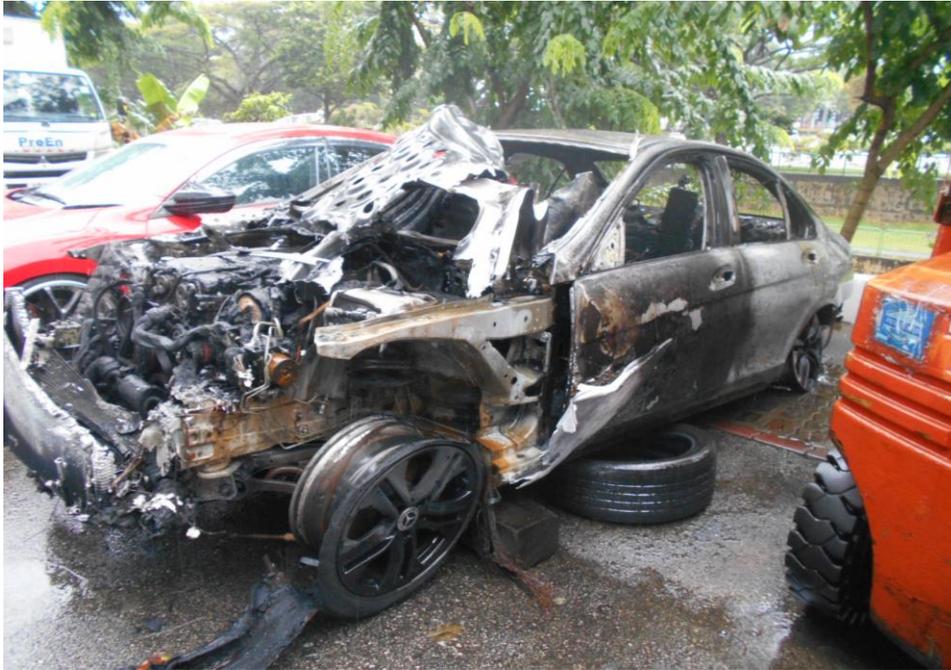
Photo 3 shows the general view of the left body of the Insured Vehicle at the time of our inspection. The Insured Vehicle was observed to have sustained extensive fire damage all around. Rust had accumulated all over the Insured Vehicle as a result of exposure to environmental condition for a period of time.

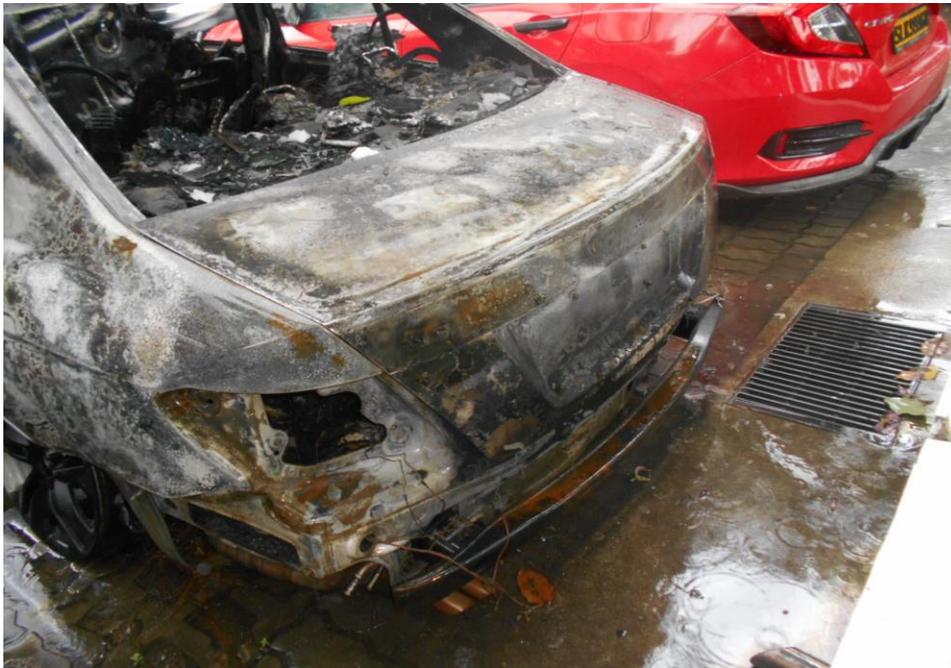
Photo 4 shows the general view of the rear portion of the Insured Vehicle at the time of our inspection. The Insured Vehicle was observed to have sustained extensive fire damage all around. Its engine compartment and interior compartment were completely burnt. Rust had accumulated all over the Insured Vehicle as a result of exposure to environmental condition for a period of time.

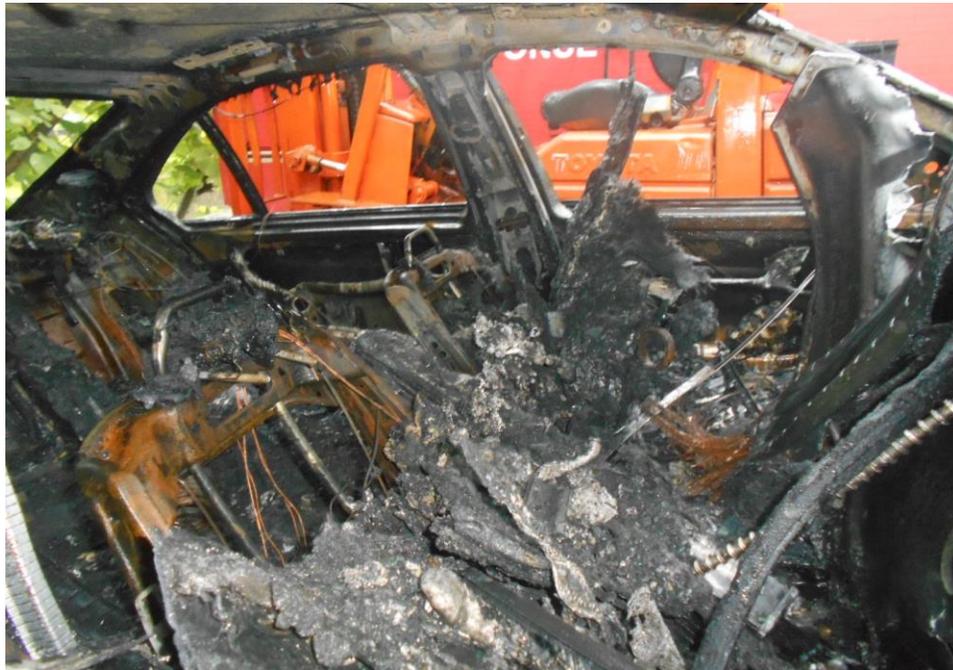
Photo 5 shows the interior compartment of the Insured Vehicle, which was significantly affected by the fire.

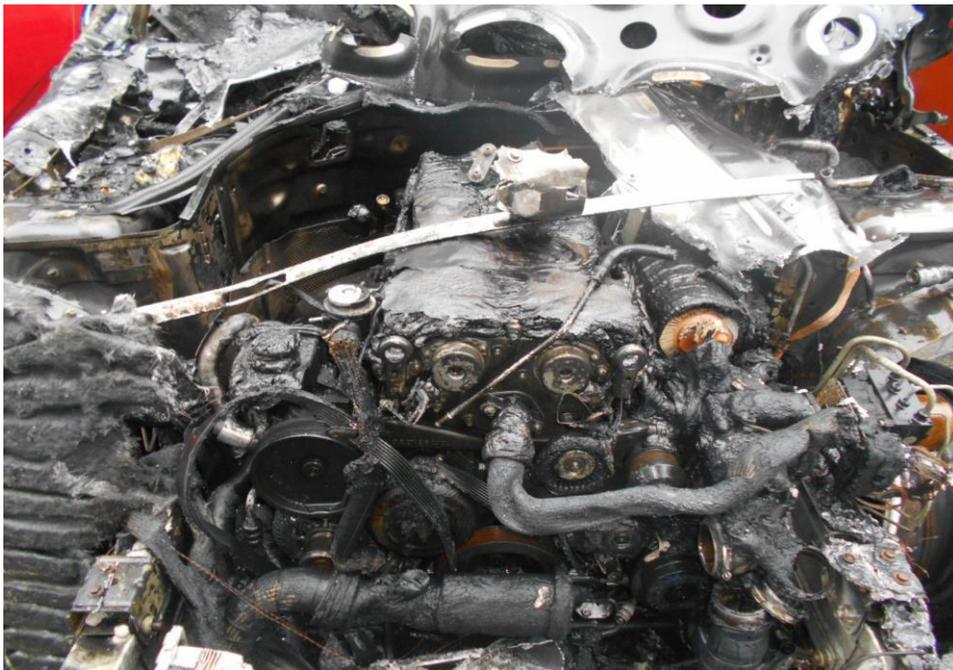
Photo 6 shows a general view of the engine compartment of the Insured Vehicle at the time of our inspection. Most of the components inside the engine compartment were found to be severely burnt and/or melted as a result of the fire.

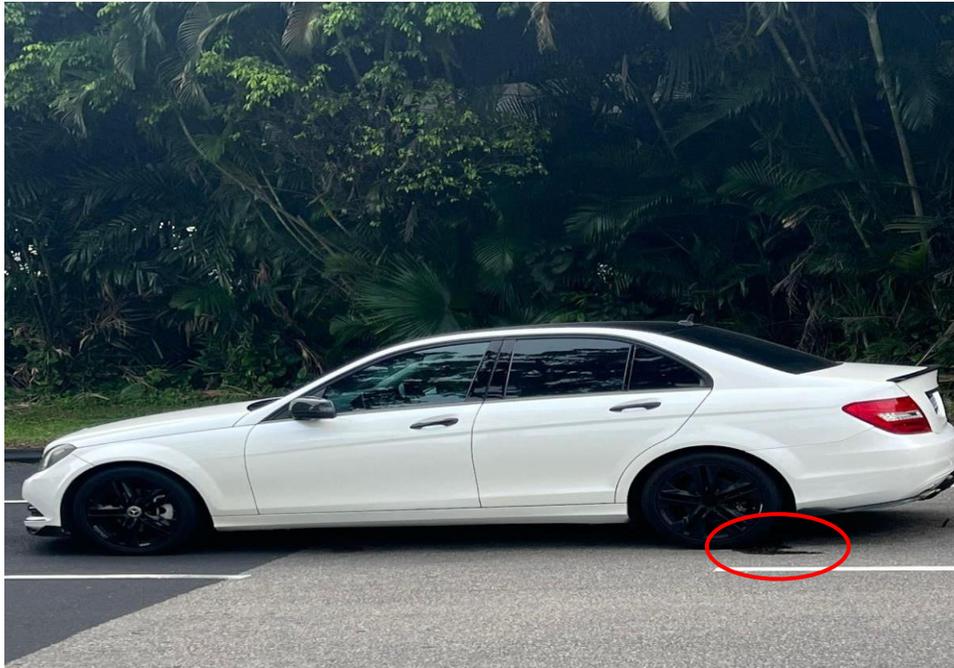
Photo 7 shows the general view of the Insured Vehicle before the fire incident, and a puddle of fuel/petrol (red circle) as mentioned to us by Ms Chia on the ground around the rear left tyre portion of the Insured Vehicle.

17. Given the circumstances of the incident as reported, the possibility of the cause of fire to the Insured Vehicle is due to fluid fire caused by fluid leakage contacting onto the Insured Vehicle hot surfaces of the exhaust system. as Ms Chia had mentioned to us that she smelt and saw a puddle of fuel/petrol on the rear left tyre area.

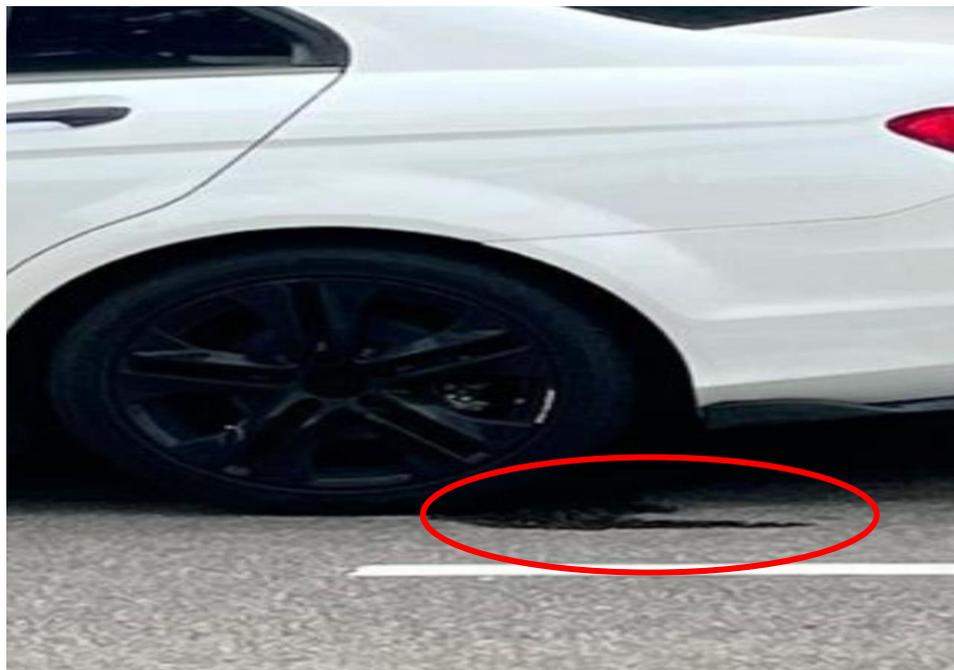
Photo 8 shows a closer view of the puddle of fuel/petrol on the ground around the rear left tyre portion area before the arise of the fire (red circled).

19. Having investigated and technically analysed the damages of burnt nature to the Insured Vehicle, we are of the view that the cause of fire to the Insured Vehicle was fluid leak in particular fuel/petrol which contacted on to hot surfaces of the Insured Vehicle's exhaust that caused the self-ignition of fire. For this particular case, the fire had originated from the undercarriage area somewhere around the rear left fuel/petrol tank of the Insured Vehicle.

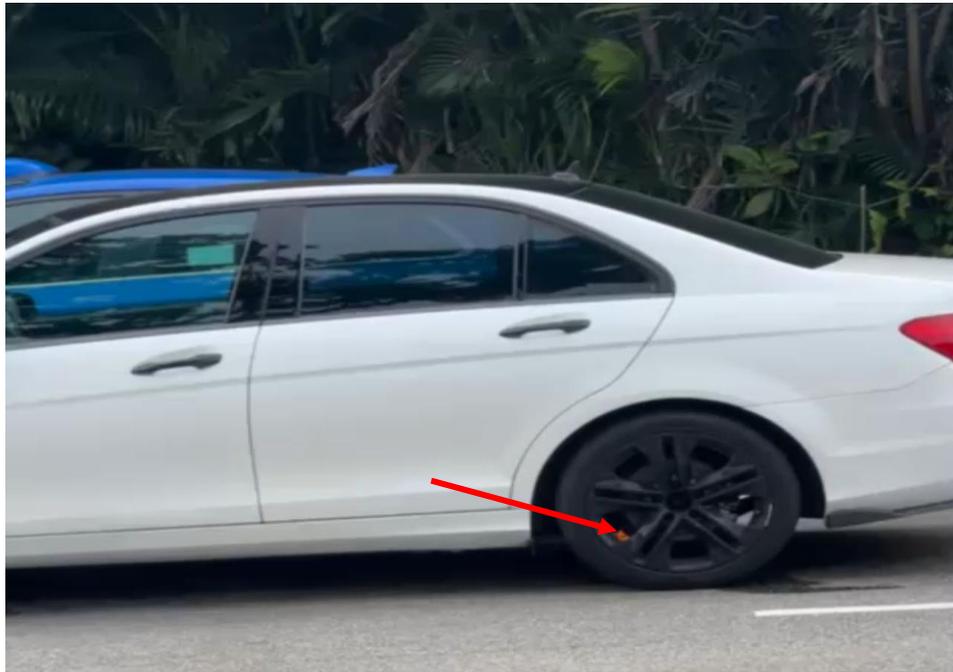
Photo 9 shows a close up view of the rear left tyre portion, in particular flames (red arrow) starting to arise from the inner rear left wheel well area.

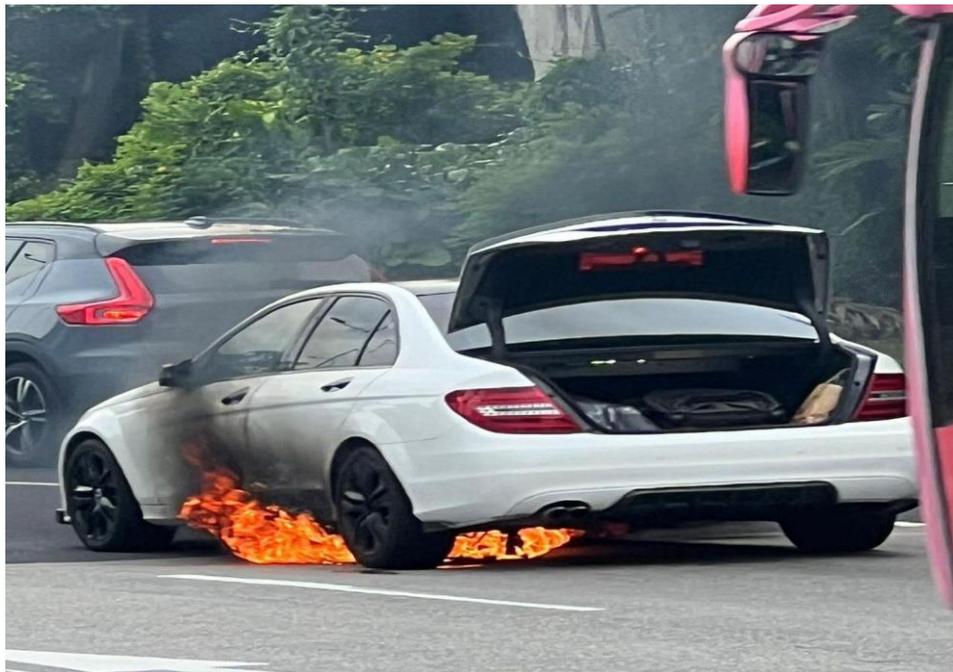
Photo 10 shows the Insured Vehicle rear left tyre area bursting into flames.

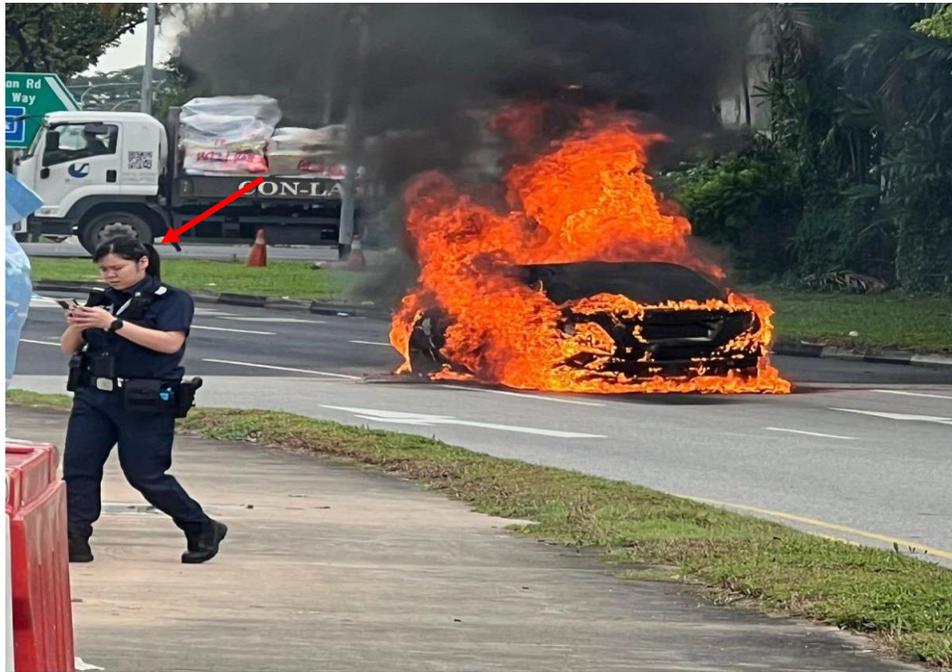
Photo 11 shows the Insured Vehicle engulfed in flames with the Police (red arrow) attending to the scene shortly before the arrival of the SCDF.

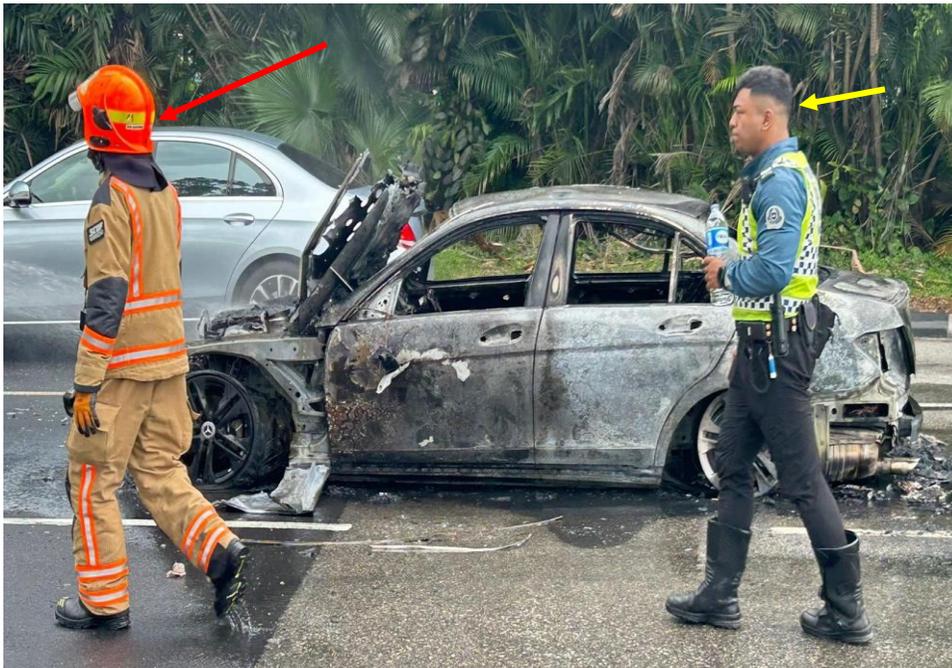
Photo 12 shows the SCDF fire fighter ensuring the last ruminants of the fire is extinguished along with Aetos/LTA road traffic marshal (yellow arrow).
