Our Ref : CS/III24060212/N

4 July 2024

**TECHNICAL INVESTIGATION REPORT OF FIRE INCIDENT INVOLVING THE INSURED VEHICLE GBH 650H ON 20 JUNE 2024**

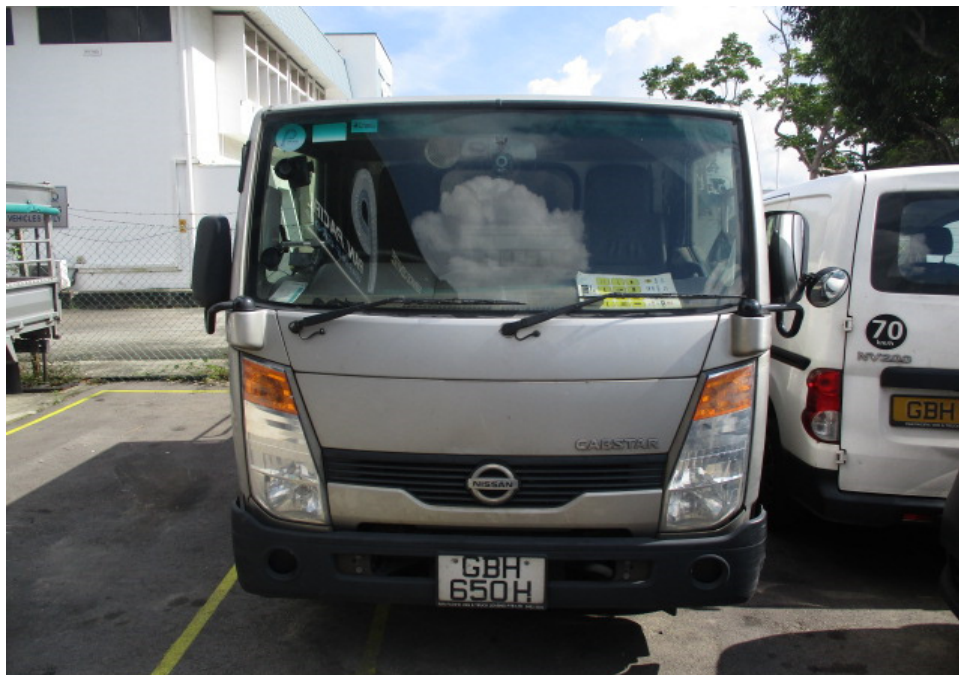
**Photo 1** shows the frontal portion of the Insured Vehicle at the time of our inspection. The damage to the Insured Vehicle was confined to its interior and engine compartments. The exterior body of the Insured Vehicle was relatively unaffected by the incident except for the right and rear portion of the driver cabin.

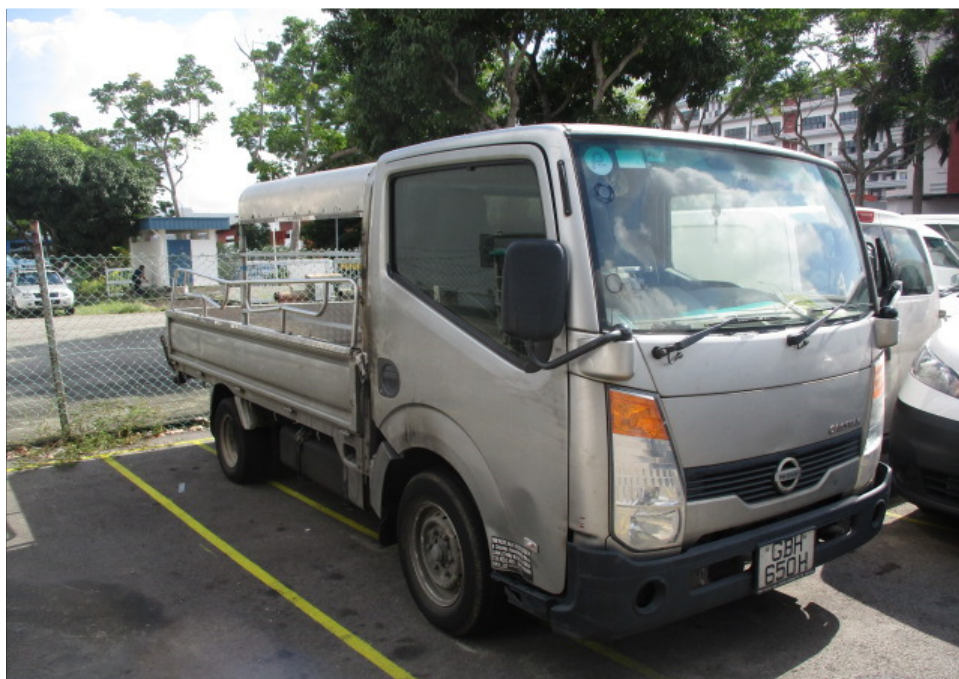
**Photo 2** shows the right frontal portion of the Insured Vehicle at the time of our inspection. The exterior body of the Insured Vehicle was relatively unaffected by the incident except for the right and rear portion of the driver cabin.

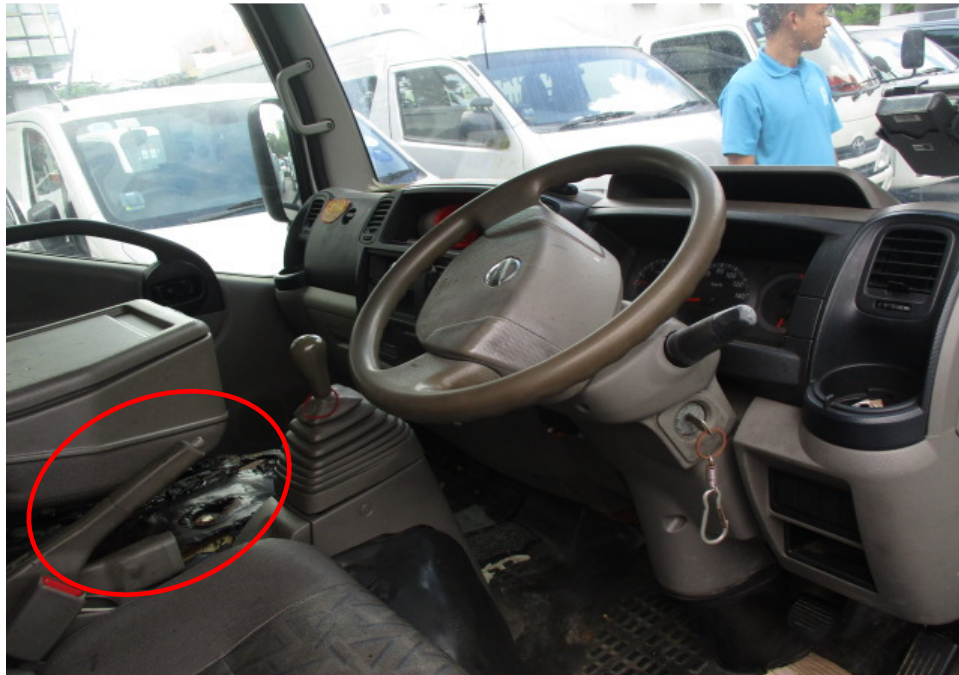
**Photo 3** shows the interior compartment the Insured Vehicle at the time of our inspection. The centre portion of the interior compartment of the Insured Vehicle was severely affected by the fire (circled).

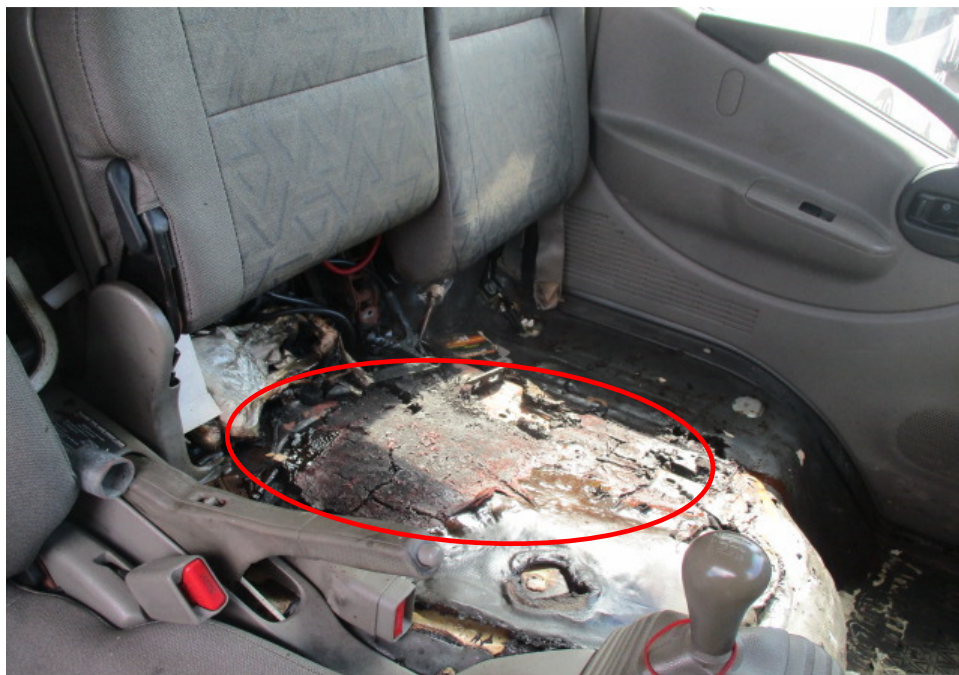
**Photo 4** shows a closer view of the interior compartment of the Insured Vehicle at the time of our inspection. The centre portion of the interior compartment of the Insured Vehicle was severely affected by the fire (circled).

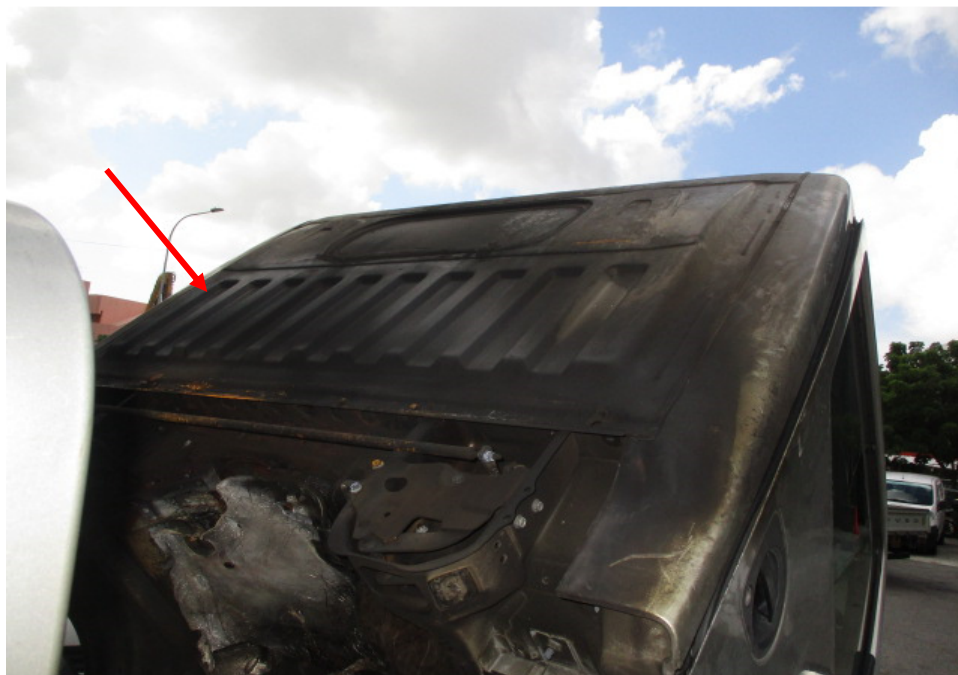
**Photo 5** shows the cab of the Insured Vehicle at the time of our inspection. The damage to the cab of the Insured Vehicle was confined to its rear portion (arrowed).

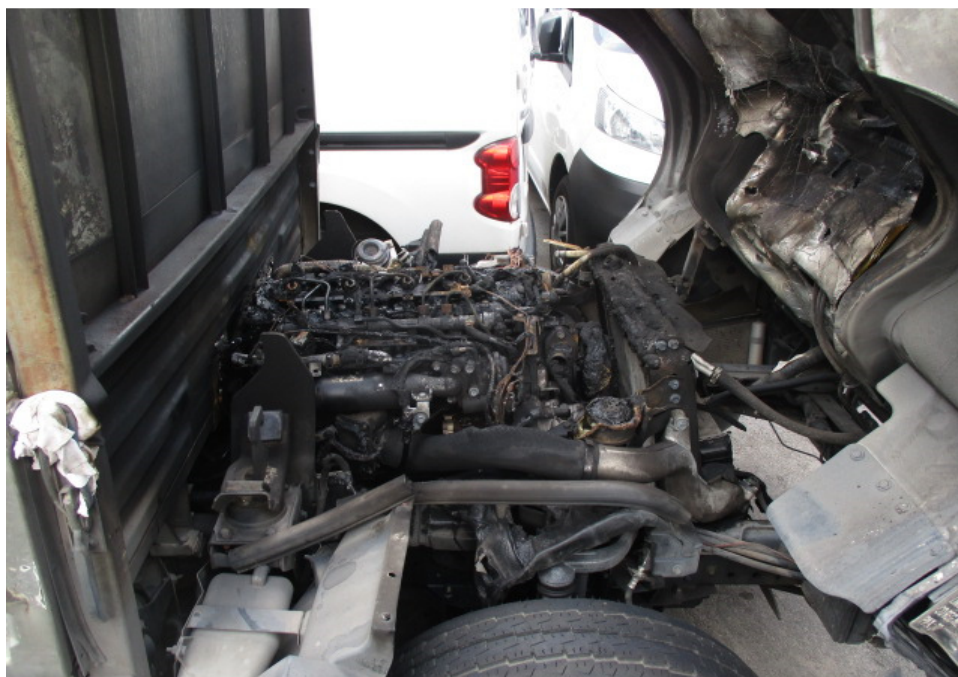
**Photo 6** shows the engine compartment of the Insured Vehicle which is situated beneath the cab at the time of our inspection. The engine compartment of the Insured Vehicle was seriously affected by the fire.

8. For this particular case, the fire appears to have originated within the engine compartment of the Insured Vehicle. This can be determined from the burn pattern and the high heat intensity burn marks (whitish burn marks) found on the underside of the cab as well as the rust that had developed on the cab mounting bracket of the Insured Vehicle.
9. The whitish burn marks are a result of exposure to prolonged heat intensity. Rust would normally start to develop around these areas soon after a fire as prolonged exposure to high heat intensity usually causes steel/metal material body parts to be exposed to natural environmental condition. The rust that had developed on the cab mounting bracket of the Insured Vehicle is an indication that the engine compartment had sustained exposure to prolonged high heat intensity. See photos 7 & 8 below.

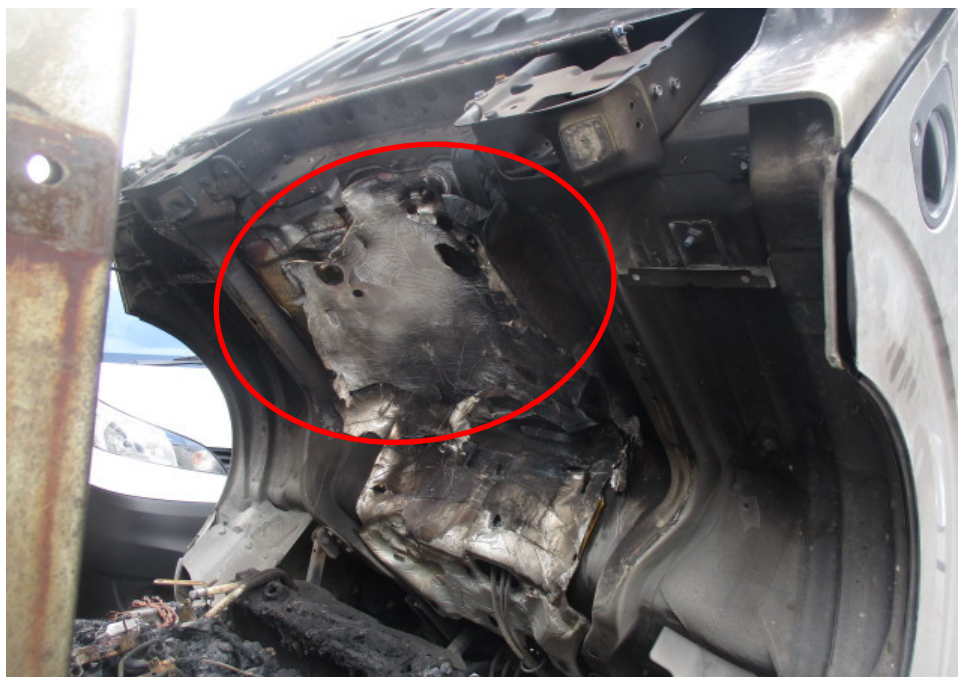
**Photo 7** shows the whitish burn marks that were found on the underside of the cab of the Insured Vehicle (circled). Such whitish burn marks are a result of exposure to prolonged heat intensity.

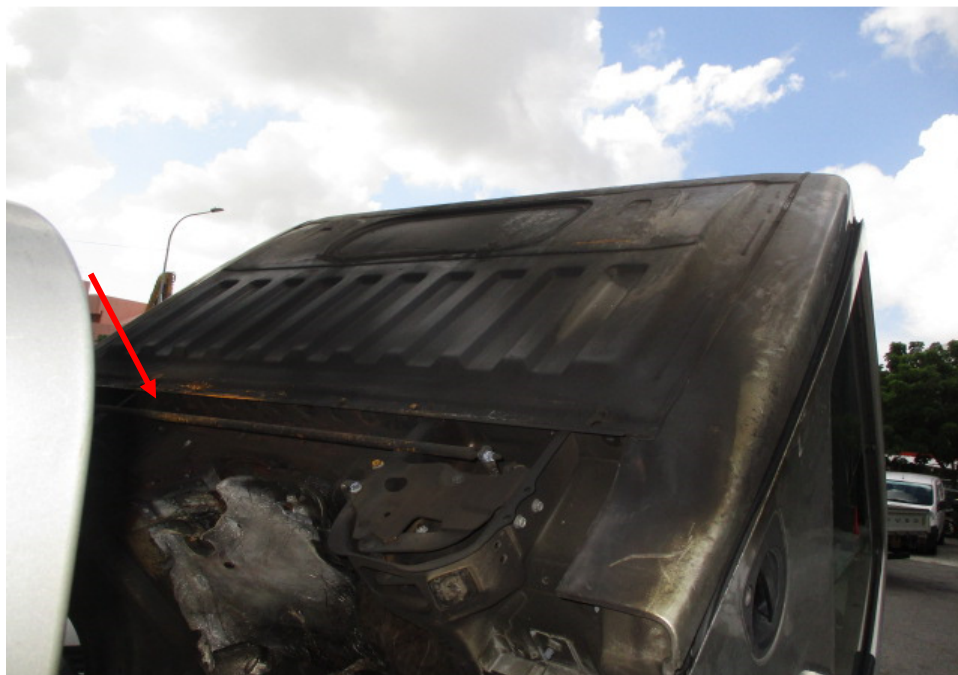
**Photo 8** shows the rust that had developed on the cab mounting bracket of the Insured Vehicle (arrowed) which is an indication that the fire to the Insured Vehicle had originated from the engine compartment. The development of rust is an indication that the area was exposed to prolonged exposure to high heat intensity, which had caused the steel/metal material of the passenger side engine access panel to be exposed to natural environmental condition.

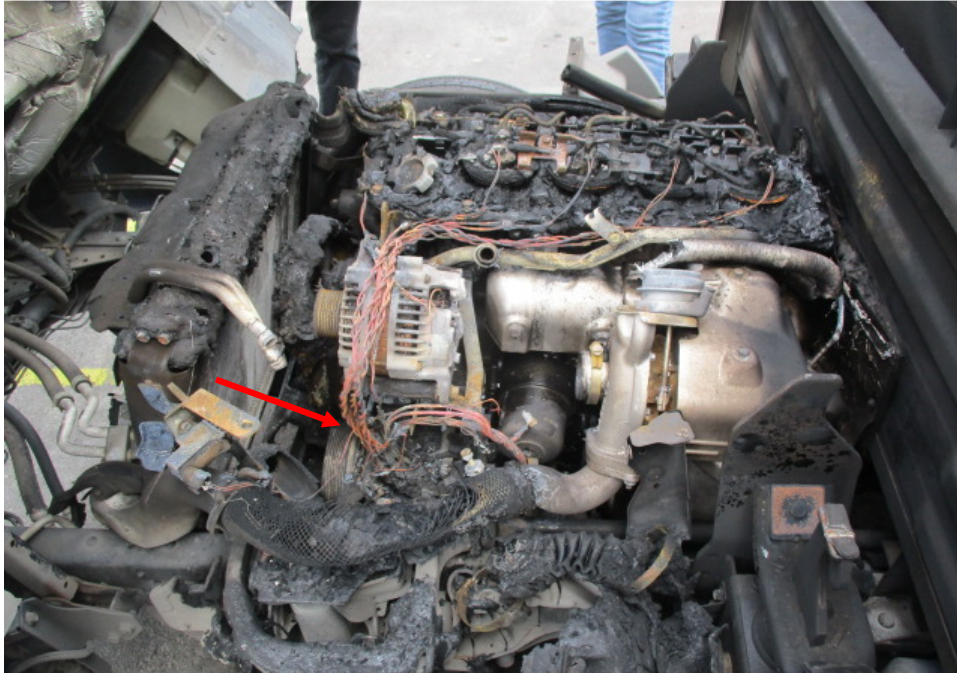
10. Upon closer examination of the engine compartment of the Insured Vehicle which was where the fire had likely started, we had found traces of greenish residue on several burnt stretches of wirings around the centre portion of the engine compartment. The wirings were original factory fitted wirings. The presence of greenish residue indicates internal heating of copper wires, a sign of an electrical short circuit occurring. The greenish residue is normally left behind from oxidation as a result of chemical reaction involving the copper wires. This physical evidence would then appear to suggest that the cause of fire to the Insured Vehicle could have possibly been due to electrical in nature. See photos 9 - 11 below.

**Photo 9** shows the burnt wirings around the centre portion of the engine compartment of the Insured Vehicle. The wirings were original factory fitted wirings. We observed traces of greenish residue on these wirings (arrowed). The presence of such greenish residue indicates internal heating of copper wires, a sign of an electrical short circuit occurring.

26. Having investigated and technically analysed the damages of burnt nature to the Insured Vehicle, we are of the view that the cause of fire to the Insured Vehicle was of electrical in nature. For this particular case, the fire had originated along the wirings around the engine compartment. The wirings were original factory wirings inside the engine compartment of the Insured Vehicle.

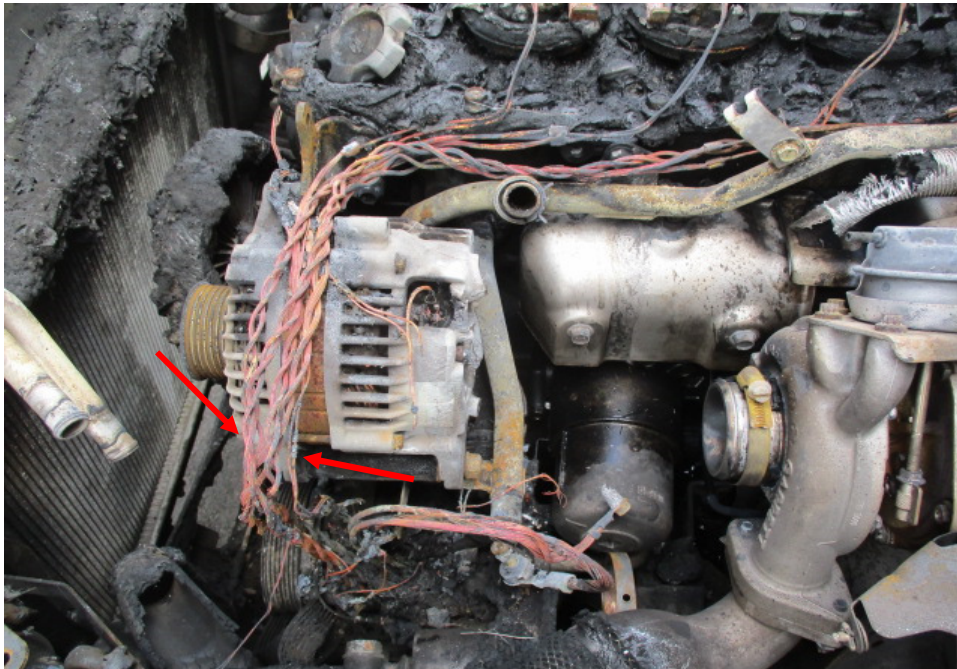
**Photo 10** shows a closer view of the greenish residue found on the wirings around the centre portion of the engine compartment of the Insured Vehicle (arrowed). The greenish residue is normally left behind from oxidation as a result of chemical reaction involving the copper wires.

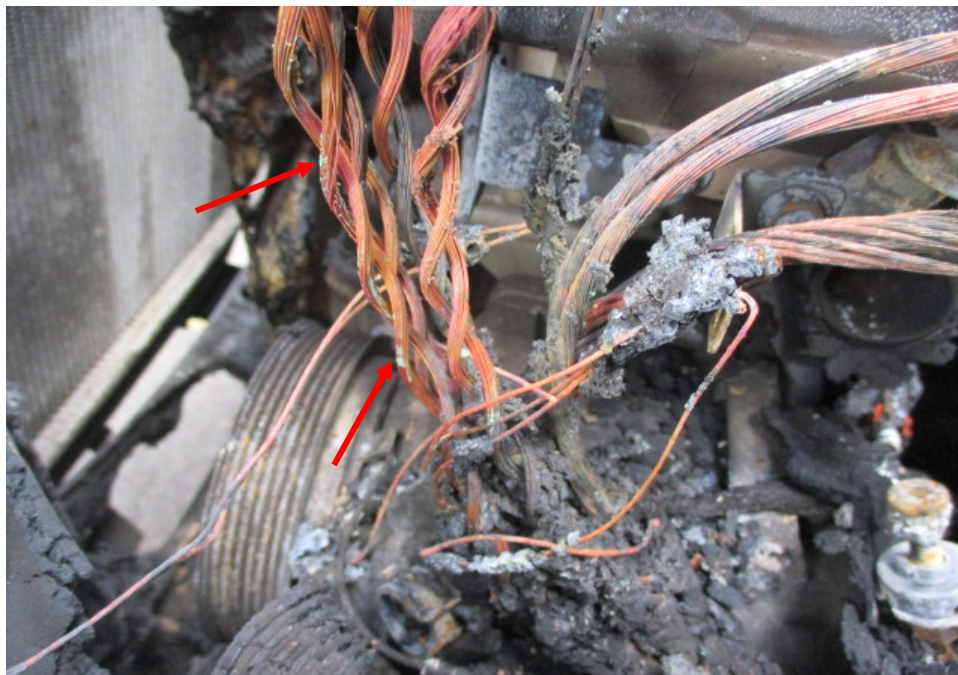
**Photo 11** shows a close up view of the greenish residue found on the wirings around the centre portion of the engine compartment of the Insured Vehicle (arrowed). This physical evidence would then appear to suggest that the cause of fire to the Insured Vehicle could have possibly been due to electrical in nature.

24. The possibility of the fire being due to electrical in nature would then seem more likely given that engine overheating and external factors would both seem unlikely. The fire being due to electrical nature is also supported by the condition of the wirings around the centre portion of the engine compartment of the Insured Vehicle, which was earlier discussed in paragraph 10 above.

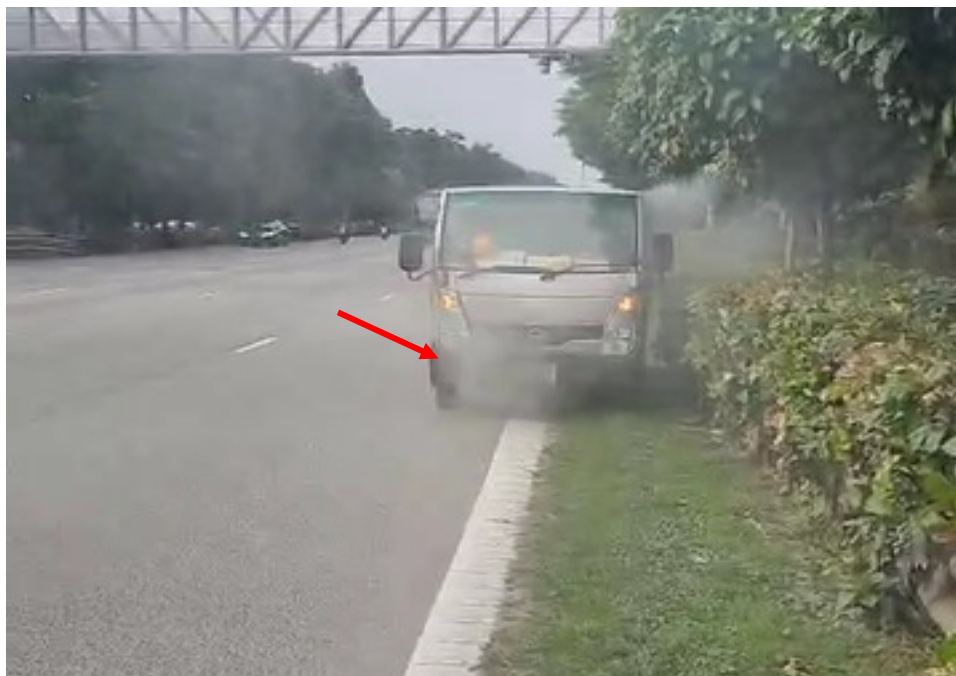
**Photo 12** shows smoke emitting from the Insured Vehicle (arrowed) before the arrival of the SCDF.

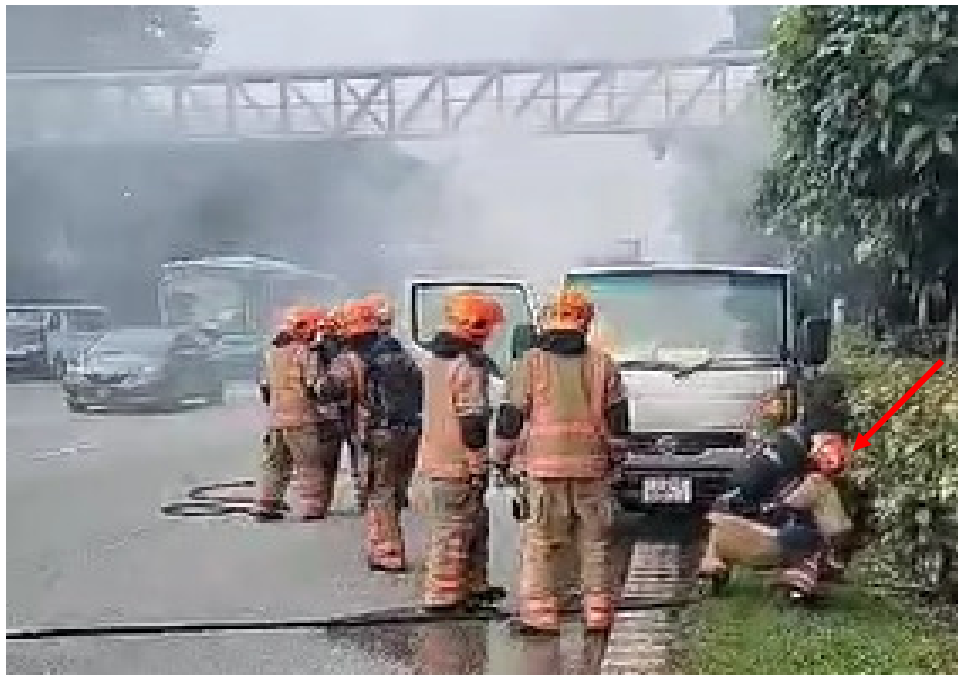
**Photo 13** shows firefighters attempting to put out the fire to the Insured Vehicle (arrowed).

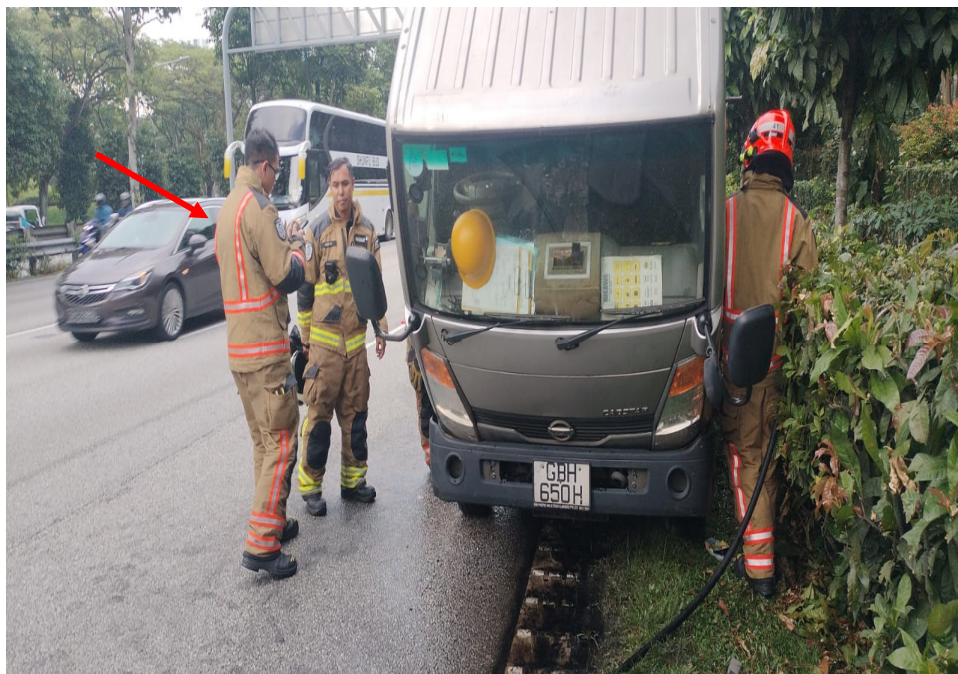
**Photo 14** shows SCDF conducting preliminary investigations post- incident (arrowed).

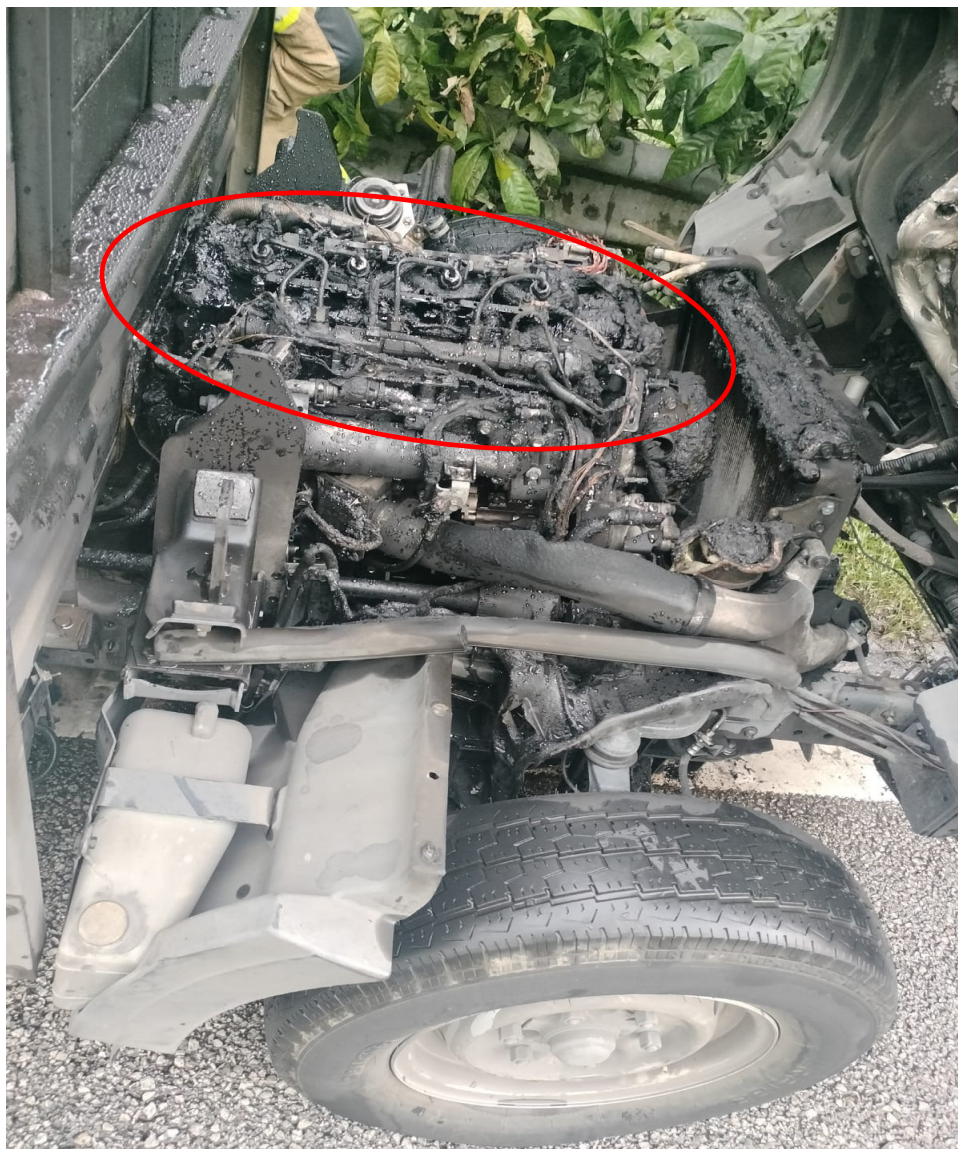
**Photo 15** shows the engine compartment of the Insured Vehicle after firefighters were able to lift the cab post- incident. In general, the damages sustained to the engine compartment and the fire extinguisher water residue found on the burnt stretches of wirings (circled) had corresponded to the events that were related to us by Mr Gazi, which is the fire had started from the engine compartment.
