Your Ref : 377372
Our Ref : CS/MSG24100365/N

4 November 2024

**AUTOMOBILE TECHNICAL INVESTIGATION REPORT OF ACCIDENT
INVOLVING SNQ 6598Y AND SMT 8924Y ON 20 OCTOBER 2024**

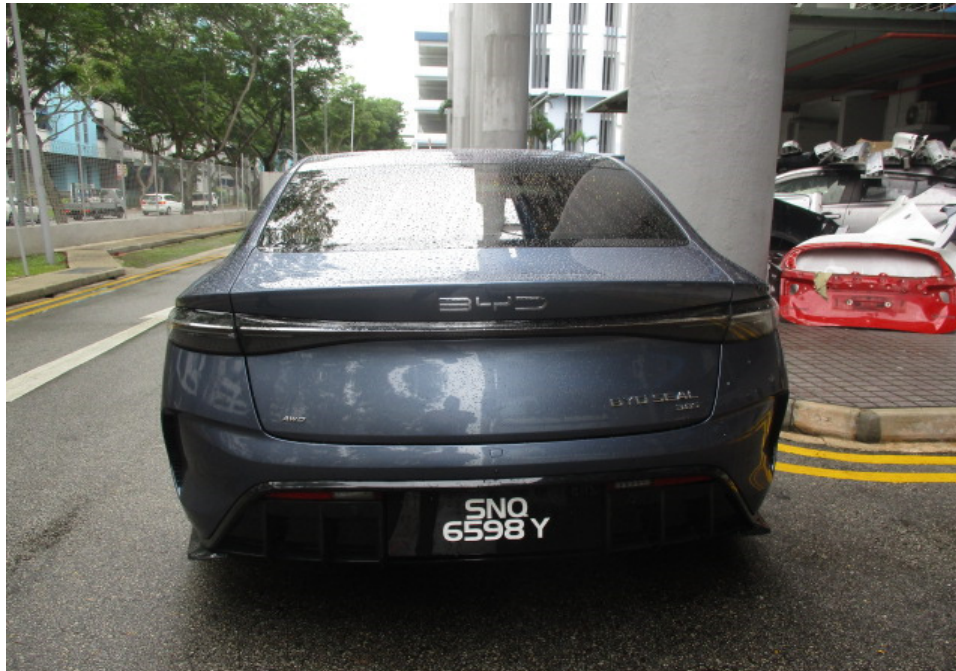
Photo 1 shows the general view of the rear portion of the BYD taken during our physical inspection. The mileage recorded was 14, 021km.

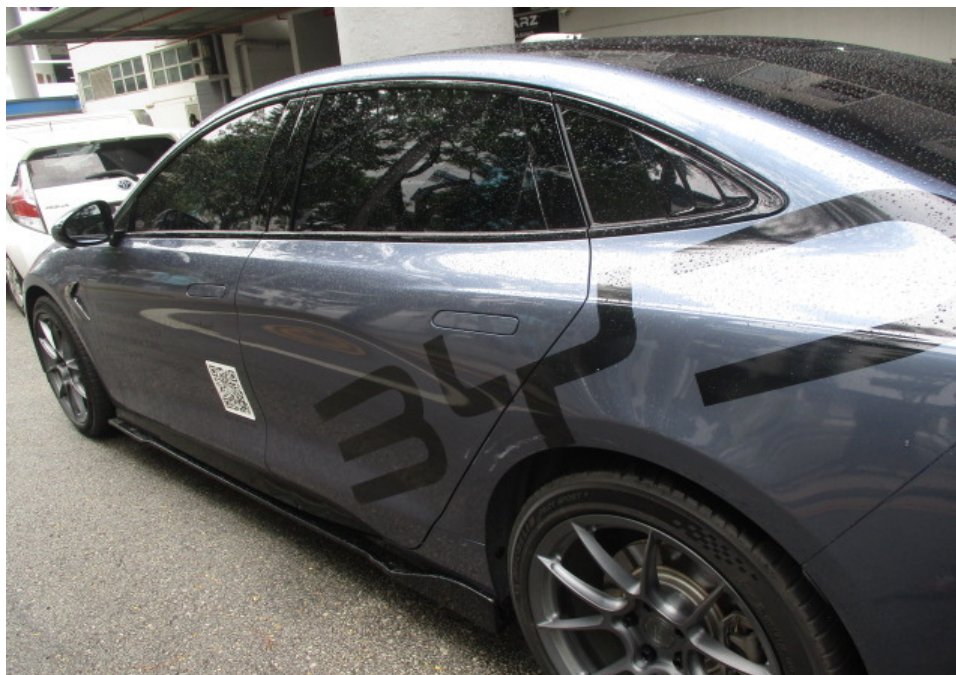
Photo 2 shows the general view of the left rear portion of the Toyota taken during our physical inspection. The physical inspection carried out had primarily focused on the left rear portion of the BYD as the driver of the BYD had reported the accident to be of a side-swipe collision where the Toyota was at the left side of the BYD at the material time.

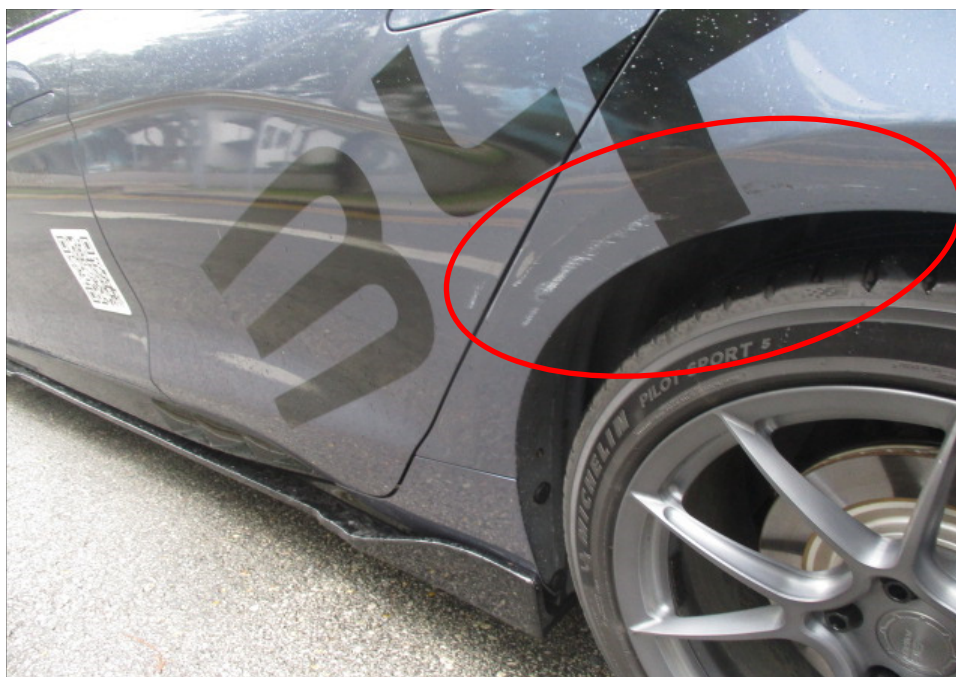
Photo 3 shows upon closer examination of the left rear portion, we observed horizontal paint graze marks on the left rear fender of the BYD (circled).

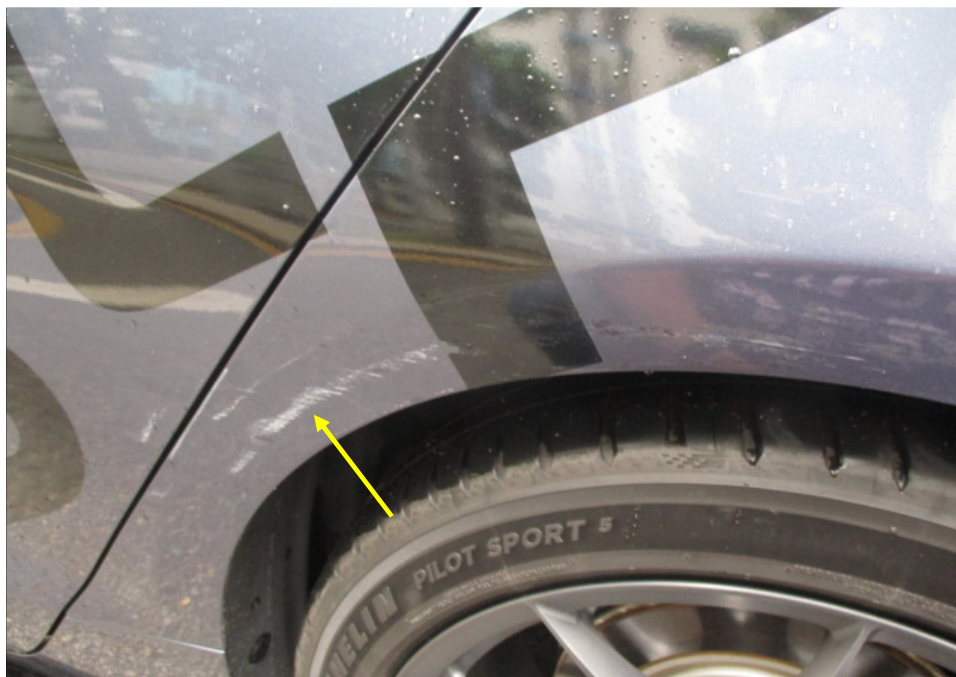
Photo 4 shows a close up view of the horizontal paint graze marks on the left rear fender of the BYD (arrowed).

22. Both damages are corresponding to their respective heights and are consistent to their nature of contact. Furthermore, the pattern of the horizontal paint graze marks observed on the right front door of the Toyota corresponds to the pattern of the horizontal paint graze marks observed on the left rear fender of the BYD.

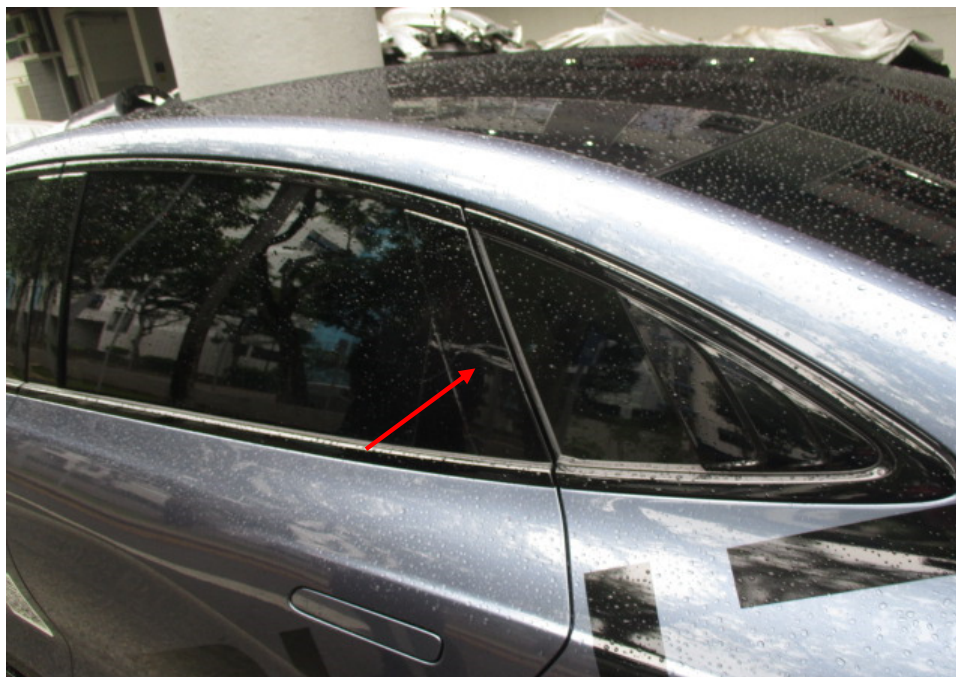
Photo 5 shows upon closer examination of the left rear door, we observed horizontal graze marks on the left rear door trim of the BYD (arrowed).

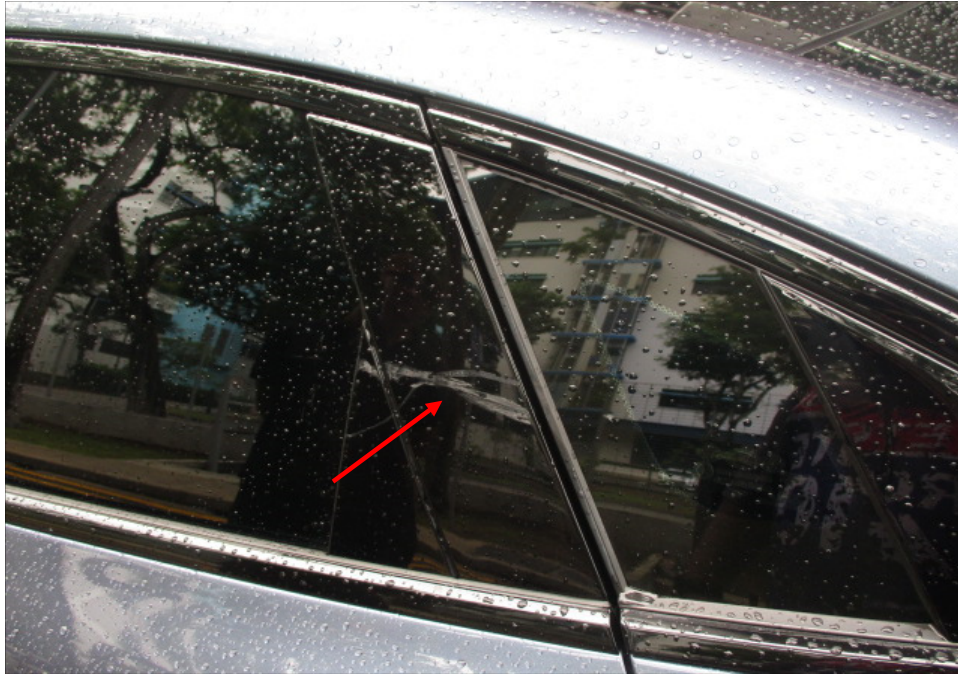
Photo 6 shows a closer view of the horizontal graze marks on the left rear door trim of the BYD (arrowed).

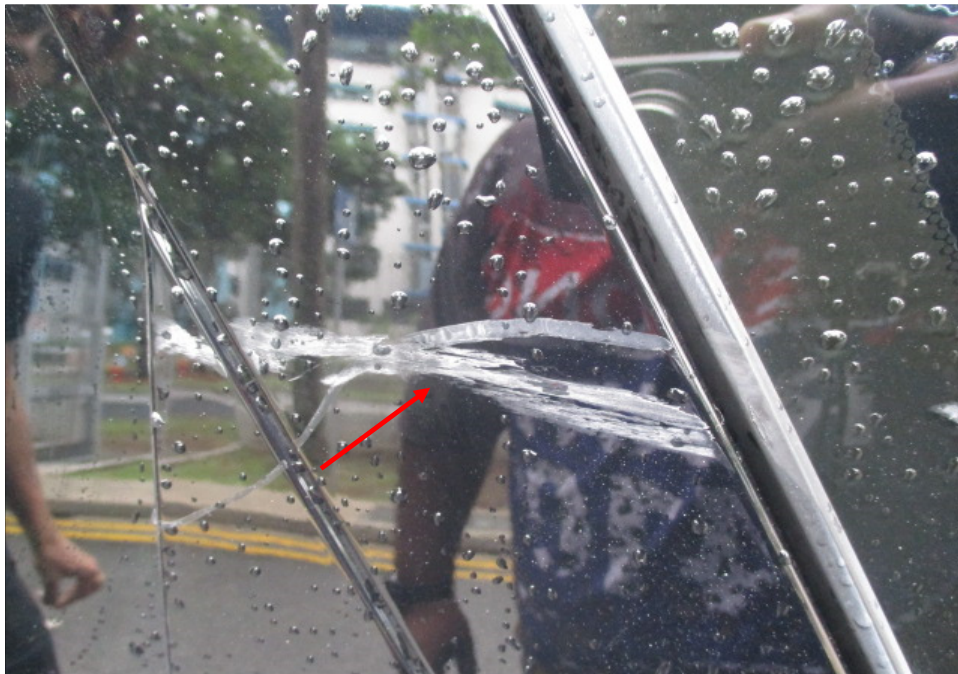
Photo 7 shows a close up view of the horizontal graze marks on the left rear door trim of the BYD (arrowed).

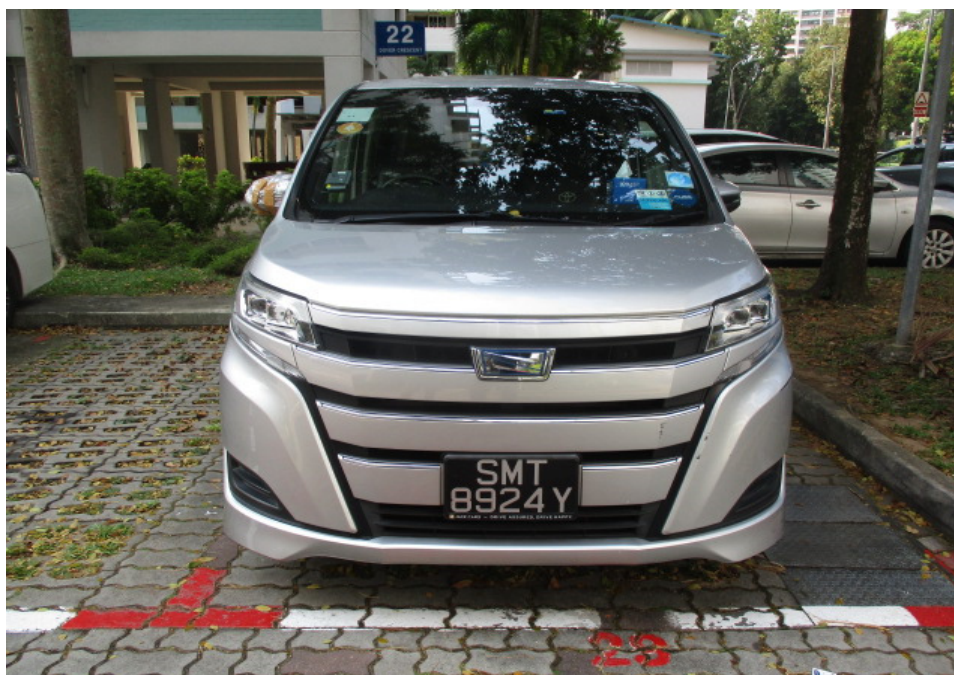
Photo 8 shows the general view of the frontal portion of the Toyota taken during our physical inspection. The mileage recorded was 74, 971km.

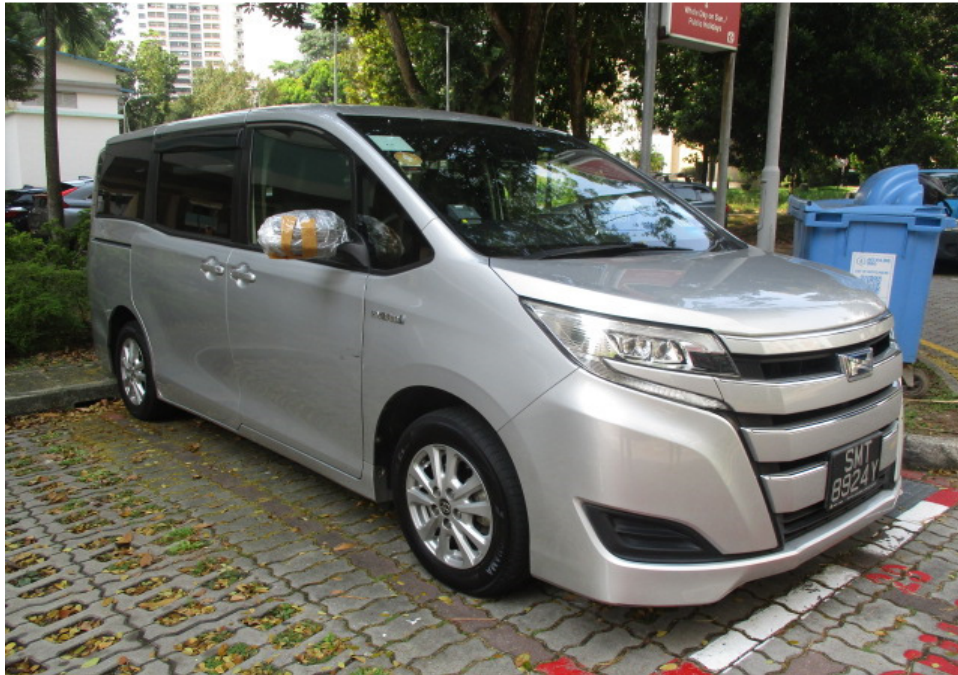
Photo 9 shows the general view of the right front body of the Toyota taken during our physical inspection. The physical inspection carried out had primarily focused on the right frontal portion of the Toyota as the driver of the Toyota had reported the accident to be of a side- swipe collision where the BYD was at the right side of the Toyota at the material time.

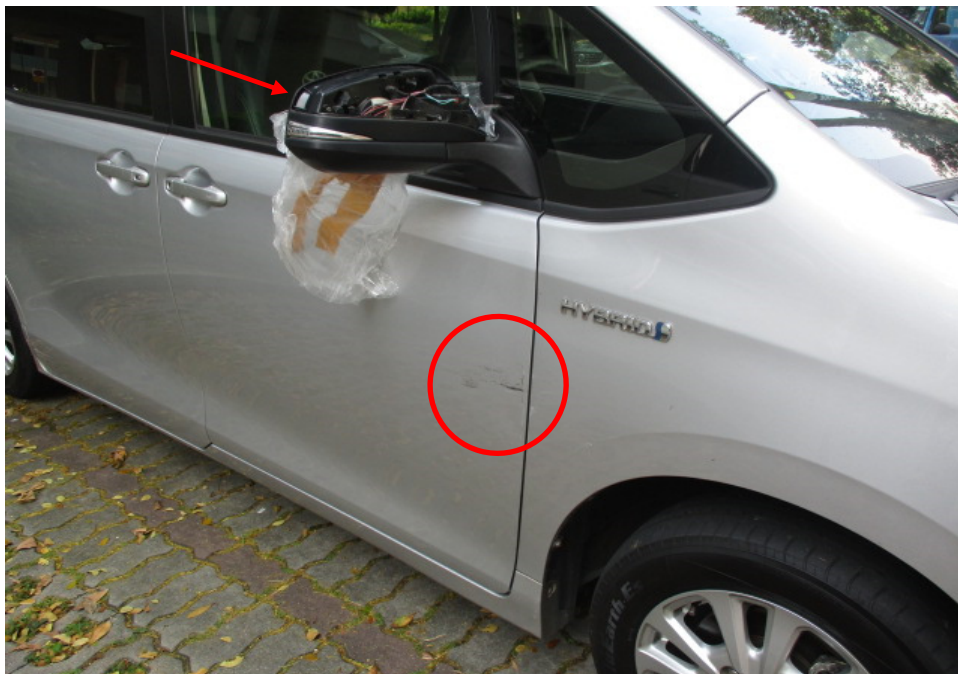
Photo 10 shows upon closer examination of the right frontal portion, we observed horizontal paint graze marks on the right front door (circled) and the deformed right side mirror (arrowed) of the Toyota.

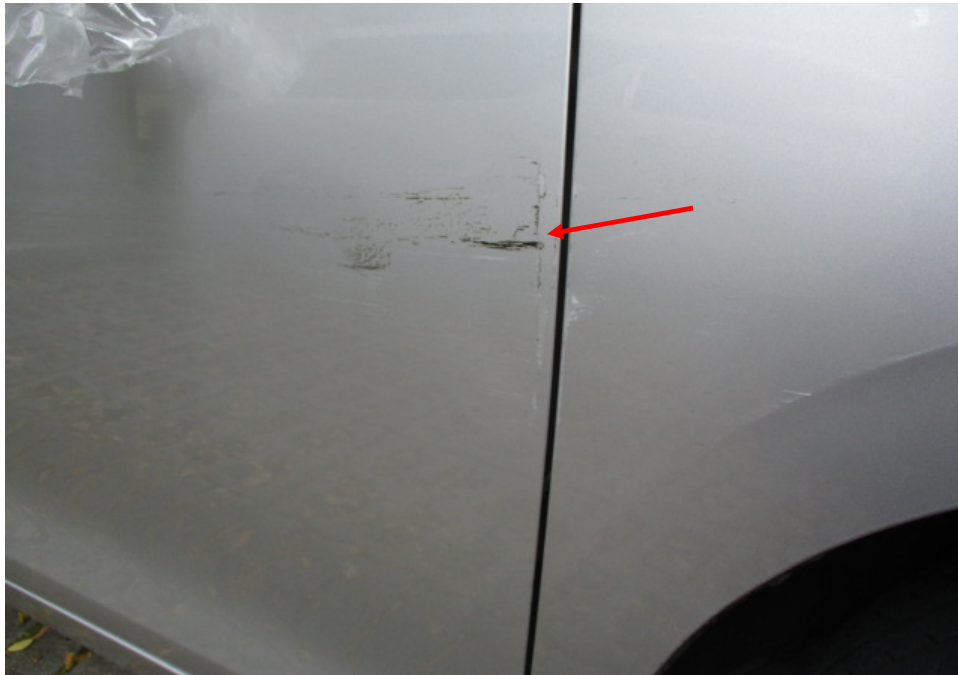
Photo 11 shows a close up view of the horizontal paint graze marks on the right front door of the Toyota (arrowed).

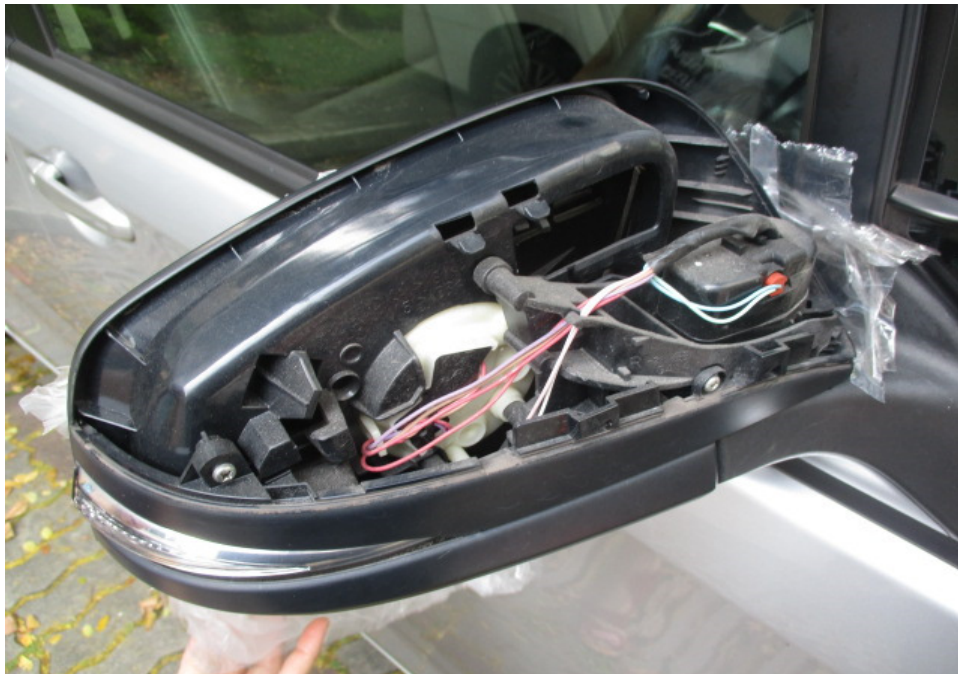
Photo 12 shows the right side mirror of the Toyota with its cover missing.

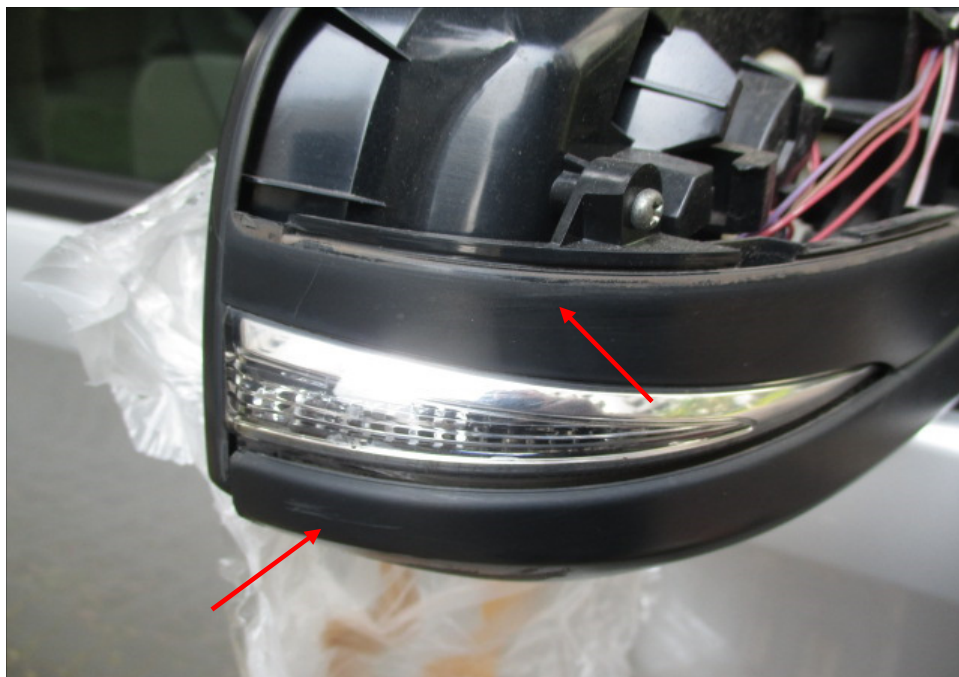
Photo 13 shows upon closer examination of the right side mirror, we observed horizontal graze marks (arrowed).

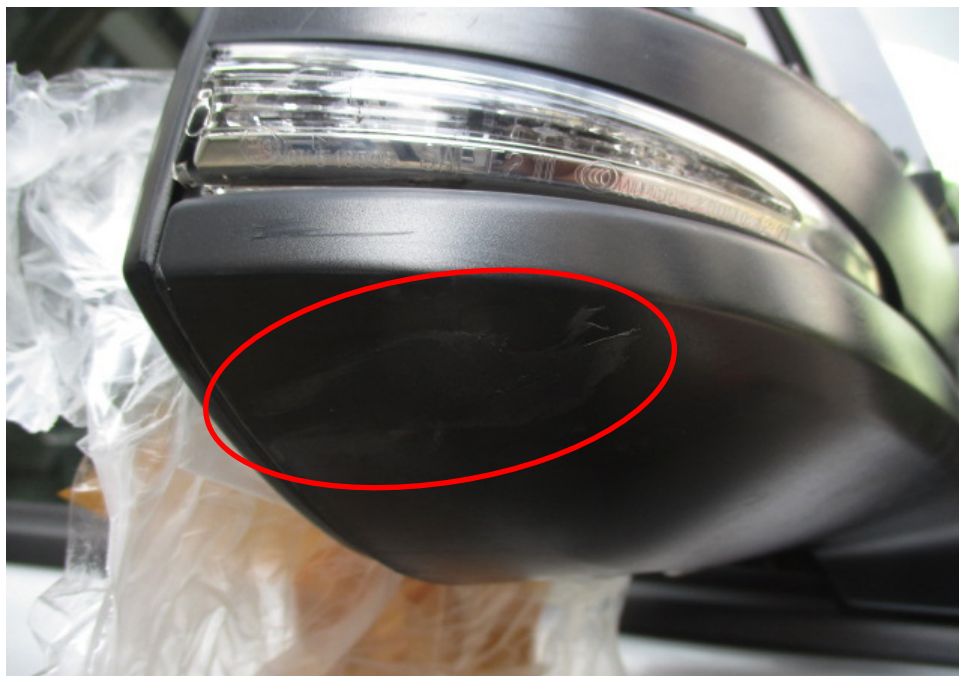
Photo 14 shows more horizontal graze marks on the underside of the right side mirror of the Toyota (circled).

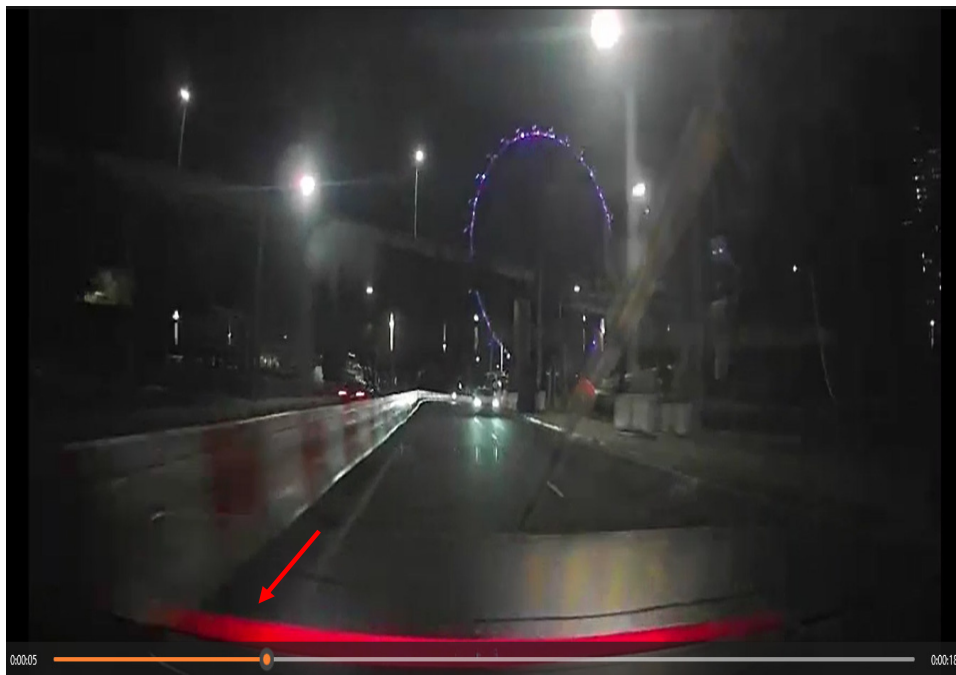
Screenshot 1 of the video recording from the video recording device that was mounted onto the rear windscreen of the BYD shows the driver of the BYD applying the brakes as the BYD approached the bend at the 5 second mark (arrowed).

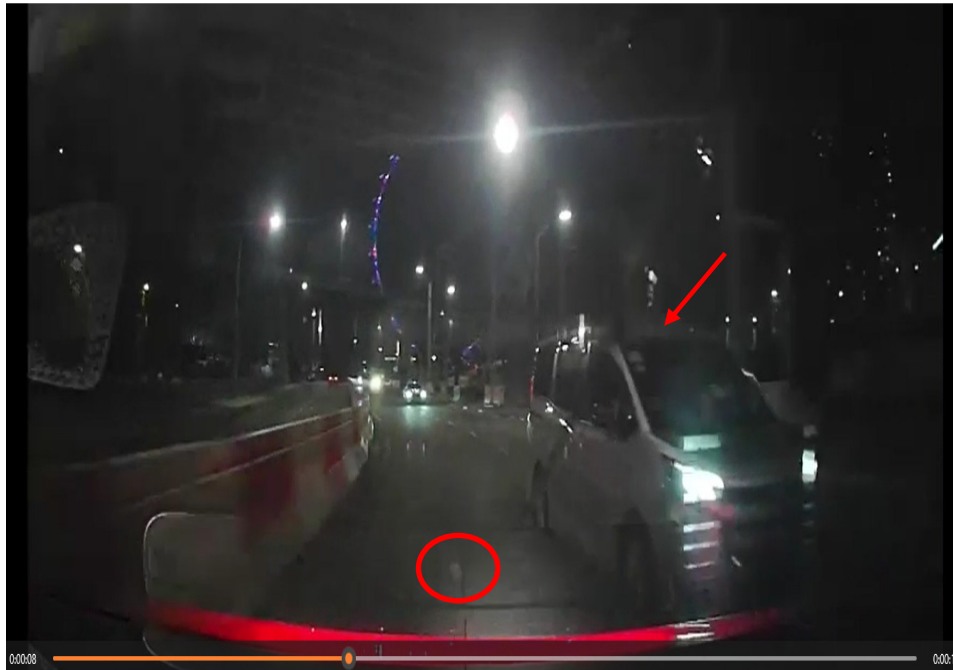
Screenshot 2 of the video recording from the video recording device that was mounted onto the rear windscreen of the BYD shows at the 8 second mark, we had noted a slight movement (jerk- like movement) of the BYD. This was when the Toyota was encroaching into the 1st lane (arrowed). We also noticed an object falling to the ground after this jerk- like movement which was most likely the right side mirror cover of the Toyota (circled). The capturing of this slight movement is a sign that there was jerk- like movement to the BYD itself. Ultimately, indicating that there was contact between the left rear portion of the BYD and the right front portion of the Toyota. However one would have to view the recording to see this slight movement.

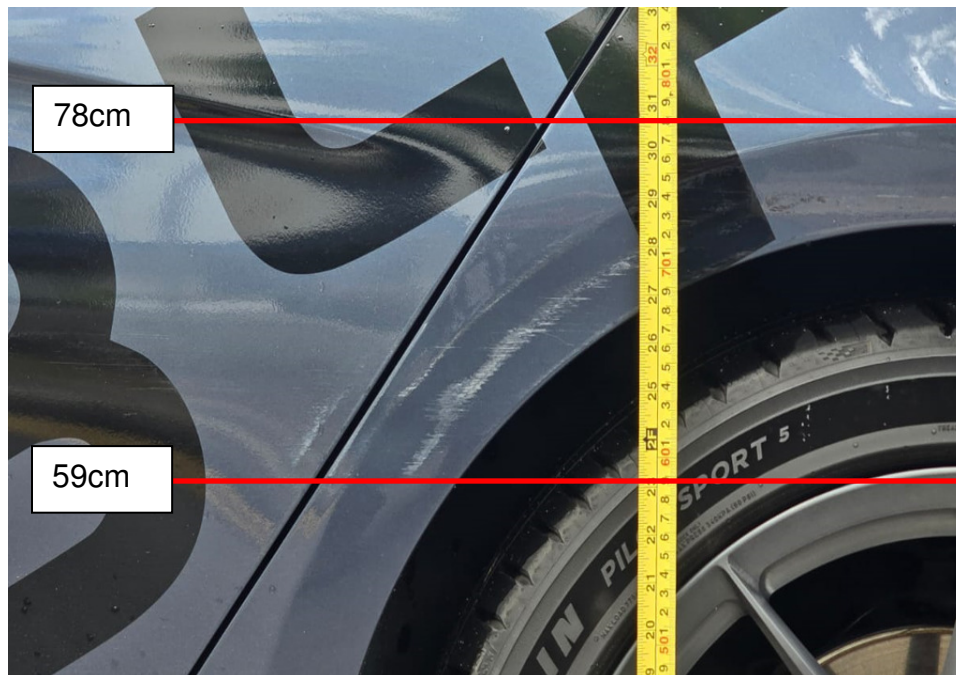
Photo 15 shows the height measurement being conducted on the left rear portion of the BYD. The horizontal paint graze marks observed on the left rear fender of the BYD were measured to be between 59cm and 78cm above ground level.

- a) The horizontal paint graze marks observed on the left rear fender of the BYD were measured to be between 59cm and 78cm above ground level;
- b) the horizontal graze marks observed on the left rear door trim of the BYD were measured to be between 114cm and 119cm above ground level;

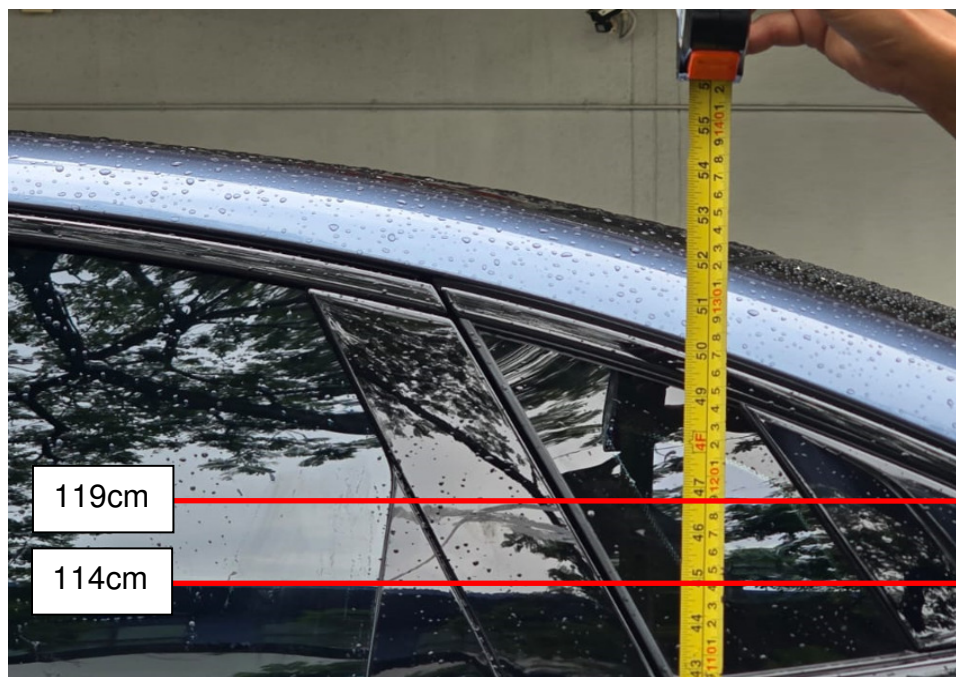
Photo 16 shows the height measurement being conducted on the left rear portion of the BYD. The horizontal graze marks observed on the left rear door trim of the BYD were measured to be between 114cm and 119cm above ground level.

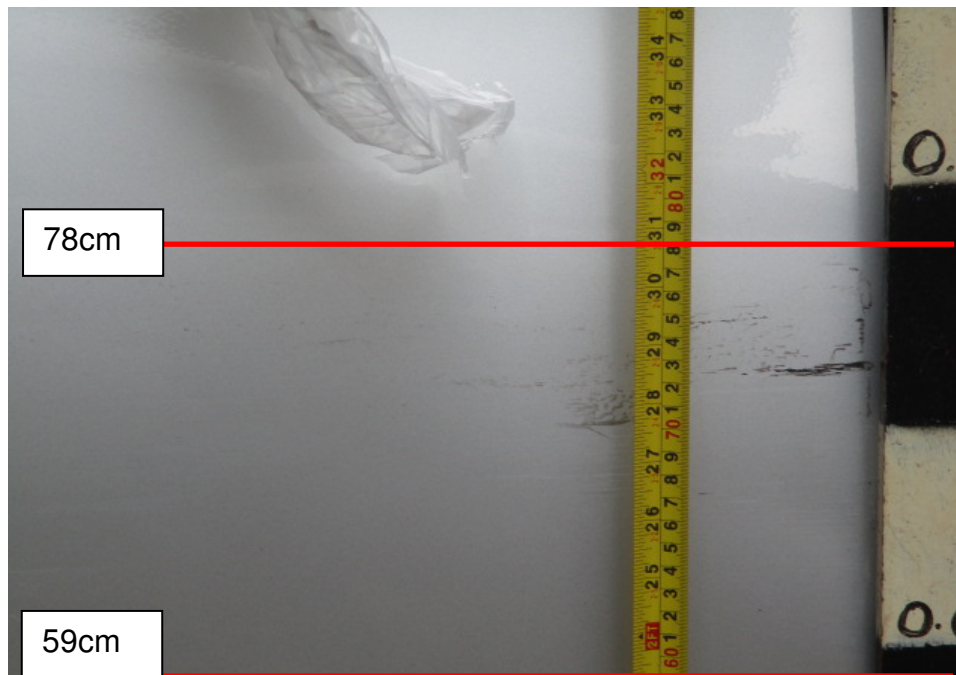
Photo 17 shows the height measurement being conducted on the right front door of the Toyota. The body part at the height range of between 59cm to 78cm above ground level was the centre portion of the right front door where the horizontal paint graze marks were found.

- c) the body part at the height range of between 59cm to 78cm above ground level was the centre portion of the right front door of the Toyota where the horizontal paint graze marks were found;

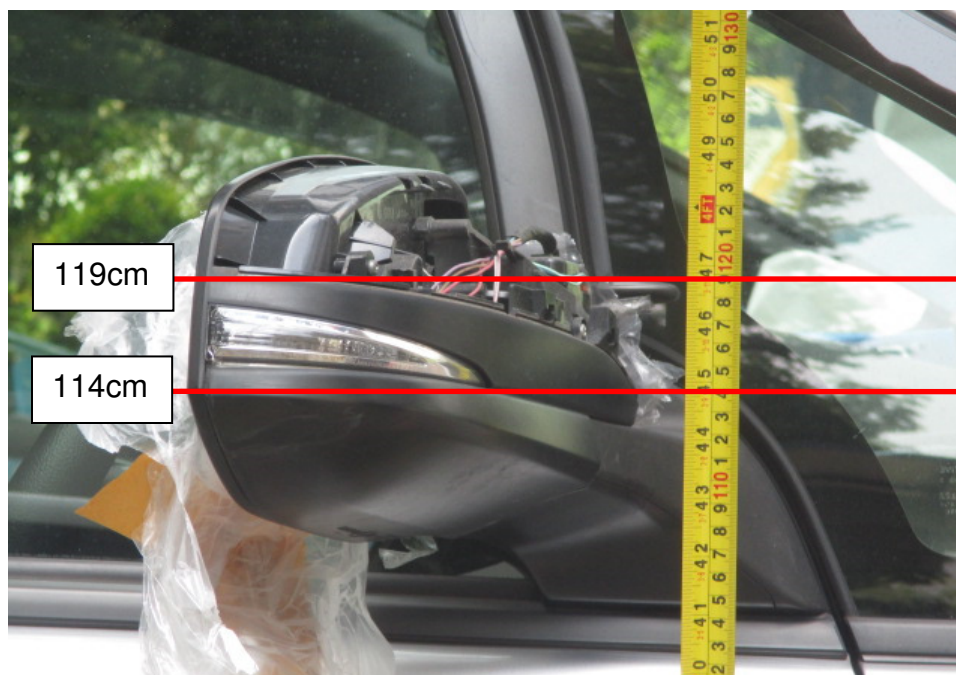
Photo 18 shows the height measurement being conducted on the right side mirror of the Toyota. The body part at the height range of between 114cm to 119cm above ground level was the centre portion of the right side mirror where the horizontal graze marks were found.

- d) the body part at the height range of between 114cm to 119cm above ground level was the centre portion of the right side mirror of the Toyota where the horizontal graze marks were found;
