## Vehicle Survey Report

| <b>Insurer:</b> | <b>Direct Asia Insurance (Singapore) Pte. Ltd.</b> | <b>Claim Number:</b> | 137345/FA |
| <b>Vehicle No:</b> | SLU 2336R | <b>Vehicle Make &amp; Model:</b> | Toyota Corolla Axio Hybrid 1.5 CVT |

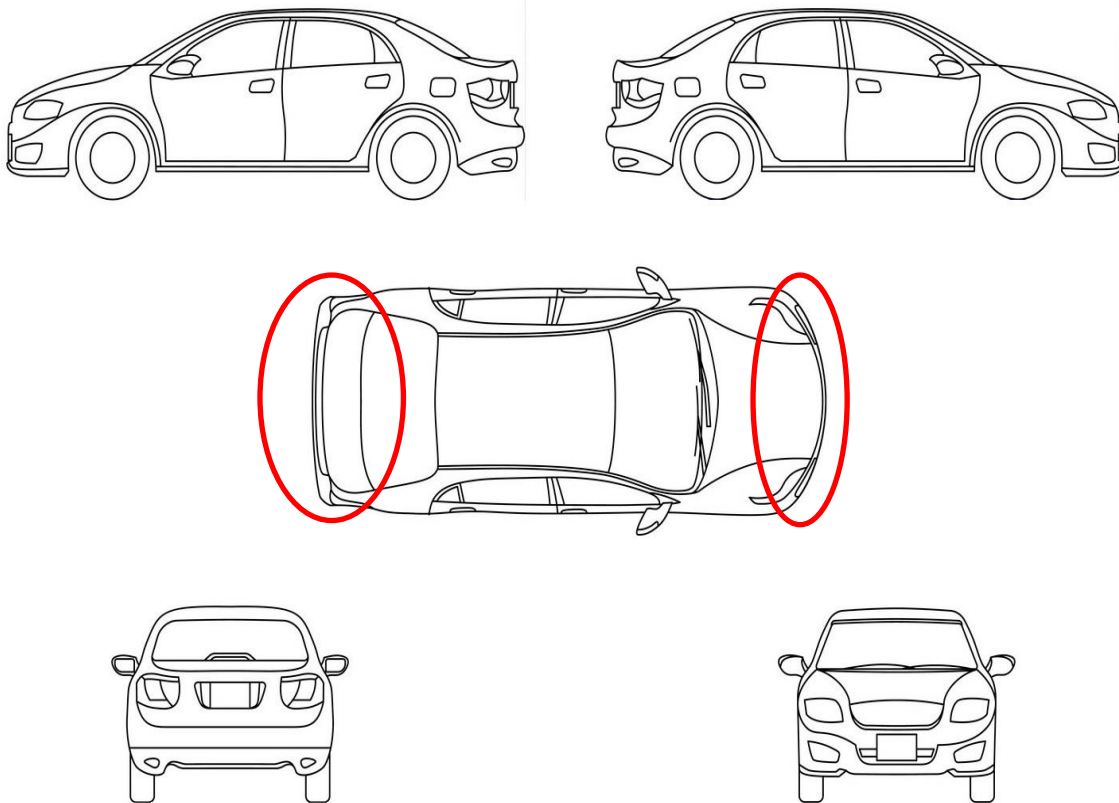
The vehicle sustained damage on the front and rear portions.

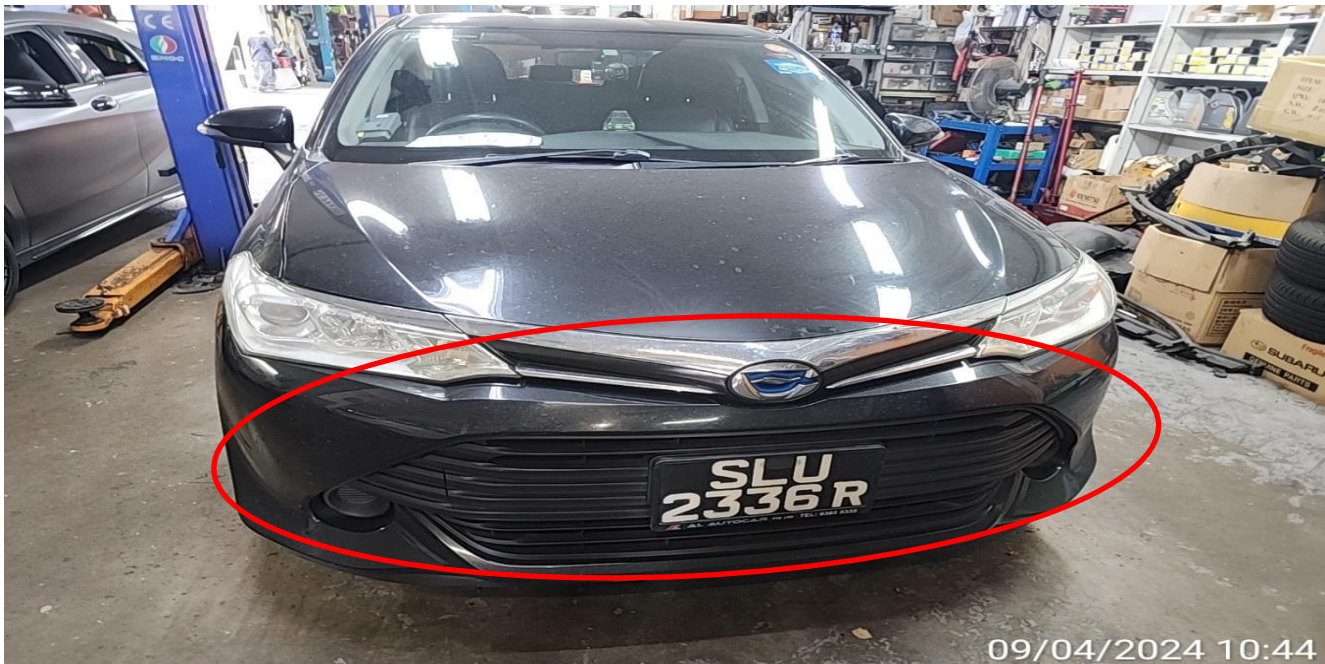
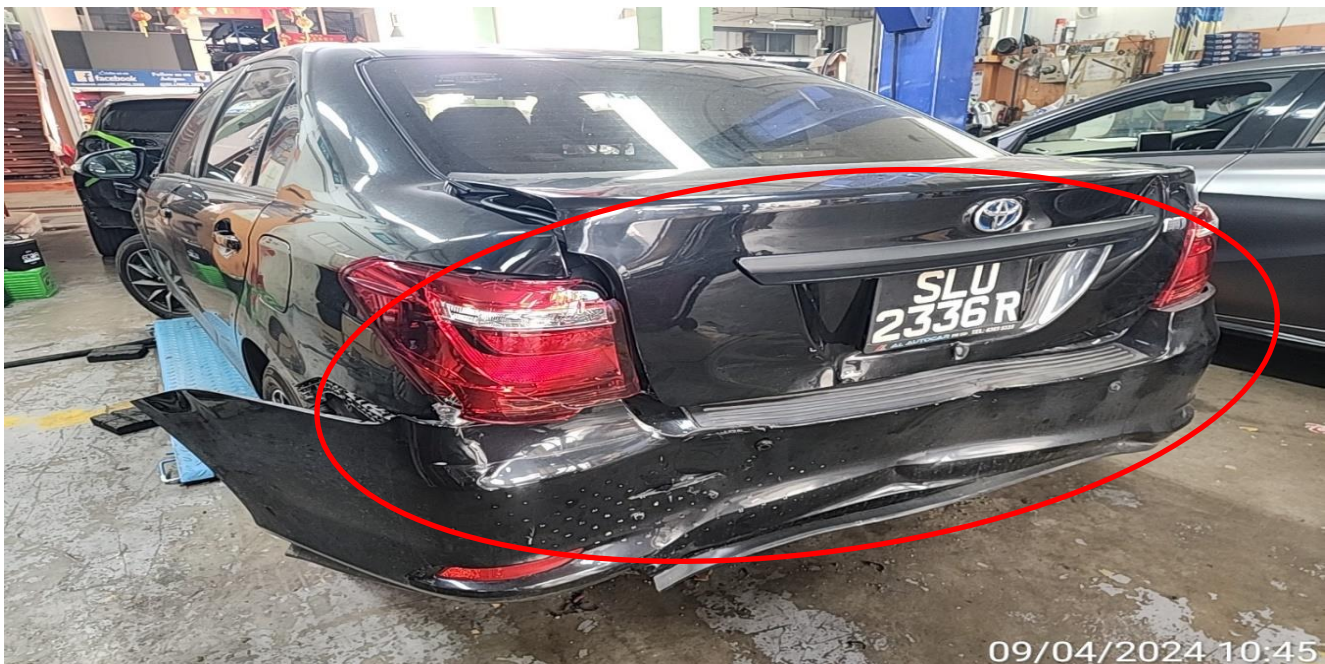
ACCIDENT AREA

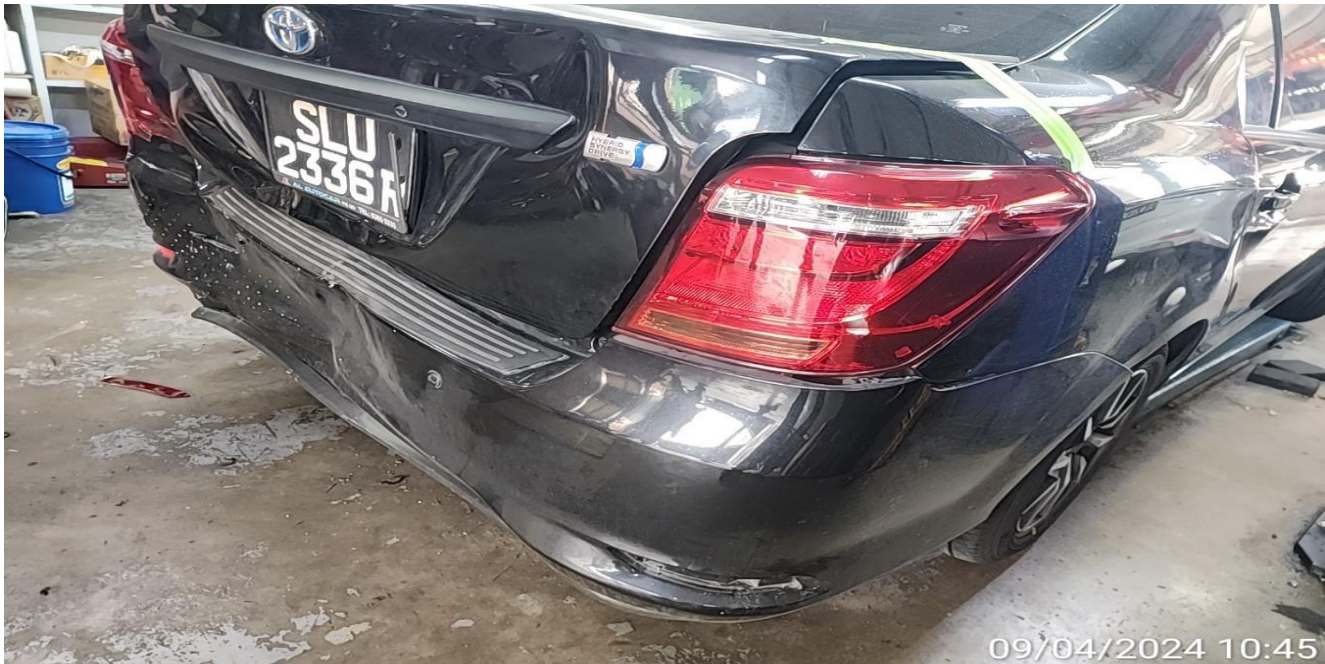
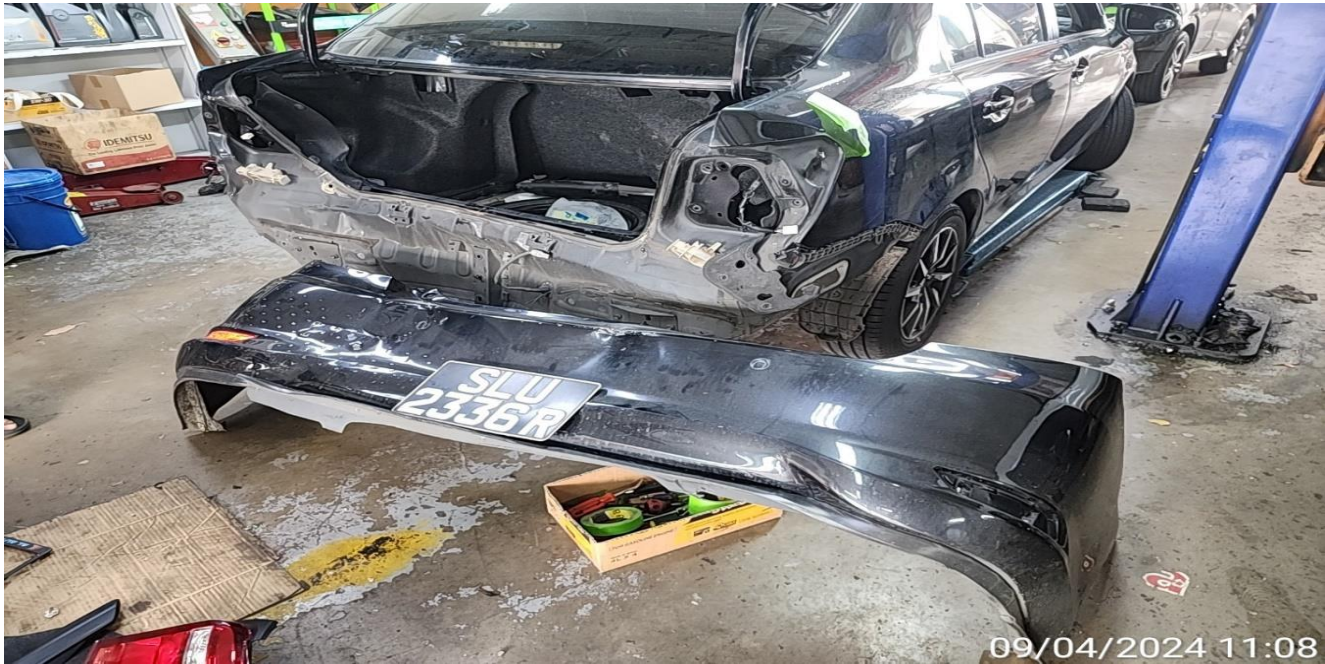
REAR BUMPER DEFORMED

| No. | Qty | Description of Parts | Condition | Our Recommendation<br>S\$ |
|---|---|---|---|---|
| 8 | 1 | Rear bumper | Deformed | 684.00 |

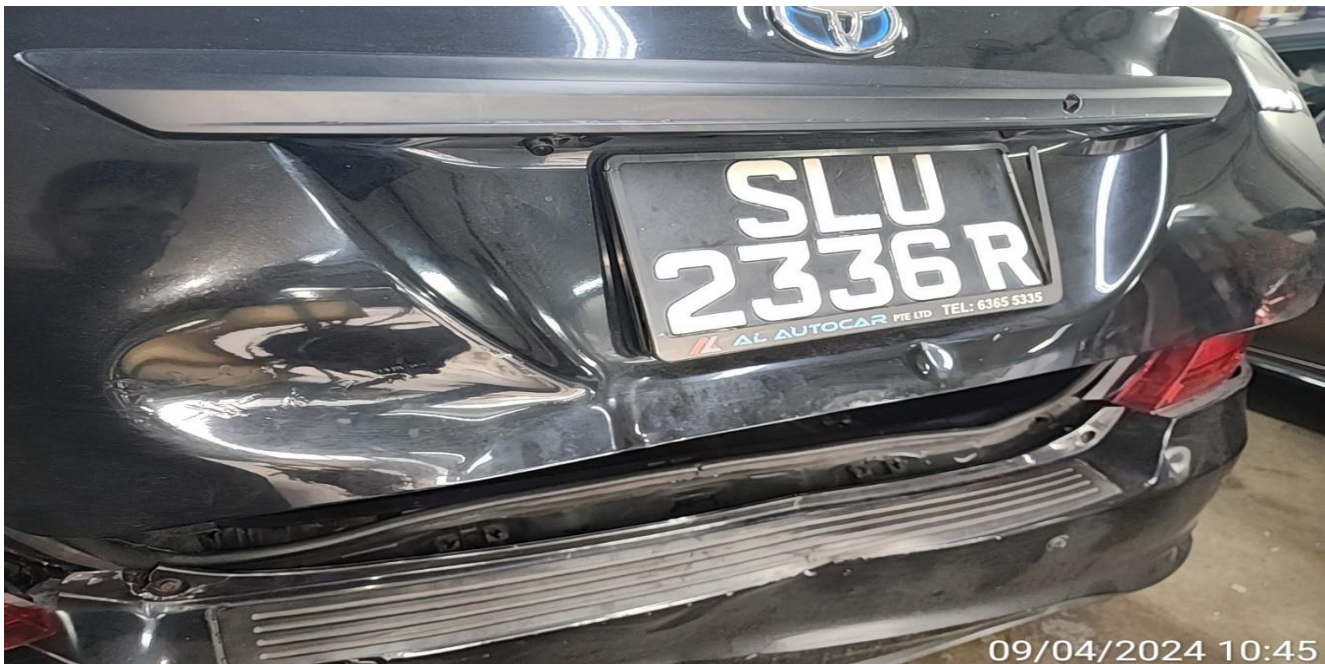
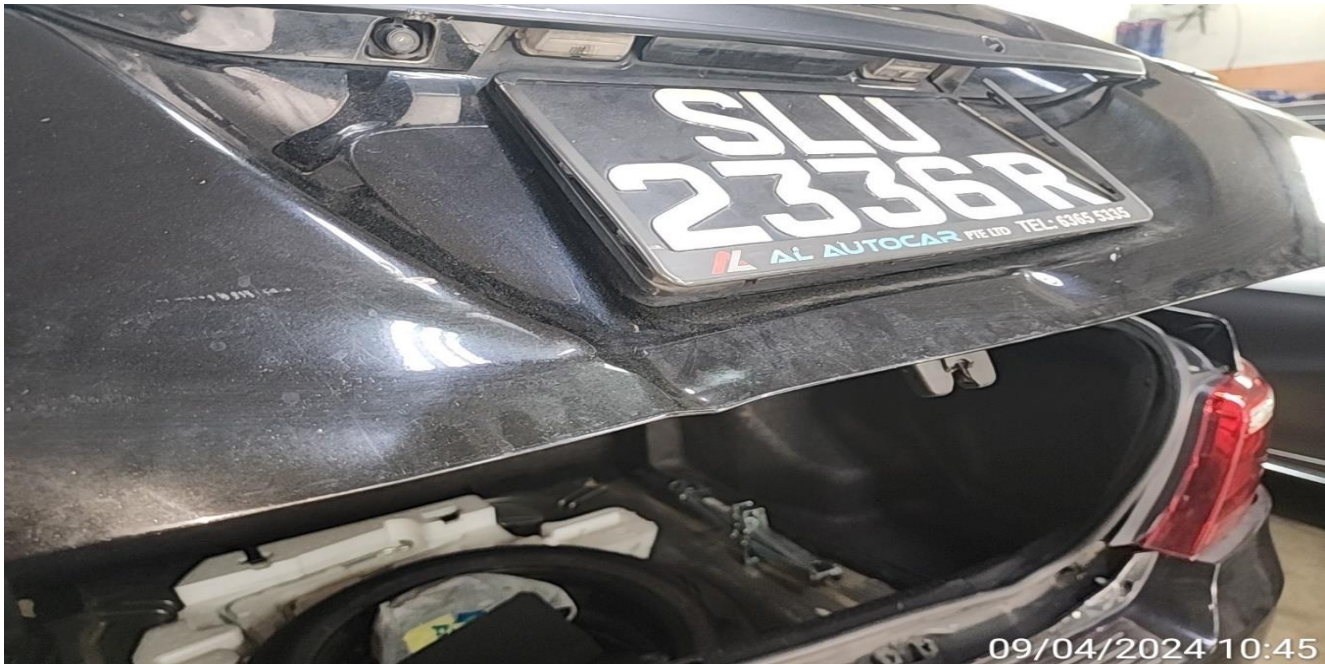
BOOTLID BUCKLED

| No. | Qty | Description of Parts | Condition | Our Recommendation<br>S\$ |
|---|---|---|---|---|
| 1 | 1 | Bootlid | Buckled | 1,075.00 |

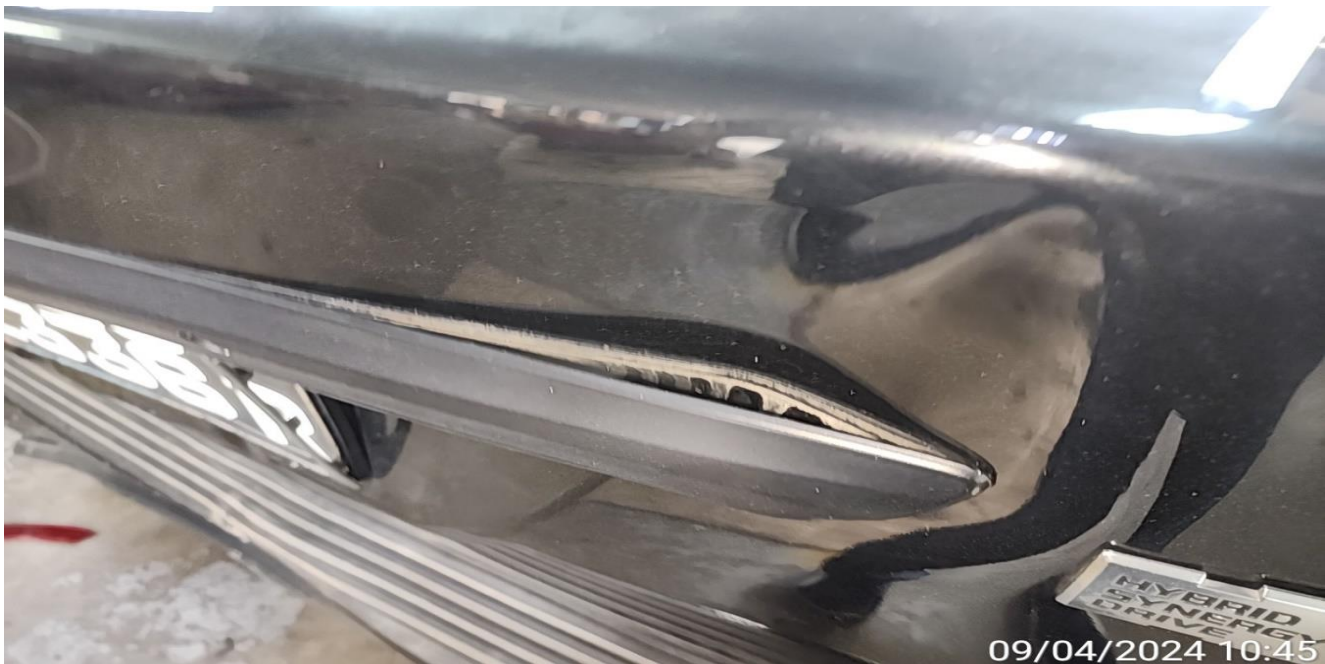
BOOTLID OUTER CHROME GARNISH CRACKED

| No. | Qty | Description of Parts | Condition | Our Recommendation<br>S\$ |
|---|---|---|---|---|
| 2 | 1 | Bootlid outer chrome garnish | Cracked | 385.00 |

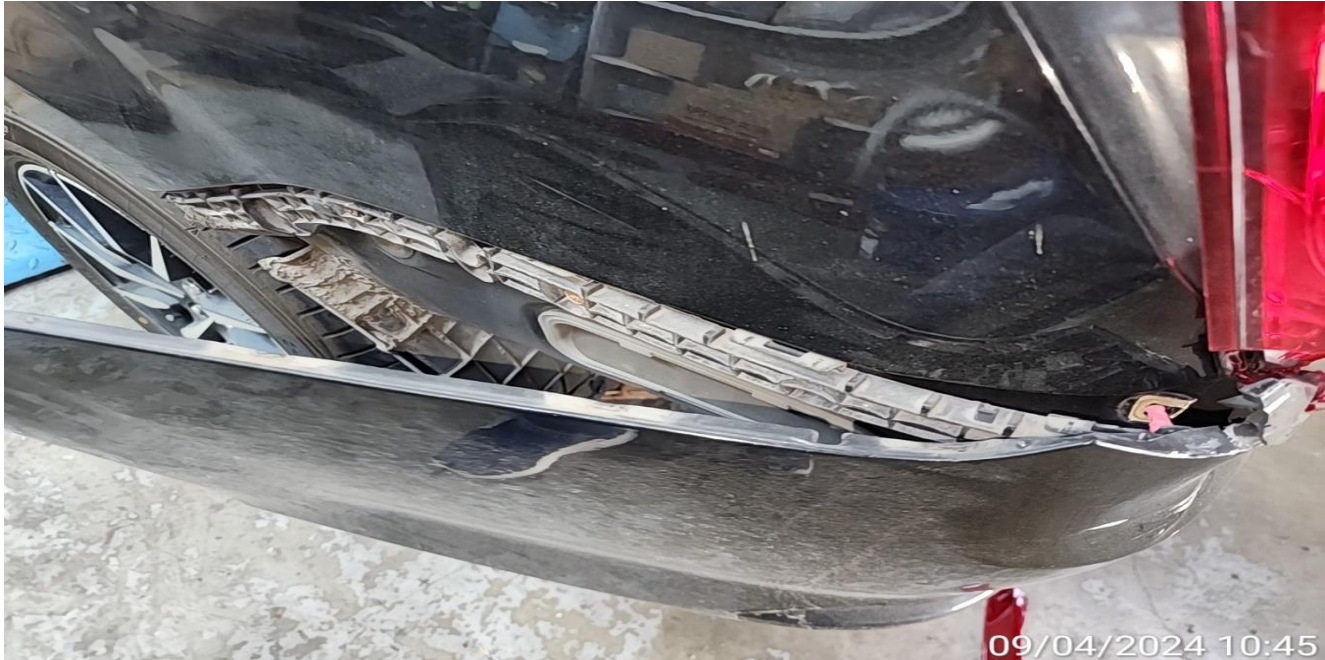
REAR BUMPER SIDE RETAINER CRACKED

| No. | Qty | Description of Parts | Condition | Our Recommendation<br>S\$ |
|---|---|---|---|---|
| 9 | 2 | Rear bumper side retainer | Cracked | 195.00 |

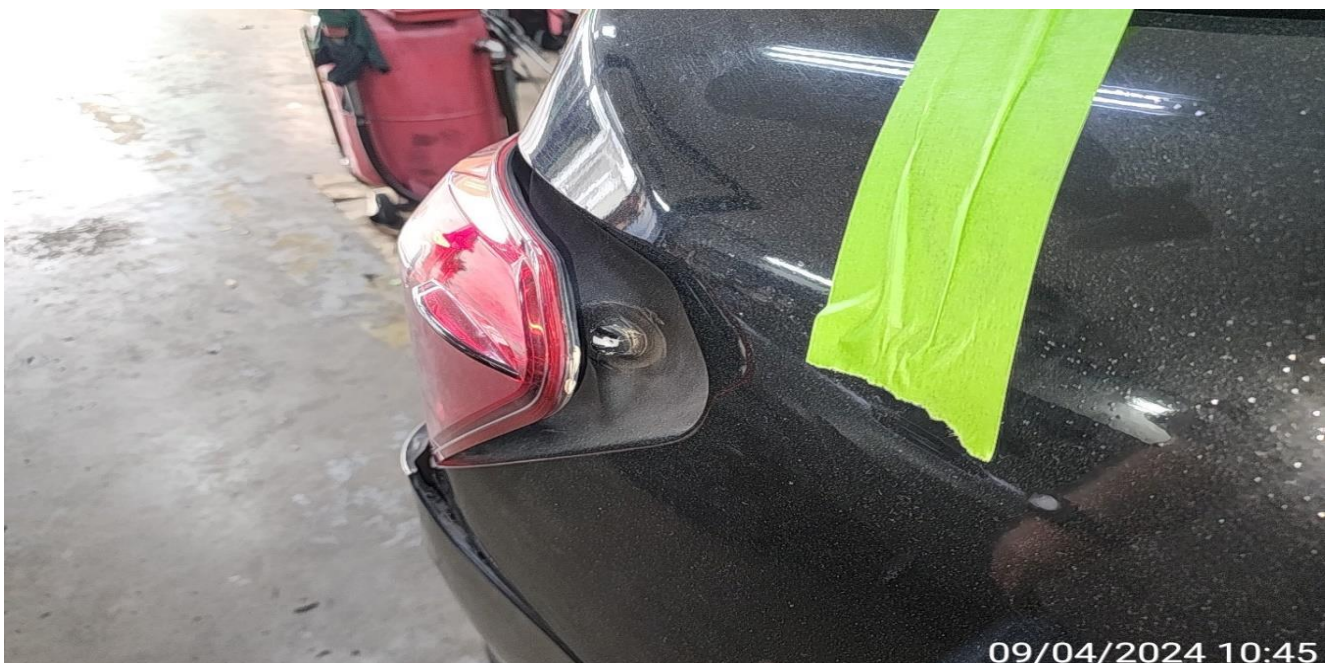
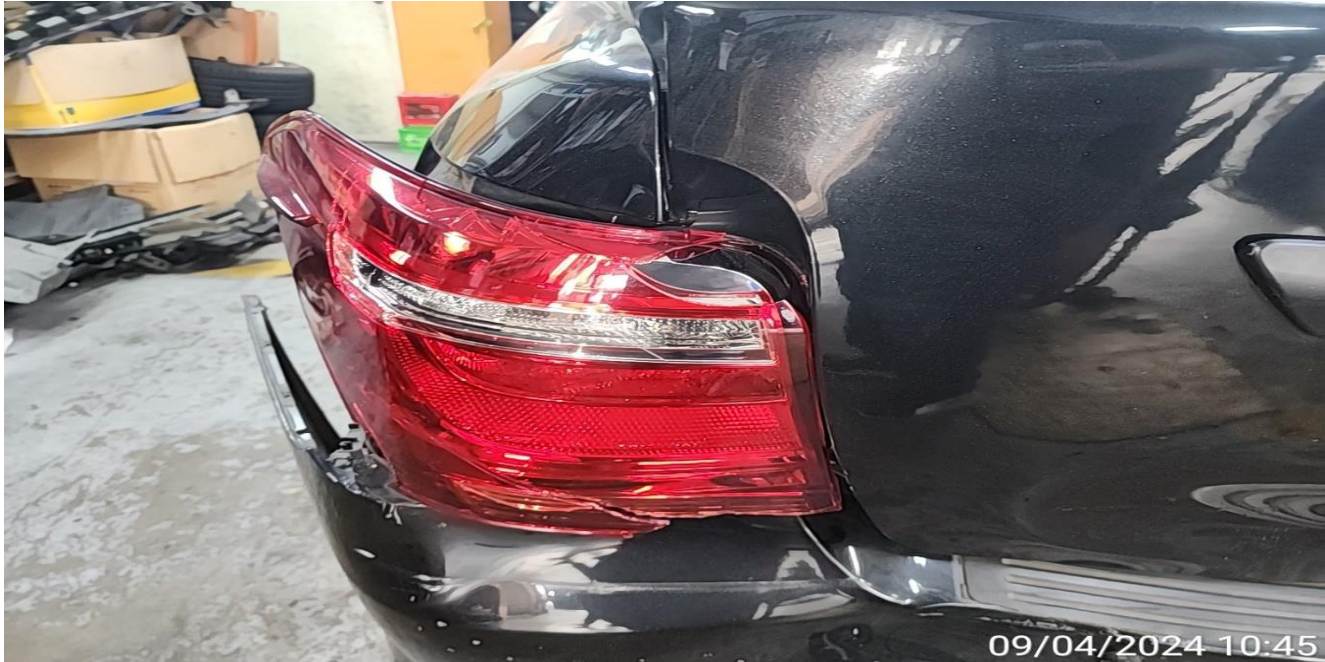
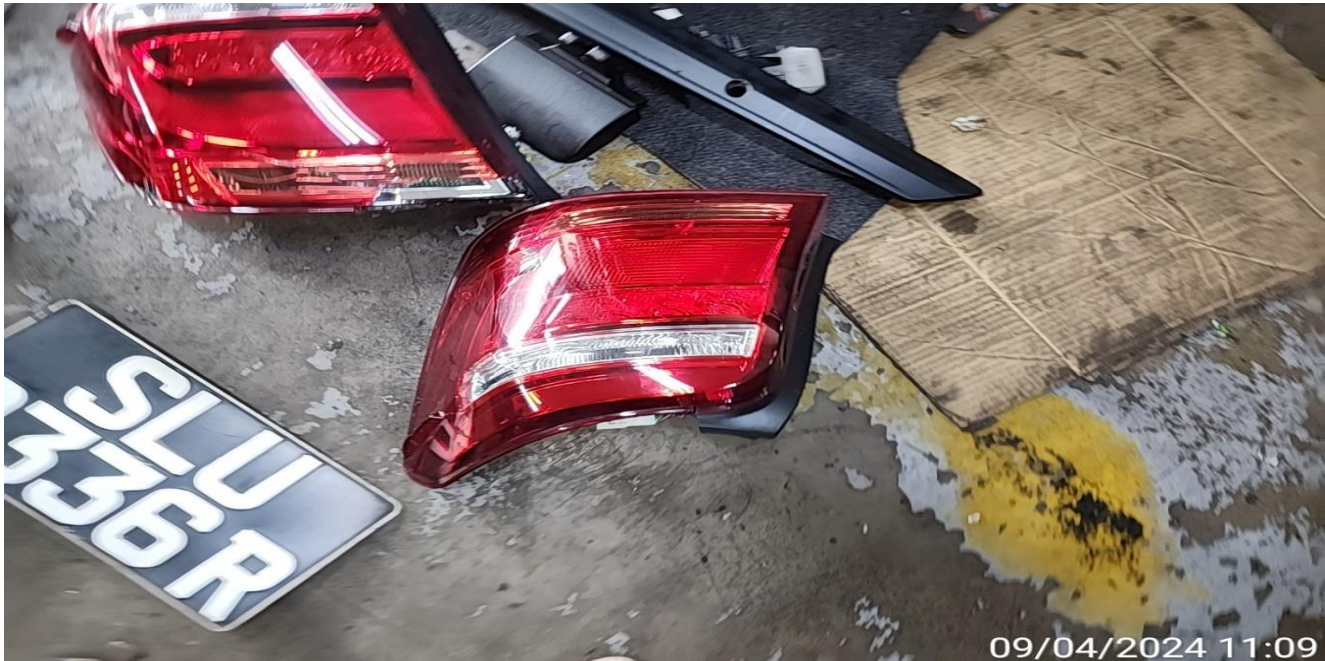
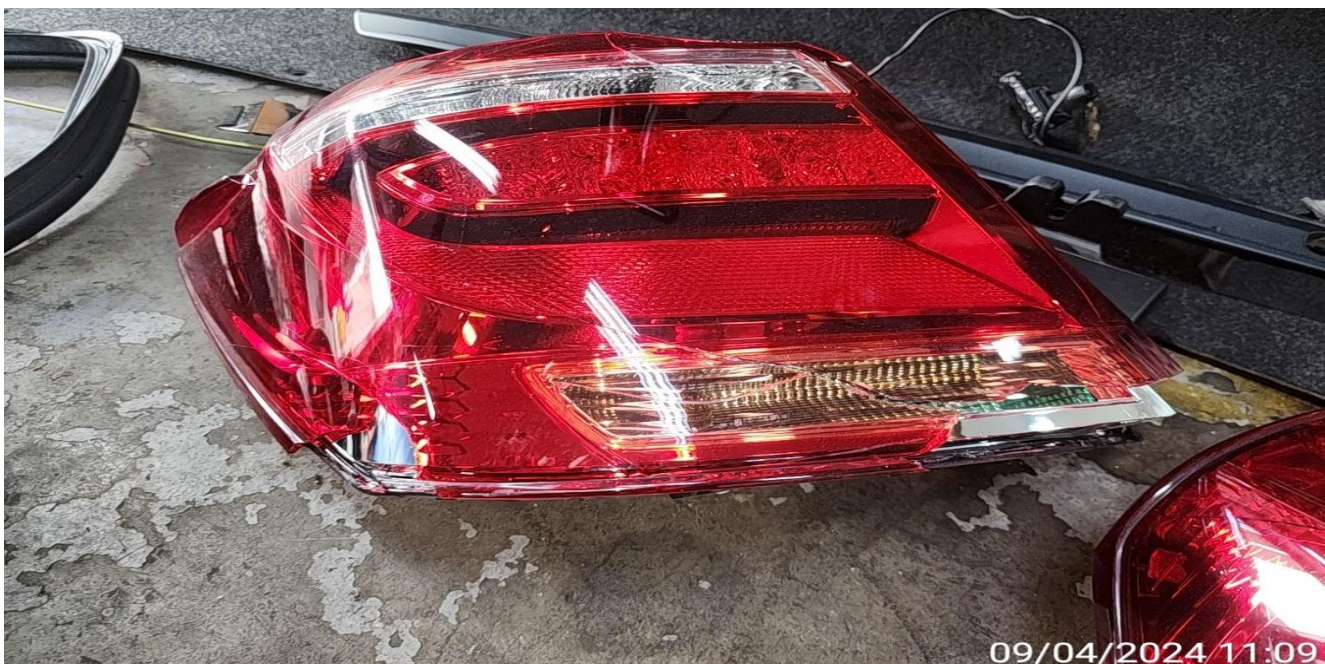
TAILLAMP CRACKED

| No. | Qty | Description of Parts | Condition | Our Recommendation<br>S\$ |
|---|---|---|---|---|
| 6 | 2 | Taillamp | Cracked | 1,544.00 |

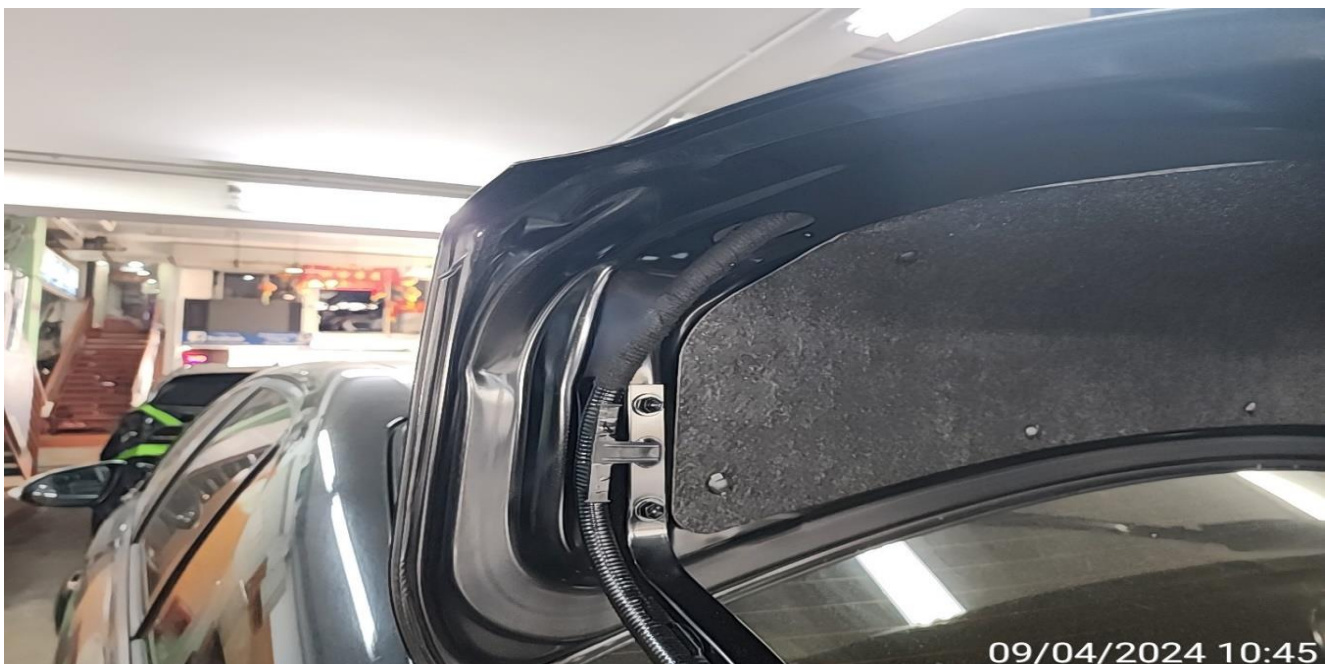
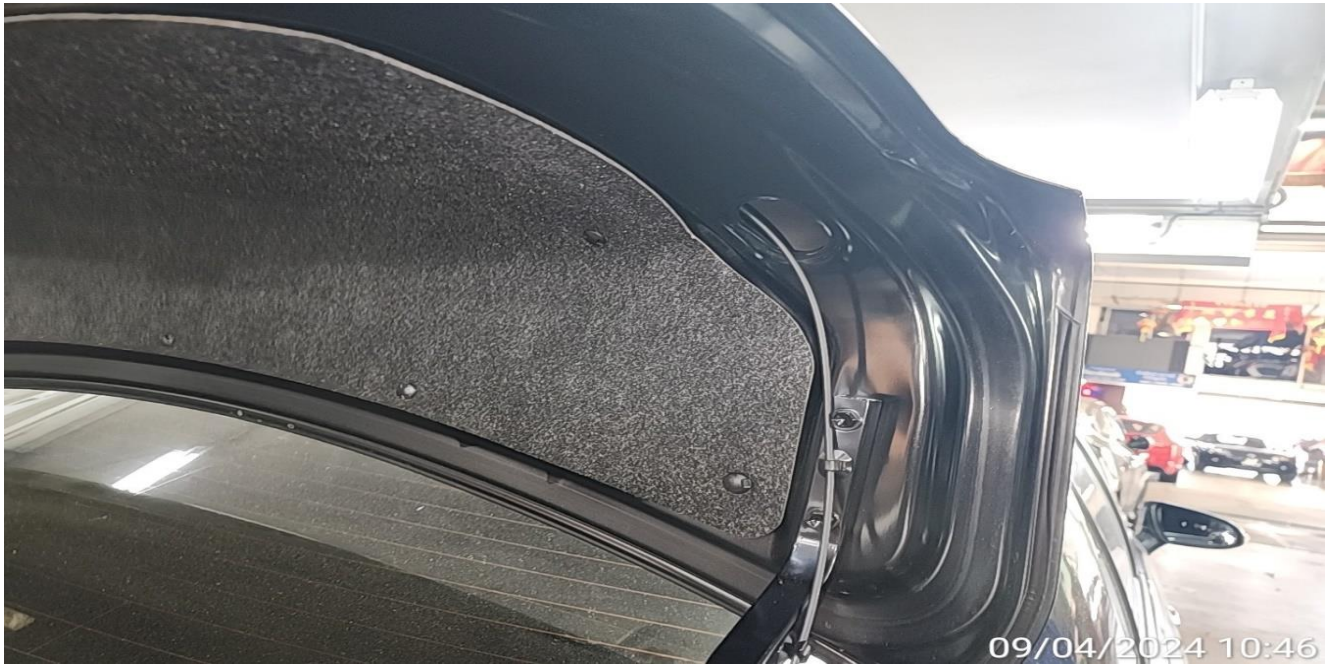
BOOTLID HINGE BENT

| No. | Qty | Description of Parts | Condition | Our Recommendation<br>S\$ |
|---|---|---|---|---|
| 5 | 2 | Bootlid hinges | Bent | 253.00 |

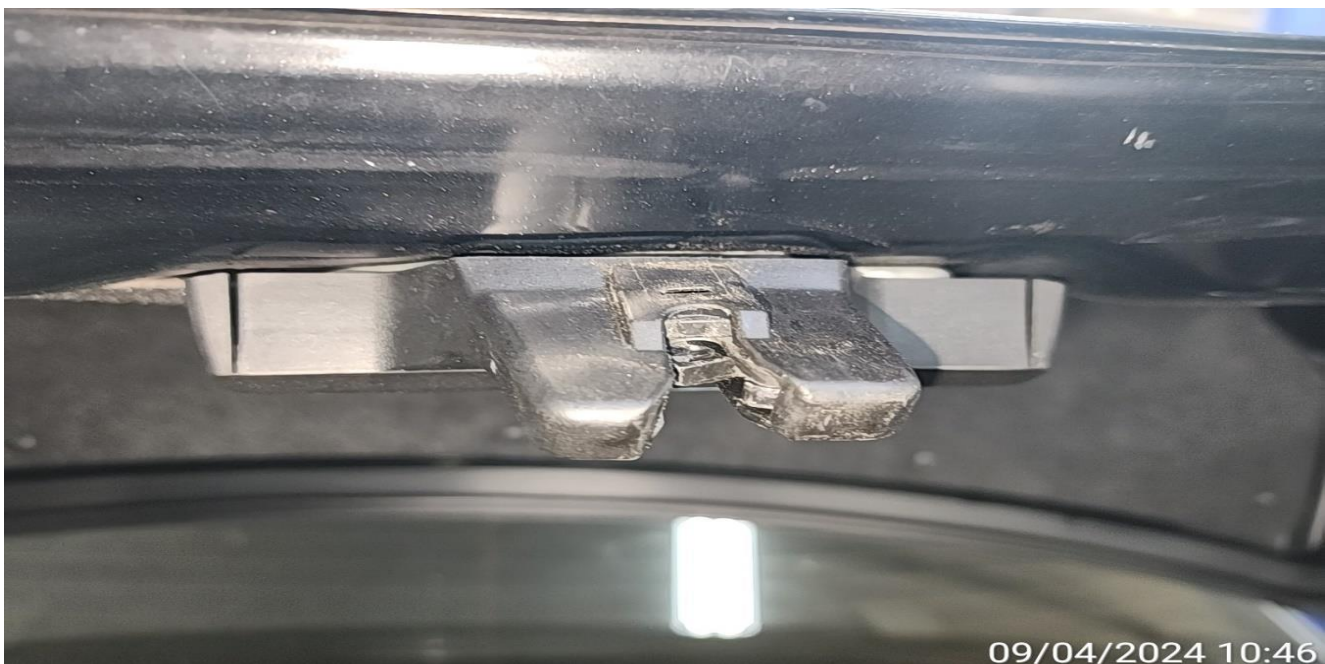
BOOTLID LOCK DISTORTED

| No. | Qty | Description of Parts | Condition | Our Recommendation<br>S\$ |
|---|---|---|---|---|
| 3 | 1 | Bootlid lock | Distorted | 190.00 |

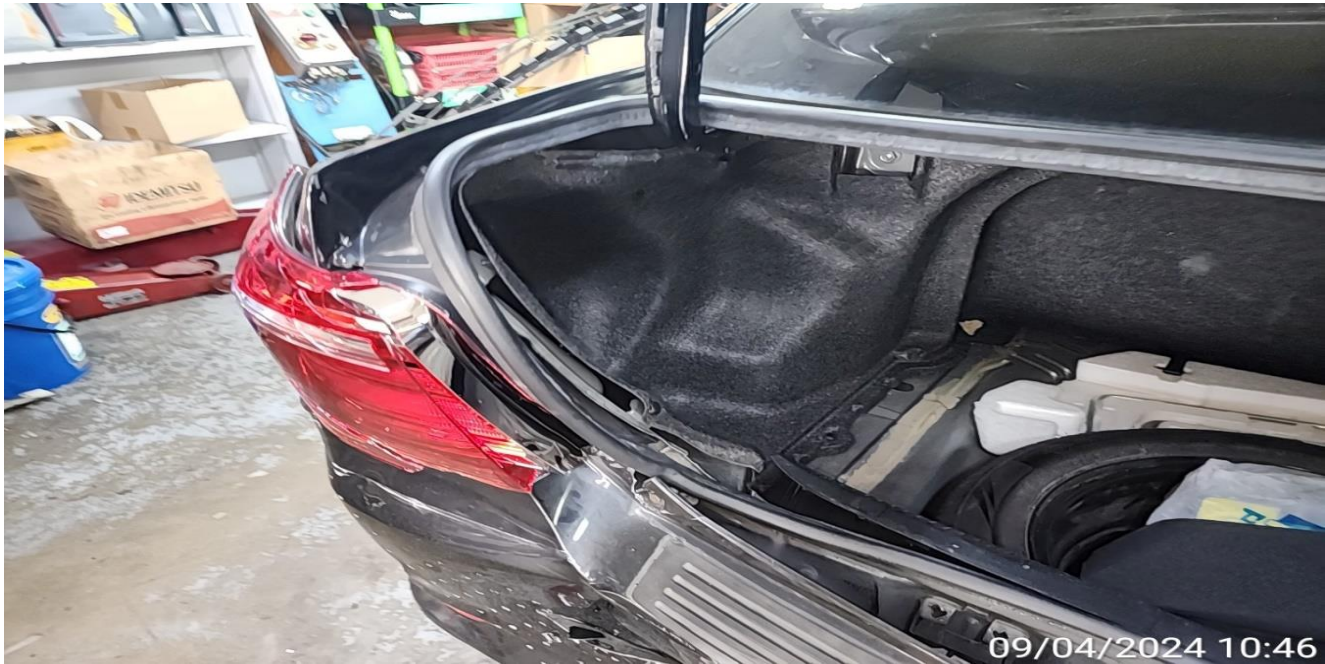
BOOTLID WEATHERSTRIP CUT

| No. | Qty | Description of Parts | Condition | Our Recommendation<br>S\$ |
|---|---|---|---|---|
| 4 | 1 | Bootlid weatherstrip | Cut | 187.00 |

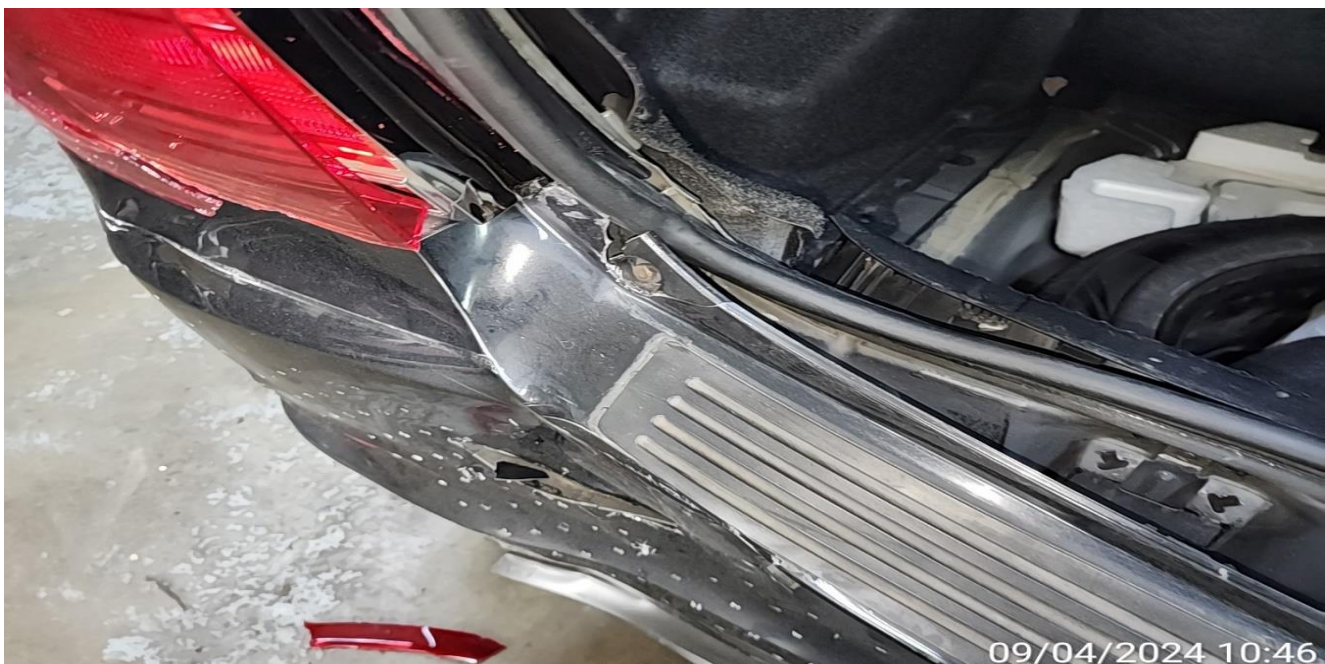
REAR BUMPER RUBBER MAT DEFORMED

| 1 | 1 | Rear bumper black mat | Deformed | 50.00 |

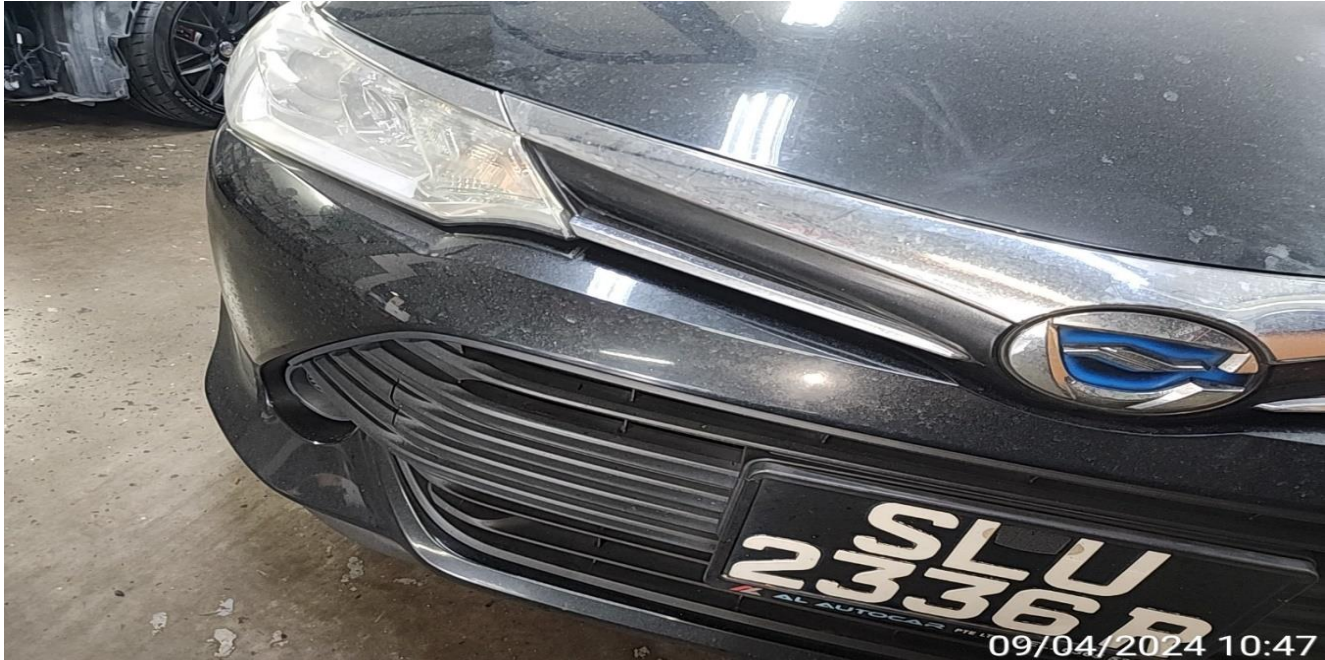
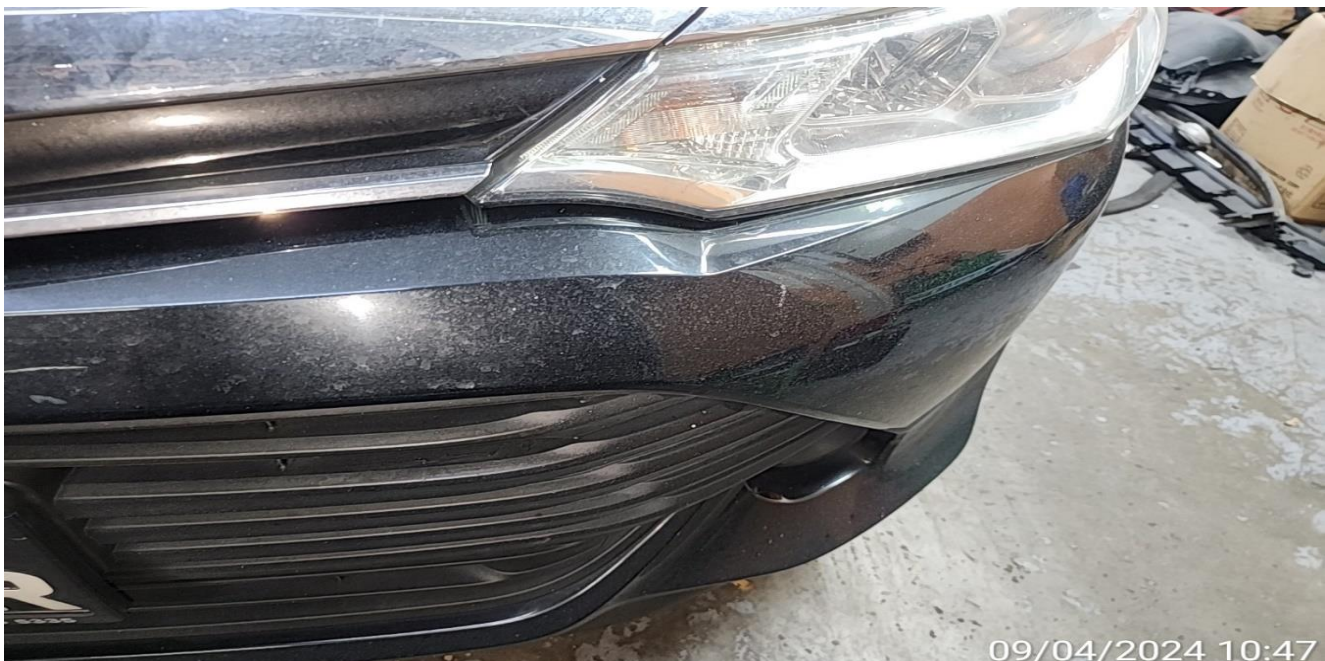
FRONT BUMPER REPAIR

| No. | Qty | Description of Parts | Condition | Our Recommendation<br>S\$ |
|---|---|---|---|---|
| 15 | 1 | Front bumper | Repair | -- |

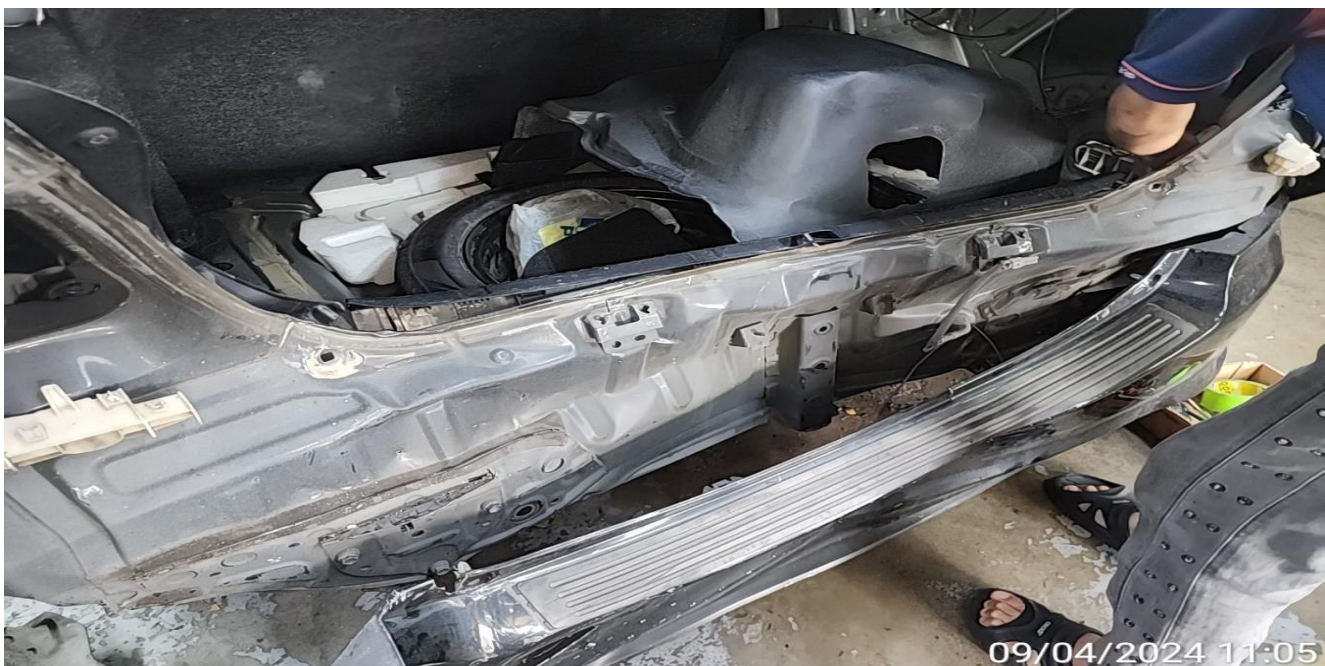
REAR END PANEL BUCKLED

| No. | Qty | Description of Parts | Condition | Our Recommendation<br>S\$ |
|---|---|---|---|---|
| 12 | 1 | Rear end panel | Buckled | 798.00 |

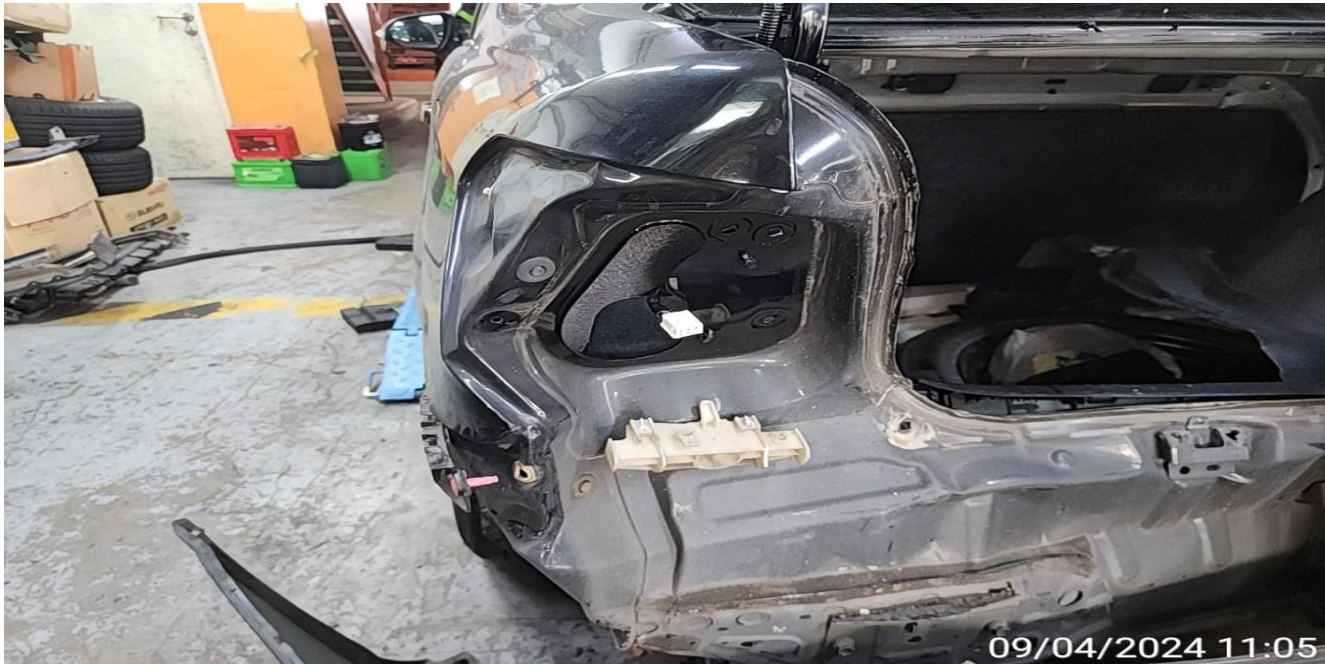
TAILLAMP PANEL LH BUCKLED

| No. | Qty | Description of Parts | Condition | Our Recommendation<br>S\$ |
|---|---|---|---|---|
| 14 | 1 | Taillamp panel LH | Buckled | 220.00 |

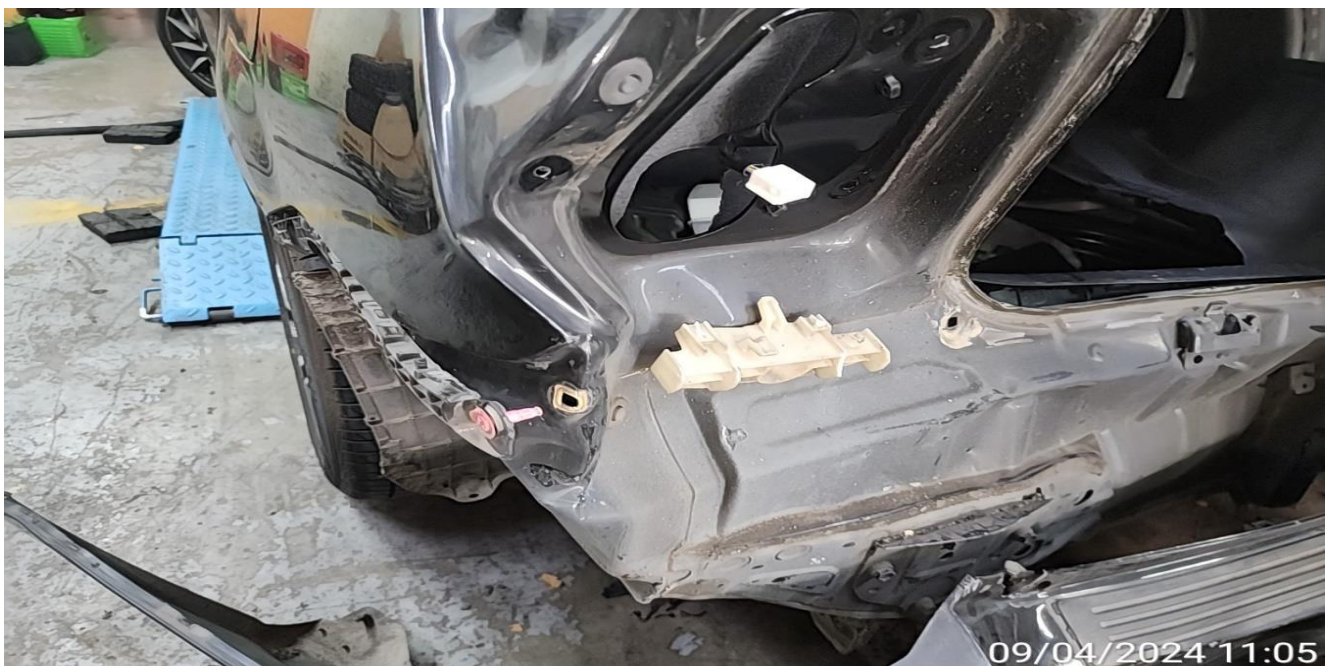
REAR FENDER LH REPAIR

| No. | Qty | Description of Parts | Condition | Our Recommendation<br>S\$ |
|---|---|---|---|---|
| 7 | 1 | Rear fender LH | Repair | -- |

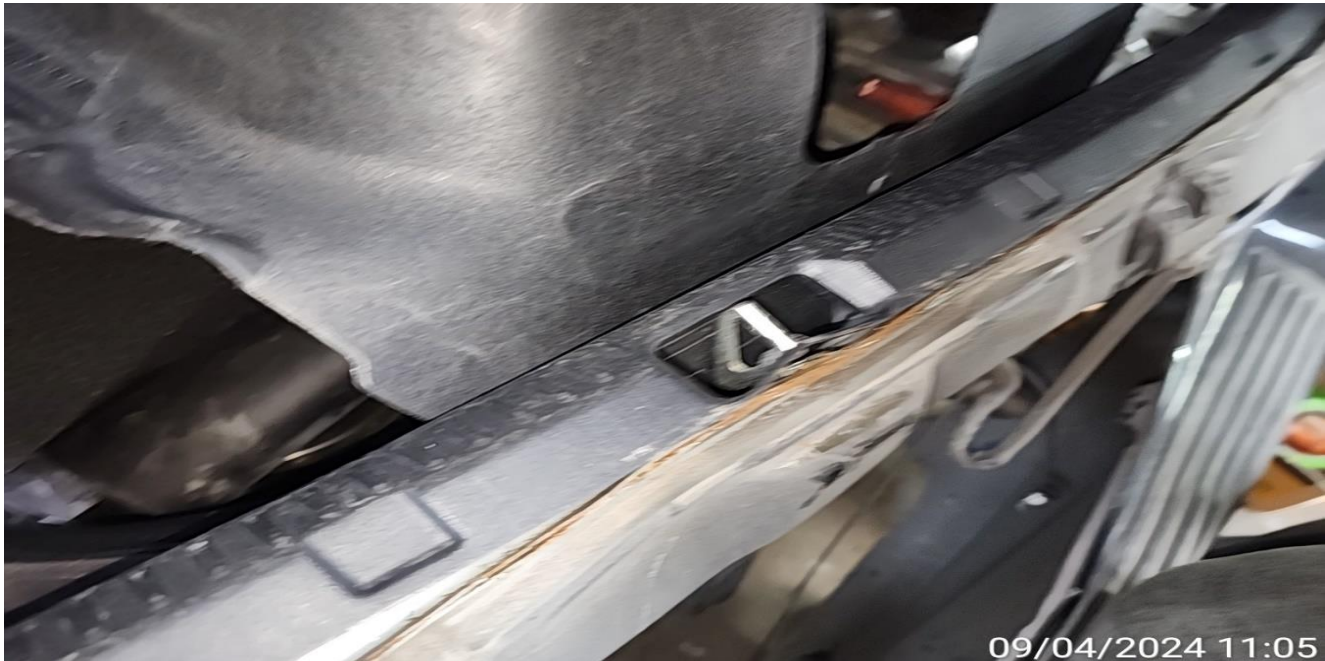
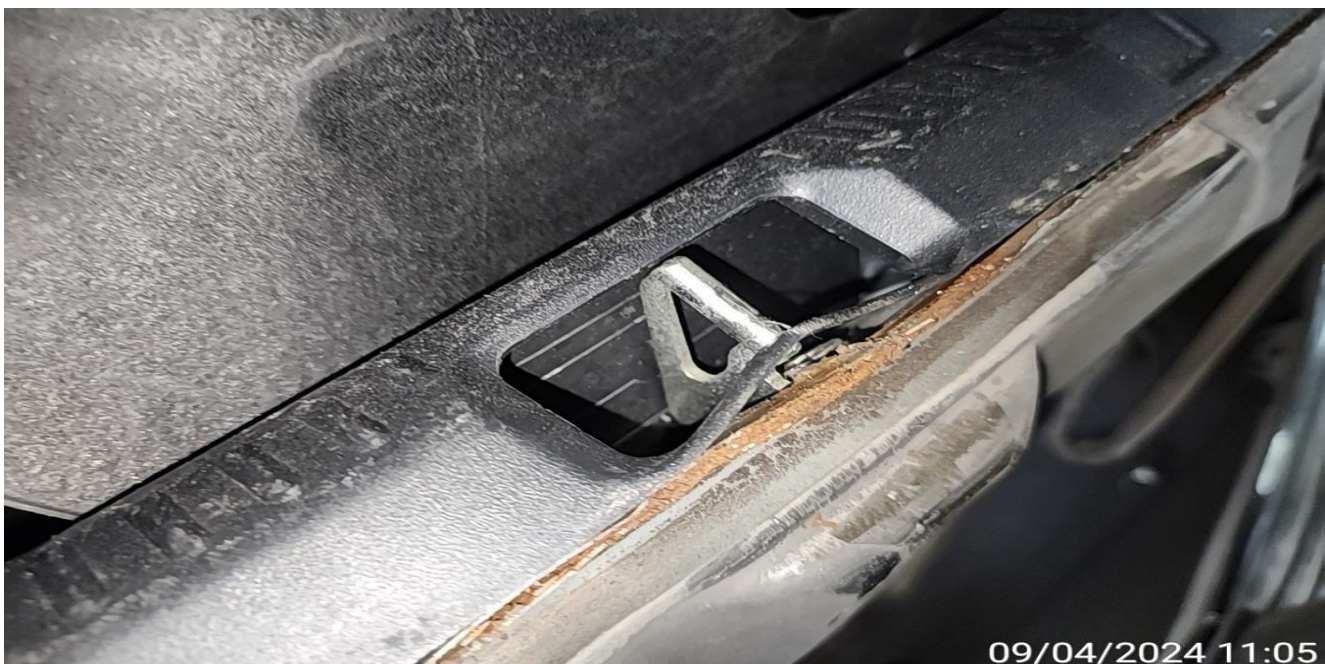
REAR END PANEL INNER TRIM DEFORMED

| No. | Qty | Description of Parts | Condition | Our Recommendation<br>S\$ |
|---|---|---|---|---|
| 13 | 1 | Rear end panel inner trim | Deformed | 295.00 |
