## Vehicle Survey Report

| <b>Insurer:</b> | <b>Direct Asia Insurance (Singapore) Pte. Ltd.</b> | <b>Claim Number:</b> | 137345/FA |
| <b>Vehicle No:</b> | SLU 2336R | <b>Vehicle Make &amp; Model:</b> | Toyota Corolla Axio Hybrid 1.5 CVT |

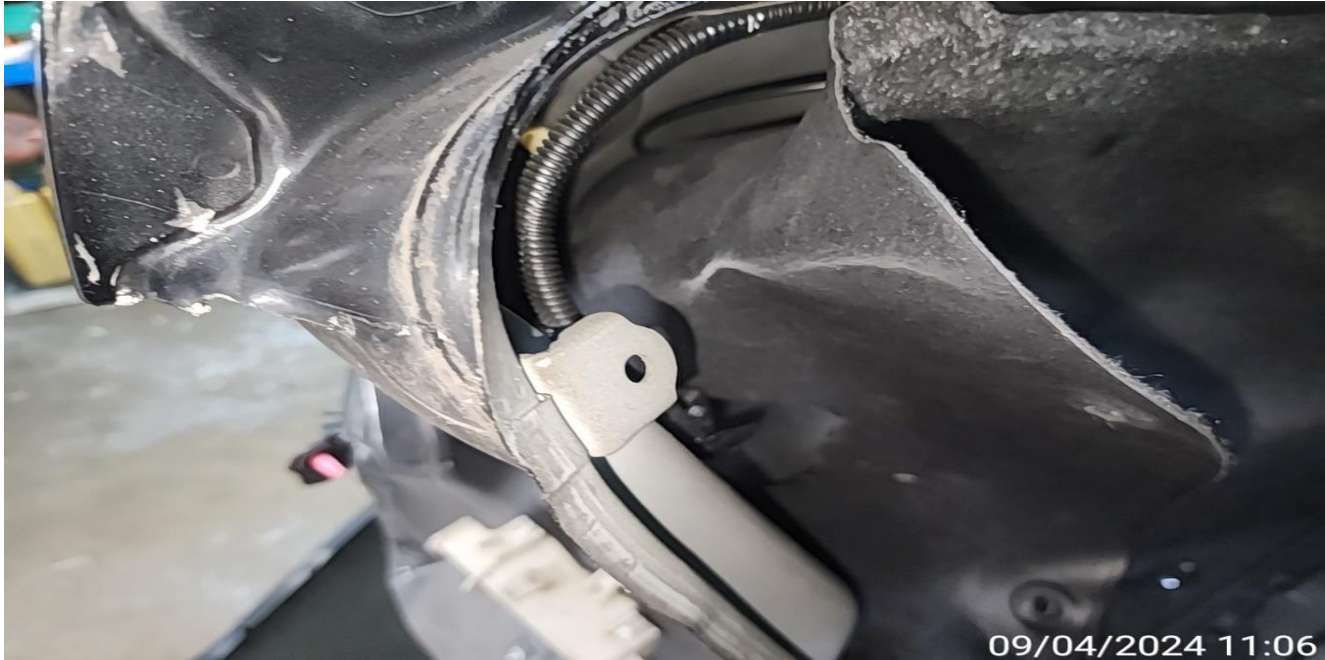
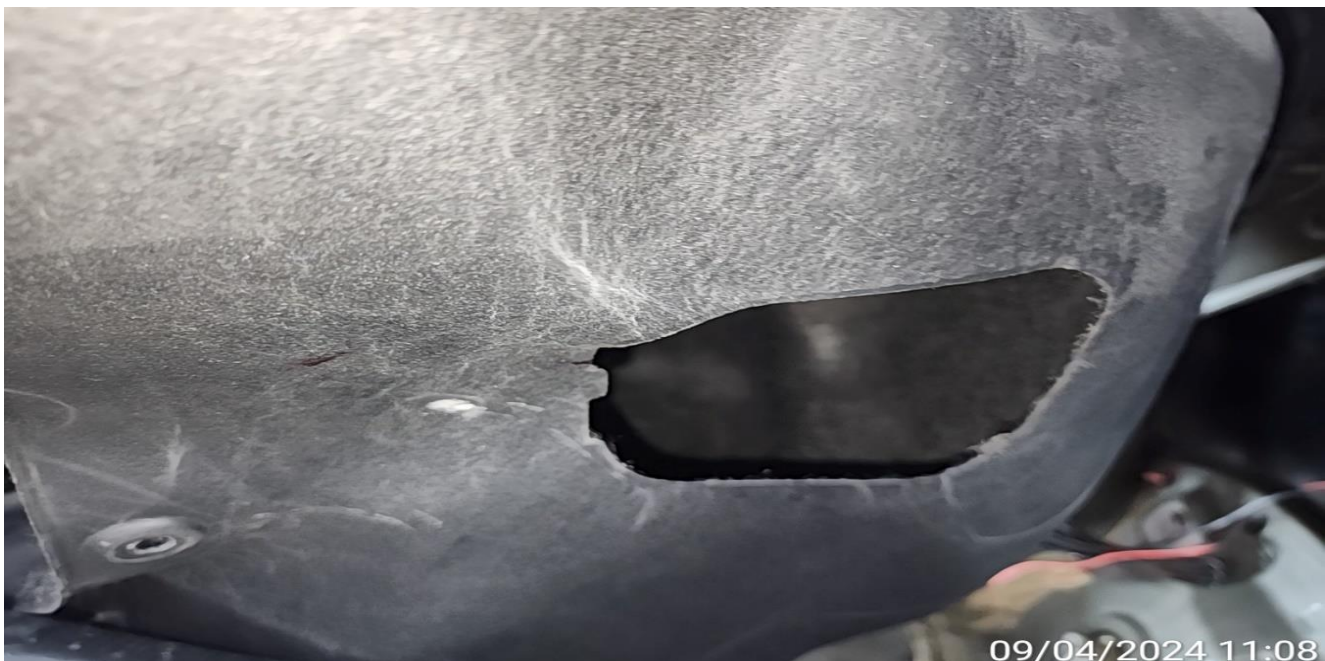
REAR FENDER INNER TRIM CRACKED

| No. | Qty | Description of Parts | Condition | Our Recommendation<br>S\$ |
|---|---|---|---|---|
| 11 | 1 | Rear fender inner trim LH | Cracked | 450.00 |

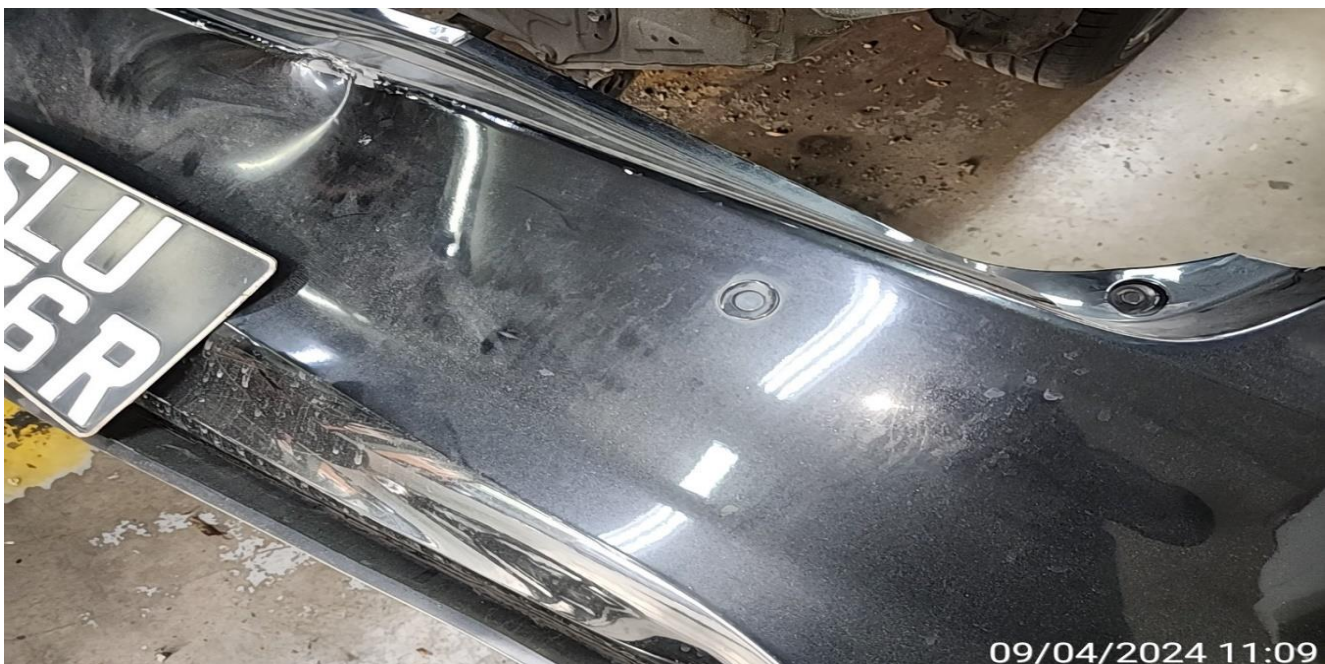
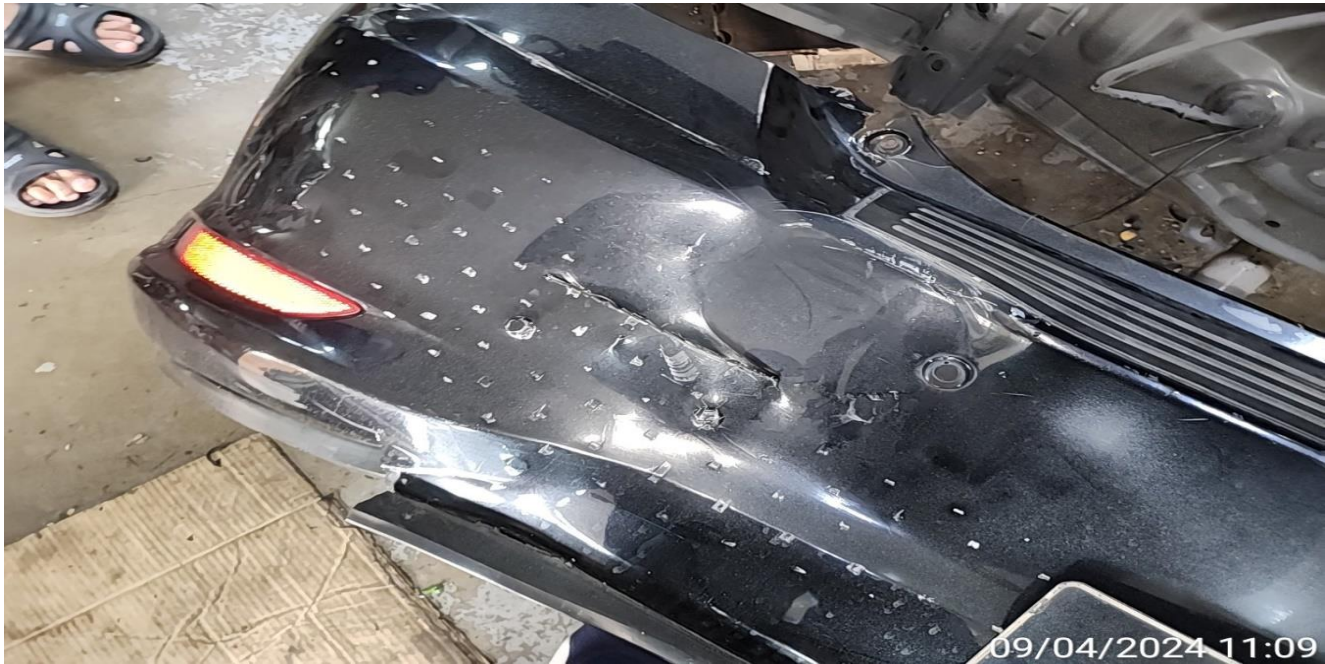
REAR REVERSE SENSOR DISTORTED

| 2 | 1 | Rear reverse sensor | Distorted | 200.00 |

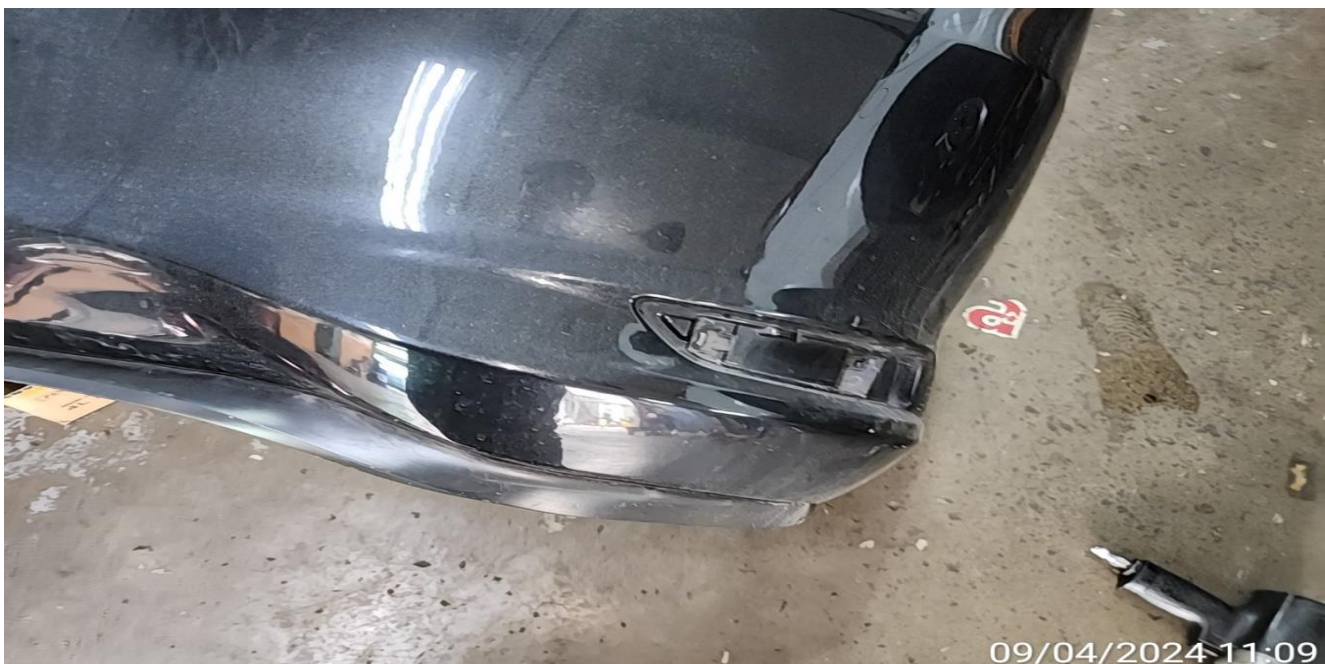
REAR BUMPER REFLECTOR CRACKED/ MISSING

| No. | Qty | Description of Parts | Condition | Our Recommendation<br>S\$ |
|---|---|---|---|---|
| 10 | 1 | Rear bumper reflector | Cracked | 160.00 |
