TECHNICAL INVESTIGATION REPORT OF FIRE INCIDENT INVOLVING THE INSURED VEHICLE YN 605K ON 31st OCTOBER 2024

Vehicle Registration No.	: YN 605K
Make / Model	: DULEVO, 5000 VELOCE EU4 A
Chassis No	: ZA9S5020E4DC38063
Year of Registration	: 18 NOV 2009
Mileage	: N.A (wiring affected)

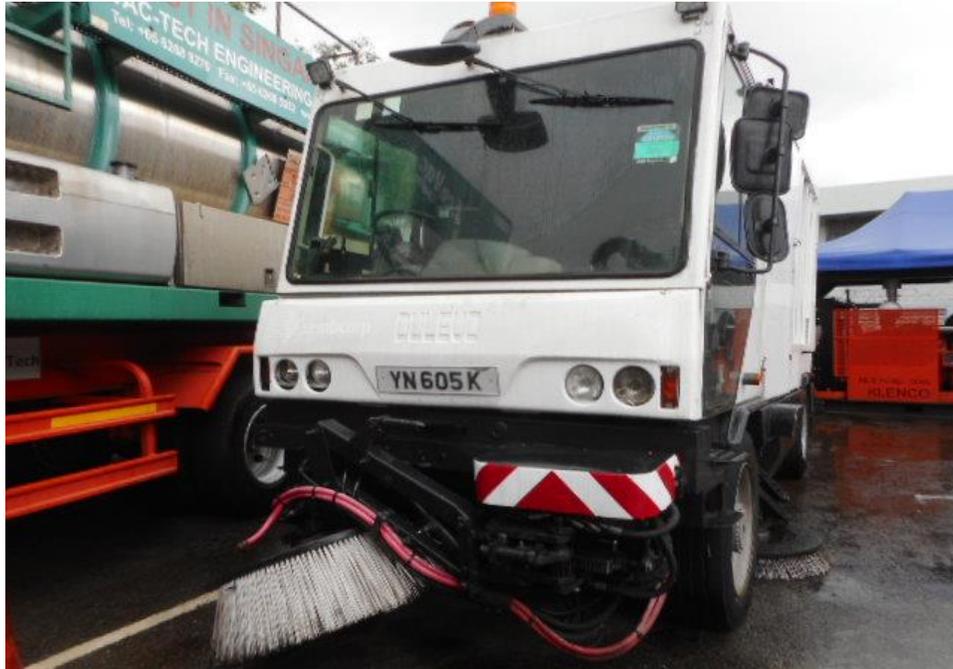
Photo 1 shows the front portion of the Insured Vehicle, which was observed to be unaffected by the fire.

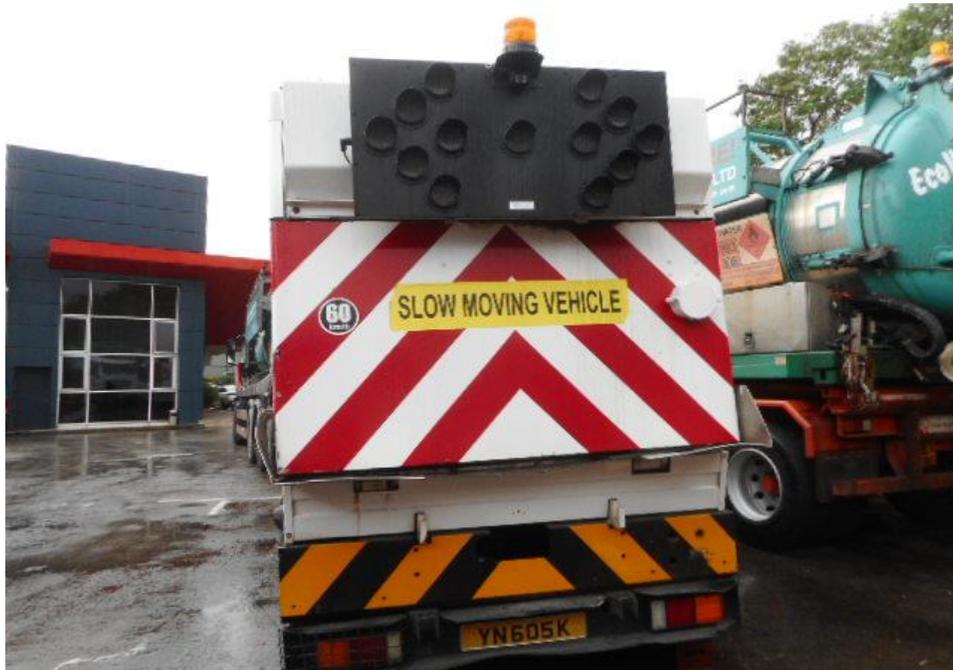
Photo 2 shows the rear portion of the Insured Vehicle, which was observed to be unaffected by the fire.

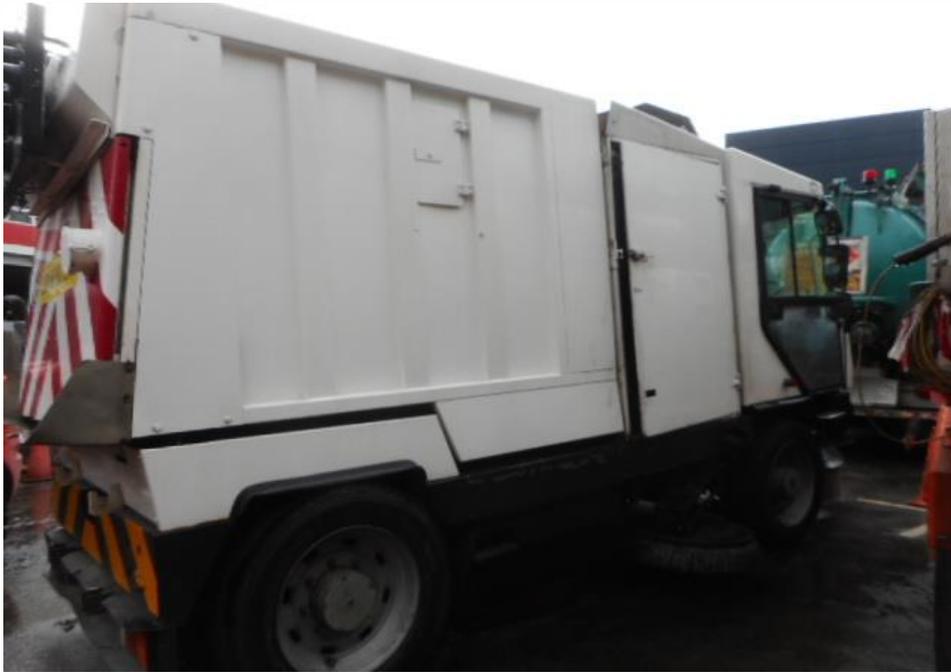
Photo 3 shows the right body of the Insured Vehicle, which was observed to be unaffected by the fire.

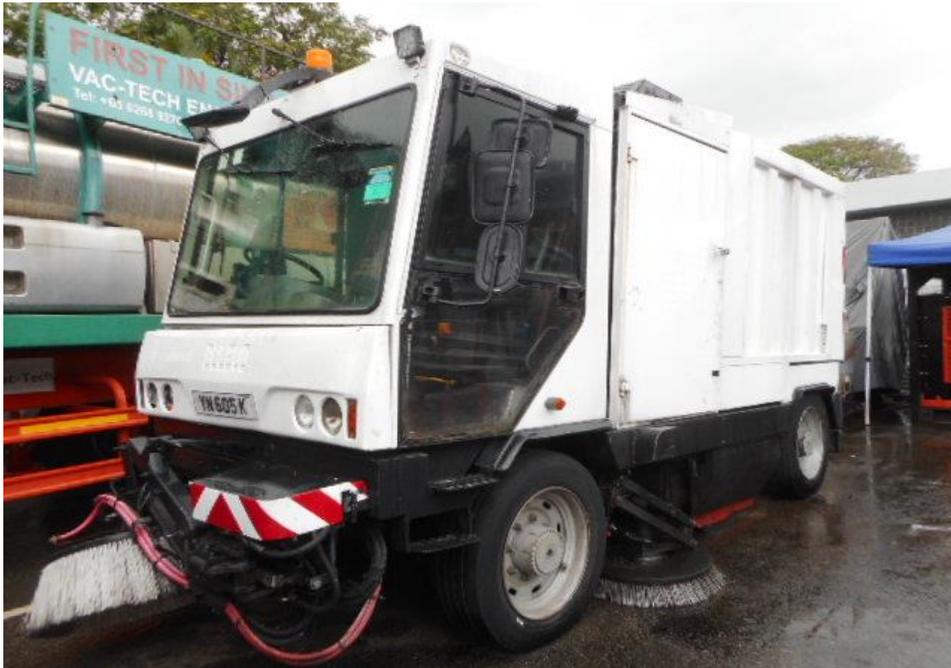
Photo 4 shows the left body of the Insured Vehicle, which was observed to be unaffected by the fire.

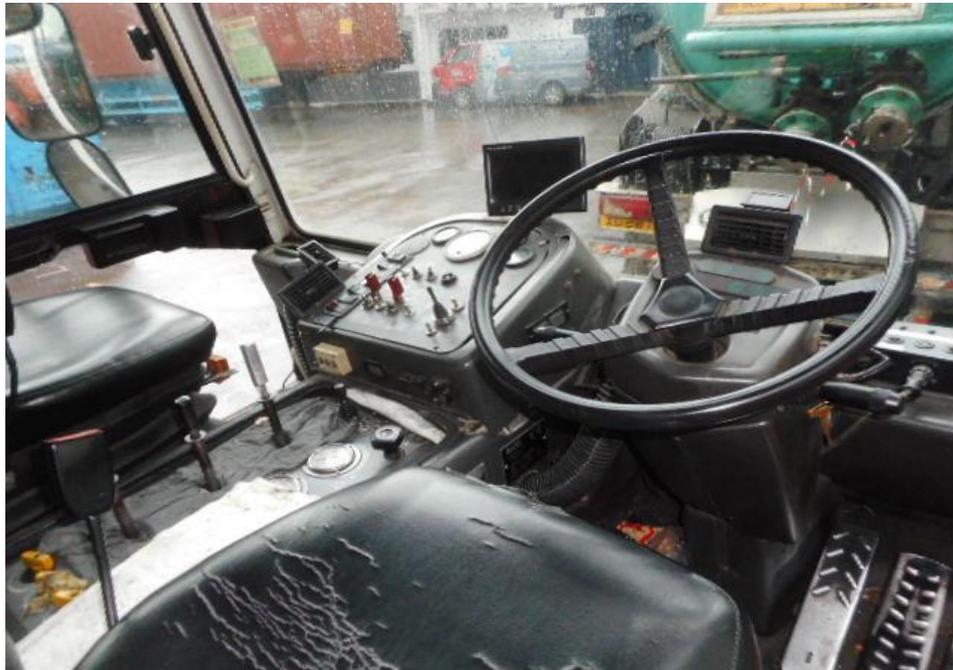
Photo 5 shows the general view of the interior compartment of the Insured Vehicle at the time of our inspection was observed to be unaffected by the fire.

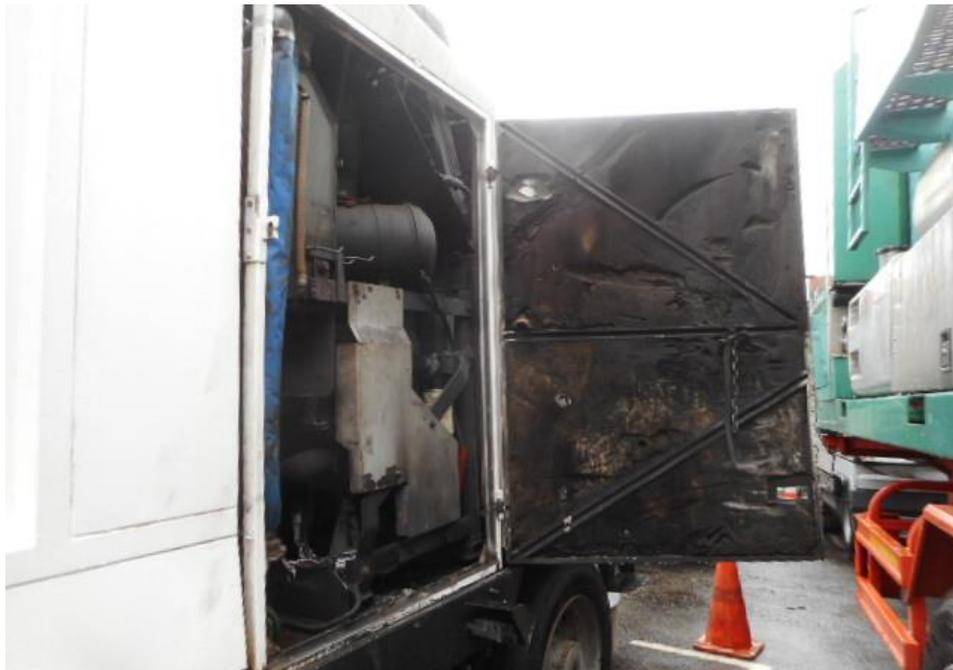
5. The Insured Vehicle was observed to have sustained minor fire damage confined only to its engine compartment in the middle right side, the electrical wirings around the middle right engine area was damaged as a result of the fire. The other parts of the Insured Vehicle was not affected by the fire See photos 1 – 7 below.

Photo 6 shows the engine compartment in the middle right portion of the Insured Vehicle at the time of our inspection. The engine compartment of the Insured Vehicle was observed to sustained heat and smoke damages. The electrical wirings was damaged as a result of the fire.

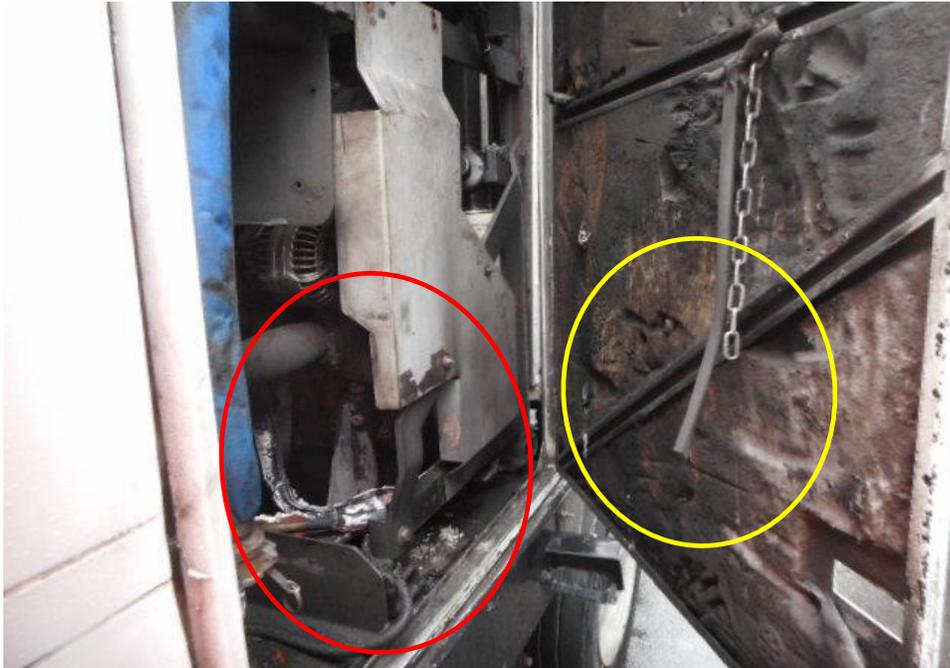
Photo 7 shows the engine compartment of the Insured Vehicle at the time of our inspection. The Insured Vehicle was observed to have sustained fire damage to its electrical wirings and components (red circle) and the right engine door panel (yellow circle) was damaged as a result of the fire.

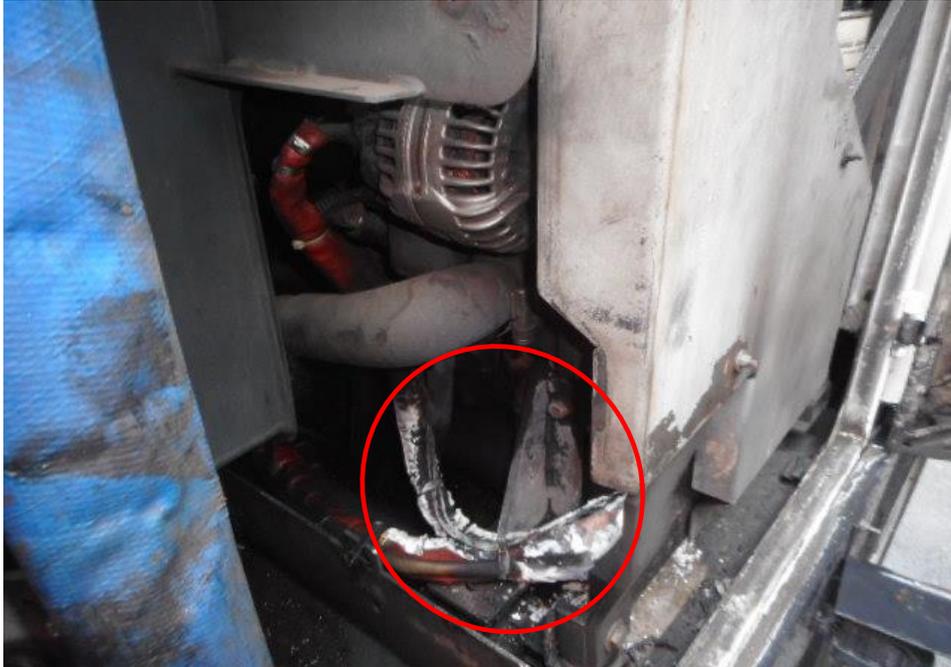
7. Based on the circumstances for this particular case, the fire appears to have originated from the engine area of the Insured Vehicle, somewhere around the middle right portion. This can be determined basing on the area where the extent of fire damage was most severe, the circumstances of the fires' origin at the material time of incident and also the high heat intensity burn marks (whitish burn marks) that were found on the exterior surface close to the engine middle right portion.

8. These whitish burn marks are a result of exposure to prolong heat intensity. Rust would normally start to develop around these areas soon after a fire as the prolonged exposure to high heat intensity usually causes the bare steel/metal material of the body parts to be exposed to natural environmental condition. The rust that had developed on the front bonnet and centre portion, in the immediate vicinity of where these whitish burn marks were found, would also support our findings of where the fire had affected the Insured Vehicle. See photo 8 and 9 below.

Photo 8 shows the close up view of the engine right portion of the Insured Vehicle at the time of our inspection. The burn pattern of the various components which were observed to be partly melted and burn from the high heat intensity and exposure of bare copper wirings (circled) indicates that the fire had originated from the wirings of the engine right portion of the Insured Vehicle.

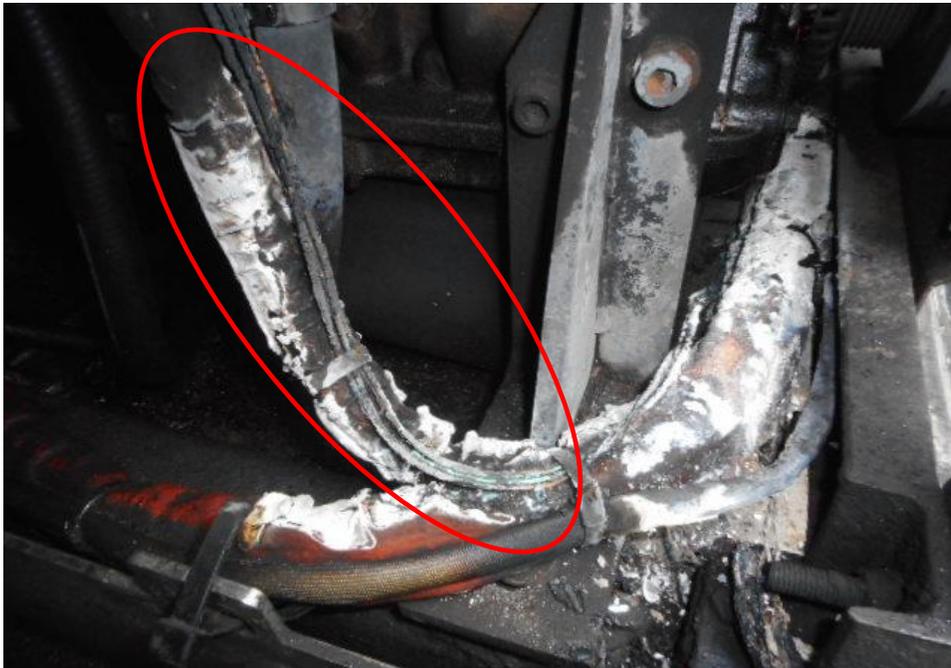
Photo 9 shows the close up view of the engine of the Insured Vehicle at the time of our inspection. The burn pattern of the various components which were observed to be partly melted and burn from the high heat intensity and exposure of bare copper wirings (circled) indicates that the fire had originated from the wirings of the engine portion of the Insured Vehicle.

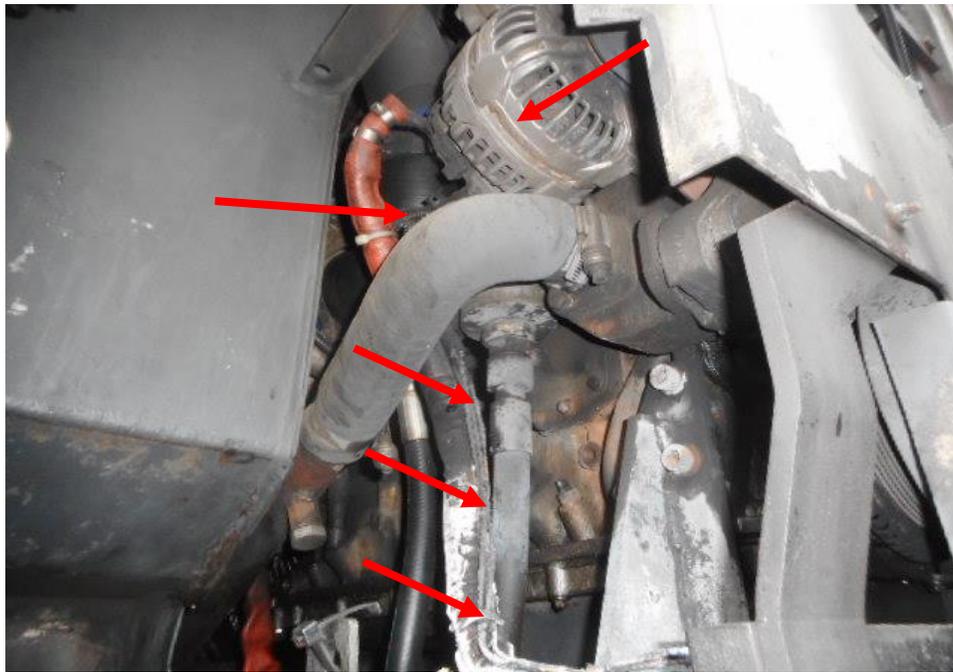
9. Upon closer examination of the engine compartment portion Insured Vehicle, which was where the fire had likely started, we had found traces of greenish residue on the main wiring's harnesses leading from the alternator to the electrical components of the Insured Vehicle. The wirings were original wirings fitted from the manufacturer. The presence of greenish residue indicates internal heating of copper wires, a sign of an electrical short circuit occurring. The greenish residue is normally left behind from the oxidation as a result of chemical reaction involving the copper wires. This physical evidence would then appear to suggest that the cause of fire to the Insured Vehicle could have possibly been due to electrical in nature. See photos 10 to 12 below.

Photo 10 shows the general view of the engine compartment of the Insured Vehicle at the time of our inspection. The fire damage to the Insured Vehicle has affected its engine compartment. Its wirings from the alternator (arrowed) to its electrical components and various original wiring harnesses was amongst the parts in the compartment that were found to have been affected as a result of the fire.

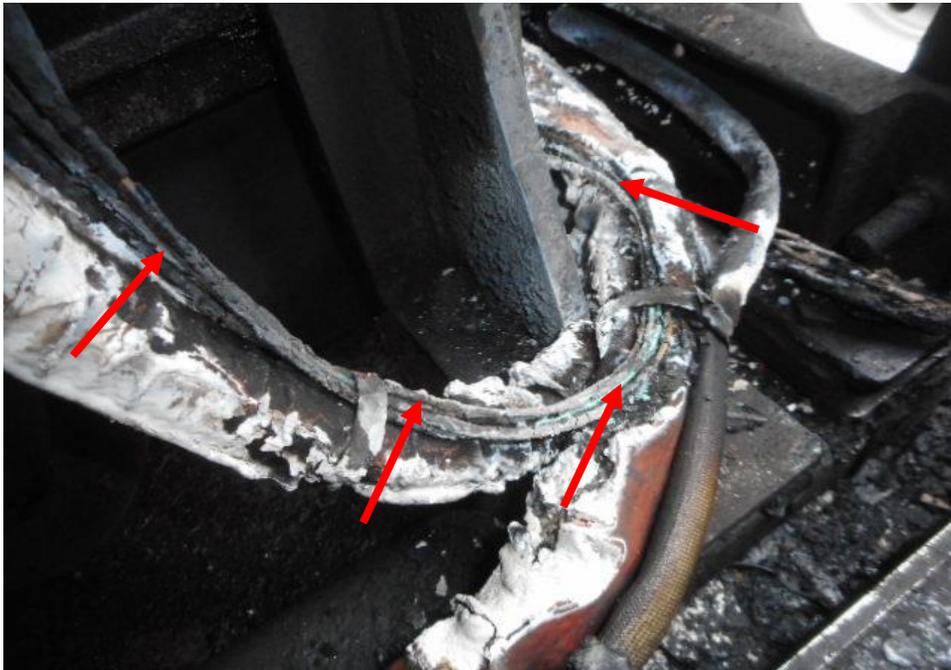
Photo 11 shows a close up view of the original wiring harness from the alternator (arrowed) was observed with greenish residue on the surface. The presence of greenish residue indicates internal heating of copper wires, a sign of an electrical short circuit occurring. The greenish residue is normally left behind from oxidation as a result of chemical reaction involving the copper wires.

20. The possibility of the fire being due to electrical in nature would then seem more likely given that engine overheating and external factors would both seem unlikely. The fire being due to electrical nature is also supported by the condition of the several stretches of original wirings from the alternator to its electrical components which was burnt internally to its bare copper state on the Insured Vehicle which was a sign of short circuit that which was earlier discussed in paragraph 9 above.

22. Having investigated and technically analysed the damages of burnt nature to the Insured Vehicle, we are of the view that the cause of fire to the Insured Vehicle was of electrical nature. For this particular case, the fire had originated from the wiring harnesses of the alternator leading to its electrical components in the engine compartment of the Insured Vehicle.
23. We did not find any evidence which had suggested that the cause of fire to the Insured Vehicle was due to poor maintenance and/or recurring electrical problem.

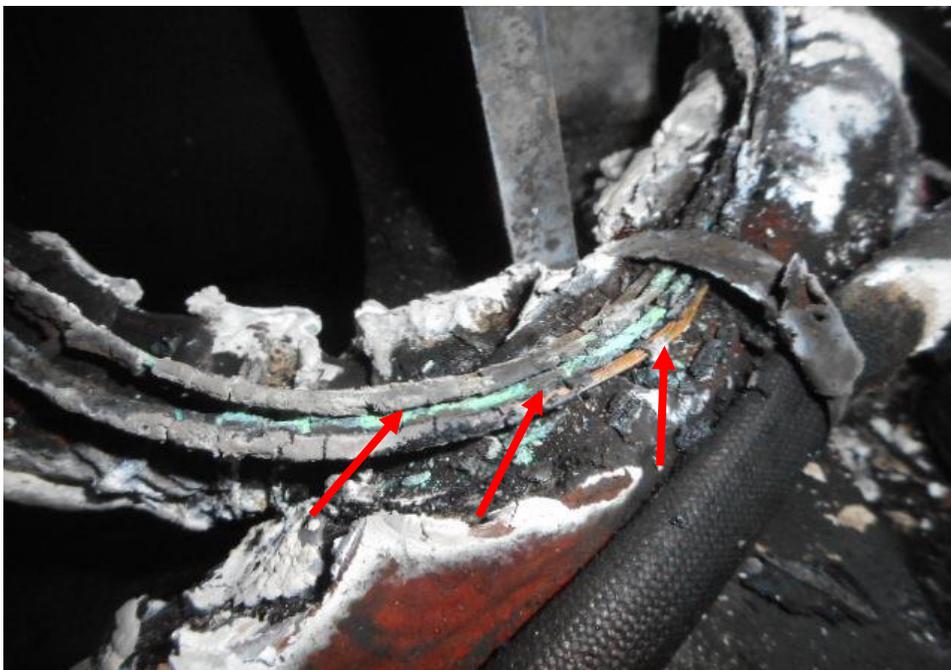
Photo 12 shows close up view of the original wiring harness from the alternator (arrowed) to the electrical components was observed with greenish residue on the surface. The presence of greenish residue indicates internal heating of copper wires, a sign of an electrical short circuit occurring. The greenish residue is normally left behind from oxidation as a result of chemical reaction involving the copper wires.

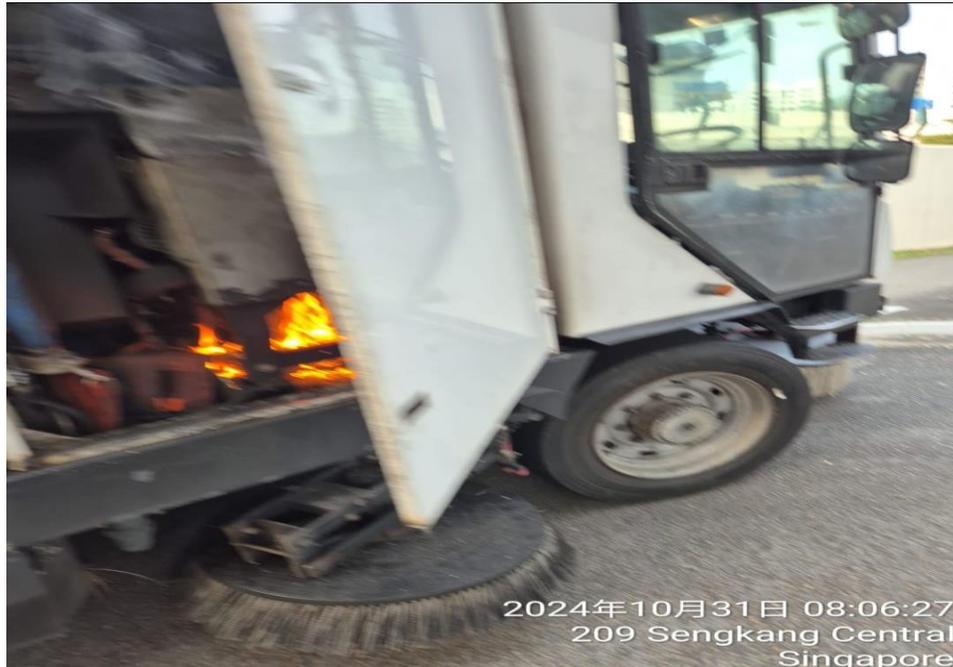
Photo 13 shows the Insured Vehicle middle right portion on fire. In general, the information that could be gathered from this photograph had corresponded to the events that were related to us by Mr Wong, location when the fire broke out.

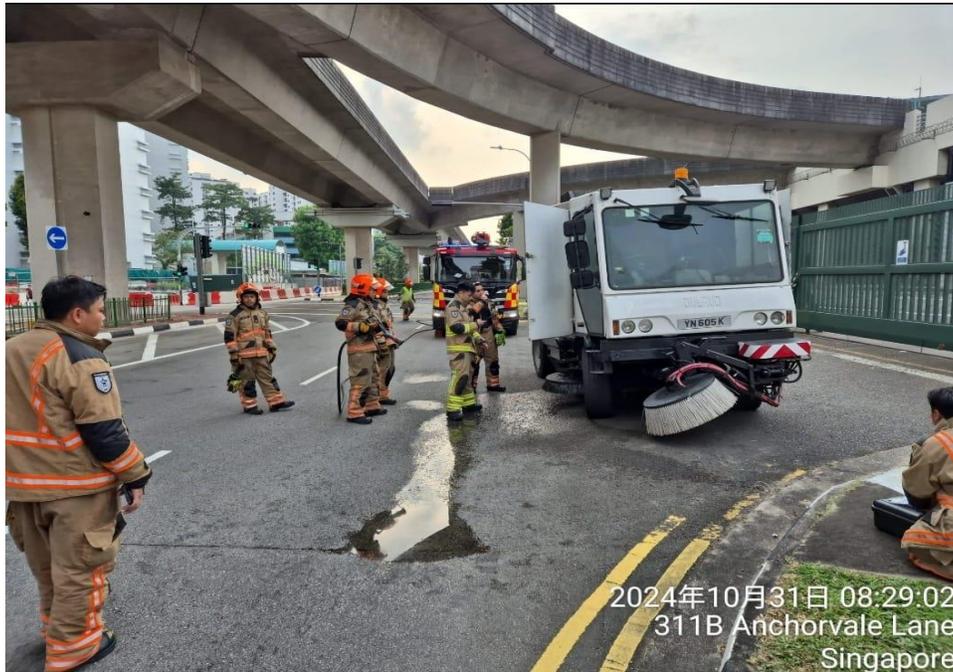
Photo 14 shows the SCDF officer on scene after the fire was put out on the Insured Vehicle. In general, the information that could be gathered from this photograph had corresponded to the events that were related to us by Mr Wong, location when the fire broke out.
