Our Ref : CS/C3-000124110301/N

15 November 2024

MECHANICAL INSPECTION REPORT OF MOTORCYCLE FBP 3260M

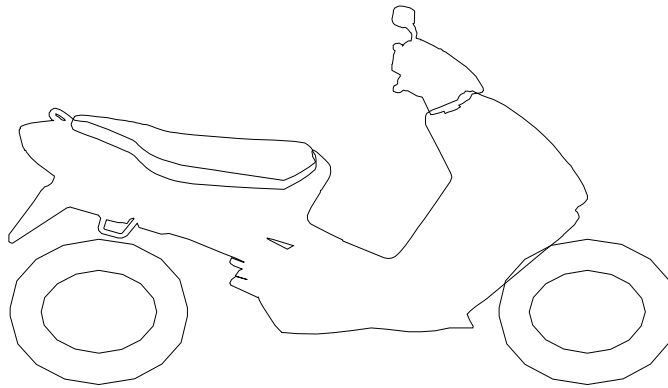
7. The tyre brand, tyre size and remaining tread depth of the 2 tyres were recorded as follows:-

Michelin 80/90 - 17 (3mm)

Michelin 70/90 - 17 (3mm)

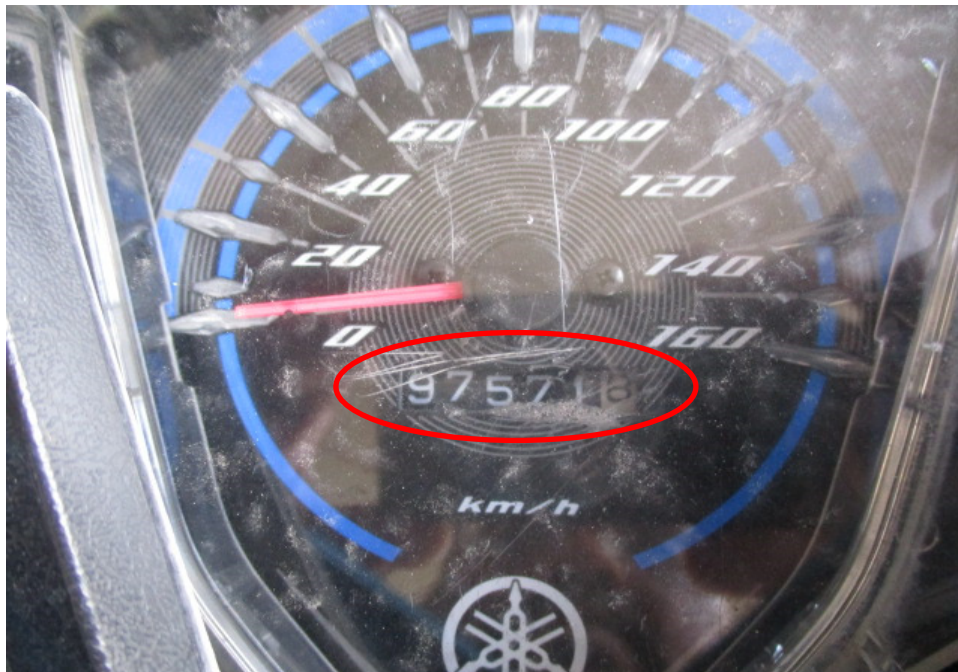
Photo 1 shows the speedometer gauge of the Motorcycle where the mileage recorded at the time of our inspection was 97, 571km (circled).

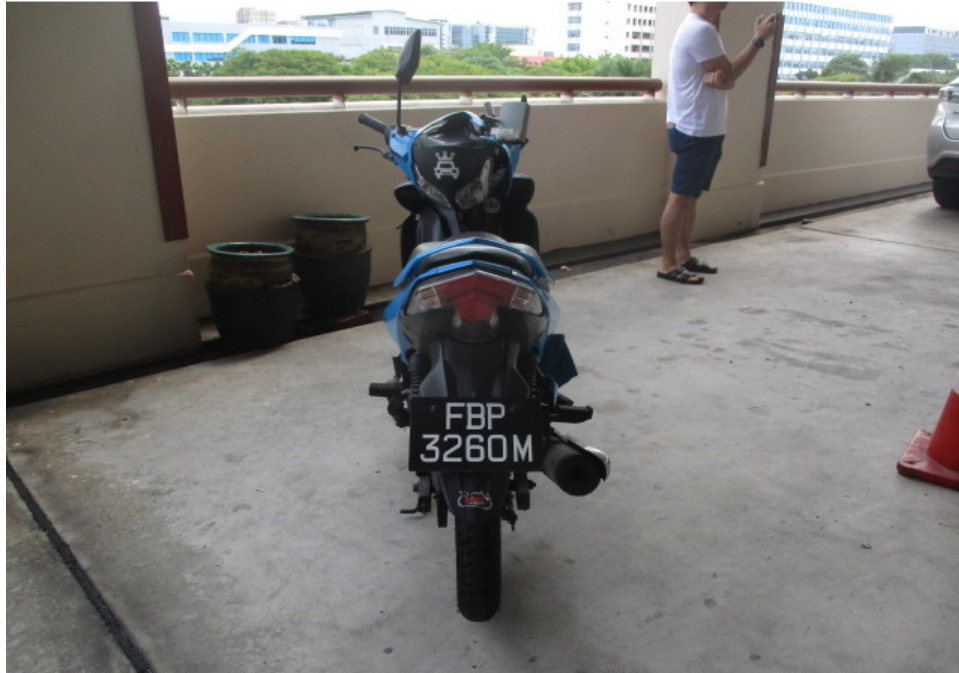
Photo 2 shows a general view of the rear portion of the Motorcycle at the time of our inspection. The Motorcycle had sustained damages all around.

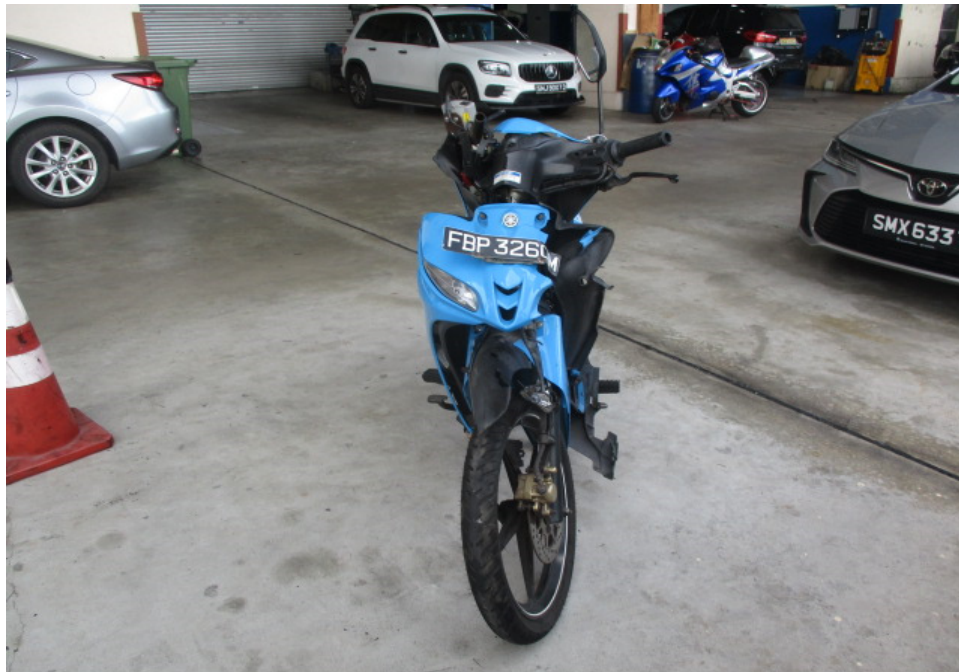
Photo 3 shows a general view of the frontal portion of the Motorcycle at the time of our inspection. The Motorcycle had sustained damages all around.

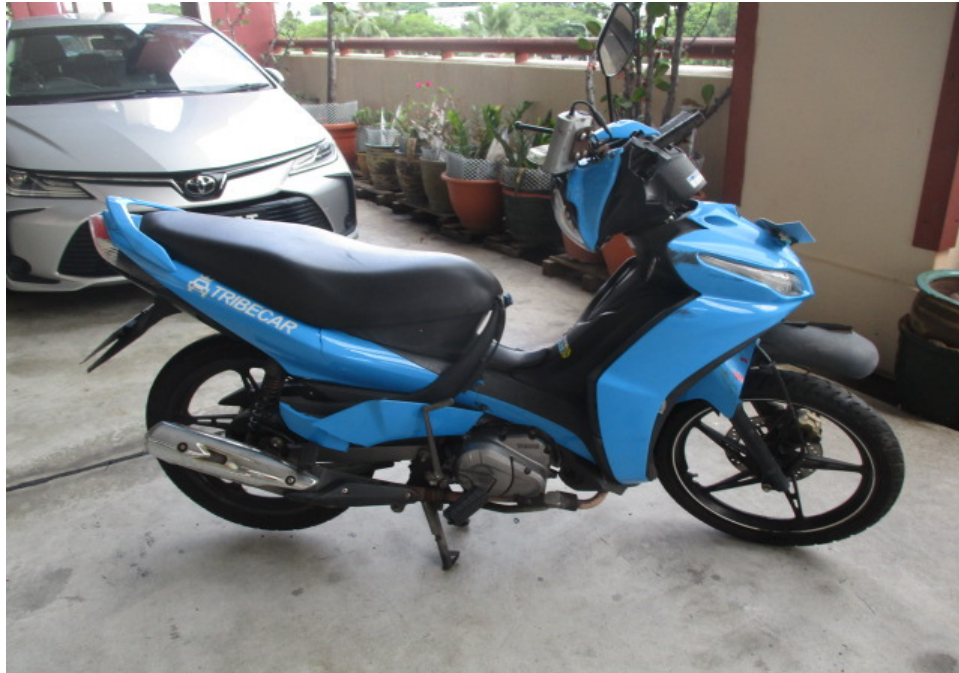
Photo 4 shows a general view of the right body of the Motorcycle at the time of our inspection. The Motorcycle had sustained damages all around.

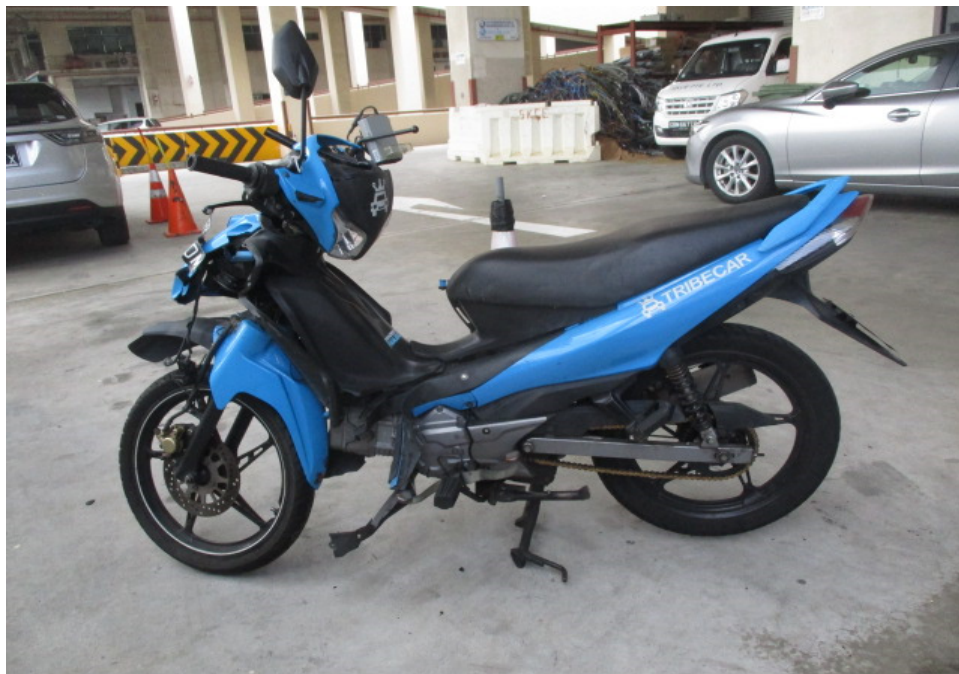
Photo 5 shows a general view of the rear portion of the Motorcycle at the time of our inspection. The Motorcycle had sustained damages all around. Body parts that were found to have been damaged include its headlight, head cowl, steering stem, front cowl, front mudguard, left handlebar grip, left side mirror, centre inner cowl, side cowls, right front footrest, right pillion footrest, rear side covers and right side cover, amongst others.

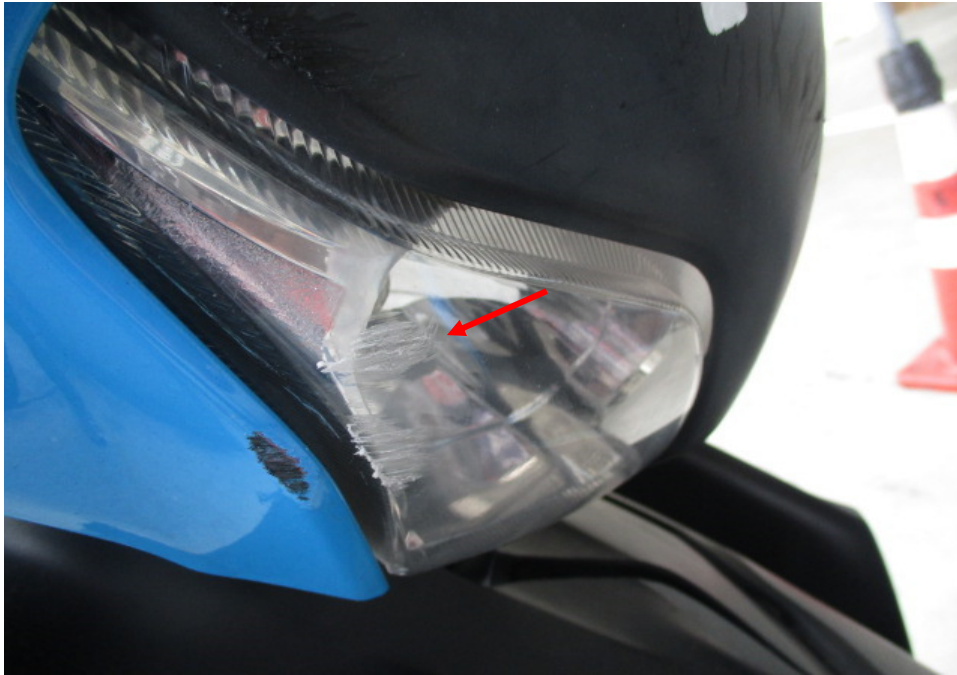
Photo 6 shows a closer view of the grazed headlight (arrowed) of the Motorcycle at the time of our inspection.

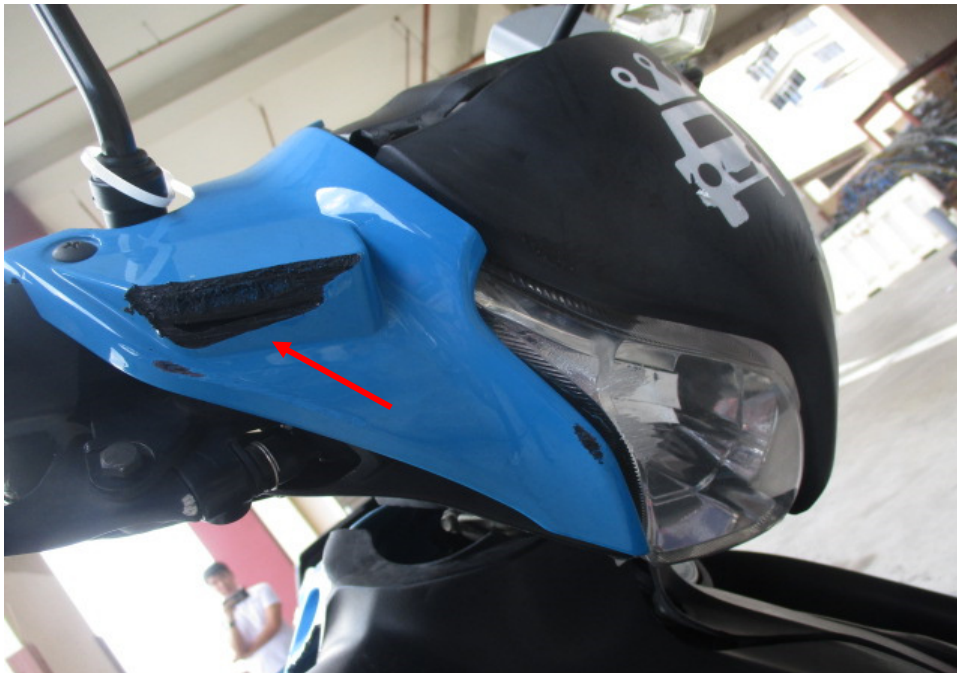
Photo 7 shows a closer view of the grazed head cowl of the Motorcycle (arrowed) at the time of our inspection.

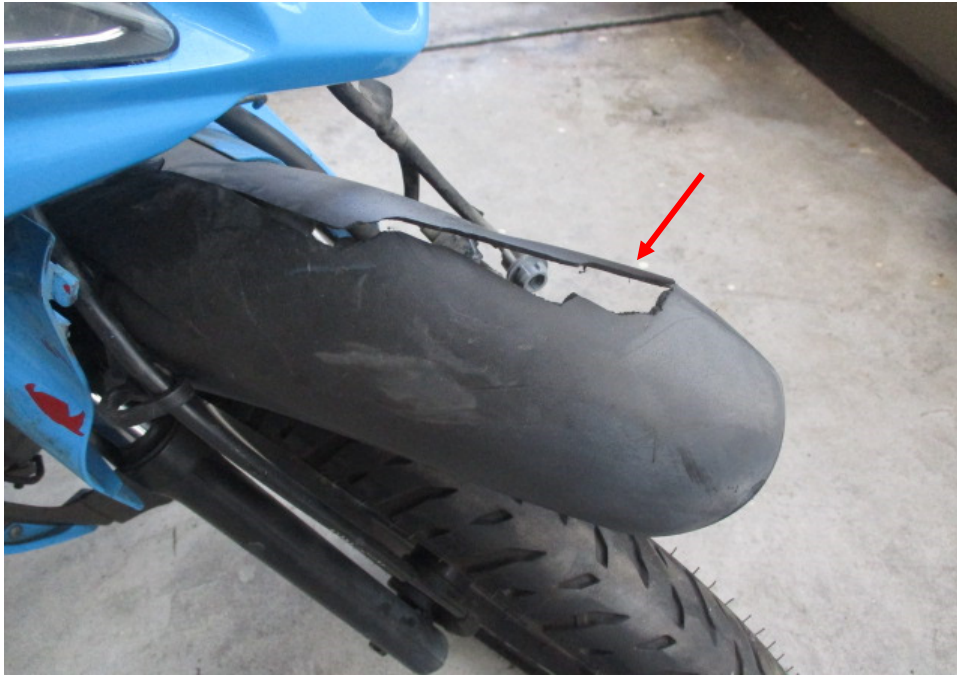
Photo 8 shows a closer view of the cracked front mudguard of the Motorcycle (arrowed) at the time of our inspection.

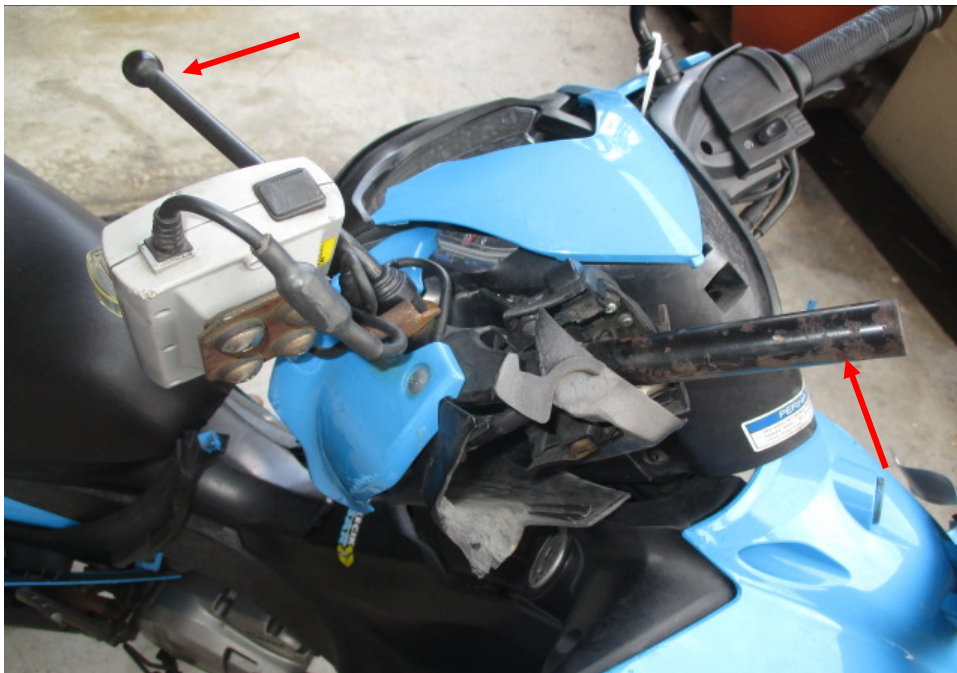
Photo 9 shows a closer view of the missing left side mirror and left handlebar grip of the Motorcycle (arrowed) at the time of our inspection.

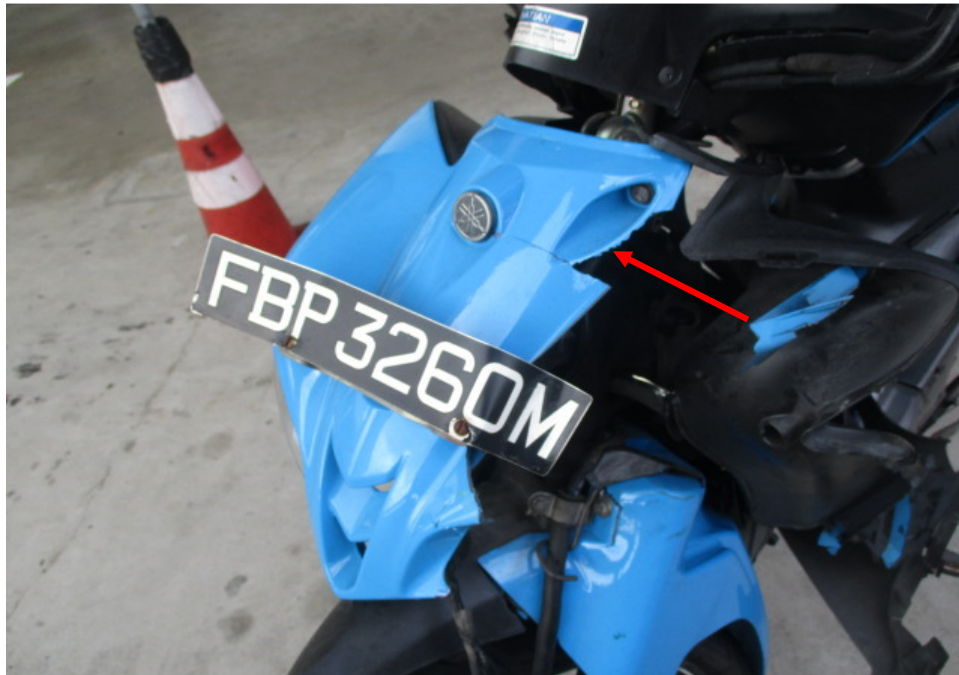
Photo 10 shows a closer view of the cracked front cowling of the Motorcycle at the time of our inspection (arrowed).

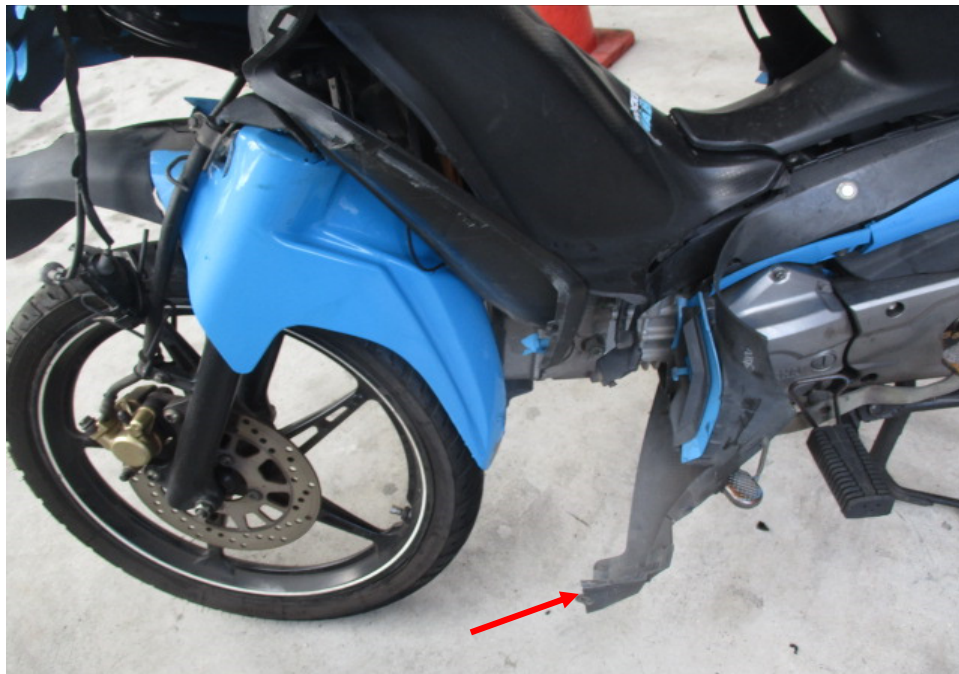
Photo 11 shows a closer view of the cracked left cowling of the Motorcycle at the time of our inspection (arrowed).

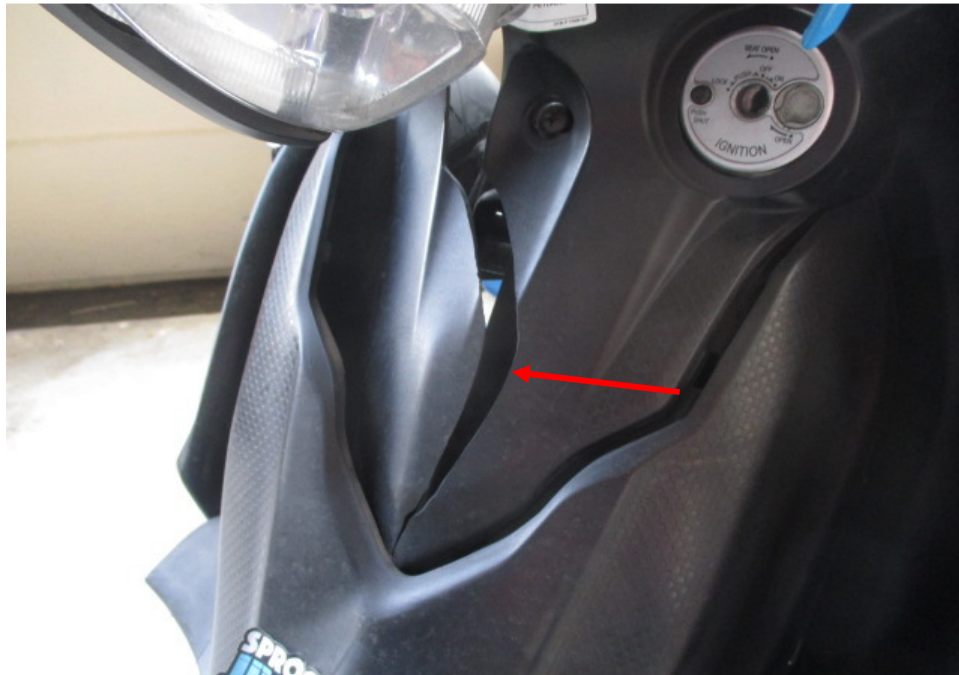
Photo 12 shows a closer view of the cracked centre inner cowling of the Motorcycle at the time of our inspection (arrowed).

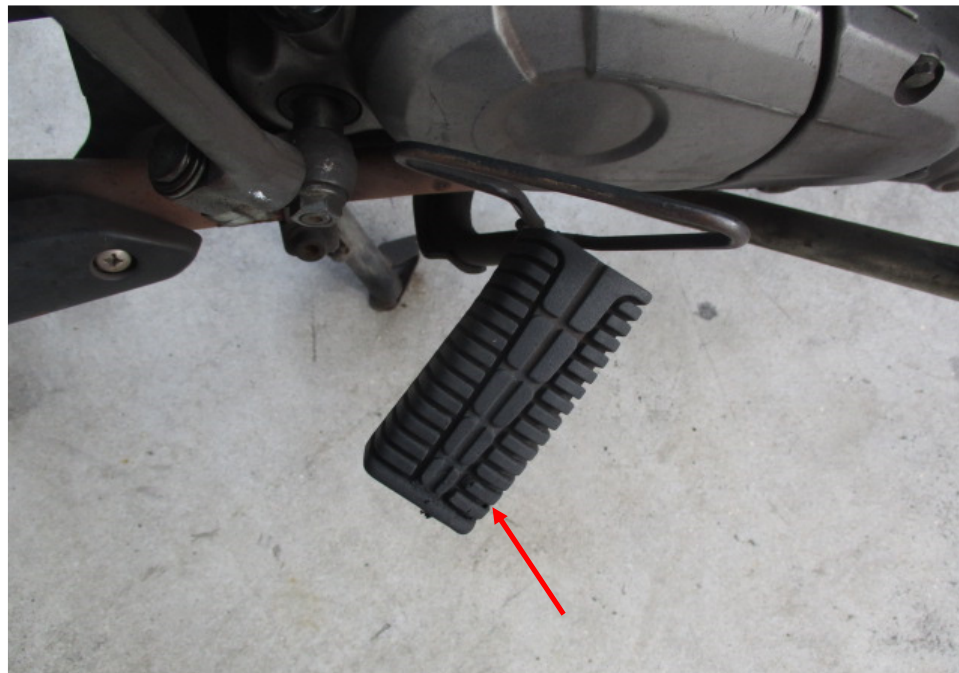
Photo 13 shows the bent right front footrest (arrowed) of the Motorcycle at the time of our inspection.

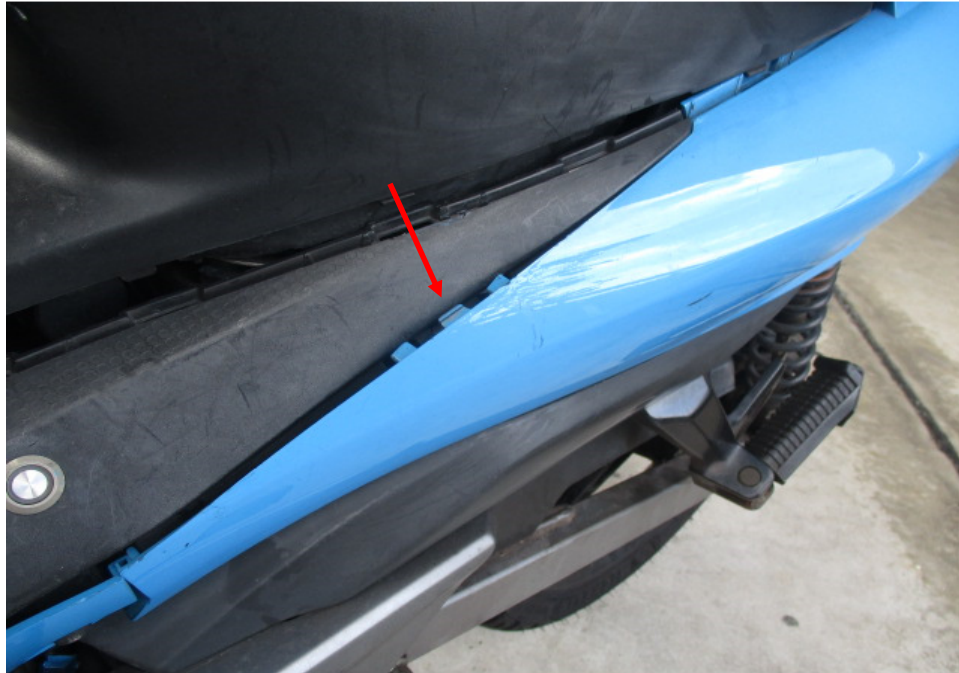
Photo 14 shows a closer view of the cracked left rear side cover of the Motorcycle at the time of our inspection (arrowed).

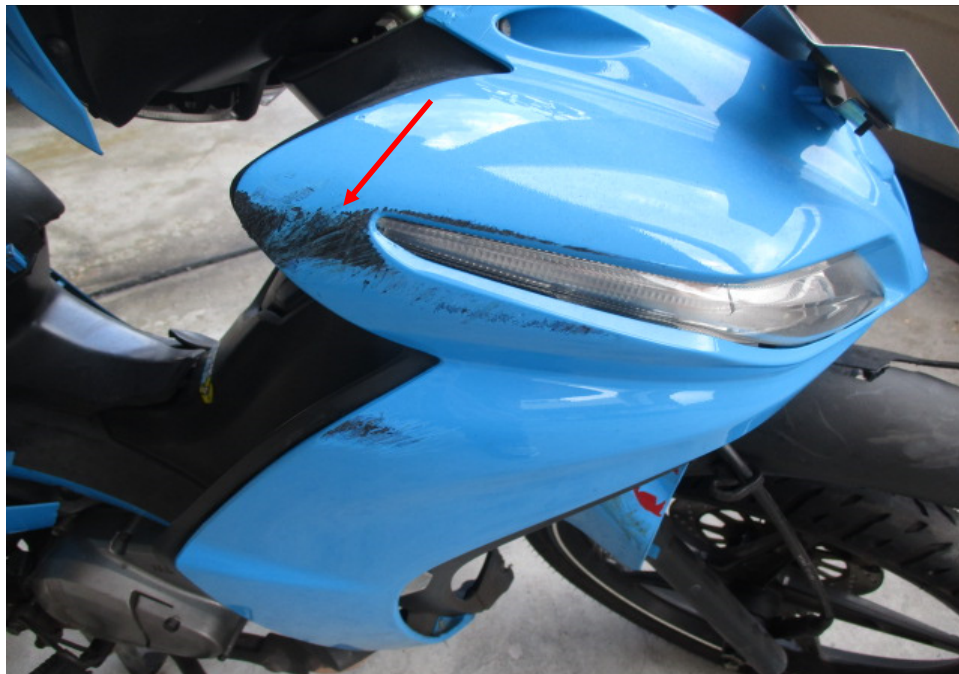
Photo 15 shows a closer view of the grazed right cowling of the Motorcycle (arrowed) at the time of our inspection.

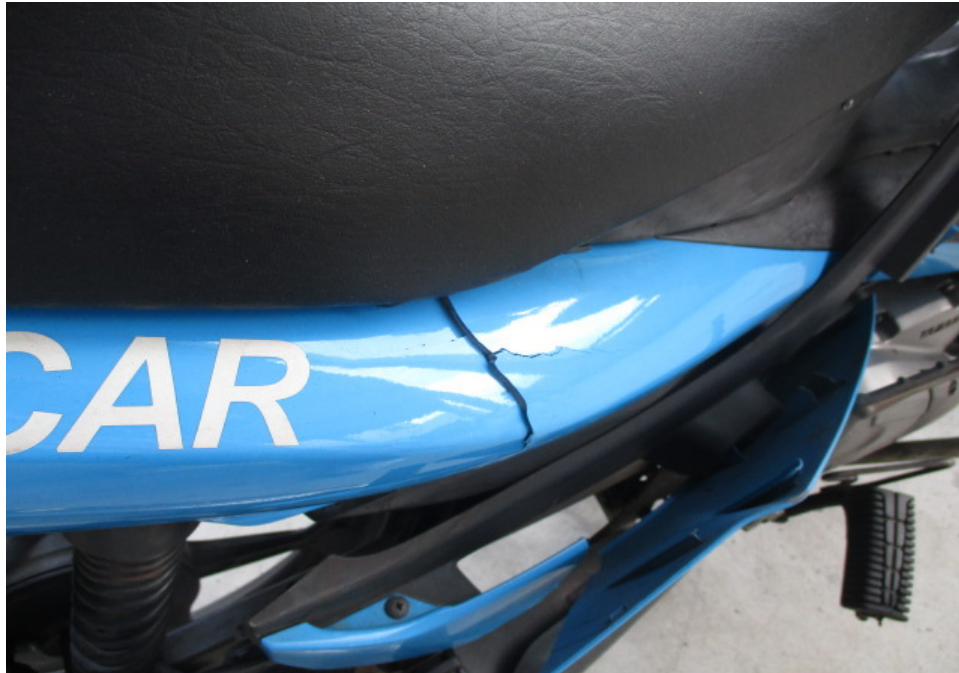
Photo 16 shows the cracked right rear side cover (arrowed) of the Motorcycle at the time of our inspection.

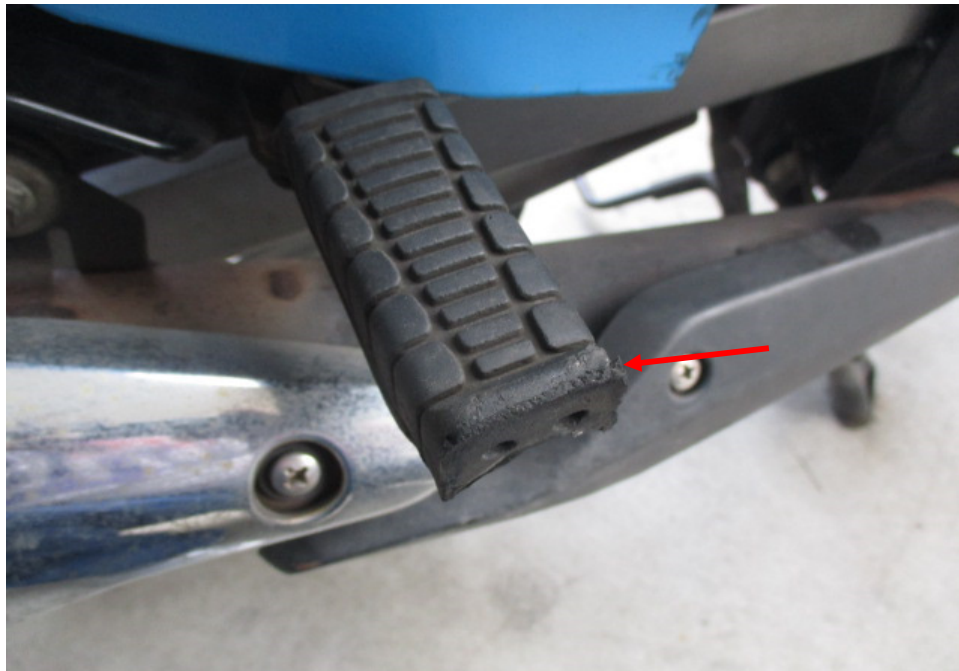
Photo 17 shows the grazed right pillion footrest (arrowed) of the Motorcycle at the time of our inspection.

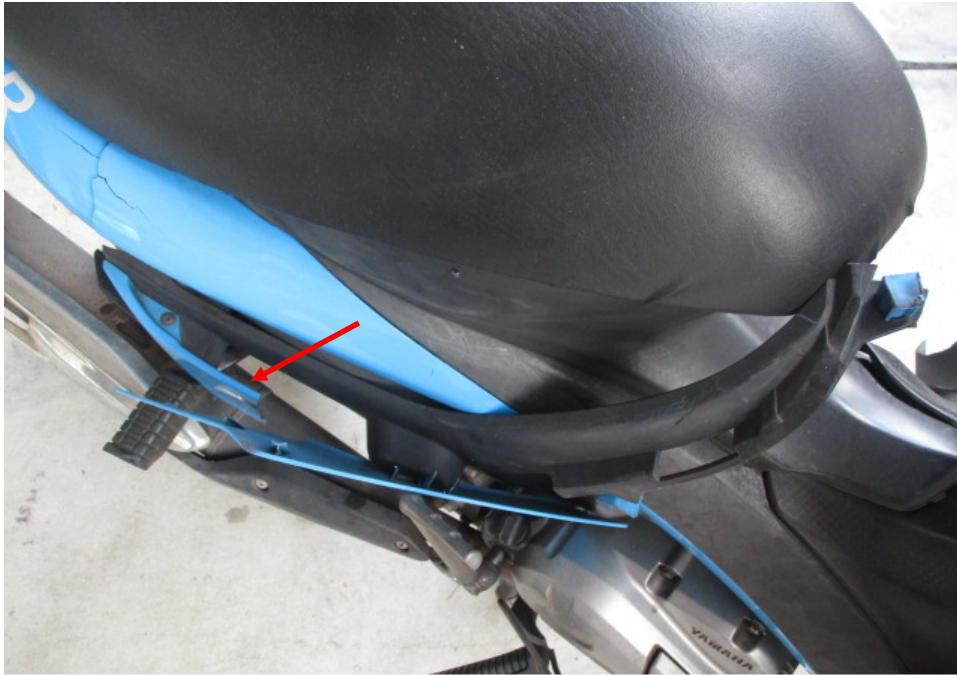
Photo 18 shows the cracked right side cover (arrowed) of the Motorcycle at the time of our inspection.

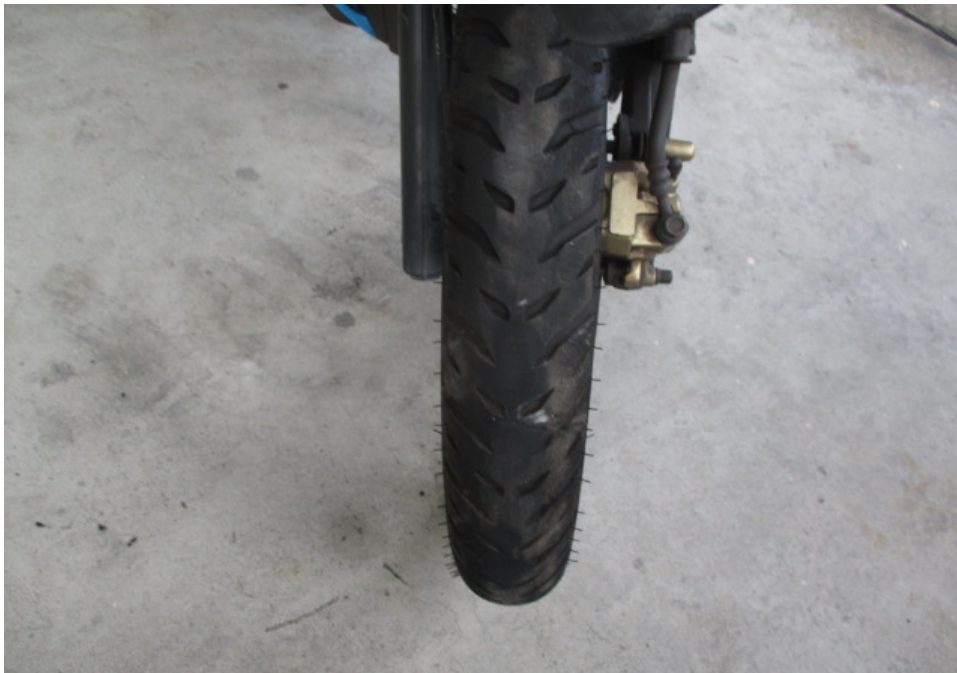
Photo 19 shows the condition of the Motorcycle's front tyre. The front tyre was observed to be in serviceable condition with remaining tread depth of approximately 3mm. There was no tear, burst mark(s) and/or punctured hole(s) on the sidewalls as well as across the tread of the front tyre. The front tyre was also observed to be sufficiently inflated for vehicular operation.

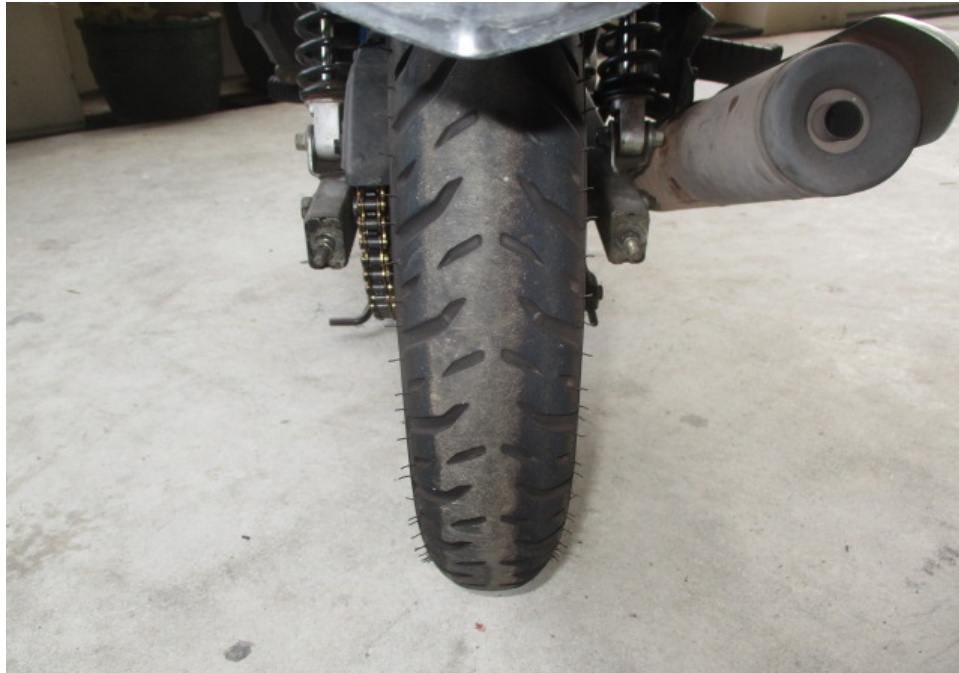
Photo 20 shows the condition of the Motorcycle's rear tyre. The rear tyre was observed to be in serviceable condition with remaining tread depth of approximately 3mm. We did not observe any tear, burst mark(s) and/or punctured hole(s) on the sidewalls as well as across the tread of the rear tyre. The rear tyre was also observed to be sufficiently inflated for vehicular operation.

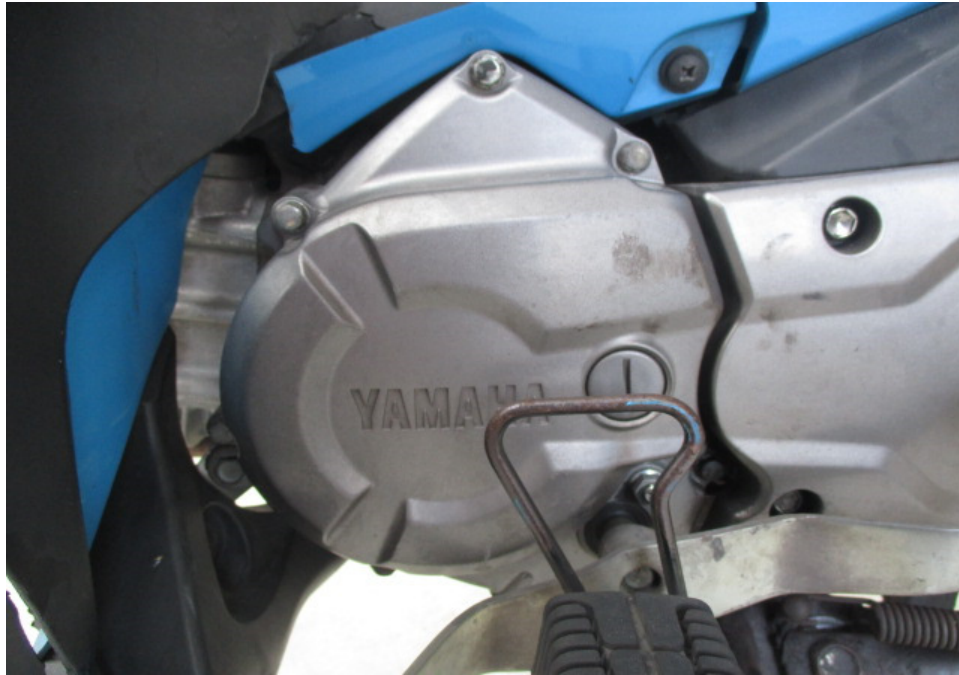
Photo 21 shows the left side of the engine of the Motorcycle at the time of our inspection. The various engine related parts and components were found to be intact with no visible damage. There was also no sign(s) or indication(s) of fluid leak observed around the left engine area of the Motorcycle.

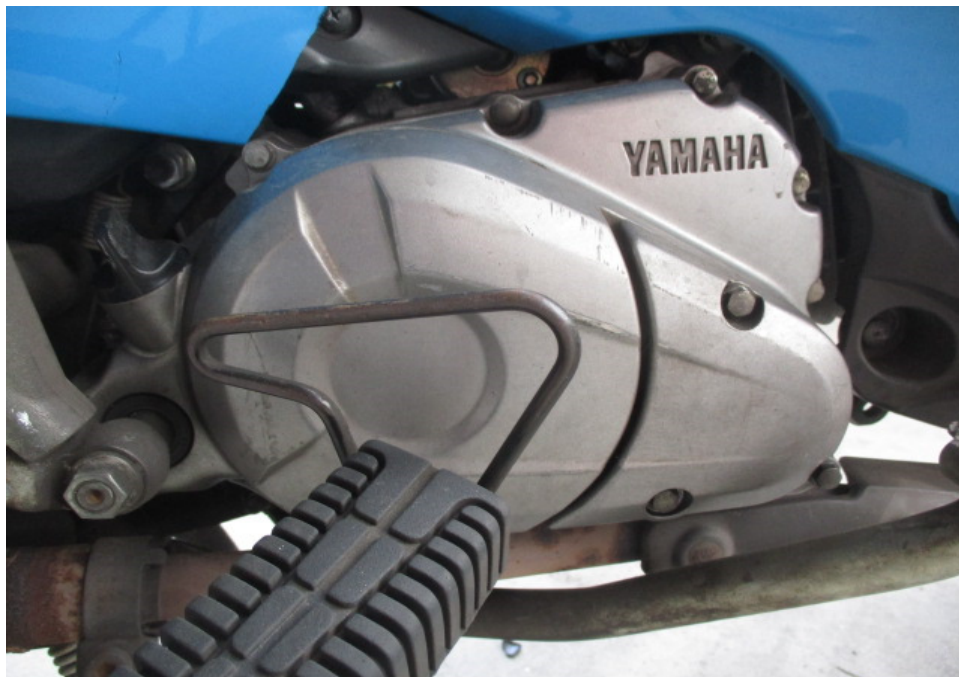
Photo 22 shows the right side of the engine of the Motorcycle at the time of our inspection. The various engine related parts and components were found to be intact with no visible damage. There was also no sign(s) or indication(s) of fluid leak observed around the right engine area of the Motorcycle.

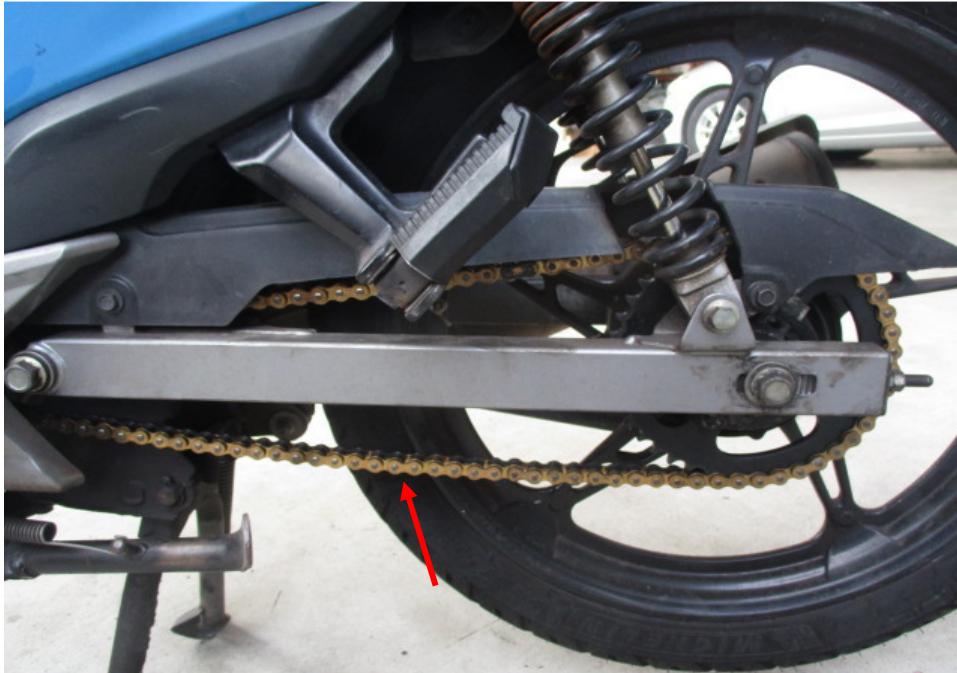
Photo 23 shows the gear train (arrowed) of the Motorcycle, which was observed to be intact with no misalignment. It was also adequately lubricated for operating purposes. The gear train rotates the rear wheel of the Motorcycle.

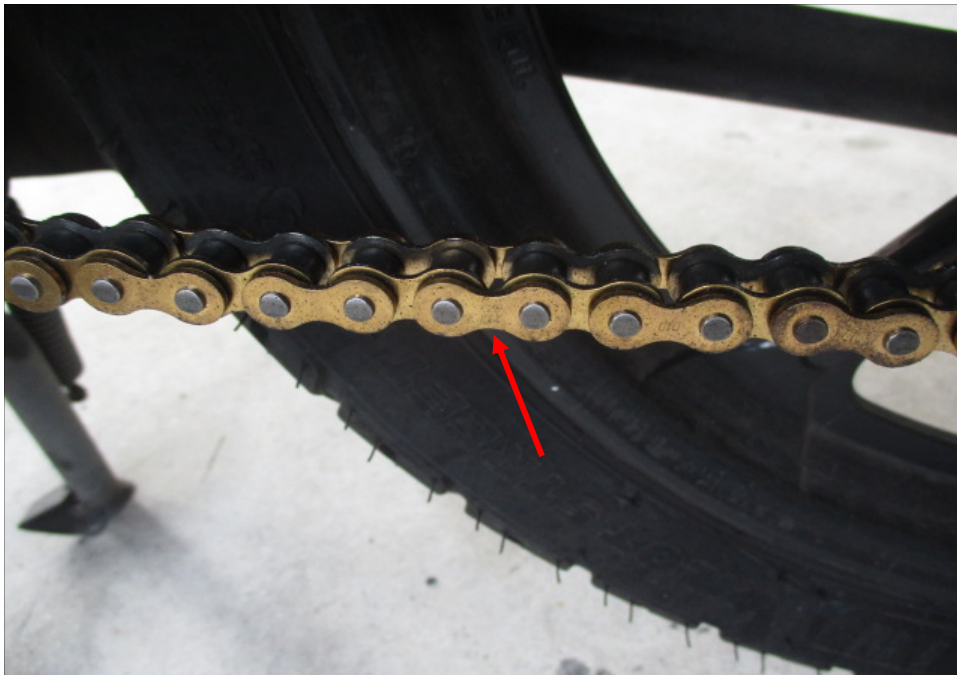
Photo 24 shows the closer view of the gear train (arrowed) of the Motorcycle, which was observed to be intact with no misalignment. It was also adequately lubricated for operating purposes.

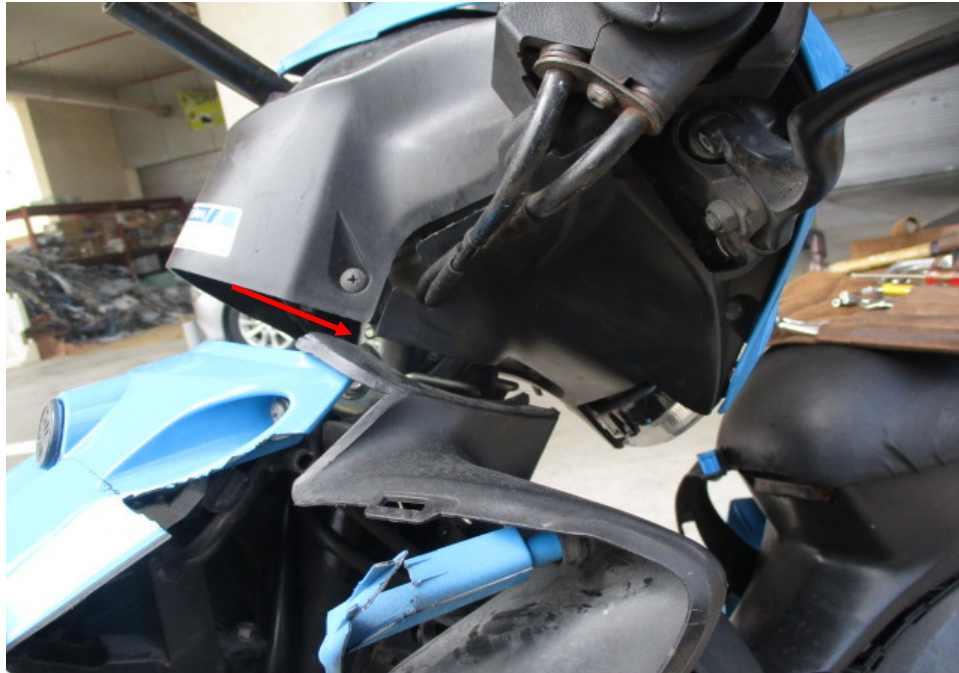
11. For this case, we were not able to conduct any test(s) on the steering system of the Motorcycle due to the damage to its steering stem. The steering stem was observed to be bent most likely as a result of the accident.

Photo 25 shows the steering stem of the Motorcycle. The steering stem was observed to be bent most likely as a result of the accident (arrowed). We were hence not able to conduct any tests on the steering system of the Motorcycle.

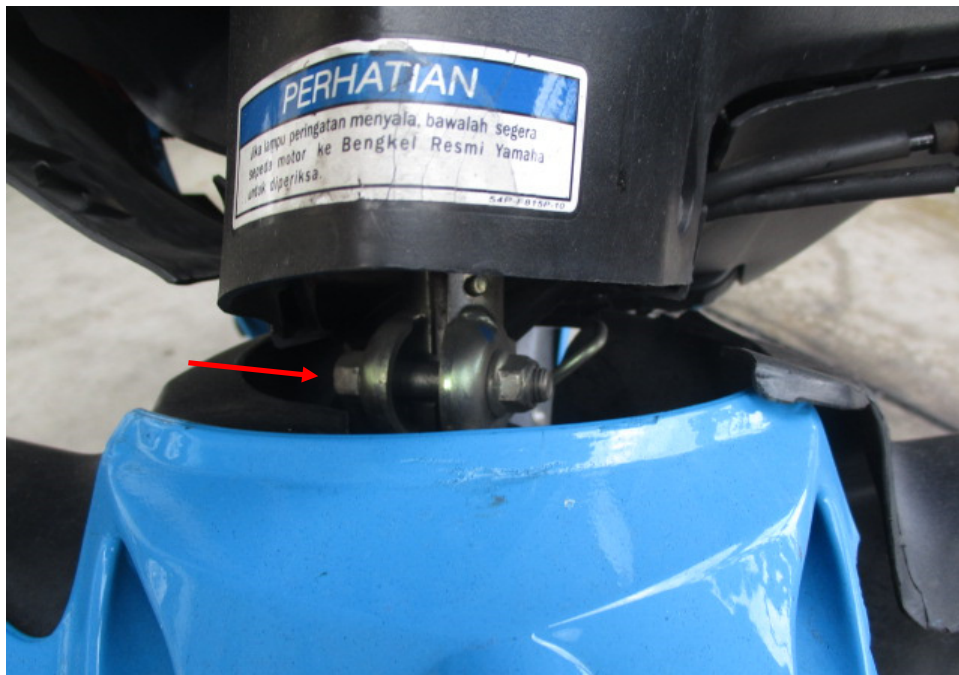
Photo 26 shows a close up view of the bent steering stem of the Motorcycle most likely as a result of the accident (arrowed). We were hence not able to conduct any tests on the steering system of the Motorcycle.

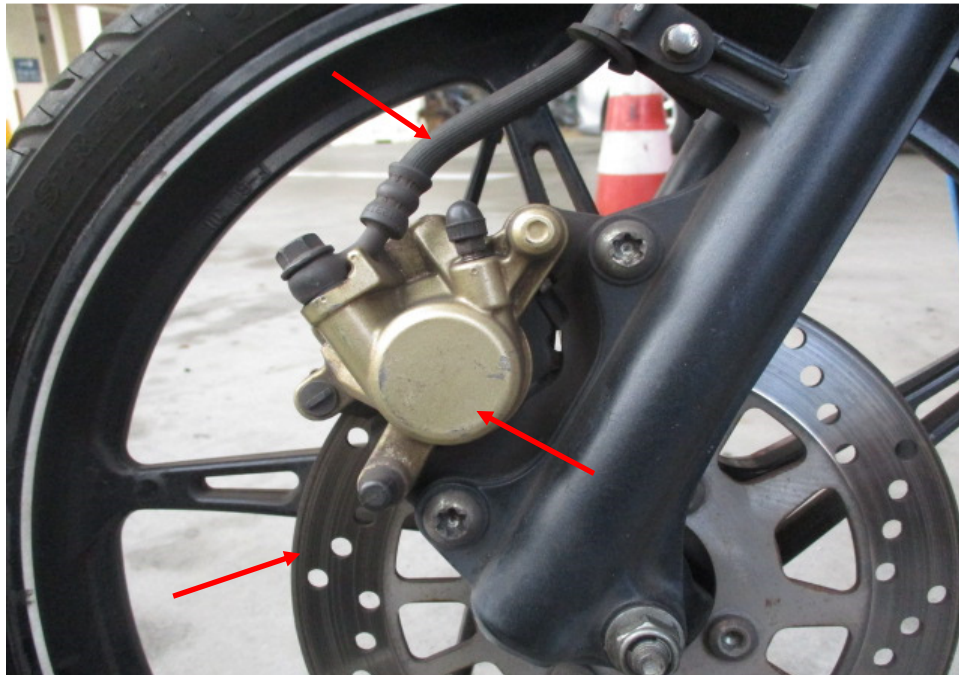
Photo 27 shows a close up view of the front brake caliper, front brake disc and front brake hose (arrowed) of the Motorcycle, which are all part of the components in the hydraulic front brake system of the Motorcycle. Our visual checks of these various components had revealed all to be intact with no visible damage. No leakage of brake fluid was also observed.

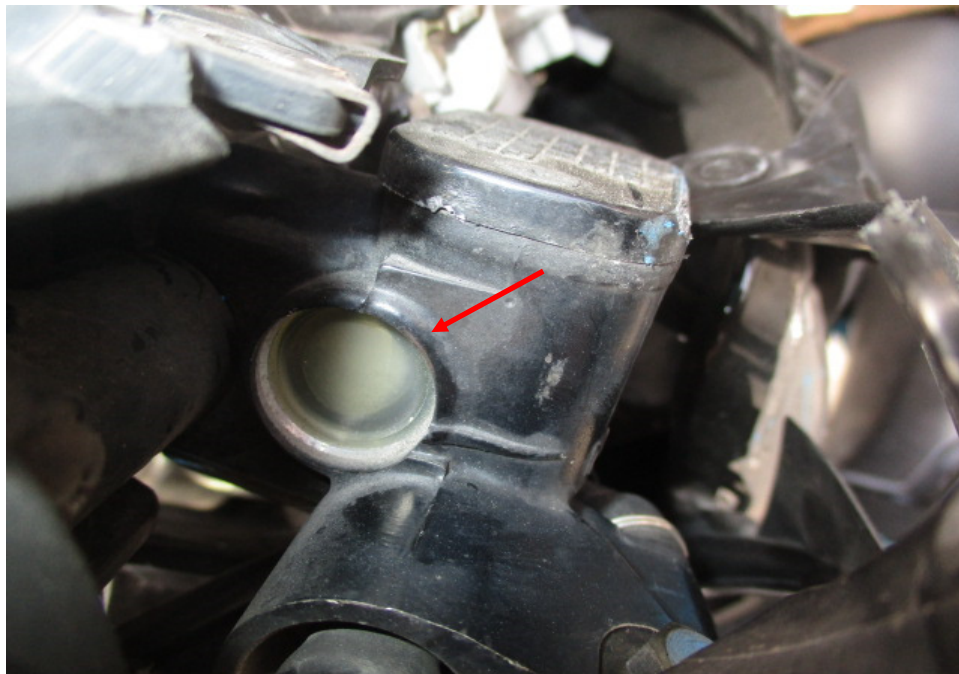
Photo 28 shows the brake fluid reservoir for the front brake of the Motorcycle. The brake fluid was found to be of sufficient level for operating purposes (arrowed).

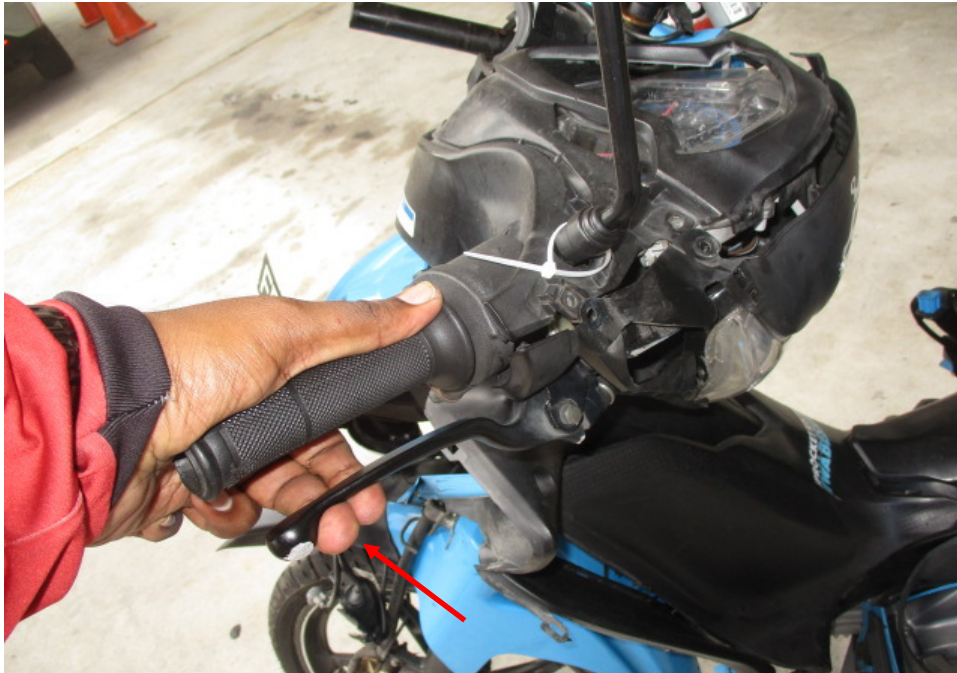
13. Static brake tests conducted on the Motorcycle had appeared to indicate that the front brake system of the Motorcycle was in serviceable condition. There was some resistance felt (spongy like feel) upon pressing the front brake lever. This would indicate that there's no leakage of pressure/vacuum in the front brake system. See photos 25 – 30 below.

Photo 29 shows the front brake lever being depressed. There was some resistance felt (spongy like feel) upon pressing the front brake lever (arrowed). This would indicate that there is no leakage of pressure/vacuum in the front brake system.

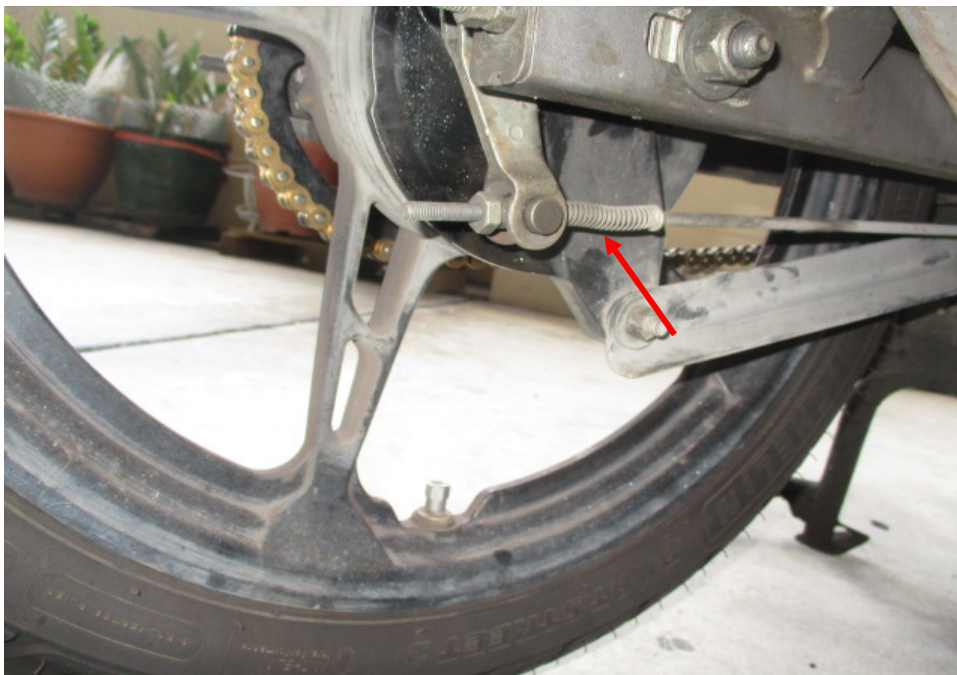
Photo 30 shows the rear wheel of the Motorcycle. The type of brake system for the rear wheel was of a mechanical type, controlled by the brake foot pedal of the Motorcycle. Our checks of the cable (arrowed), spring and drum which are all part of the components in the rear brake system of the Motorcycle reveal all to be intact and without damage.
