Your Ref : D24010145MFCT
Our Ref : CS/FCI24110385/N

2 December 2024

M/s First Capital Insurance Limited

**TECHNICAL INVESTIGATION REPORT OF FIRE INCIDENT INVOLVING THE
INSURED VEHICLE SHA 7884U ON 17 NOVEMBER 2024**

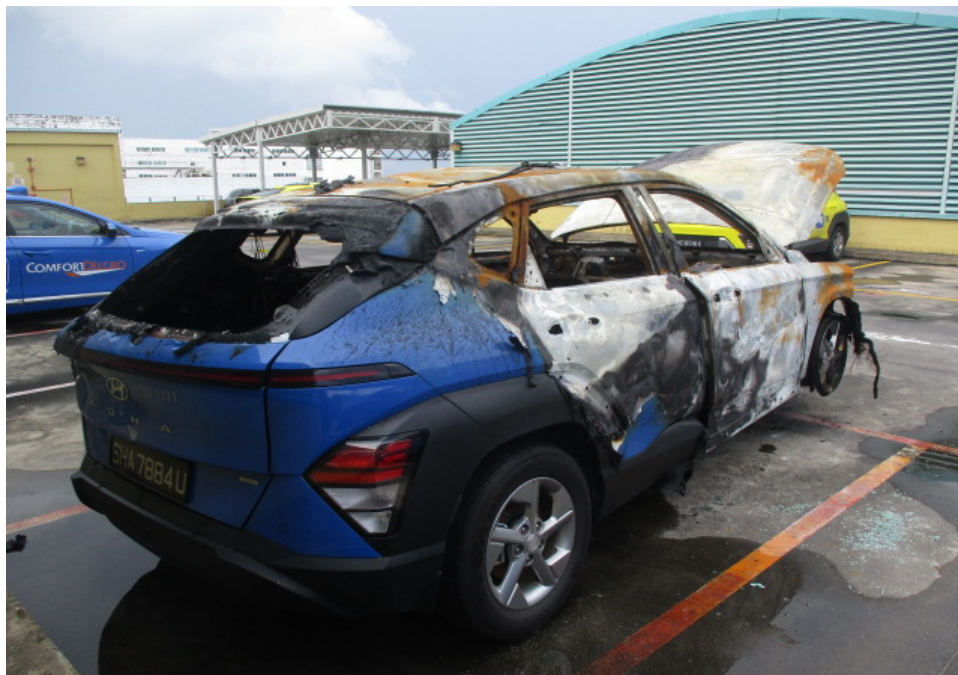
Photo 1 shows the general view of the right rear portion of the Insured Vehicle at the time of our inspection. The rear portion of the Insured Vehicle was relatively unaffected by the fire.

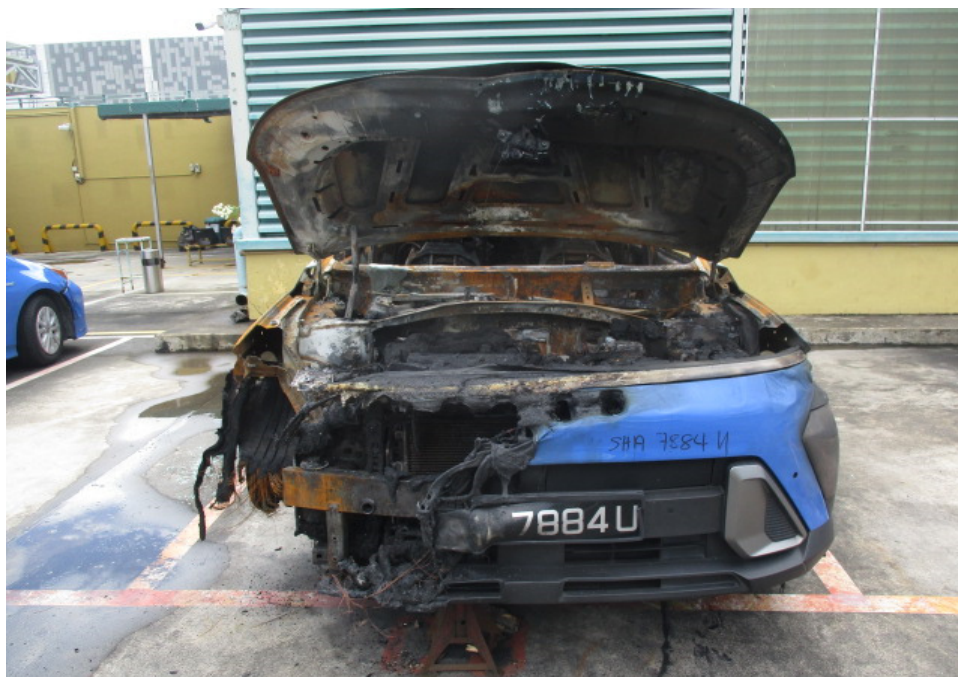
Photo 2 shows the general view of the frontal portion of the Insured Vehicle at the time of our inspection. The fire damage to the Insured Vehicle was confined to its frontal portion, left body and right body. The entire engine compartment of the Insured Vehicle was observed to be severely burnt while the interior compartment was observed to be severely affected by the fire.

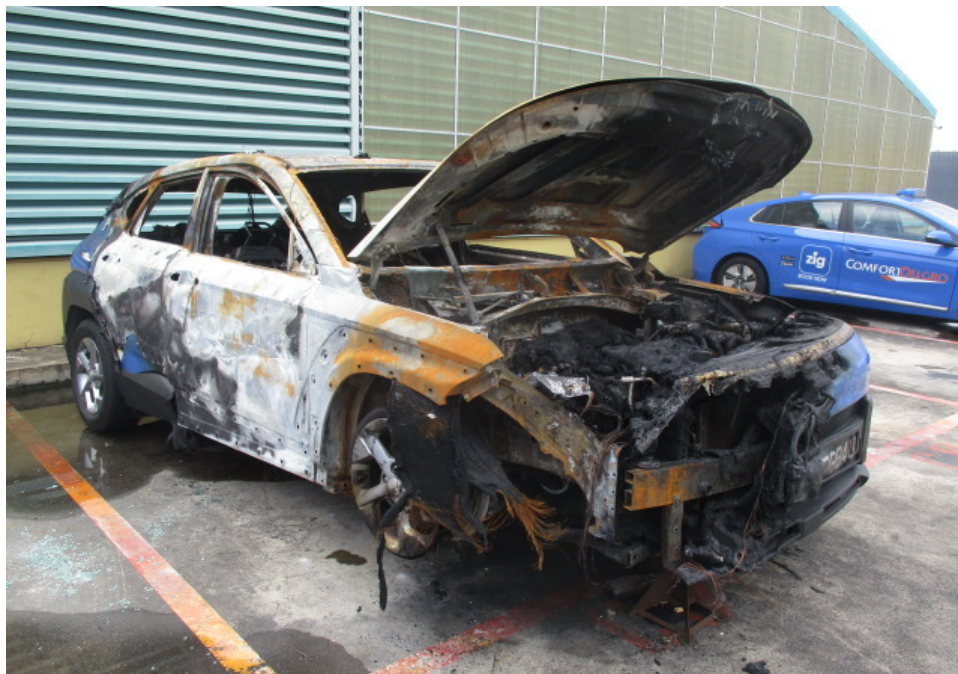
Photo 3 shows the closer view of the right front body of the Insured Vehicle at the time of our inspection. The fire damage to the Insured Vehicle was confined to its frontal portion, left body and right body. Its front bumper, front bonnet, front support panel, front grille, front headlamps, front windscreen, front wheel rims, left body, right body and front tyres were amongst the body parts that were found to have been affected by the fire.

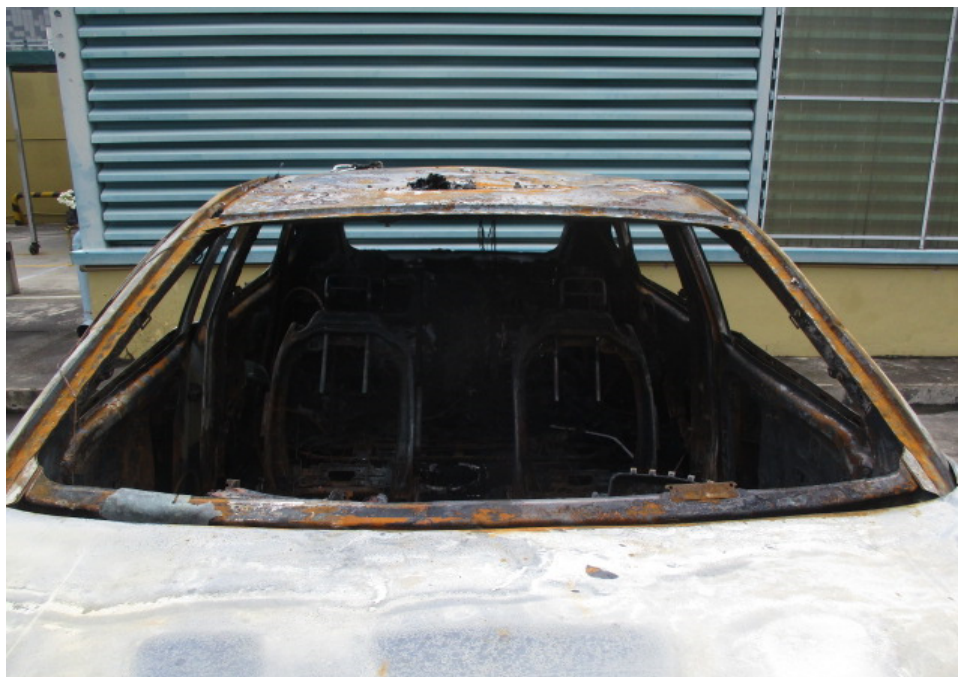
Photo 4 shows the general view of the front windscreen of the Insured Vehicle at the time of our inspection. The fire damage to the front windscreen was extensive.

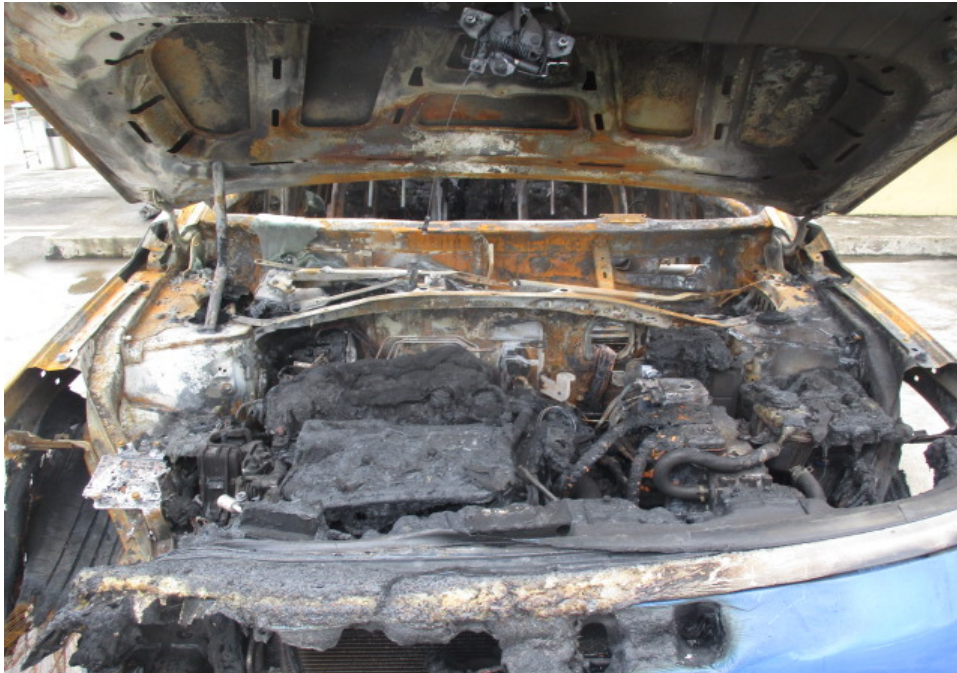
Photo 5 shows the engine compartment of the Insured Vehicle at the time of our inspection. The entire engine compartment of the Insured Vehicle was observed to be severely burnt. Most of the parts inside the engine compartment were found to be burnt and/or melted as a result of the fire.

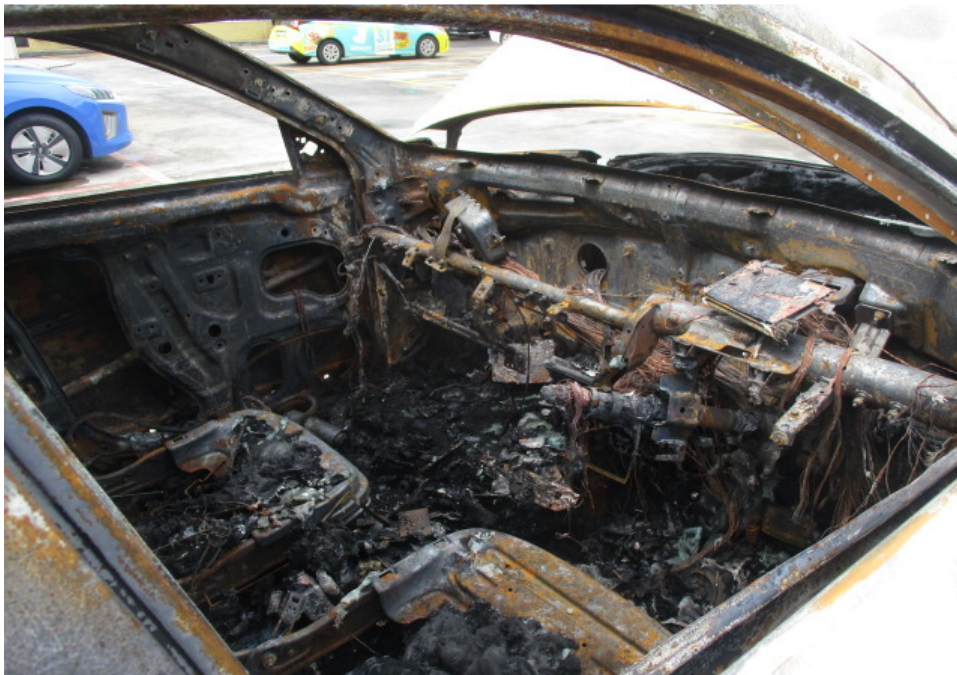
Photo 6 shows the interior compartment of the Insured Vehicle, which was severely affected by the fire.

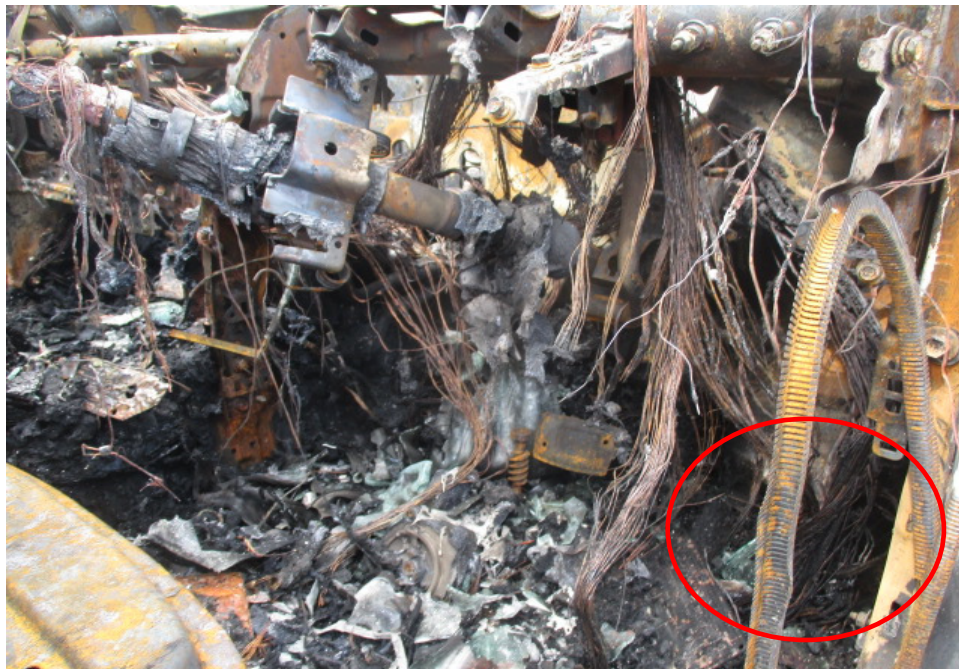
7. For this particular case, the fire appears to have originated within the interior compartment of the Insured Vehicle based on the circumstances of the incident as reported by the driver of the Insured Vehicle.
8. Upon closer examination of the right bottom portion of the driver dashboard panel, which was where the fire to the Insured Vehicle had likely started, we had found faint traces of greenish residue on several stretches of burnt wirings. The presence of greenish residue indicates internal heating of copper wires, a sign of an electrical short circuit occurring. The greenish residue is normally left behind from oxidation as a result of chemical reaction involving the copper wires. This physical evidence would then appear to suggest that the cause of fire to the Insured Vehicle could have possibly been due to electrical in nature. See photos 7 - 9 below.

Photo 7 shows the wirings around the right bottom portion of the driver dashboard panel, which is in the immediate vicinity where the fire to the Insured Vehicle had likely started. We noticed faint traces of greenish residue on several stretches of burnt wirings (circled). The presence of greenish residue indicates internal heating of copper wires, a sign of an electrical short circuit occurring.

26. Having investigated and technically analysed the damages of burnt nature to the Insured Vehicle, we are of the view that the cause of fire to the Insured Vehicle was of electrical in nature. For this particular case, the fire had originated along the original factory fitted wirings inside the interior compartment, somewhere around the right bottom portion of the driver dashboard panel.

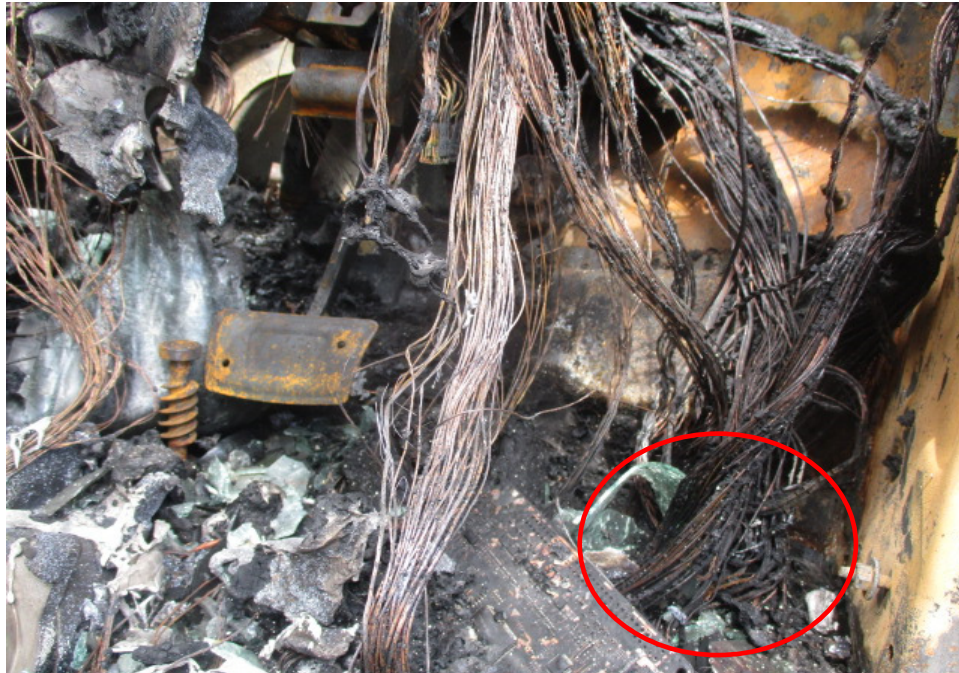
Photo 8 shows a closer view of the burnt wirings around the right bottom portion of the driver dashboard panel. We noticed faint traces of greenish residue on several stretches of the burnt wirings (circled). The greenish residue is normally left behind from oxidation as a result of chemical reaction involving the copper wires.

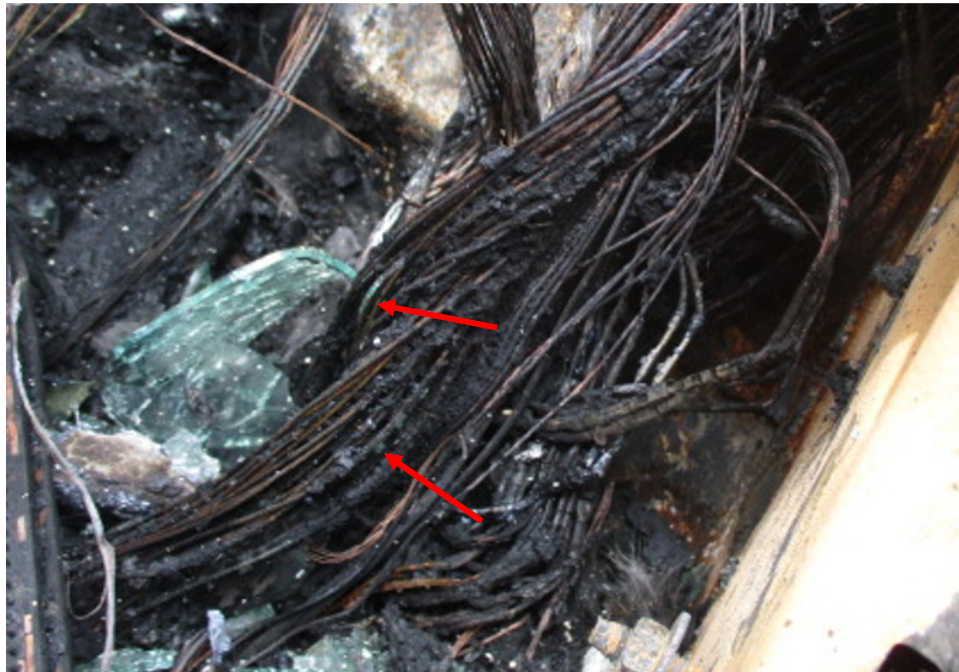
Photo 9 shows a close up view of the faint traces of greenish residue found on several stretches of burnt wirings (arrowed). The presence of such greenish residue suggests occurrence of an electrical short circuit.

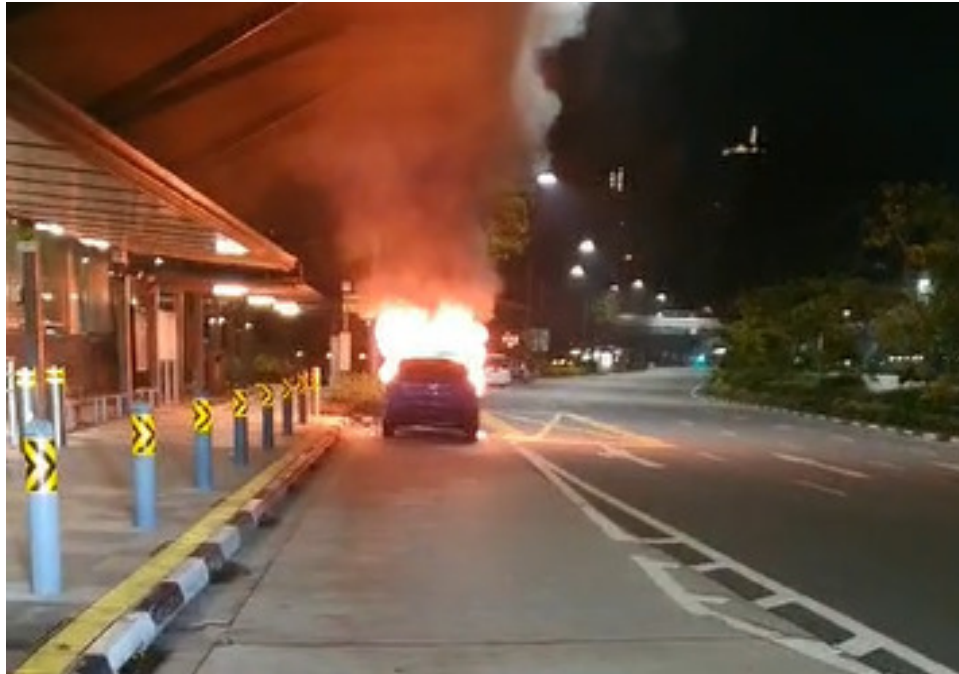
Photo 10 shows the Insured Vehicle on fire before the arrival of the SCDF.

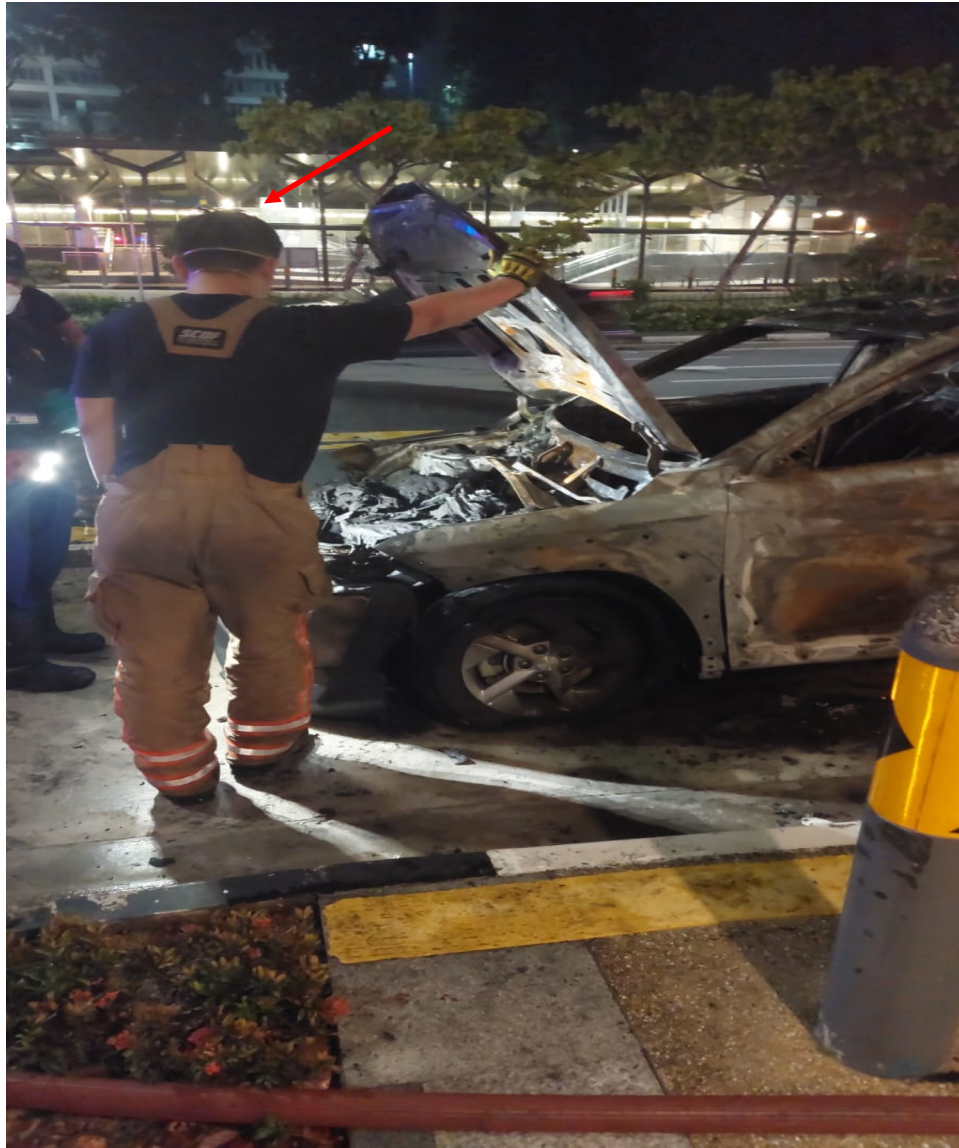
Photo 11 shows firefighters conducting preliminary investigations on the Insured Vehicle post- incident. In general, the information that could be gathered from this photograph had corresponded to the events that were related to us by Mr Cheong, which is the SCDF were present at the incident location (arrowed).
