**TP Motor Claims by SMC 2842 D**

## **DAMAGED VEHICLE (SMC 2842 D) INSPECTION REPORT (WITHOUT PREJUDICE)**

| Registration No | : SMC 2842 D | Mileage | : 164922 Km |
| Make & Model | : TOYOTA C-HR HYBRID 1.8S | Chassis No. | : ZYX102124430 |

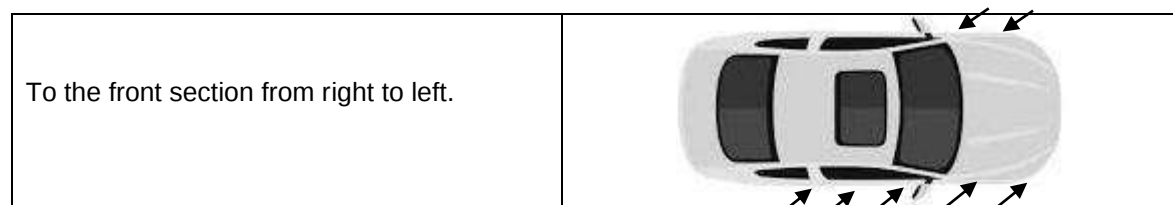
(E) Point of Impact

The impact of the collision has damaged/affected the headlamp, front fender, front door panel, front wheel rims, front suspension and etc.

Our adjusted cost of lump sum repair is **\$18,100.00** and an estimated **9** days is required to repair the vehicle. Please refer to the Annex for a detailed account of the cost estimates.
