Our Ref: TP / HHM SMC2842D/ 10.12/24

DAMAGED VEHICLE (SMC 2842 D) INSPECTION REPORT (WITHOUT PREJUDICE)

Registration No	: SMC 2842 D	Mileage	: 164922 Km
Make & Model	: TOYOTA C-HR HYBRID 1.8S	Chassis No.	: ZYX102124430
Date of Registration	: 28 th June 2018	Engine No.	: 2ZR8457924
Colour	: Red	Engine Capacity.	: 1,797 cc

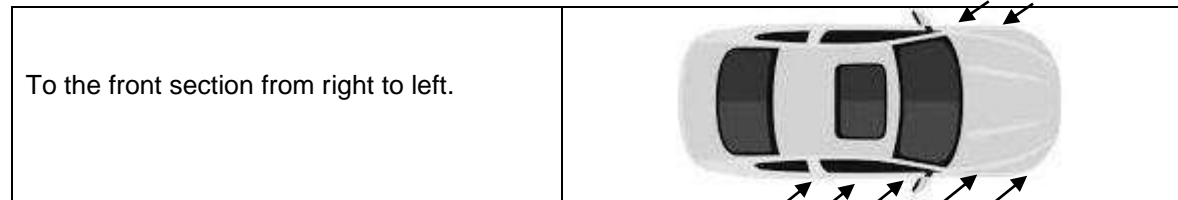
(E) Point of Impact

The impact of the collision has damaged/affected the headlamp, front fender, front door panel, front wheel rims, front suspension and etc.

Our adjusted cost of lump sum repair is **\$18,100.00** and an estimated **9** days is required to repair the vehicle. Please refer to the Annex for a detailed account of the cost estimates.
