LKK Auto Consultants
#01-25 Paya Ubi Industrial Park, 51 Ubi
Avenue 1
408933

Full Report
Registration: SMF9358Z
Printed: 16/12/2024 8:27 AM

Vehicle	
Manufacturer:	TOYOTA
Model:	CAMRY
Sub Model:	BASE MODEL
Model Sheet Number:	70 CR 01
Registration:	SMF9358Z
VIN number:	MR053DK5100113606
Odometer:	40112

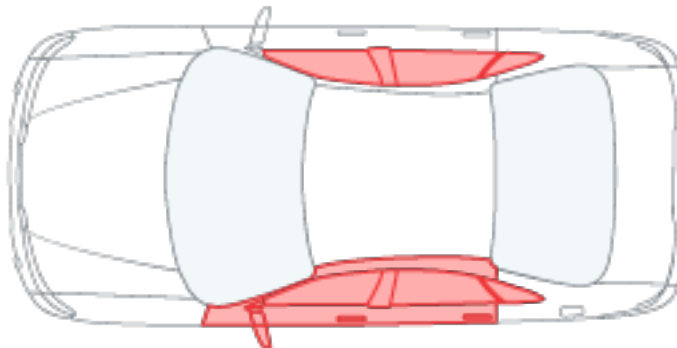
Damage Areas

Time Base 10 WU/h	Price = 42.00 SGD/h	
Code	Description		WU	Price SGD
B200	R + R L/F DOOR		5.0	21.00
NO NUMBER	DIS + ASS L/F DOOR (REMOVED)		17.0	71.40
NO NUMBER	RENEW L/F DOOR PANELLING (DOOR REMOVED)		20.0	84.00
NO NUMBER	R + R LEFT MIRROR		1.0	4.20
0741	L/F WING REPAIR			
1781	L/R DOOR REPAIR		20.0*	84.00
2185	L/SILL MOULDING REPAIR		10.0*	42.00
Labour Cost		Hrs	WU	
Panel / Mechanical Labour		7.30	73.0	306.60
Total of Labour				306.60

prices as at 2015-06-01/01
Code	Description	Part Number	Part Source	Price SGD
1737	L/DOOR MIRROR	87940 33D20	Original	480.00
1485	L/F DOORSKIN	67112 33100	Original	780.00
1519	L/F DOOR WINDOW	68102 33330	Original	260.00
1659	L/F LWR WINDOW MLDG	75720 33170	Original	95.00
