Your Ref: CMTD2403707
Our Ref : CI/SMO24006488/J

5 December 2024

**TECHNICAL INVESTIGATION REPORT OF INSURED VEHICLE SKU 7160J
INVOLVED IN AN ACCIDENT ON 14 NOVEMBER 2024**

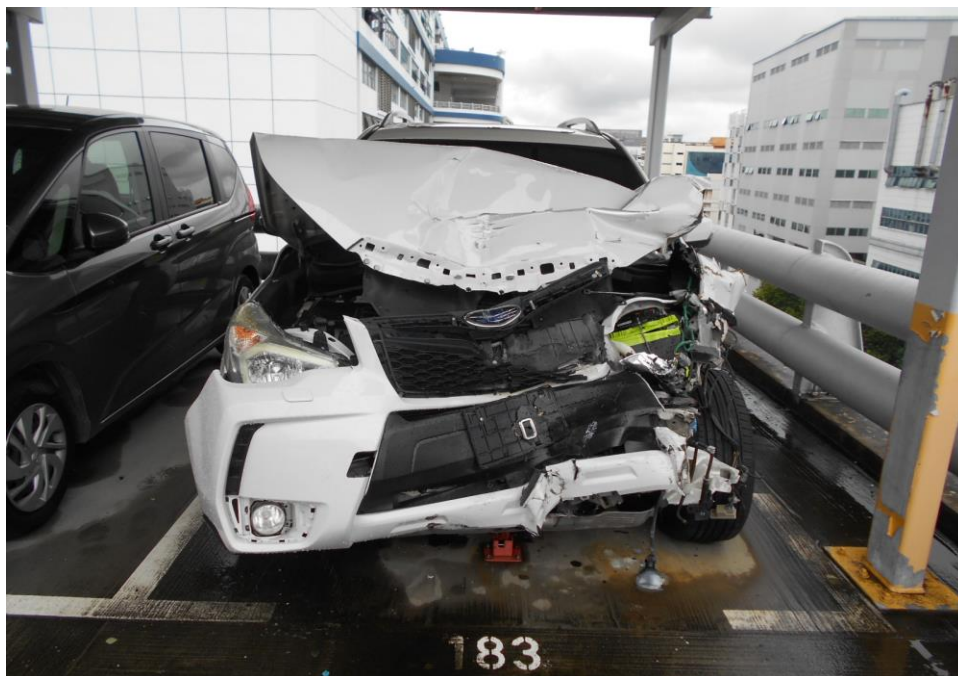
Photo 1 shows a general view of the Insured Vehicle front portion at the time of my inspection. The Insured Vehicle was observed to have sustained damage at its front portion. Its front windscreen, front bonnet, front headlamps and front bumper was amongst the body parts damaged as a result of the accident.

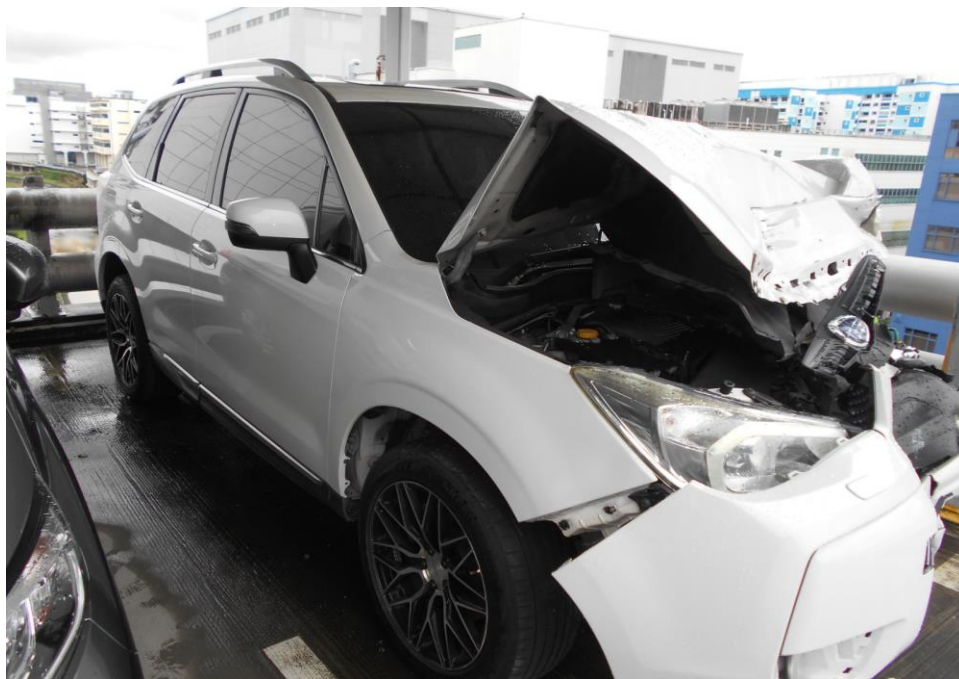
Photo 2 shows the general view of the right body of the insured vehicle at the time of my inspection its unaffected by the accident.

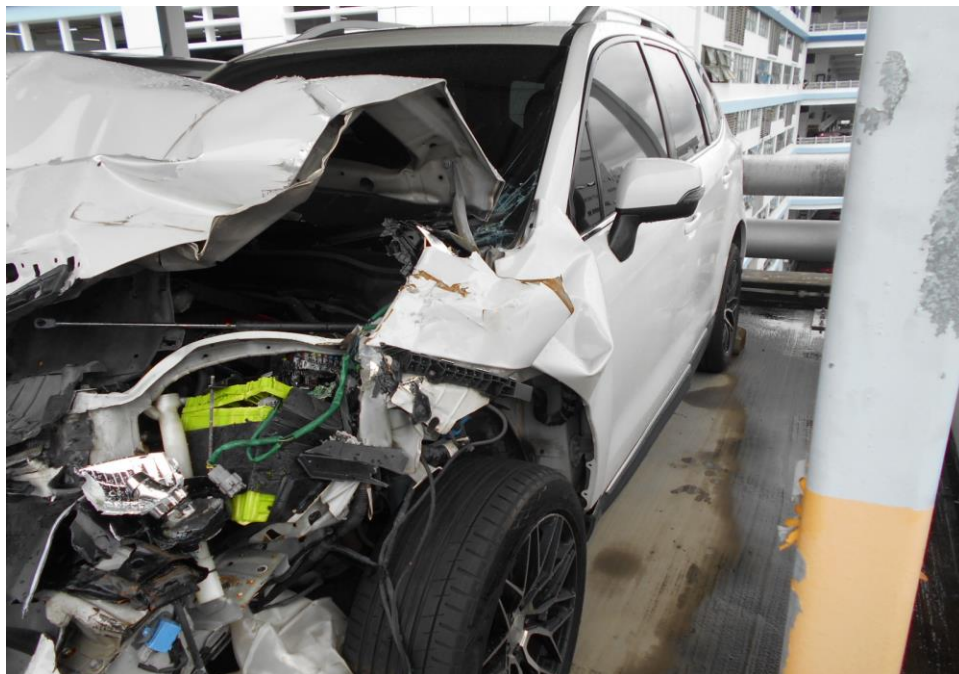
Photo 3 shows a general view of the Insured Vehicle left body at the time of my inspection. The Insured Vehicle was observed to have sustained damage at its left body. Its front left fender was amongst the body parts damaged as a result of the accident.

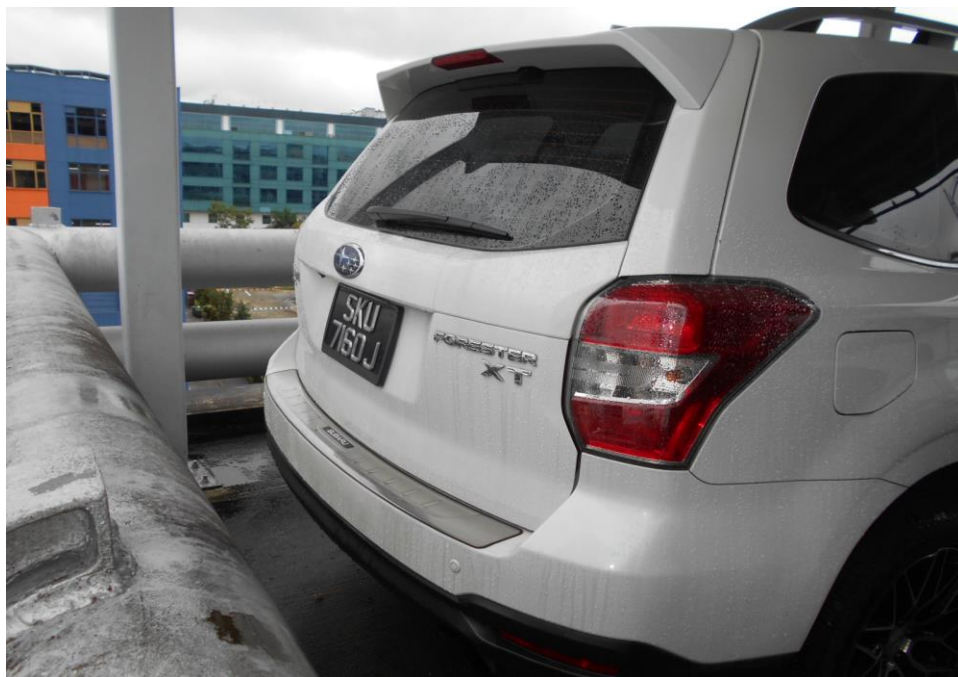
Photo 4 shows the general view of the rear portion of the insured vehicle at the time of my inspection its unaffected by the accident.

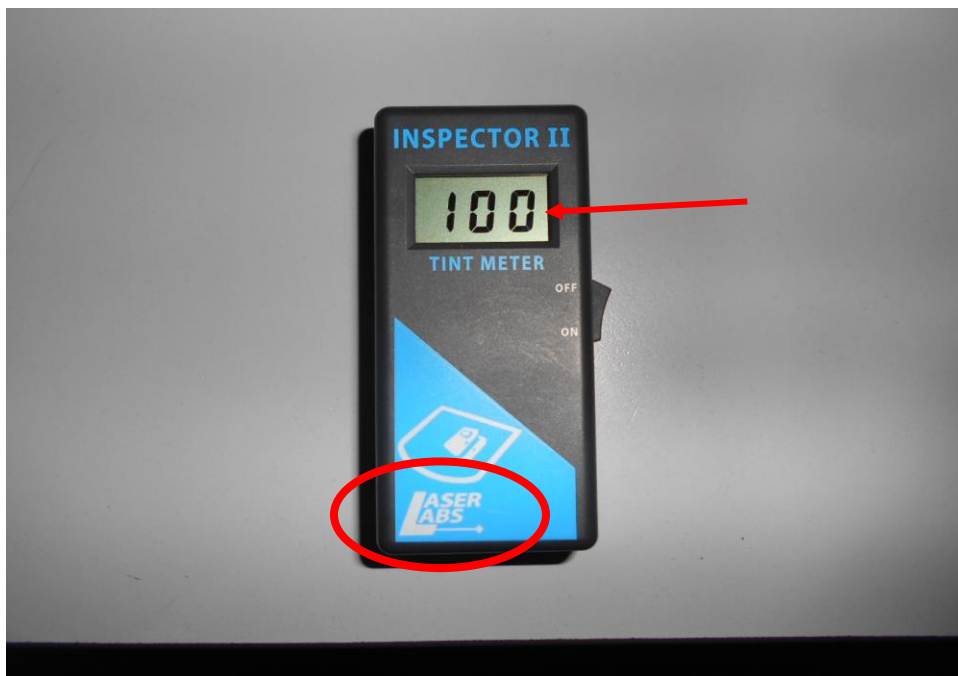
Photo 5 shows the Tint Meter used to measure the Visible Light Transmission (VLT) on the Insured Vehicle's windscreen and windows which has been recalibrated (red arrow) before the testing of the Visible Light Transmission (VLT) of the window and windscreen tints. The brand of the Tint Meter was 'Laser ABS'

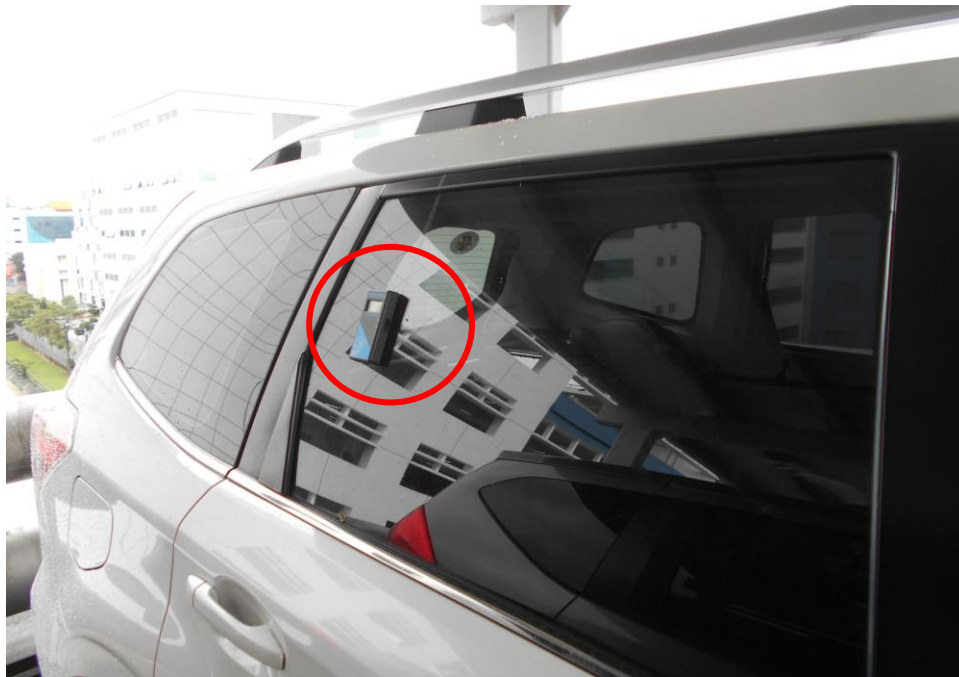
Photo 6 shows a general view of the measurement of the rear right window tint of the Insured Vehicle using a tint meter (red circle). Which measures the amount of Visible Light Transmission (VLT) that passes through a material. The Visible Light Transmission (VLT) measured on a scale of 0- 100%, with 0% meaning no light passes through and 100% meaning all light passes through.

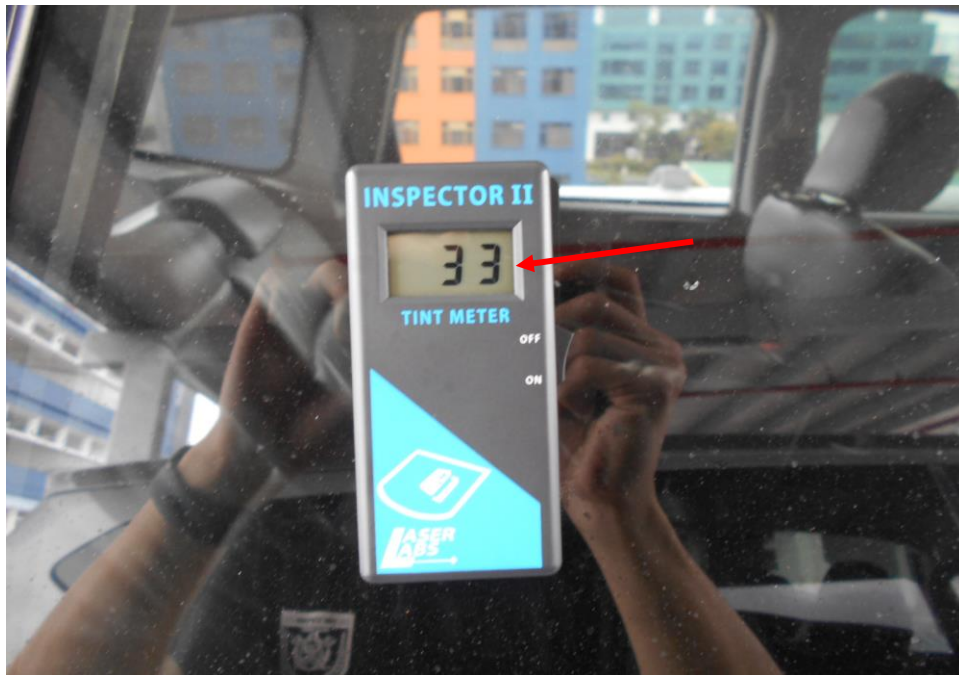
Photo 7 shows the window tint reading of the rear right side window on the Insured Vehicle at the time of my inspection. The rear right side window tint is measured at 33% (red arrow) Visible Light Transmission (VLT) which is within the

51 UBI AVE 1, #01-25 Requirements: DTT 25% LAR 35% PVE 35% TPA (0.00033) Rear: (065) 67414108
LTA requirements, as 25% of light must be able to pass through the rear windscreen and two rear side windows.

11. However, having examined the rear right side window and rear left side window, along with the rear windscreen, it was revealed that the rear right side window was measured at 33% Visible Light Transmission (VLT), the rear left side window was measured at 32% Visible Light Transmission (VLT) and the rear windscreen was measured at 26% which is within the requirements of the LTA.

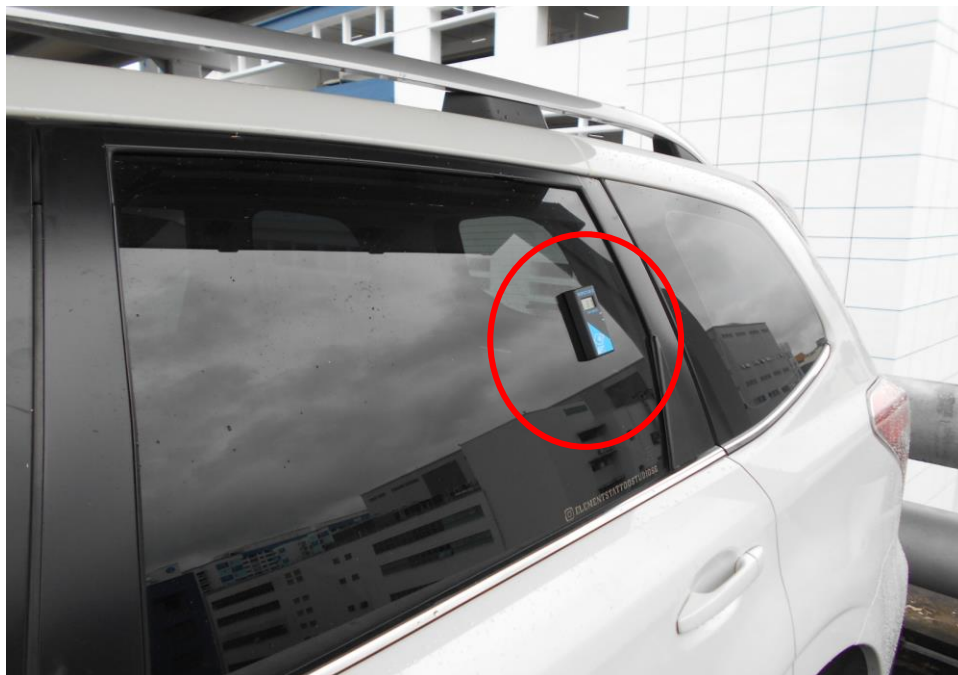
Photo 8 shows a general view of the measurement of the rear left window tint of the Insured Vehicle using a tint meter (red circle). Which measures the amount of Visible Light Transmission (VLT) that passes through a material. The Visible Light Transmission (VLT) measured on a scale of 0- 100%, with 0% meaning no light passes through and 100% meaning all light passes through.

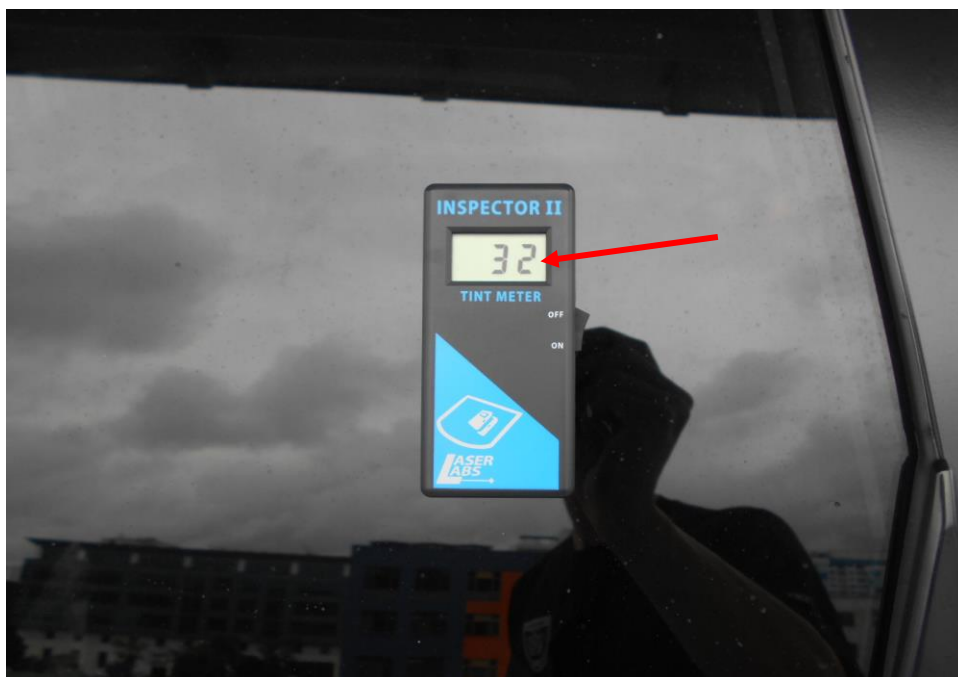
Photo 9 shows the window tint reading of the rear left side window on the Insured Vehicle at the time of my inspection. The rear right side window tint is measured at 32% (red arrow) Visible Light Transmission (VLT) which is within the

LTA requirements, as 25% of light must be able to pass through the rear windscreen and two rear side windows.

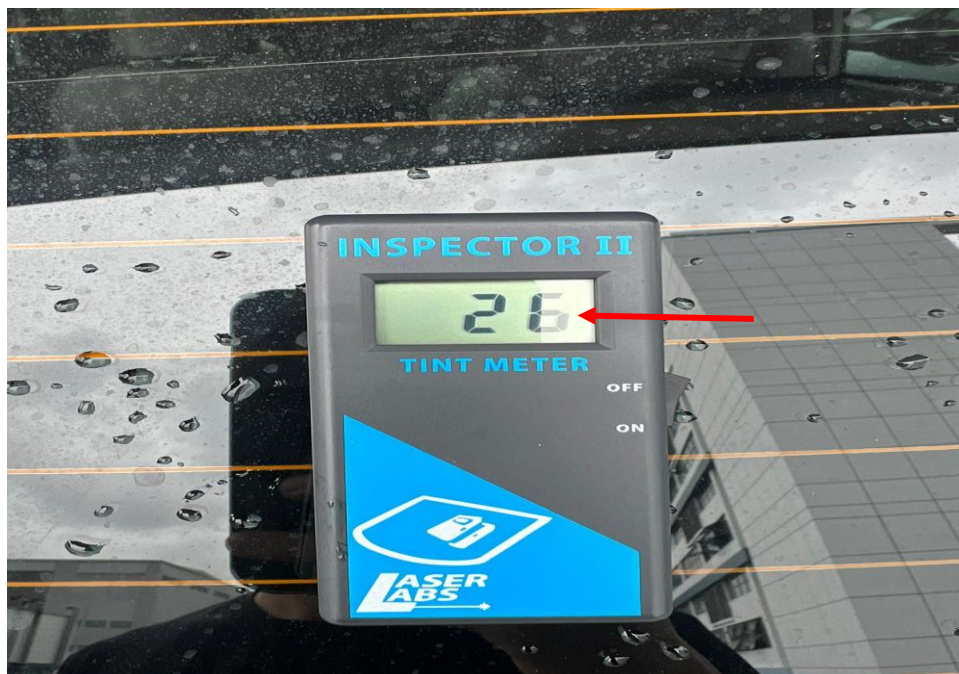
Photo 10 shows the window tint reading of the rear windscreen on the Insured Vehicle at the time of my inspection. The rear windscreen tint percentage is measured at 26% (red arrow) Visible Light Transmission (VLT) which is within the LTA requirements, as 25% of light must be able to pass through the rear windscreen and two rear side windows.

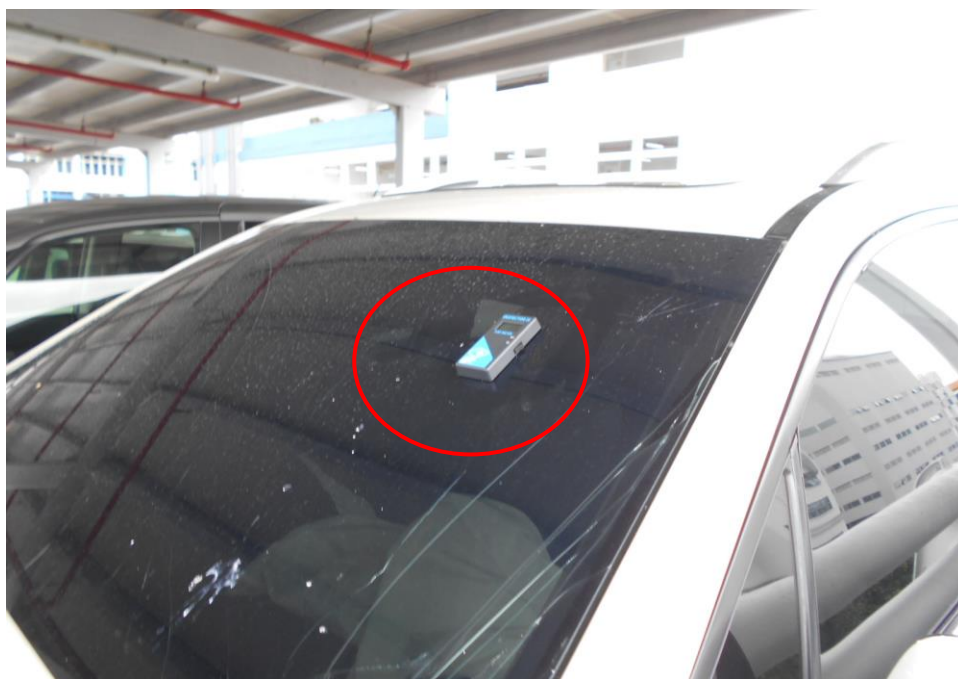
Photo 12 shows a general view of the measurement of the front windscreen tint of the Insured Vehicle using a tint meter (red circle) which measures the amount of Visible Light Transmission (VLT) that passes through a material. The Visible Light Transmission (VLT) measured on a scale of 0- 100%, with 0% meaning no light passes through and 100% meaning all light passes through.

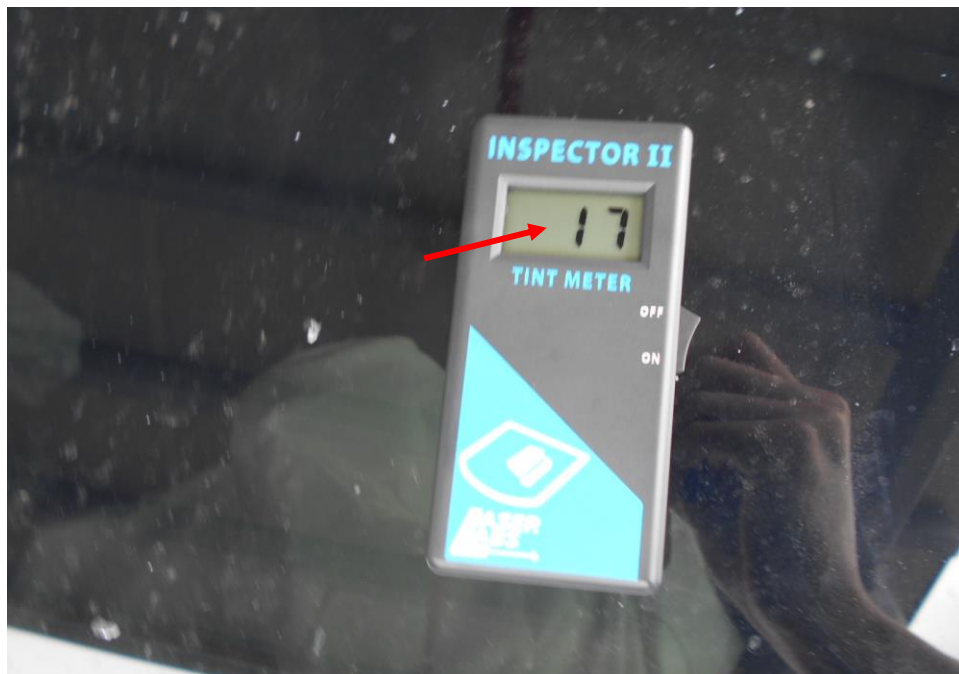
Photo 13 shows the window tint reading of the front windscreen on the Insured Vehicle at the time of my inspection. The front windscreen tint is measured at 17% (red arrow) Visible Light Transmission (VLT) which is not within LTA requirements, as 70% of light must be able to pass through the front windscreen and two front side windows.

10. In general, the front windscreen was measured at 17% Visible Light Transmission (VLT), whilst the front right side was measured at 15% Visible Light Transmission (VLT) and front left side window were measured at 13% Visible Light Transmission (VLT). Which was not within the requirements of the LTA. As according to the LTA guidelines and compliance at least 70% of light must be able to pass through the front windscreen and the two front side windows

12. Having inspected the Insured Vehicle, and also having considered the nature of the accident. We are of view that the 3 window tint film installed on the Insured Vehicle was not within the requirements of the LTA. These window tint film installed could have possibly slightly contributed to the accident on 14 November 2024, as at the material time (day hours) of accident. The driver's visibility would have been impaired as compared to a vehicle with LTA compliant window tints or un-tinted windows and windscreens.

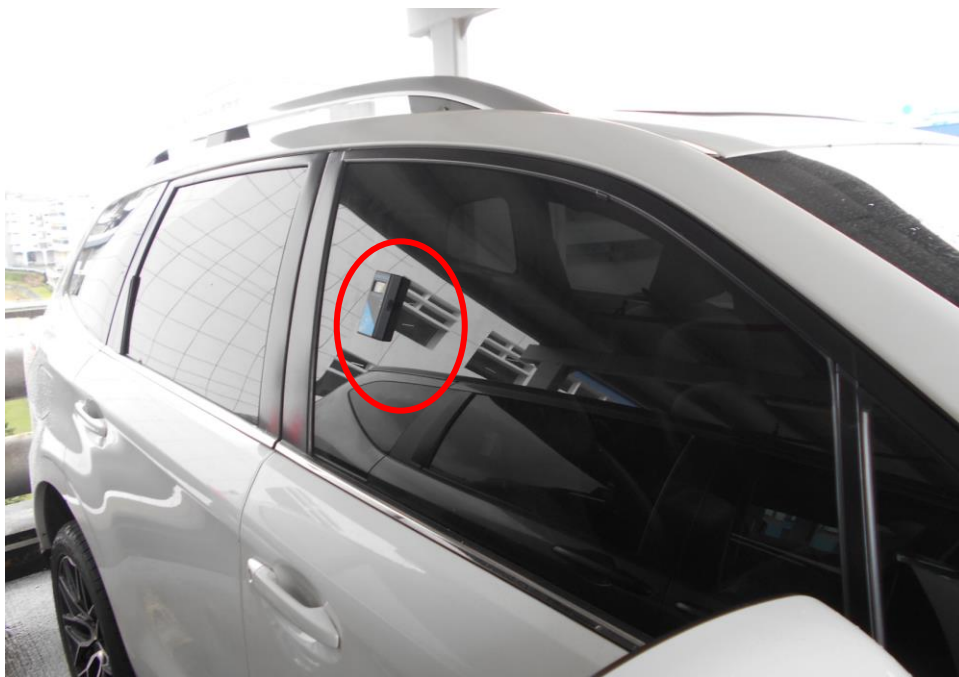
Photo 14 shows a general view of the measurement of the front right window tint of the Insured Vehicle using a tint meter (red circle). Which measures the amount

51 UBI AVE 1, #01-01 UBI TECH PARK, SINGAPORE 408725 Tel: (065) 67414108
of Visible Light Transmission (VLT) that passes through a material. The Visible
Light Transmission (VLT) measured on a scale of 0- 100%, with 0% meaning no
light passes through and 100% meaning all light passes through.

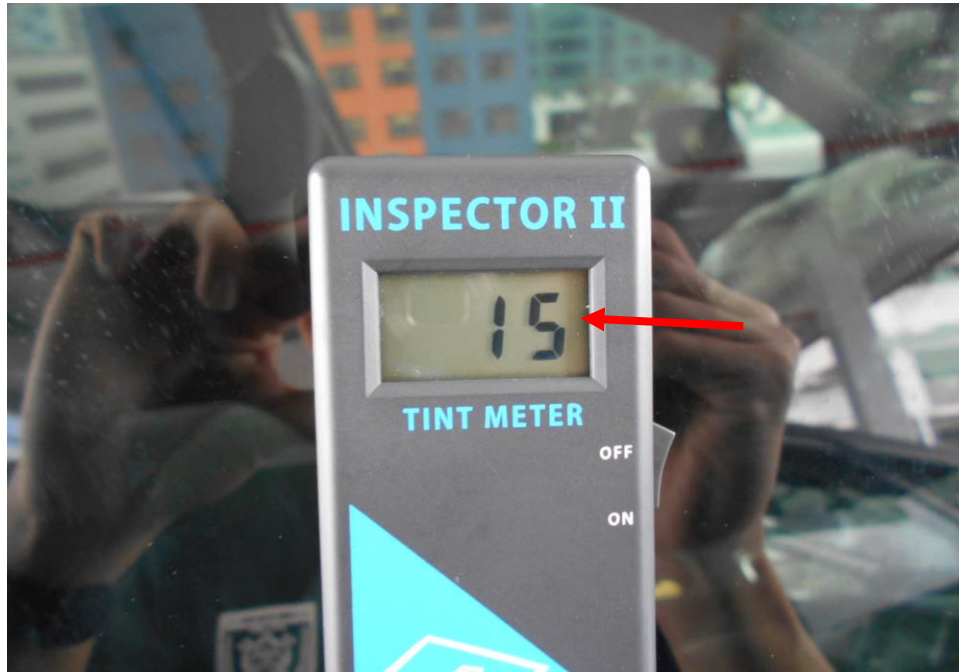
Photo 15 shows the window tint reading of the front right side window on the Insured Vehicle at the time of my inspection. The front right window tint is measured at 15% (red arrow) Visible Light Transmission (VLT) which is not within LTA requirements, as 70% of light must be able to pass through the front windscreen and two front side windows.

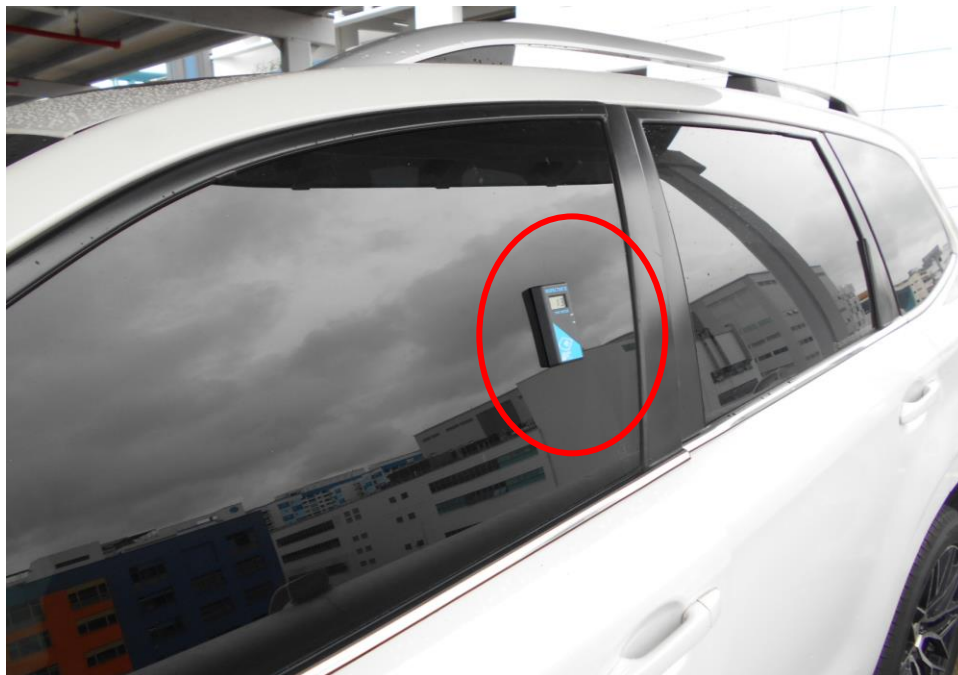
Photo 16 shows a general view of the measurement of the front left window tint of the Insured Vehicle using a tint meter (red circle). Which measures the amount

51 UBI AVE 1, #01-25 UBI TECH PARK, SINGAPORE 408725 Tel: (065) 67414108
of Visible Light Transmission (VLT) that passes through a material. The Visible
Light Transmission (VLT) measured on a scale of 0- 100%, with 0% meaning no
light passes through and 100% meaning all light passes through.

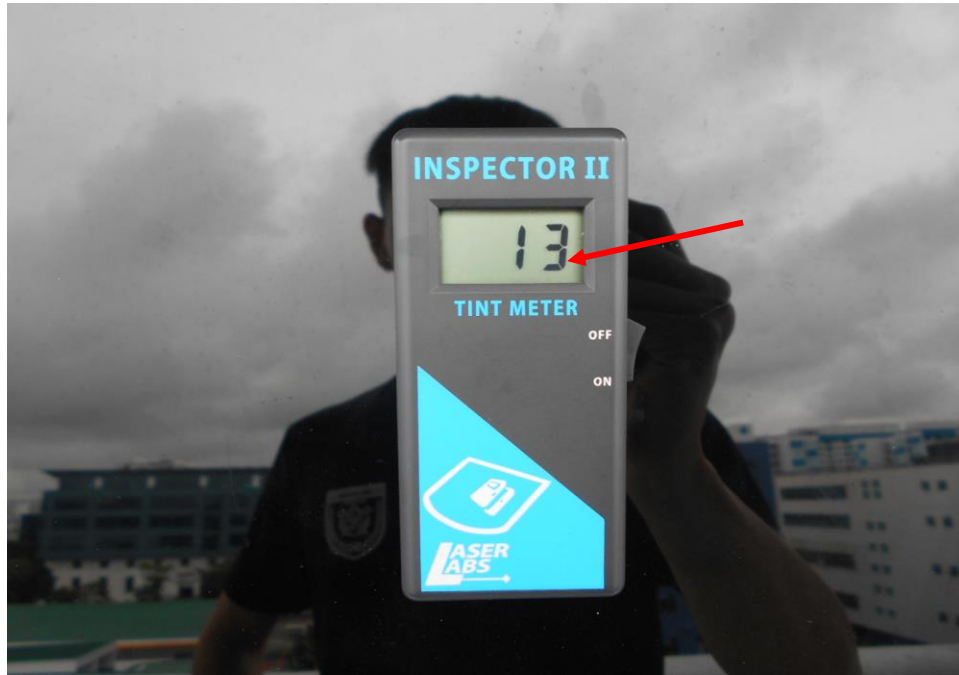
Photo 17 shows the window tint reading of the front left side window on the Insured Vehicle at the time of my inspection. The front left side window tint is measured at 5% (red arrow) Visible Light Transmission (VLT) which is not within LTA requirements, as 70% of light must be able to pass through the front windscreen and two front side windows.
