## VEHICLE APPRAISAL REPORT

Our Reference: **TP19-108156**  
 Your Reference: -  
 Vehicle Number: **SJT3131L**

Assessment of Vehicle No: **SJT3131L**  
 Date of Accident: **26-Oct-19**  
 Date of Inspection: **29-Oct-19**

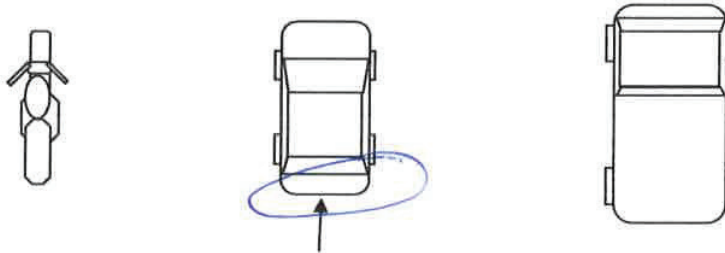
At the time of inspection, this vehicle sustained damages to the **Rear portion**. Please see attached scheduled details.
