## VEHICLE APPRAISAL REPORT

Our Reference: **TP19-108156**  
 Your Reference: -  
 Vehicle Number: **SJT3131L**

Assessment of Vehicle No: **SJT3131L**  
 Date of Accident: **26-Oct-19**  
 Date of Inspection: **29-Oct-19**

Reg No:	SJT3131L	Make:	BMW
Reg date:	2009	Model:	318i 2.0L
Colour:	Silver	Engine No:	-
Type:	-	Chassis No:	WBAPF72000A143203
Type of Claim:	-	Odometer No:	186131 km
Market Value:	-	Engine Cap.:	1995 cc

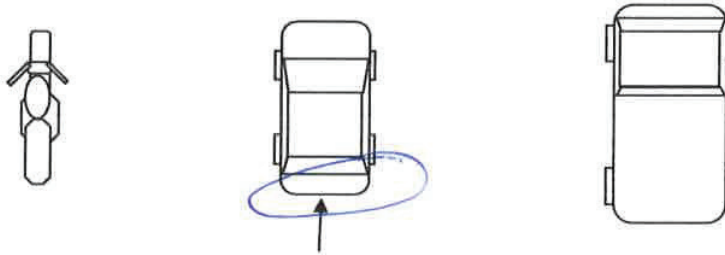
#### **DESCRIPTION OF DAMAGE**

At the time of inspection, this vehicle sustained damages to the **Rear portion**. Please see attached scheduled details.
