**TECHNICAL INVESTIGATION REPORT OF INSURED VEHICLE SKZ 8123J
INVOLVED IN AN ACCIDENT ON 14 DECEMBER 2024**

Registration Number : SKZ 8123J
Make & Model : TOYOTA ALPHARD 2.5G CVT ABS D/AIRBAG 2WD 5DR
Year of Registration : APRIL 2016
Chassis Number : AGH300032567
Speedo Reading : N/A

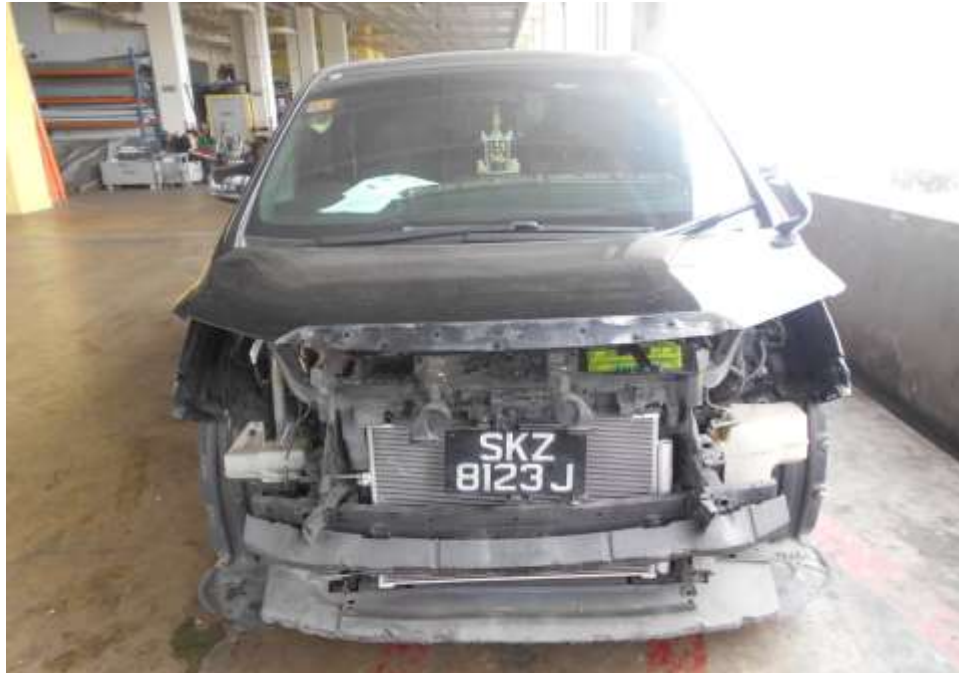
Photo 1 shows a general view of the Insured Vehicle front portion at the time of my inspection. The Insured Vehicle was observed to be in satisfactory condition.

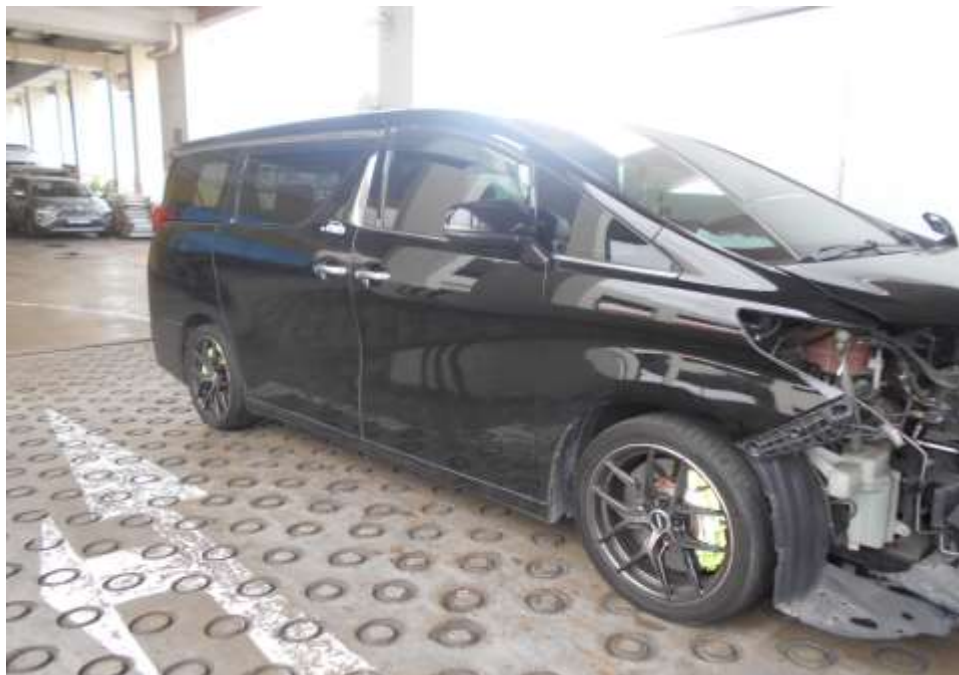
Photo 2 shows a general view of the Insured Vehicle right body at the time of my inspection. The Insured Vehicle was observed to be in satisfactory condition.

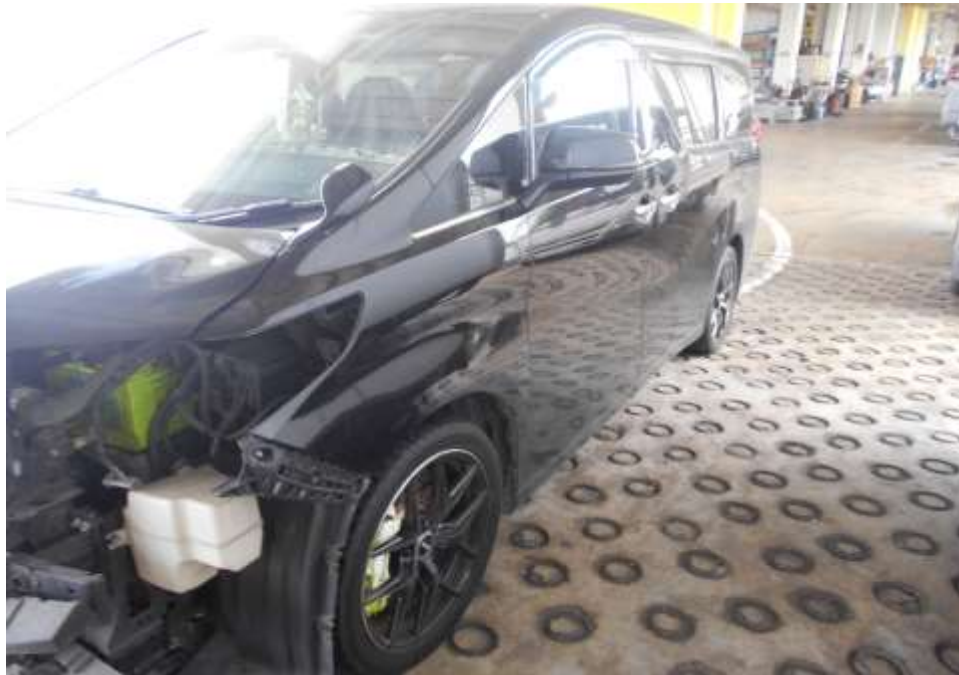
Photo 3 shows a general view of the Insured Vehicle left body at the time of my inspection. The Insured Vehicle was observed to be in satisfactory condition.

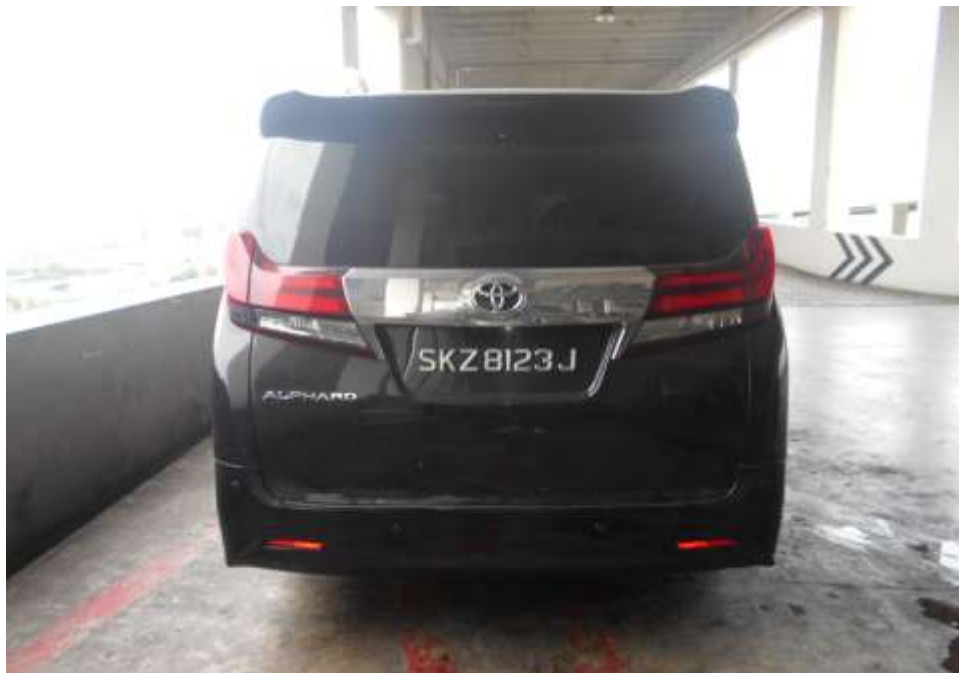
Photo 4 shows the general view of the rear portion of the insured vehicle at the time of my inspection its unaffected by the accident.

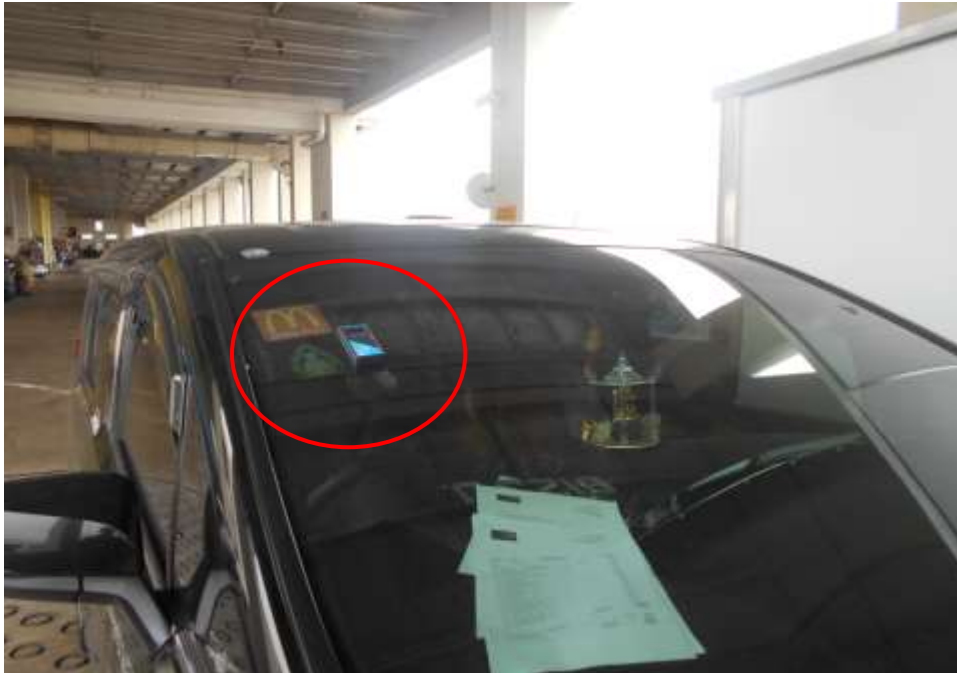
Photo 6 shows a general view of the measurement of the front windscreen tint of the Insured Vehicle using a tint meter (red circle) which measures the amount of Visible Light Transmission (VLT) that passes through a material. The Visible Light Transmission (VLT) measured on a scale of 0- 100%, with 0% meaning no light passes through and 100% meaning all light passes through.

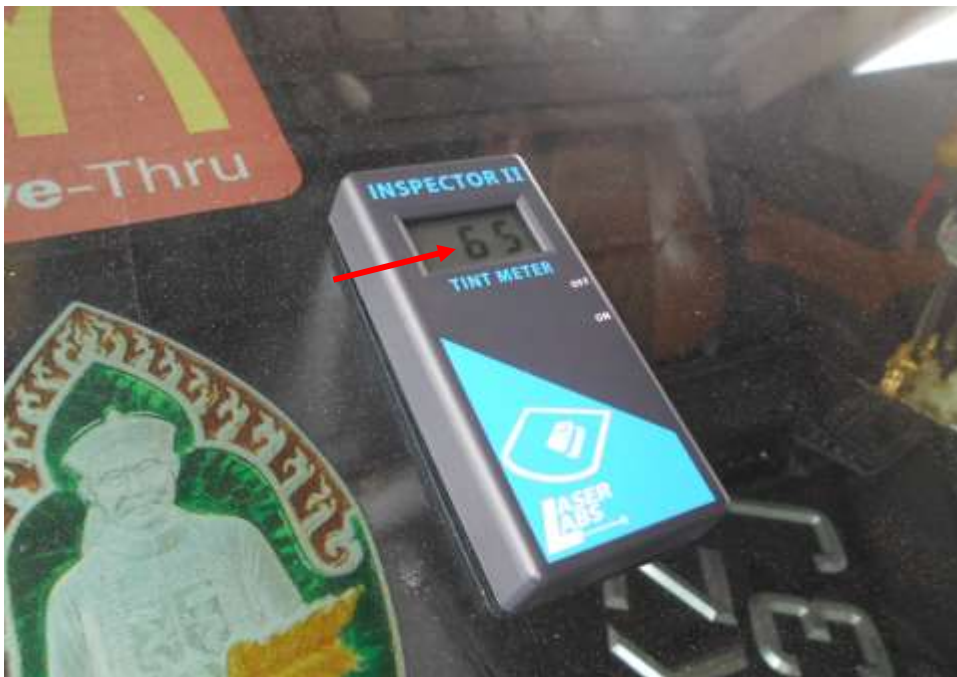
Photo 7 shows the window tint reading of the front windscreen on the Insured Vehicle at the time of my inspection. The front windscreen tint is measured at 65% (red arrow) Visible Light Transmission (VLT) which is not within LTA requirements, as 70% of light must be able to pass through the front windscreen and two front side windows.

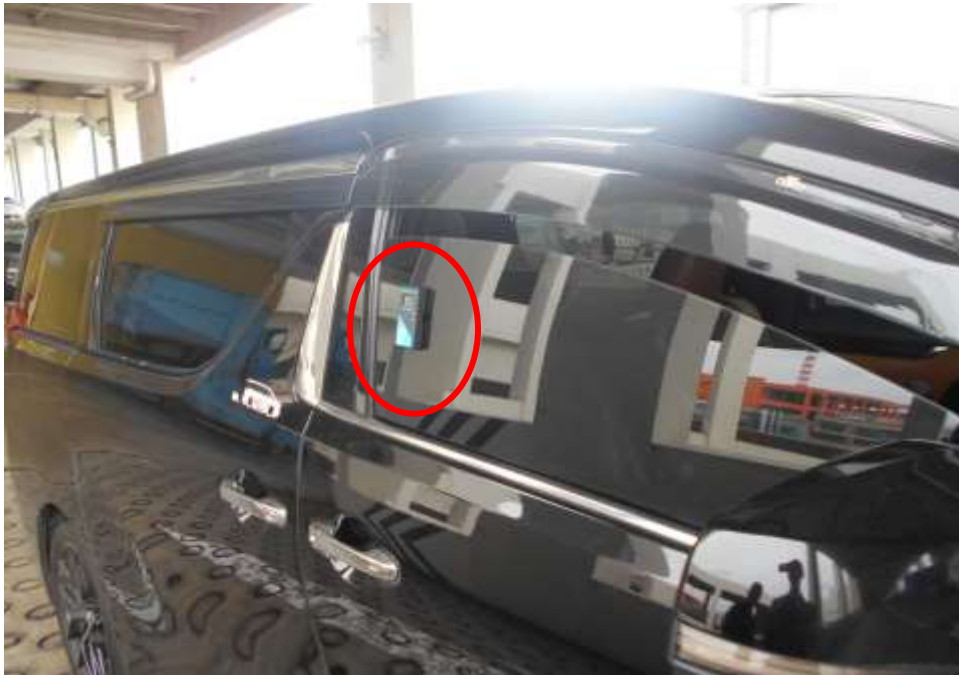
Photo 8 shows a general view of the measurement of the front right window tint of the Insured Vehicle using a tint meter (red circle). Which measures the amount of Visible Light Transmission (VLT) that passes through a material. The Visible Light Transmission (VLT) measured on a scale of 0- 100%, with 0% meaning no light passes through and 100% meaning all light passes through.

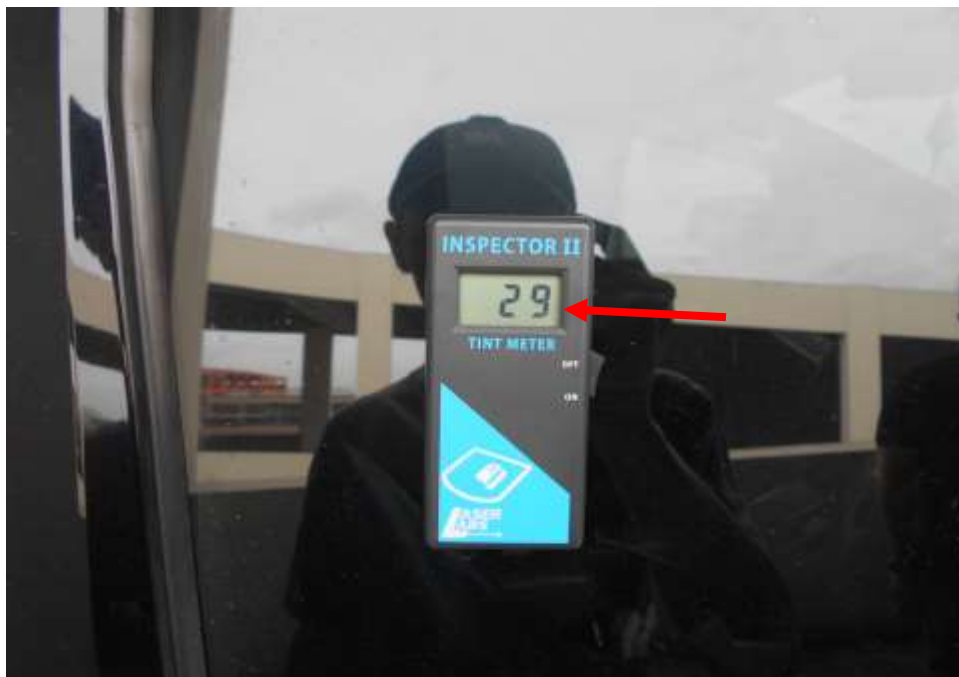
Photo 9 shows the window tint reading of the front right side window on the Insured Vehicle at the time of my inspection. The front right window tint is measured at 29% (red arrow) Visible Light Transmission (VLT) which is not within LTA requirements, as 70% of light must be able to pass through the front windscreen and two front side windows.

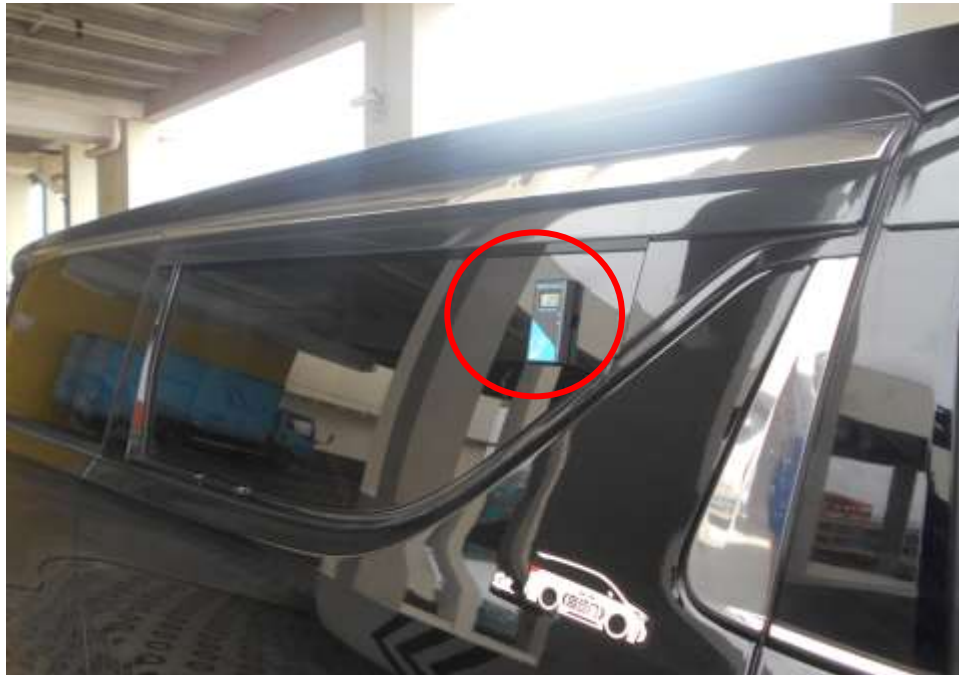
Photo 10 shows a general view of the measurement of the rear right centre window tint of the Insured Vehicle using a tint meter (red circle). Which measures the amount of Visible Light Transmission (VLT) that passes through a material. The Visible Light Transmission (VLT) measured on a scale of 0- 100%, with 0% meaning no light passes through and 100% meaning all light passes through.

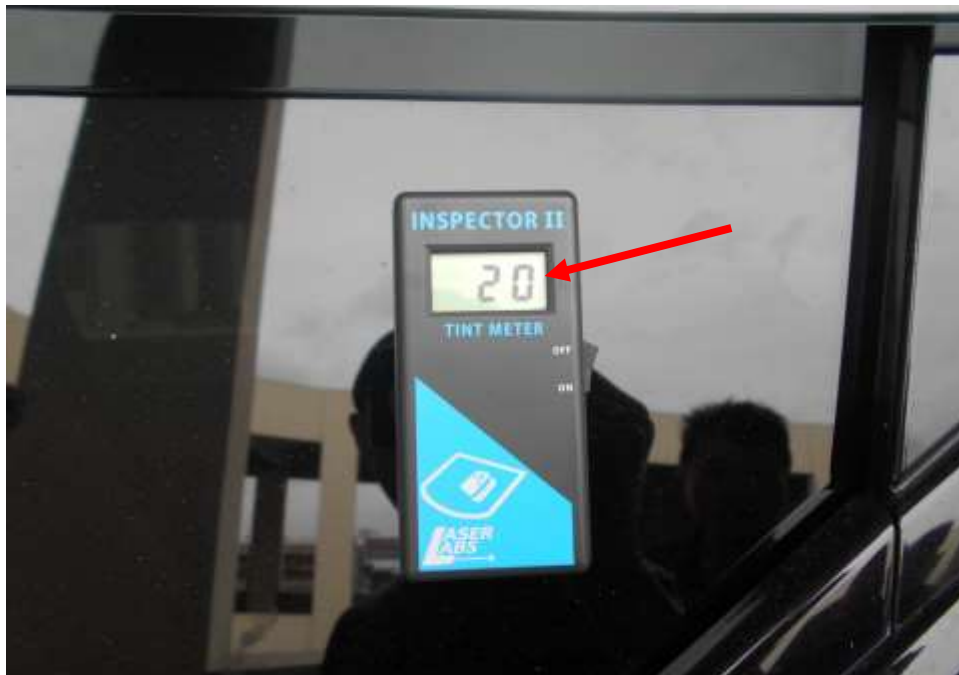
Photo 11 shows the window tint reading of the rear right side centre window on the Insured Vehicle at the time of my inspection. The rear right side window tint is measured at 20% (red arrow) Visible Light Transmission (VLT) which is not within LTA requirements, as 25% of light must be able to pass through the rear windscreen and two rear side windows.

12. The rear right centre/rear right windows along with the rear left centre/ rear left windows, along with the rear windscreen, were measured at 20% (VLT) for the rear right centre window, 21% (VLT) for the rear right window, 21% (VLT) for the rear left centre window, 24% (VLT) for the rear left window and 19% (VLT) for the rear windscreen which was not within the requirements of the LTA. (Refer to photo 22 above.

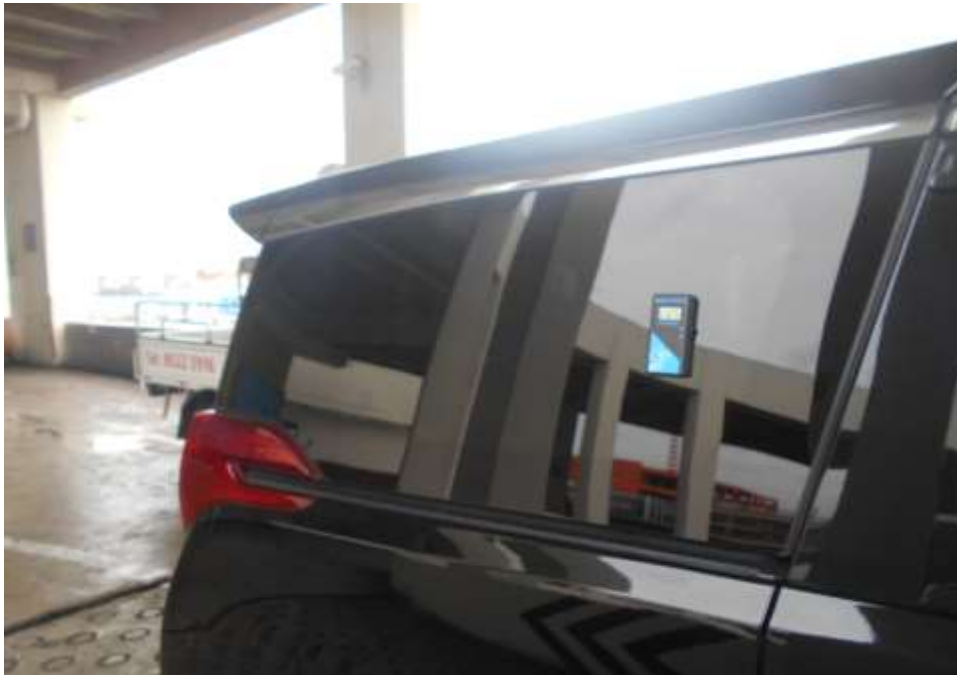
Photo 12 shows a general view of the measurement of the rear right window tint of the Insured Vehicle using a tint meter (red circle). Which measures the amount of Visible Light Transmission (VLT) that passes through a material. The Visible Light Transmission (VLT) measured on a scale of 0- 100%, with 0% meaning no light passes through and 100% meaning all light passes through.

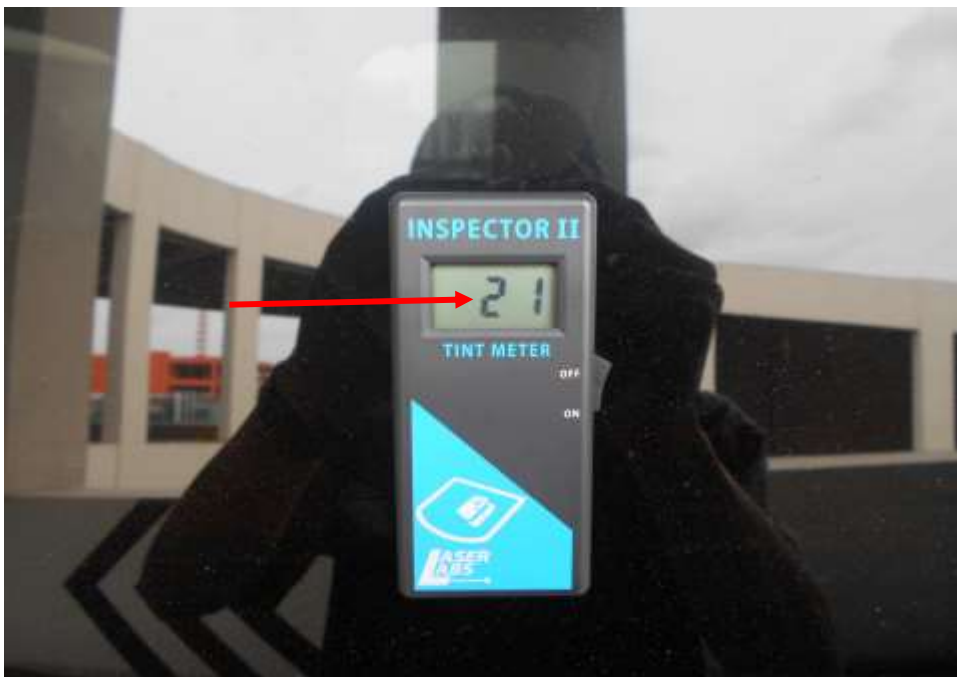
Photo 13 shows the window tint reading of the rear right side window on the Insured Vehicle at the time of my inspection. The rear right side window tint is measured at 21% (red arrow) Visible Light Transmission (VLT) which is not within LTA requirements, as 25% of light must be able to pass through the rear windscreen and two rear side windows.

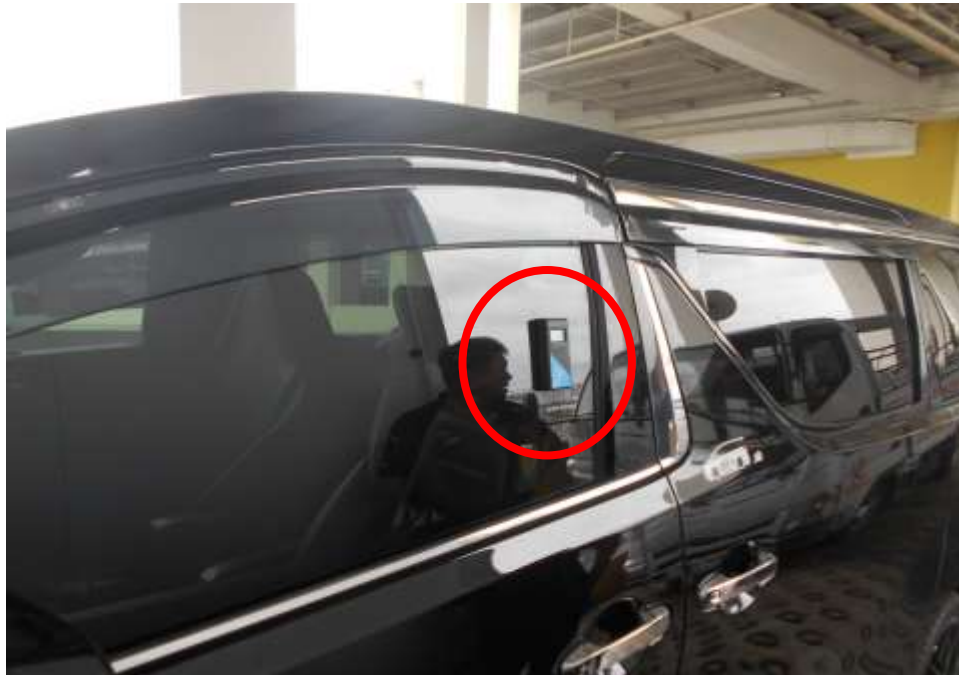
Photo 14 shows a general view of the measurement of the front left window tint of the Insured Vehicle using a tint meter (red circle). Which measures the amount of Visible Light Transmission (VLT) that passes through a material. The Visible Light Transmission (VLT) measured on a scale of 0- 100%, with 0% meaning no light passes through and 100% meaning all light passes through.

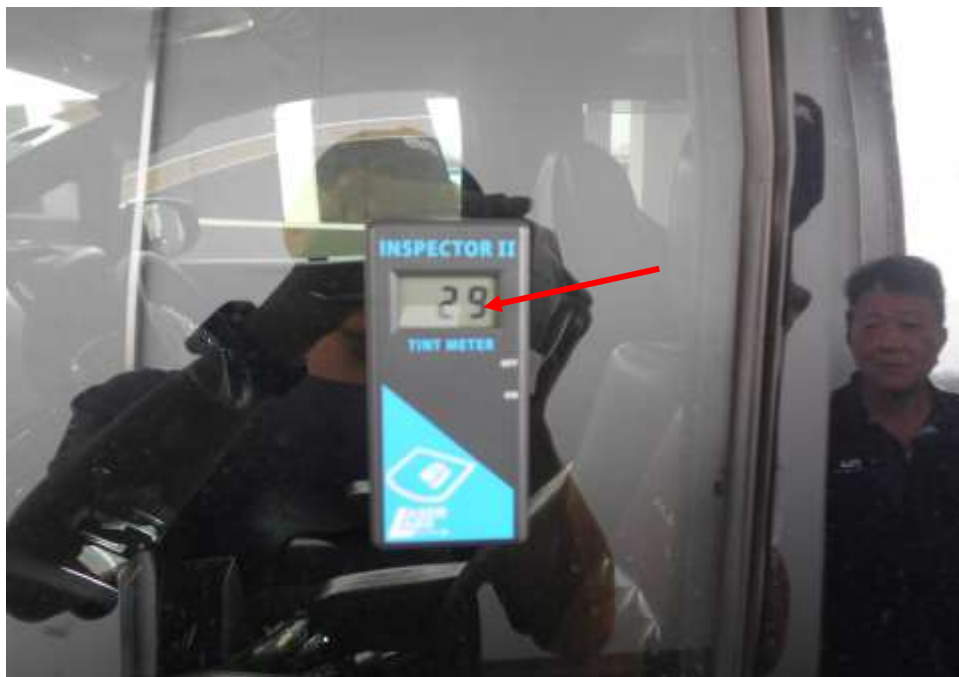
Photo 15 shows the window tint reading of the front left side window on the Insured Vehicle at the time of my inspection. The front left side window tint is measured at 5% (red arrow) Visible Light Transmission (VLT) which is not within LTA requirements, as 70% of light must be able to pass through the front windscreen and two front side windows.

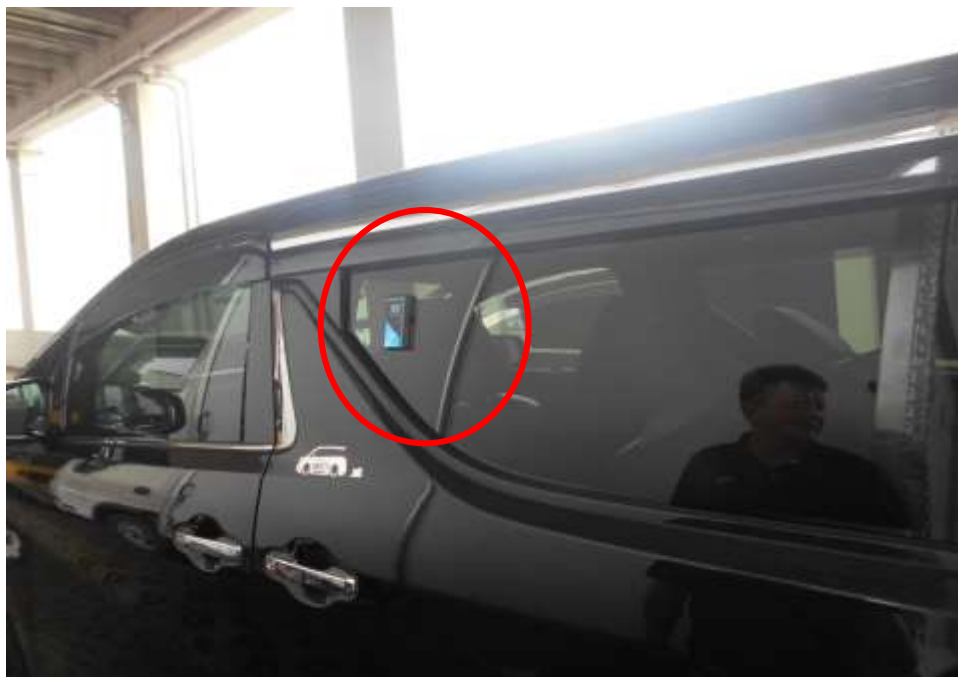
Photo 16 shows a general view of the measurement of the rear left centre window tint of the Insured Vehicle using a tint meter (red circle). Which measures the amount of Visible Light Transmission (VLT) that passes through a material. The Visible Light Transmission (VLT) measured on a scale of 0- 100%, with 0% meaning no light passes through and 100% meaning all light passes through.

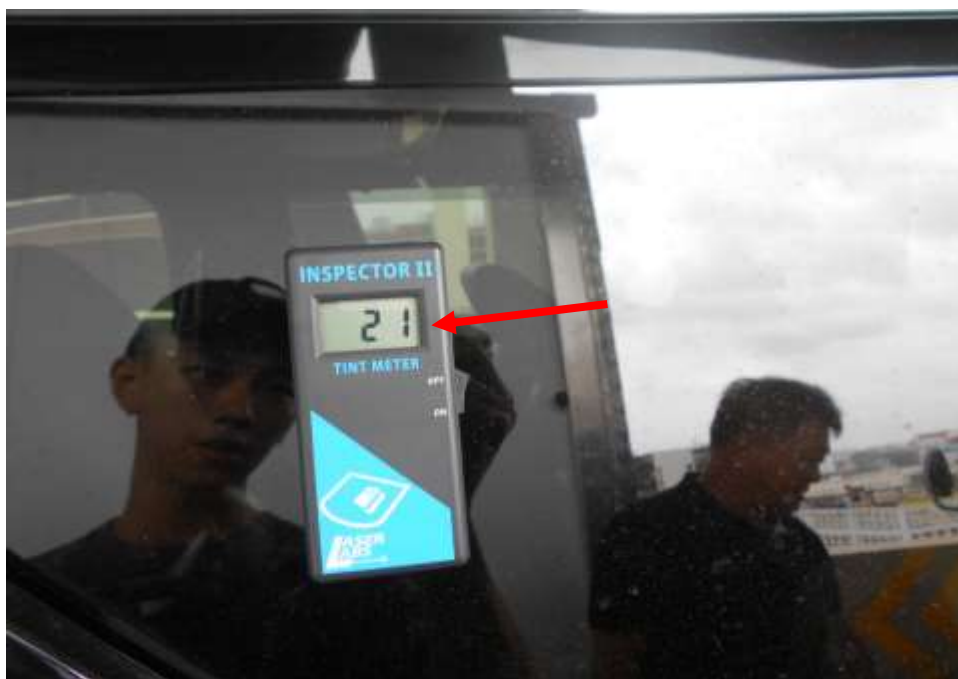
Photo 17 shows the window tint reading of the rear left centre side window on the Insured Vehicle at the time of my inspection. The rear left side window tint is measured 21% (red arrow) Visible Light Transmission (VLT) which is not within LTA requirements, as 25% of light must be able to pass through the rear windscreen and two rear side windows.

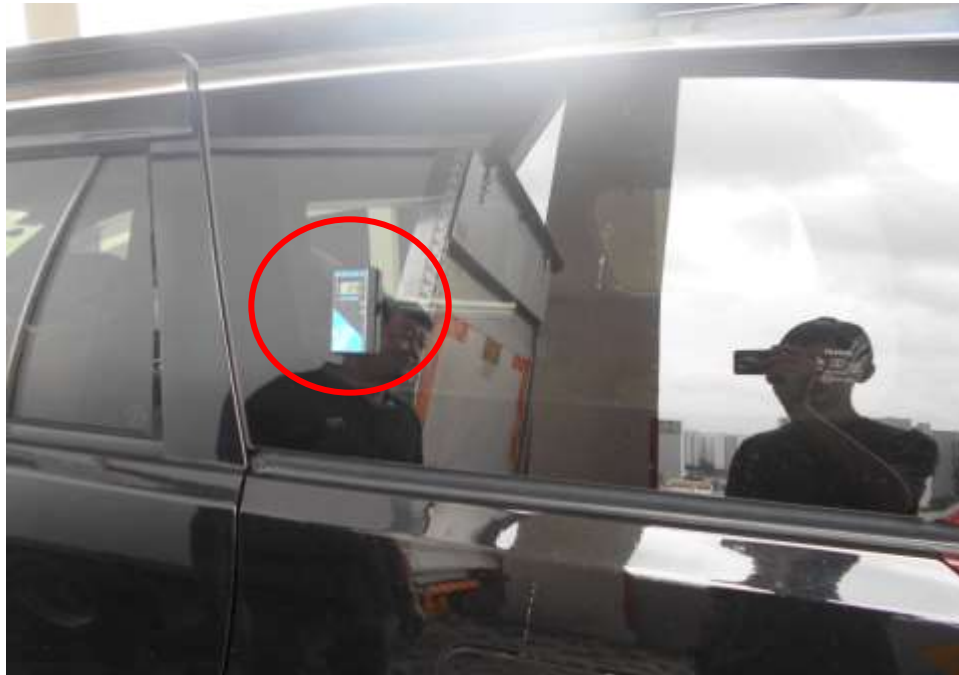
Photo 18 shows a general view of the measurement of the rear left window tint of the Insured Vehicle using a tint meter (red circle). Which measures the amount of Visible Light Transmission (VLT) that passes through a material. The Visible Light Transmission (VLT) measured on a scale of 0- 100%, with 0% meaning no light passes through and 100% meaning all light passes through.

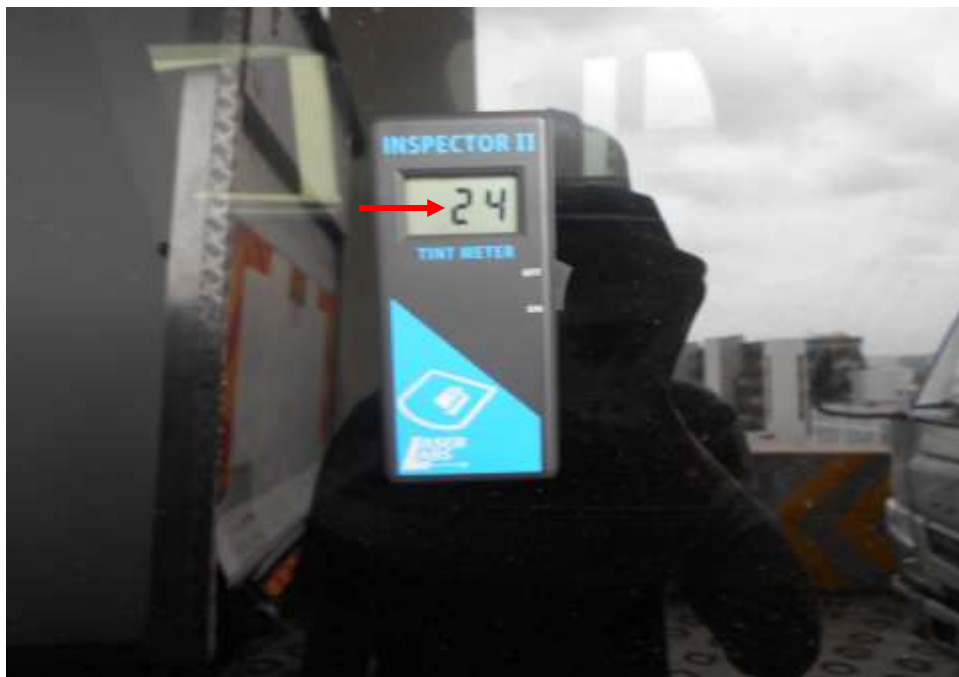
Photo 19 shows the window tint reading of the rear left side window on the Insured Vehicle at the time of my inspection. The rear left side window tint is measured 24% (red arrow) Visible Light Transmission (VLT) which is not within LTA requirements, as 25% of light must be able to pass through the rear windscreen and two rear side windows.

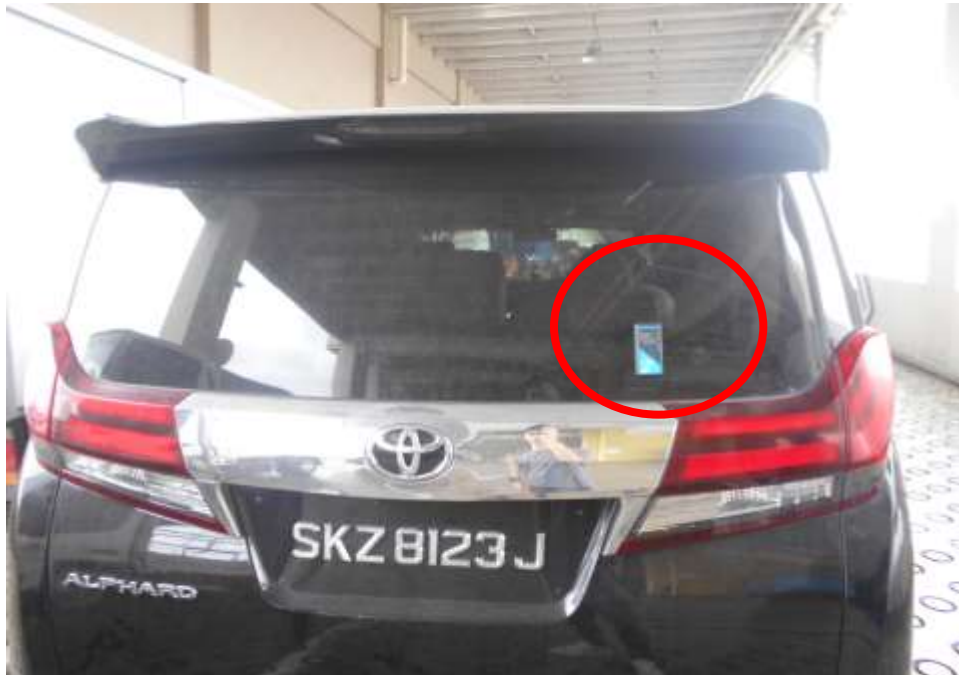
Photo 20 shows a general view of the measurement of the rear windscreen tint of the Insured Vehicle using a tint meter (red circle). Which measures the amount of Visible Light Transmission (VLT) that passes through a material. The Visible Light Transmission (VLT) measured on a scale of 0- 100%, with 0% meaning no light passes through and 100% meaning all light passes through.

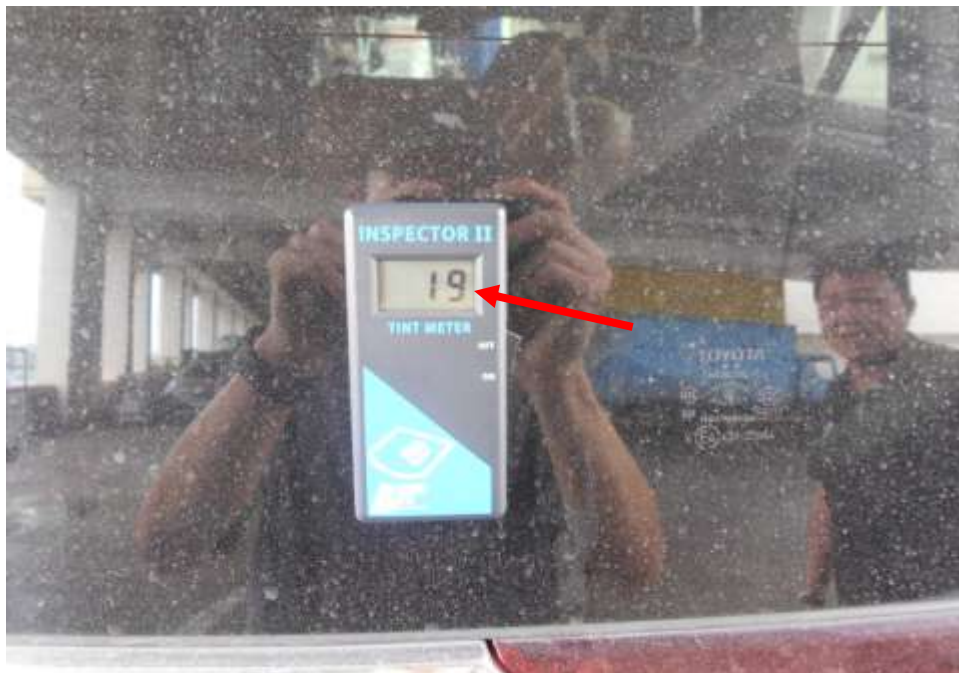
Photo 21 shows the window tint reading of the rear windscreen on the Insured Vehicle at the time of my inspection. The rear windscreen tint percentage is measured at 19% (red arrow) Visible Light Transmission (VLT) which is not within LTA requirements, as 25% of light must be able to pass through the rear windscreen and two rear side windows.

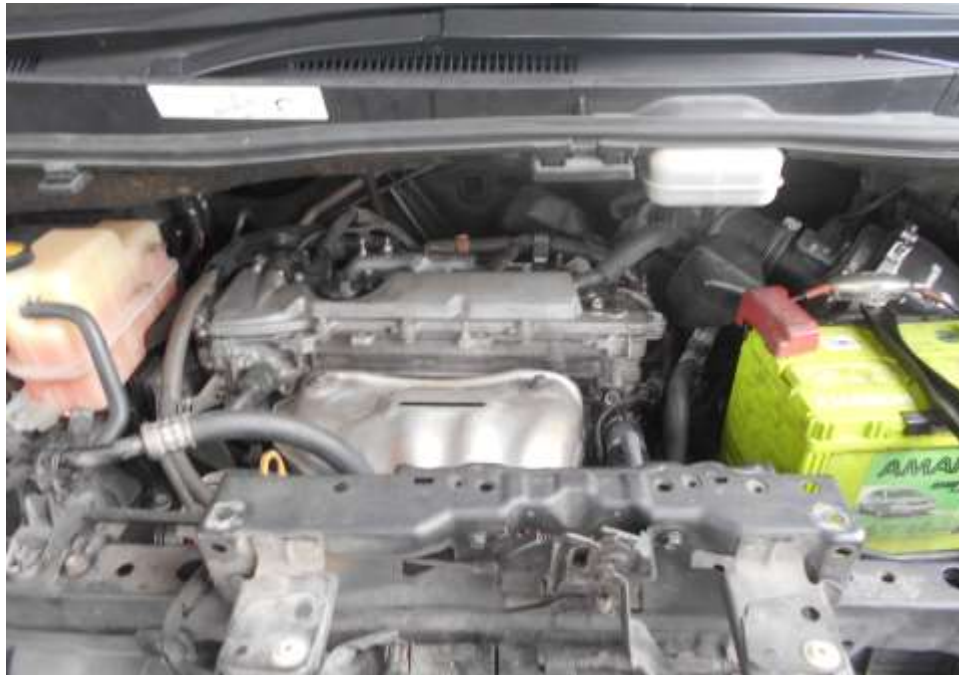
Photo 23 shows a general view of the engine compartment of the Insured Vehicle. Additional non-standard parts were found fitted. This includes a non-standard open pod air filter and a battery voltage stabilizer.

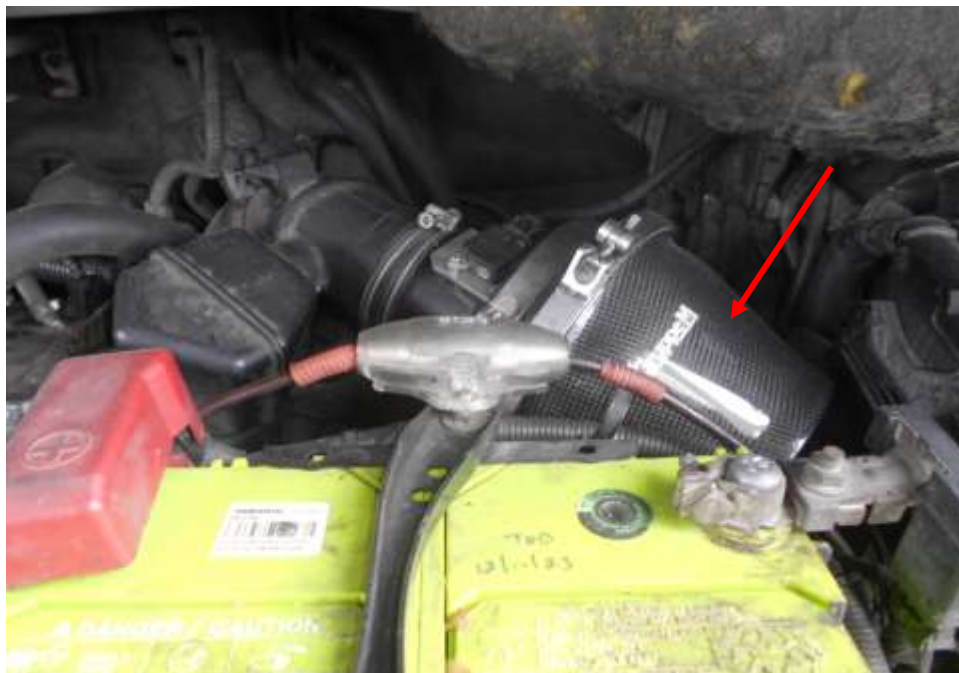
Photo 24 shows the general view close up view of the non- standard open pod air filter fitted onto the Insured Vehicle upon our inspection (arrowed).

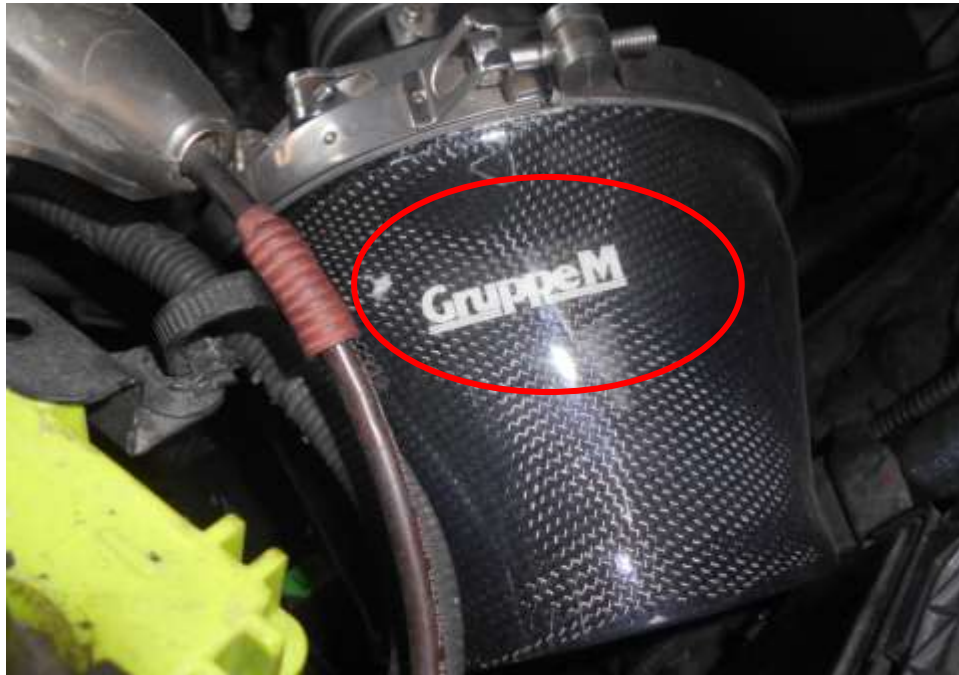
Photo 25 shows the close up view of the non- standard open pod air filter fitted onto the Insured Vehicle upon our inspection (circled). The brand of the open pod air filter was 'GruppeM' (circled).

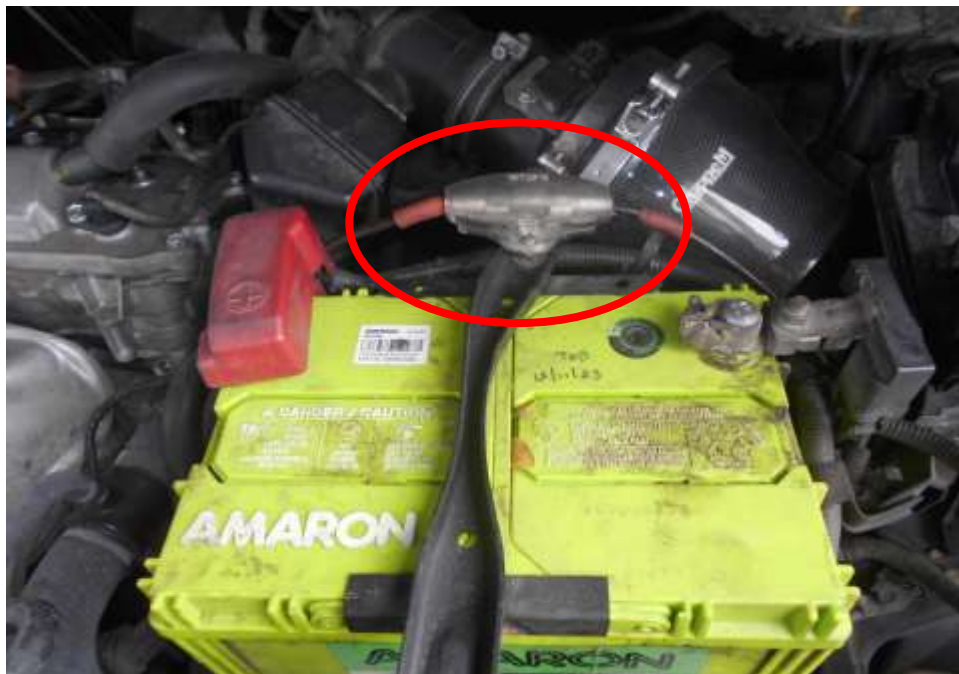
Photo 26 shows the general view close up view of the non- standard battery voltage stabilizer fitted onto the Insured Vehicle upon our inspection (circled).

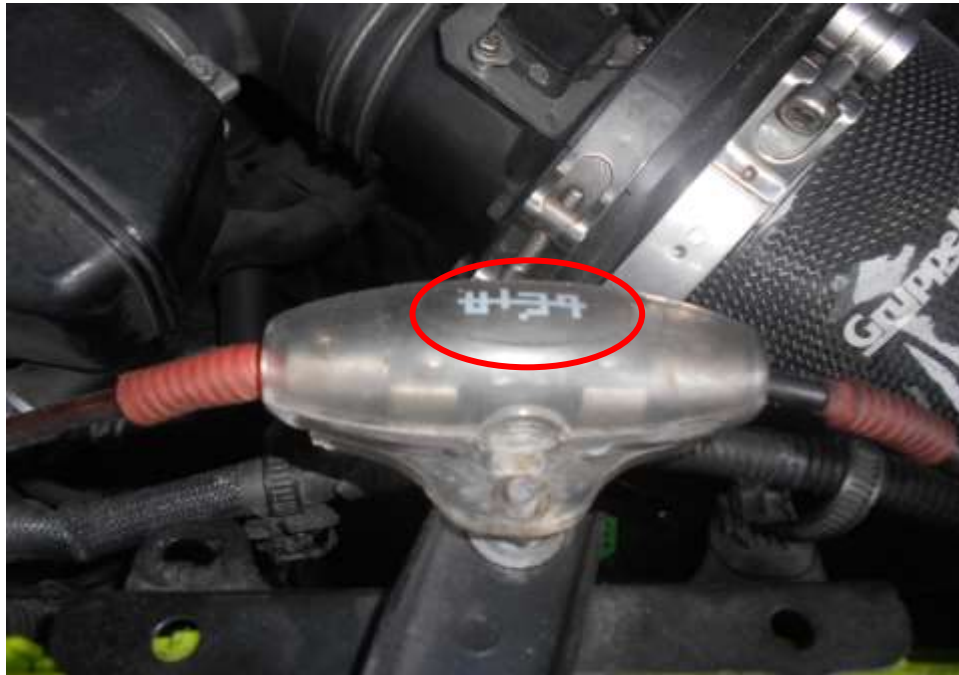
Photo 27 shows the close up view of the non- standard battery voltage stabilizer onto the Insured Vehicle upon our inspection (circled). The brand of the battery voltage stabilizer was 'bEiA' (circled).

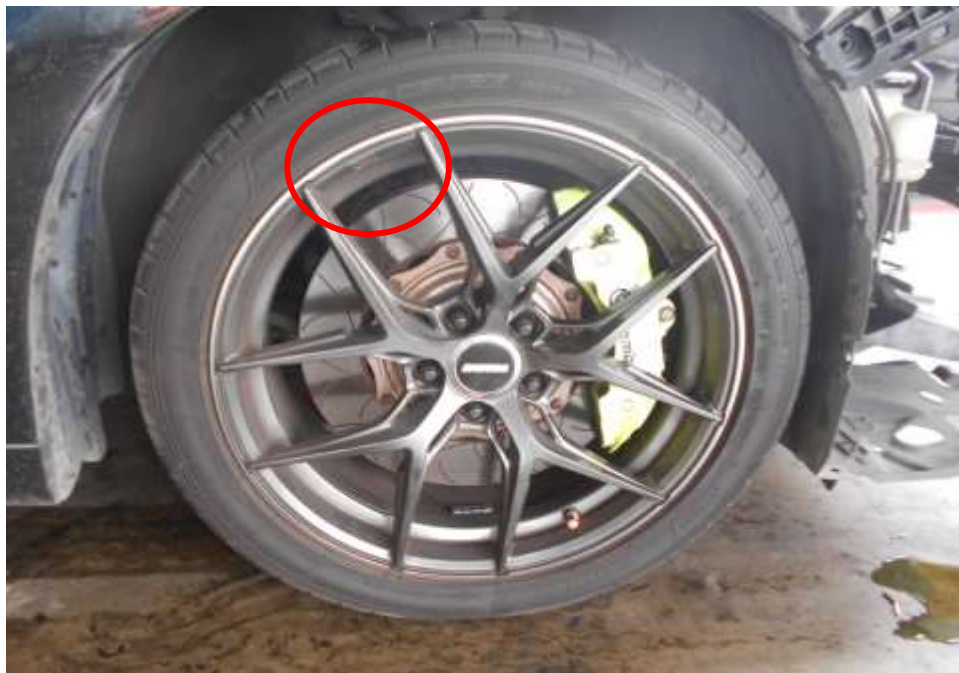
Photo 28 shows the non-standard rim and non- standard front brake kit found to be fitted on the Insured Vehicle at the time of our inspection. The 19- inch alloy rims fitted on the Insured Vehicle were not the standard type for the Insured Vehicle. The brand of the non- standard rims was 'TOMMI' (red circle).

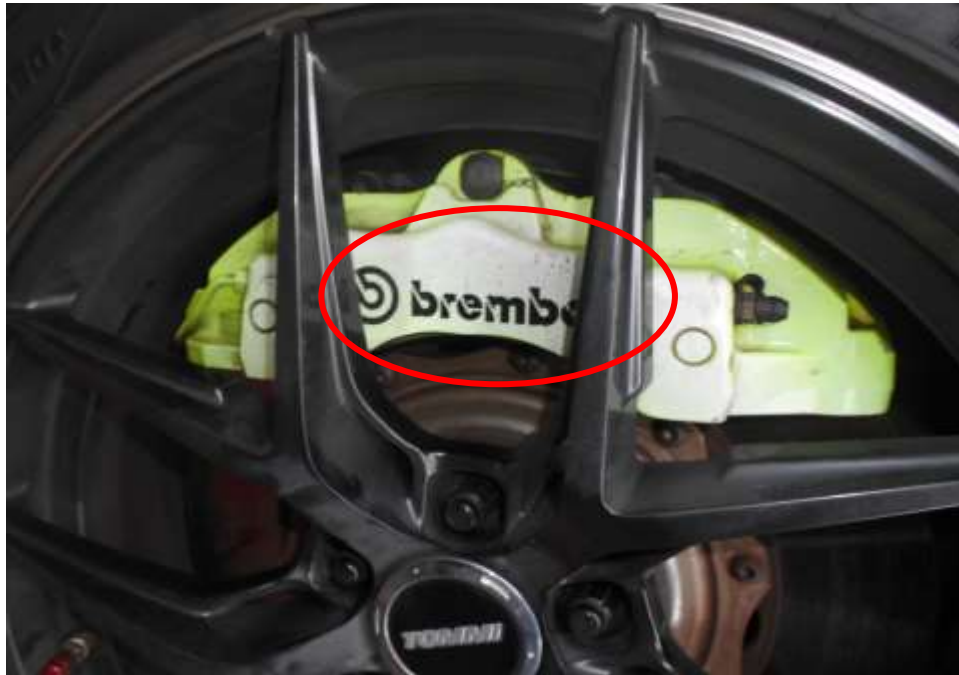
Photo 29 shows a close up view of the non- standard front brake kit (circled) fitted onto the Insured Vehicle upon our inspection. The brand of the brake kit was 'brembo' (circled).

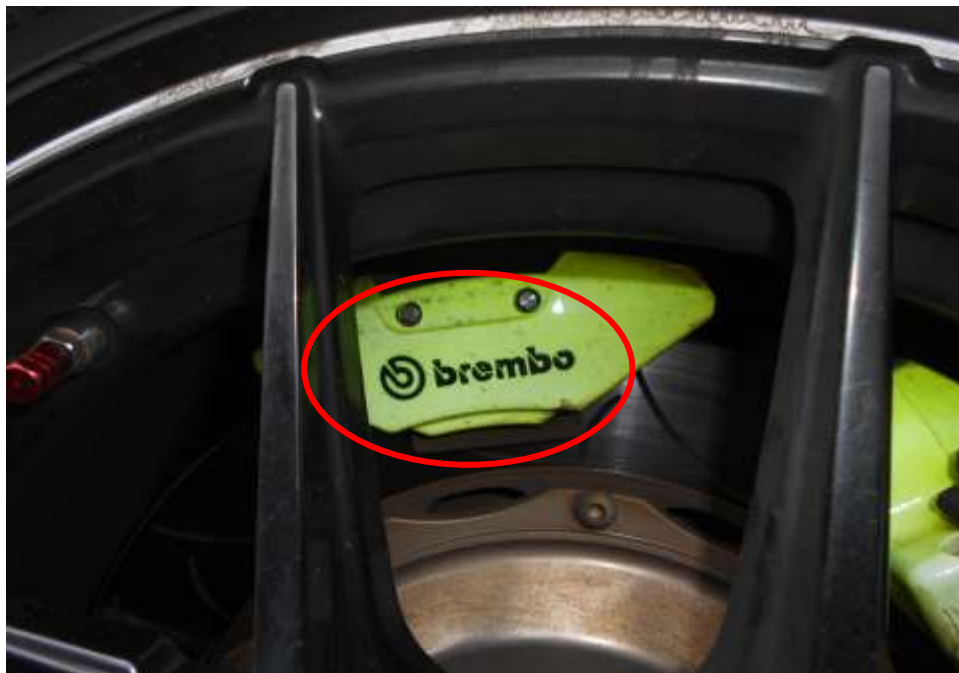
Photo 30 shows a close up view of the non- standard rear brake kit (circled) fitted onto the Insured Vehicle upon our inspection. The brand of the brake kit was 'brembo' (circled).
