## LKK Auto Consultants Pte Ltd

| Affiliated to Federation Internationale Des Experts En Automobile | | | | |
|---|---|---|---|--|
| <b>1. Policy Particulars :- PRE-REPAIR SURVEY</b> | | | | |
| Insured Veh. | SMB 1390C | Veh. Inspected | FBR 6231S | |
| Make & Model | YAMAHA AEROX | C.C | 155 | |

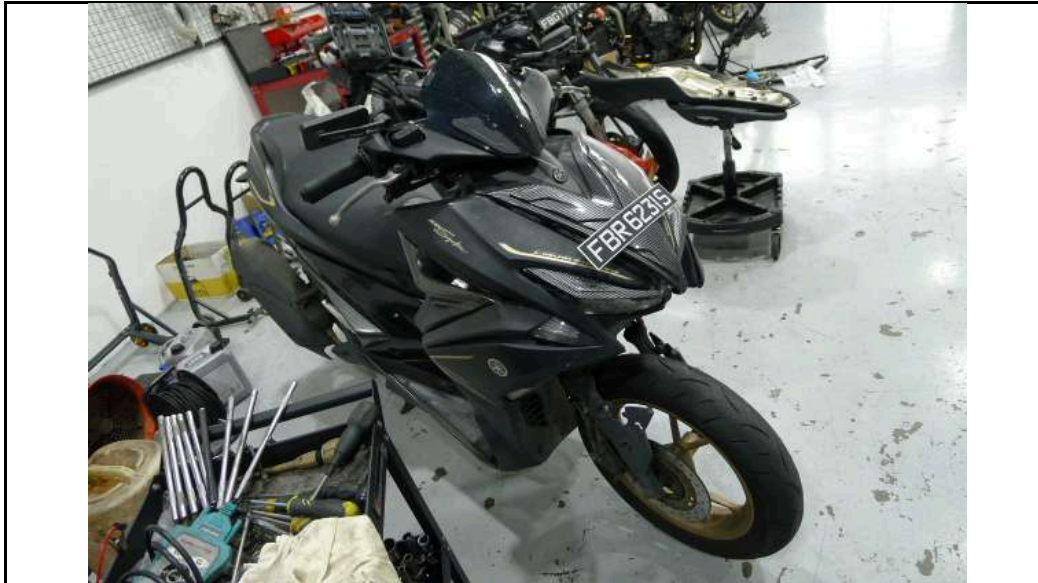
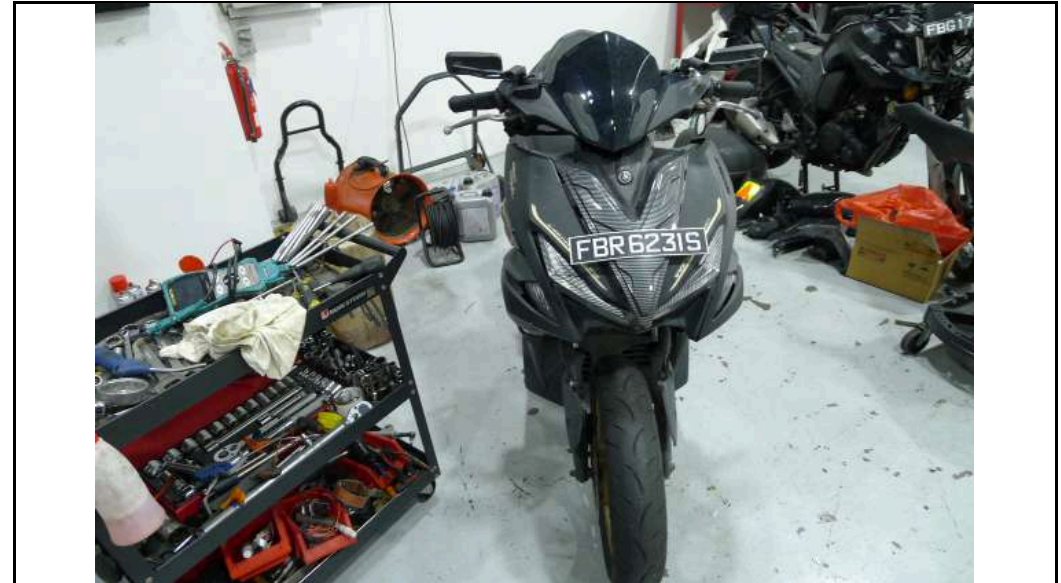
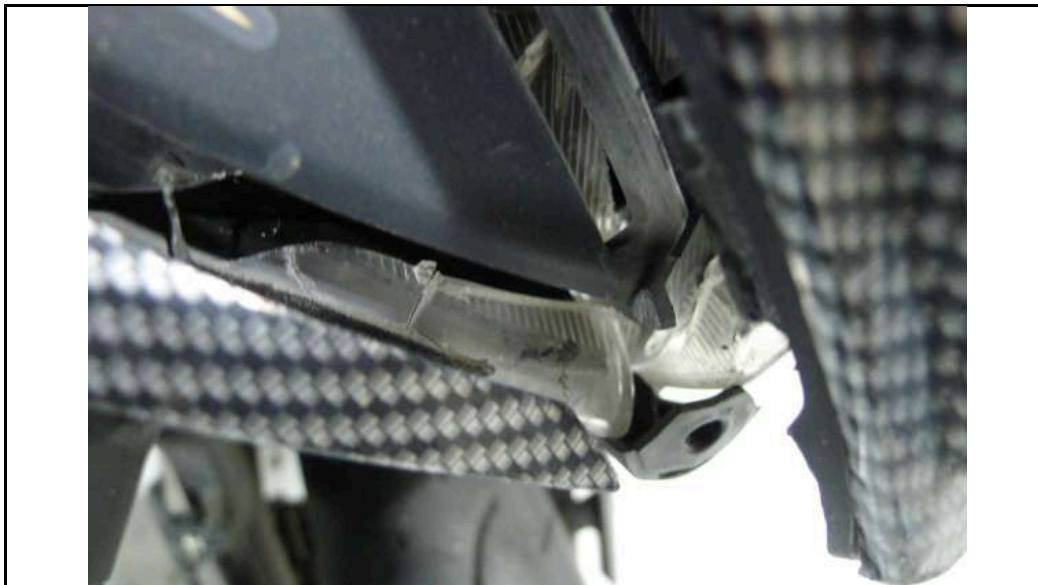
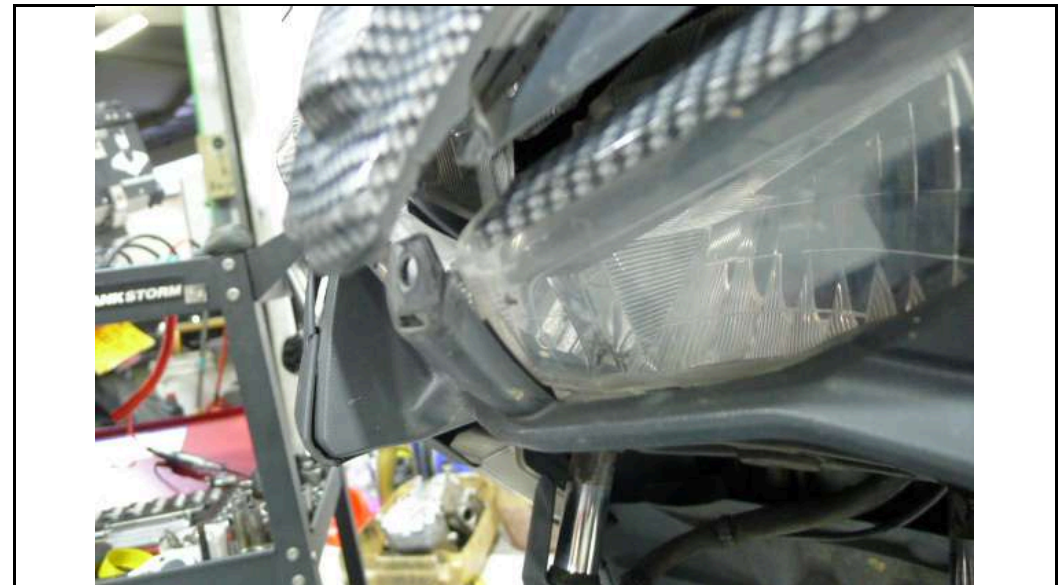
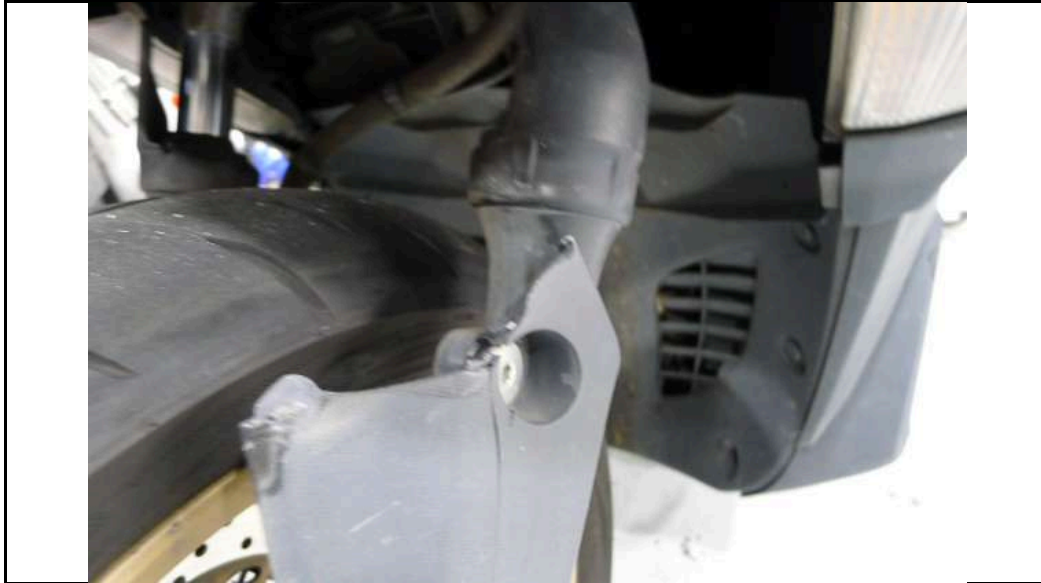
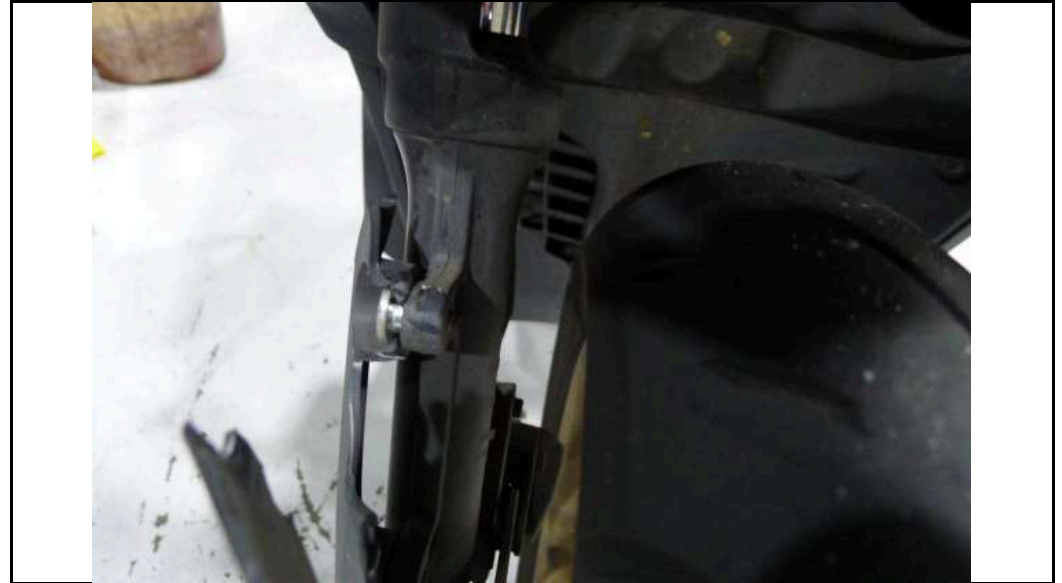
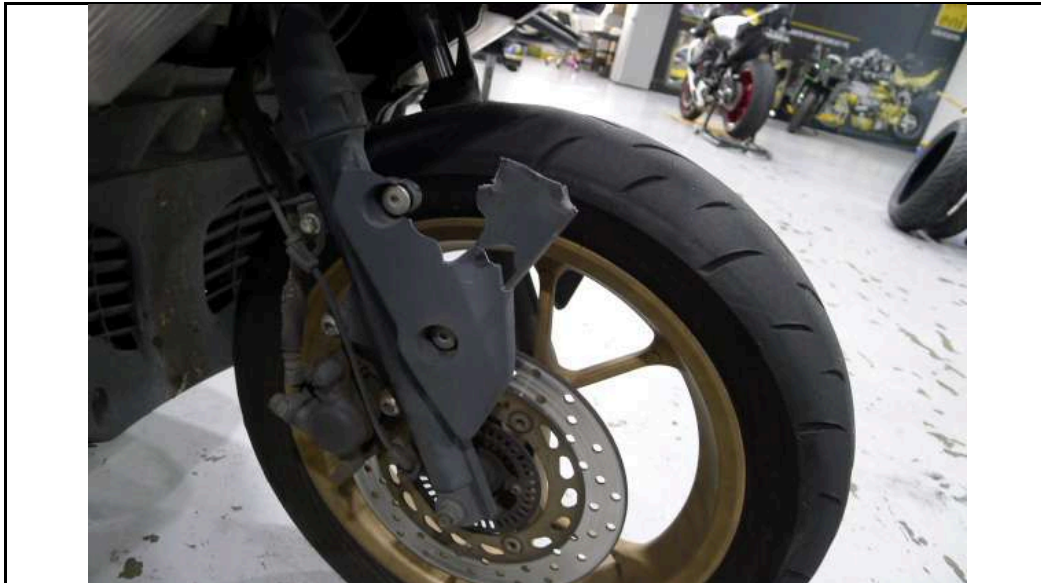
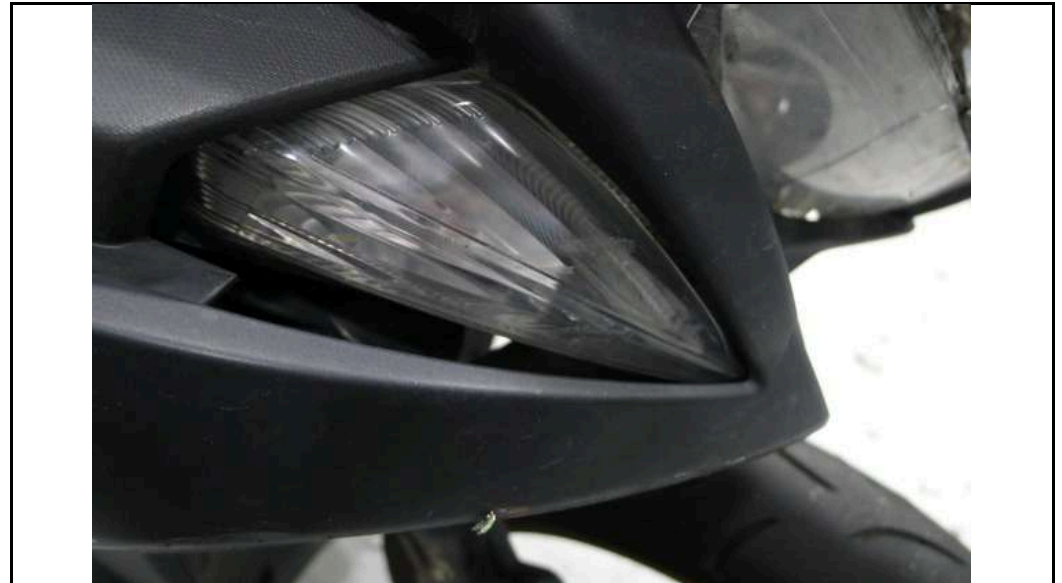
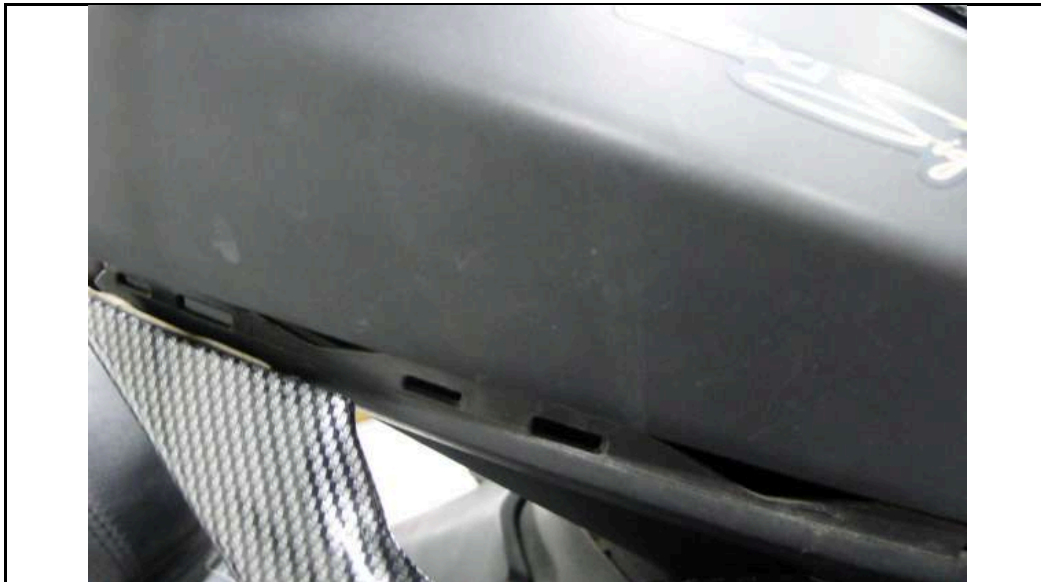
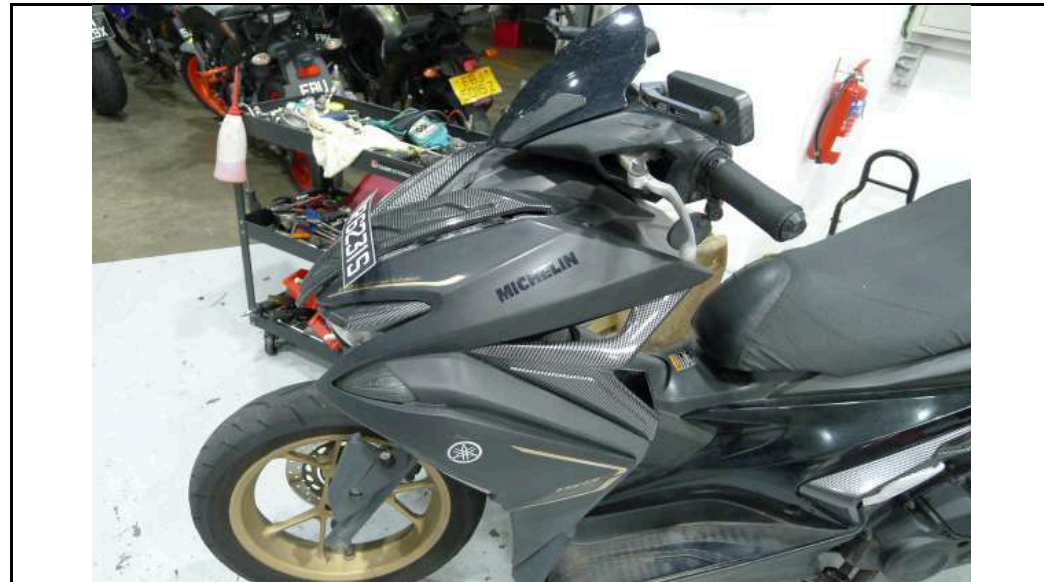
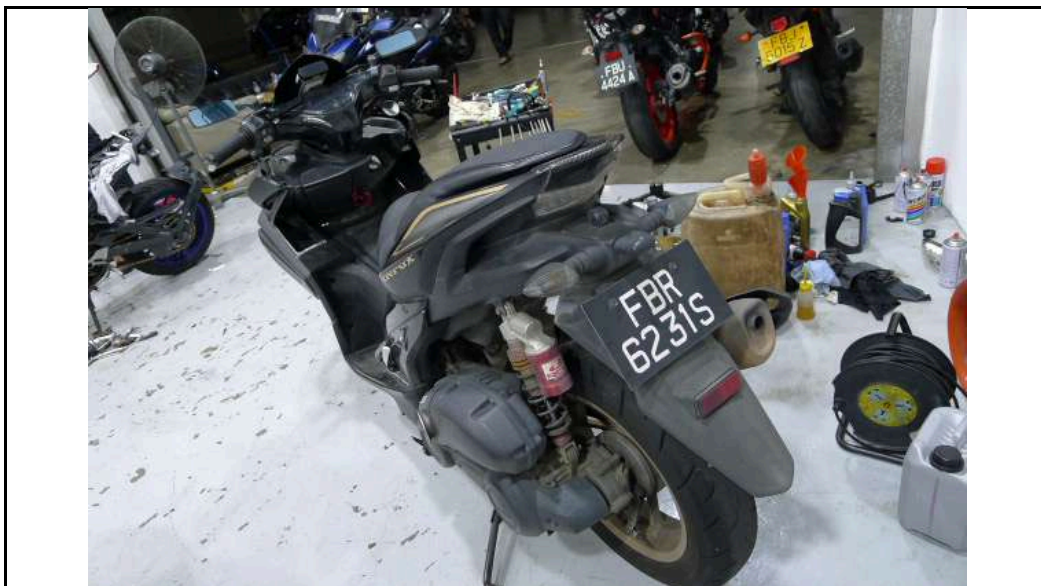
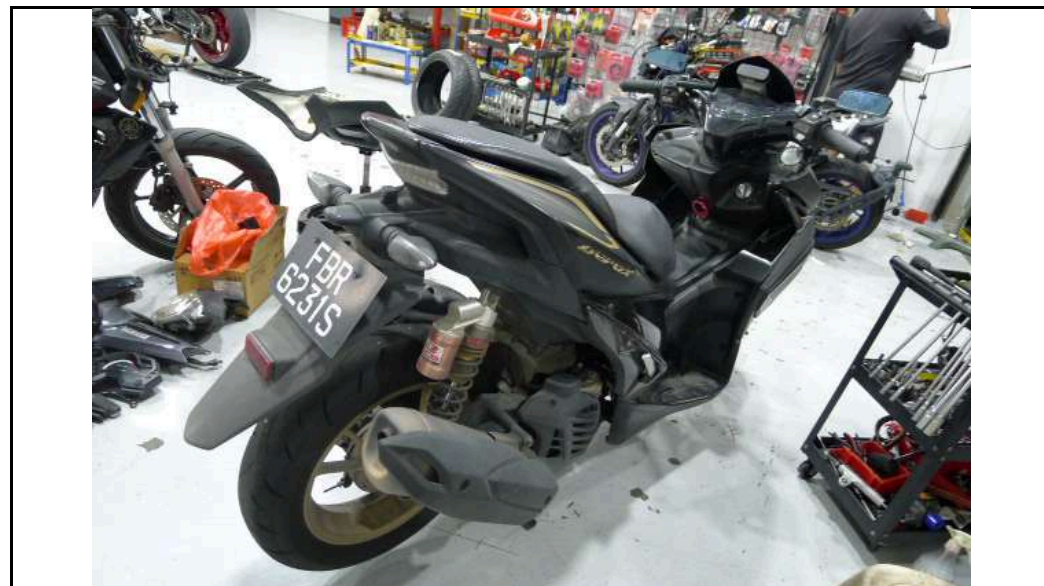
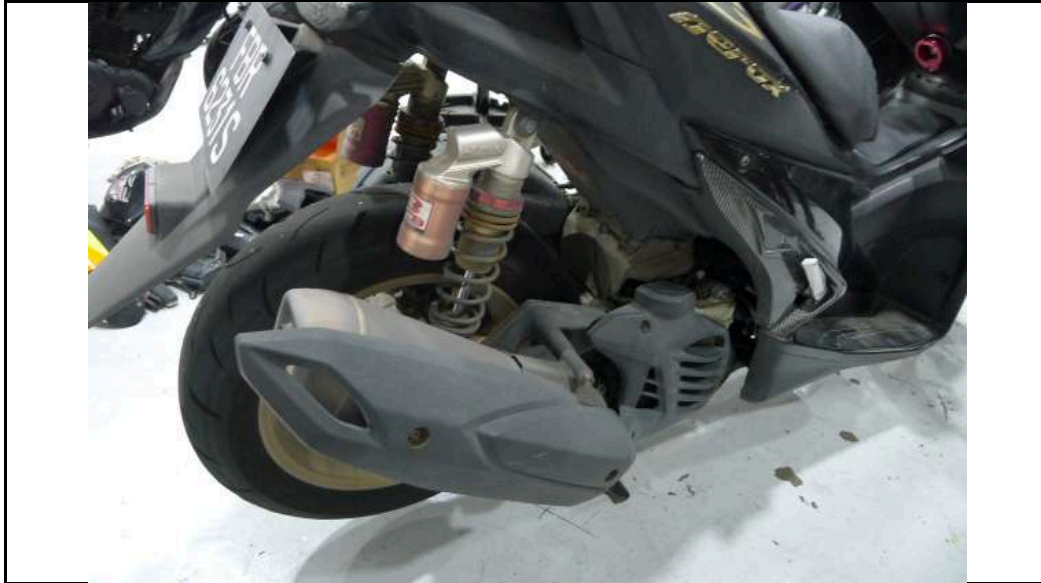
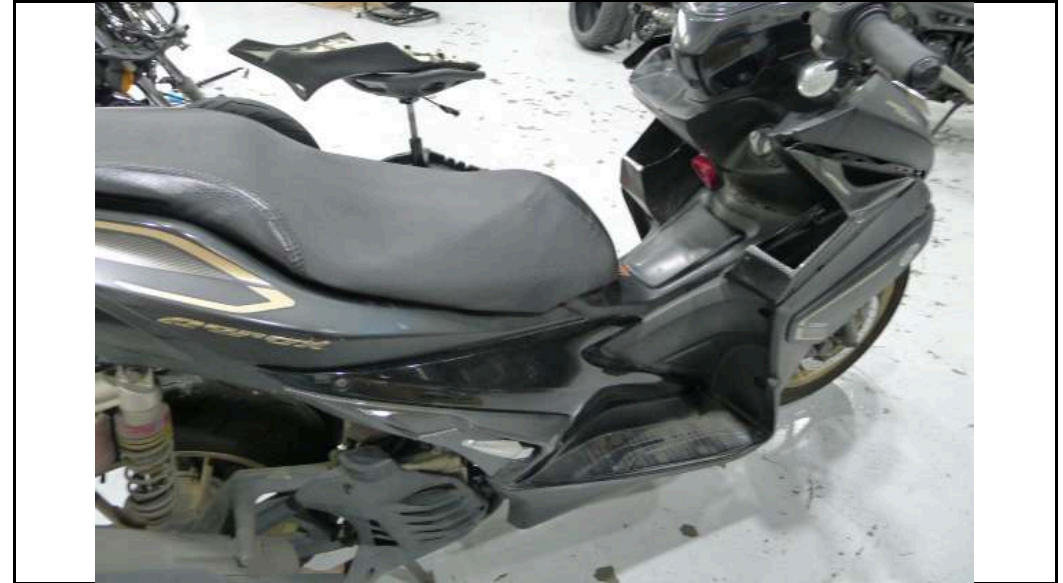
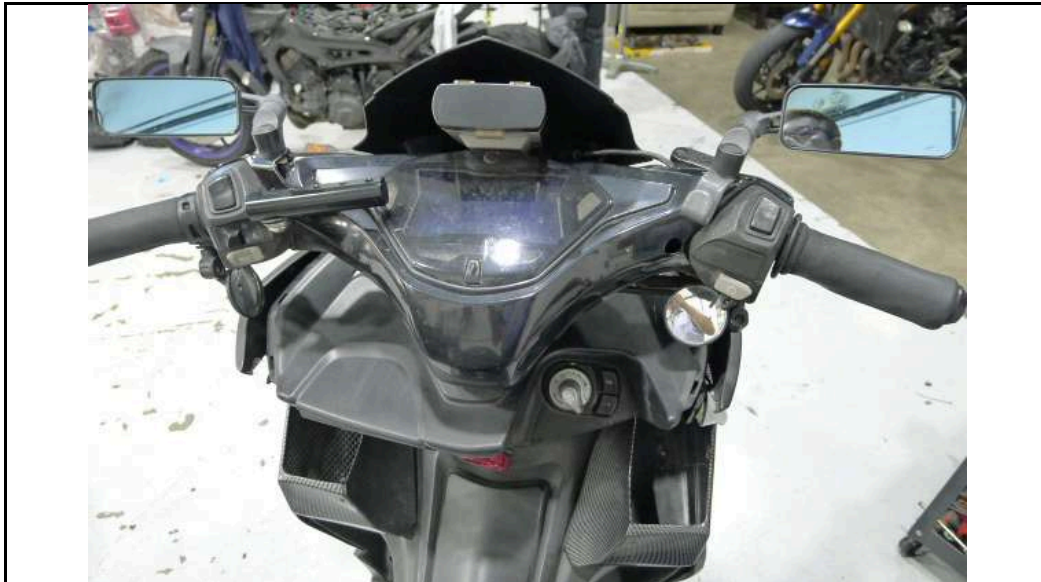
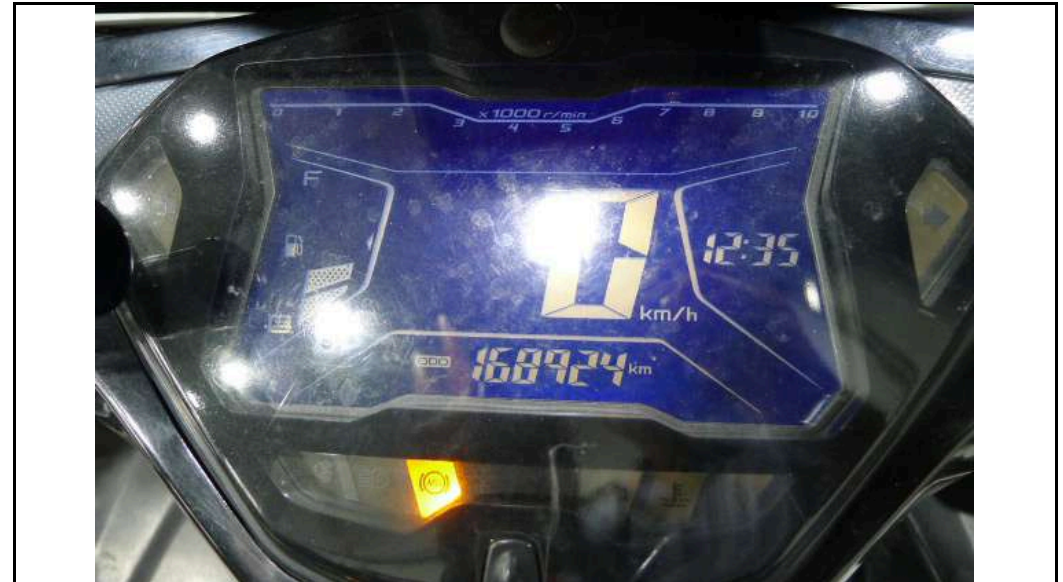
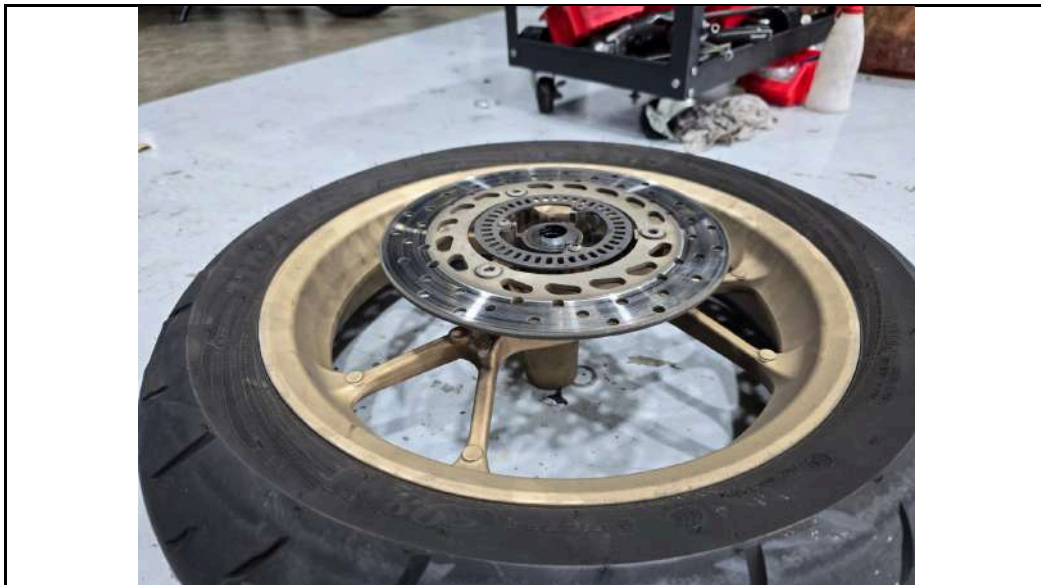
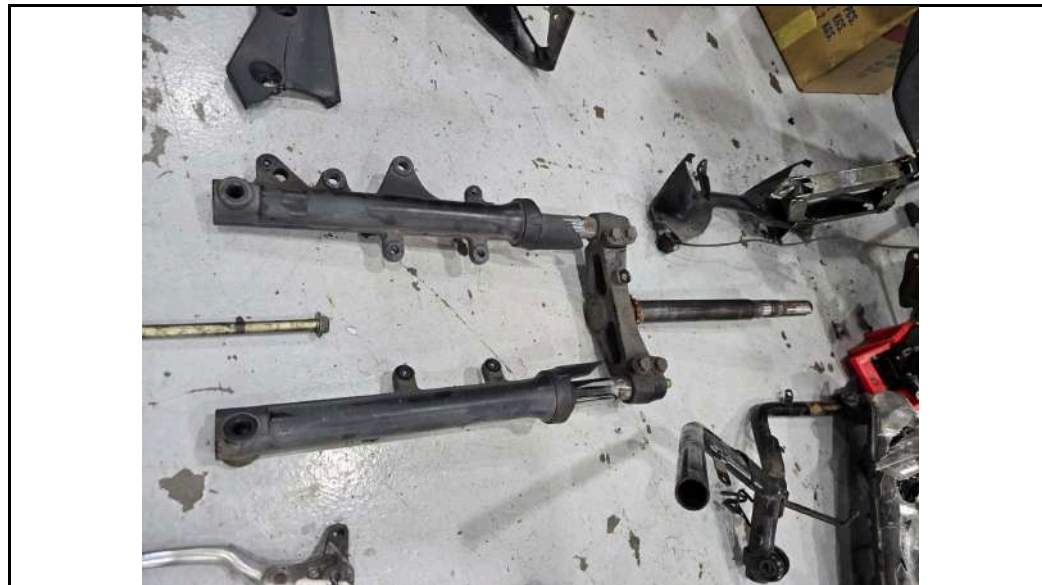
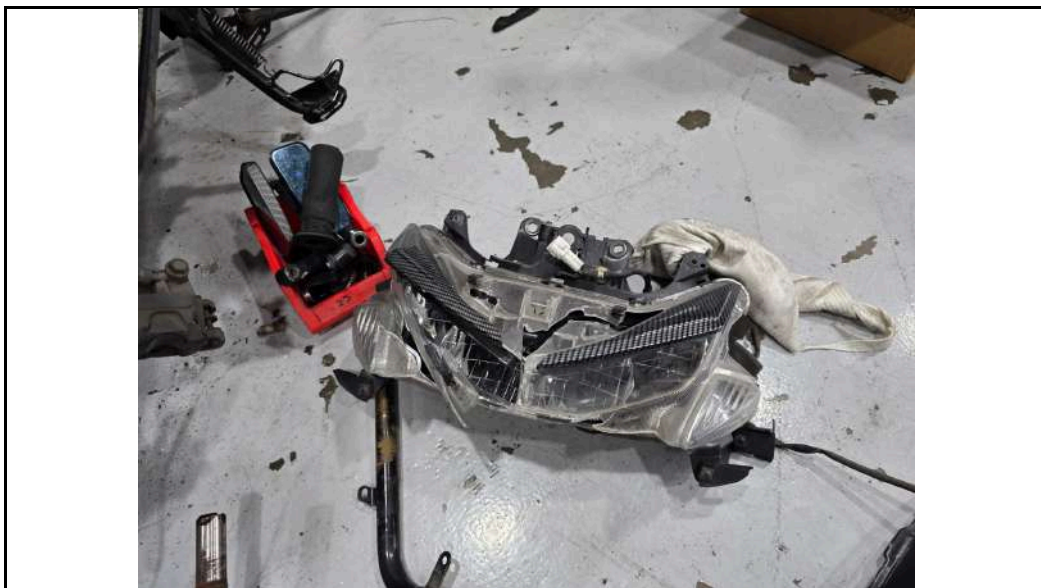
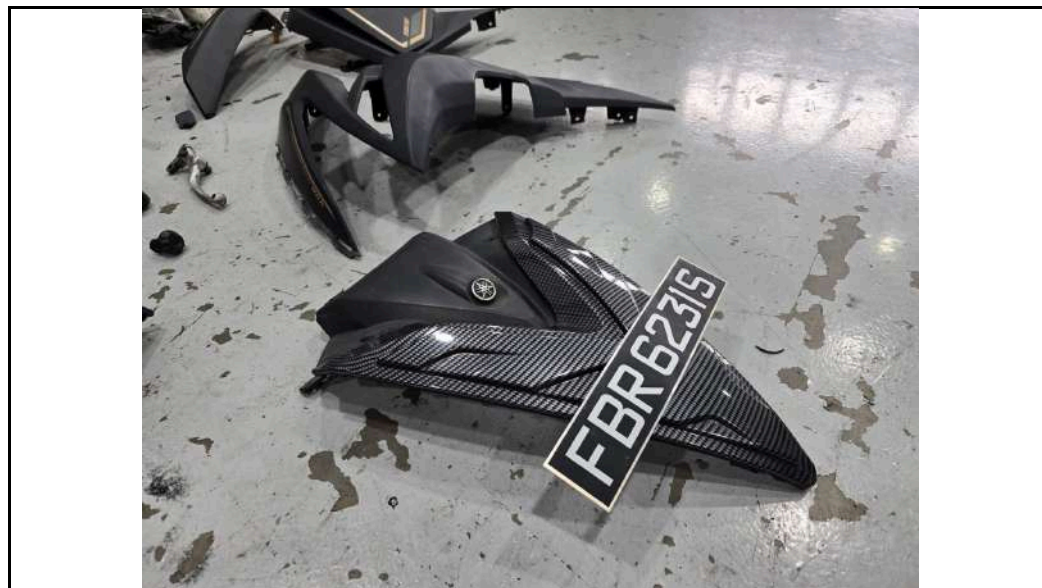
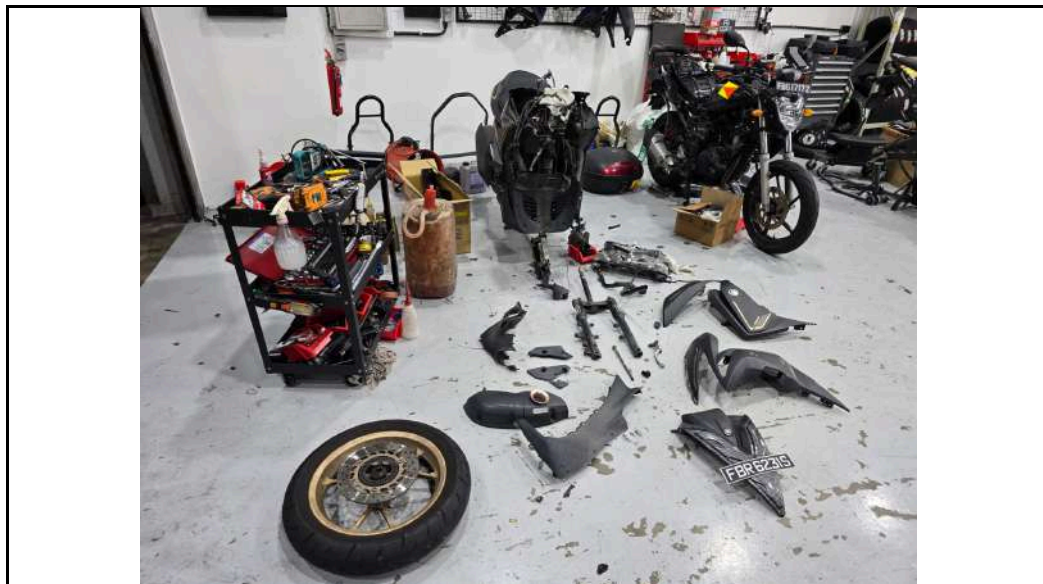
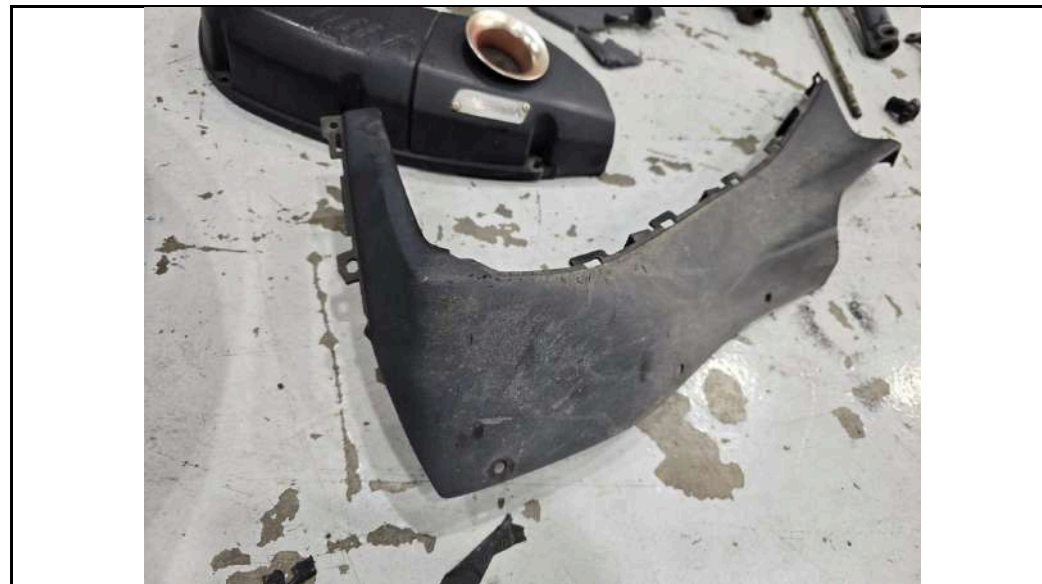
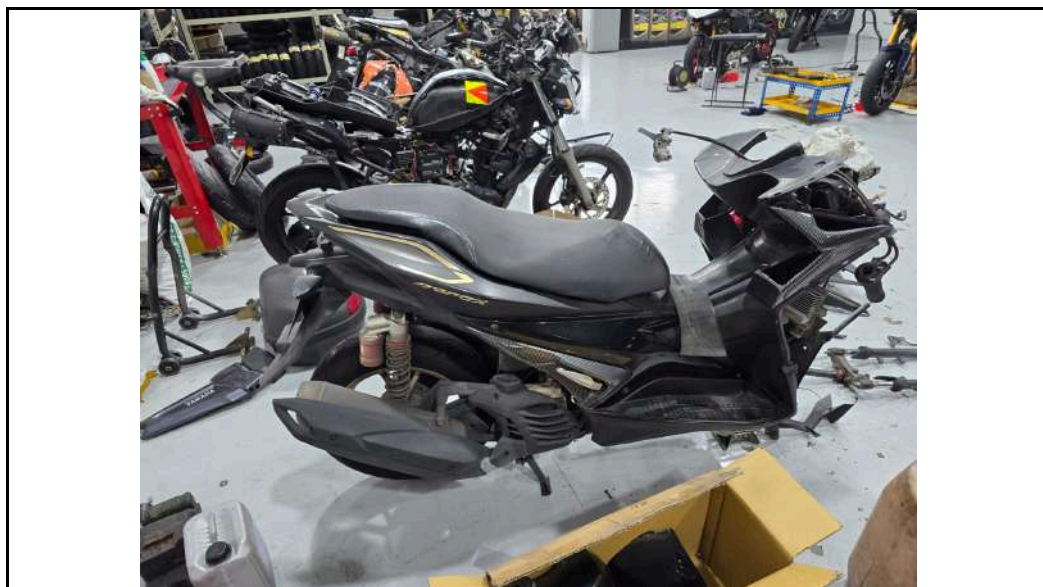
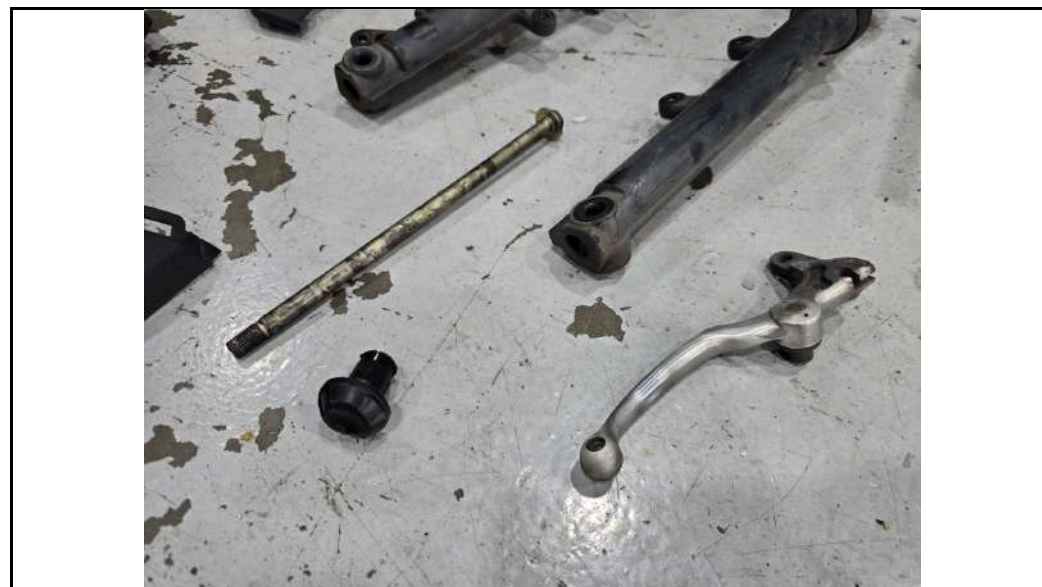
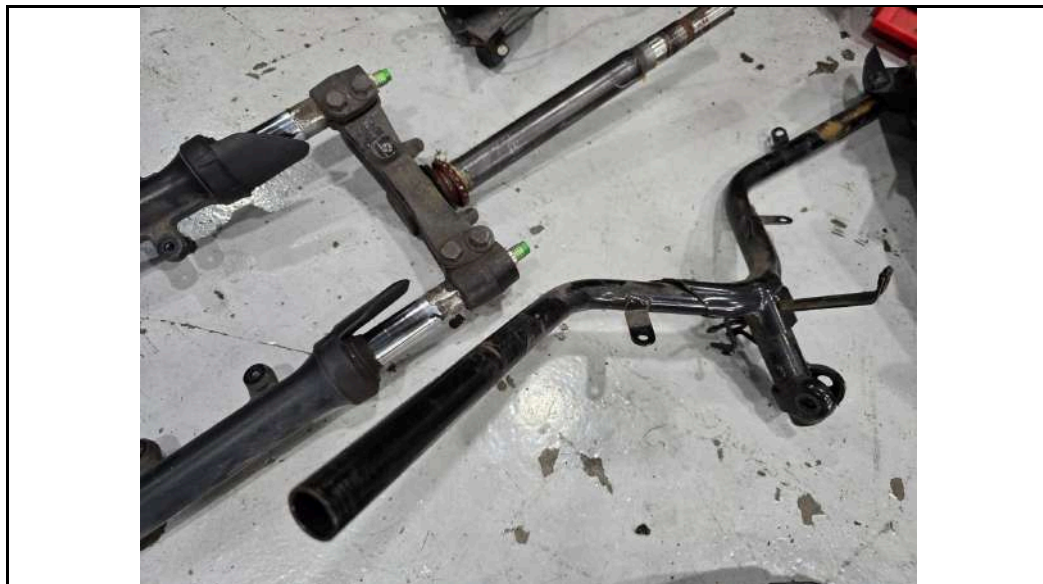
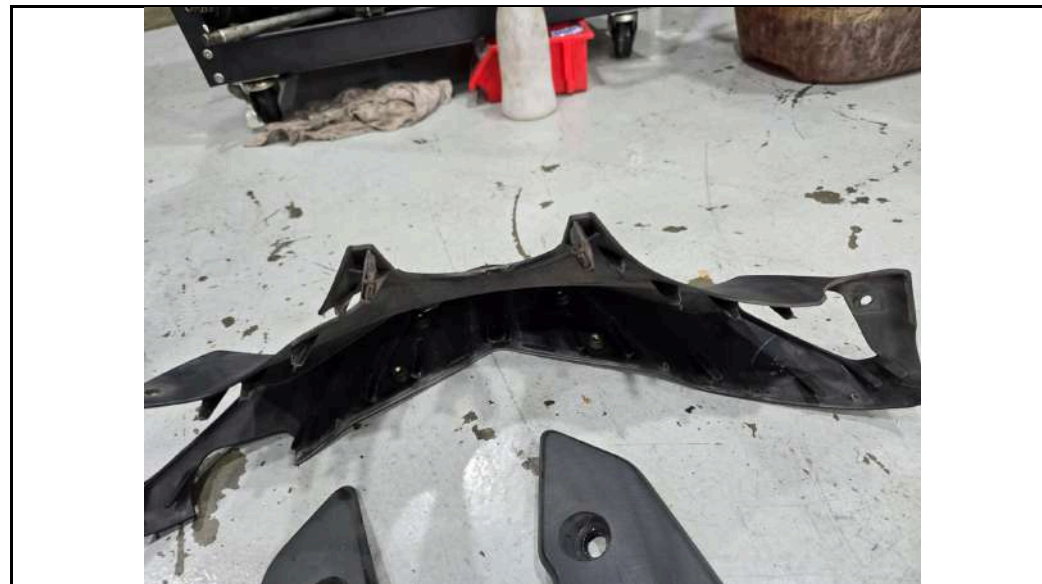
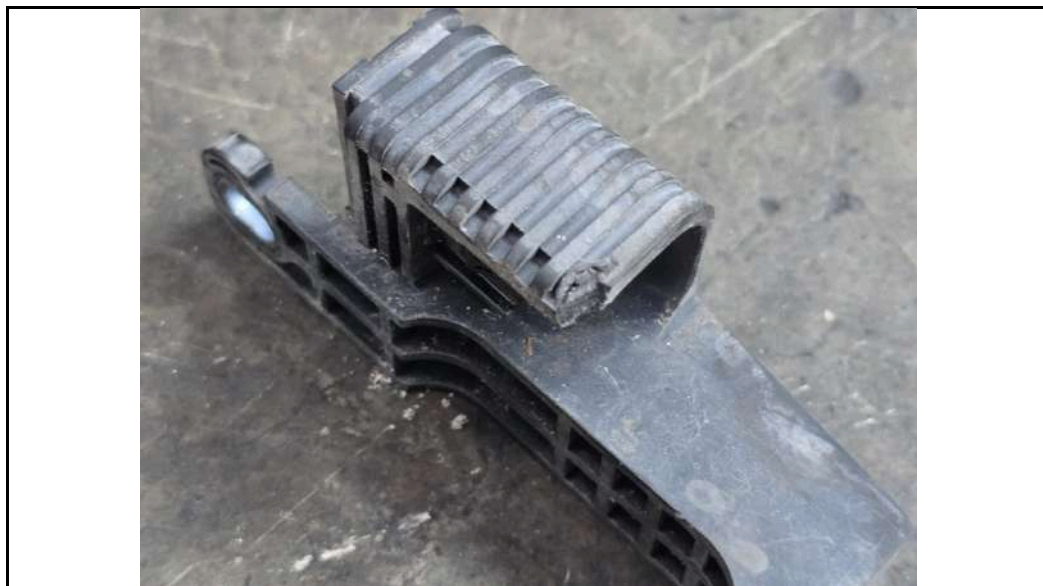
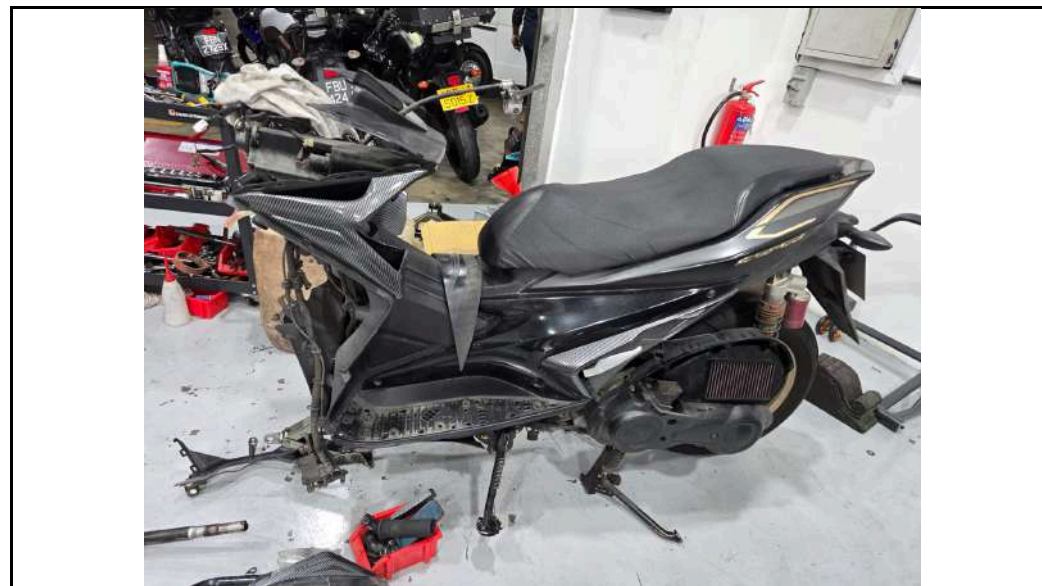
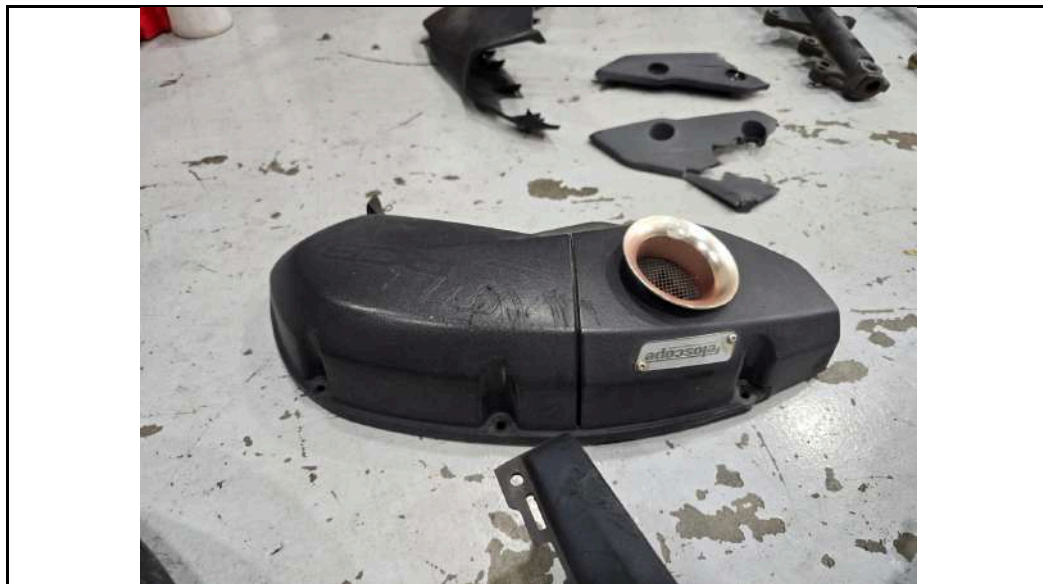
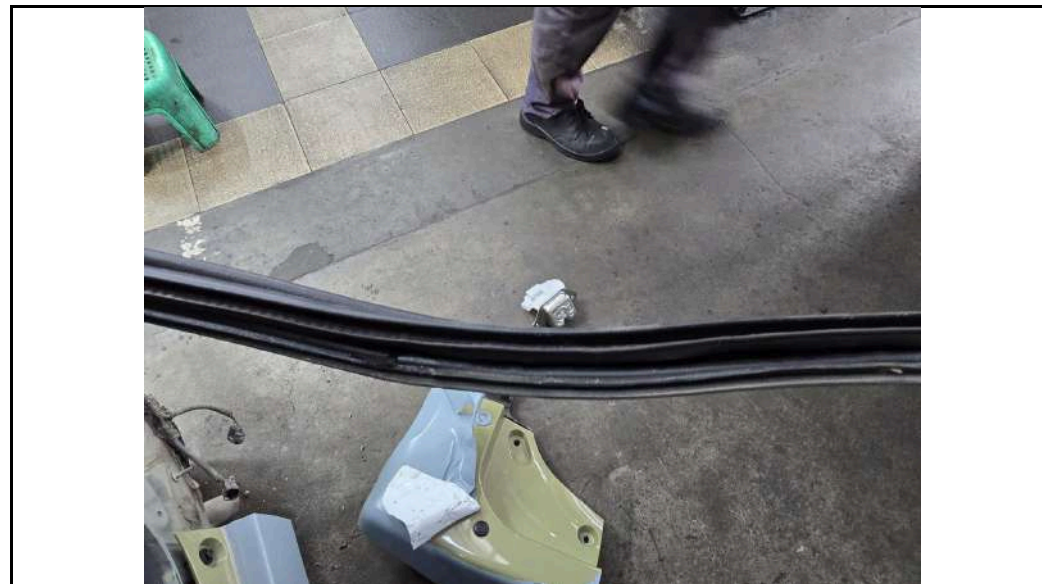
**PHOTOGRAPHS FOR VEHICLE NO. : FBR 6231S**

| Affiliated to Federation Internationale Des Experts En Automobile | | | | |
|---|---|---|---|--|
| THE VEHICLE SUSTAINED DAMAGES AT THE FRONT PORTION. | | | | |

| Affiliated to Federation Internationale Des Experts En Automobile | | | | |
|---|---|---|---|--|
| D) THE ESTIMATED REPAIR COST OF THE DAMAGED VEHICLE IS IN THE REGION OF \$2,000-\$3,000 | | | | |
