**TECHNICAL INVESTIGATION REPORT OF INSURED VEHICLE SNE 4441S
INVOLVED IN AN ACCIDENT ON 19 DECEMBER 2024**

Registration Number : SNE 4441S
Make & Model : MERCEDES BENZ E200 AMG LINE (R19 LED)
Year of Registration : JULY 2018
Chassis Number : WDD2130422A468163
Speedo Reading : N/A

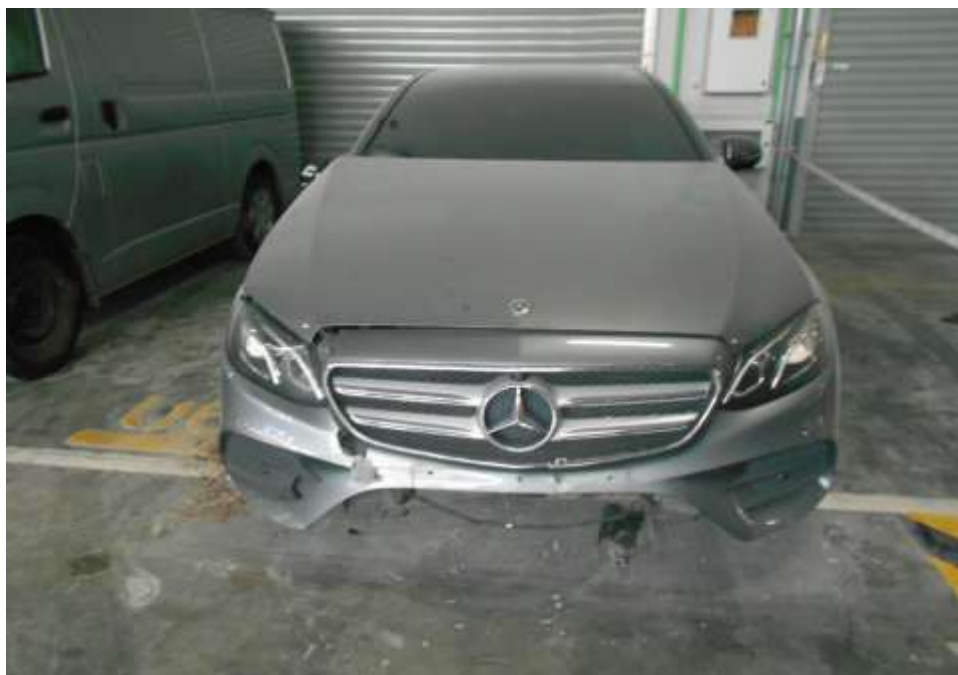
5. The insured vehicle was observed to have sustained impact damages on its front portion, right body and left body. Its front bonnet, front bumper, front right rear view mirror and front left fender were amongst the exterior body parts which were observed to have been damaged as a result of the accident. See photo 1- 4 below.

Photo 1 shows a general view of the Insured Vehicle front portion at the time of my inspection. The Insured Vehicle was observed to have sustained damage at its front portion. Its front bonnet and front bumper was amongst the body parts damaged as a result of the accident.

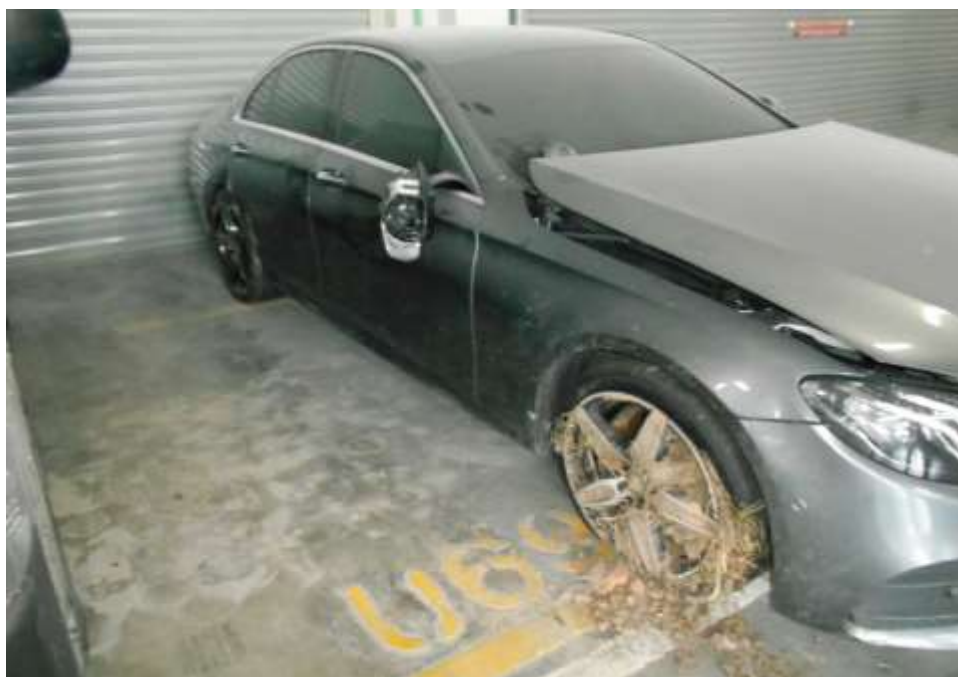
Photo 2 shows a general view of the Insured Vehicle right body at the time of my inspection. The Insured Vehicle was observed to have sustained damage at its right body. Its front right rear view mirror was amongst the body parts damaged as a result of the accident.

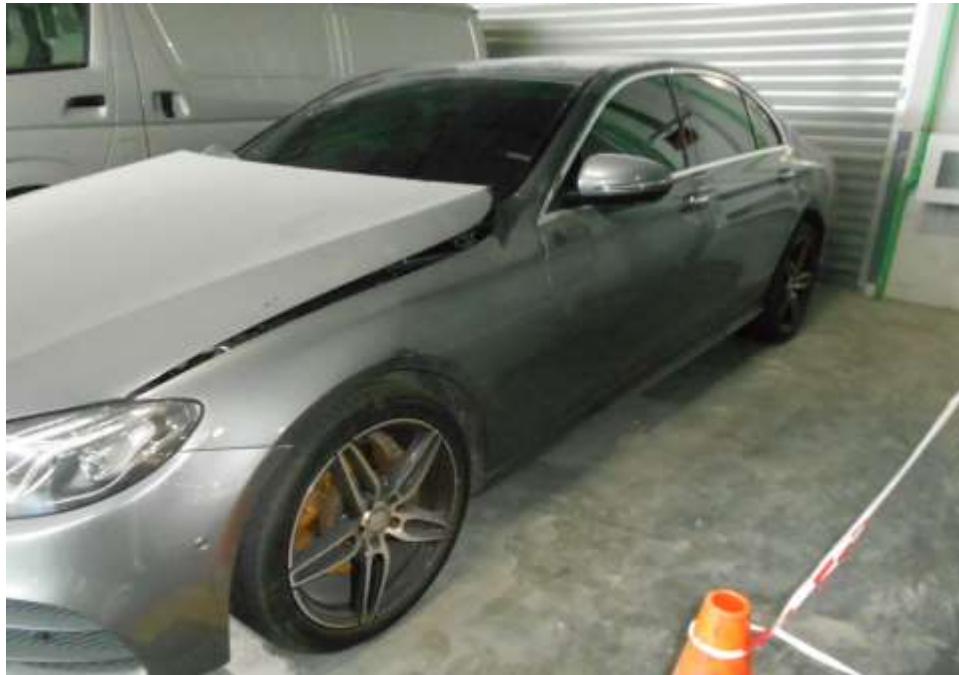
Photo 3 shows a general view of the Insured Vehicle left body at the time of my inspection. The Insured Vehicle was observed to have sustained damage at its left body. Its front left fender was amongst the body parts damaged as a result of the accident.

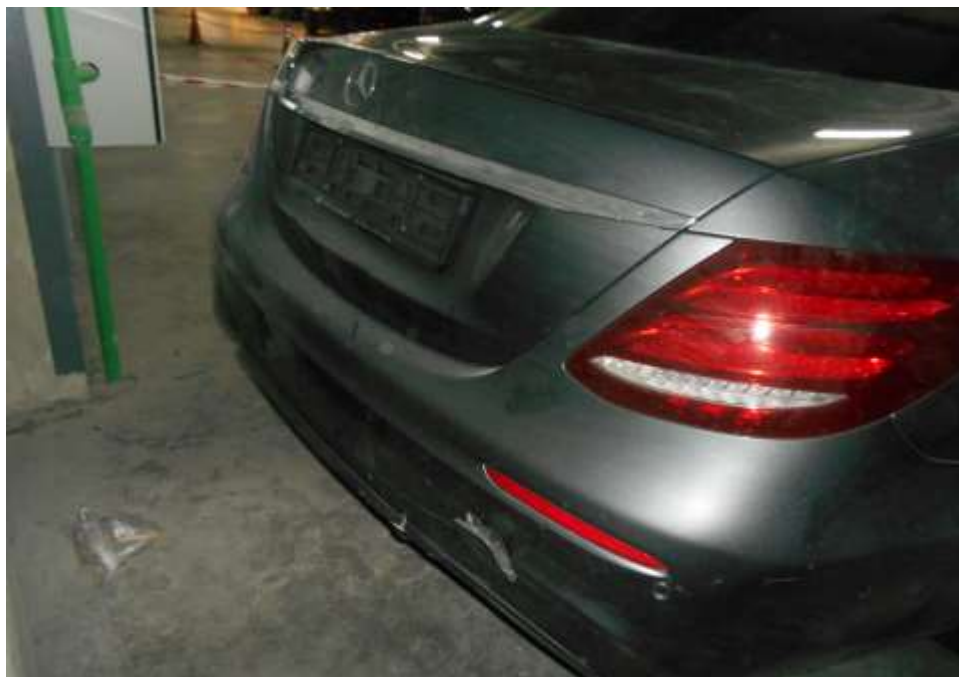
Photo 4 shows the general view of the rear portion of the insured vehicle at the time of my inspection its unaffected by the accident.

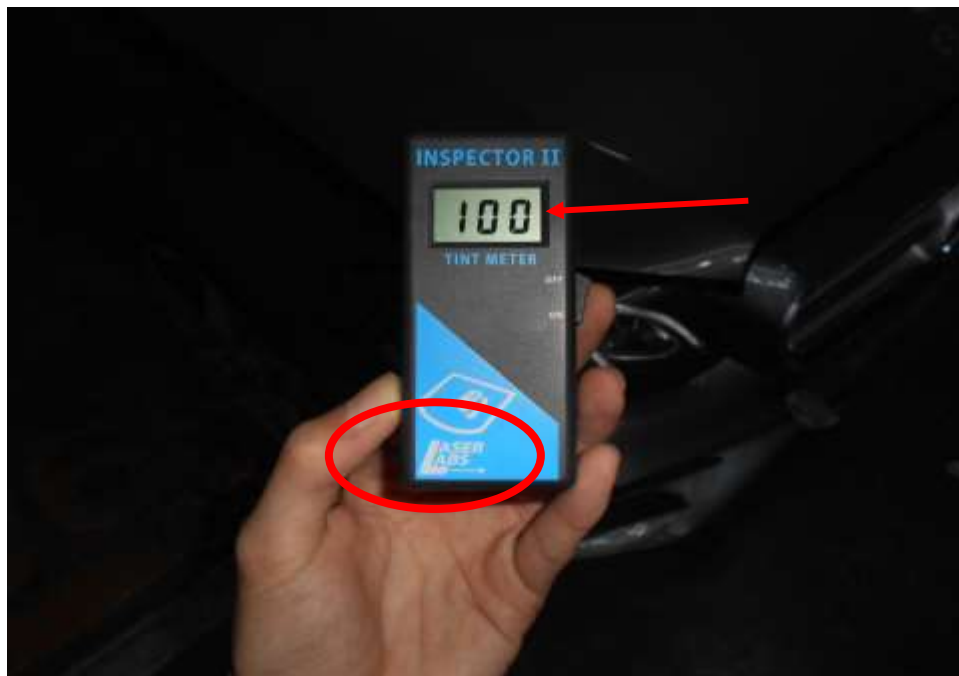
Photo 5 shows the Tint Meter used to measure the Visible Light Transmission (VLT) on the Insured Vehicle's windscreen and windows which has been recalibrated (red arrow) before the testing of the Visible Light Transmission (VLT) of the window and windscreen tints. The brand of the Tint Meter was 'Laser ABS'

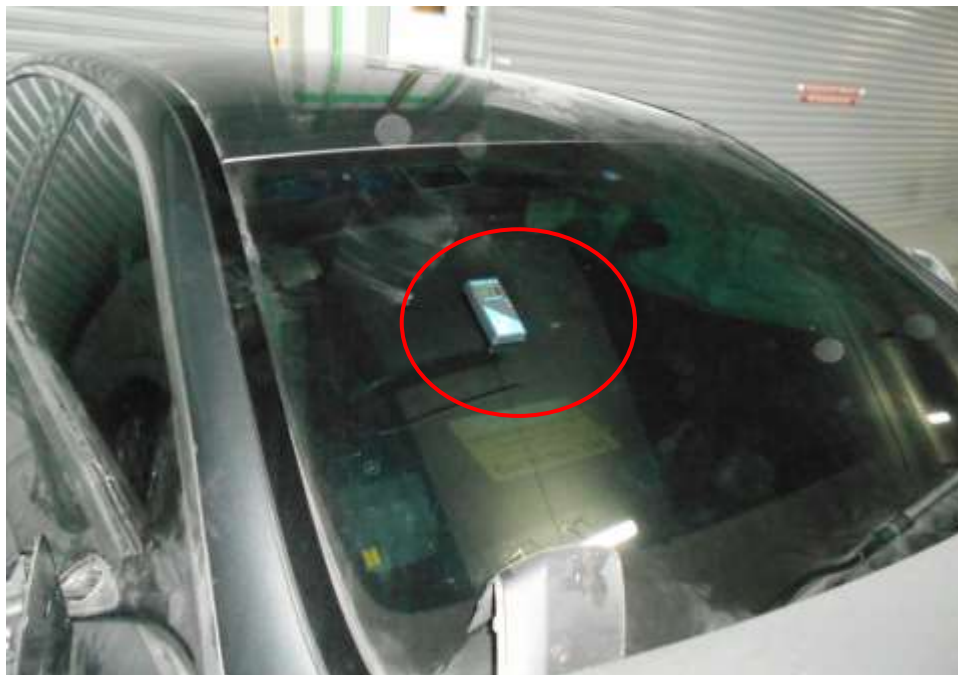
Photo 6 shows a general view of the measurement of the front windscreen tint of the Insured Vehicle using a tint meter (red circle) which measures the amount of Visible Light Transmission (VLT) that passes through a material. The Visible Light Transmission (VLT) measured on a scale of 0- 100%, with 0% meaning no light passes through and 100% meaning all light passes through.

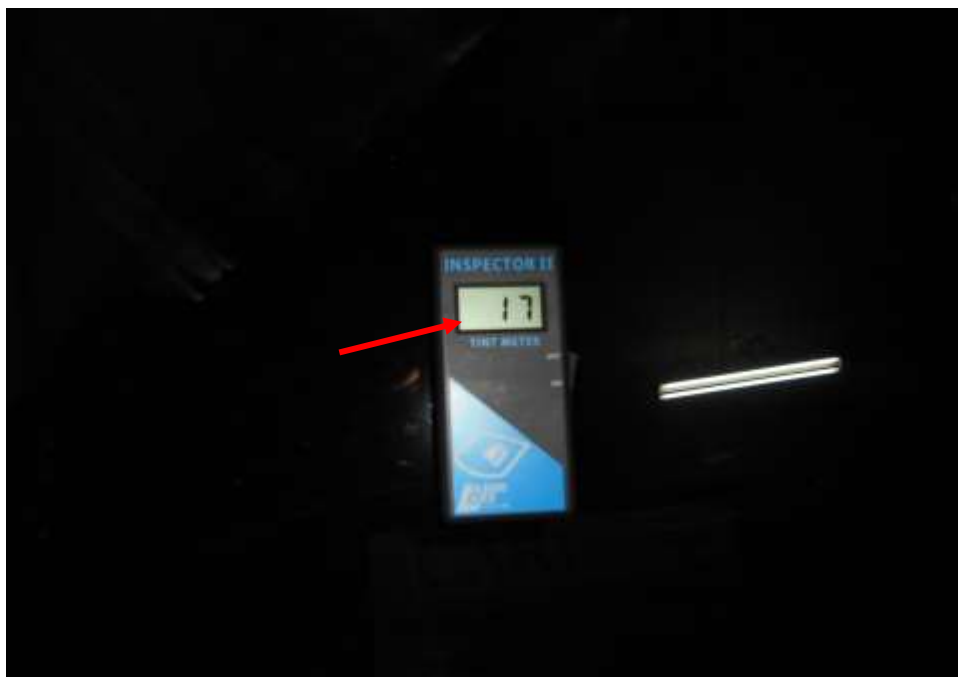
Photo 7 shows the window tint reading of the front windscreen on the Insured Vehicle at the time of my inspection. The front windscreen tint is measured at 17% (red arrow) Visible Light Transmission (VLT) which is not within LTA requirements, as 70% of light must be able to pass through the front windscreen and two front side windows.

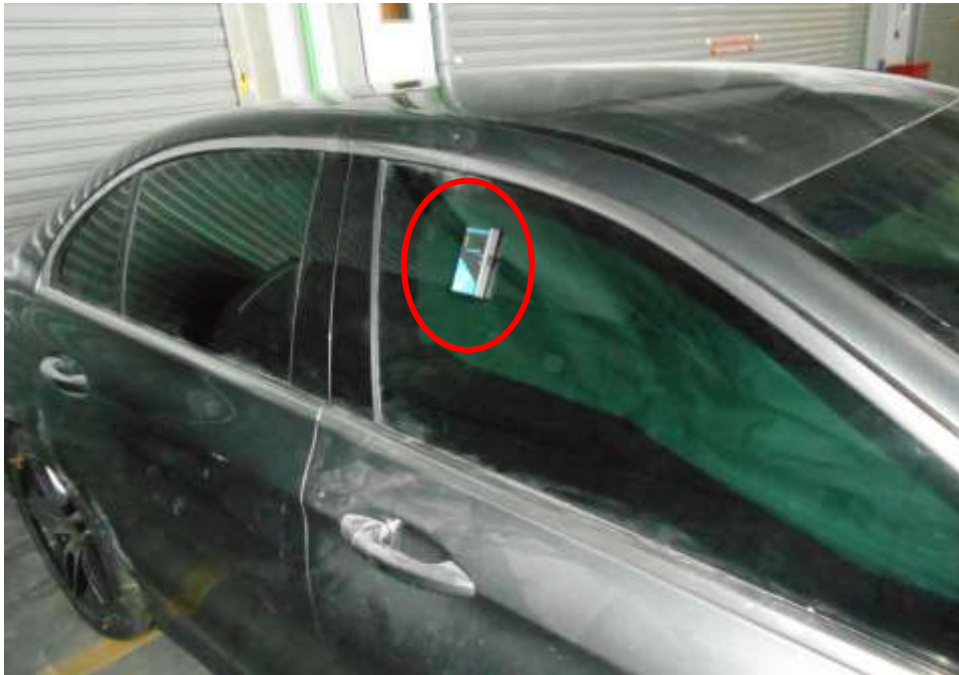
Photo 8 shows a general view of the measurement of the front right window tint of the Insured Vehicle using a tint meter (red circle). Which measures the amount of Visible Light Transmission (VLT) that passes through a material. The Visible Light Transmission (VLT) measured on a scale of 0- 100%, with 0% meaning no light passes through and 100% meaning all light passes through.

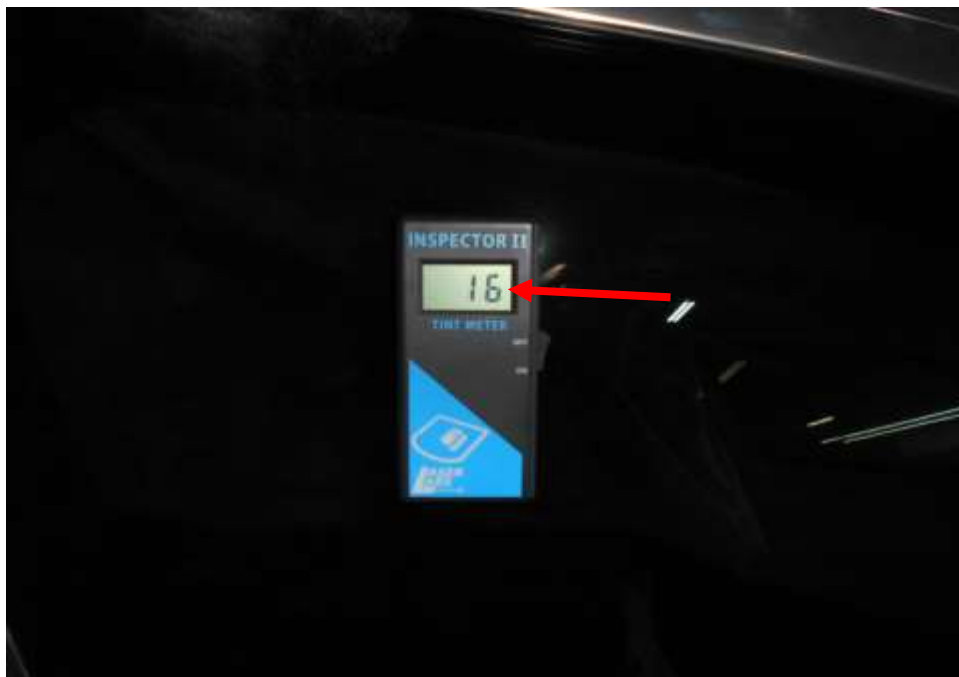
Photo 9 shows the window tint reading of the front right side window on the Insured Vehicle at the time of my inspection. The front right window tint is measured at 16% (red arrow) Visible Light Transmission (VLT) which is not within LTA requirements, as 70% of light must be able to pass through the front windscreen and two front side windows.

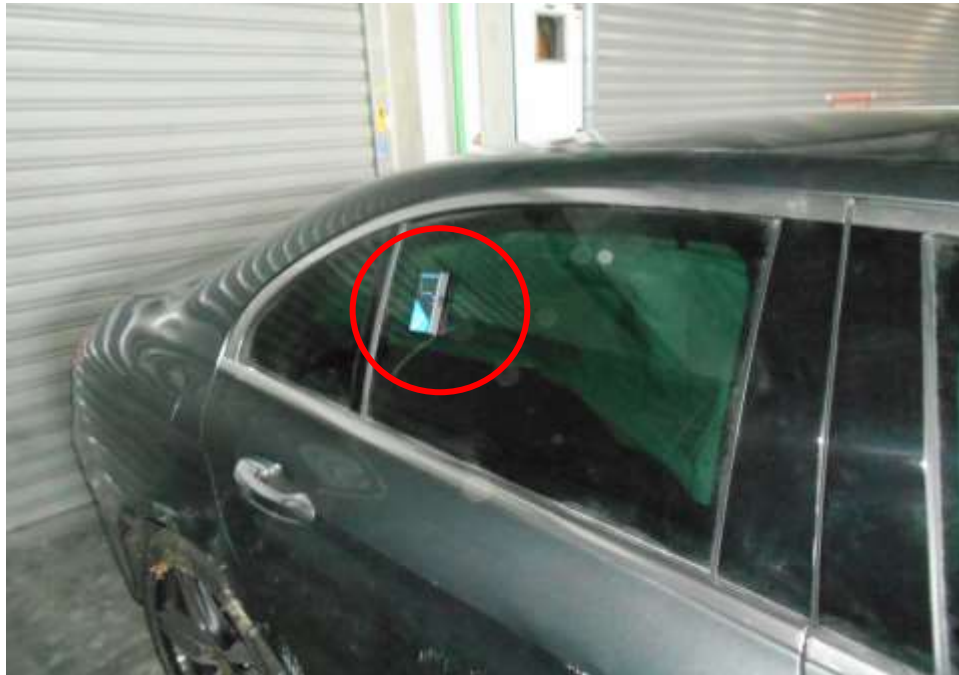
Photo 10 shows a general view of the measurement of the rear right window tint of the Insured Vehicle using a tint meter (red circle). Which measures the amount of Visible Light Transmission (VLT) that passes through a material. The Visible Light Transmission (VLT) measured on a scale of 0- 100%, with 0% meaning no light passes through and 100% meaning all light passes through.

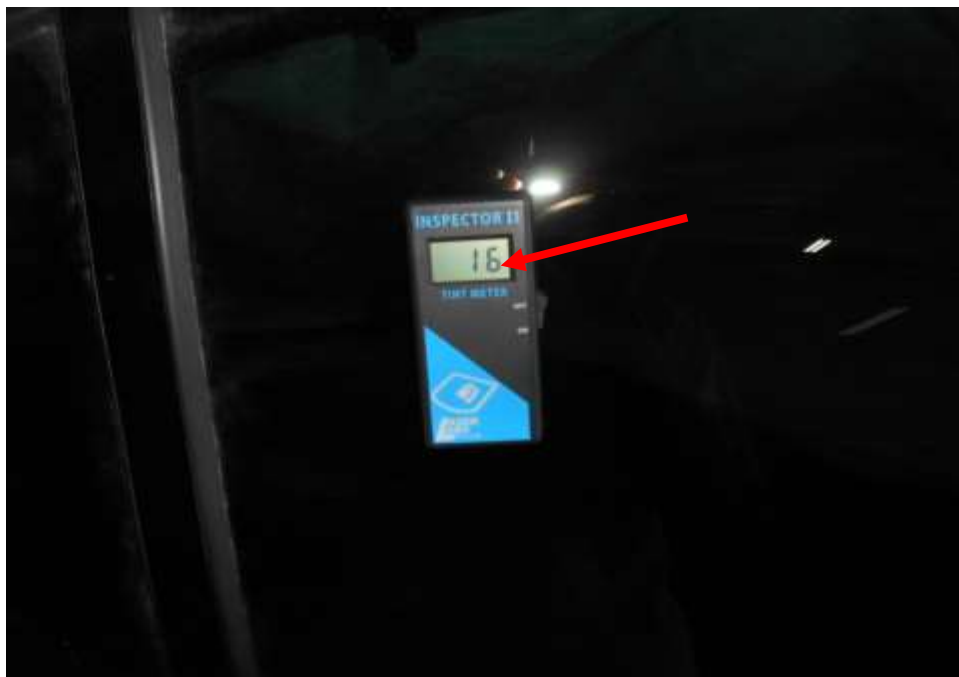
Photo 11 shows the window tint reading of the rear right side window on the Insured Vehicle at the time of my inspection. The rear right side window tint is measured at 16% (red arrow) Visible Light Transmission (VLT) which is not within LTA requirements, as 25% of light must be able to pass through the rear windscreen and two rear side windows.

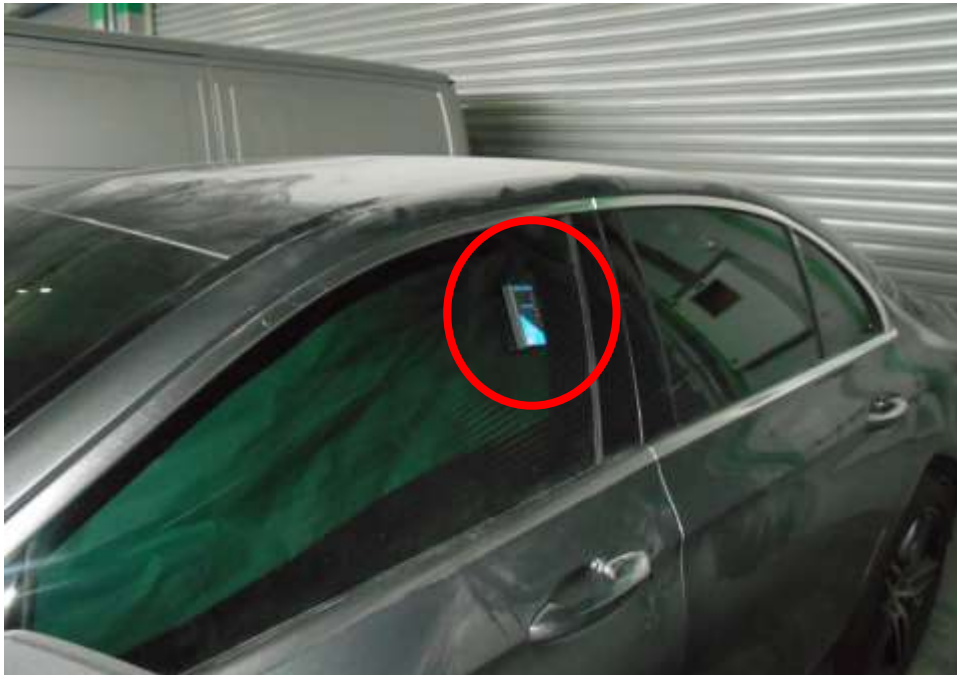
Photo 12 shows a general view of the measurement of the front left window tint of the Insured Vehicle using a tint meter (red circle). Which measures the amount of Visible Light Transmission (VLT) that passes through a material. The Visible Light Transmission (VLT) measured on a scale of 0- 100%, with 0% meaning no light passes through and 100% meaning all light passes through.

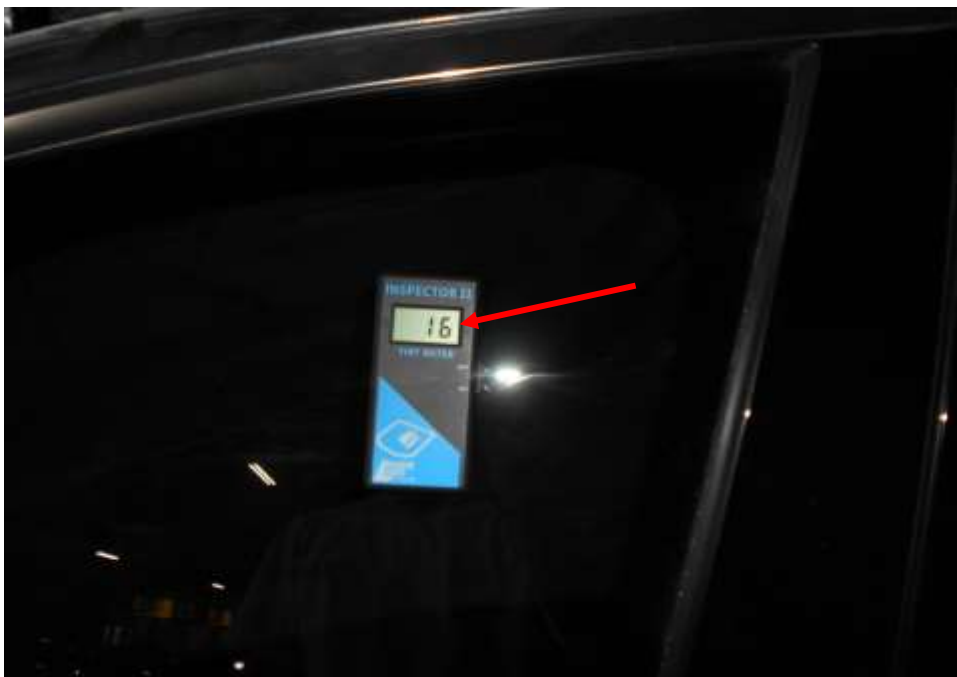
Photo 13 shows the window tint reading of the front left side window on the Insured Vehicle at the time of my inspection. The front left side window tint is measured at 16% (red arrow) Visible Light Transmission (VLT) which is not within LTA requirements, as 70% of light must be able to pass through the front windscreen and two front side windows.

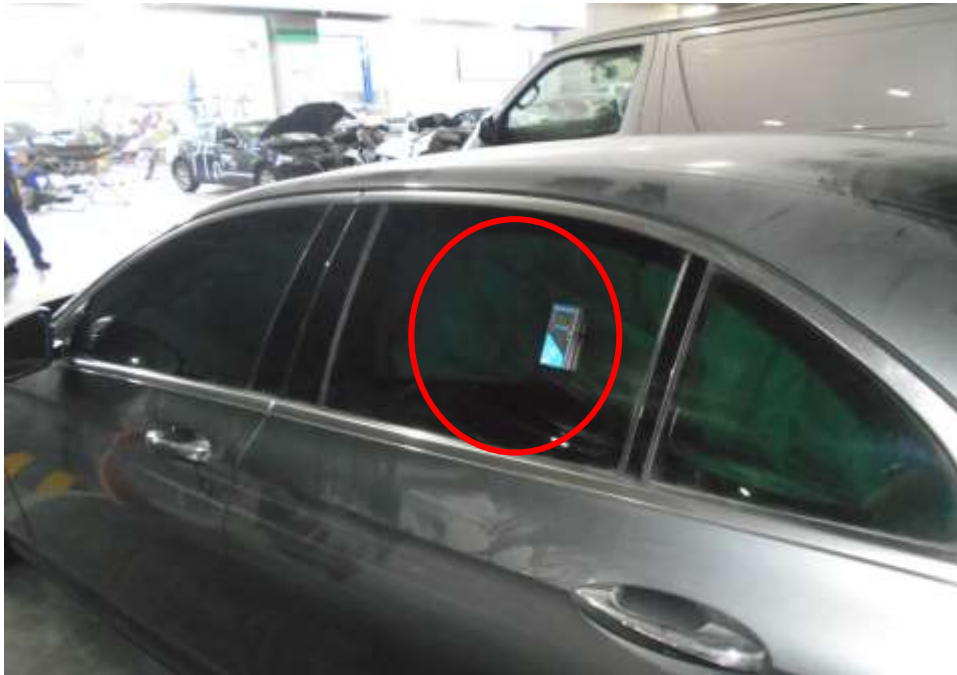
Photo 14 shows a general view of the measurement of the rear left window tint of the Insured Vehicle using a tint meter (red circle). Which measures the amount of Visible Light Transmission (VLT) that passes through a material. The Visible Light Transmission (VLT) measured on a scale of 0- 100%, with 0% meaning no light passes through and 100% meaning all light passes through.

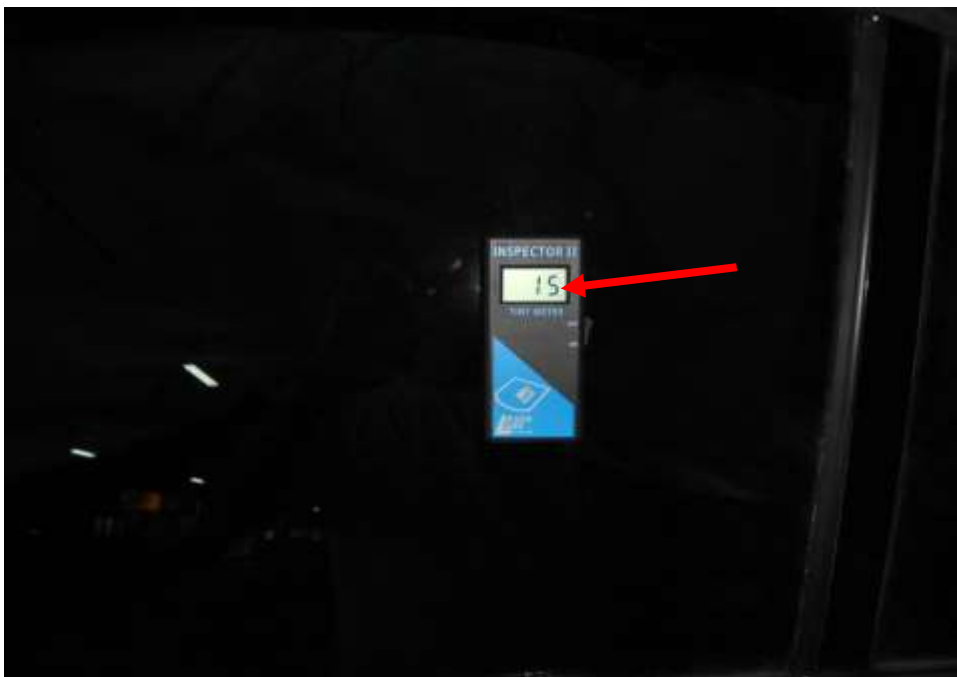
Photo 15 shows the window tint reading of the rear left side window on the Insured Vehicle at the time of my inspection. The rear left side window tint is measured 15% (red arrow) Visible Light Transmission (VLT) which is not within LTA requirements, as 25% of light must be able to pass through the rear windscreen and two rear side windows.

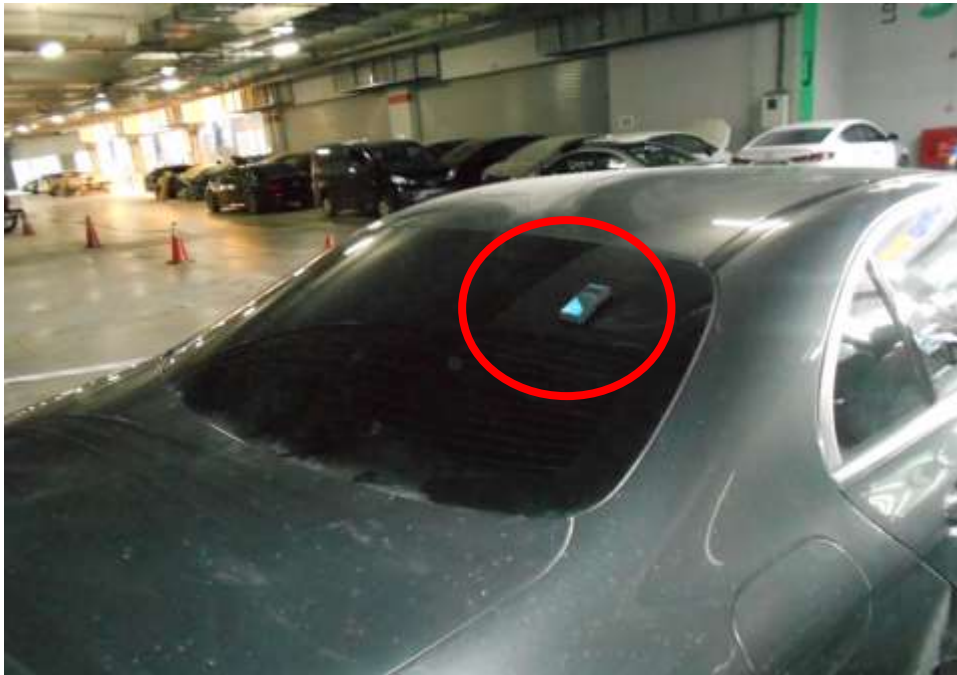
Photo 16 shows a general view of the measurement of the rear windscreen tint of the Insured Vehicle using a tint meter (red circle). Which measures the amount of Visible Light Transmission (VLT) that passes through a material. The Visible Light Transmission (VLT) measured on a scale of 0- 100%, with 0% meaning no light passes through and 100% meaning all light passes through.

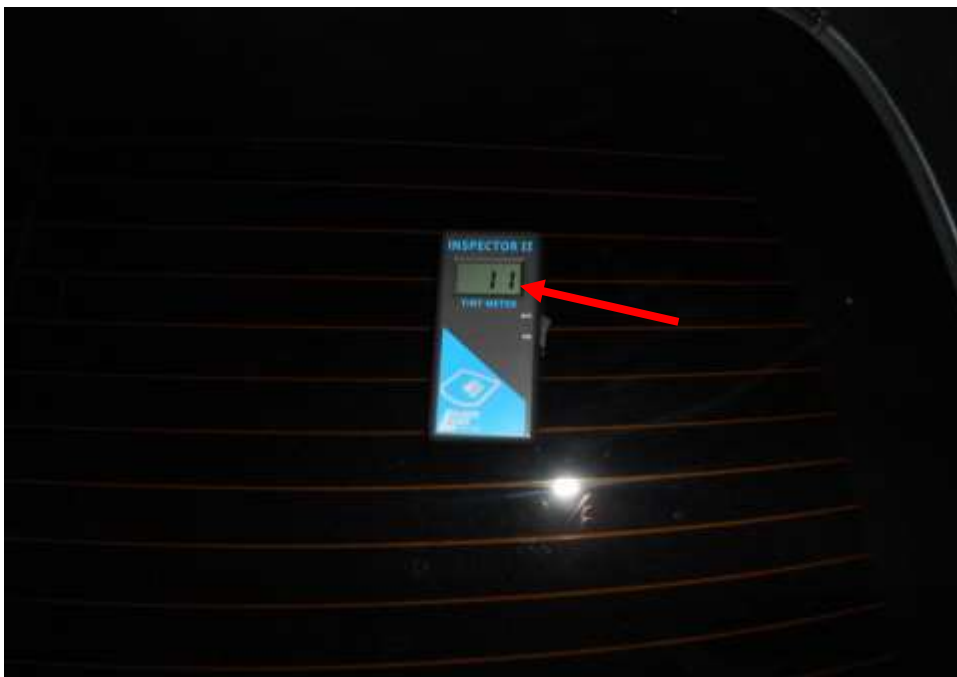
Photo 17 shows the window tint reading of the rear windscreen on the Insured Vehicle at the time of my inspection. The rear windscreen tint percentage is measured at 11% (red arrow) Visible Light Transmission (VLT) which is not within LTA requirements, as 25% of light must be able to pass through the rear windscreen and two rear side windows.

8. In general, the front windscreen was measured at 17% Visible Light Transmission (VLT), while the front right side, rear right side and front left side windows were measured at 16% Visible Light Transmission (VLT). The rear left side window were measured at 15% Visible Light Transmission (VLT), along with the rear windscreen that were each measured at 11% Visible Light Transmission (VLT) which was not within the requirements of the LTA.
