Our Ref : TP / YKA SLC1950T/ 03.21/24

## **DAMAGED VEHICLE (SLC 1950 T) INSPECTION REPORT (WITHOUT PREJUDICE)**

| Registration No | : SLC 1950 T | Mileage | : 419801 km |
| Make & Model | : TOYOTA COROLLA ALTIS 1.6 | Engine No | : 1ZRY241891 |

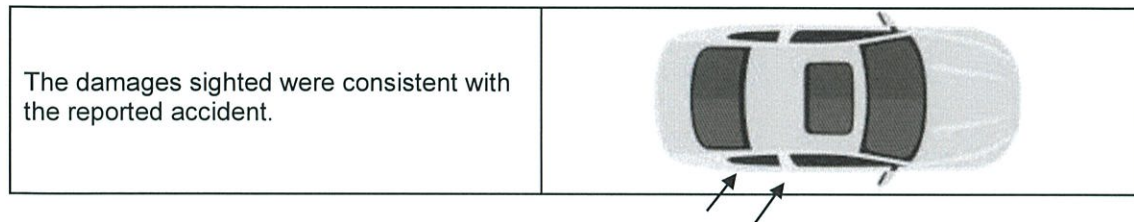
(E) Point of Impact

The impact of the collision has damaged/affected the RH rear wheel rim, RH rear tyre, RH rear suspension, rear fender, rear bumper, rear door, front door and etc.

Our adjusted cost of repair is **\$11,481.18** and an estimated **8** days is required to repair the vehicle. Please refer to the Annex for a detailed account of the cost estimates.
