ALLIED AUTO APPRAISAL

Our Ref: Allied/TP/22-10009

Veh No : **SJL 9262 U**
Date Report : **7-Feb-23**
Date of Accident : **10-Oct-22**
Date of Survey : **11-Oct-22**

Make & Model	: Honda Fit 1.3G A	Date of Registration	: 16-Dec-08
Engine No	: L13A4131608	Engine c.c.	: 1339 cc
Chassis No	: GE61119657	COE Expiry Date	: 15-Dec-23

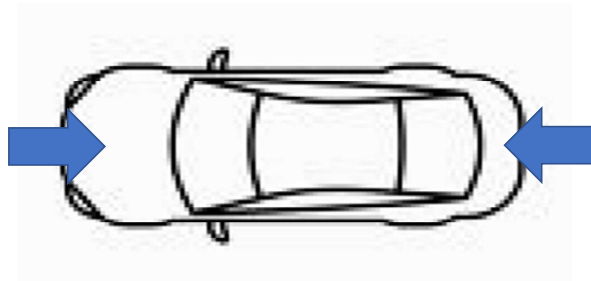
The inspected vehicle sustained damage at the **FRONT & REAR** portion.

During visual inspection, our surveyor noted that the bonnet, front bumper, headlamps, tailgate, rear bumper, taillamps, spare tyre panel and among other parts were affected.

The repairer agree to repair the vehicle on a **Lump Sum Basis** with our recommendation of **SGD 27,850.00 (SGD Twenty Seven Thousand Eight Hundred and Fifty only)** and we are in the opinion the repairer would need about a **12.0** working day period to repair the vehicle.
