Your Ref: SNM24D203376  
Our Ref : CS/CTI24060058/K

**TECHNICAL INVESTIGATION REPORT OF INSURED VEHICLE YQ 1422Z  
INVOLVED IN AN ACCIDENT ON 10 JUNE 2024**

Registration Number : YQ 1422Z  
Make & Model : HINO XZU710R 14FT WIDE CAB 5T  
Year of Registration : December 2012  
Chassis Number : JHHUCV3H70K031982  
Speedo Reading : N/A

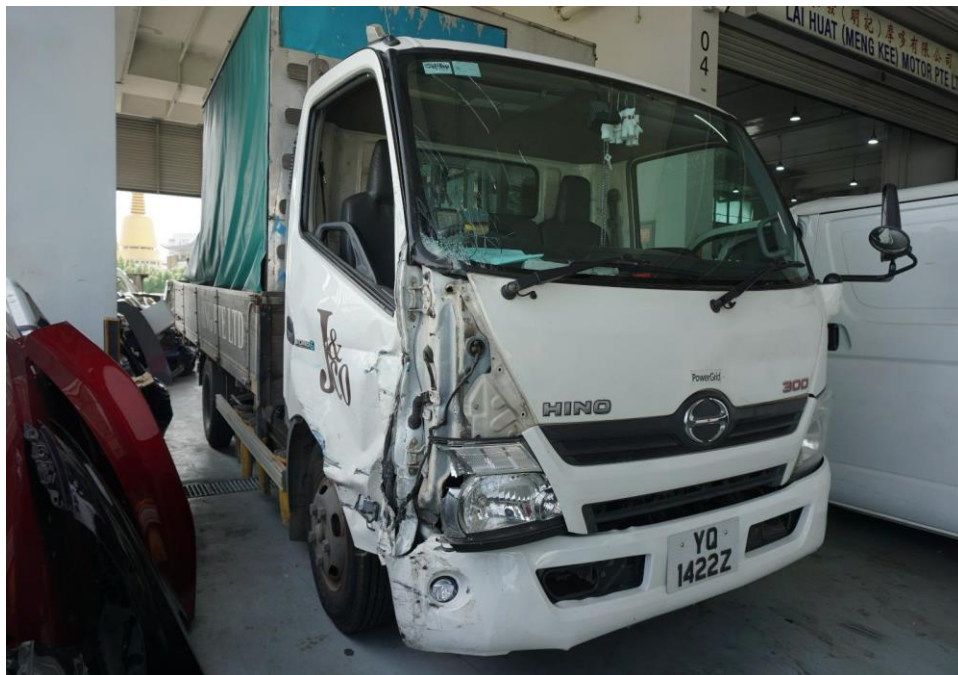
5. The insured vehicle was observed to have sustained impact damages on its front portion and right body. Its front windscreen, front body panel, front bumper, front right headlamp and right front door were amongst the exterior body parts which were observed to have been damaged as a result of the accident.

**Photo 1** shows a general view of the Insured Vehicle front portion at the time of my inspection. The Insured Vehicle was observed to have sustained damage at its front portion. Its front windscreen, front body panel, front right headlamp and front bumper was amongst the body parts damaged as a result of the accident.

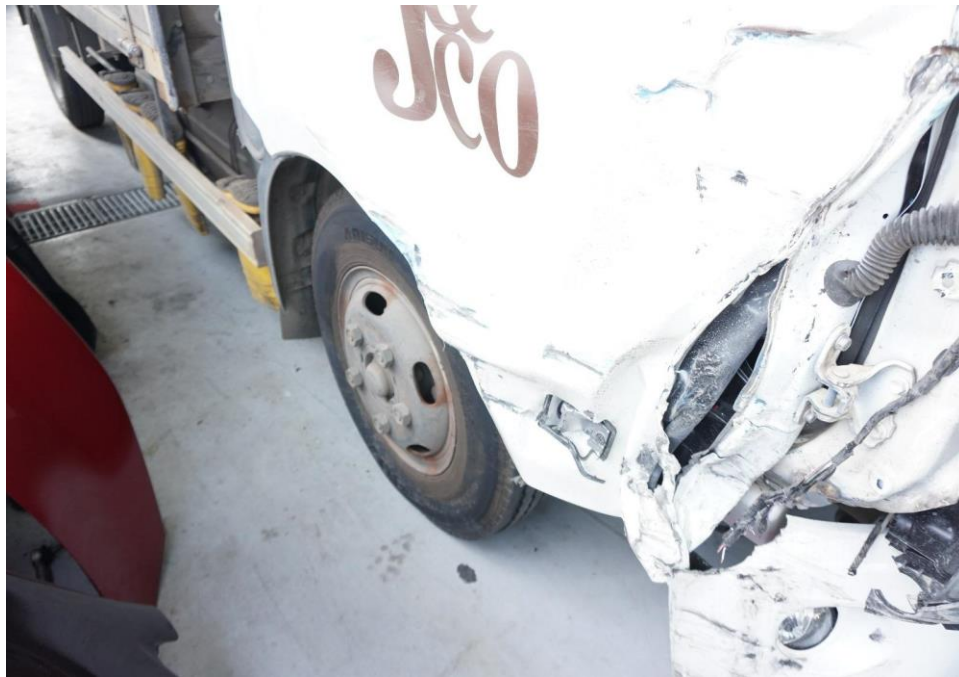
**Photo 2** shows the close up view of the right of the insured vehicle at the time of my inspection. Its front right door was observed to be damaged as a result of the accident.

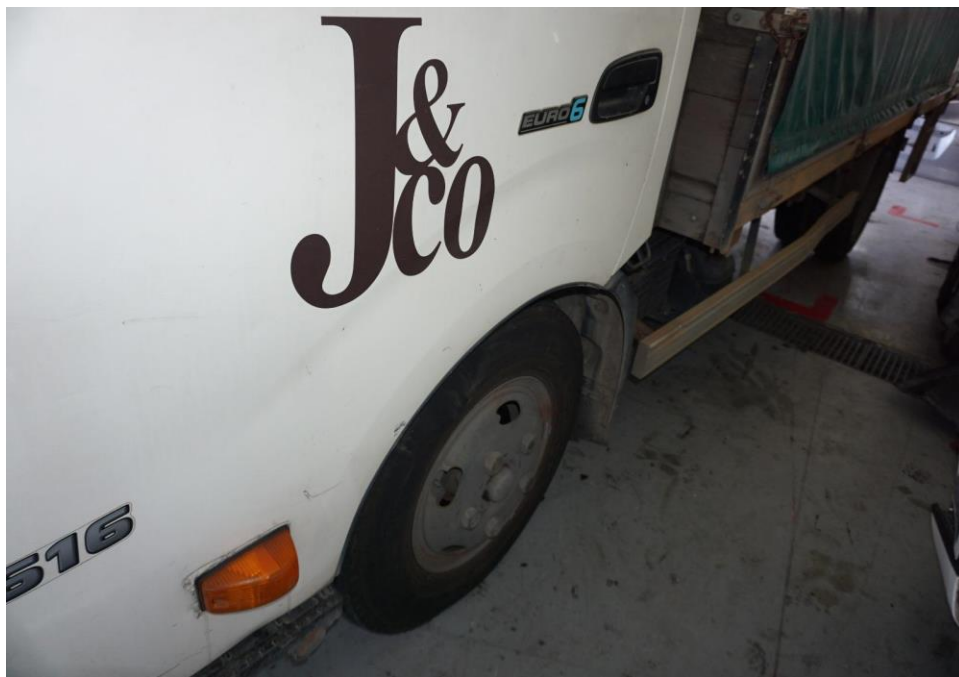
**Photo 3** shows the general view of the left body of the insured vehicle at the time of my inspection its unaffected by the accident.

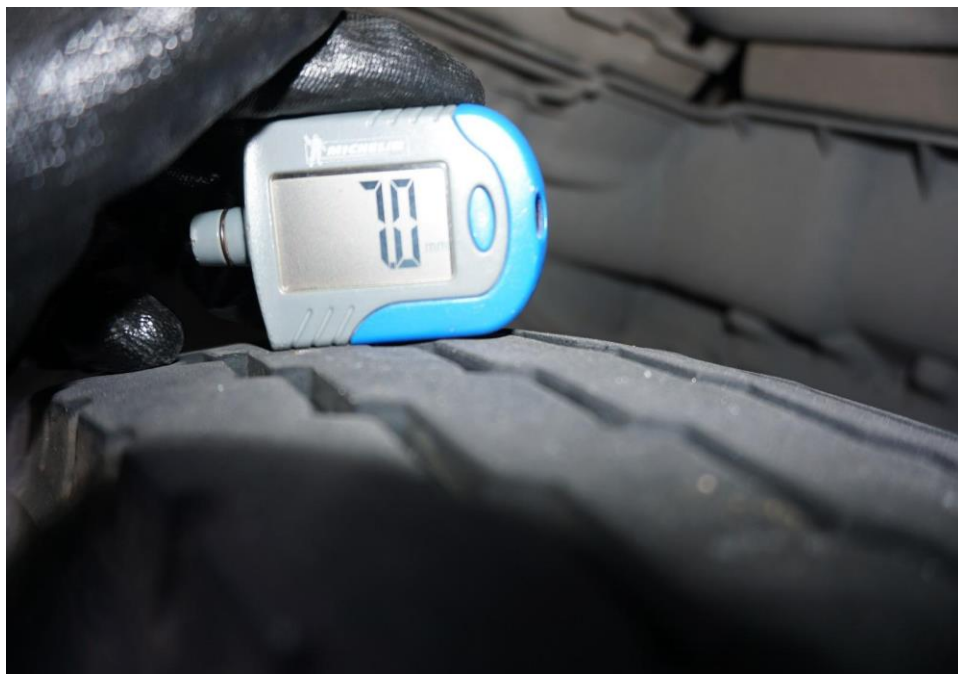
**Photo 4** shows the tread depth of the front right tyre on the insured vehicle at the time of my inspection. The remaining tread depth is 7mm which is within the LTA requirements.

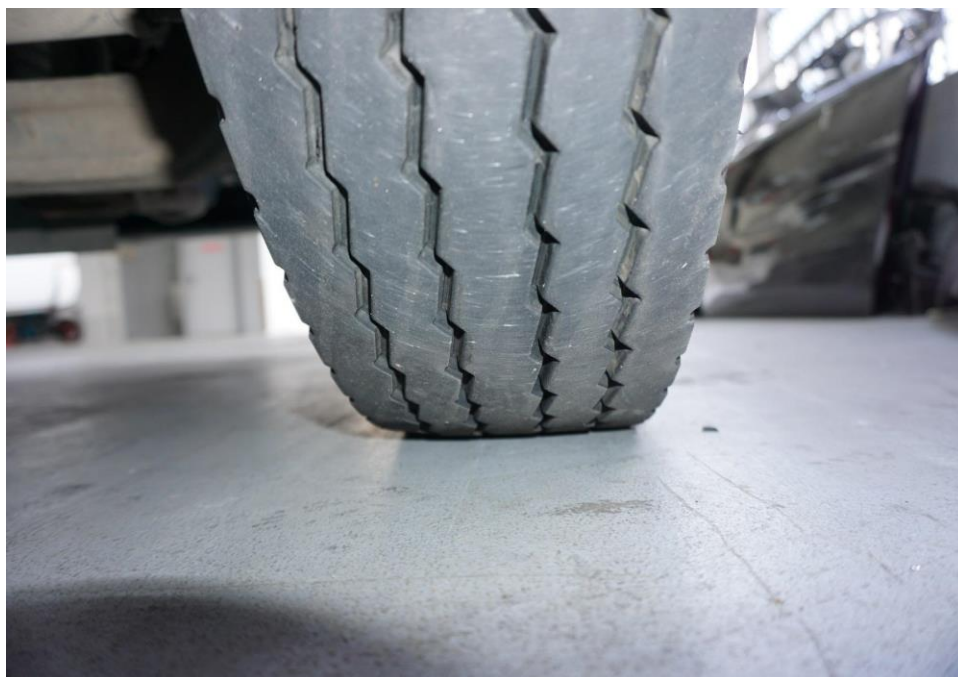
**Photo 5** shows front right tyre of the insured vehicle at the time of my inspection. The front right tyre of the insured vehicle was observed to be in serviceable condition with remaining tread depth of 5.62mm which is within LTA requirements.

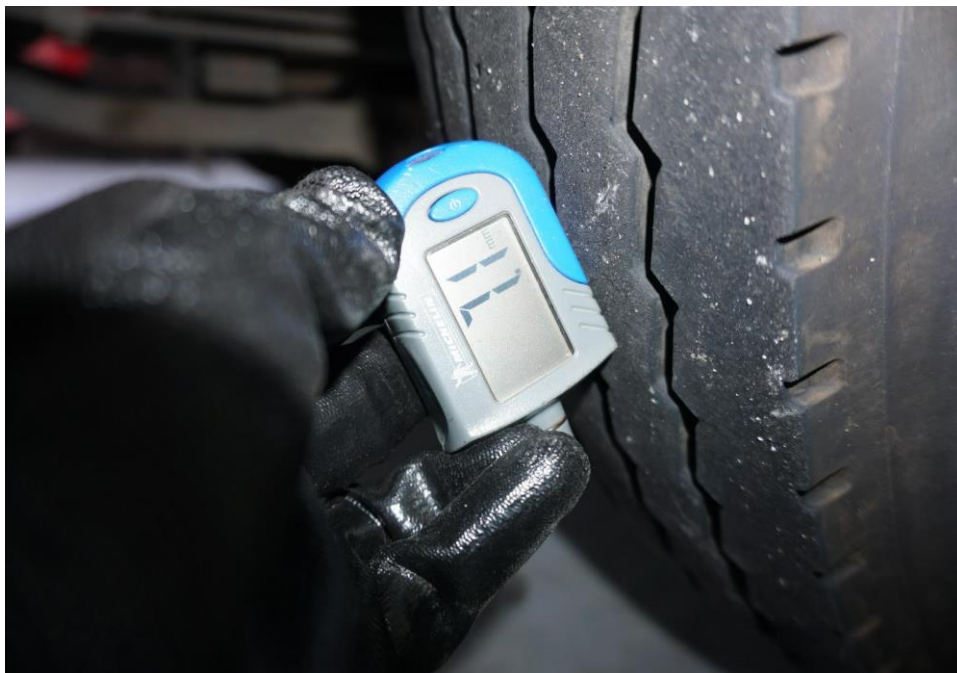
**Photo 6** shows the tread depth of the front left tyre on the insured vehicle at the time of my inspection. The remaining tread depth is 7.1mm which is within the LTA requirements.

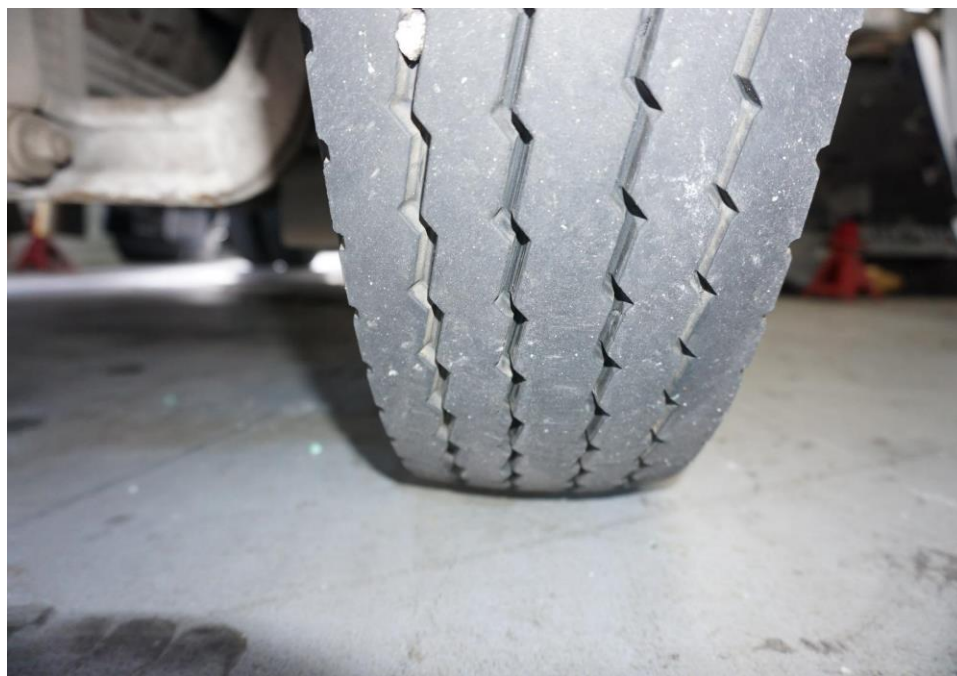
**Photo 7** shows the front left tyre of the insured vehicle at the time of my inspection. The front left tyre of the insured vehicle was observed to be in serviceable condition with the remaining tread depth of 7.1mm which is within LTA requirements.

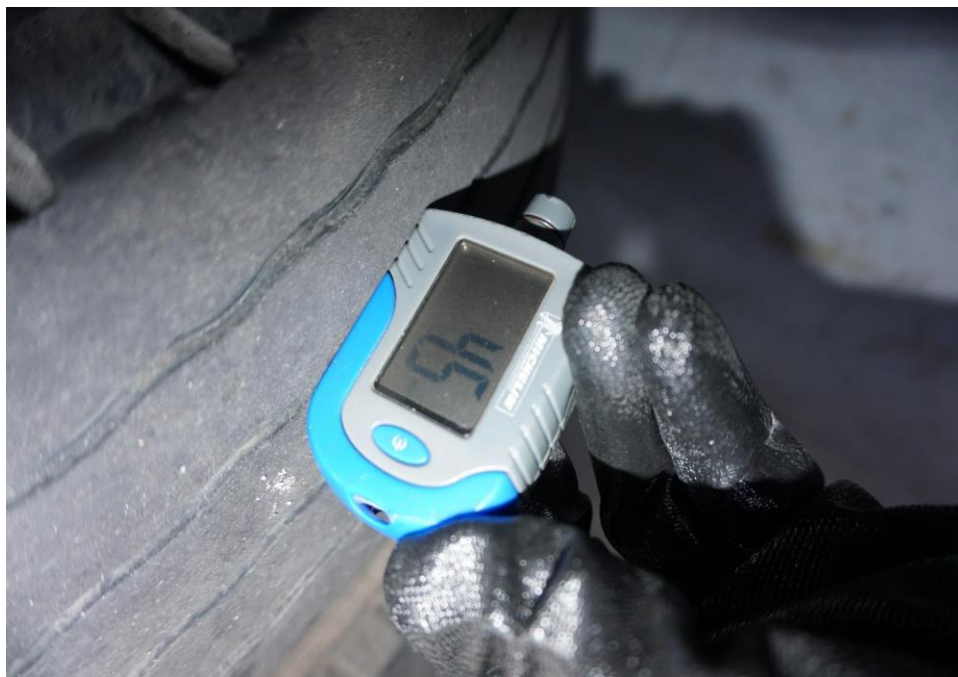
**Photo 8** shows the tread depth of the rear right outer tyre on the insured vehicle at the time of my inspection. The remaining tread depth is 4.5mm which is within the LTA requirements.

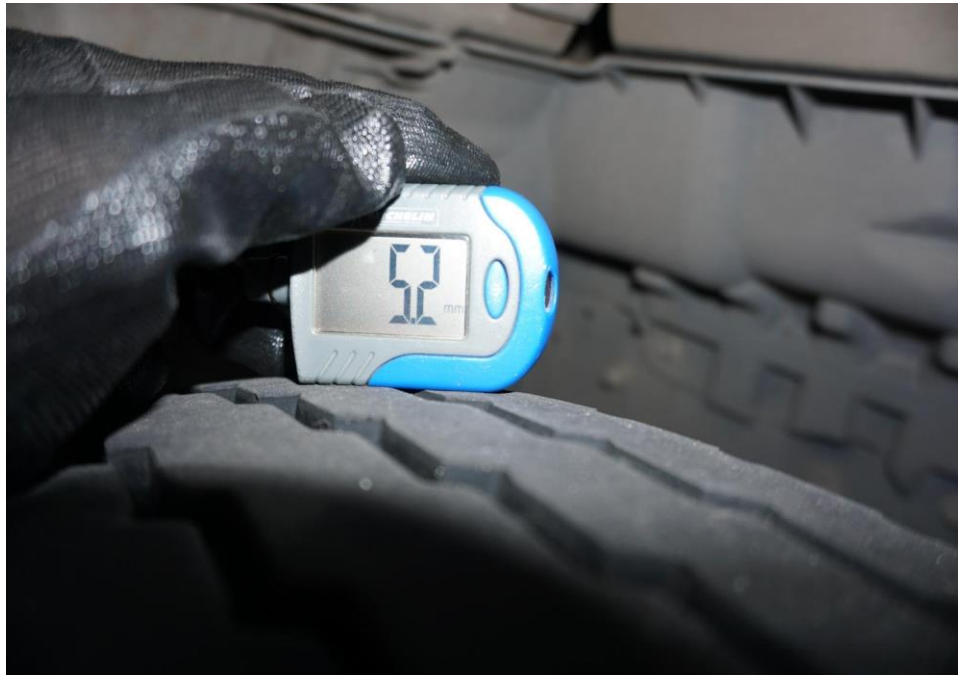
**Photo 9** shows the tread depth of the rear right inner tyre on the insured vehicle at the time of my inspection. The remaining tread depth is 4.5mm which is within the LTA requirements.

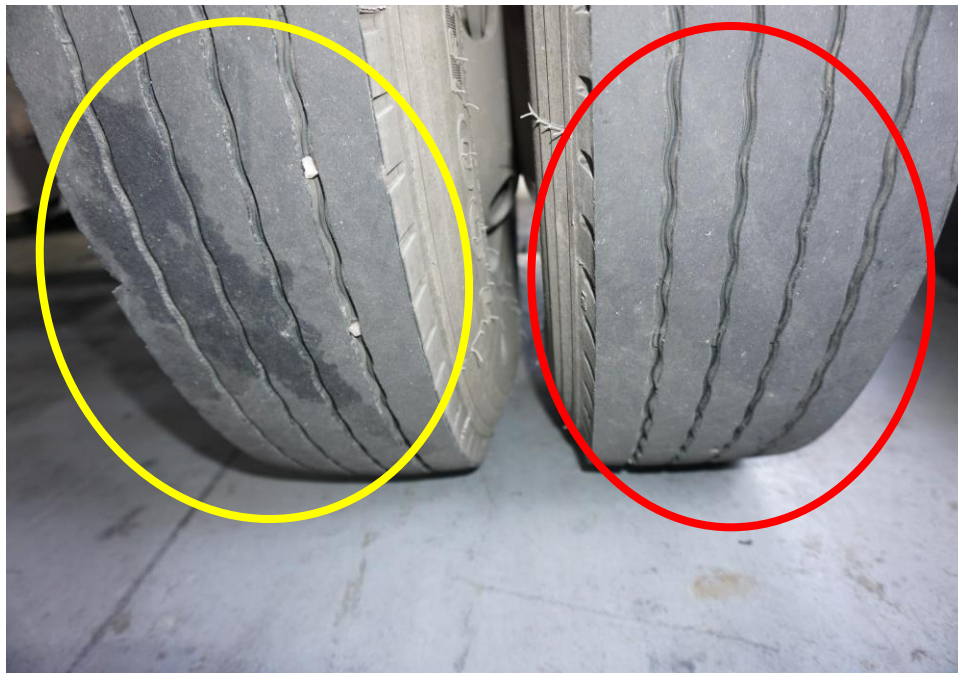
**Photo 10** shows rear right tyre tyres of the insured vehicle at the time of my inspection. The rear right tyres of the insured vehicle was observed to be in serviceable condition with remaining tread depth of 4.5mm on the rear right outer tyre (red circle) and 5.2mm on the rear right inner tyre (yellow circle) which is within LTA requirements.

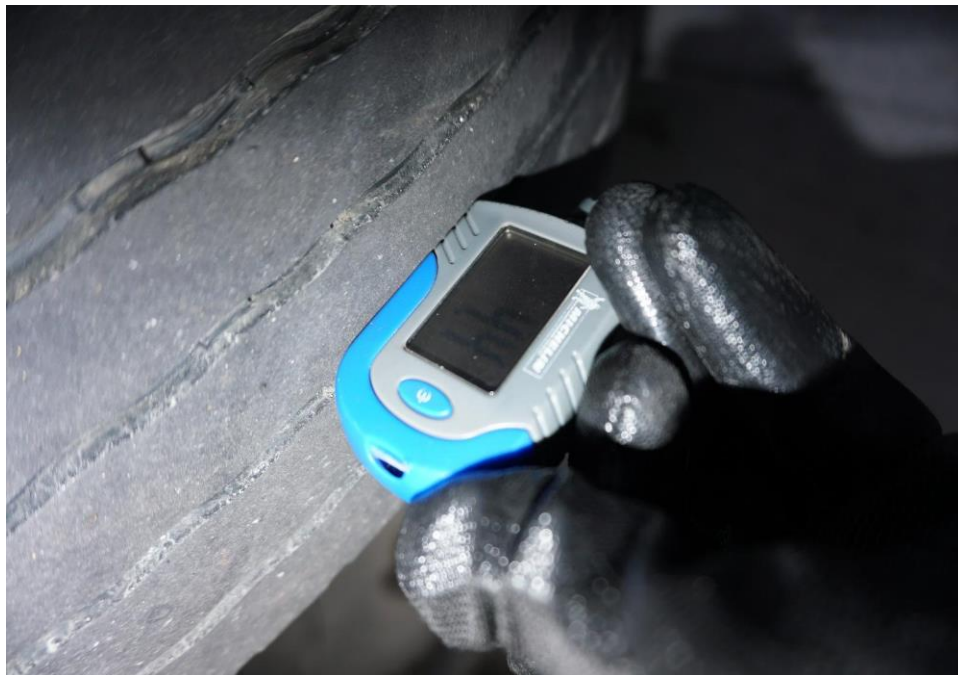
**Photo 11** shows the tread depth of the rear left outer tyre on the insured vehicle at the time of my inspection. The remaining tread depth is 4.4mm which is within the LTA requirements.

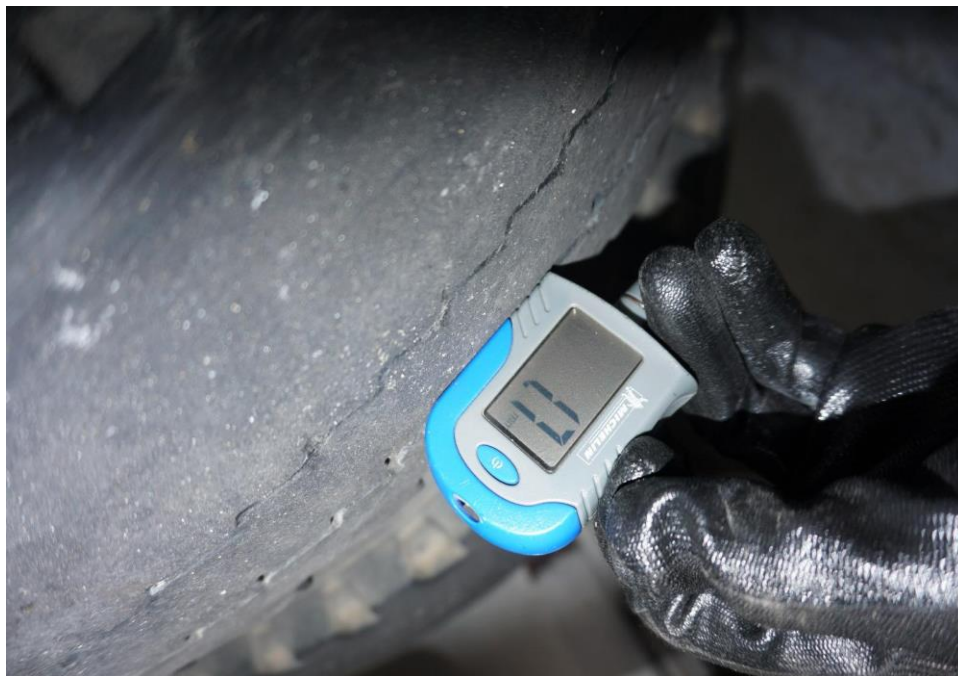
**Photo 12** shows the tread depth of the rear left inner tyre (outer tread) on the insured vehicle at the time of my inspection. The remaining tread depth is 1.7mm which is within the LTA requirements.

10. Although the rear left inner tyre, was found to be with remaining tread depth of 0.0mm – 0.02mm, the outer area was still found to be with 1.7mm. This does not cover 75% of the breath of the thread and the entire circumference hence we are of the view that this tyre was still within the requirements of the road traffic act.

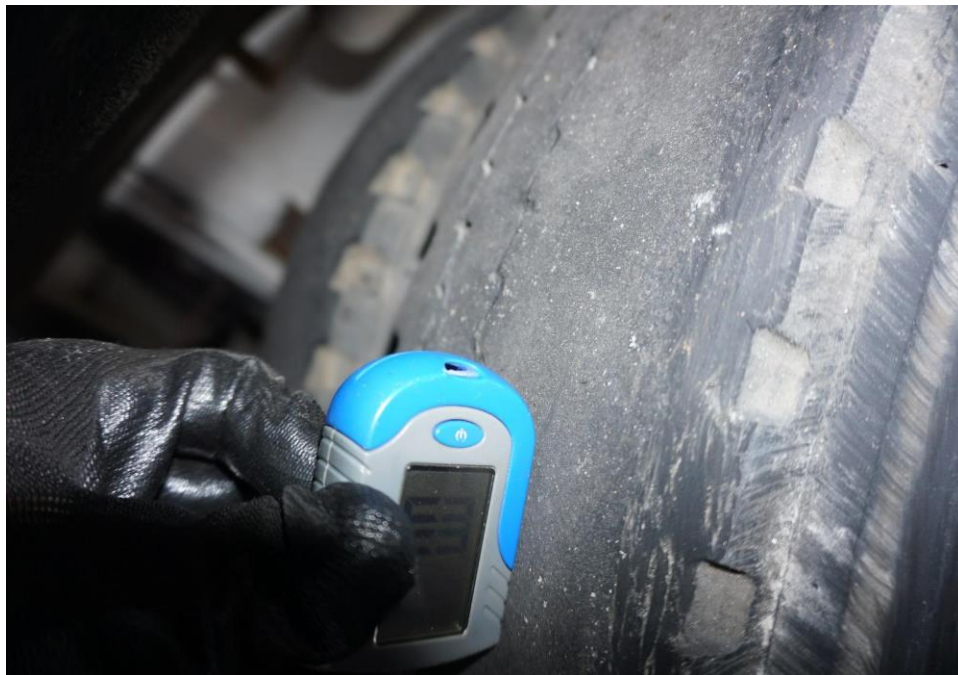
**Photo 13** shows the tread depth of the rear left inner tyre (inner tread) on the insured vehicle at the time of my inspection. The remaining tread depth is 0.0mm which is not within the LTA requirements

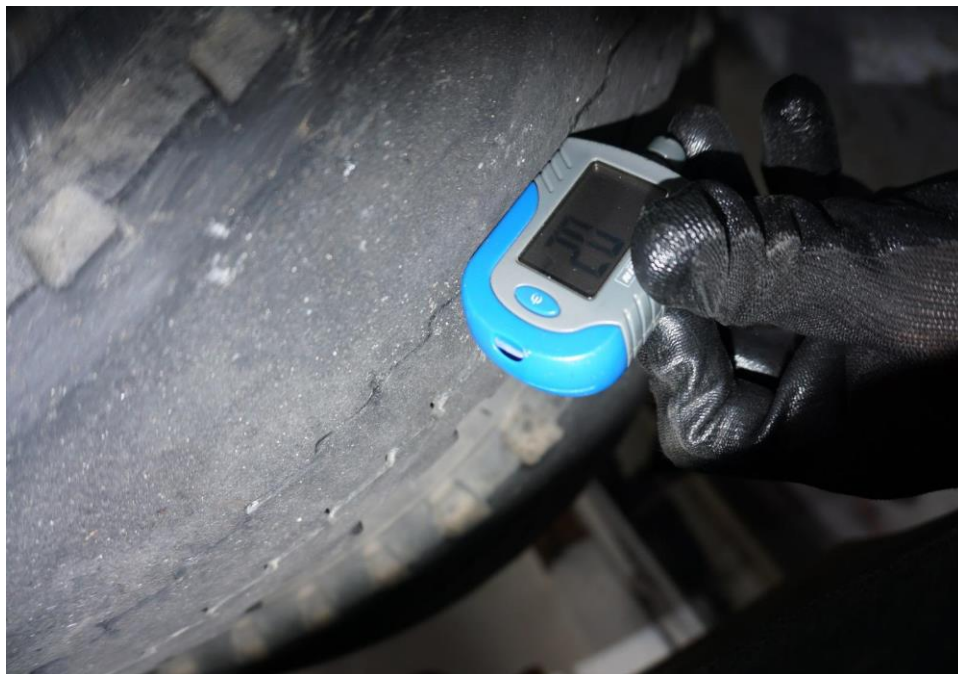
**Photo 14** shows the tread depth of the rear left inner tyre (inner tread) on the insured vehicle at the time of my inspection. The remaining tread depth is 0.2mm which is not within the LTA requirements

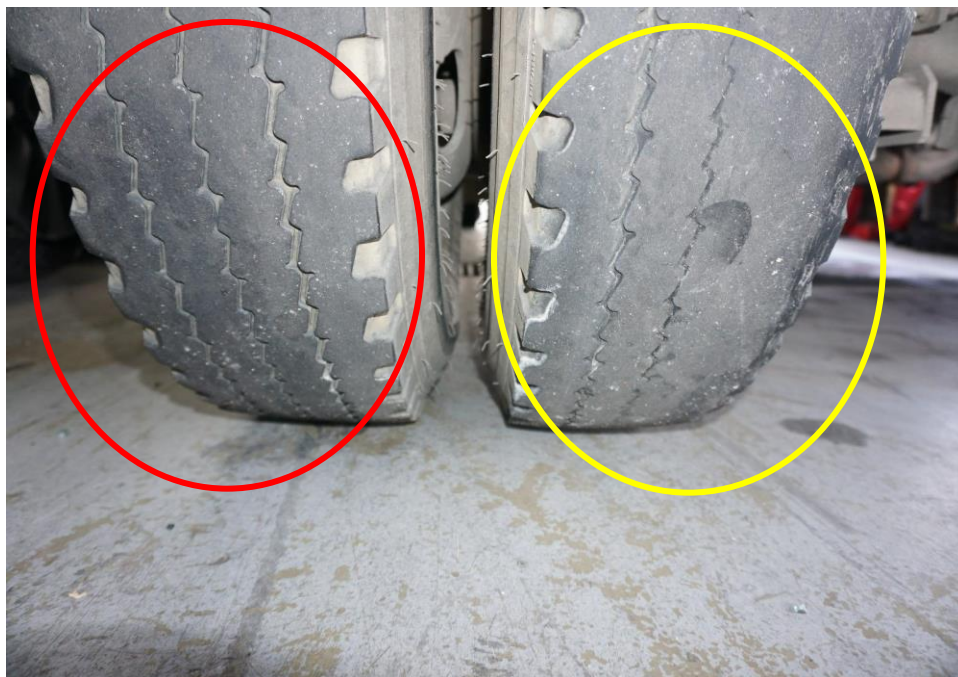
**Photo 15** shows rear left tyre of the insured vehicle at the time of my inspection. The rear left tyres of the insured vehicle with remaining tread depth of 4.4mm on the rear left outer tyre (red circle) and 0.0mm on the rear left inner tyre (yellow circle).

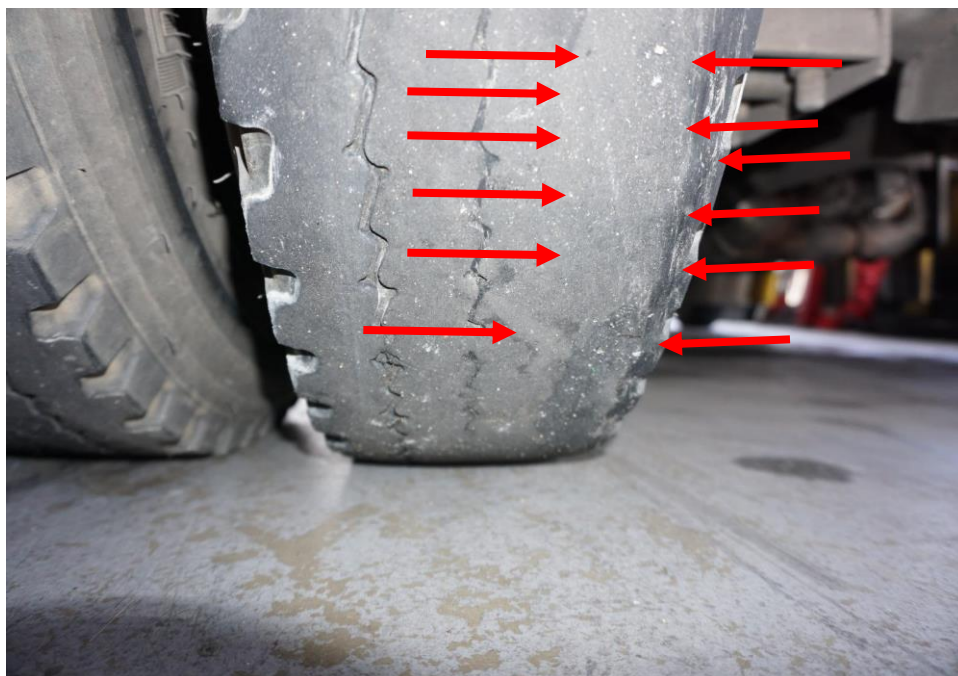
**Photo 16** shows a general view of the rear left inner tyre of the insured vehicle at the time of my inspection. The rubber compound at the inner side of the tyre, around 50% of its circumference, was observed to be worn (red arrows).
