# NCVI INVOLVING MID21536 AND CIVILIAN BUS SG 5021U ALONG YISHUN AVENUE 1 TOWARDS MANDAI AVENUE ON 24 JUL 2024 AT ABOUT 1113HRS

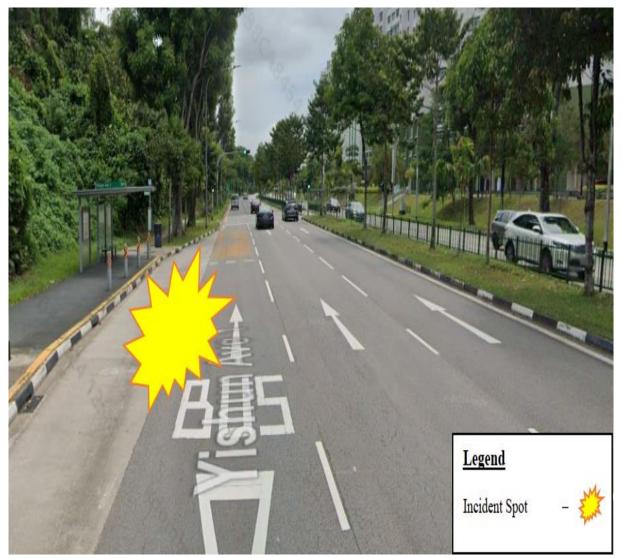
Figure A-1: View of Incident Site

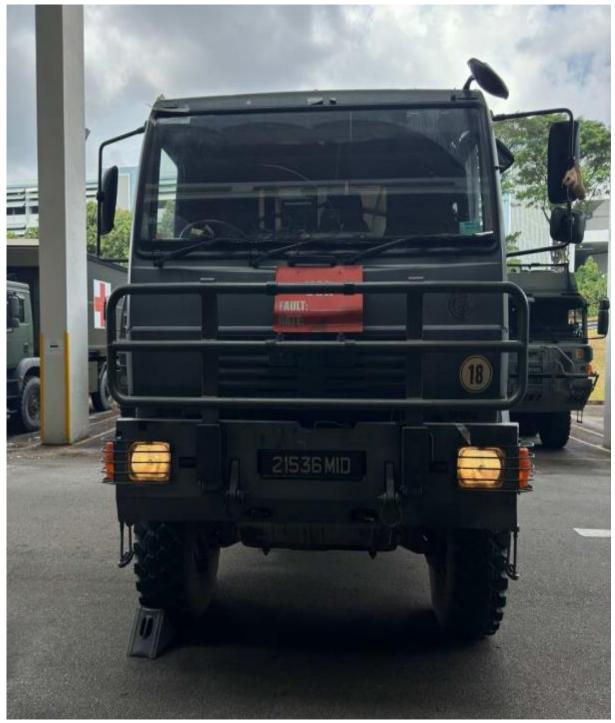
Figure B-1: Front View of MID21536

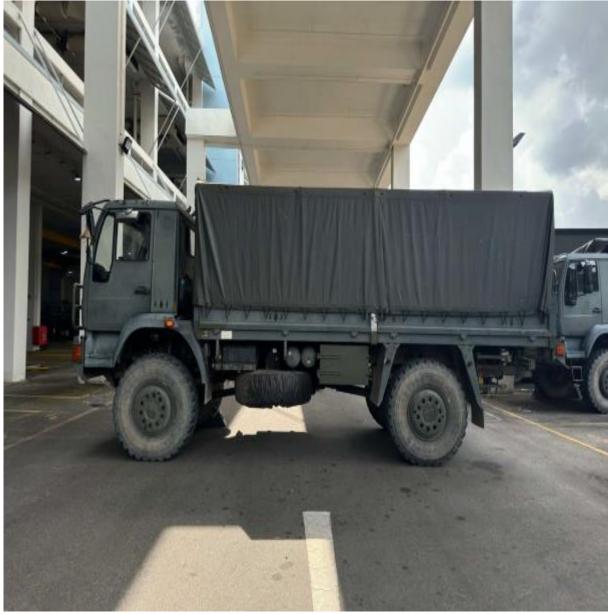
Figure B-2: Left Side View of MID21536

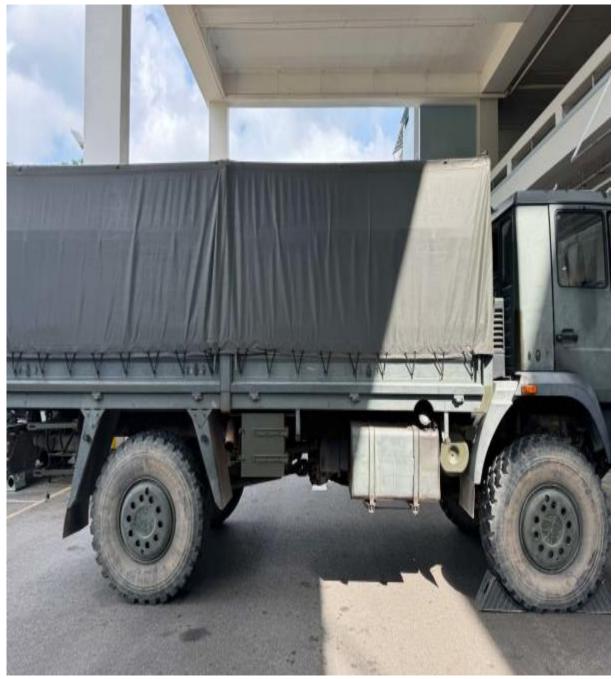
Figure B-3: Right Side View of MID21536

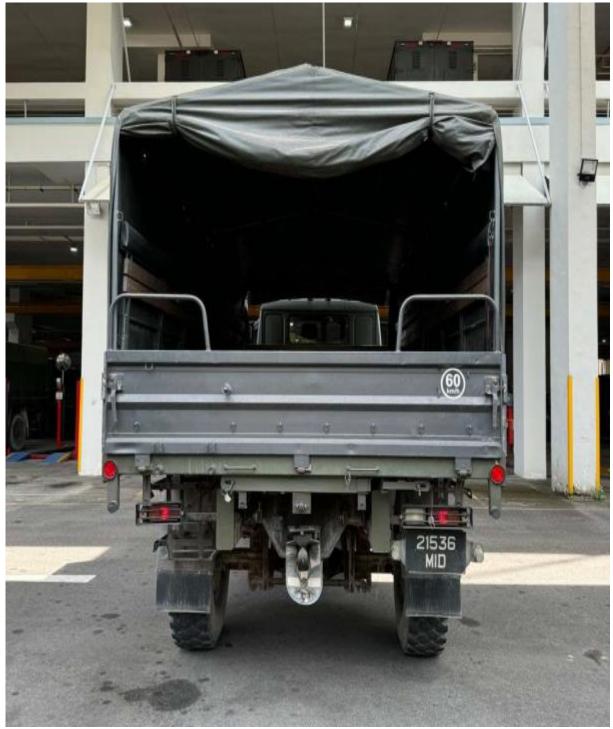
Figure B-4: Rear View of MID21536

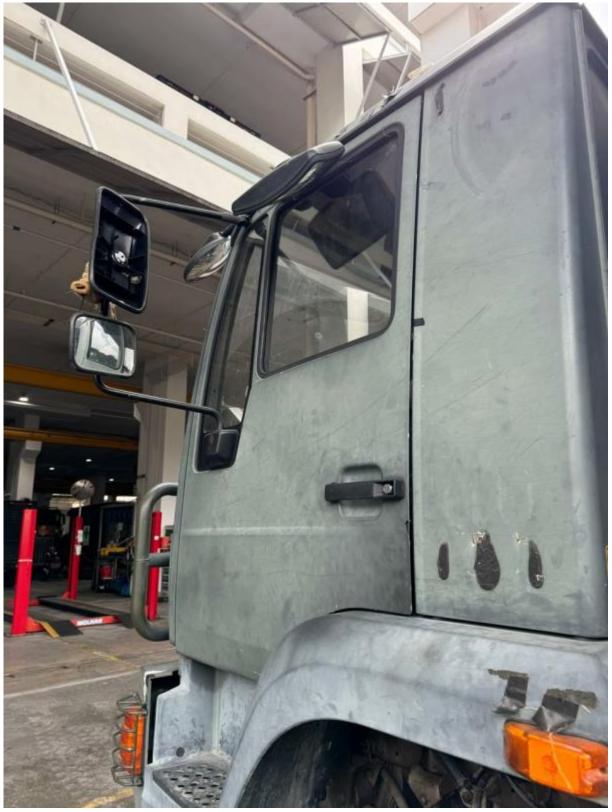
Figure B-5: Zoomed-in View of MID21536 Damage

Damage Assessment: Both left side mirrors broken

As I approached closer, I realized the rear of the bus was out too much, I immediately looked into my right rearview mirror and saw an oncoming vehicle on my right, there was no way for me to turn right to avoid the bus and be met with an oncoming vehicle on my right. The left rear-view mirror hit the rear of the bus and broke.
