Our Ref : CS/LPC24070505/N

7 August 2024

**TECHNICAL INVESTIGATION REPORT OF FIRE INCIDENT INVOLVING THE
INSURED VEHICLE GBE 4567E ON 24 JULY 2024**

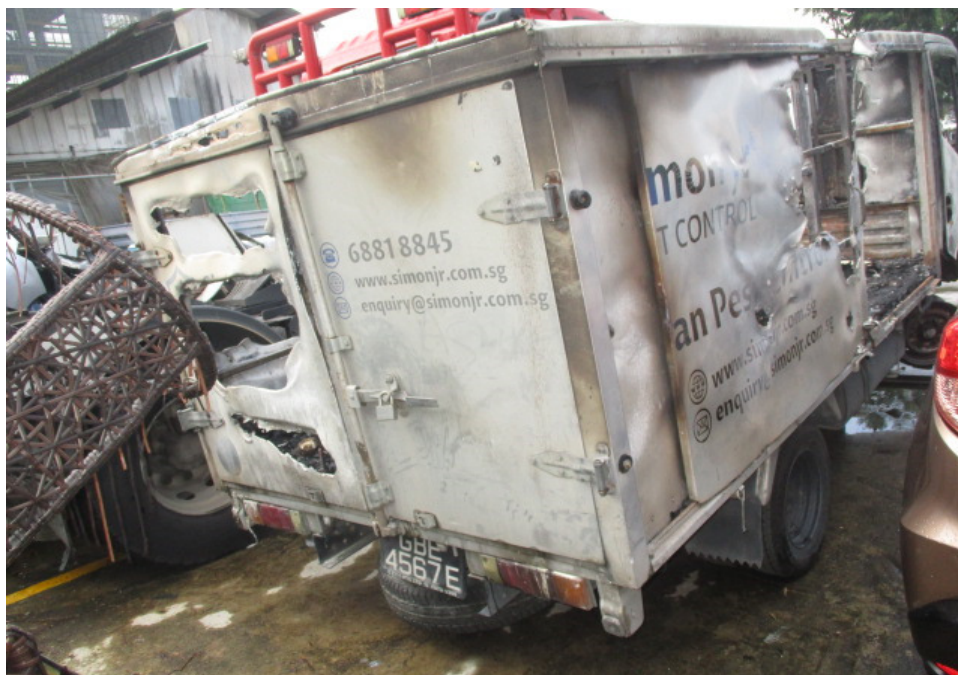
Photo 1 shows the general view of the rear portion of the Insured Vehicle at the time of our inspection. The Insured Vehicle was observed to have sustained extensive fire damage all around.

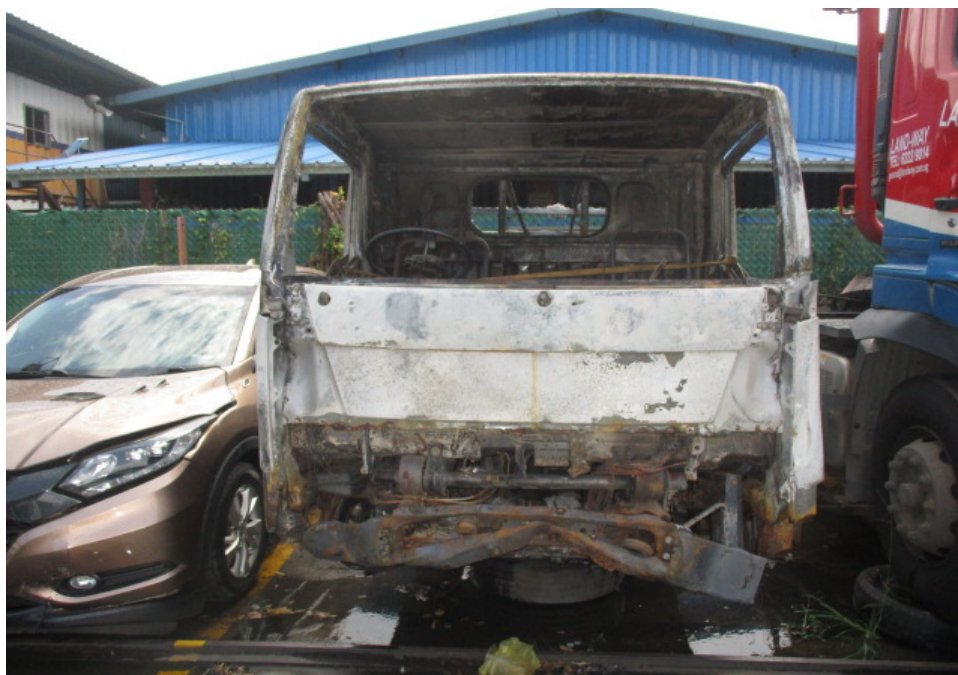
Photo 2 shows the general view of the frontal portion of the Insured Vehicle at the time of our inspection. The Insured Vehicle was observed to have sustained extensive fire damage all around. Its engine compartment and interior compartment were completely burnt. Rust had accumulated all over the Insured Vehicle as a result of exposure to environmental condition for a period of time.

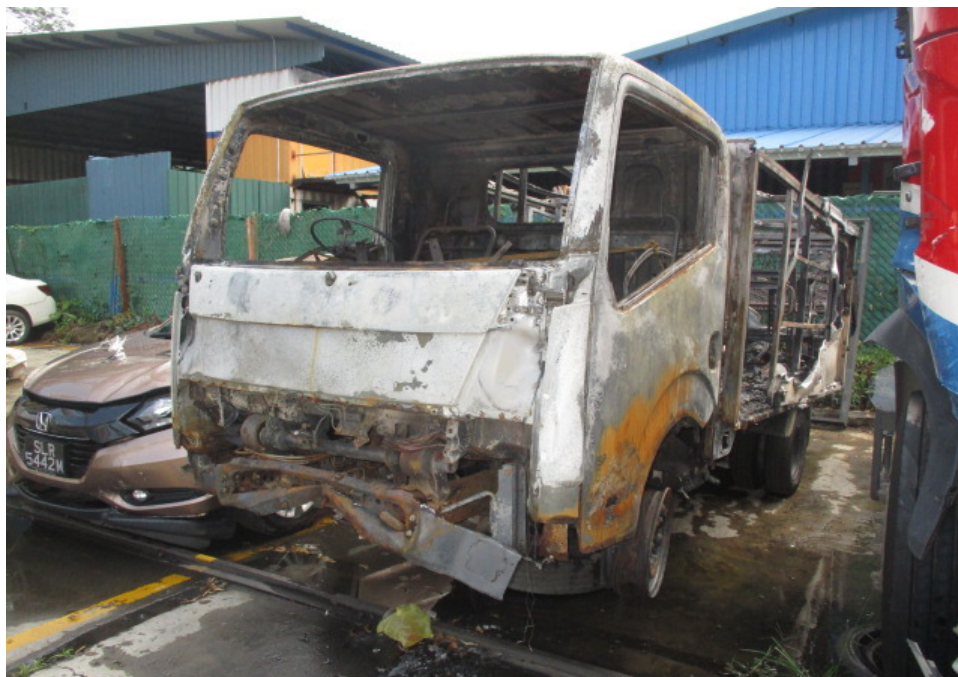
Photo 3 shows the general view of the left body of the Insured Vehicle at the time of our inspection. The Insured Vehicle was observed to have sustained extensive fire damage all around. Rust had accumulated all over the Insured Vehicle as a result of exposure to environmental condition for a period of time.

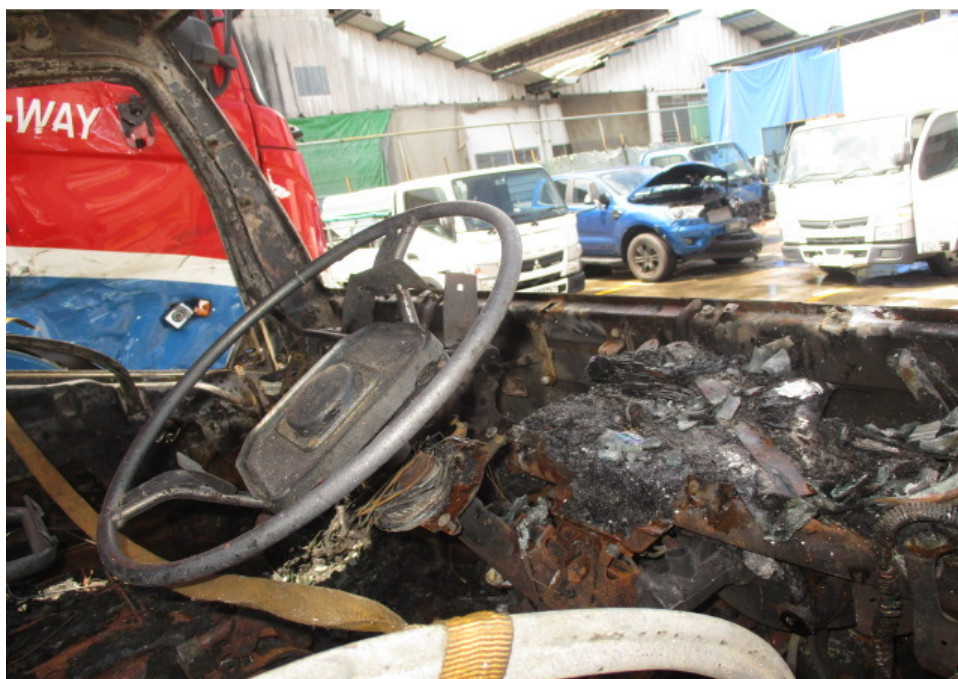
Photo 4 shows the general view of the interior compartment of the Insured Vehicle at the time of our inspection. Its interior compartment was completely burnt.

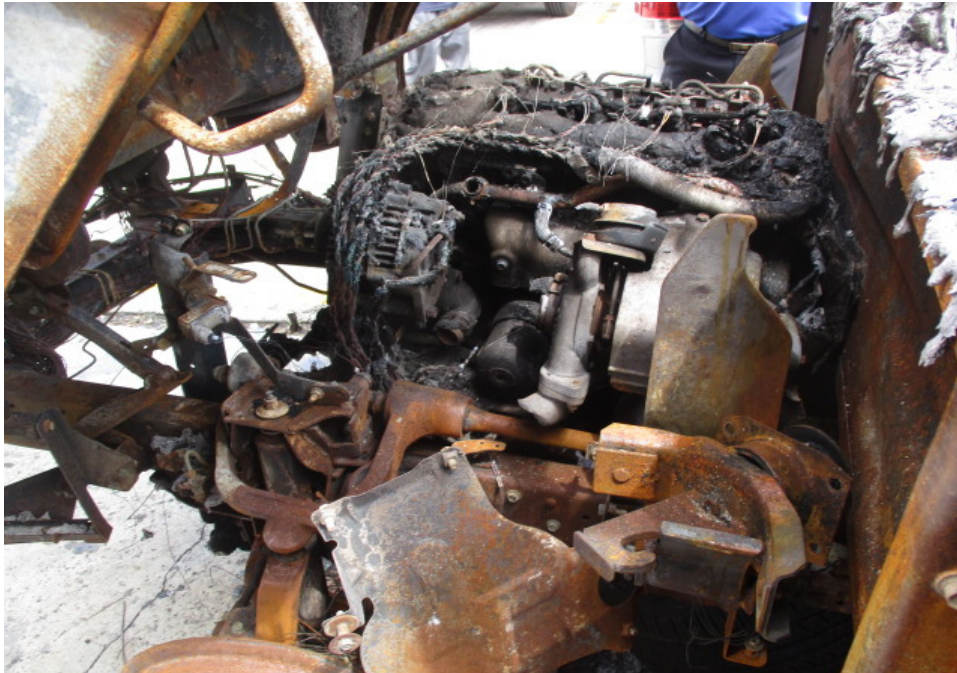
Photo 5 shows the engine compartment of the Insured Vehicle which is situated beneath the cab at the time of our inspection. The entire engine compartment of the Insured Vehicle was observed to be severely burnt. Most of the parts inside the engine compartment were found to be burnt and/or melted as a result of the fire.

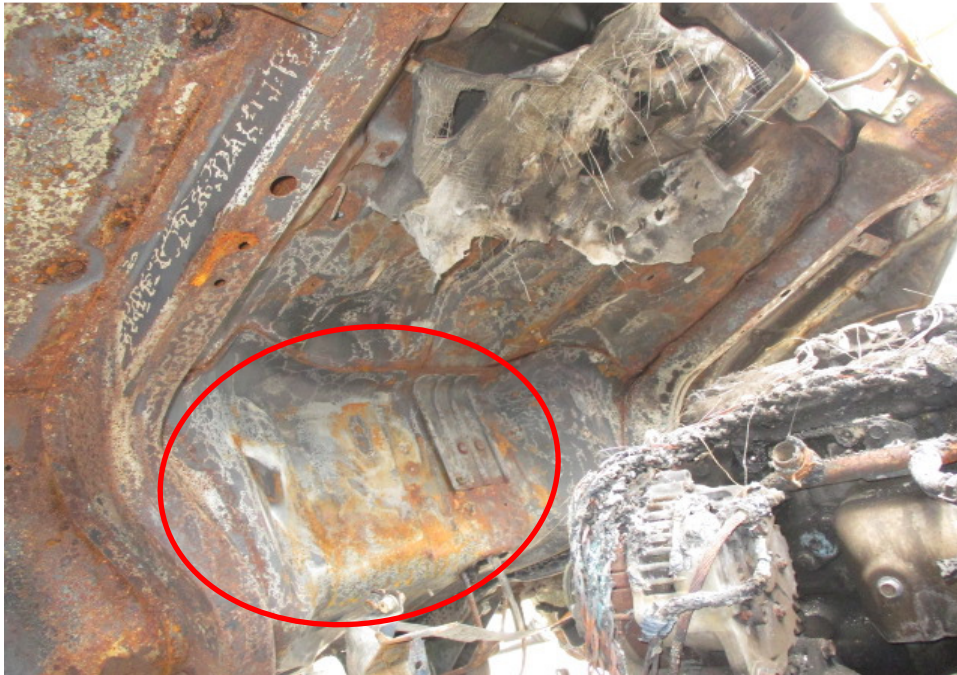
7. For this particular case, the fire appears to have originated within the engine compartment of the Insured Vehicle. This can be determined from the burn pattern and the high heat intensity burn marks (whitish burn marks) found on the underside of the cab as well as the rust that had developed on the underside of the cab of the Insured Vehicle.
8. The whitish burn marks are a result of exposure to prolonged heat intensity. Rust would normally start to develop around these areas soon after a fire as prolonged exposure to high heat intensity usually causes steel/metal material body parts to be exposed to natural environmental condition. The rust that had developed on the underside of the cab of the Insured Vehicle is an indication that the engine compartment had sustained exposure to prolonged high heat intensity. See photos 6 & 7 below.

Photo 6 shows the whitish burn marks that were found on the underside of the cab of the Insured Vehicle (circled). Such whitish burn marks are a result of exposure to prolonged heat intensity.

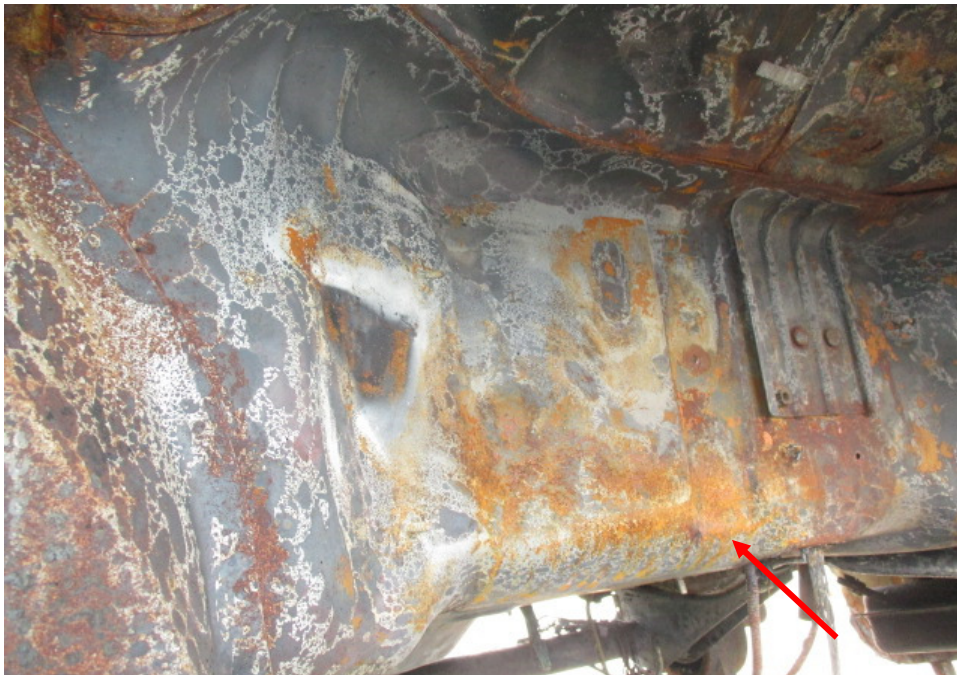
Photo 7 shows the rust that had developed on the underside of the cab of the Insured Vehicle (arrowed) which is an indication that the fire to the Insured Vehicle had originated from the engine compartment. The development of rust is an indication that the area was exposed to prolonged exposure to high heat intensity, which had caused the steel/metal material of the cab to be exposed to natural environmental condition.

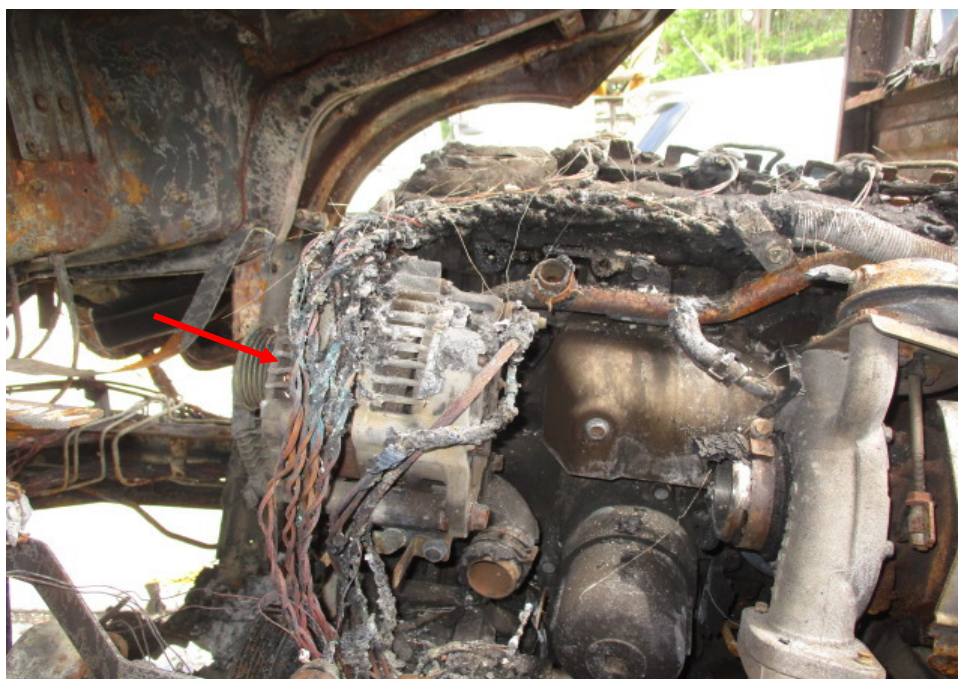
9. Upon closer examination of the engine compartment of the Insured Vehicle which was where the fire had likely started, we had found traces of greenish residue on several burnt stretches of wirings around the centre portion of the engine compartment. The wirings were original factory fitted wirings. The presence of greenish residue indicates internal heating of copper wires, a sign of an electrical short circuit occurring. The greenish residue is normally left behind from oxidation as a result of chemical reaction involving the copper wires. This physical evidence would then appear to suggest that the cause of fire to the Insured Vehicle could have possibly been due to electrical in nature. See photos 8 - 11 below.

Photo 8 shows the burnt wirings around the centre portion of the engine compartment of the Insured Vehicle. The wirings were original factory fitted wirings. We observed traces of greenish residue on these wirings (arrowed). The presence of such greenish residue indicates internal heating of copper wires, a sign of an electrical short circuit occurring.

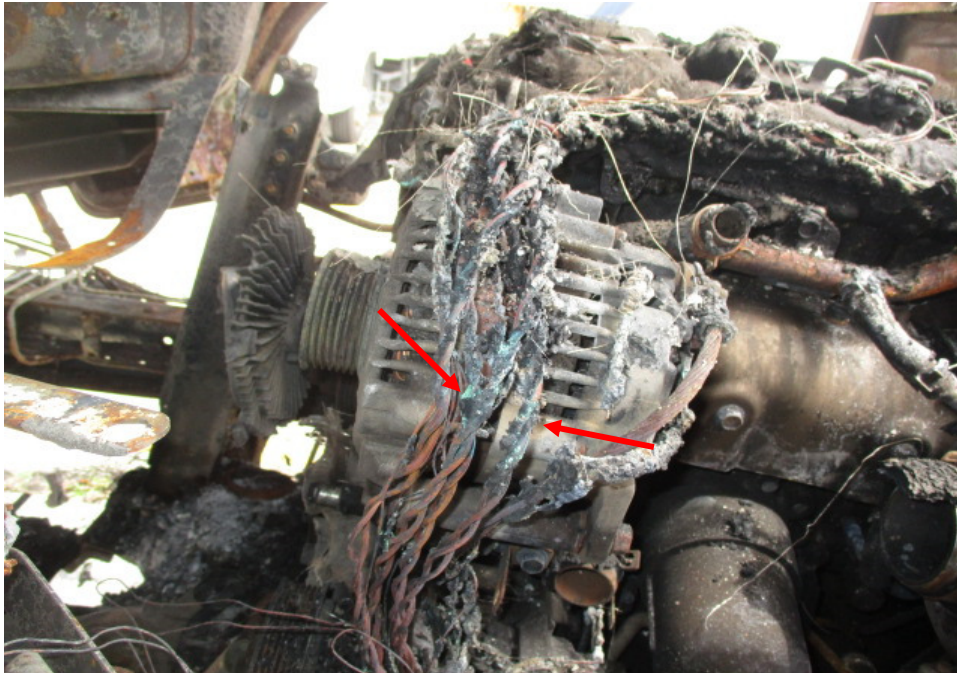
Photo 9 shows a closer view of the greenish residue found on the wirings around the centre portion of the engine compartment of the Insured Vehicle (arrowed). The greenish residue is normally left behind from oxidation as a result of chemical reaction involving the copper wires.

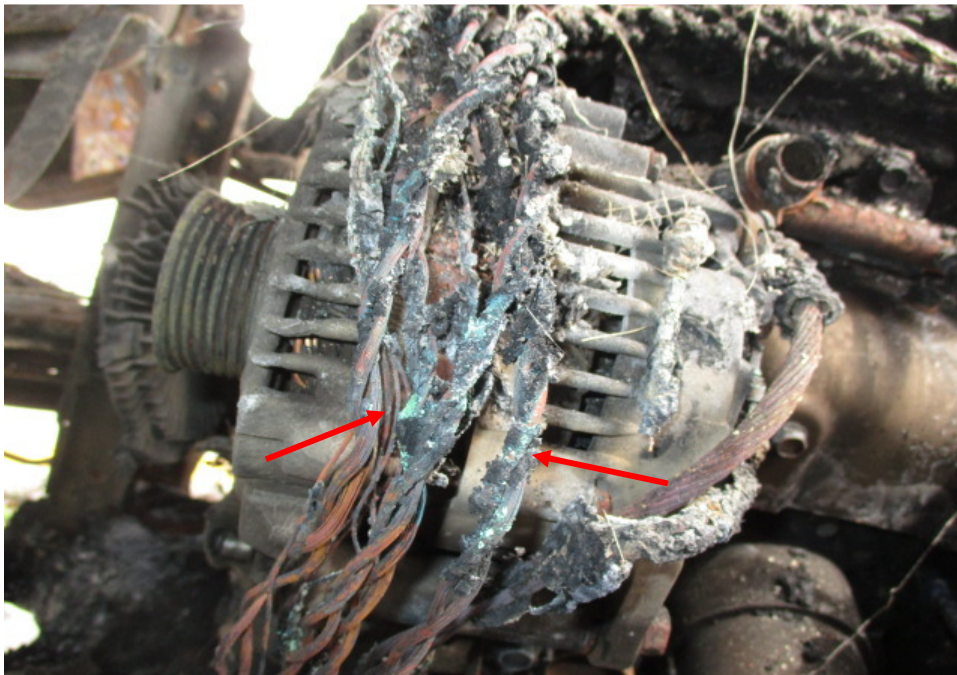
Photo 10 shows a close up view of the greenish residue found on the wirings around the centre portion of the engine compartment of the Insured Vehicle (arrowed). This physical evidence would then appear to suggest that the cause of fire to the Insured Vehicle could have possibly been due to electrical in nature.

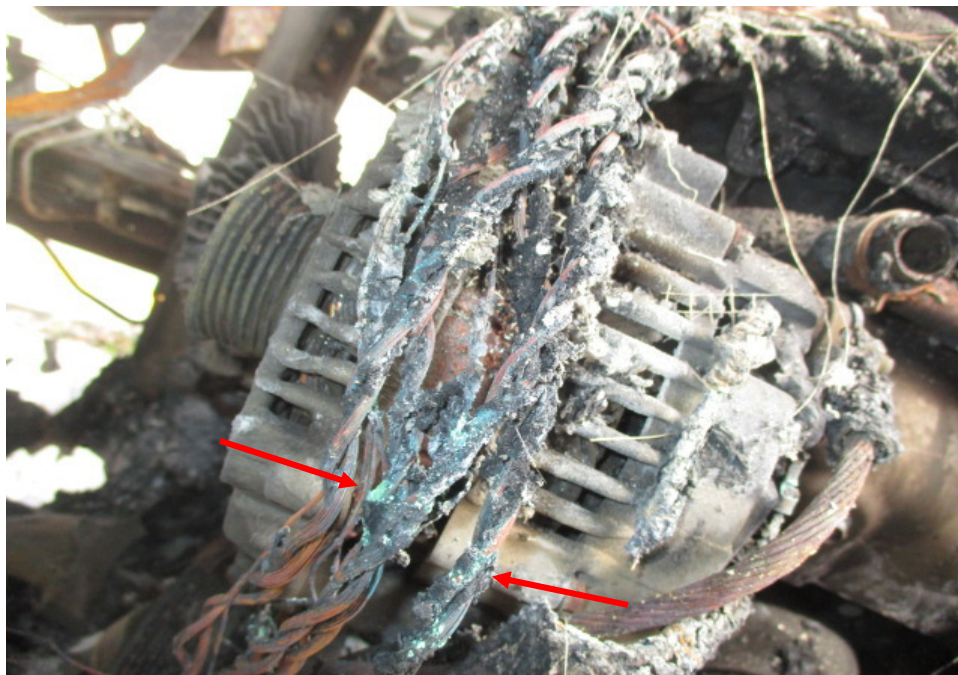
Photo 11 shows a close up view of the greenish residue found on the wirings around the centre portion of the engine compartment of the Insured Vehicle (arrowed). This physical evidence would then appear to suggest that the cause of fire to the Insured Vehicle could have possibly been due to electrical in nature.
