**LKK Auto Consultants Pte Ltd**

ADJUSTMENT ON REPAIR COST FOR VEHICLE NO SHB 9618D

PHOTOGRAPHS FOR VEHICLE NO. : SHB 9618D

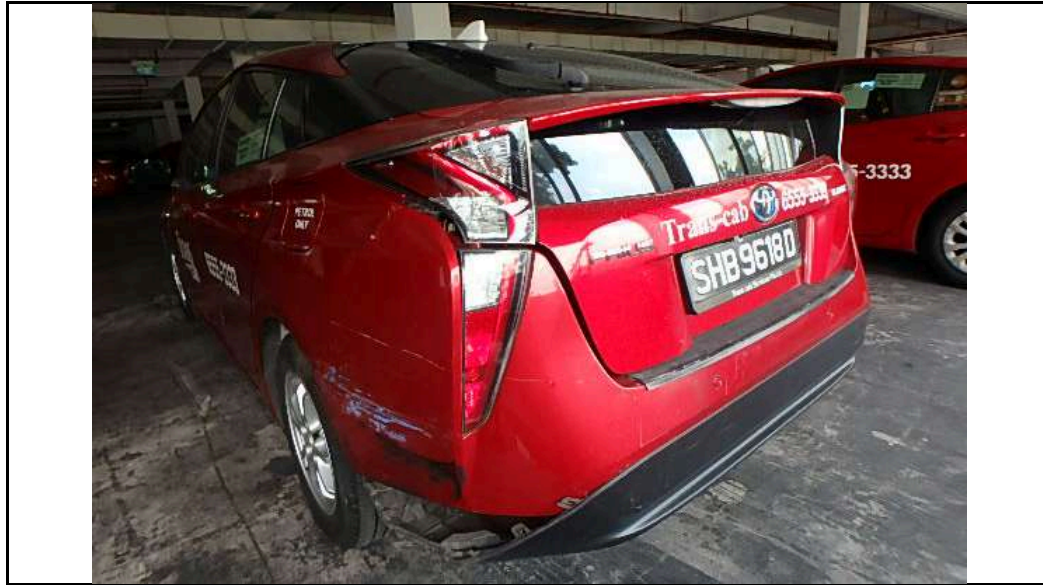
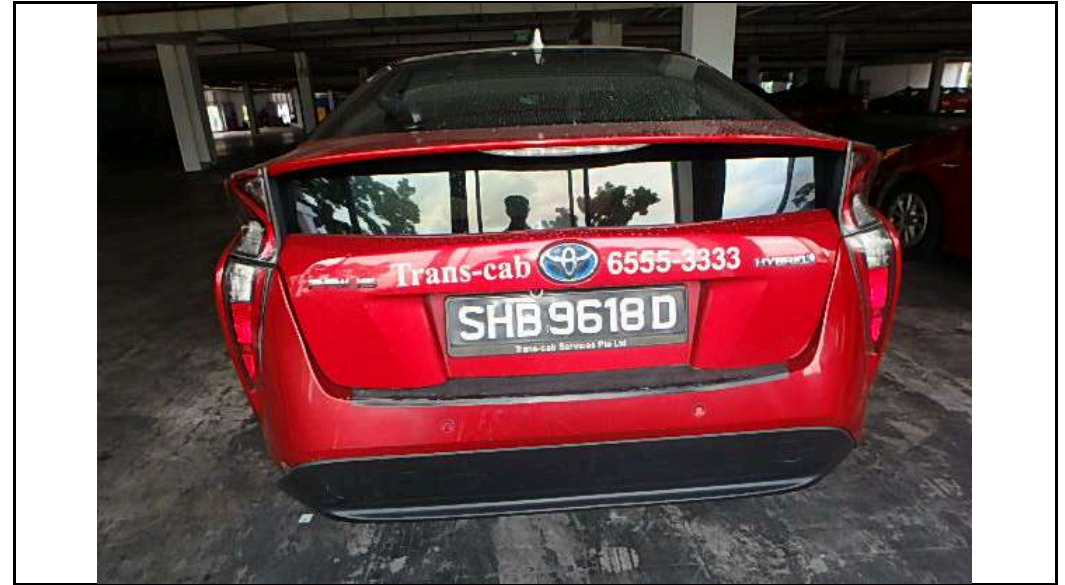
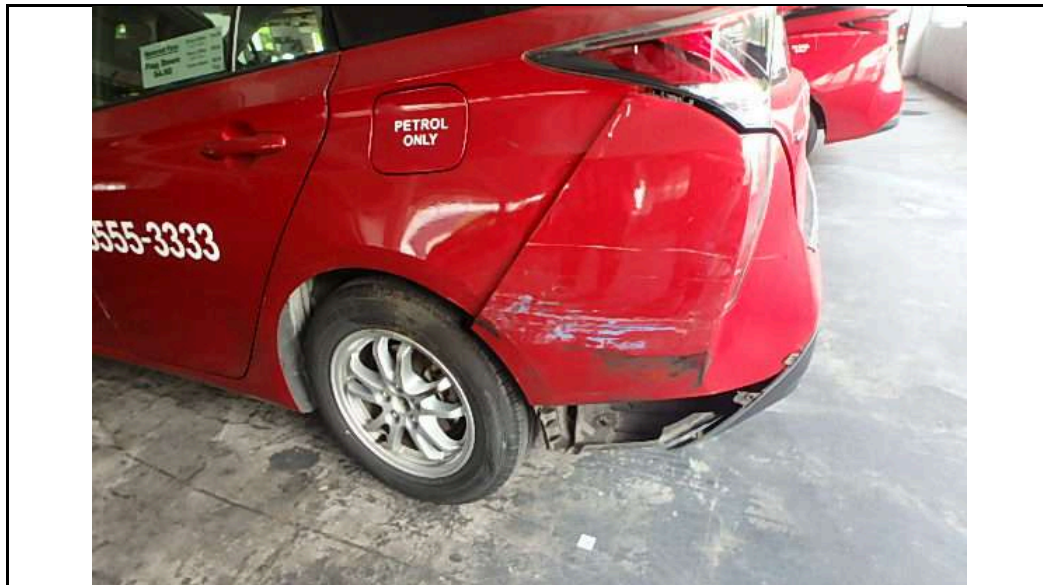
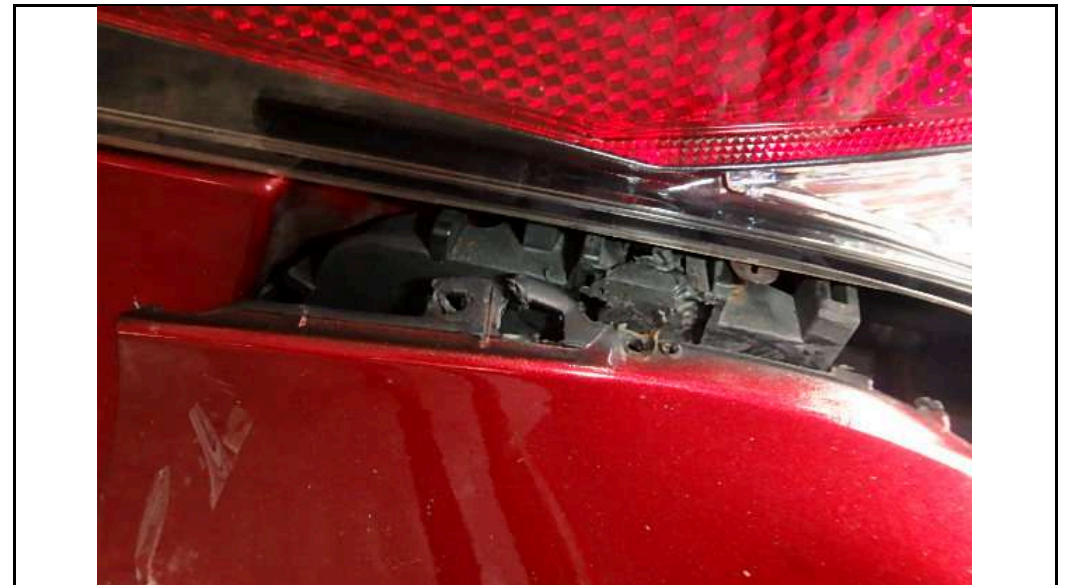
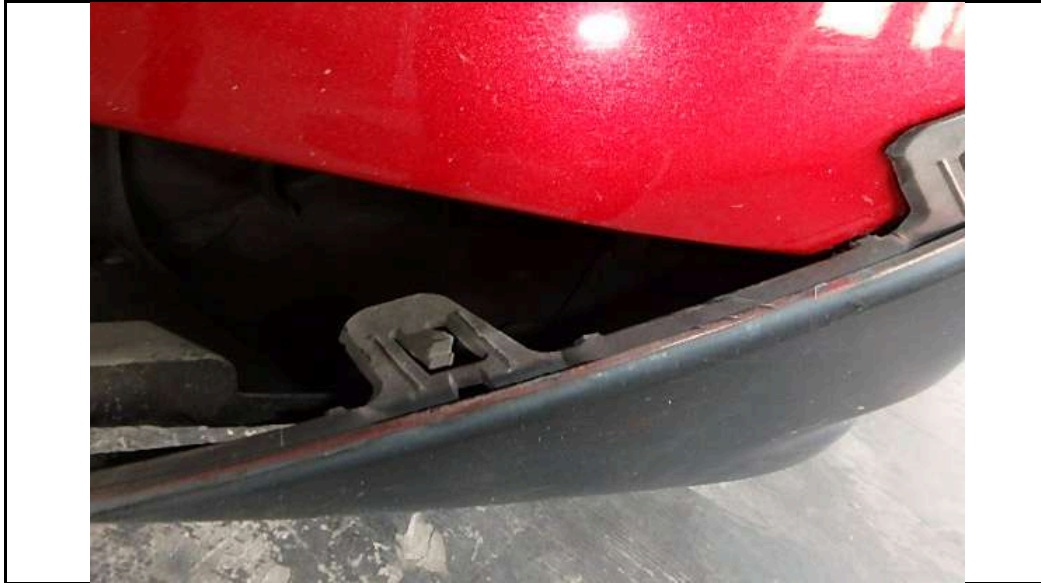
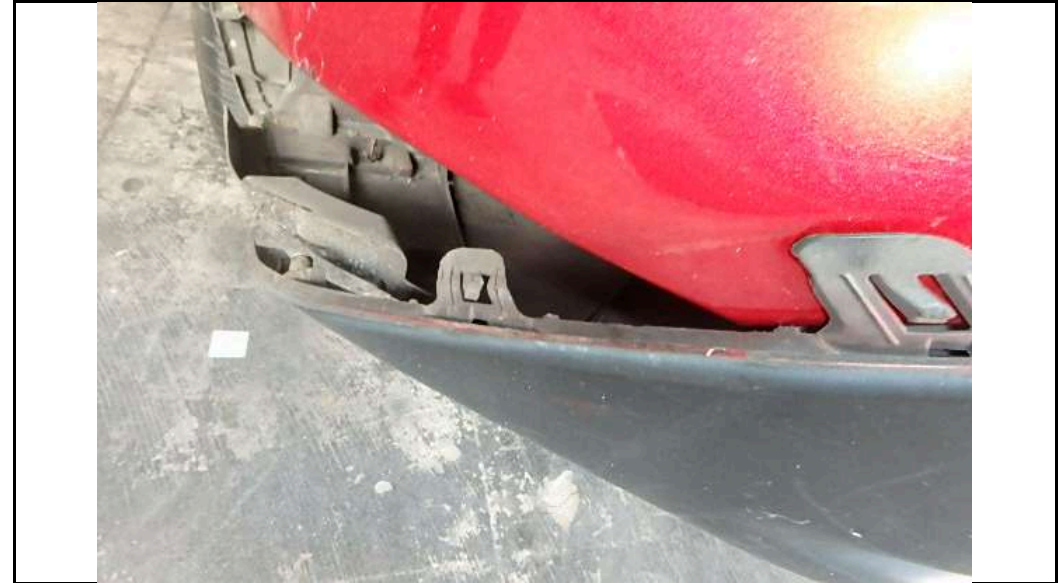
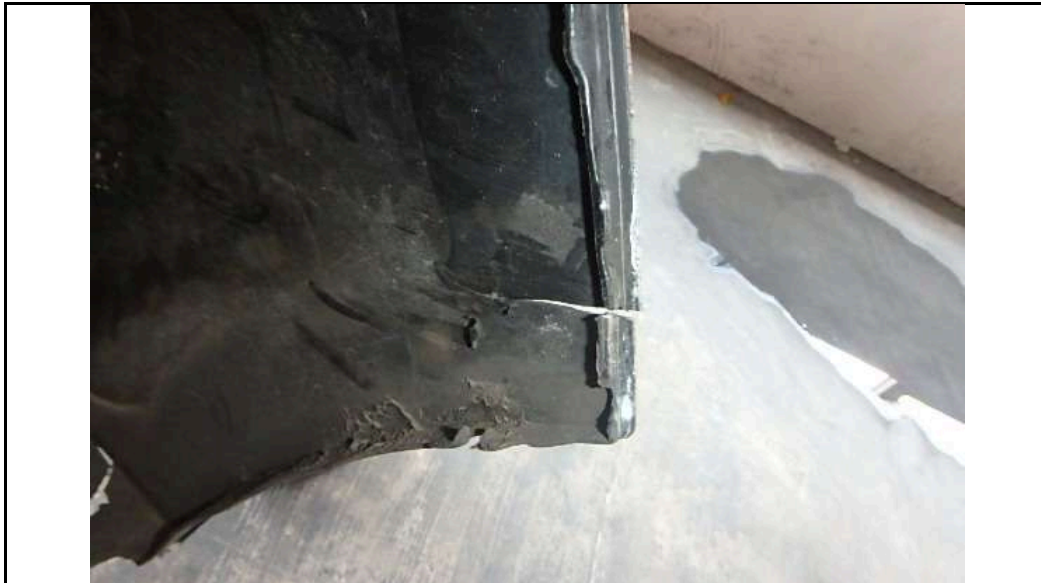
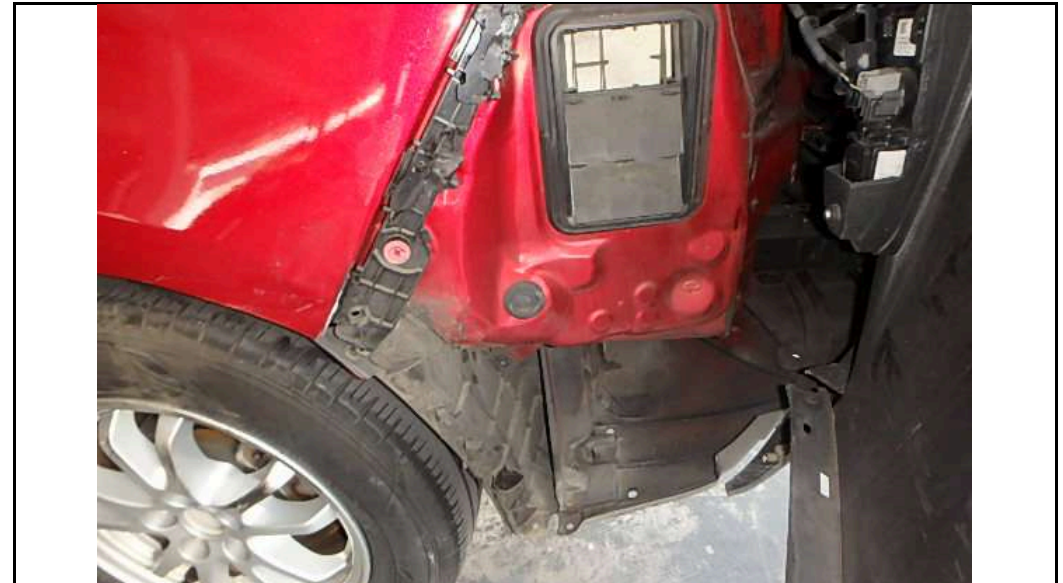
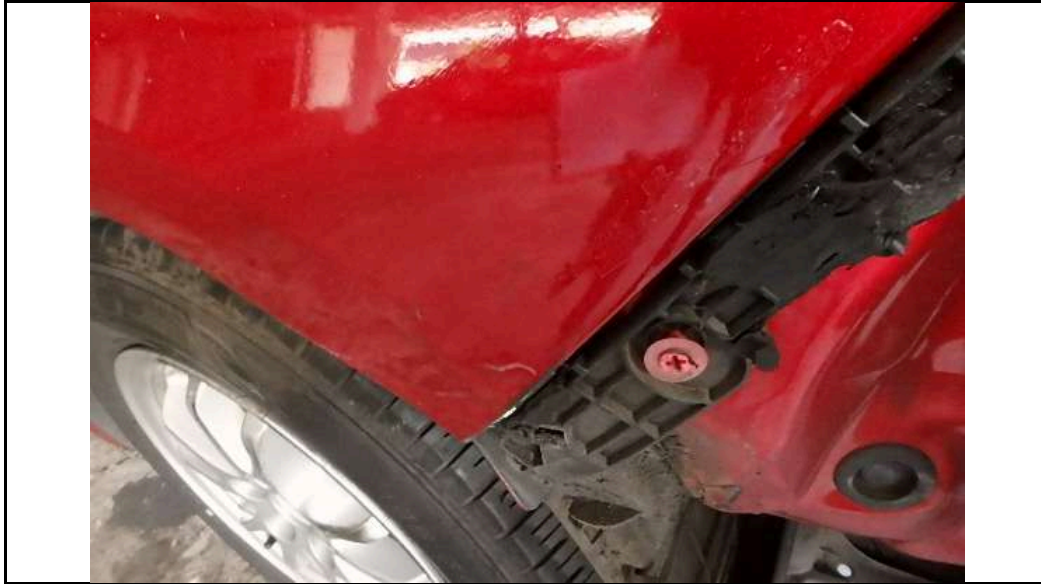
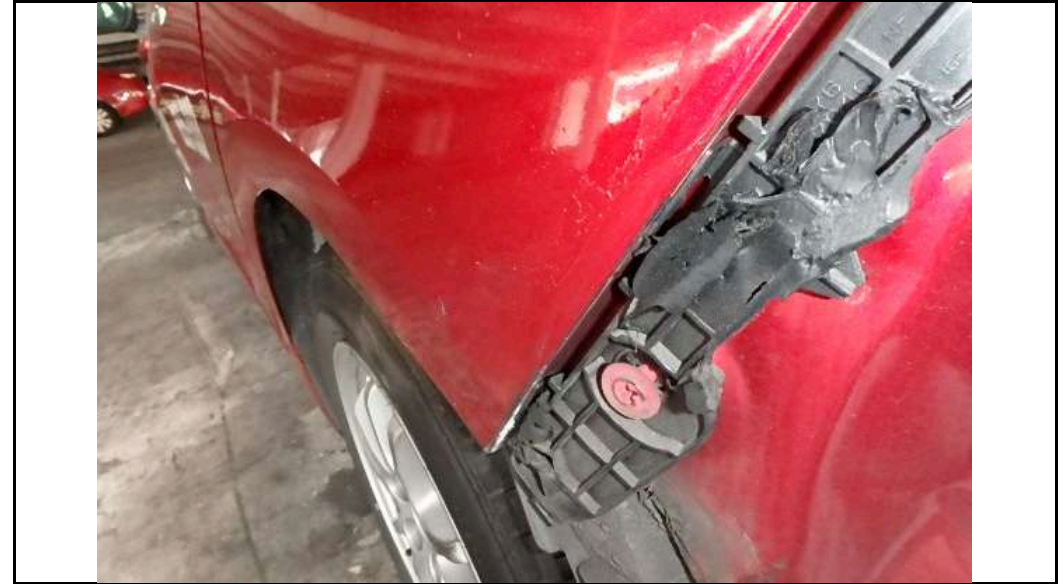
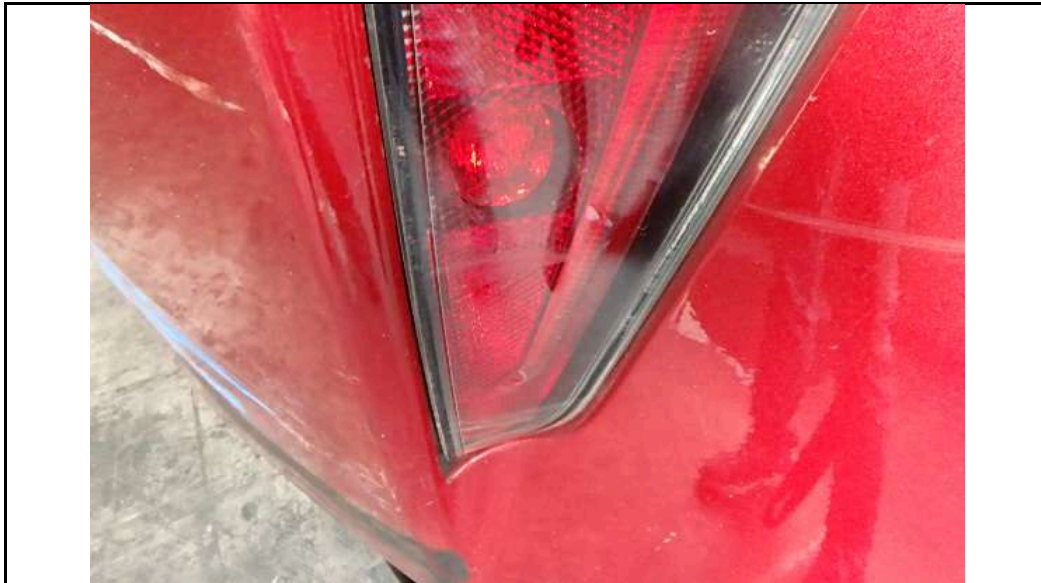
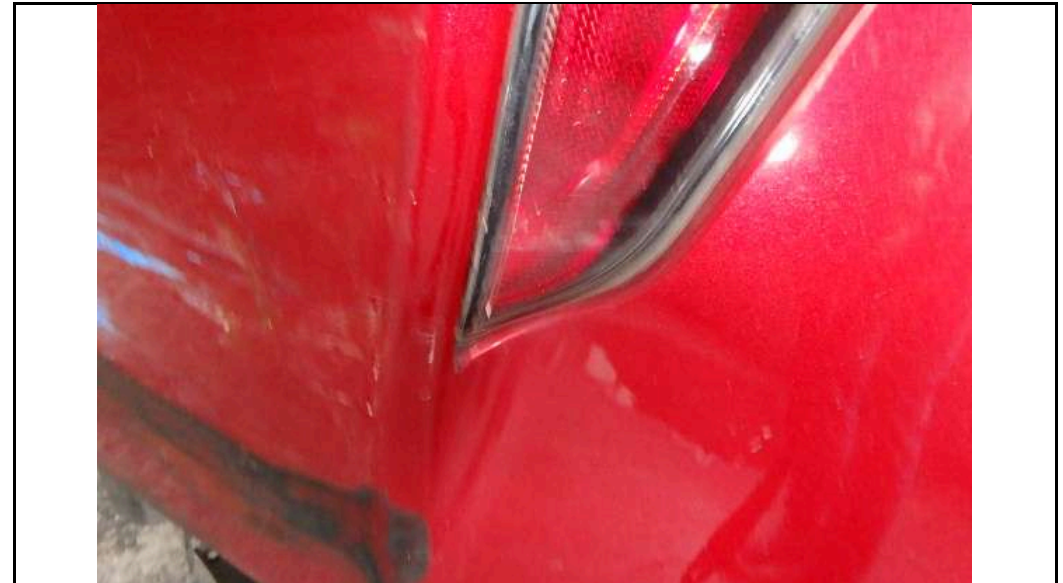
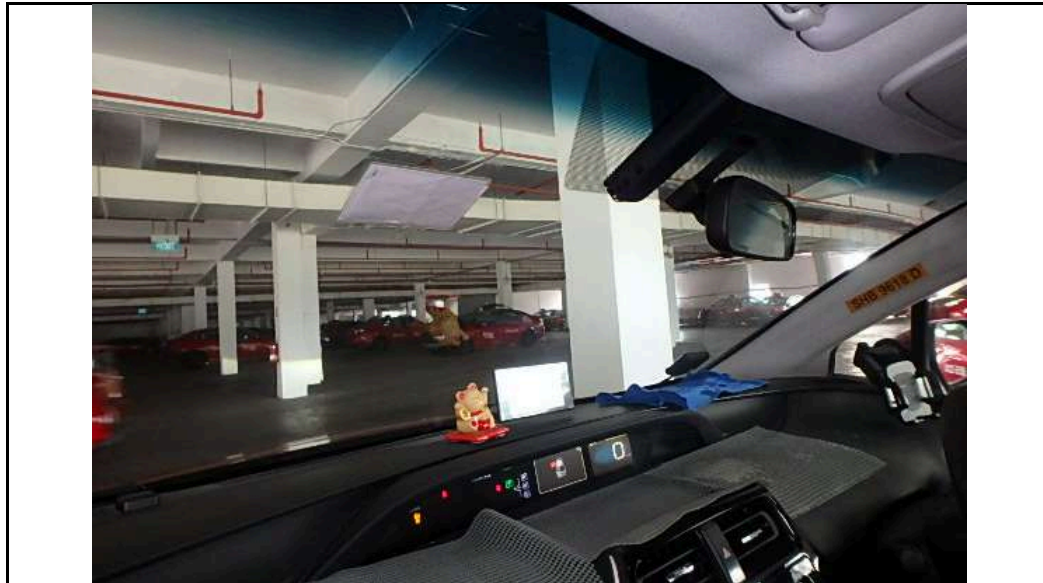
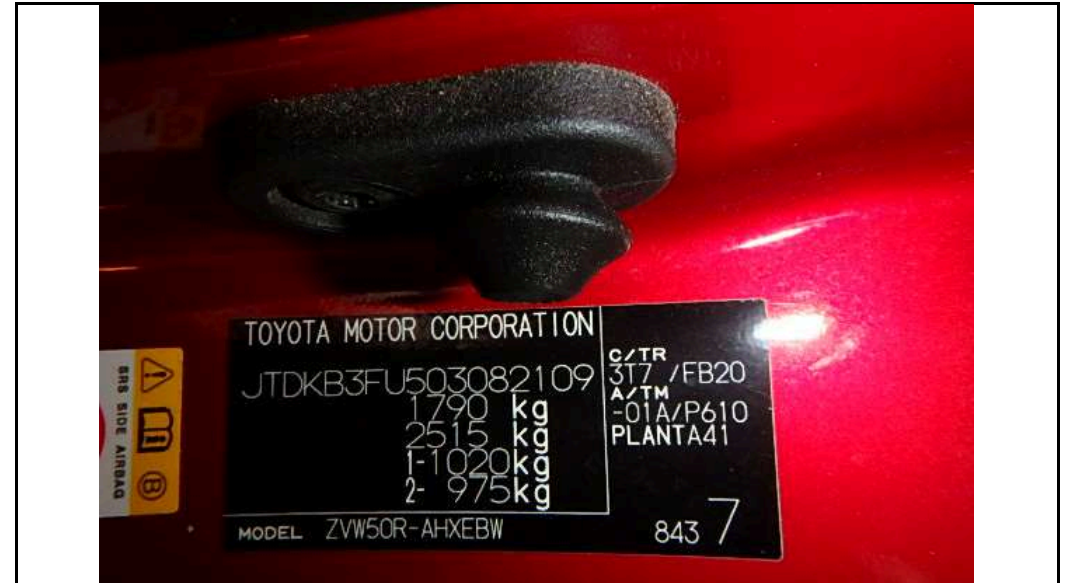
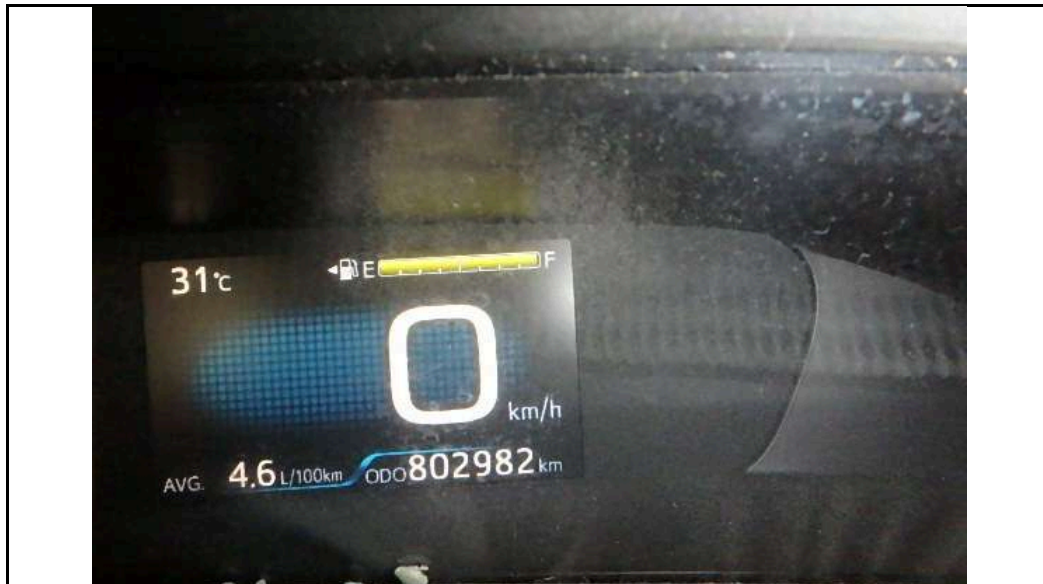
4. Description of Damages				
THE VEHICLE SUSTAINED DAMAGES AT THE N/S REAR PORTION.				
DAMAGES SEE DETAILS.				
5. General Information				
Accident Date	27/07/2024	Inspection Date	31/07/2024	
Survey held at	TRANS-CAB AUTO SERVICES PTE LTD NO.2 ANG MO KIO ST 63 SINGAPORE 569111			
5a. Remarks
