## LKK Auto Consultants Pte Ltd

Vehicle No. SHB 9618D  
Insured Veh. SHC 3623Y  
Claim No. D24006642MFCT/CTPL/JS  
Policy No. D-24101861MFCT  
Accident Date 27/07/2024  
Inspection Date 31/07/2024

| Make & Model | TOYOTA PRIUS 5DR HATCHBACK (AUTO) | C.C | 1798 |

## ADJUSTMENT ON REPAIR COST FOR VEHICLE NO SHB 9618D

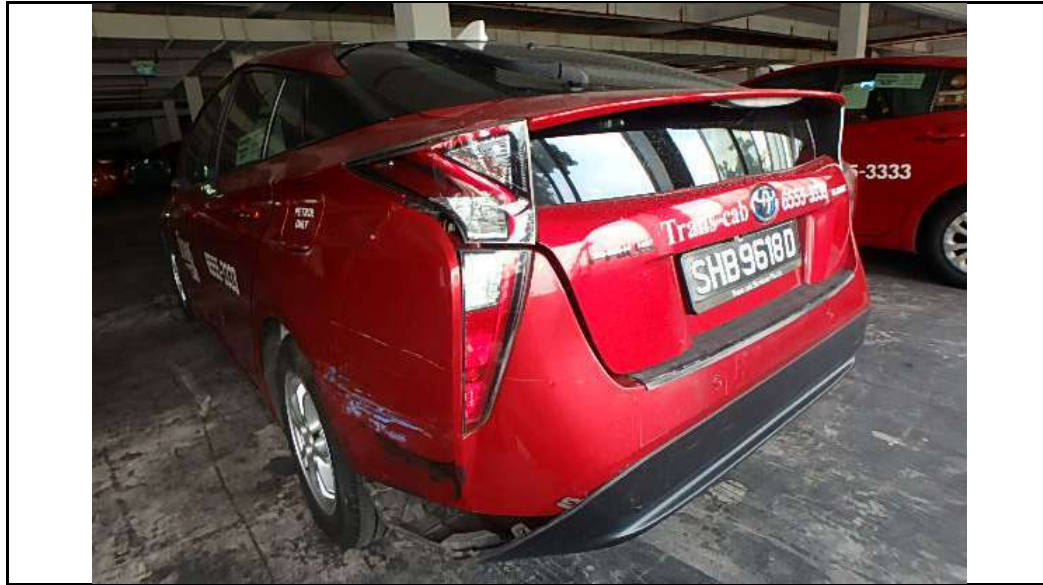
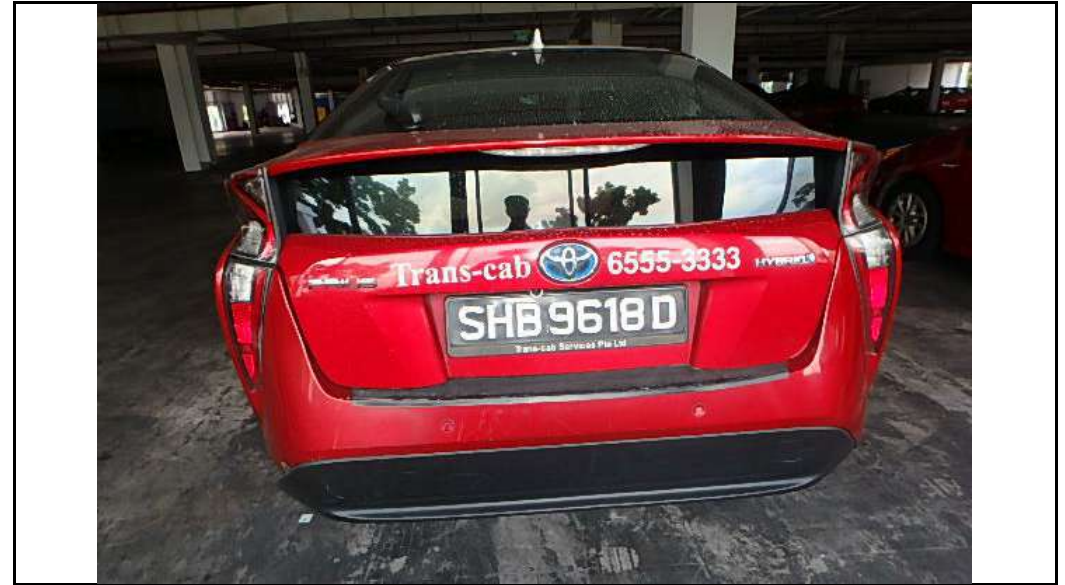
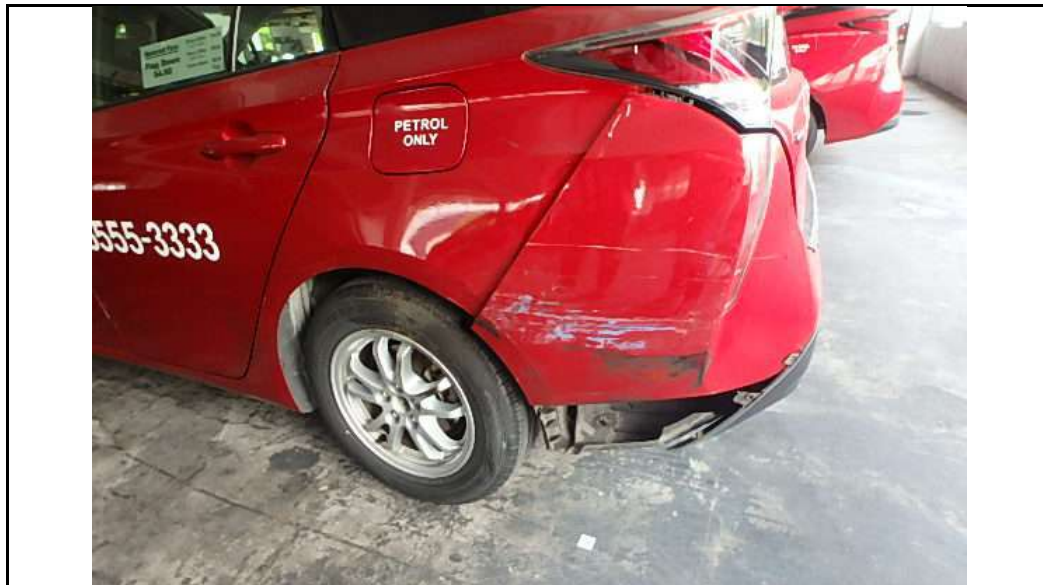
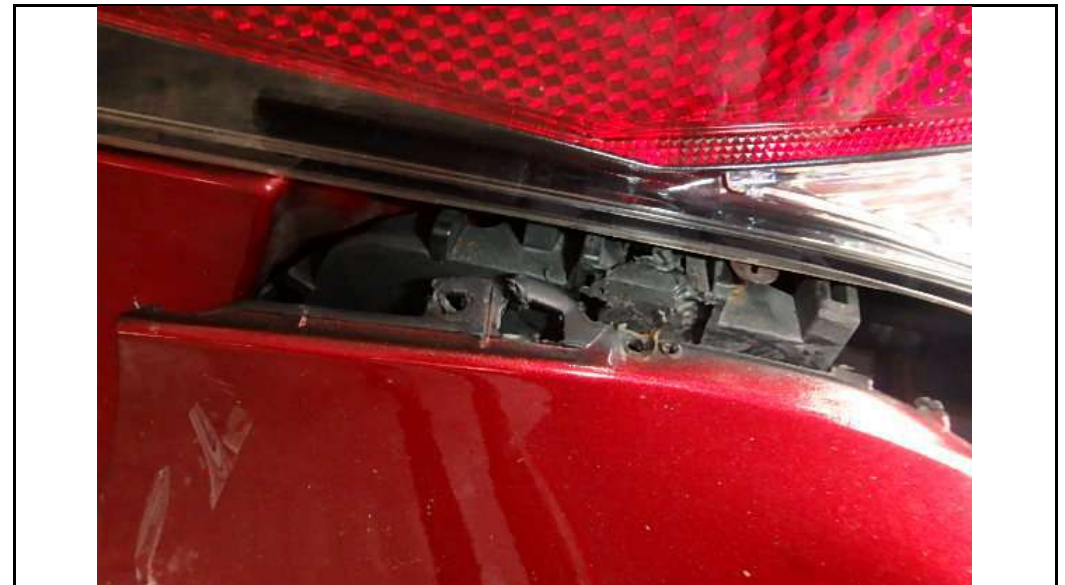
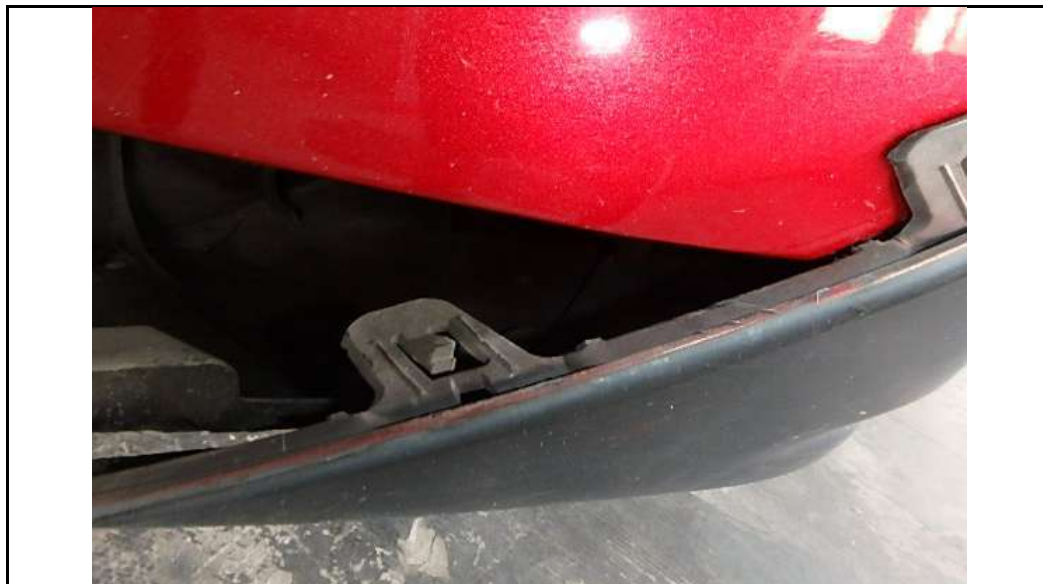
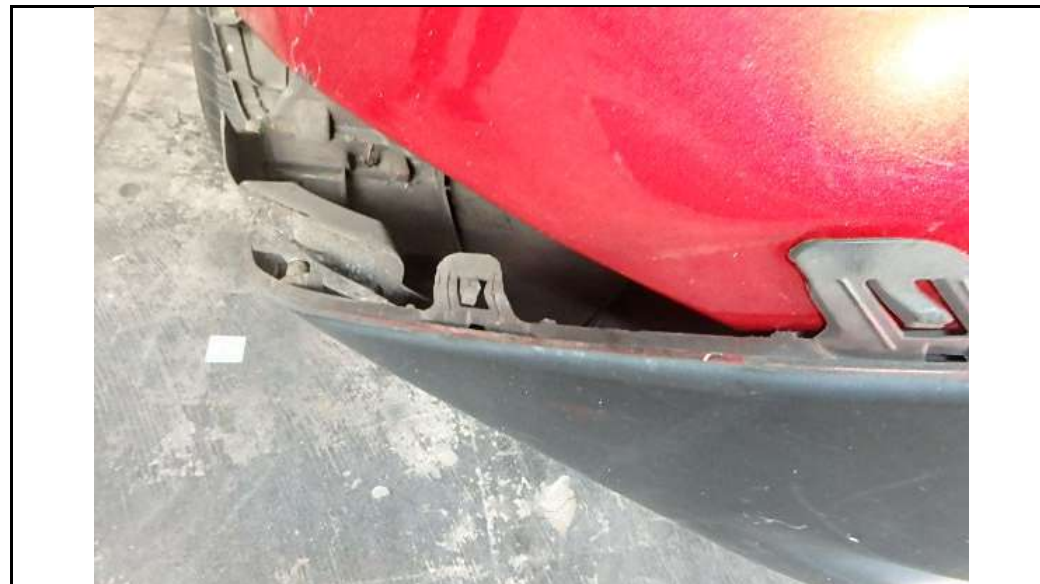
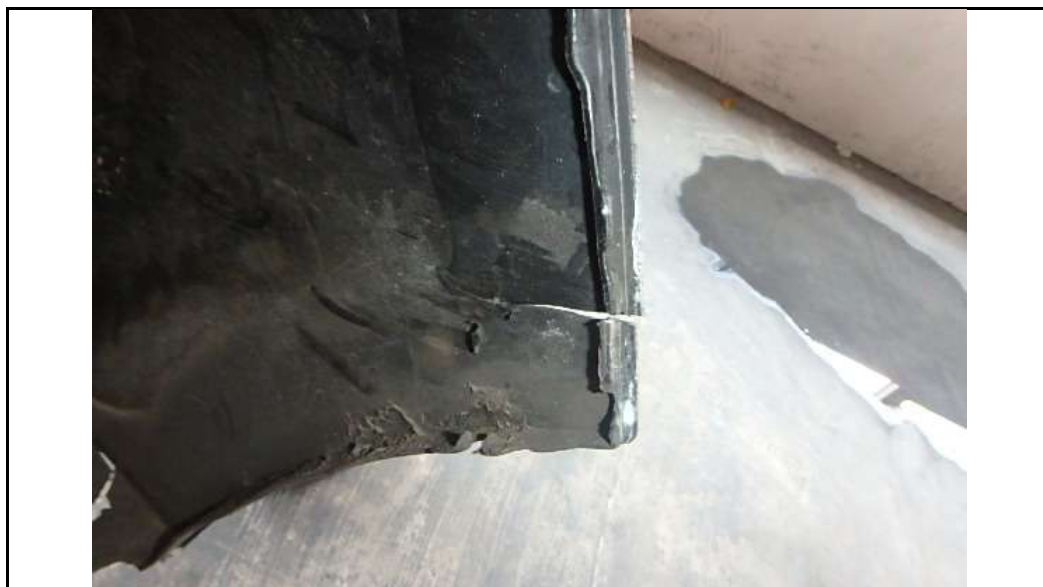
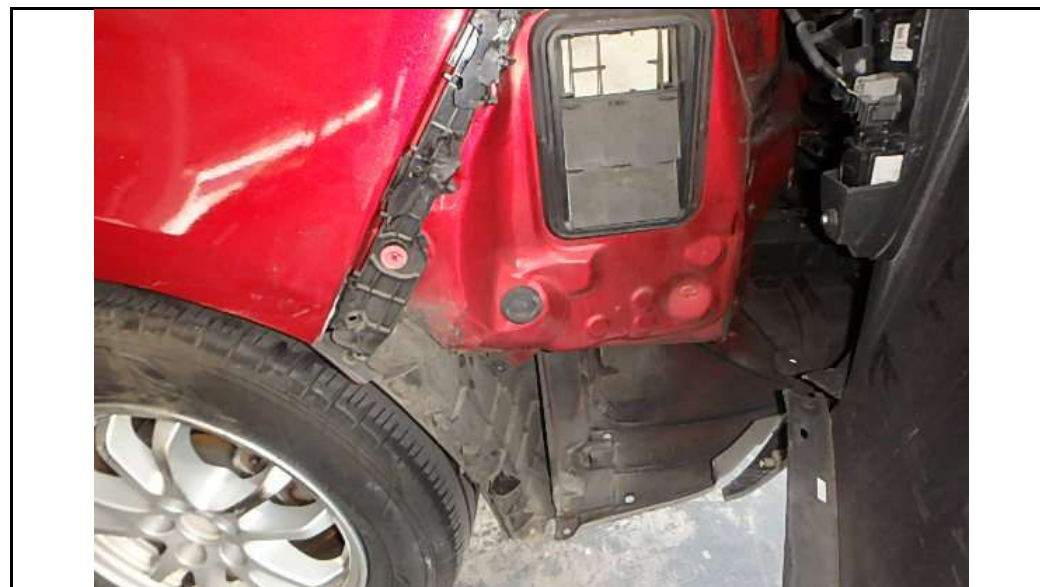
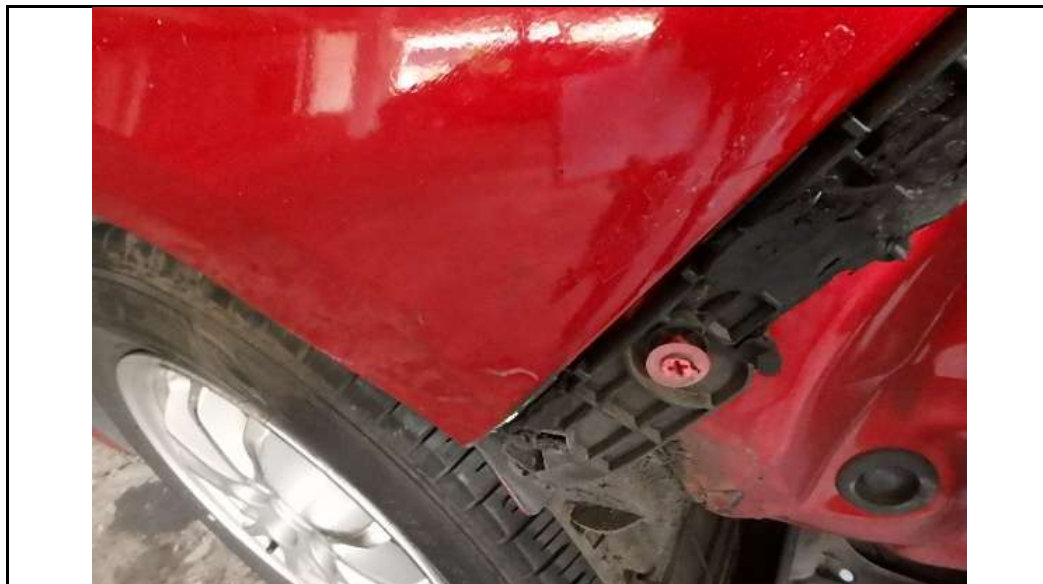
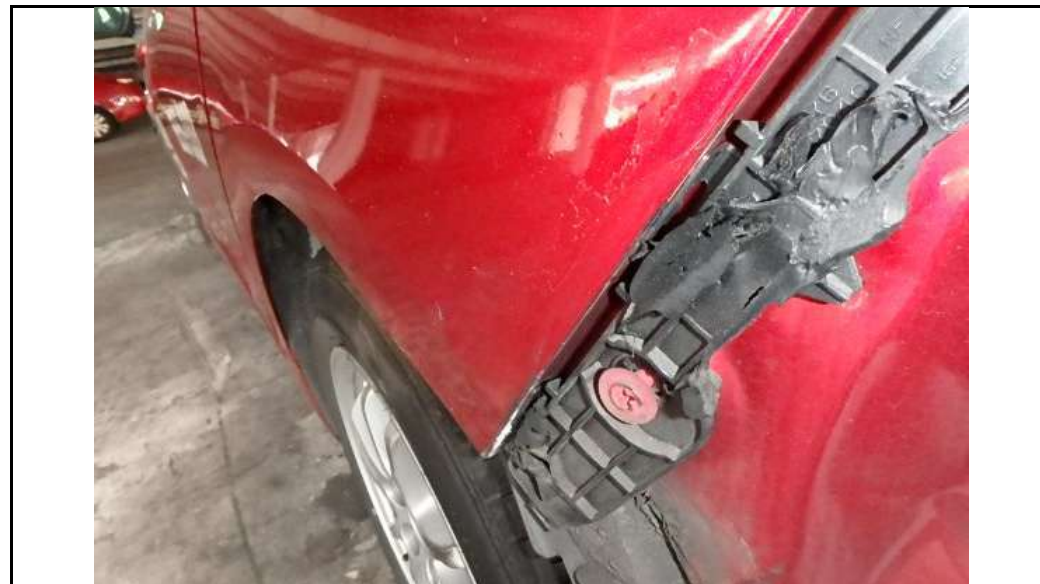
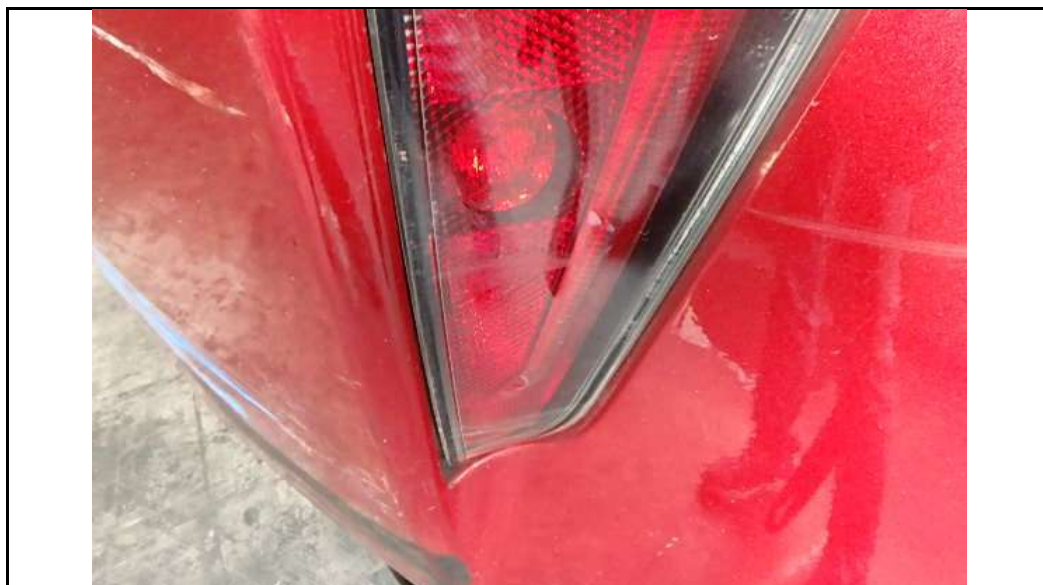
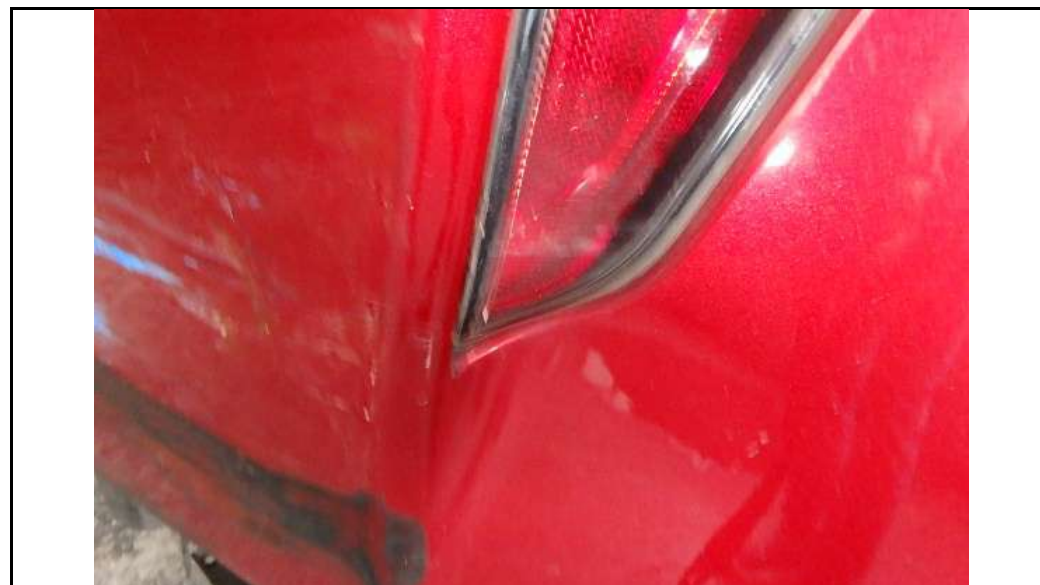
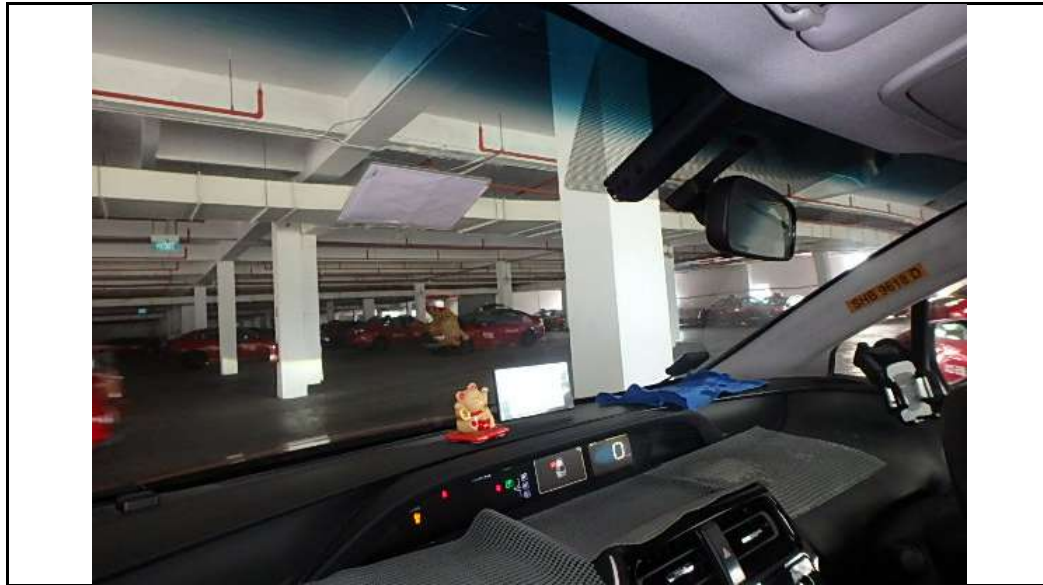
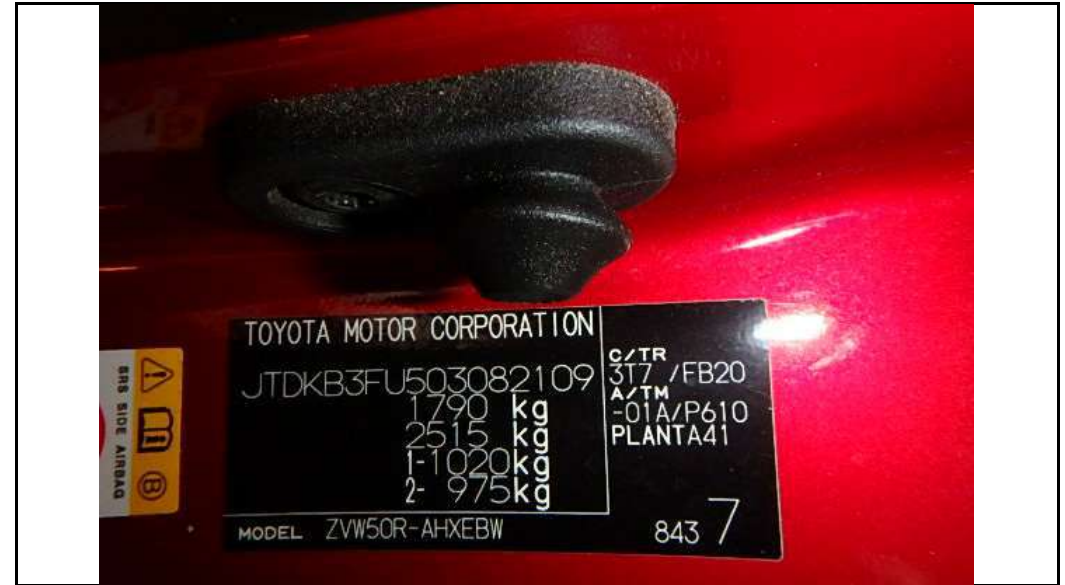
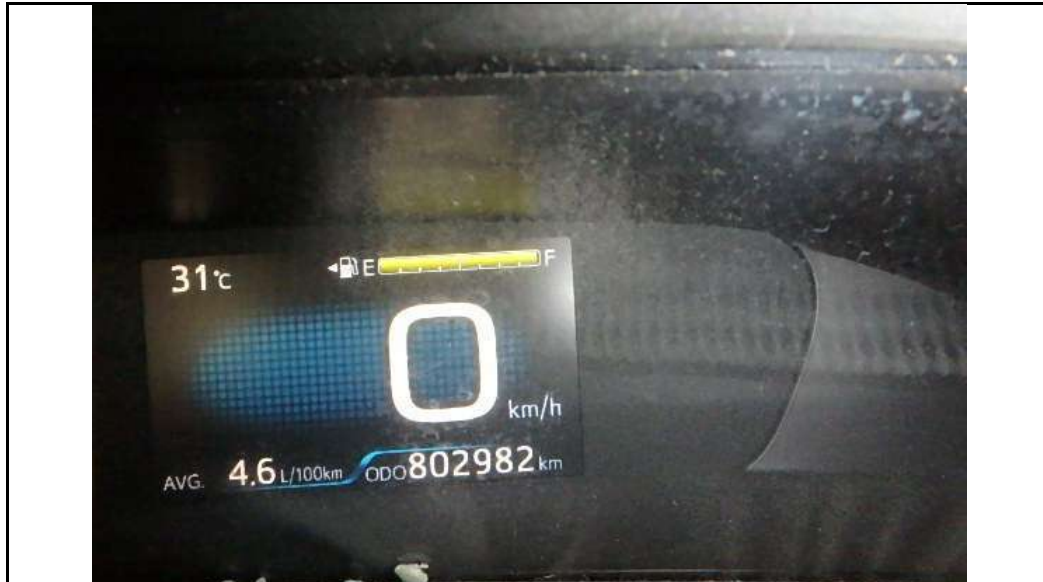
**PHOTOGRAPHS FOR VEHICLE NO. : SHB 9618D**

THE VEHICLE SUSTAINED DAMAGES AT THE N/S REAR PORTION.

| Labour | | | | |
|---|---|---|---|---|
| RECOMMENDED COST OF LUMP SUM REPAIRS<br>(TO ITS PRE-ACCIDENT CONDITION) | | | | \$2,000.00 |
