Your Ref: SNM24D204080
Our Ref: CS/CTI24080003/N

**TECHNICAL INVESTIGATION REPORT OF INSURED VEHICLE YQ 7566C
INVOLVED IN AN INCIDENT ON 13 JULY 2024**

Registration Number : YQ 7566C
Make & Model : TOYOTA DYNA 150 5MT
Year of Registration : July 2022
Chassis Number : JHHAGV4680K002382
Speedo Reading : N/A

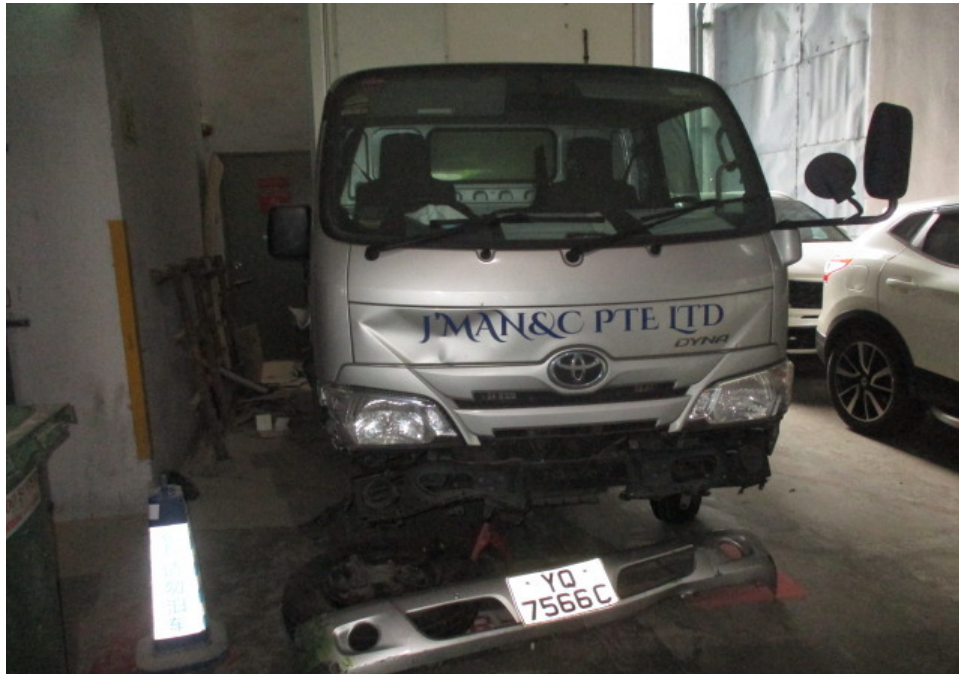
5. The Insured Vehicle was observed to have sustained impact damage sustained that was confined to its frontal portion and right front body. Its front body panel, front bumper, right headlamp, and right front door were amongst the exterior body parts which were observed to have been damaged as a result of the incident. The right front tyre was also found to be dislodged as a result of the incident.

Photo 1 shows a general view of the frontal portion of the Insured Vehicle at the time of our inspection. The Insured Vehicle was observed to have sustained damage at its frontal portion and right front body. Its front body panel, right headlamp and front bumper were amongst the body parts damaged as a result of the incident.

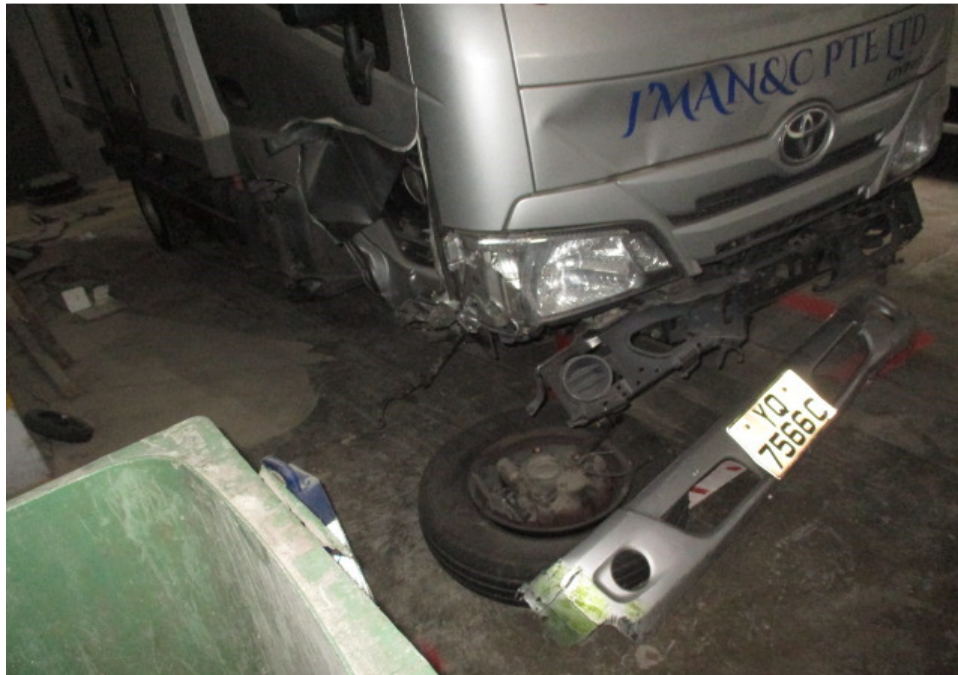
Photo 2 shows the close up view of the right frontal body of the Insured Vehicle at the time of our inspection. Its right front door was observed to be damaged as a result of the incident. The right front tyre was also found to be dislodged as a result of the incident.

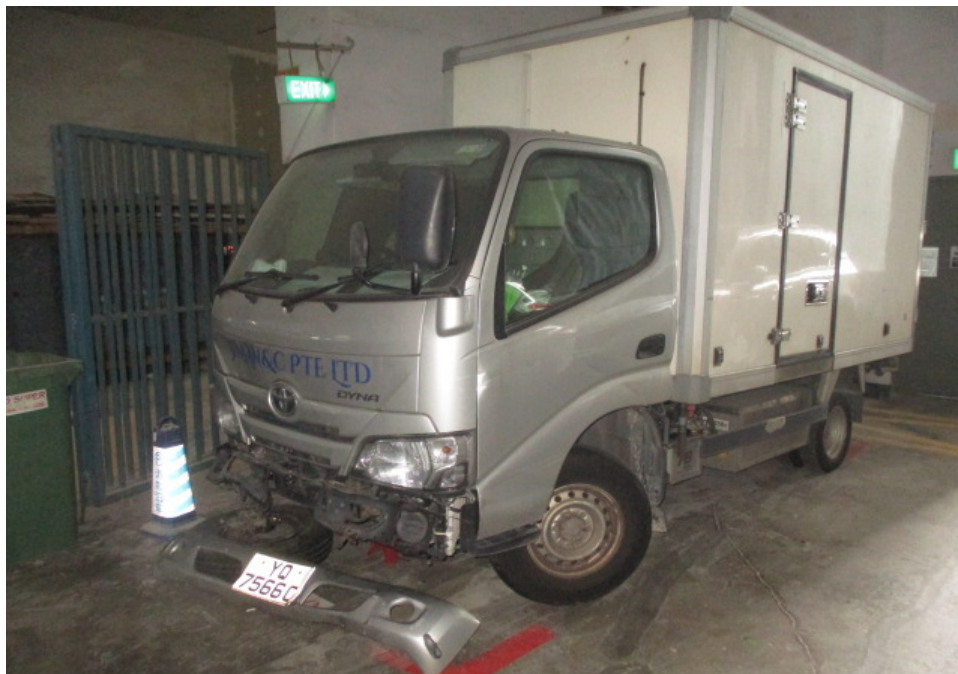
Photo 3 shows the general view of the left body of the Insured Vehicle at the time of our inspection which is relatively unaffected by the incident.

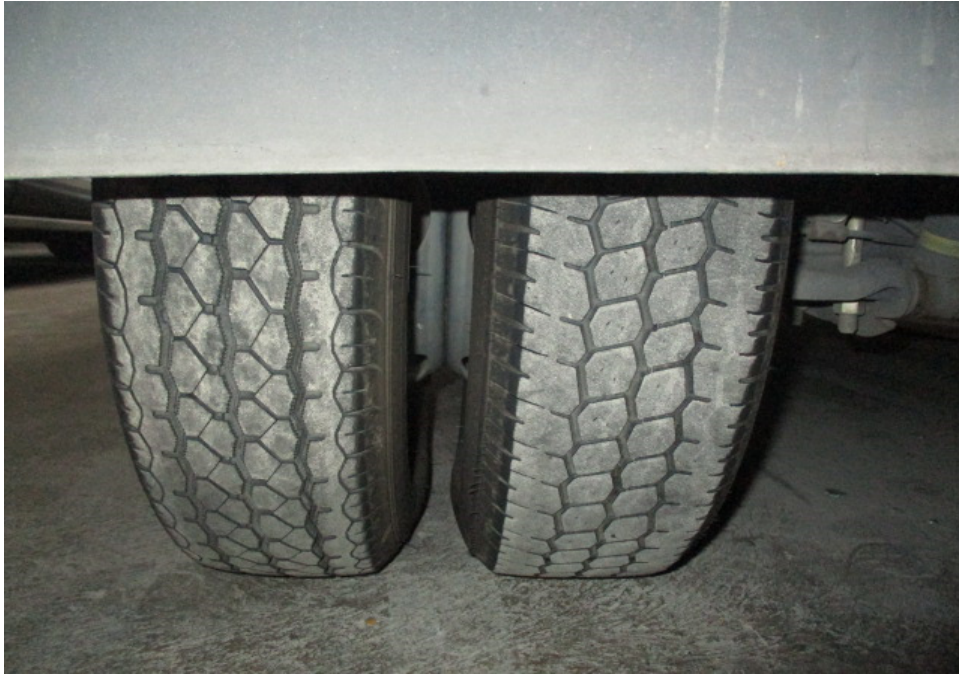
Photo 4 shows the left rear tyres of the Insured Vehicle at the time of our inspection. The left rear tyres of the Insured Vehicle were observed to be in serviceable condition. The pattern of the tread was generally still visible. The remaining tread depth was measured to be approximately 3mm.

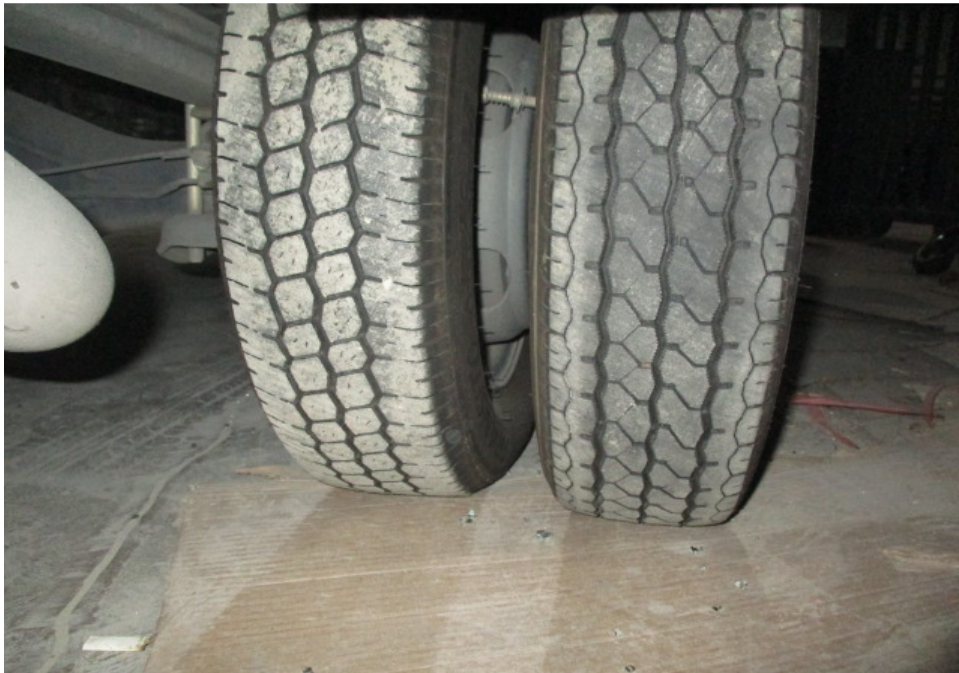
Photo 5 shows the right rear tyres of the Insured Vehicle at the time of our inspection. The right rear tyres of the Insured Vehicle were observed to be in serviceable condition. The pattern of the tread was generally still visible. The remaining tread depth was measured to be approximately 4mm.

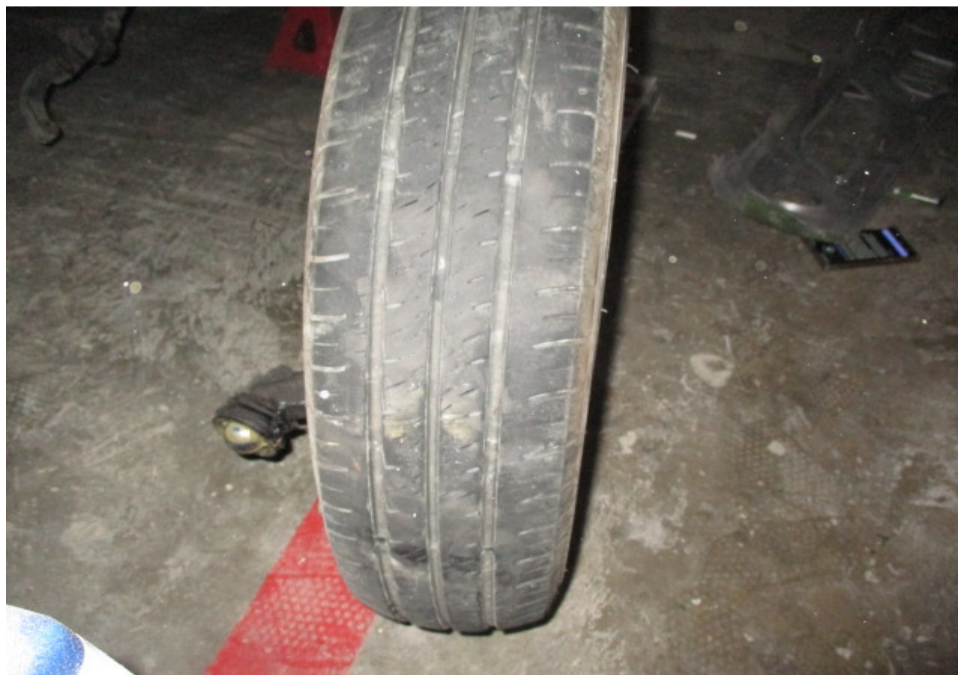
7. The dislodged right front tyre of the Insured Vehicle was also found to be in serviceable condition. The pattern of the tread was generally still visible. The tyre wear indicators, normally built into the groove of the tread pattern, were also observed to be not flushed with the tread pattern. The remaining depth of the tread was measured to be approximately 4mm which is all within the LTA requirements.

Photo 6 shows the dislodged right front tyre of the Insured Vehicle at the time of our inspection. The right front tyre of the Insured Vehicle was observed to be in serviceable condition. The pattern of the tread was generally still visible. The remaining tread depth was measured to be approximately 4mm.

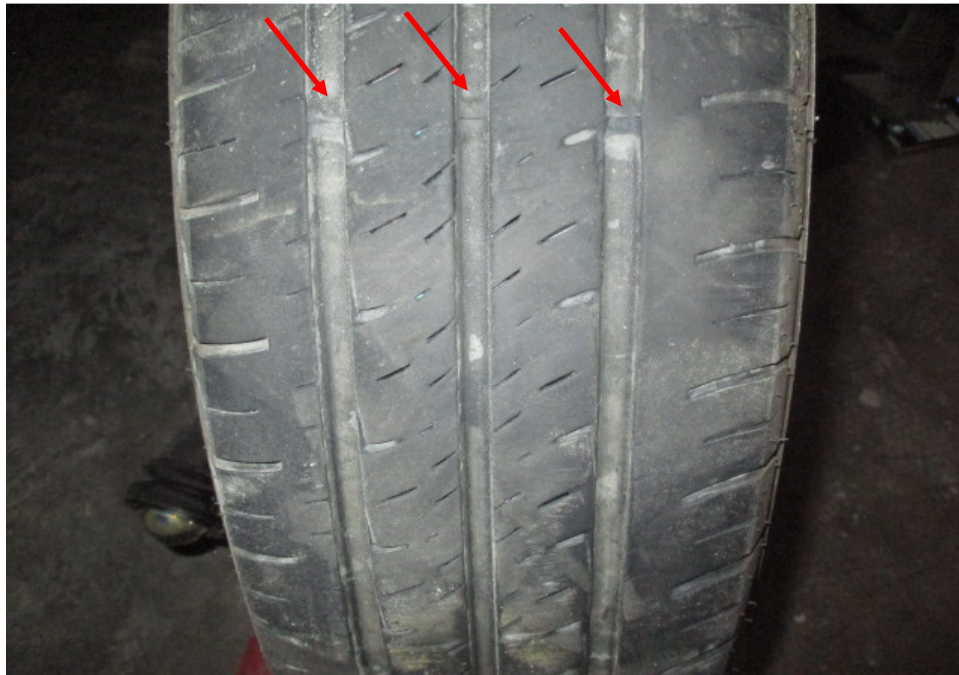
Photo 7 shows a closer view of the dislodged right front tyre of the Insured Vehicle at the time of our inspection. The pattern of the tread was generally still visible. The tyre wear indicators (arrowed), normally built into the groove of the tread pattern, were also observed to be not flushed with the tread pattern.

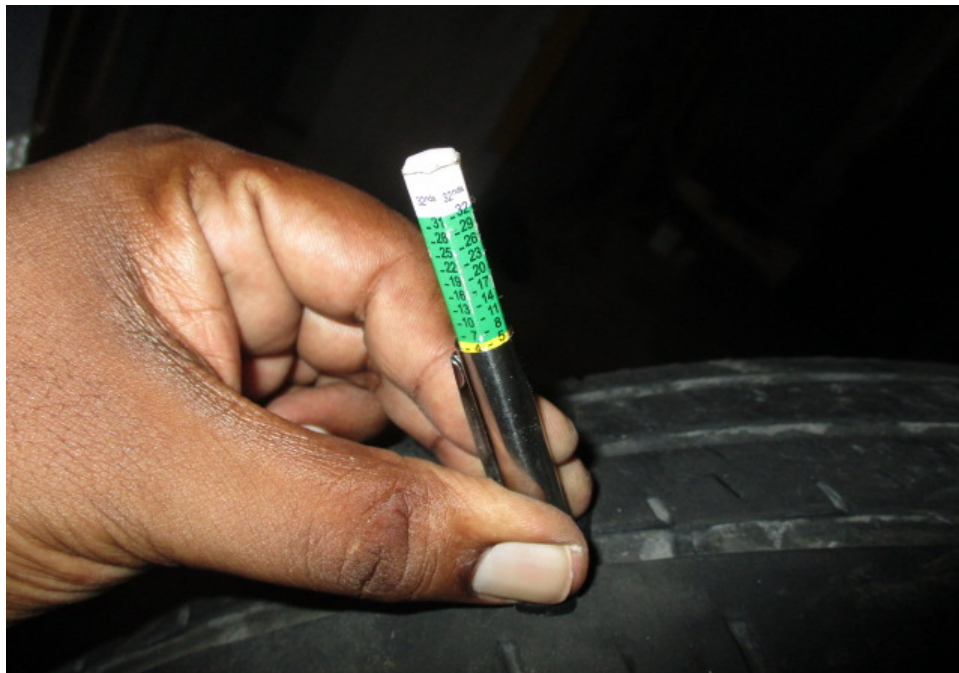
Photo 8 shows measurements being conducted on the remaining tread depth of the dislodged right front tyre of the Insured Vehicle. The remaining tread depth was measured to be approximately 4mm which is within the LTA requirements.

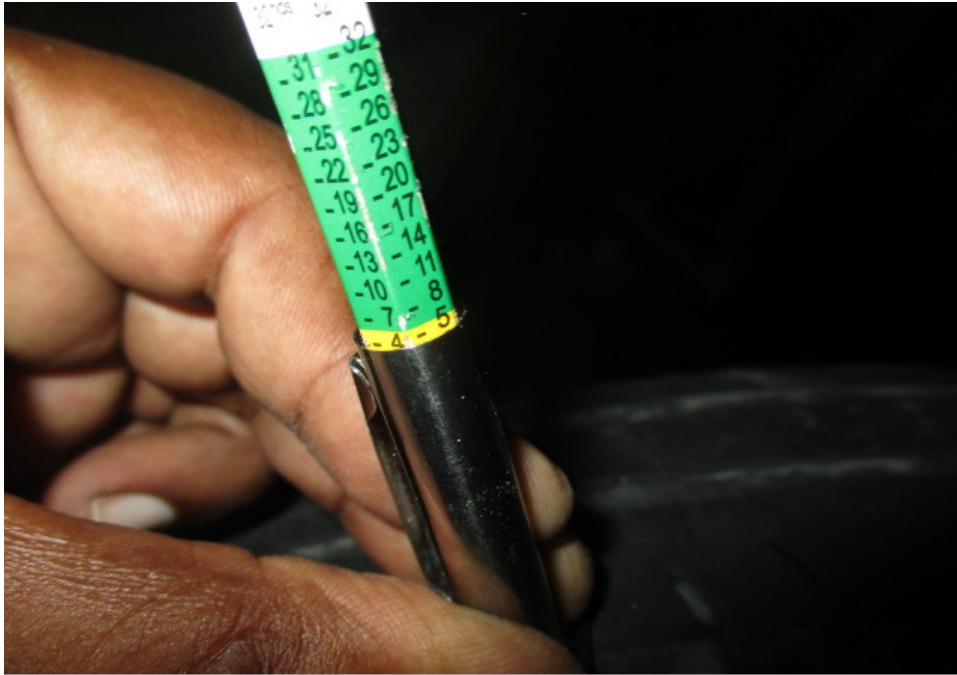
Photo 9 shows a close up view of the measurements being conducted on the remaining tread depth of the dislodged right front tyre of the Insured Vehicle. The remaining tread depth at the outer side of the right front tyre was measured to be approximately 4mm.

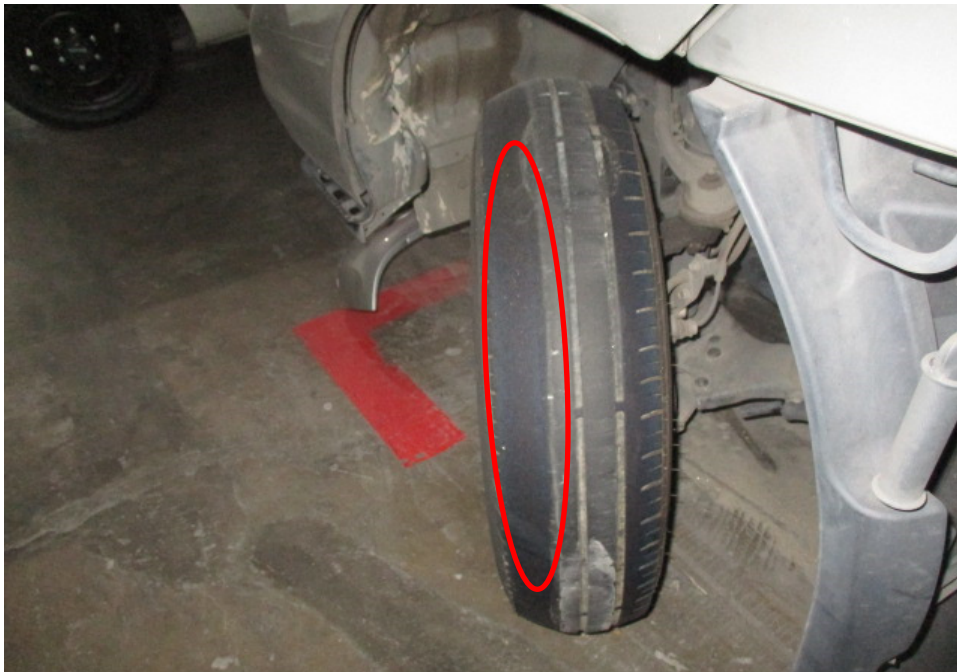
8. Upon examination of the left front tyre of the Insured Vehicle, we had observed that the rubber at the outer side of the tread was partially worn. The pattern at some areas at the outer side of the tread was vaguely visible due to worn rubber however the reinforcing belts that are found within the tyre were not exposed at the time of our inspection. The pattern at the outer side of the tread was also observed to be flushed with the tyre wear indicator. The areas at the outer tread with pattern worn was measured to be approximately 0.0 and 0.2mm which not within the LTA requirements. The pattern at the inner side of the tread was still visible and measured to be approximately 2mm. See photos 6 - 17 below.

Photo 10 shows the left front tyre of the Insured Vehicle at the time of our inspection. The rubber at the outer side of the tread was partially worn (circled). The pattern at some areas on the outer side of the tread was vaguely visible due to worn rubber however the reinforcing belts that are found within the tyre were not exposed at the time of our inspection.

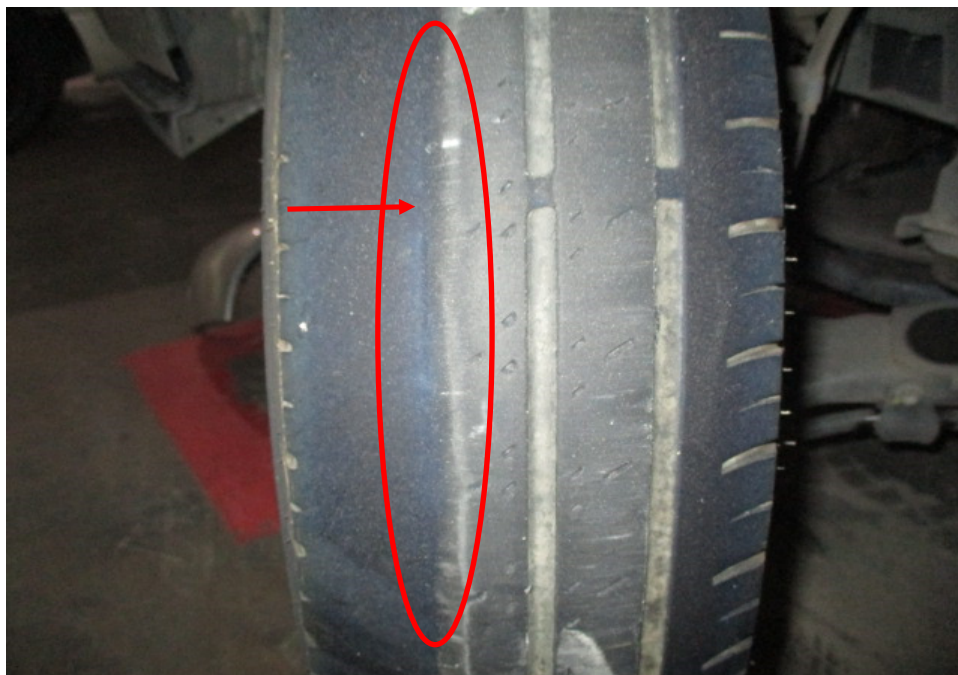
Photo 11 shows a close up view of the left front tyre of the Insured Vehicle at the time of our inspection. The rubber at the outer side of the tread was partially worn (circled). The pattern at the outer side of the tread was also observed to be flushed with the tyre wear indicator (arrowed).

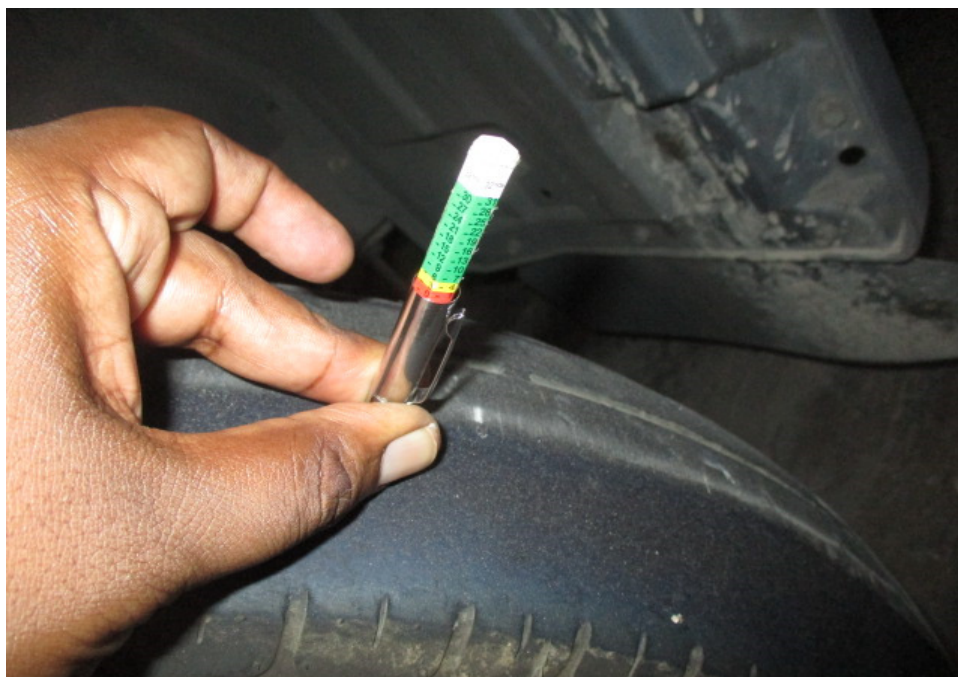
Photo 12 shows measurements being conducted on the remaining tread depth of the left front tyre of the Insured Vehicle. The remaining tread depth was measured to be approximately 0.0mm and 0.2mm which is not within the LTA requirements.

10. However, we are in view that the condition of the left front tyre of the Insured Vehicle was not within the requirements of SECTION 109(f) CAP 276 of THE MOTOR VEHICLES (CONSTRUCTION AND USE) RULES, 1974, 1978 OF THE ROAD TRAFFIC ACT. Under this section it states that "no person shall use, or cause or permit to be used on a road any motor vehicle or trailer, a wheel of which is fitted with a pneumatic tyre, where the tyre is fitted to the wheel of any other motor vehicle or any trailer, the tread pattern (excluding any tie-bar) of the tyre does not have a depth of at least one millimetre throughout at least 75% of the breadth of the tread and round the entire outer circumference of the tyre and the rear left inner tyre tread depth was observed to be at 0mm.

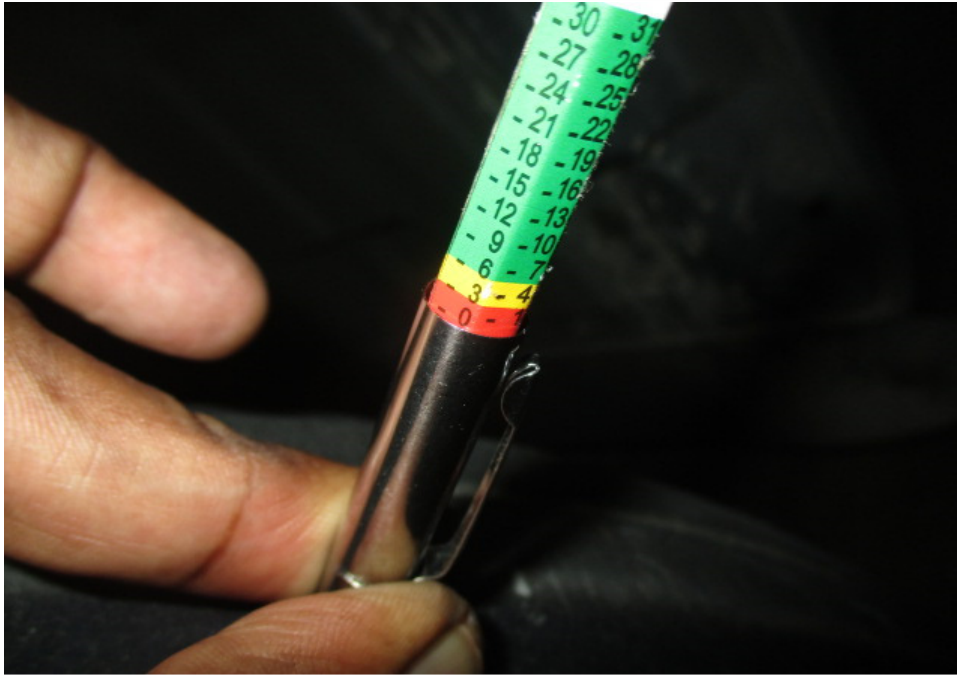
Photo 13 shows a close up view of the measurements being conducted on the remaining tread depth of the left front tyre of the Insured Vehicle. The remaining tread depth at the outer side of the left front tyre was measured to be approximately 0.0mm and 0.2mm which is not within the LTA requirements.

16. In general, having physically inspected the Insured Vehicle and also having considered the nature of the incident, we are of the view that the condition of the left front tyre of the Insured Vehicle could have possibly contributed to the incident on 13 July 2024. The left front tyre of the Insured Vehicle also does not comply with the requirements of SECTION 109(f) CAP 276 of THE MOTOR VEHICLES (CONSTRUCTION AND USE) RULES, 1974, 1978 OF THE ROAD TRAFFIC ACT.

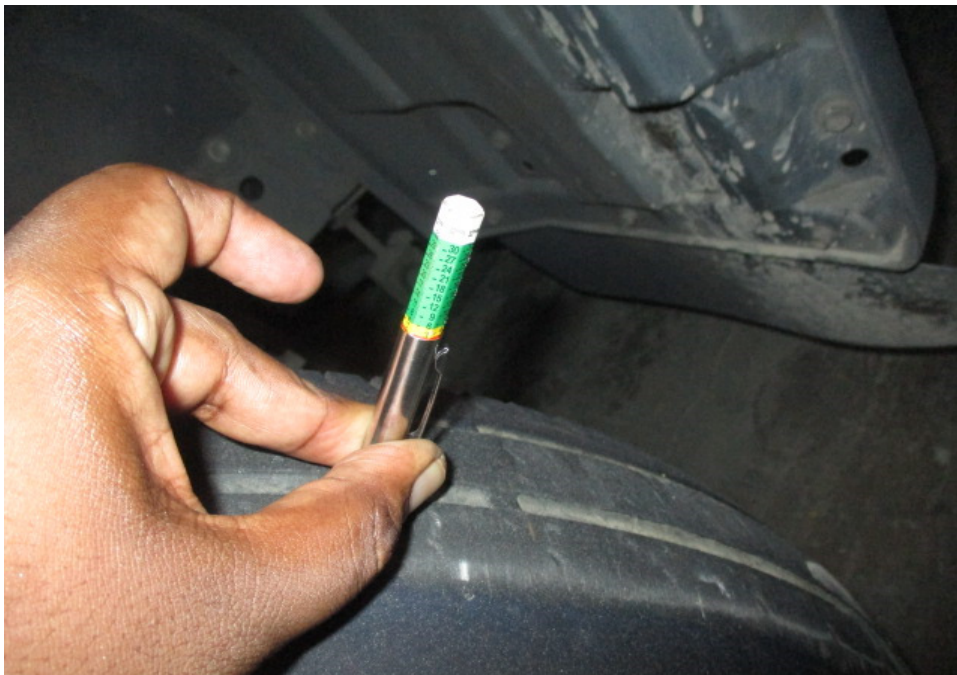
Photo 14 shows measurements being conducted on the remaining tread depth of the left front tyre of the Insured Vehicle. The remaining tread depth at the centre of the left front tyre was measured to be approximately 2mm.

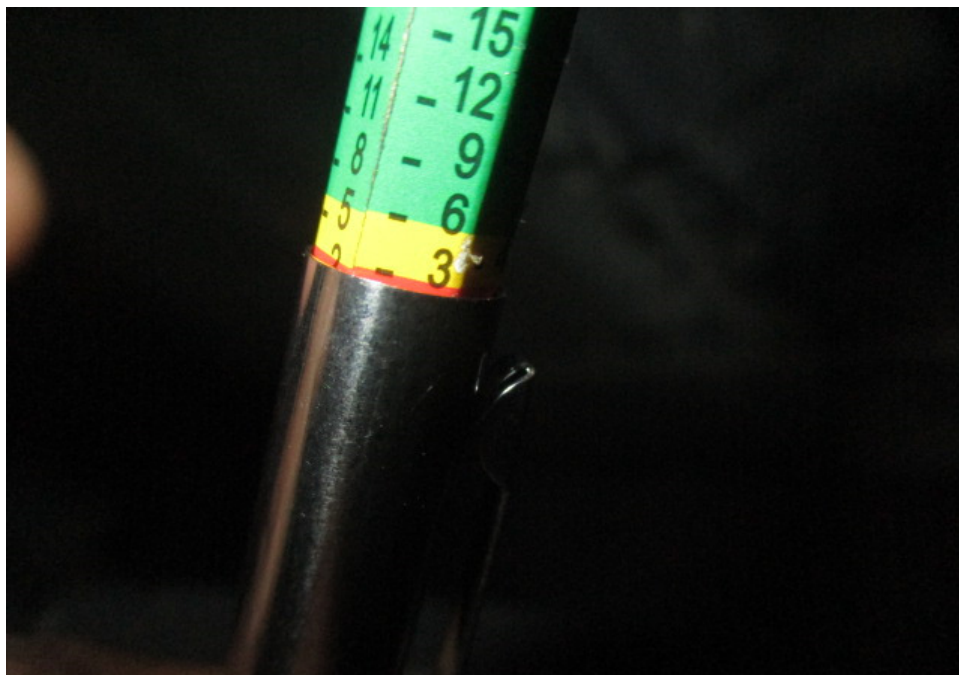
Photo 15 shows a close up view of the measurements being conducted on the remaining tread depth of the left front tyre of the Insured Vehicle. The remaining tread depth at the centre of the left front tyre was measured to be approximately 2mm.

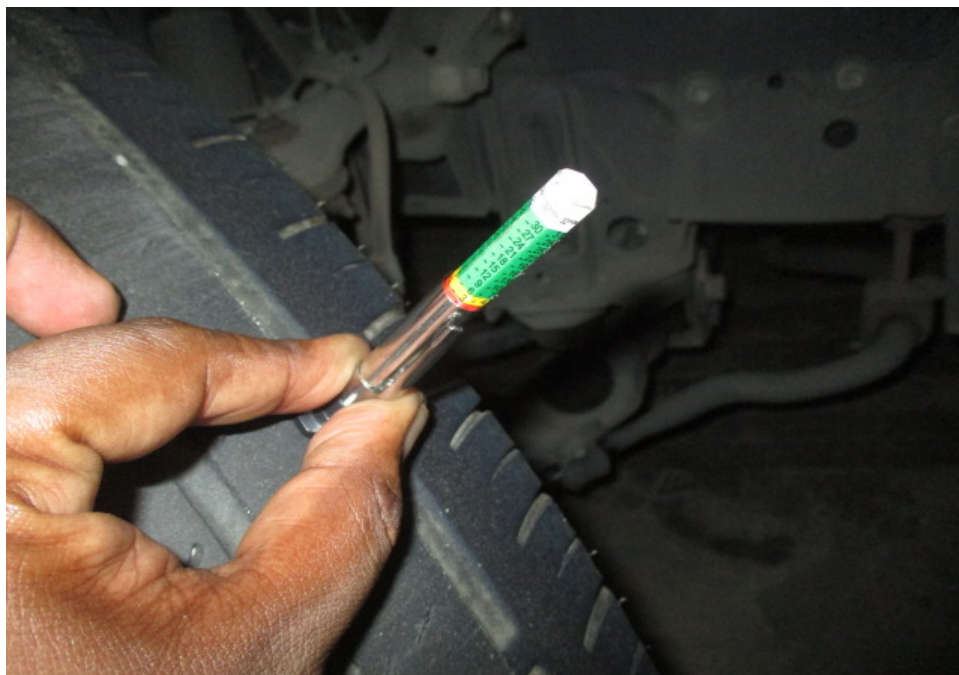
Photo 16 shows measurements being conducted on the remaining tread depth of the left front tyre of the Insured Vehicle. The remaining tread depth at the inner side of the left front tyre was measured to be approximately 2mm.

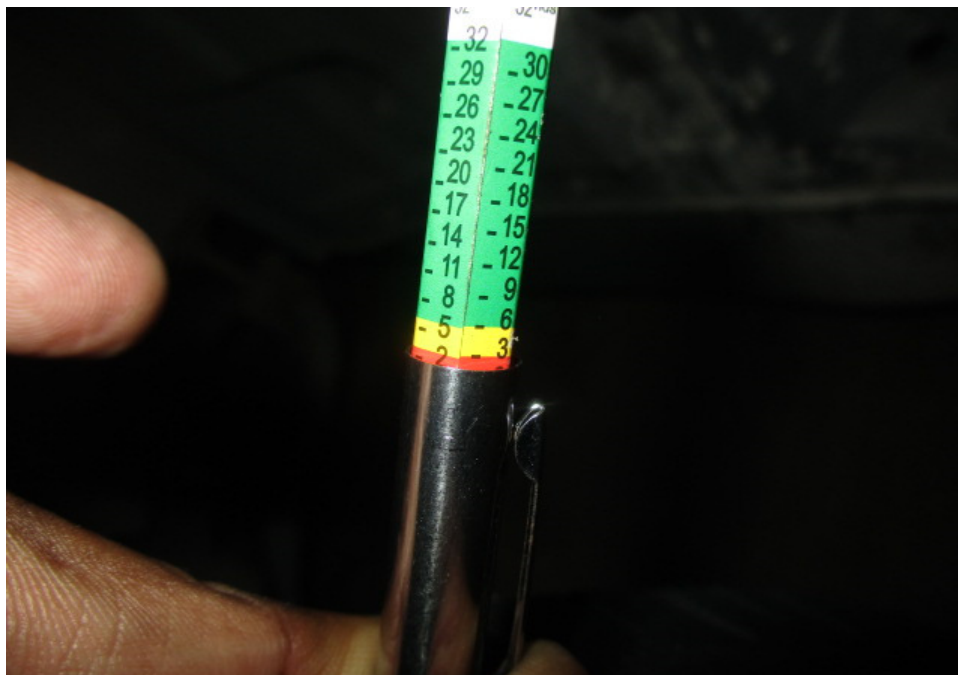
Photo 17 shows a close up view of the measurements being conducted on the remaining tread depth of the left front tyre of the Insured Vehicle. The remaining tread depth at the inner side of the left front tyre was measured to be approximately 2mm.
