Final repair bill for FBC7315G HONDA CB400

VEHICLE INSPECTION REPORT

Ref. no.	: TLA/2023/08/011	3rd party Veh.	: SHA8282A
Accident on	: 19 Jul 2023	Claim tyre	: Third Party
Assign on	: 08 Aug 2023	Claim number	: To be advice
Inspection on	: 08 Aug 2023	Policy number	: To be advice
Workshop name	: MY BIKE GARAGE PTE LTD	Finalize on	: 28 Dec 2023
Inspection at	: 48 Toh Guan Road East #02-126 Enterprise Hub Singapore 608586	Final report on	: 02 Jan 2024

Vehicle number	: FBC7315G	Registration date	: 20 Jun 2008
Make	: HONDA	Chassis number	: JH2NC42998M000056
Model	: CB400	Engine number	: NC42E1003016
Body colour	: BLACK	Engine capacity	: 399 CC
Odometer	: LOW BATT	Transmission	: AUTOMATIC

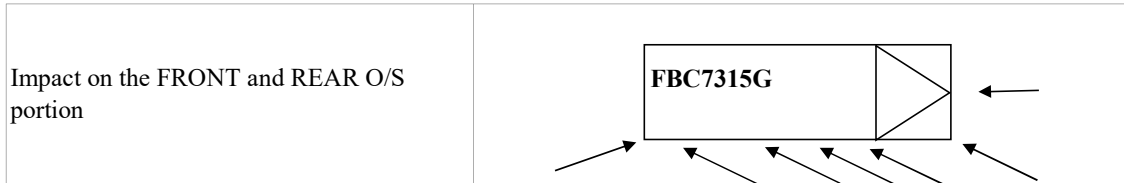
POINT OF IMPACT

The impact of the collision has damaged/affected the front mudguard, front rim assy, both front fork assy, steering assy, front foot rest assy, rear footrest assy, handlebar assy, seat assy, rear fairing, head lamp assy, rear exhaust pipe assy and etc...
