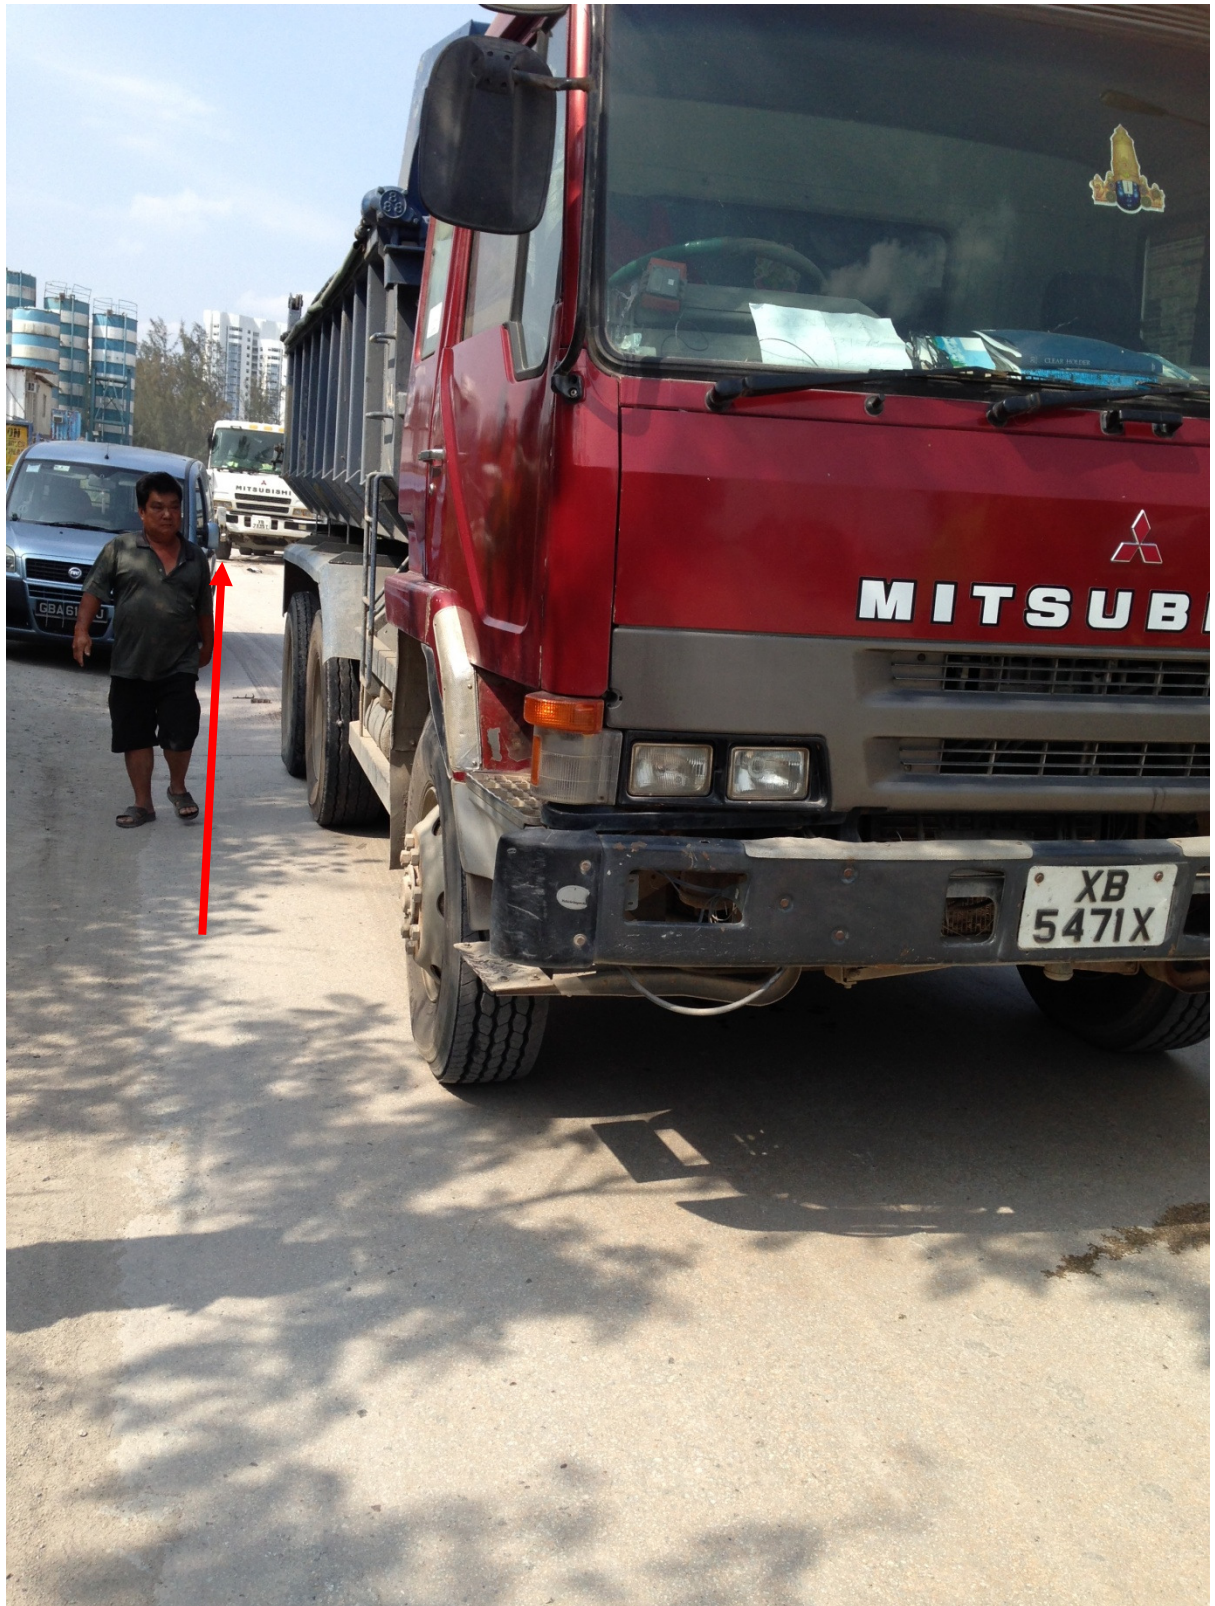
Figure-1

- Refer the **Figure-1**, the opponent lorry hit with our lorry at right side back tire barrier.

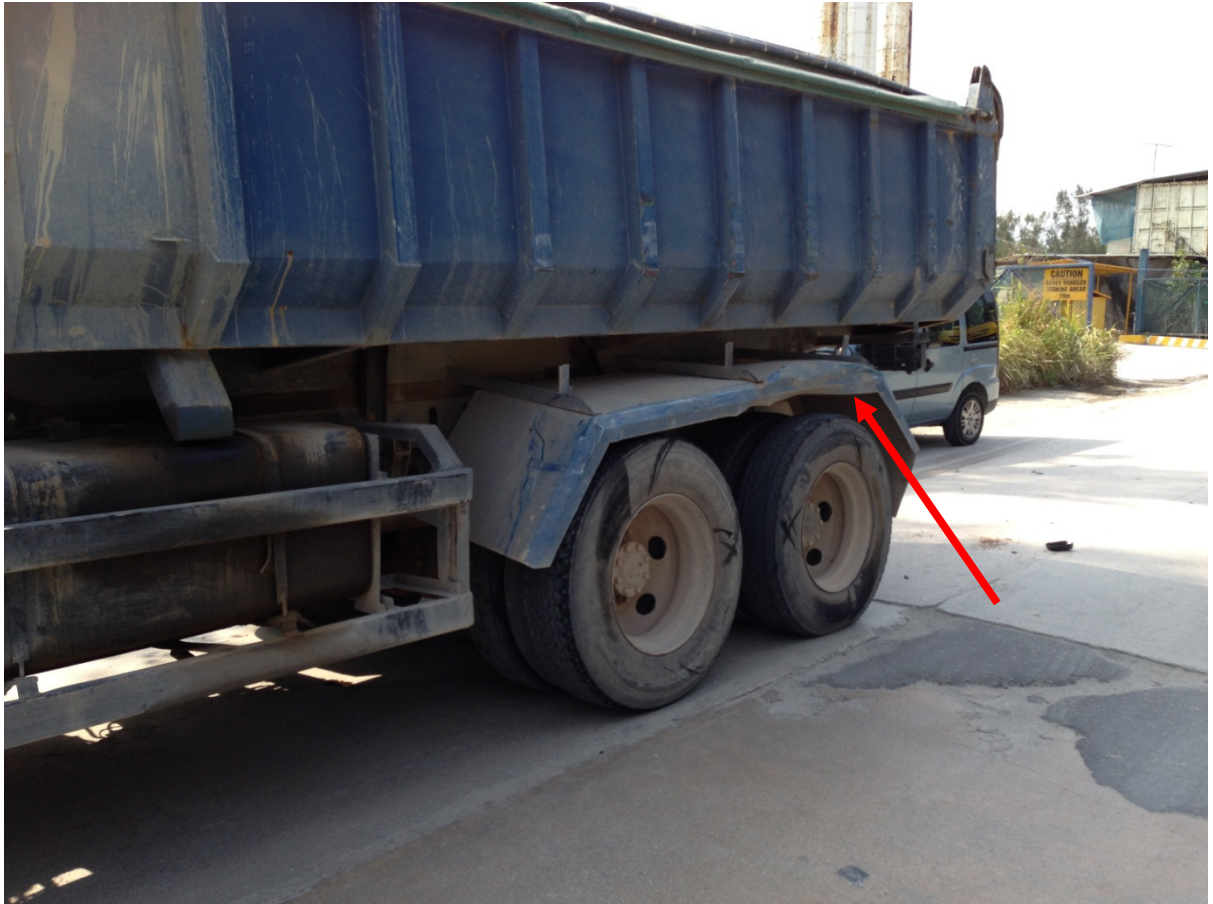
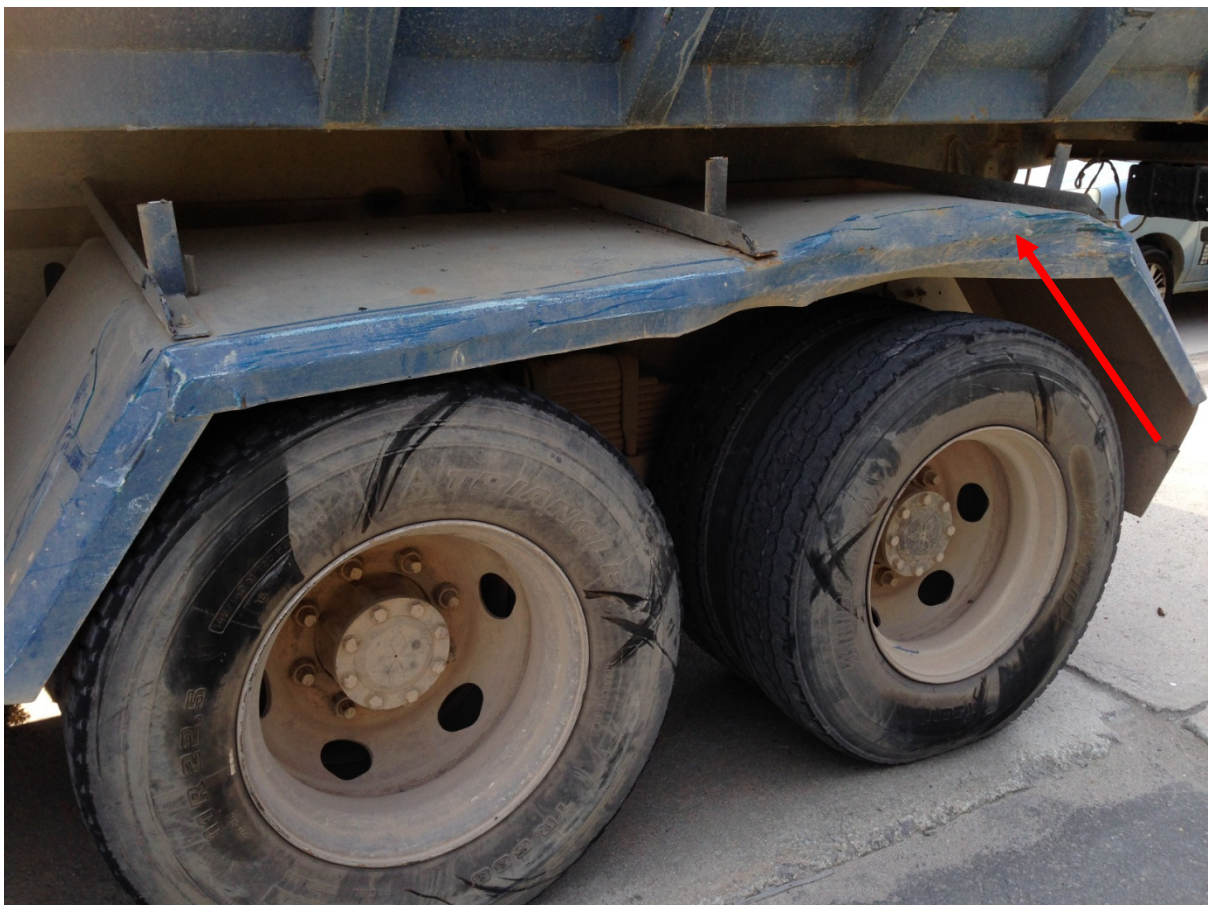
- The lorry **XB7335T** DID NOT signal and suddenly turned right side without watching the behind the our lorry from the right side road.
- When our lorry **XB5471X** going towards to next site, the opponent lorry HIT our lorry's **left side BACK Tire barrier** (refer **Figure-2**)

Figure-2 The opponent lorry hit into our lorry at back tire barrier when suddenly turned right from the left side after waiting (as indicated below)

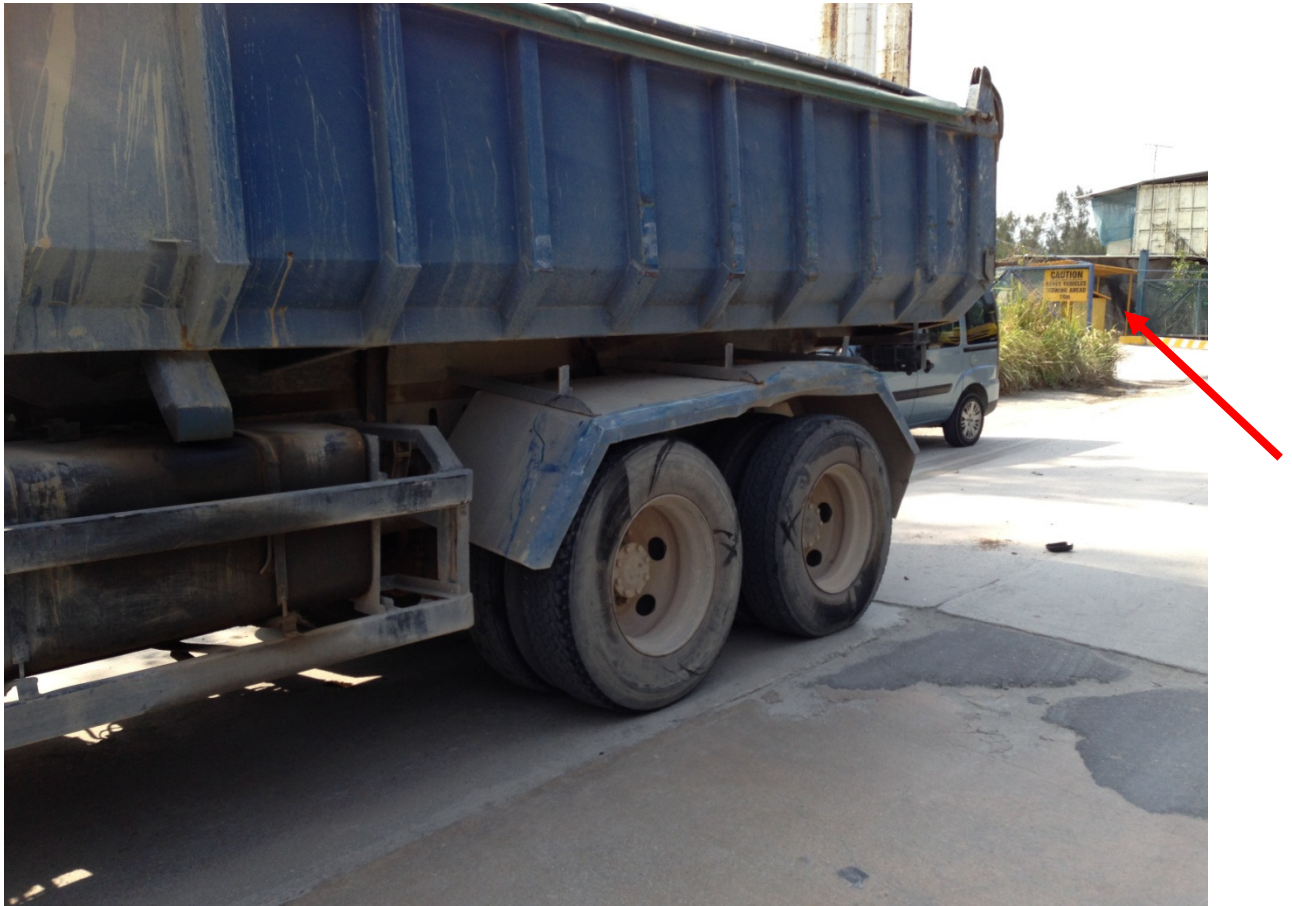
**Figure-3** : The opponent lorry **XB7335T** trying to turn right and enter into the site at the time of accident

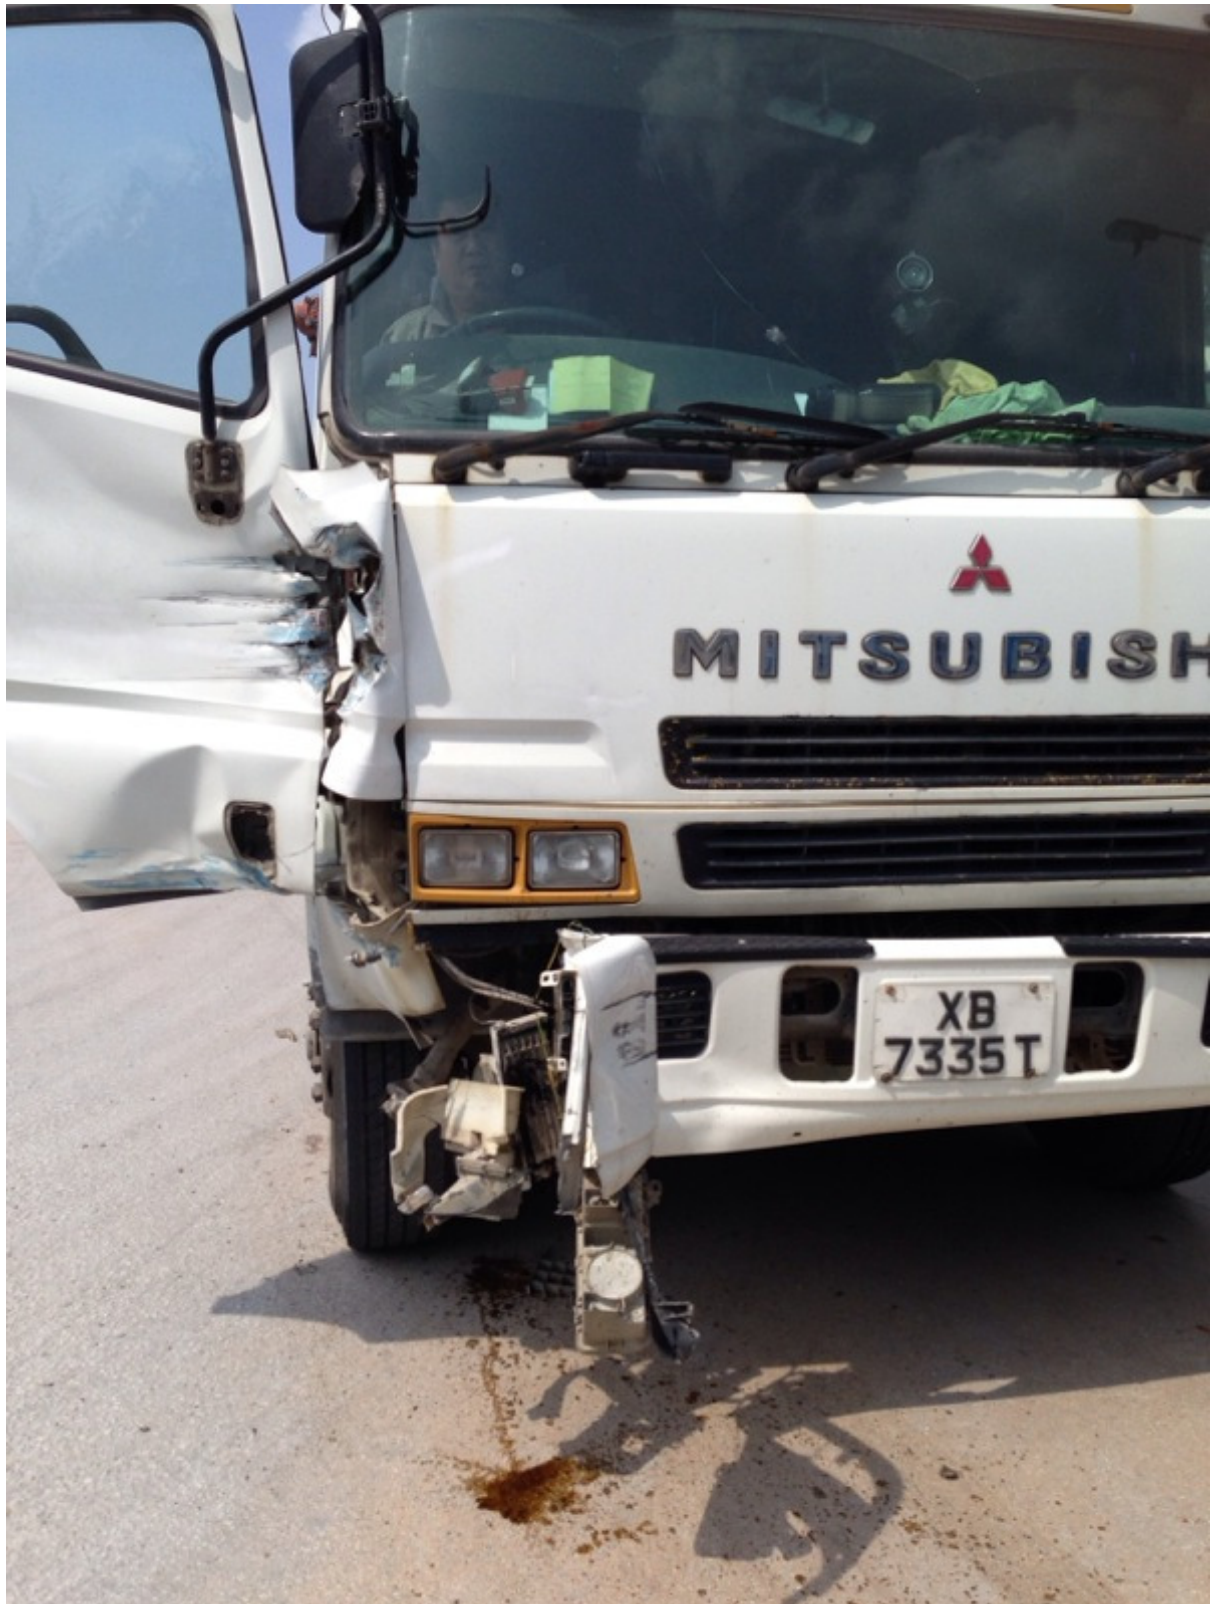
**Figure-4** : The opponent lorry damaged after hit into our lorry behind while turning right into LTA site after waiting in road side
