**Preliminary Advice**

| Vehicle No | : SGG161Z | Accident Date | : 27/07/2016 |
| Make | : VOLKSWAGEN JETTA | Policy No. | : A27158598QMY |

The vehicle sustained impact / damages front o/s portion and parts claimed are consistent to the accident.

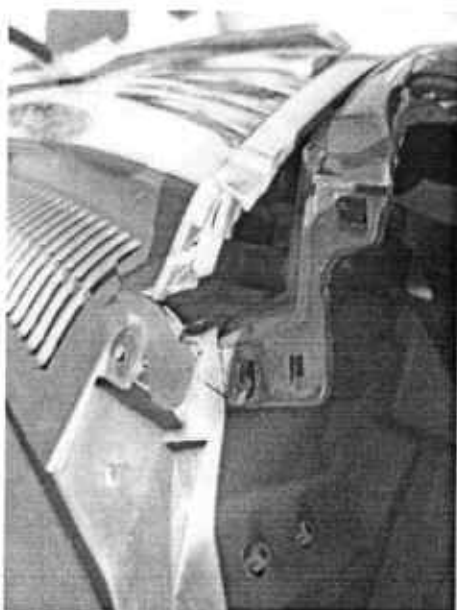
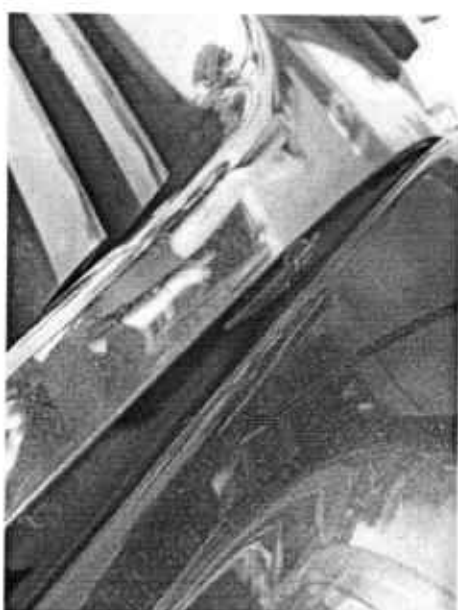
- Based on the photographs taken, the front grille base was cracked, front grille chrome frame and front grille chrome stripe was with deformation due to the impact. As for the front logo & old grille base clips it is necessary to be replaced when the front grille is being replaced.
- Labour was given \$1000 to replace front bumper, front bumper <sup>and</sup> front RH fender, and to repair the front RH fender inner panel and front RH door which was affected due to the accident.

Front grille chrome stripe crack

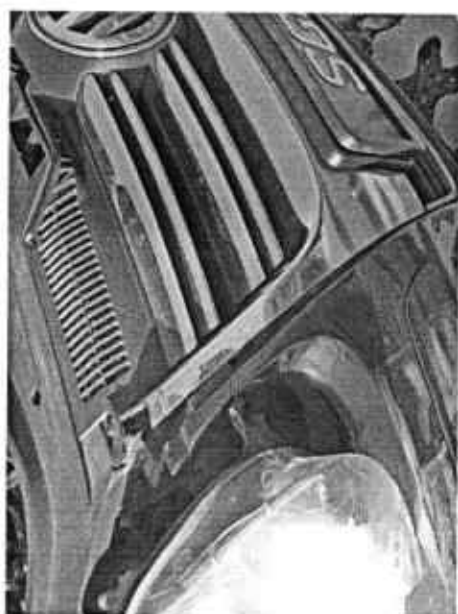
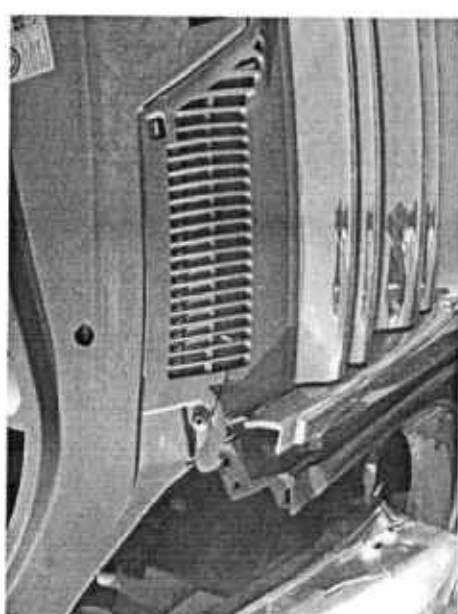
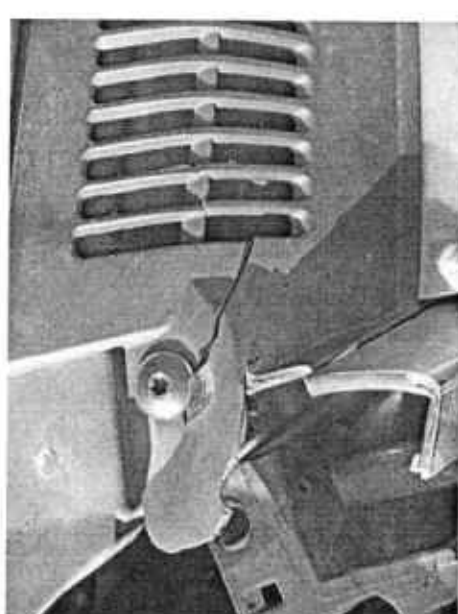
Front grille base crack.

| No. | Qty | Part No. | Particulars | Condition | Repairer's | Amount |
|---|---|---|---|---|---|---|
| 16 | 1 | | *FRT GRILLE BASE (WCP) | Cracked | 169.50 F | *169.50 F |
