Ref : CC3/CTI17003784/K1ha3q2

### 1. Policy Particulars :- THIRD PARTY CLAIM

## ADJUSTMENT ON REPAIR COST FOR VEHICLE NO. SHB 429S

PHOTOGRAPHS FOR VEHICLE NO. SHB 429S

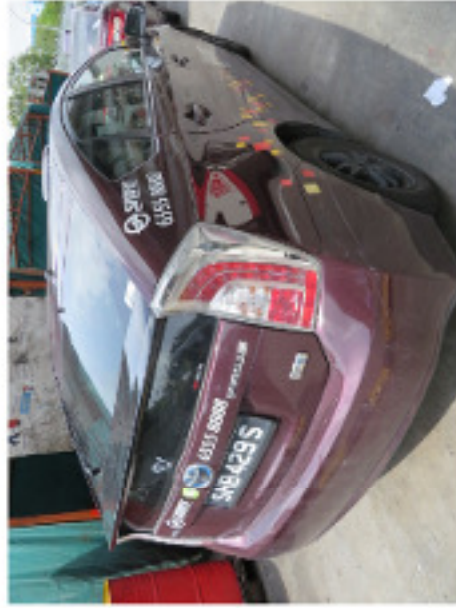
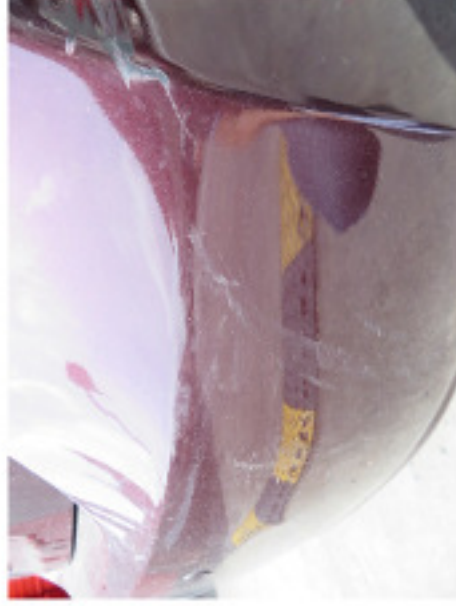
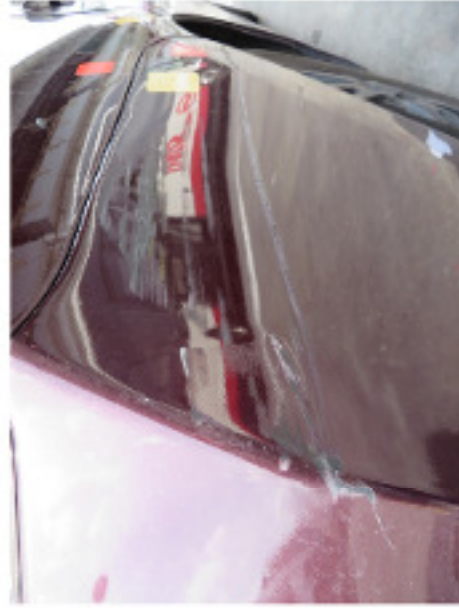
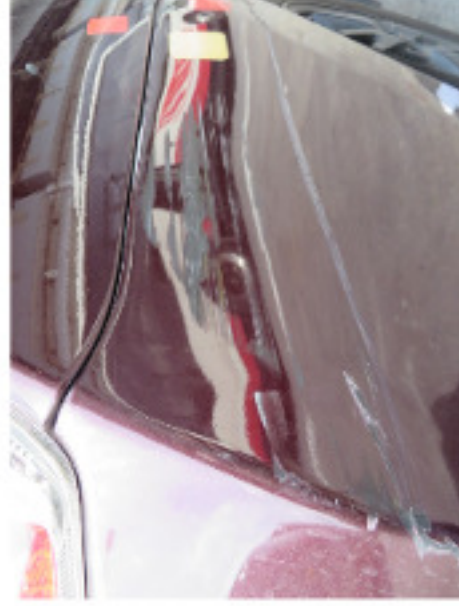
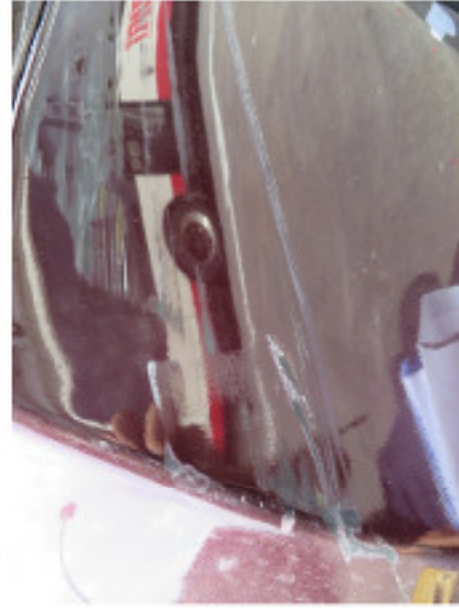
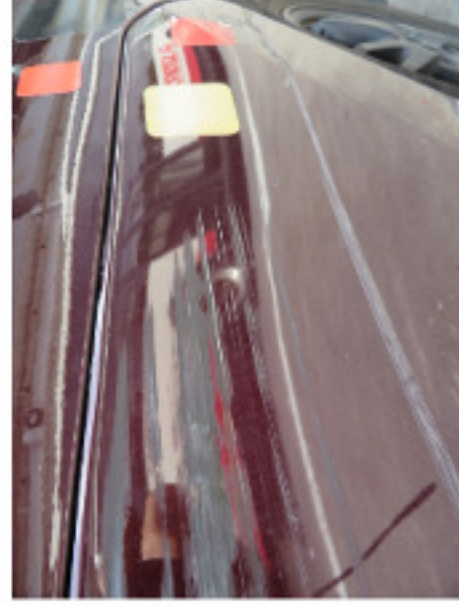
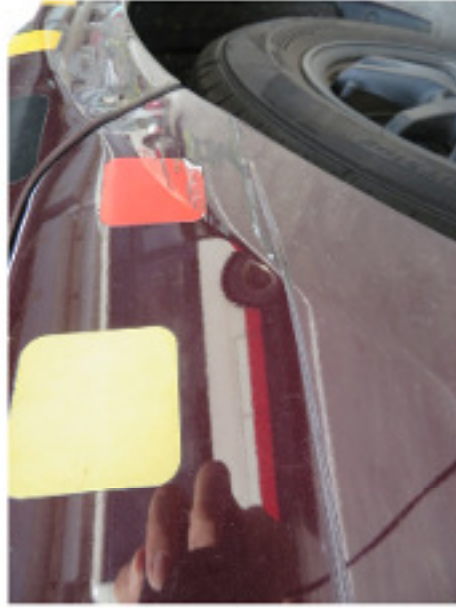
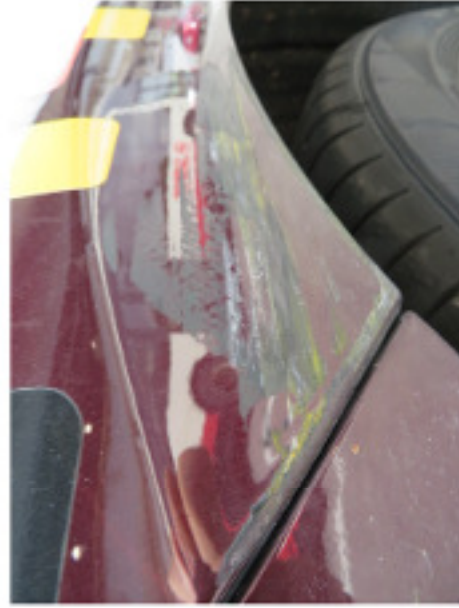
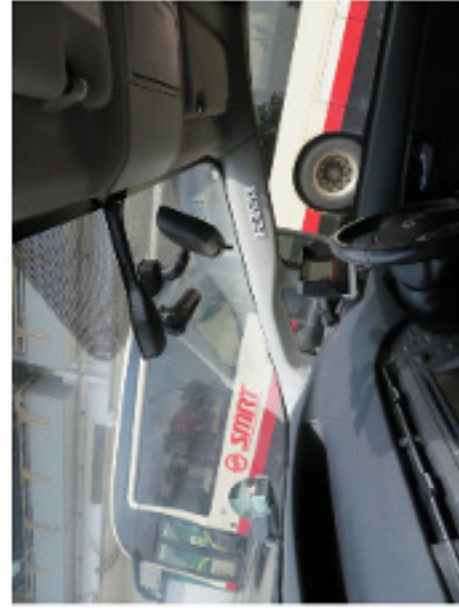
THE VEHICLE SUSTAINED DAMAGES AT THE O/S REAR PORTION. DAMAGES SEE DETAILS.
--

PANEL BEATING & BODY WORK.INCLUSIVE OF THE REPAIR OF BUMPER REAR AND FENDER RR/RH.			845.00	200.00
SPRAY PAINT.			936.00	400.00
TO CHECK WIRING AND SYSTEM FUNCTION .			80.00	20.00
TO APPLY RUST-PROOFING ON AFFECTED AREA.		NOT NECESSARY	100.00	-
TO REMOVE & REFIT REAR QUARTER GLASS RH .		NOT NECESSARY	120.00	-
TO TEST AND REFIX REVERSE SENSOR SYSTEM.		NOT NECESSARY	120.00	-
TO DO WHEEL ALIGNMENT /TYRE BALANCING .		NOT NECESSARY	120.00	-
